Facility: **WOMENS INFANTS & CHILDREN**

Address: 330 HARRIS ST.

Facility: **LEMORE HEALTH CLINIC**
 Address: 229 C ST.

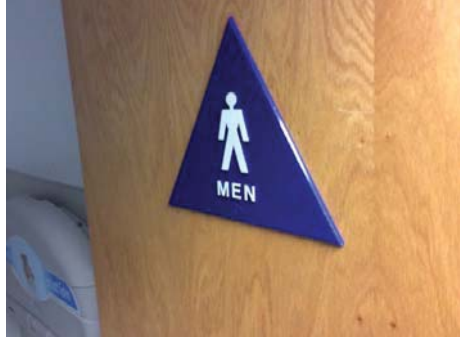
Item No. and Name	Existing Architectural Barrier and Proposed Solution	Codes / Mitigation Info	Qty	Unit	Cost	Total
Signage						
4402	<ul style="list-style-type: none"> <i>As-Built Description:</i> Entrance to wheelchair accessible toilet or bathing facility not identified with the International Symbol of Accessibility when not all are accessible. <i>Proposed Solution:</i> Provide sanitary facility sign that shows the international symbol. 	PCODE SA11 ADAAG 4.1.2(7)(d) ADA 2010 216.8 CBC 2010 1117B.5.8.1.2 CBC 2013 11B-216.8 Priority 3 Severity 3 FY 22-23 Maintenance Work	1	JOB	\$90	\$90

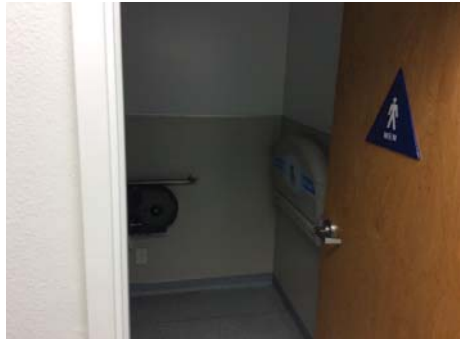
4401	<ul style="list-style-type: none"> <i>As-Built Description:</i> Entrance to toilet or bathing facility not identified with ADAAG compliant signage. <i>Proposed Solution:</i> Provide ADAAG compliant sign mounted 5' high on center on nearest adjacent wall, on latch side if a single door (located not to cause a Braille reader to stand within the door swing). 	PCODE SA11A ADAAG 4.1.3(16)(a) ADA 2010 216.8 CBC 2013 11B-216.8 Priority 3 Severity 3 FY 22-23 Maintenance Work	1	JOB	\$90	\$90

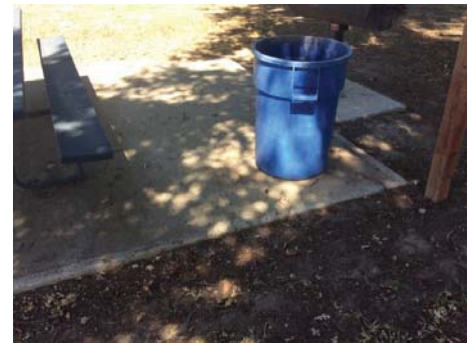
4941	<ul style="list-style-type: none"> <i>As-Built Description:</i> Walk: Pavement dislocation creates abrupt change in level exceeding 1/2" in accessible route. <i>As-Built:</i> 1"-4" <i>Proposed Solution:</i> Remove, replace or repair area of pavement sufficient to correct abrupt change in level. 	PCODE EF03REF				
		ADAAG 4.3.8				
		ADA 2010 403.4				
		CBC 2010 1133B.7.4				
		CBC 2013 11B-403.4				
		Priority 2 Severity 2 FY 23-24 Contract Work

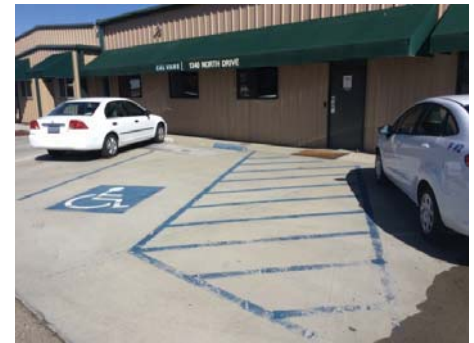
3571	<ul style="list-style-type: none"> As-Built Description: Sign for accessible parking space is missing or non-compliant. Proposed Solution: Provide compliant parking signage. Notes: 12 to 1 Acc. 	PCODE EA04B ADAAG 4.6.4 ADA 2010 502.6 CBC 2010 1129B.4 CBC 2013 11B-502.6 Priority 1 Severity 4 FY 24-25 Maintenance Work	1	JOB	\$315	\$315
------	---	---	---	-----	-------	-------

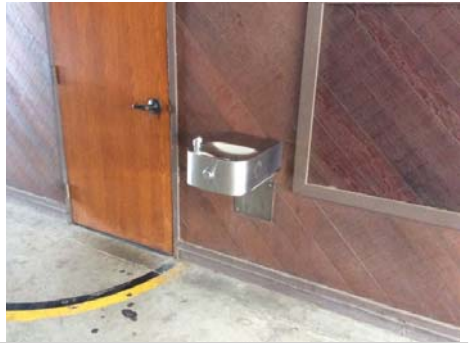
511	<ul style="list-style-type: none"> As-Built Description: Where only one drinking fountain is provided per floor: Fountain is not accessible to individuals who use wheelchairs, or to those who have difficulty bending or stooping. Proposed Solution: Relocate and provide additional fountain or hi-lo combination fountain. 	PCODE IA01A ADAAG 4.1.3(10)(a) ADA 2010 211.1 CBC 2010 1115B.4.6.1 CBC 2013 11B-211.1 Priority 3 Severity 2 FY 25-26 Contract Work	1	JOB	\$2,000	\$2,000

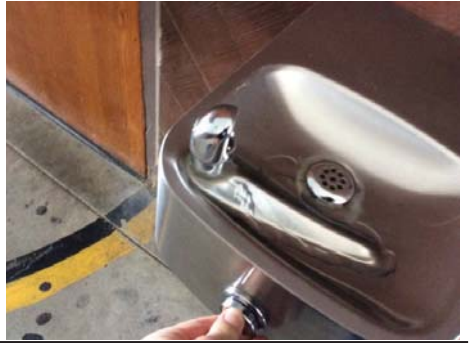
513	<ul style="list-style-type: none"> As-Built Description: Drinking fountain water flow less than 4" high; unit in good condition. As-Built: 0.25" Proposed Solution: Adjust water flow. 	PCODE IA03D ADAAG 4.15.3 ADA 2010 602.6 CBC 2010 1115B.4.6.5 CBC 2013 11B-602.6 Priority 3 Severity 1 FY 25-26 Contract Work	1	JOB	\$75	\$75

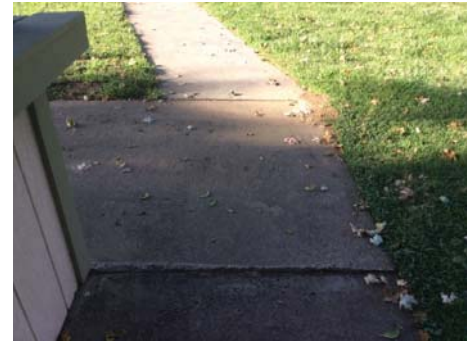
5035	<ul style="list-style-type: none"> <i>As-Built Description:</i> Walk: Pavement dislocation creates abrupt change in level exceeding 1/2" in accessible route. <i>As-Built:</i> 0.5-1" <i>Proposed Solution:</i> Remove, replace or repair area of pavement sufficient to correct abrupt change in level. 	PCODE EF03 ADAAG 4.3.8 ADA 2010 403.4 CBC 2010 1133B.7.4 CBC 2013 11B-403.4 Priority 2 Severity 4 FY 25-26 Contract Work	8	SF	\$21	\$168
------	---	---	---	----	------	-------

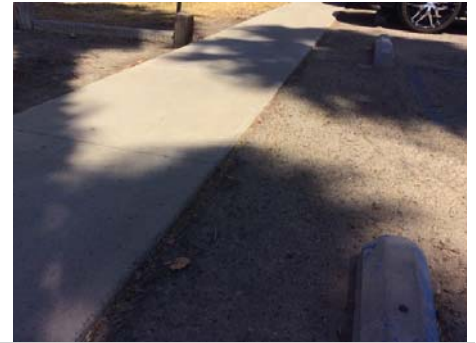
5012	<ul style="list-style-type: none"> <i>As-Built Description:</i> Walk: Pavement dislocation creates abrupt change in level exceeding 1/2" in accessible route. <i>As-Built:</i> 0.5"-1" change <i>Proposed Solution:</i> Remove, replace or repair area of pavement sufficient to correct abrupt change in level. 	<p>PCODE EF03REF ADAAG 4.3.8 ADA 2010 403.4 CBC 2010 1133B.7.4 CBC 2013 11B-403.4 Priority 1 Severity 4 TBD Contract Work</p>
------	---	--

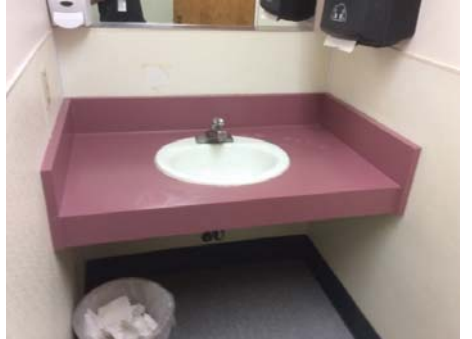
<u>Lavatory</u>						
4968	<ul style="list-style-type: none"> <i>As-Built Description:</i> Wheelchair clearance under lavatory apron or lavatory counter front edge less than 29" high. <i>As-Built:</i> 27.5" <i>Proposed Solution:</i> Provide new accessible lavatory. Remodel restroom as needed. 	PCODE WD03 ADAAG 4.19.2 ADA 2010 606.3 CBC 2010 1115B.4.3.3 CBC 2013 11B-606.3 Priority 4 Severity 2 TBD Contract Work	1	JOB	\$3,400	\$3,400

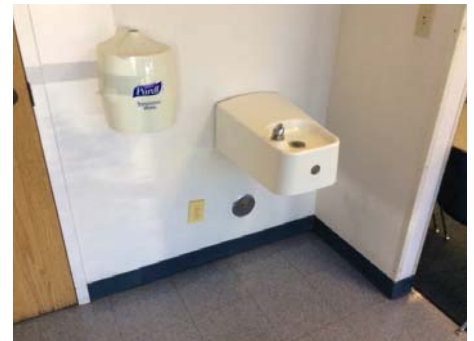
4257

- *As-Built Description:*
 Wall- and post-mounted cantilevered units: Knee space not provided at drinking fountain (27" high, 8" deep, 30" wide from front of drinking fountain). Unit in good condition.
- *As-Built:* 26.5"
- *Proposed Solution:*
 Remount fountain at accessible height.

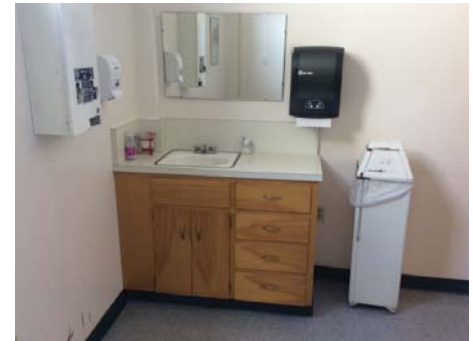
Restroom

4633 • *As-Built Description:*
 Single accommodation restroom not accessible; multiple compliance violations.

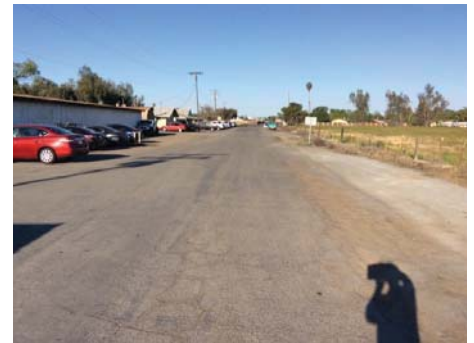
Changes in Level

- 2840
- As-Built Description:**
Walk: Pavement dislocation creates abrupt change in level exceeding 1/2" in accessible route.
 - As-Built:** 1"
 - Proposed Solution:**
Remove, replace or repair area of pavement sufficient to correct abrupt change in level.
 - Notes:**
Extend concrete to 18'

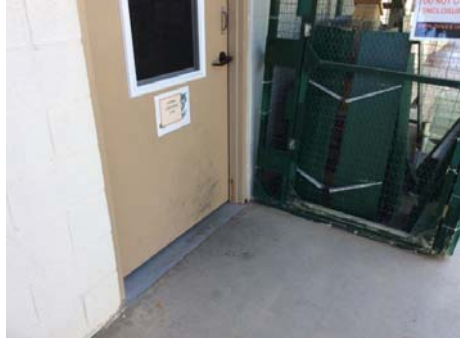
Door						
2883	<ul style="list-style-type: none"> As-Built Description: Surface of required maneuvering clearance at door slopes more than 1/4":12" (2.0%). As-Built: 5.9% Proposed Solution: Modify surface slope at door. 	PCODE ID11REF ADAAG 4.13.6 ADA 2010 404.2.4.4 CBC 2010 1133B.2.4 CBC 2013 11B-404.2.4 Priority 2 Severity 3 TBD Contract Work				
						REF

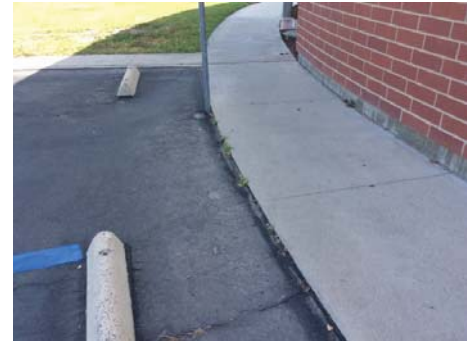
3705	<ul style="list-style-type: none"> <i>As-Built Description:</i> Walk: Pavement dislocation creates abrupt change in level exceeding 1/2" in accessible route. <i>As-Built:</i> 0.75" <i>Proposed Solution:</i> Remove, replace or repair area of pavement sufficient to correct abrupt change in level. 	PCODE EF03 ADAAG 4.3.8 ADA 2010 403.4 CBC 2010 1133B.7.4 CBC 2013 11B-403.4 Priority 1 Severity 4 TBD Contract Work	17	SF	\$21	\$357
------	--	--	----	----	------	--------------

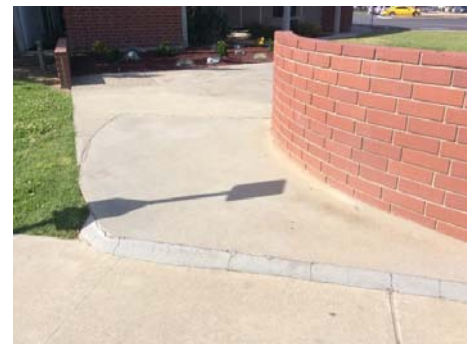
3708	<ul style="list-style-type: none"> <i>As-Built Description:</i> Walk: Pavement dislocation creates abrupt change in level exceeding 1/2" in accessible route. <i>As-Built:</i> 3" <i>Proposed Solution:</i> Remove, replace or repair area of pavement sufficient to correct abrupt change in level. 	PCODE EF03 ADAAG 4.3.8 ADA 2010 403.4 CBC 2010 1133B.7.4 CBC 2013 11B-403.4 Priority 1 Severity 1 TBD Contract Work	70	SF	\$21	\$1,470
------	---	--	----	----	------	----------------

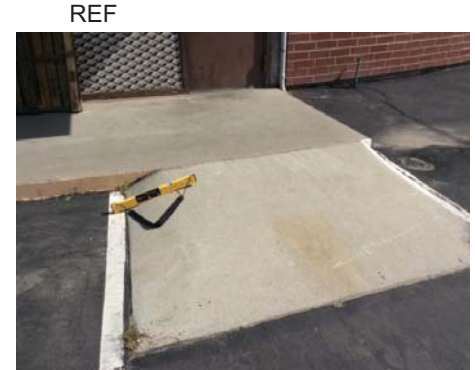
Item No. and Name	Existing Architectural Barrier and Proposed Solution	Codes / Mitigation Info	Qty	Unit	Cost	Total
3714	<ul style="list-style-type: none"> <i>As-Built Description:</i> Curb ramp: Side slopes more than 1:10 (10%). <i>As-Built:</i> 25-30% <i>Proposed Solution:</i> Modify curb ramp. Demolish side slopes and replace with 1:10 side slopes if 48" level top landing is provided. 	PCODE EH05AREF ADAAG 4.7.5 ADA 2010 406.3 CBC 2010 1127B.5.3 CBC 2013 11B-406.2.2 Priority 1 Severity 1 TBD Contract Work

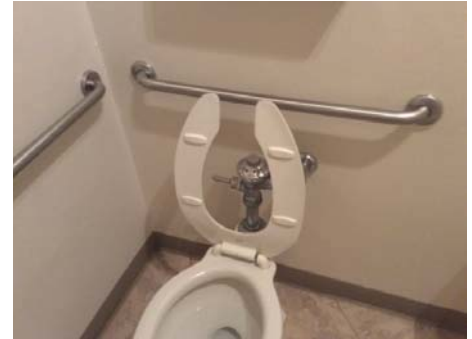
Item No. and Name	Existing Architectural Barrier and Proposed Solution	Codes / Mitigation Info	Qty	Unit	Cost	Total
3658	<ul style="list-style-type: none"> <i>As-Built Description:</i> Flush Control: Operating handle not mounted toward wide side of stall. <i>Proposed Solution:</i> Replace flush control with properly mounted accessible type, or install sensor flush. 	PCODE WB10 ADAAG 4.16.5 ADA 2010 604.6 CBC 2010 1115B.4.1.5 CBC 2013 11B-604.6 Priority 3 Severity 3 TBD Contract Work	1	JOB	\$500	\$500

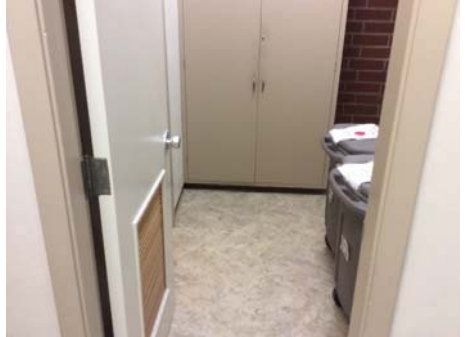
Item No. and Name	Existing Architectural Barrier and Proposed Solution	Codes / Mitigation Info	Qty	Unit	Cost	Total
<u>Restroom</u>						
3667	<ul style="list-style-type: none"> <i>As-Built Description:</i> Single accommodation restroom not accessible; multiple compliance violations. <i>Proposed Solution:</i> Remodel area to provide single-occupant accessible restroom. <i>Notes:</i> Demolish door frames and provide compliant restroom. 	PCODE WA01 ADAAG 4.22 ADA 2010 603 CBC 2010 1115B.3.2 CBC 2013 11B-603 Priority 3 Severity 2 TBD Contract Work	1	JOB	\$30,000	\$30,000

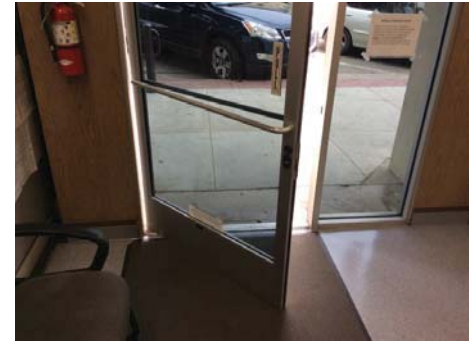
3808	<ul style="list-style-type: none"> As-Built Description: Door on accessible route has less than 32" clear and 80" (78" min. to closer if provided) opening width when 90° open. As-Built: Difficult to open 90 degrees Proposed Solution: Provide new, larger door and frame with new accessible hardware. Notes: change inside door sign to "push" 	PCODE ID01REF ADAAG 4.13.5 ADA 2010 404.2.3 CBC 2010 1133B.1.1.1.1 CBC 2013 11B-404.2.3 Priority 1 Severity 4 TBD Contract Work	REF			
------	---	--	-----	--	--	--

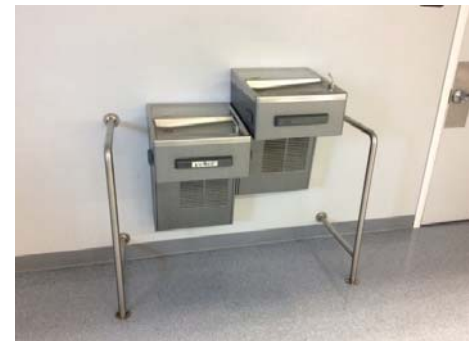
3812	<ul style="list-style-type: none"> As-Built Description: Wall- and post-mounted cantilevered units: Knee space not provided at drinking fountain (27" high, 8" deep, 30" wide from front of drinking fountain). Unit in good condition. As-Built: 26.5" high knee space Proposed Solution: Remount fountain at accessible height. 	PCODE IA02A ADAAG 4.15.5(1) ADA 2010 602.2 CBC 2010 1115B.4.6.2 CBC 2013 11B-602.2 Priority 3 Severity 2 TBD Contract Work	1	JOB	\$1,200	\$1,200
------	---	---	---	-----	---------	---------

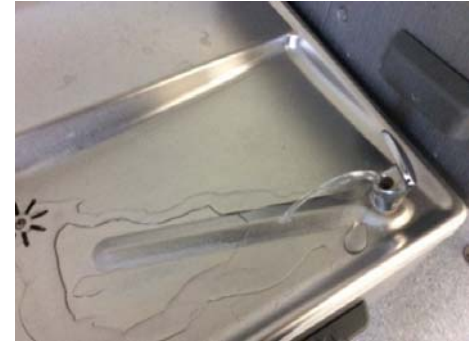
Item No. and Name	Existing Architectural Barrier and Proposed Solution	Codes / Mitigation Info	Qty	Unit	Cost	Total
3827	<ul style="list-style-type: none"> • <i>As-Built Description:</i> Drinking fountain water flow less than 4" high; unit in good condition. • <i>As-Built:</i> 1" • <i>Proposed Solution:</i> Adjust water flow. 	<p>PCODE IA03D ADAAG 4.15.3 ADA 2010 602.6 CBC 2010 1115B.4.6.5 CBC 2013 11B-602.6 Priority 3 Severity 3 TBD Contract Work</p>	1	JOB	\$75	\$75

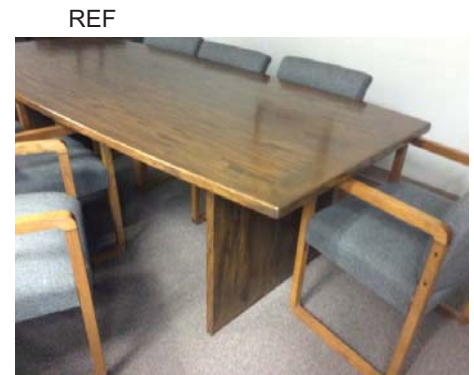
3877	<ul style="list-style-type: none"> As-Built Description: Recommended only: Accessible non-fixed table or desk (top 28" to 34" high; knee space at least 27" high x 19" deep x 30" wide) not provided. As-Built: End is 12" deep. No clearance at sides Proposed Solution: Provide table or desk with accessible dimensions when purchasing new furniture. Notes: Relocate chairs and slide table over to allow side access when needed. 	<p>PCODE IN02AREF ADAAG 4.32.3 & .4 ADA 2010 306.1 CBC 2010 1122B.3 & 4 CBC 2013 11B-306.1 & 11B-902.3 Priority 2 Severity 2 TBD Contract Work</p>				
------	--	---	--	--	--	--

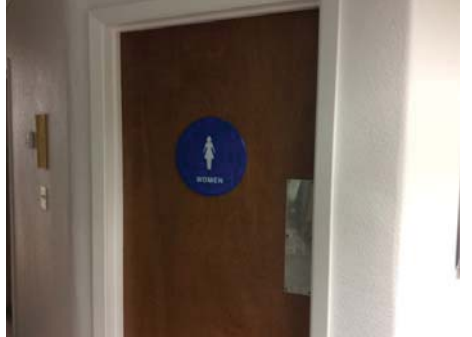
Item No. and Name	Existing Architectural Barrier and Proposed Solution	Codes / Mitigation Info	Qty	Unit	Cost	Total
<u>Restroom</u>						
3886	<ul style="list-style-type: none"> <i>As-Built Description:</i> Multiple accommodation restroom not accessible; multiple compliance violations. <i>Proposed Solution:</i> Remodel area to provide accessible restroom with one accessible stall, lavatory (and one urinal at Mens). <i>Notes:</i> Interim solution provide directional sign to Acc. JTO RRs 	PCODE WA01A ADAAG 4.22 ADA 2010 603 CBC 2010 1115B.3.1 CBC 2013 11B-603 Priority 3 Severity 1 TBD Contract Work	1	JOB	\$35,000	\$35,000

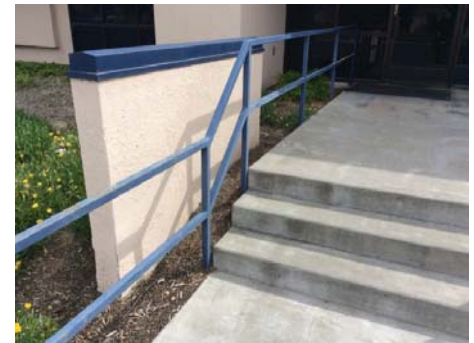
3794	<ul style="list-style-type: none"> <i>As-Built Description:</i> Handrail gripping surface top not mounted between 34" and 38" above ramp surface or stair nosings. <i>As-Built:</i> 30"-33" <i>Proposed Solution:</i> Remove existing and provide new handrail. 	PCODE ED02 ADAAG 4.9.4(5) ADA 2010 505.4 CBC 2010 1133B.4.2.1 & CBC 2013 11B-505.4 Priority 4 Severity 3 TBD Contract Work	12	LF	\$75	\$900
------	--	---	----	----	------	-------

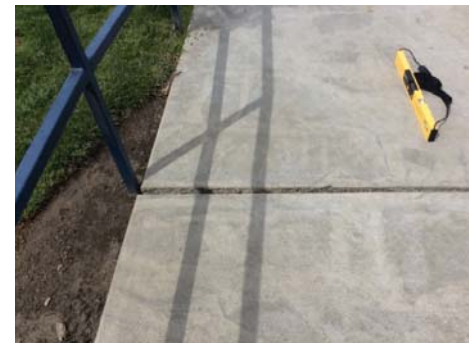
3798	<ul style="list-style-type: none"> <i>As-Built Description:</i> Ramp: Pavement dislocation creates abrupt change in level exceeding 1/2" in ramp. <i>As-Built:</i> 0.75" <i>Proposed Solution:</i> Remove, replace or repair area of pavement sufficient to correct abrupt change in level. 	PCODE EB04REF ADAAG 4.5.2 ADA 2010 303.4 CBC 2010 1133B.7.1 CBC 2013 11B-405.4 Priority 1 Severity 4 TBD Contract Work	REF			
------	--	---	-----	--	--	--

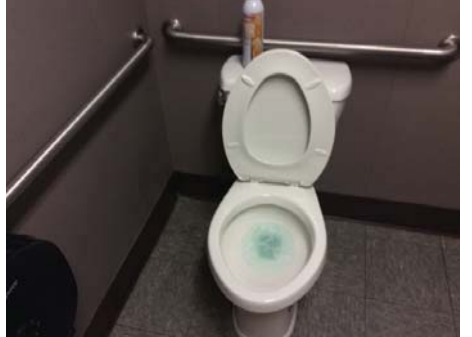
Item No. and Name	Existing Architectural Barrier and Proposed Solution	Codes / Mitigation Info	Qty	Unit	Cost	Total
<u>Water Closet</u>						
4001	<ul style="list-style-type: none"> <i>As-Built Description:</i> More than 18" from near side wall to centerline of water closet. <i>As-Built:</i> 21" o.c. <i>Proposed Solution:</i> Provide new accessible water closet and relocate plumbing. 	PCODE WB02A ADAAG Fig. 28 ADA 2010 604.2 CBC 2010 1115B.4.1.1 CBC 2013 11B-604.2 Priority 3 Severity 3 TBD Contract Work	1	JOB	\$4,500	\$4,500

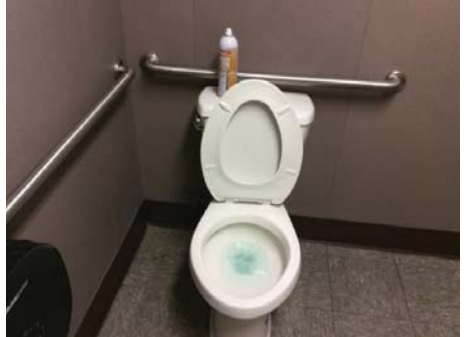
4000	<ul style="list-style-type: none"> <i>As-Built Description:</i> Flush Control: Operating handle not mounted toward wide side of stall. <i>Proposed Solution:</i> Replace flush control with properly mounted accessible type, or install sensor flush. 	PCODE WB10 ADAAG 4.16.5 ADA 2010 604.6 CBC 2010 1115B.4.1.5 CBC 2013 11B-604.6 Priority 3 Severity 3 TBD Contract Work	1	JOB	\$500	\$500

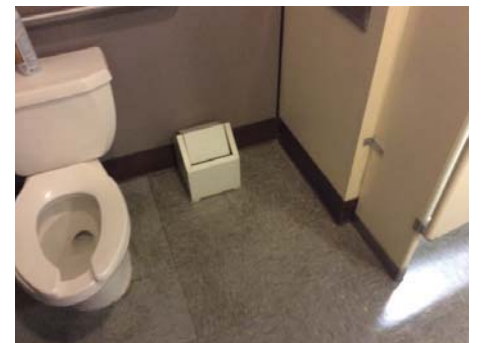
4086	<ul style="list-style-type: none"> <i>As-Built Description:</i> Toilet stall less than 60" wide. <i>As-Built:</i> 57"-59" <i>Proposed Solution:</i> Provide new accessible stall. 	PCODE WB06 ADAAG 4.17.3 ADA 2010 604.8.1.1 CBC 2010 1115B.3.1.4.1 CBC 2013 11B-604.8.1.1 Priority 4 Severity 4 TBD Contract Work	1	JOB	\$1,500	\$1,500
------	--	---	---	-----	---------	----------------

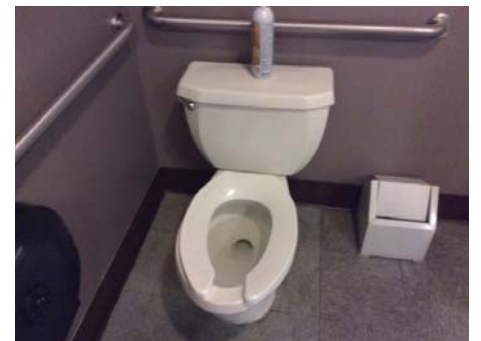
<u>Water Closet</u>						
4087	<ul style="list-style-type: none"> <i>As-Built Description:</i> Flush Control: Operating handle not mounted toward wide side of stall. <i>Proposed Solution:</i> Replace flush control with properly mounted accessible type, or install sensor flush. 	PCODE WB10 ADAAG 4.16.5 ADA 2010 604.6 CBC 2010 1115B.4.1.5 CBC 2013 11B-604.6 Priority 4 Severity 3 TBD Contract Work	1	JOB	\$500	\$500

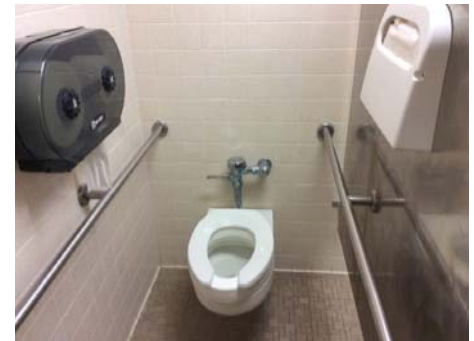
377	<ul style="list-style-type: none"> <i>As-Built Description:</i> Flush Control: Operating handle not mounted toward wide side of stall. <i>Proposed Solution:</i> Replace flush control with properly mounted accessible type, or install sensor flush when remodeling restroom. 	PCODE WB10 ADAAG 4.16.5 ADA 2010 604.6 CBC 2010 1115B.4.1.5 CBC 2013 11B-604.6 Priority 3 Severity 3 TBD Contract Work	1	JOB	\$500	\$500
-----	---	---	---	-----	-------	-------

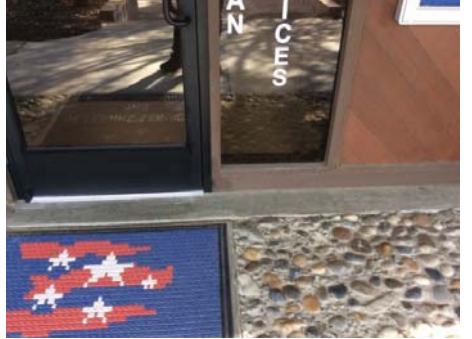
<u>Operable Part</u>						
1587	<ul style="list-style-type: none"> <i>As-Built Description:</i> Operable part(s) require tight grasping, pinching, or twisting of the wrist with one hand. <i>As-Built:</i> 61" <i>Proposed Solution:</i> Modify or replace the operable part(s) to not require tight grasping, pinching, or twisting of the wrist with one hand. 	PCODE IC02 ADAAG 4.27.4 ADA 2010 309.4 CBC 2010 1117B.6.4 CBC 2013 11B-309.4 Priority 3 Severity 2 TBD Contract Work	1	JOB	\$300	\$300

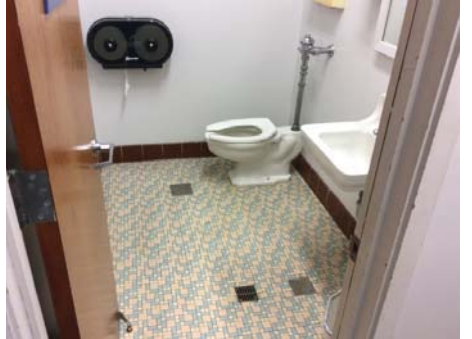
<u>Water Closet</u>						
2677	<ul style="list-style-type: none"> As-Built Description: CA only: In single-accommodation restroom less than 48" in front of water closet provided. As-Built: 30" Proposed Solution: Remodel restroom to provide at least 48" in front of water closet. 	PCODE WB03AREF CBC 2010 1115B.3.2.1 CBC 2013 11B-604.3.1 Priority 4 Severity 1 TBD Contract Work				
						REF

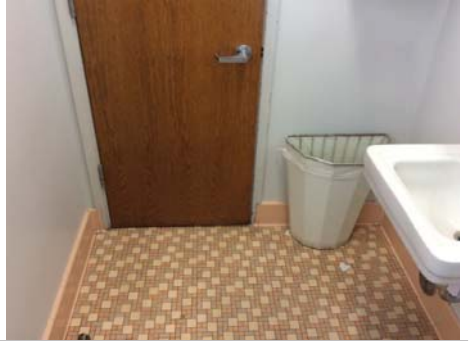
<u>Restroom</u>						
2683	<ul style="list-style-type: none"> <i>As-Built Description:</i> Single accommodation restroom not accessible; multiple compliance violations. <i>Proposed Solution:</i> Remodel area to provide single-occupant accessible restroom. Notes: RR 60"x88" 	<p>PCODE WA01</p> <p>ADAAG 4.22</p> <p>ADA 2010 603</p> <p>CBC 2010 1115B.3.2</p> <p>CBC 2013 11B-603</p> <p>Priority 4</p> <p>Severity 2</p> <p>TBD Contract Work</p>	1	JOB	\$30,000	\$30,000

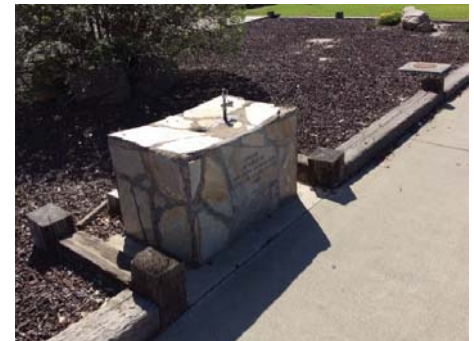
2949 • *As-Built Description:*
 Drinking fountain water flow less than 4" high; unit in good condition.
 • *Proposed Solution:*
 Adjust water flow.

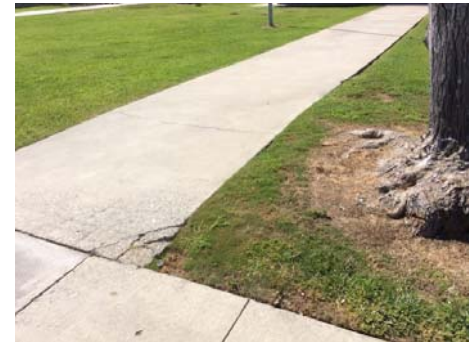
2930	<ul style="list-style-type: none"> <i>As-Built Description:</i> Walk: Pavement dislocation creates abrupt change in level exceeding 1/2" in accessible route. <i>As-Built:</i> 1" gap <i>Proposed Solution:</i> Remove, replace or repair area of pavement sufficient to correct abrupt change in level. 	PCODE EF03REF ADAAG 4.3.8 ADA 2010 403.4 CBC 2010 1133B.7.4 CBC 2013 11B-403.4 Priority 1 Severity 4 TBD Contract Work	REF			
------	---	---	-----	--	--	--

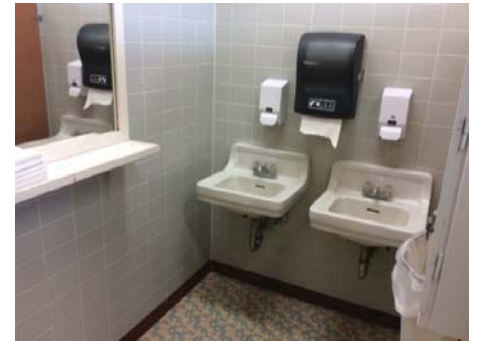
<u>Restroom</u>						
2371	<ul style="list-style-type: none"> As-Built Description: Multiple accommodation restroom not accessible; multiple compliance violations. As-Built: 32" wide Proposed Solution: Remodel area to provide accessible restroom with one accessible stall, lavatory (and one urinal at Mens). 	PCODE WA01A ADAAG 4.22 ADA 2010 603 CBC 2010 1115B.3.1 CBC 2013 11B-603 Priority 4 Severity 1 TBD Contract Work	1	JOB	\$35,000	\$35,000

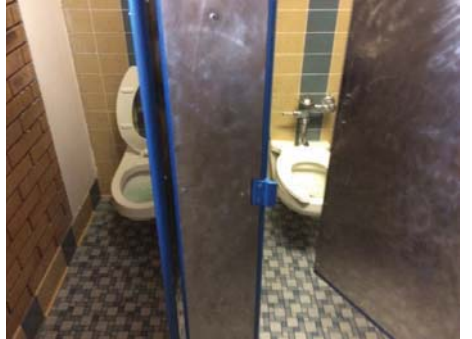
<u>Toilet Stall</u>						
3010	<ul style="list-style-type: none"> <i>As-Built Description:</i> Toilet stall less than 60" wide. <i>As-Built:</i> 31.5" <i>Proposed Solution:</i> Provide new accessible stall (alternate stalls 36" x 69" or 48" x 69" not recommended). 	PCODE WB06REF ADAAG 4.17.3 ADA 2010 604.8.1.1 CBC 2010 1115B.3.1.4.1 CBC 2013 11B-604.8.1.1 Priority 3 Severity 1 TBD Contract Work				
						REF

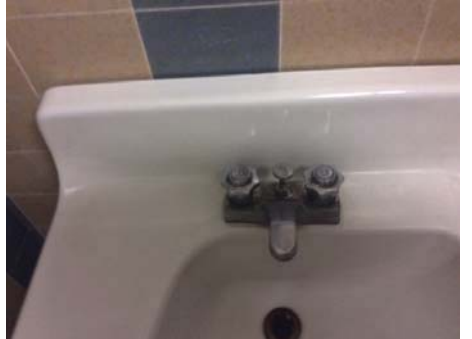
<u>Restroom</u>						
3017	<ul style="list-style-type: none"> <i>As-Built Description:</i> Multiple accommodation restroom not accessible; multiple compliance violations. <i>Proposed Solution:</i> Remodel area to provide accessible restroom with one accessible stall, lavatory (and one urinal at Mens). 	PCODE WA01A ADAAG 4.22 ADA 2010 603 CBC 2010 1115B.3.1 CBC 2013 11B-603 Priority 3 Severity 1 TBD Contract Work	1	JOB	\$35,000	\$35,000
