CENTRAL VALLEY REGIONAL WATER QUALITY CONTROL BOARD

INSPECTION REPORT

17 March 2000

DISCHARGER: Manuel Galhandro
LOCATION & COUNTY: 9240 19 1/2 Avenue, Lemoore 93245 (Kings County)
CONTACT(S): Mr. John Galhandro
INSPECTION DATE: 24 February 2000
INSPECTED BY: Cliff Raley (CEG), Matt Scroggins (WRCE)
ACCOMPANIED BY: NA

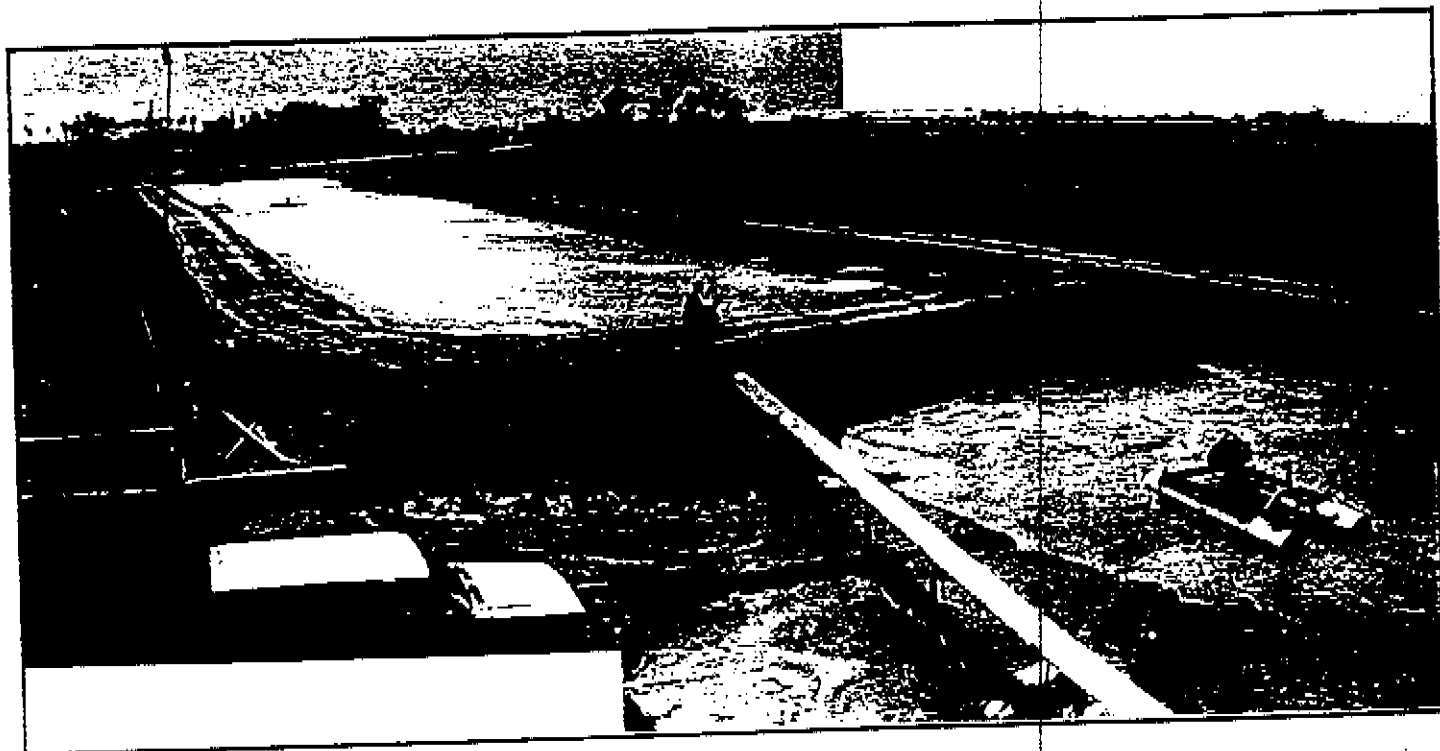
4. During the inspection, we observed that cows are kept in dry corrals on the north side of the dairy, and in freestalls on the south side. As shown in Photographs Nos. 1 and 2, the freestalls and a feed lane on the south side are flushed to a series of wastewater ponds. Two of the ponds are on the west side of the dairy and the third pond (not visible in Photographs Nos. 1 and 2) is on the south side of the corrals. The wastewater holding system appeared adequate to hold 120 days of wastewater, and all storm runoff through manured areas during a 25-year, 24-hour storm as required by Title 27, CCR, Section 22562(a).

Photograph No. 2. Galhandro Dairy (2/24/00). This composite photo is a continuation of the panoramic view shown in Photograph No. 1. The view is facing south on the left side of the photo and toward the southwest on the right side. Wastewater is flushed to the ponds on the right side of the photo through a mechanical separator, and then piped to the upper wastewater pond on the 2-inch pipe shown in the center of the photo. The land on the upper right side of the photo appears to be under separate ownership because the wastewater had been discharged there. The Galhandro is partially visible in the upper left corner of the photo.

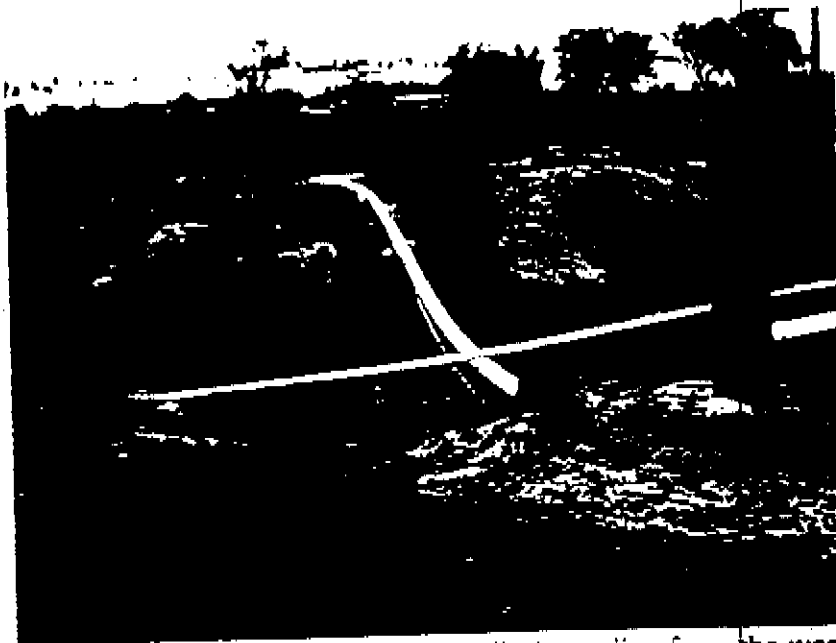
6. As shown in Photographs Nos. 5 and 6, a canal traverses the western boundary of the disposal field. An approximately 4-inch PVC pipe led from the wastewater pond, crossed the canal (supported by a stick), and discharged to the perimeter ditch surrounding the disposal field. There was no evidence that wastewater had been discharged to the canal. (The Specific Conductance of the canal water was approximately 350 $\mu\text{mhos/cm}$ upgradient and downgradient from the dairy). However,

Photograph No. 5. Gaihandro Dairy (2/24/00). The discharge line from the wastewater pond to the disposal field crosses the canal.

the discharge line appeared susceptible to rupture and poses a threat to water quality. Therefore, the line needs to be rerouted around the canal.
