Facility: **WOMENS INFANTS & CHILDREN**

Address: 330 HARRIS ST.

Facility: **LEMORE HEALTH CLINIC**
 Address: 229 C ST.

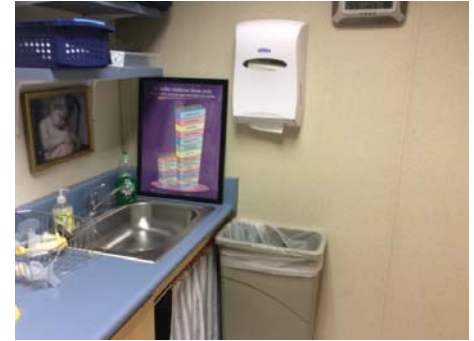
Item No. and Name	Existing Architectural Barrier and Proposed Solution	Codes / Mitigation Info	Qty	Unit	Cost	Total
Reach Range						
2820	<ul style="list-style-type: none"> As-Built Description: Reach height to control or access point, where only forward approach is available, exceeds 48" or is less than 15". As-Built: PTD: 51" Proposed Solution: Modify equipment or mounting. 	PCODE IE01 ADAAG 4.2.5 ADA 2010 308.2.1 CBC 2010 1118B.5 CBC 2013 11B-308.2.1 Priority 3 Severity 4 FY 22-23 Maintenance Work	1	JOB	\$100	\$100

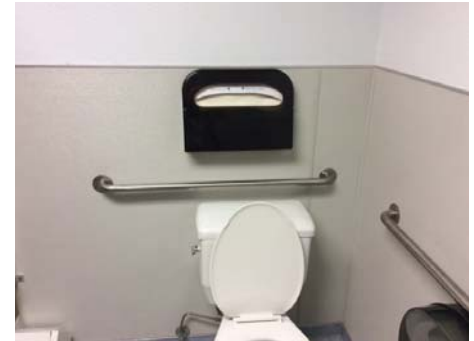
Accessories

4399	<ul style="list-style-type: none"> <i>As-Built Description:</i> Dispensers in sanitary facilities, such as for towels, soap, sanitary napkins, seat covers, etc., and waste receptacles more than 48" (CA only: 40") from floor to highest operating slot or control. <i>As-Built:</i> SCD: 47" <i>Proposed Solution:</i> Relocate existing restroom accessories. 	PCODE WG01A ADAAG 4.23.7 ADA 2010 308.2.1 CBC 2010 1115B.8.3 CBC 2013 11B-603.5 Priority 3 Severity 3 FY 22-23 Maintenance Work	1	JOB	\$100	\$100
------	--	--	---	-----	-------	-------

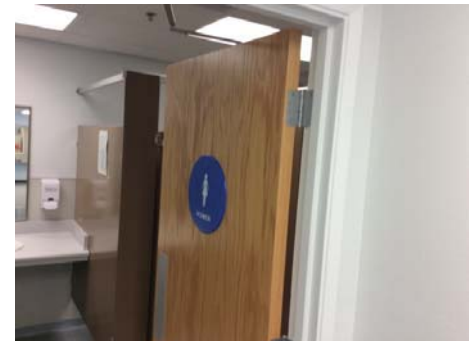
Door Closer

4388	<ul style="list-style-type: none"> <i>As-Built Description:</i> Excessive force required to open door. <i>As-Built:</i> 14 lbs <i>Proposed Solution:</i> Adjust regular door closer to accessible standards (5 lbs max). 	PCODE ID03 ADAAG 4.13.11 ADA 2010 404.2.9 CBC 2010 1133B.2.5 CBC 2013 11B-404.2.9 Priority 3 Severity 3 FY 22-23 Maintenance Work	1	JOB	\$25	\$25
------	---	--	---	-----	------	------

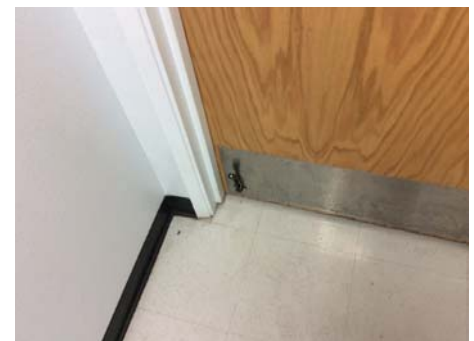
Door Stopper

4387	<ul style="list-style-type: none"> <i>As-Built Description:</i> At push side of door on accessible route, bottom 10" does not have a smooth, uninterrupted surface. <i>Proposed Solution:</i> Remove door stopper when altering area. Provide rubber wedge. 	PCODE ID06A ADA 2010 404.2.10 CBC 2010 1133B.2.6 CBC 2013 11B-404.2.10 Priority 3 Severity 3 FY 22-23 Maintenance Work	1	JOB	\$25	\$25
------	---	---	---	-----	------	------

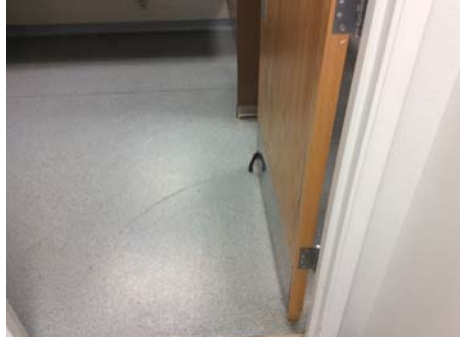
Item No. and Name	Existing Architectural Barrier and Proposed Solution	Codes / Mitigation Info	Qty	Unit	Cost	Total
<u>Door Swing</u>						
4389	<ul style="list-style-type: none"> <i>As-Built Description:</i> Front approach: At pull side, door does not have clear and level maneuvering space measuring door width plus 18" x 60". <i>As-Built:</i> 53" to partition <i>Proposed Solution:</i> Provide power door operator. 	PCODE ID23C ADAAG Fig. 25(a) ADA 2010 404.2.4 CBC 2010 11B-26A(a) CBC 2013 11B-404.2.4 Priority 3 Severity 3 FY 22-23 Maintenance Work	1	JOB	\$5,000	\$5,000

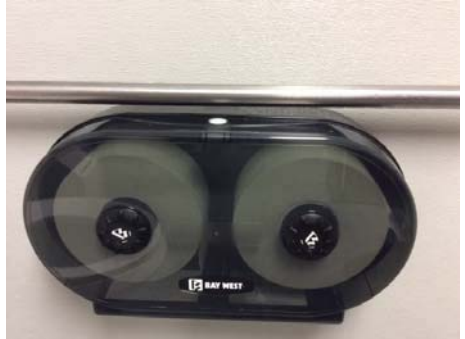
<u>Grab Bars</u>						
4397	<ul style="list-style-type: none"> <i>As-Built Description:</i> Accessories/dispensers in accessible stall located closer than 1-1/2" below or 12" above grab bar impedes its use. <i>As-Built:</i> 0.5" <i>Proposed Solution:</i> Relocate accessories/dispensers to be no closer than 1-1/2" below and 12" above grab bars (except if accessories are recessed, flush with wall, and have no sharp edges). 	PCODE WB07I ADAAG 4.26.2 ADA 2010 609.3 CBC 2010 1133B.4.2.5 CBC 2013 11B-609.3 Priority 3 Severity 4 FY 22-23 Maintenance Work	1	JOB	\$75	\$75

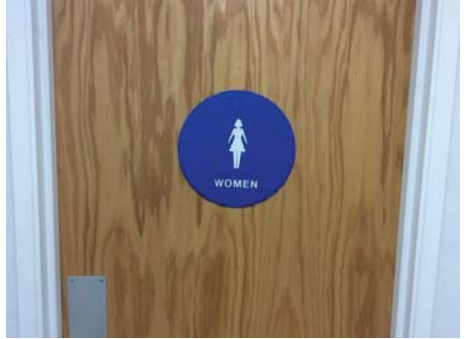
Item No. and Name	Existing Architectural Barrier and Proposed Solution	Codes / Mitigation Info	Qty	Unit	Cost	Total
Signage						
4386	<ul style="list-style-type: none"> <i>As-Built Description:</i> Entrance to wheelchair accessible toilet or bathing facility not identified with the International Symbol of Accessibility when not all are accessible. <i>Proposed Solution:</i> Provide sanitary facility sign that shows the international symbol. 	PCODE SA11 ADAAG 4.1.2(7)(d) ADA 2010 216.8 CBC 2010 1117B.5.8.1.2 CBC 2013 11B-216.8 Priority 3 Severity 3 FY 22-23 Maintenance Work	1	JOB	\$90	\$90

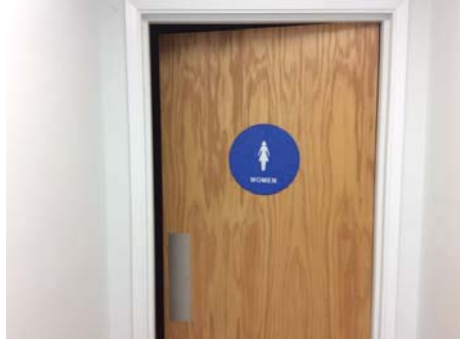
4385	<ul style="list-style-type: none"> <i>As-Built Description:</i> Entrance to toilet or bathing facility not identified with ADAAG compliant signage. <i>Proposed Solution:</i> Provide ADAAG compliant sign mounted 5' high on center on nearest adjacent wall, on latch side if a single door (located not to cause a Braille reader to stand within the door swing). 	PCODE SA11A ADAAG 4.1.3(16)(a) ADA 2010 216.8 CBC 2013 11B-216.8 Priority 3 Severity 3 FY 22-23 Maintenance Work	1	JOB	\$90	\$90

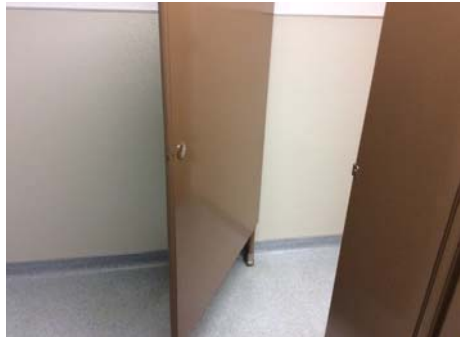
Stall Door						
4396	<ul style="list-style-type: none"> <i>As-Built Description:</i> Stall door to accessible compartment not self closing. <i>Proposed Solution:</i> Adjust closer. 	PCODE WB05B ADAAG 4.22.4 ADA 2010 604.8.1.2 CBC 2010 1115B.3.1.4.4 CBC 2013 11B-604.8.1.2 Priority 3 Severity 4 FY 22-23 Maintenance Work	1	JOB	\$25	\$25

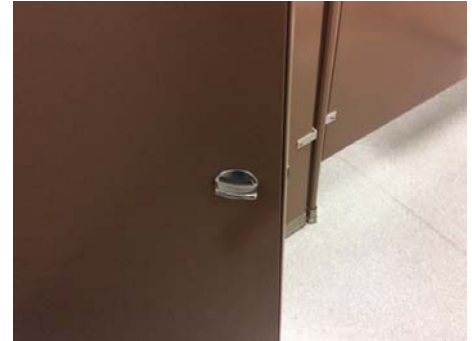
Item No. and Name	Existing Architectural Barrier and Proposed Solution	Codes / Mitigation Info	Qty	Unit	Cost	Total
4395	<ul style="list-style-type: none"> <i>As-Built Description:</i> Stall door does not have accessible operating hardware (U-pulls on both sides, flip-over or sliding lock). <i>Proposed Solution:</i> Provide new accessible locking hardware that does not require grasping, pinching, or twisting and U-pulls on both sides. 	PCODE WB05C ADAAG 4.17.5 ADA 2010 604.8.1.2 CBC 2010 1115B.3.1.4.5 CBC 2013 11B-604.8.1.2 Priority 3 Severity 3 FY 22-23 Maintenance Work	1	JOB	\$100	\$100

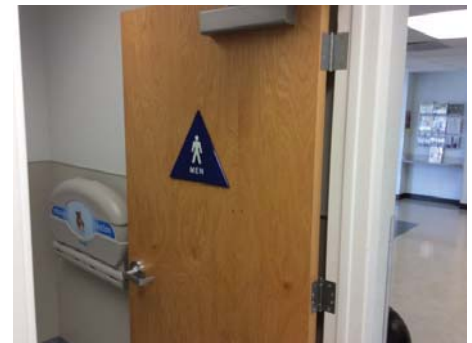
Door Closer

4403	<ul style="list-style-type: none"> <i>As-Built Description:</i> Excessive force required to open door. <i>As-Built:</i> 12 lbs <i>Proposed Solution:</i> Adjust regular door closer to accessible standards (5 lbs max). 	PCODE ID03 ADAAG 4.13.11 ADA 2010 404.2.9 CBC 2010 1133B.2.5 CBC 2013 11B-404.2.9 Priority 3 Severity 3 FY 22-23 Maintenance Work	1	JOB	\$25	\$25
------	---	--	---	-----	------	------

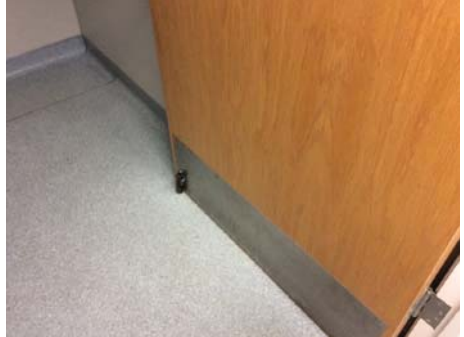
Item No. and Name	Existing Architectural Barrier and Proposed Solution	Codes / Mitigation Info	Qty	Unit	Cost	Total
<u>Door Stopper</u>						
4400	<ul style="list-style-type: none"> <i>As-Built Description:</i> At push side of door on accessible route, bottom 10" does not have a smooth, uninterrupted surface. <i>Proposed Solution:</i> Remove door stopper when altering area. Provide rubber wedge. 	PCODE ID06A ADA 2010 404.2.10 CBC 2010 1133B.2.6 CBC 2013 11B-404.2.10 Priority 3 Severity 3 FY 22-23 Maintenance Work	1	JOB	\$25	\$25

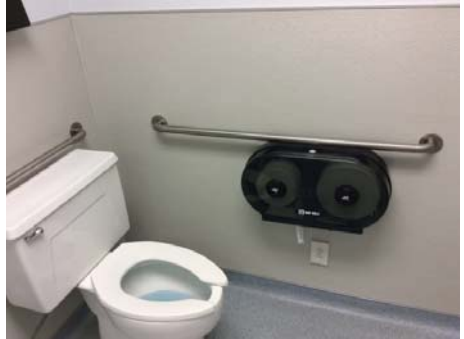
<u>Grab Bars</u>						
4411	<ul style="list-style-type: none"> <i>As-Built Description:</i> Side grab bar less than 42" long, or located more than 12 inches max. from the rear wall, or extending less than 54" from rear wall (CA only: front end min. 24" in front of water closet). <i>As-Built:</i> 42"@55" <i>Proposed Solution:</i> Provide or relocate accessible side grab bar. 	PCODE WB07A ADAAG Fig. 29(b) ADA 2010 604.5.1 CBC 2010 1115B.4.1.3.1 CBC 2013 11B-604.5.1 Priority 3 Severity 4 FY 22-23 Maintenance Work	1	JOB	\$260	\$260

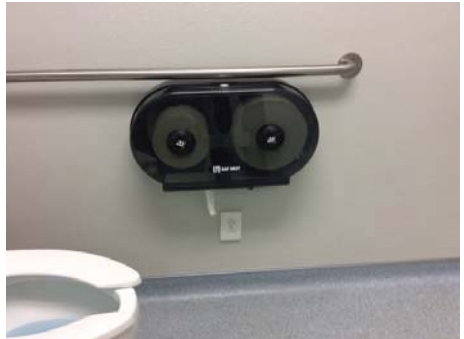
4410	<ul style="list-style-type: none"> <i>As-Built Description:</i> Accessories/dispensers in accessible stall located closer than 1-1/2" below or 12" above grab bar impedes its use. <i>As-Built:</i> 0.5" <i>Proposed Solution:</i> Relocate accessories/dispensers to be no closer than 1-1/2" below and 12" above grab bars (except if accessories are recessed, flush with wall, and have no sharp edges). 	PCODE WB07I ADAAG 4.26.2 ADA 2010 609.3 CBC 2010 1133B.4.2.5 CBC 2013 11B-609.3 Priority 3 Severity 4 FY 22-23 Maintenance Work	1	JOB	\$75	\$75

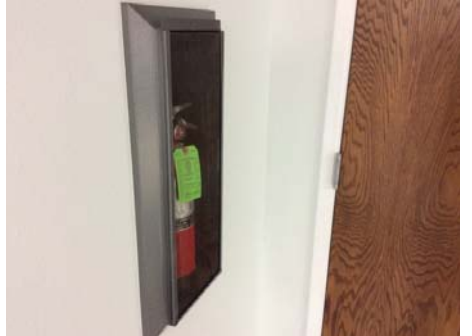
Reach Range						
4452	<ul style="list-style-type: none"> <i>As-Built Description:</i> Reach height to control or access point, where only forward approach is available, exceeds 48" or is less than 15". <i>As-Built:</i> FE: 52" <i>Proposed Solution:</i> Modify equipment or mounting. <i>Notes:</i> must Break glass 	PCODE IE01 ADAAG 4.2.5 ADA 2010 308.2.1 CBC 2010 1118B.5 CBC 2013 11B-308.2.1 Priority 3 Severity 4 FY 22-23 Maintenance Work	1	JOB	\$100	\$100

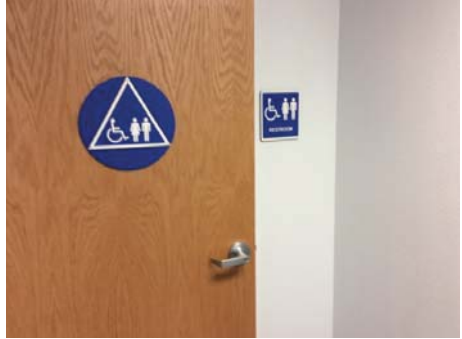
Item No. and Name	Existing Architectural Barrier and Proposed Solution	Codes / Mitigation Info	Qty	Unit	Cost	Total
<u>Door Closer</u>						
4446	<ul style="list-style-type: none"> As-Built Description: Excessive force required to open door. As-Built: 7 lbs Proposed Solution: Adjust regular door closer to accessible standards (5 lbs max). 	PCODE ID03 ADAAG 4.13.11 ADA 2010 404.2.9 CBC 2010 1133B.2.5 CBC 2013 11B-404.2.9 Priority 3 Severity 4 FY 22-23 Maintenance Work	1	JOB	\$25	\$25

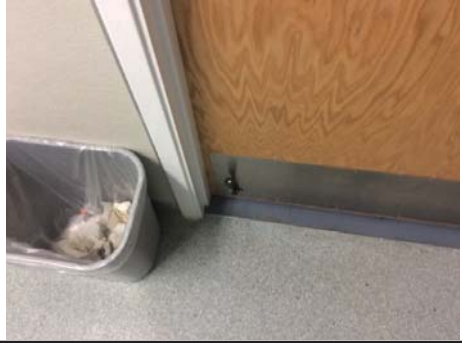
<u>Door Stopper</u>						
4447	<ul style="list-style-type: none"> As-Built Description: At push side of door on accessible route, bottom 10" does not have a smooth, uninterrupted surface. Proposed Solution: Remove door stopper when altering area. Provide rubber wedge. 	PCODE ID06A ADA 2010 404.2.10 CBC 2010 1133B.2.6 CBC 2013 11B-404.2.10 Priority 3 Severity 3 FY 22-23 Maintenance Work	1	JOB	\$25	\$25

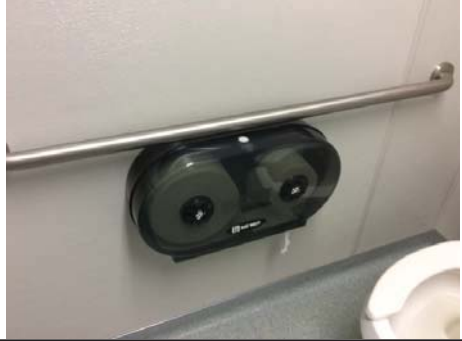
<u>Grab Bars</u>						
4450	<ul style="list-style-type: none"> As-Built Description: Accessories/dispensers in accessible stall located closer than 1-1/2" below or 12" above grab bar impedes its use. As-Built: 0.5" Proposed Solution: Relocate accessories/dispensers to be no closer than 1-1/2" below and 12" above grab bars (except if accessories are recessed, flush with wall, and have no sharp edges). 	PCODE WB07I ADAAG 4.26.2 ADA 2010 609.3 CBC 2010 1133B.4.2.5 CBC 2013 11B-609.3 Priority 3 Severity 4 FY 22-23 Maintenance Work	1	JOB	\$75	\$75

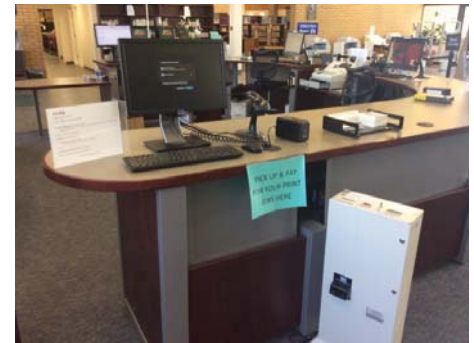
Desk

2984	<ul style="list-style-type: none"> <i>As-Built Description:</i> Accessible fixed table or desk (top 28" to 34" high; knee space at least 27" high x 19" deep x 30" wide) not provided. <i>As-Built:</i> Top: 39" No knee space <i>Proposed Solution:</i> Provide new fixed accessible table or desk. 	PCODE	IN02	1	JOB	\$2,500	\$2,500
		ADAAG	4.32.3 & .4				
		ADA 2010	306.1				
		CBC 2010	1122B.3 & 4				
		CBC 2013	11B-306.1				
		Priority	2				
		Severity	2				
		FY 23-24	Contract Work

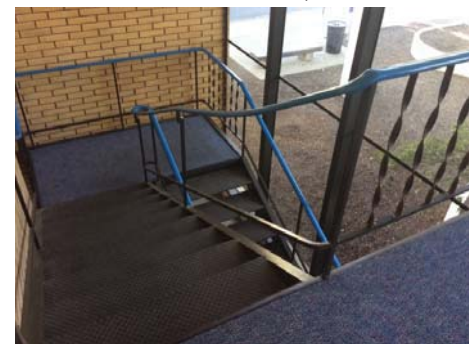
Handrail

2992	<ul style="list-style-type: none"> <i>As-Built Description:</i> Open guards does not have balusters or ornamental patterns such that a 4-inch-diameter (102 mm) sphere cannot pass through any opening. <i>As-Built:</i> 22" openings <i>Proposed Solution:</i> Provide new guards which do not allow passage of an 4 inch sphere at any opening. 	PCODE	ED08A	40	LF	\$120	\$4,800
		ADA 2010	405.9.2				
		CBC 2010	1013.3				
		CBC 2013	11B-405.9.2				
		Priority	2				
		Severity	2				
				FY 23-24	Contract Work

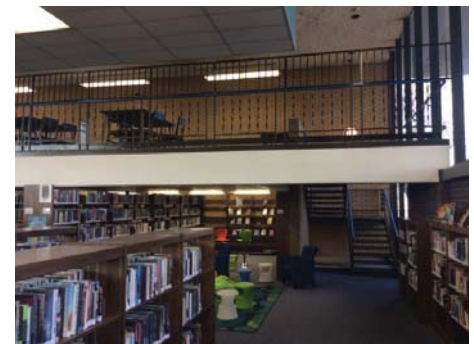
Lifts

2989	<ul style="list-style-type: none"> <i>As-Built Description:</i> Wheelchair lift not provided between levels. <i>As-Built:</i> 9' level change <i>Proposed Solution:</i> Provide equivalent facilitation on ground floor by providing same type of accommodations. <i>Notes:</i> Things that must be equivalent provided include Wifi Hot spot and accessible tables. 	PCODE	I001	1	JOB	\$20,000	\$20,000
		ADAAG	4.11.1; 4.11.2				
		ADA 2010	410.1				
		CBC 2010	1116B.2				
		CBC 2013	11B-410.1				
		Priority	2				
		Severity	2				
		FY 23-24	Contract Work

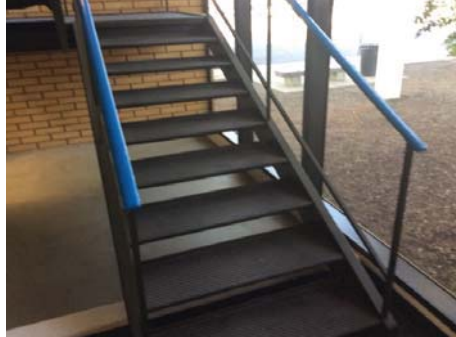
Item No. and Name	Existing Architectural Barrier and Proposed Solution	Codes / Mitigation Info	Qty	Unit	Cost	Total
<u>Top & Bottom Extension at Stairs</u>						
2991	<ul style="list-style-type: none"> <i>As-Built Description:</i> Stair handrail does not extend horizontally 12" minimum beyond top nosing, and one tread width sloped, plus 12" minimum horizontally beyond the bottom nosing. <i>Proposed Solution:</i> Extend stair handrail at top and bottom (cost for each extension piece). <i>Notes:</i> Stairs on both sides of mezzanine 	PCODE ED06 ADAAG 4.9.4(2) ADA 2010 505.10.2; 505.10.3 CBC 2010 1133B.4.2.2 CBC 2013 11B-505.10.2; 11B-505.10.3 Priority 2 Severity 2 FY 23-24 Contract Work	8	JOB	\$170	\$1,360

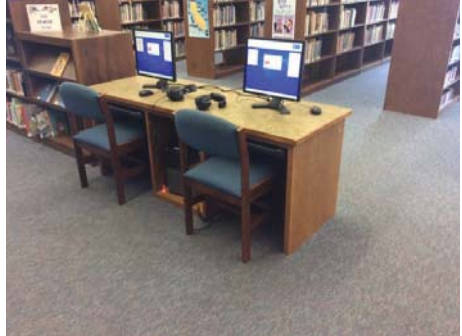
Non-Fixed Desk

2997	<ul style="list-style-type: none"> <i>As-Built Description:</i> Accessible non-fixed table or desk (top 28" to 34" high; knee space at least 27" high x 19" deep x 30" wide) not provided. <i>As-Built:</i> Adult Stations. 24" high x 24" wide knee space <i>Proposed Solution:</i> Provide table or desk with accessible dimensions when purchasing new furniture. 	PCODE IN02A ADAAG 4.32.3 & .4 ADA 2010 306.1 CBC 2010 1122B.3 & 4 CBC 2013 11B-306.1 & 11B-902.3 Priority 2 Severity 2 FY 23-24 Contract Work	1	JOB	\$1,600	\$1,600

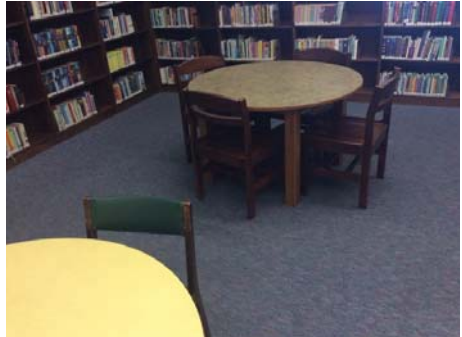
2998	<ul style="list-style-type: none"> <i>As-Built Description:</i> Accessible non-fixed table or desk (top 28" to 34" high; knee space at least 27" high x 19" deep x 30" wide) not provided. <i>As-Built:</i> Adult table 25.25" high x 25.25" wide. <i>Proposed Solution:</i> Provide table or desk with accessible dimensions when purchasing new furniture. 	PCODE IN02A ADAAG 4.32.3 & .4 ADA 2010 306.1 CBC 2010 1122B.3 & 4 CBC 2013 11B-306.1 & 11B-902.3 Priority 2 Severity 2 FY 23-24 Contract Work	1	JOB	\$1,600	\$1,600

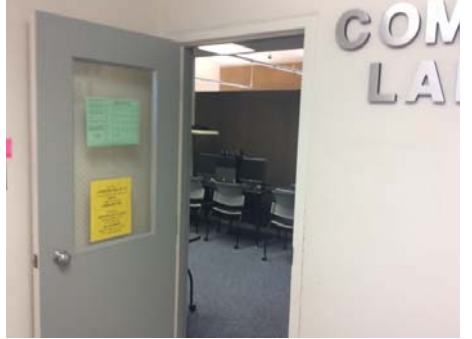
Item No. and Name	Existing Architectural Barrier and Proposed Solution	Codes / Mitigation Info	Qty	Unit	Cost	Total
<u>Door Clearance</u>						
3043	<ul style="list-style-type: none"> As-Built Description: Door on accessible route has less than 32" clear and 80" (78" min. to closer if provided) opening width when 90° open. As-Built: 27" Proposed Solution: Provide new, larger door and frame with new accessible hardware. 	PCODE ID01 ADAAG 4.13.5 ADA 2010 404.2.3 CBC 2010 1133B.1.1.1.1 CBC 2013 11B-404.2.3 Priority 2 Severity 2 FY 23-24 Contract Work	1	JOB	\$2,600	\$2,600

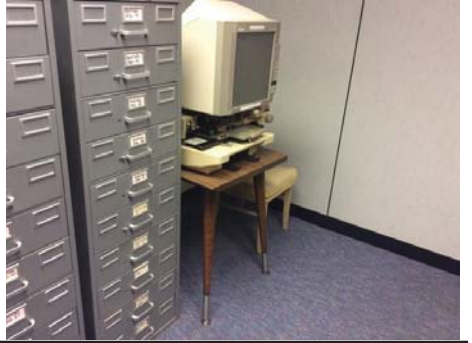
<u>Non-Fixed Desk</u>						
3046	<ul style="list-style-type: none"> As-Built Description: Accessible non-fixed table or desk (top 28" to 34" high; knee space at least 27" high x 19" deep x 30" wide) not provided. As-Built: Micro film: 14" wide Proposed Solution: Provide table or desk with accessible dimensions when purchasing new furniture. 	PCODE IN02A ADAAG 4.32.3 & .4 ADA 2010 306.1 CBC 2010 1122B.3 & 4 CBC 2013 11B-306.1 & 11B-902.3 Priority 2 Severity 2 FY 23-24 Contract Work	1	JOB	\$1,600	\$1,600

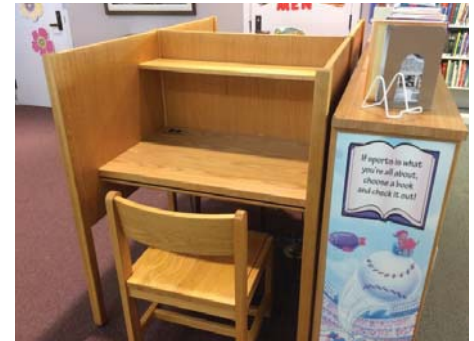
- 4534
- *As-Built Description:*
 Accessible non-fixed table or desk (top 28" to 34" high; knee space at least 27" high x 19" deep x 30" wide) not provided.
 - *As-Built:* Study carrel: 26.5"
 - *Proposed Solution:*
 Provide table or desk with accessible dimensions when purchasing new furniture.

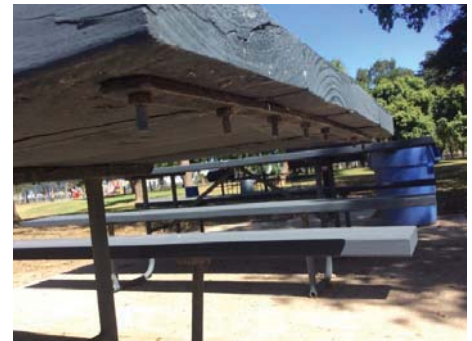
4943	<ul style="list-style-type: none"> <i>As-Built Description:</i> Knee clearance at minimums 27" high, 30" wide, and 19" deep is not provided. <i>As-Built:</i> Cover or remove long bolts at designated accessible areas/tables <i>Proposed Solution:</i> Modify picnic table as required to provide knee clearance. 	PCODE NH11A				
		ADAAG 16.5.4.				
		ADA 2010 902.2				
		CBC 2010 1132B.1				
		CBC 2013 11-902.2				
		Priority 2 Severity 2 FY 23-24 Contract Work

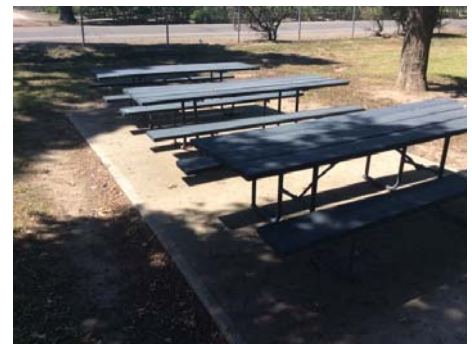
4942	<ul style="list-style-type: none"> <i>As-Built Description:</i> Min. 36" clear floor or ground space surrounding the useable portion of the table as measured from seating is not provided. <i>As-Built:</i> 8" level change <i>Proposed Solution:</i> Reconfigure floor or ground space surrounding table to provide clear space as required. 	PCODE NH14A				
		ADAAG 16.5.5				
		ADA 2010 226.1				
		CBC 2010 1132B.1				
		CBC 2013 11B-226.1				
		Priority 2 Severity 2 FY 23-24 Contract Work

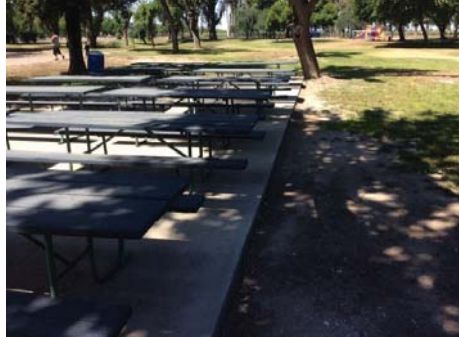
Item No. and Name	Existing Architectural Barrier and Proposed Solution	Codes / Mitigation Info	Qty	Unit	Cost	Total
<u>Picnic Area</u>						
4948	<ul style="list-style-type: none"> • <i>As-Built Description:</i> Min. 36" clear floor or ground space surrounding the useable portion of the table as measured from seating is not provided. • <i>As-Built:</i> 8" • <i>Proposed Solution:</i> Reconfigure floor or ground space surrounding table to provide clear space as required. • <i>Notes:</i> 12 tables. 	PCODE NH14A ADAAG 16.5.5 ADA 2010 226.1 CBC 2010 1132B.1 CBC 2013 11B-226.1 Priority 2 Severity 2 FY 23-24 Contract Work	1	JOB

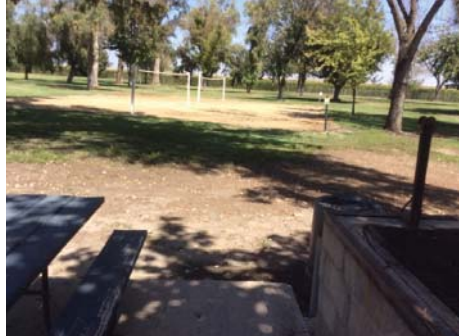
<u>Participation Area</u>						
5129	<ul style="list-style-type: none"> • <i>As-Built Description:</i> An accessible path of travel is not provided to and from all participation and activity areas, including athletic team rooms/facilities, playing fields/running tracks, baseball/softball player dugouts and sanitary/locker facilities (home and guest). • <i>Proposed Solution:</i> Provide an accessible path of travel to all participation areas. 	PCODE GF07AREF ADAAG 4.1.1 (1) ADA 2010 206.2.12 CBC 2010 1104B.4.3 CBC 2013 11B-206.2.12 Priority 2 Severity 2 FY 23-24 Contract Work		REF

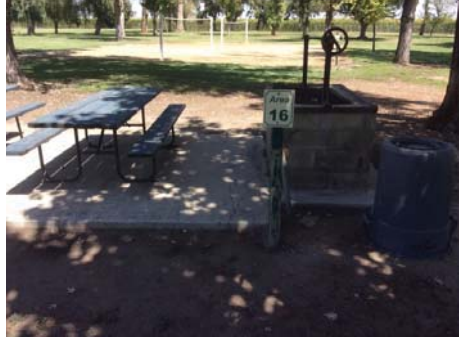
Item No. and Name	Existing Architectural Barrier and Proposed Solution	Codes / Mitigation Info	Qty	Unit	Cost	Total
<u>Picnic Area</u>						
5127	<ul style="list-style-type: none"> <i>As-Built Description:</i> Min. 36" clear floor or ground space surrounding the useable portion of the table as measured from seating is not provided. <i>As-Built:</i> 14" wide <i>Proposed Solution:</i> Reconfigure floor or ground space surrounding table to provide clear space as required. 	PCODE NH14A ADAAG 16.5.5 ADA 2010 226.1 CBC 2010 1132B.1 CBC 2013 11B-226.1 Priority 2 Severity 2 FY 23-24 Contract Work	1	JOB

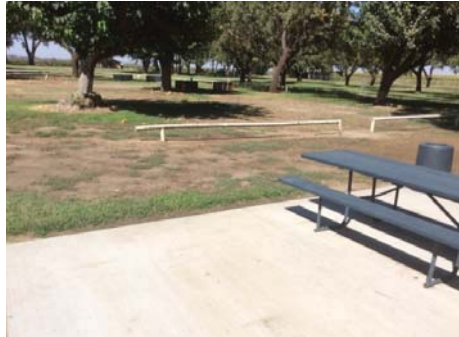
7 Upper Lot Serving Area 22 & Play Structure

<u>Participation Area</u>						
5157	<ul style="list-style-type: none"> <i>As-Built Description:</i> An accessible path of travel is not provided to and from all participation and activity areas, including athletic team rooms/facilities, playing fields/running tracks, baseball/softball player dugouts and sanitary/locker facilities (home and guest). <i>As-Built:</i> Horse shoe pits and t-ball field. <i>Proposed Solution:</i> Provide an accessible path of travel to all participation areas. 	PCODE GF07A ADAAG 4.1.1 (1) ADA 2010 206.2.12 CBC 2010 1104B.4.3 CBC 2013 11B-206.2.12 Priority 2 Severity 2 FY 23-24 Contract Work	1	REF

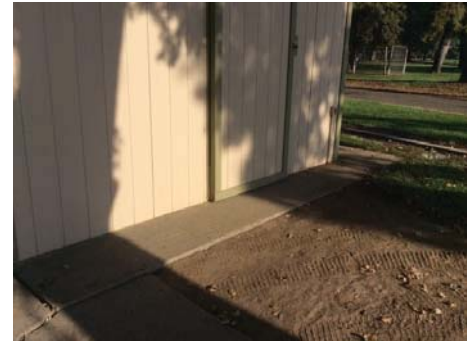
Door

5037	<ul style="list-style-type: none"> <i>As-Built Description:</i> Surface of required maneuvering clearance at door slopes more than 1/4":12" (2.0%). <i>As-Built:</i> No maneuvering clearance at door <i>Proposed Solution:</i> Modify surface slope at door. 	<p>PCODE ID11 ADAAG 4.13.6 ADA 2010 404.2.4.4 CBC 2010 1133B.2.4 CBC 2013 11B-404.2.4 Priority 2 Severity 2 FY 23-24 Contract Work</p>	25	SF	\$40	\$1,000
------	--	---	----	----	------	----------------

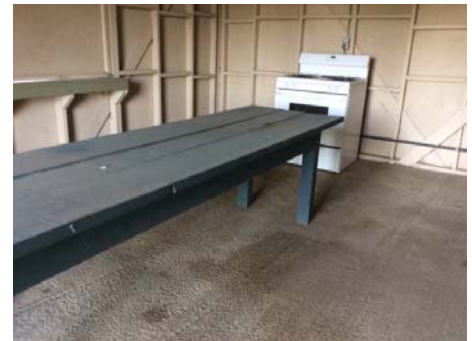
Non-Fixed Desk

5239	<ul style="list-style-type: none"> <i>As-Built Description:</i> Accessible non-fixed table or desk (top 28" to 34" high; knee space at least 27" high x 19" deep x 30" wide) not provided. <i>As-Built:</i> 22.5" high knee space. <i>Proposed Solution:</i> Modify table. 	<p>PCODE IN02A ADAAG 4.32.3 & .4 ADA 2010 306.1 CBC 2010 1122B.3 & 4 CBC 2013 11B-306.1 & 11B-902.3 Priority 2 Severity 2 FY 23-24 Contract Work</p>	1	JOB	\$1,600	\$1,600
------	---	---	---	-----	---------	----------------

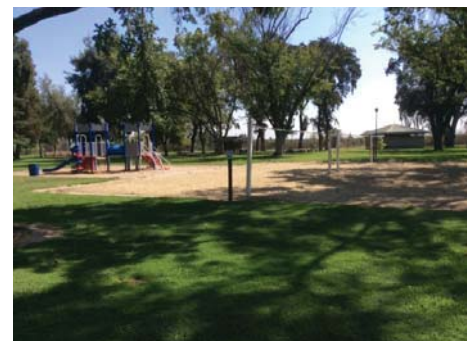
Participation Area

5121	<ul style="list-style-type: none"> <i>As-Built Description:</i> An accessible path of travel is not provided to and from all participation and activity areas, including athletic team rooms/facilities, playing fields/running tracks, baseball/softball player dugouts and sanitary/locker facilities (home and guest). <i>As-Built:</i> Volley ball & play area <i>Proposed Solution:</i> Provide an accessible path of travel to all participation areas. 	<p>PCODE GF07AREF ADAAG 4.1.1 (1) ADA 2010 206.2.12 CBC 2010 1104B.4.3 CBC 2013 11B-206.2.12 Priority 2 Severity 2 FY 23-24 Contract Work</p>	REF			
------	--	--	-----	--	--	--

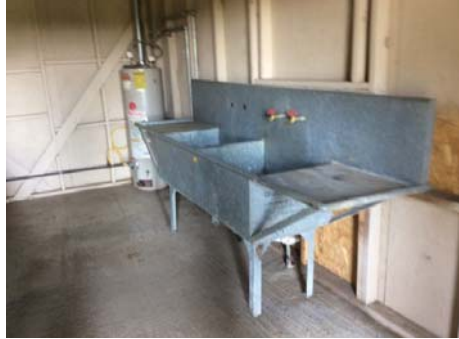
Item No. and Name	Existing Architectural Barrier and Proposed Solution	Codes / Mitigation Info	Qty	Unit	Cost	Total
Sink						
5237	<ul style="list-style-type: none"> <i>As-Built Description:</i> Sink does not have knee space min. 27" high x 19" deep x 30" wide. <i>Proposed Solution:</i> Remodel sink cabinet. 	PCODE IN06A ADAAG 4.24.3 ADA 2010 606.2 CBC 2010 1115B.4.7.1 CBC 2013 11B-606.2 Priority 2 Severity 2 FY 23-24 Contract Work	1	JOB	\$1,750	\$1,750

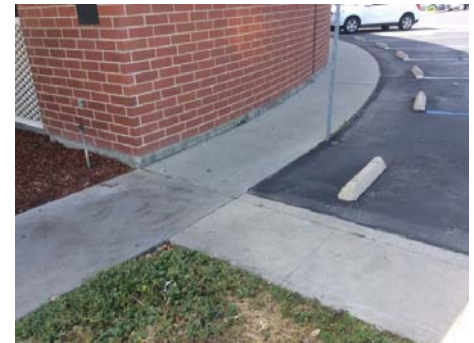
Detectable Warning

<p>3704</p> <ul style="list-style-type: none"> <i>As-Built Description:</i> 36" wide band of truncated domes not provided at walkway or crossing adjoining a vehicular way, if surfaces are not separated by a curb, railing, or other element. <i>Proposed Solution:</i> Provide 36" wide, contrasting color, band of truncated domes between pedestrian and vehicular area. 	<p>PCODE EG09 ADAAG 4.29.5 CBC 2010 1133B.8.5 CBC 2013 11B-705.1.2.5 Priority 1 Severity 3 FY 23-24 Maintenance Work</p>	<p>4 LF \$27 \$108</p>
---	---	-------------------------------

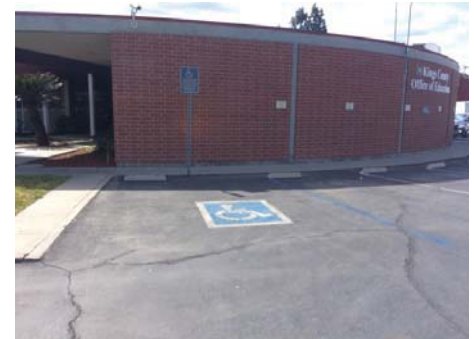
Minimum Number

<p>3700</p> <ul style="list-style-type: none"> <i>As-Built Description:</i> At parking lot with 26-50 spaces, the number of accessible spaces is less than required by code; 2 spaces required. <i>Proposed Solution:</i> Provide required accessible parking spaces with signs including a minimum of one van space. Notes: 35 total spaces 1 accessible space 0 van 	<p>PCODE EA01B ADAAG 4.1.2(5)* ADA 2010 208.2 CBC 2010 Tbl. 11B-6 CBC 2013 11B-208.2 Tbl. 11B-208.2 Priority 1 Severity 2 FY 23-24 Maintenance Work</p>	<p>1 JOB \$300 \$300</p>
--	--	---------------------------------

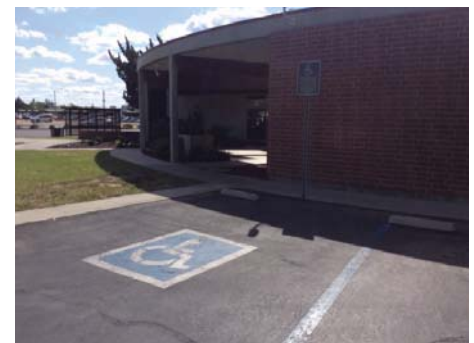
Parking

<p>3702</p> <ul style="list-style-type: none"> <i>As-Built Description:</i> No van parking provided (one in every 6 or fraction of 6 accessible spaces, but not less than one). <i>Proposed Solution:</i> Provide van parking space(s) by restriping; provide van sign. 	<p>PCODE EA07 ADAAG 4.1.2(5)(b) ADA 2010 208.2; 502.1 CBC 2010 1129B.3.2 CBC 2013 11B-208.2.4 Priority 1 Severity 2 FY 23-24 Maintenance Work</p>	<p>1 JOB \$350 \$350</p>
---	--	---------------------------------

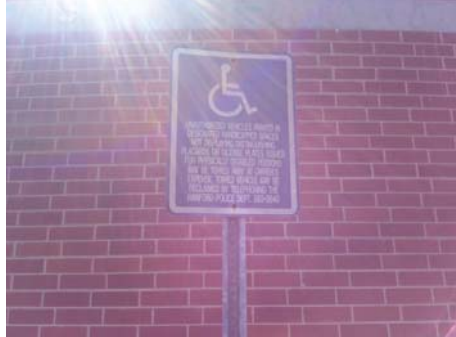
Item No. and Name	Existing Architectural Barrier and Proposed Solution	Codes / Mitigation Info	Qty	Unit	Cost	Total
<u>Parking Signage</u>						
3703	<ul style="list-style-type: none"> <i>As-Built Description:</i> CA only: Additional Sign or additional language below the symbol of accessibility stating "Minimum Fine \$250" not provided. <i>Proposed Solution:</i> Provide compliant parking signage that includes fine information. 	PCODE EA04G CBC 2010 1129B.4 CBC 2013 11B-502.6.2 Priority 1 Severity 4 FY 23-24 Maintenance Work	1	JOB	\$100	\$100

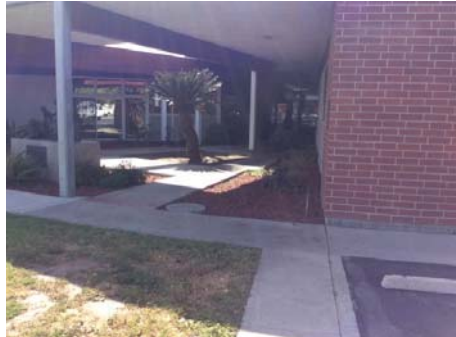
2 POT from Accessible Parking to Entrance

<u>Route Sign</u>						
3706	<ul style="list-style-type: none"> <i>As-Built Description:</i> No sign by inaccessible route directing persons to an accessible route. <i>Proposed Solution:</i> Provide directional sign. 	PCODE SA20 ADAAG 35.163(b) ADA 2010 216.3 CBC 2010 1127B.3 CBC 2013 11B-216.3 Priority 1 Severity 3 FY 23-24 Maintenance Work	1	JOB	\$170	\$170

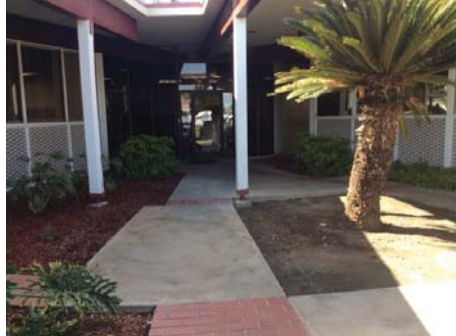
<u>Signage</u>						
3707	<ul style="list-style-type: none"> <i>As-Built Description:</i> Accessible building entrance when not all are accessible not identified with a sign showing the International Symbol of Accessibility. <i>Proposed Solution:</i> Provide building entrance sign that shows international symbol at accessible entrance. 	PCODE SA12 ADAAG 4.1.2(7)(c) ADA 2010 216.6 CBC 2010 1127B.3 CBC 2013 11B-216.6 Priority 1 Severity 3 FY 23-24 Maintenance Work	1	JOB	\$50	\$50

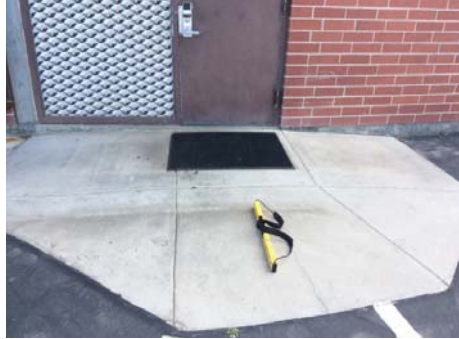
Item No. and Name	Existing Architectural Barrier and Proposed Solution	Codes / Mitigation Info	Qty	Unit	Cost	Total
<u>Curb Ramp</u>						
3710	<ul style="list-style-type: none"> <i>As-Built Description:</i> Detectable warning not provided where pedestrian crosses vehicular area. <i>Proposed Solution:</i> Provide detectable warning surface (i.e. in-line truncated domes) at regular curb ramp. 	PCODE EH07AREF ADAAG 4.7.7 ADA 2010 705.1 CBC 2010 1127B.5.7 CBC 2013 11B-705.1.2.2 Priority 1 Severity 3 FY 23-24 Maintenance Work				
						REF

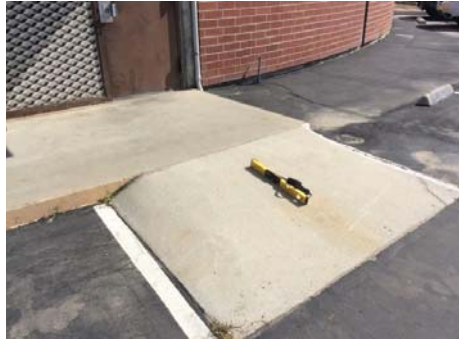
5 Conference Room Door

<u>Curb Ramp</u>						
3713	<ul style="list-style-type: none"> <i>As-Built Description:</i> Detectable warning not provided where pedestrian crosses vehicular area. <i>Proposed Solution:</i> Provide detectable warning surface (i.e. in-line truncated domes) at regular curb ramp. 	PCODE EH07AREF ADAAG 4.7.7 ADA 2010 705.1 CBC 2010 1127B.5.7 CBC 2013 11B-705.1.2.2 Priority 1 Severity 3 FY 23-24 Maintenance Work				
						REF

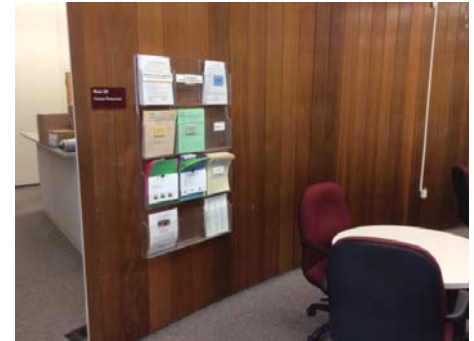
Brochure Bins

3590	<ul style="list-style-type: none"> <i>As-Built Description:</i> Information brochure bins mounted above accessible height of 48". <i>As-Built:</i> Provide same information at lower bins, 34"-70" <i>Proposed Solution:</i> Relocate/remount bins at accessible height. 	PCODE IN08 ADAAG 4.2.5 & 6 ADA 2010 308.2.1 CBC 2010 1118B.5 CBC 2013 11B-308.2.1 Priority 1 Severity 1 FY 23-24 Maintenance Work	1	JOB	\$100	\$100
------	---	--	---	-----	-------	-------

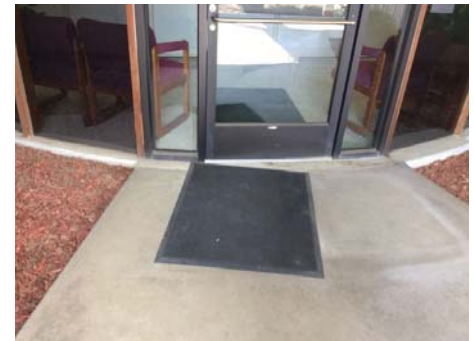
Carpet/Doormat

3583	<ul style="list-style-type: none"> <i>As-Built Description:</i> Doormat not securely attached to ground or floor structure. <i>Proposed Solution:</i> Attach doormat to floor surface or remove doormat. 	PCODE ID05A ADAAG 4.5.3 ADA 2010 302.2 CBC 2010 1124B.3 CBC 2013 11B-302.2 Priority 1 Severity 3 FY 23-24 Maintenance Work	2	JOB	\$75	\$150
------	--	---	---	-----	------	-------

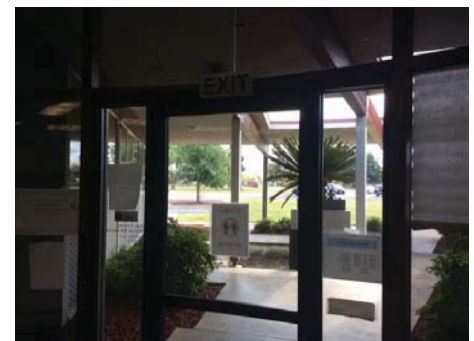
Door Closer

3586	<ul style="list-style-type: none"> <i>As-Built Description:</i> Excessive force required to open door. <i>As-Built:</i> 8 lbs <i>Proposed Solution:</i> Adjust regular door closer to accessible standards (5 lbs max). 	PCODE ID03 ADAAG 4.13.11 ADA 2010 404.2.9 CBC 2010 1133B.2.5 CBC 2013 11B-404.2.9 Priority 1 Severity 4 FY 23-24 Maintenance Work	1	JOB	\$25	\$25
------	--	--	---	-----	------	------

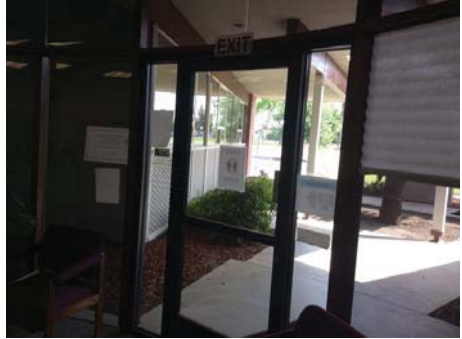
Item No. and Name	Existing Architectural Barrier and Proposed Solution	Codes / Mitigation Info	Qty	Unit	Cost	Total
Signage						
3587	<ul style="list-style-type: none"> <i>As-Built Description:</i> At final exit door to exterior: Where required exit signs are installed, signs to provide exiting information for people with vision impairment are not provided. <i>Proposed Solution:</i> Provide raised letter/Braille "EXIT" sign at door. 	PCODE SA10A ADAAG 4.1.3(16) ADA 2010 216.4.1 CBC 2010 1011.3 CBC 2013 11B-216.4.1 Priority 1 Severity 3 FY 23-24 Maintenance Work	1	JOB	\$90	\$90

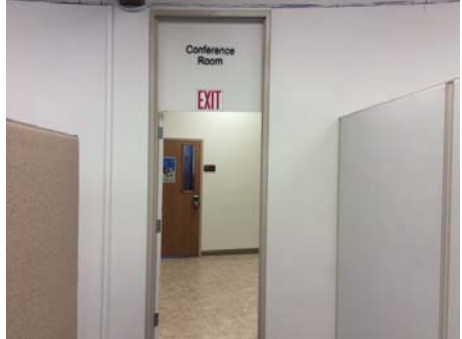
3593	<ul style="list-style-type: none"> <i>As-Built Description:</i> At door leading into exit corridor: Where required exit signs are installed, signs to provide exiting information for people with vision impairment are not provided. <i>Proposed Solution:</i> Provide raised letter/Braille "EXIT ROUTE" sign at door. 	PCODE SA10D ADAAG 4.1.3(16) ADA 2010 216.4.1 CBC 2010 1011.3 CBC 2013 11B-216.4.1 Priority 1 Severity 3 FY 23-24 Maintenance Work	1	JOB	\$90	\$90

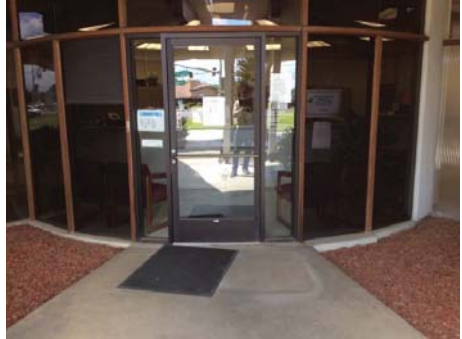
3584	<ul style="list-style-type: none"> <i>As-Built Description:</i> Accessible building entrance when not all are accessible not identified with a sign showing the International Symbol of Accessibility. <i>Proposed Solution:</i> Provide building entrance sign that shows international symbol at accessible entrance. 	PCODE SA12 ADAAG 4.1.2(7)(c) ADA 2010 216.6 CBC 2010 1127B.3 CBC 2013 11B-216.6 Priority 1 Severity 3 FY 23-24 Maintenance Work	1	JOB	\$50	\$50

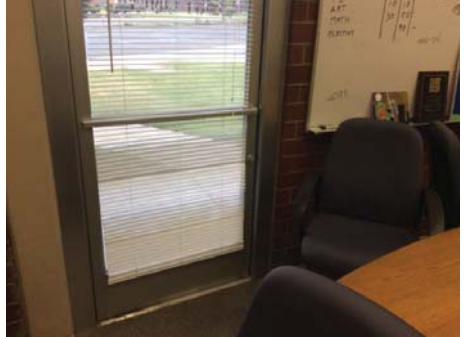
Item No. and Name	Existing Architectural Barrier and Proposed Solution	Codes / Mitigation Info	Qty	Unit	Cost	Total
<u>Door Closer</u>						
3606	<ul style="list-style-type: none"> As-Built Description: Excessive force required to open door. As-Built: 7 lbs Proposed Solution: Adjust regular door closer to accessible standards (5 lbs max). 	PCODE ID03 ADAAG 4.13.11 ADA 2010 404.2.9 CBC 2010 1133B.2.5 CBC 2013 11B-404.2.9 Priority 1 Severity 4 FY 23-24 Maintenance Work	1	JOB	\$25	\$25

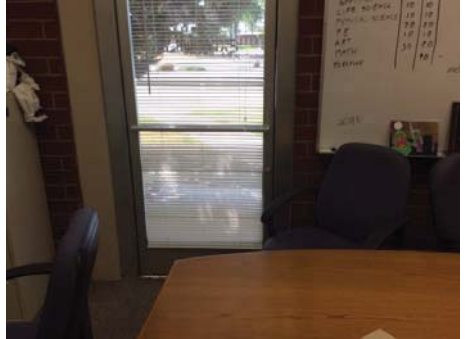
<u>Door Swing</u>						
3604	<ul style="list-style-type: none"> As-Built Description: Front approach: At push side, door does not have clear and level maneuvering space measuring door width x 48" (door width plus 12" if door has both, latch and closer). As-Built: 38" Proposed Solution: Change door swing. 	PCODE ID24 ADAAG Fig. 25(a) ADA 2010 404.2.4 CBC 2010 11B-26A(a) CBC 2013 11B-404.2.4 Priority 1 Severity 3 FY 23-24 Maintenance Work	1	JOB	\$500	\$500

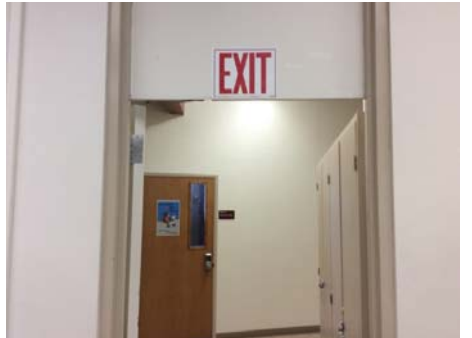
<u>Signage</u>						
3630	<ul style="list-style-type: none"> As-Built Description: At door leading into exit corridor: Where required exit signs are installed, signs to provide exiting information for people with vision impairment are not provided. Proposed Solution: Provide raised letter/Braille "EXIT ROUTE" sign at door. 	PCODE SA10D ADAAG 4.1.3(16) ADA 2010 216.4.1 CBC 2010 1011.3 CBC 2013 11B-216.4.1 Priority 1 Severity 3 FY 23-24 Maintenance Work	1	JOB	\$90	\$90

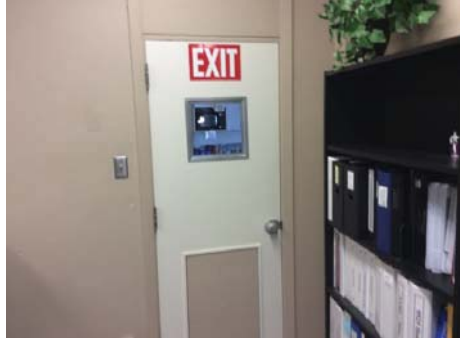
Item No. and Name	Existing Architectural Barrier and Proposed Solution	Codes / Mitigation Info	Qty	Unit	Cost	Total
Signage						
3698	<ul style="list-style-type: none"> <i>As-Built Description:</i> At door leading into exit corridor: Where required exit signs are installed, signs to provide exiting information for people with vision impairment are not provided. <i>Proposed Solution:</i> Provide raised letter/Braille "EXIT ROUTE" sign at door. 	PCODE SA10D ADAAG 4.1.3(16) ADA 2010 216.4.1 CBC 2010 1011.3 CBC 2013 11B-216.4.1 Priority 1 Severity 3 FY 23-24 Maintenance Work	1	JOB	\$90	\$90

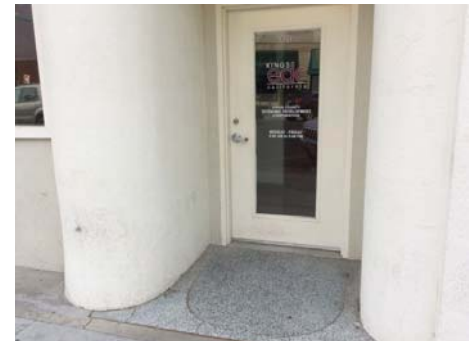
Door Swing

3871 • *As-Built Description:*
 Front approach: At push side, door does not have clear and level maneuvering space measuring door width x 48" (door width plus 12" if door has both, latch and closer).

PCODE ID24C
ADAAG Fig. 25(a)
ADA 2010 404.2.4
CBC 2010 11B-26A(a)
CBC 2013 11B-404.2.4
Priority 1
Severity 3
FY 23-24 Maintenance Work

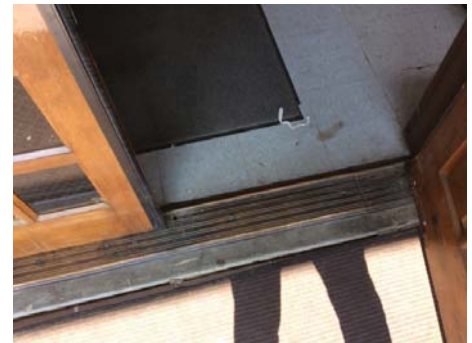
Carpet/Doormat

943	<ul style="list-style-type: none"> <i>As-Built Description:</i> Doormat not securely attached to ground or floor structure. <i>Proposed Solution:</i> Attach doormat to floor surface or remove doormat. 	PCODE ID05A ADAAG 4.5.3 ADA 2010 302.2 CBC 2010 1124B.3 CBC 2013 11B-302.2 Priority 1 Severity 3 FY 23-24 Maintenance Work	2	JOB	\$75	\$150
-----	--	---	---	-----	------	-------

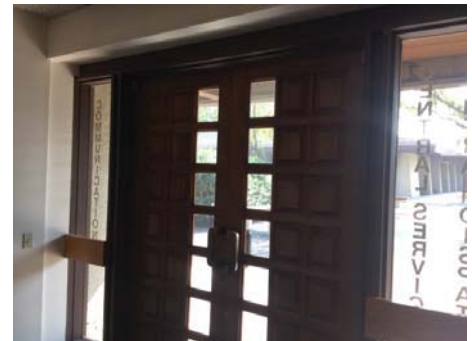
Door Closer

944	<ul style="list-style-type: none"> <i>As-Built Description:</i> Excessive force required to open door. <i>As-Built:</i> 10-12 lbs <i>Proposed Solution:</i> Adjust regular door closer to accessible standards (5 lbs max). 	PCODE ID03 ADAAG 4.13.11 ADA 2010 404.2.9 CBC 2010 1133B.2.5 CBC 2013 11B-404.2.9 Priority 1 Severity 3 FY 23-24 Maintenance Work	2	JOB	\$25	\$50
-----	--	--	---	-----	------	------

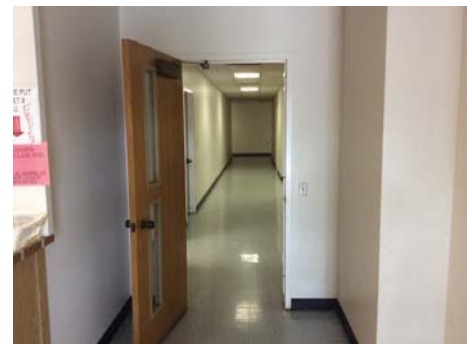
950	<ul style="list-style-type: none"> <i>As-Built Description:</i> Excessive force required to open door. <i>As-Built:</i> 8 lbs <i>Proposed Solution:</i> Adjust regular door closer to accessible standards (5 lbs max). 	PCODE ID03 ADAAG 4.13.11 ADA 2010 404.2.9 CBC 2010 1133B.2.5 CBC 2013 11B-404.2.9 Priority 1 Severity 4 FY 23-24 Maintenance Work	1	JOB	\$25	\$25
-----	--	--	---	-----	------	------

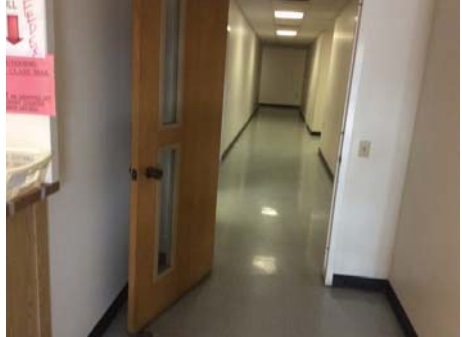
Item No. and Name	Existing Architectural Barrier and Proposed Solution	Codes / Mitigation Info	Qty	Unit	Cost	Total
<u>Door Hardware</u>						
949	<ul style="list-style-type: none"> • <i>As-Built Description:</i> Door does not have accessible operating hardware. • <i>Proposed Solution:</i> Provide lever handle or other accessible hardware. 	PCODE ID07 ADAAG 4.13.9 ADA 2010 404.2.7 CBC 2010 1133B.2.5.2 CBC 2013 11B-404.2.7 Priority 1 Severity 3 FY 23-24 Maintenance Work	1	JOB	\$250	\$250

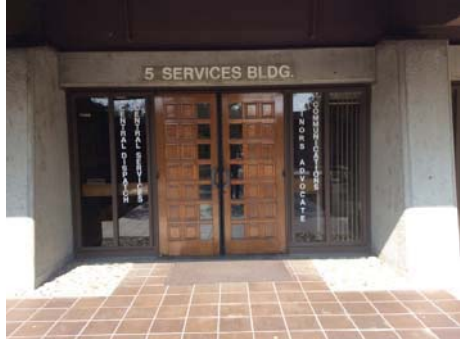
<u>Signage</u>						
941	<ul style="list-style-type: none"> • <i>As-Built Description:</i> Existing sign designating permanent room or space is noncompliant. • <i>Proposed Solution:</i> Provide compliant signage. 	PCODE SA13 ADAAG 4.1.3(16)(a) ADA 2010 216.2 CBC 2010 1117B.5 CBC 2013 11B-216.2 Priority 1 Severity 4 FY 23-24 Maintenance Work	1	JOB	\$150	\$150

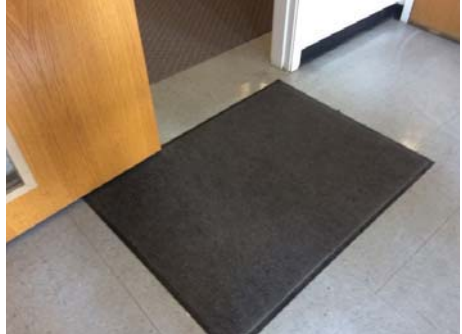
<u>Carpet/Doormat</u>						
953	<ul style="list-style-type: none"> • <i>As-Built Description:</i> Doormat not securely attached to ground or floor structure. • <i>Proposed Solution:</i> Attach doormat to floor surface or remove doormat. 	PCODE ID05A ADAAG 4.5.3 ADA 2010 302.2 CBC 2010 1124B.3 CBC 2013 11B-302.2 Priority 1 Severity 3 FY 23-24 Maintenance Work	1	JOB	\$75	\$75

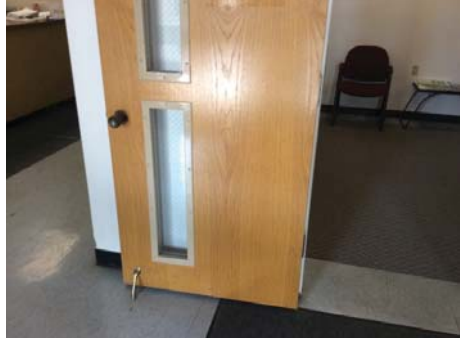
Item No. and Name	Existing Architectural Barrier and Proposed Solution	Codes / Mitigation Info	Qty	Unit	Cost	Total
<u>Door Hardware</u>						
951	<ul style="list-style-type: none"> • <i>As-Built Description:</i> Door does not have accessible operating hardware. • <i>Proposed Solution:</i> Provide lever handle or other accessible hardware. 	PCODE ID07 ADAAG 4.13.9 ADA 2010 404.2.7 CBC 2010 1133B.2.5.2 CBC 2013 11B-404.2.7 Priority 1 Severity 3 FY 23-24 Maintenance Work	1	JOB	\$250	\$250

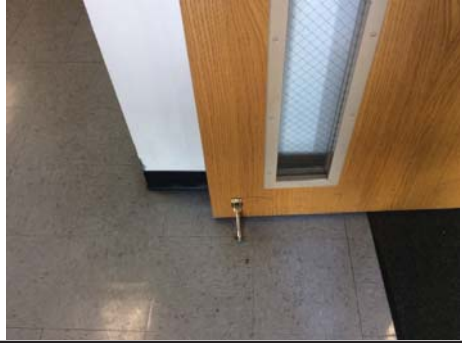
<u>Door Stopper</u>						
952	<ul style="list-style-type: none"> • <i>As-Built Description:</i> At push side of door on accessible route, bottom 10" does not have a smooth, uninterrupted surface. • <i>Proposed Solution:</i> Remove door stopper when altering area. Provide rubber wedge. 	PCODE ID06A ADA 2010 404.2.10 CBC 2010 1133B.2.6 CBC 2013 11B-404.2.10 Priority 1 Severity 3 FY 23-24 Maintenance Work	1	JOB	\$25	\$25

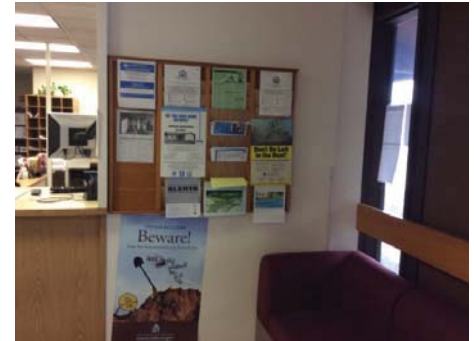
Brochure Bins

771	<ul style="list-style-type: none"> <i>As-Built Description:</i> Information brochure bins mounted above accessible height of 48". <i>As-Built:</i> 48"-63" <i>Proposed Solution:</i> Relocate/remount bins at accessible height. 	<p>PCODE IN08 ADAAG 4.2.5 & 6 ADA 2010 308.2.1 CBC 2010 1118B.5 CBC 2013 11B-308.2.1 Priority 1 Severity 2 FY 23-24 Maintenance Work</p>	1	JOB	\$100	\$100
-----	---	---	---	-----	-------	-------

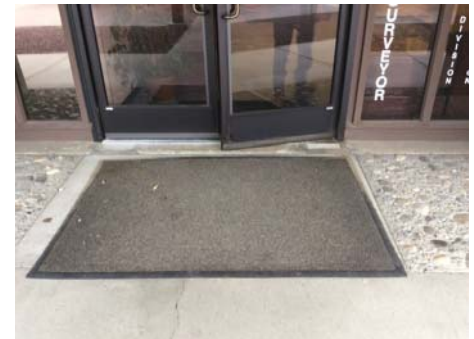
Carpet/Doormat

765	<ul style="list-style-type: none"> <i>As-Built Description:</i> Doormat not securely attached to ground or floor structure. <i>Proposed Solution:</i> Attach doormat to floor surface or remove doormat. 	<p>PCODE ID05A ADAAG 4.5.3 ADA 2010 302.2 CBC 2010 1124B.3 CBC 2013 11B-302.2 Priority 1 Severity 3 FY 23-24 Maintenance Work</p>	2	JOB	\$75	\$150
-----	--	--	---	-----	------	-------

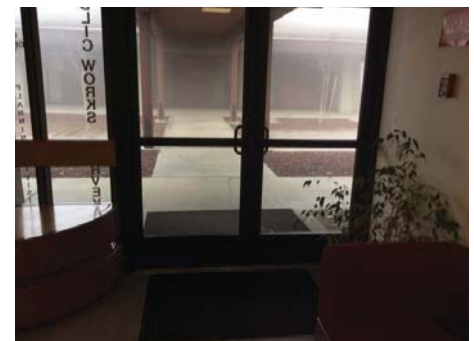
Door Closer

770	<ul style="list-style-type: none"> <i>As-Built Description:</i> Excessive force required to open door. <i>As-Built:</i> 7 lbs <i>Proposed Solution:</i> Adjust regular door closer to accessible standards (5 lbs max). 	<p>PCODE ID03 ADAAG 4.13.11 ADA 2010 404.2.9 CBC 2010 1133B.2.5 CBC 2013 11B-404.2.9 Priority 1 Severity 4 FY 23-24 Maintenance Work</p>	2	JOB	\$25	\$50
-----	--	---	---	-----	------	------

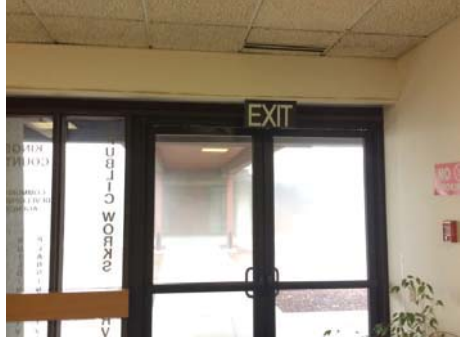
Item No. and Name	Existing Architectural Barrier and Proposed Solution	Codes / Mitigation Info	Qty	Unit	Cost	Total
Signage						
766	<ul style="list-style-type: none"> <i>As-Built Description:</i> At final exit door to exterior: Where required exit signs are installed, signs to provide exiting information for people with vision impairment are not provided. <i>Proposed Solution:</i> Provide raised letter/Braille "EXIT" sign at door. 	PCODE SA10A ADAAG 4.1.3(16) ADA 2010 216.4.1 CBC 2010 1011.3 CBC 2013 11B-216.4.1 Priority 1 Severity 3 FY 23-24 Maintenance Work	1	JOB	\$90	\$90

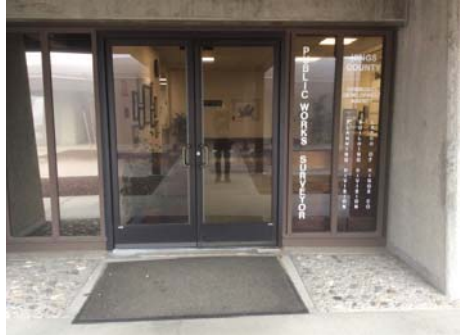
764	<ul style="list-style-type: none"> <i>As-Built Description:</i> Existing sign designating permanent room or space is noncompliant. <i>Proposed Solution:</i> Provide compliant signage. 	PCODE SA13 ADAAG 4.1.3(16)(a) ADA 2010 216.2 CBC 2010 1117B.5 CBC 2013 11B-216.2 Priority 1 Severity 4 FY 23-24 Maintenance Work	1	JOB	\$150	\$150

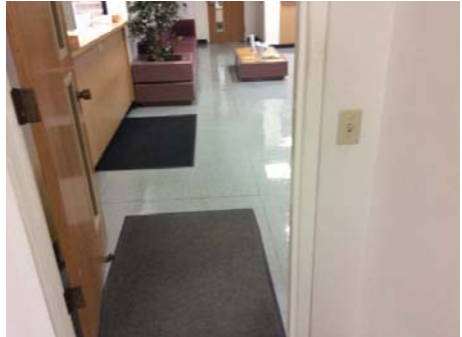
Door Swing

813	<ul style="list-style-type: none"> <i>As-Built Description:</i> Front approach: At push side, door does not have clear and level maneuvering space measuring door width x 48" (door width plus 12" if door has both, latch and closer). <i>As-Built:</i> 9.5" to wall <i>Proposed Solution:</i> Provide door operator. 	PCODE ID24C ADAAG Fig. 25(a) ADA 2010 404.2.4 CBC 2010 11B-26A(a) CBC 2013 11B-404.2.4 Priority 1 Severity 4 FY 23-24 Maintenance Work	1	JOB	\$5,000	\$5,000

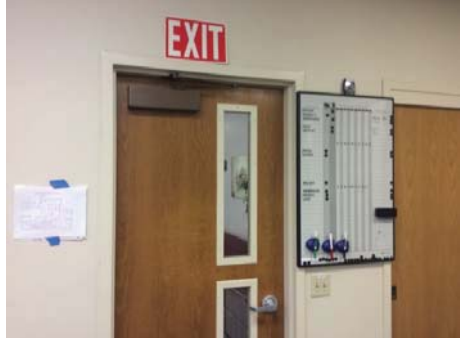
Item No. and Name	Existing Architectural Barrier and Proposed Solution	Codes / Mitigation Info	Qty	Unit	Cost	Total
Signage						
857	<ul style="list-style-type: none"> <i>As-Built Description:</i> At door leading into exit corridor: Where required exit signs are installed, signs to provide exiting information for people with vision impairment are not provided. <i>Proposed Solution:</i> Provide raised letter/Braille "EXIT ROUTE" sign at door. 	PCODE SA10D ADAAG 4.1.3(16) ADA 2010 216.4.1 CBC 2010 1011.3 CBC 2013 11B-216.4.1 Priority 1 Severity 3 FY 23-24 Maintenance Work	1	JOB	\$90	\$90

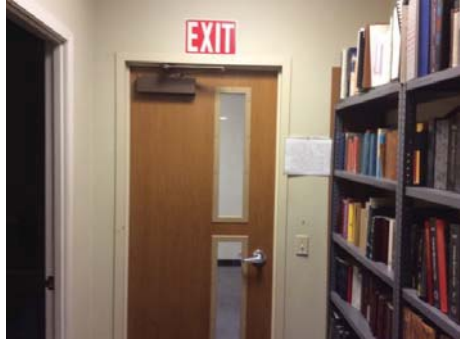
860	<ul style="list-style-type: none"> <i>As-Built Description:</i> At door leading into exit corridor: Where required exit signs are installed, signs to provide exiting information for people with vision impairment are not provided. <i>Proposed Solution:</i> Provide raised letter/Braille "EXIT ROUTE" sign at door. 	PCODE SA10D ADAAG 4.1.3(16) ADA 2010 216.4.1 CBC 2010 1011.3 CBC 2013 11B-216.4.1 Priority 1 Severity 3 FY 23-24 Maintenance Work	1	JOB	\$90	\$90

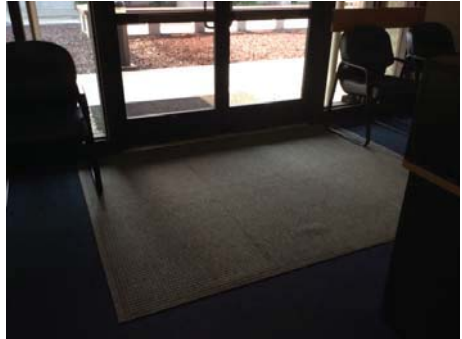
Carpet/Doormat

881	<ul style="list-style-type: none"> <i>As-Built Description:</i> Doormat not securely attached to ground or floor structure. <i>Proposed Solution:</i> Attach doormat to floor surface or remove doormat. 	PCODE ID05A ADAAG 4.5.3 ADA 2010 302.2 CBC 2010 1124B.3 CBC 2013 11B-302.2 Priority 1 Severity 3 FY 23-24 Maintenance Work	1	JOB	\$75	\$75

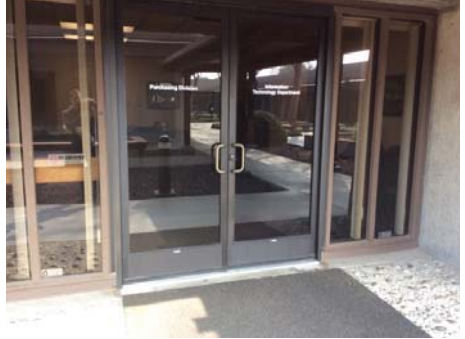
Item No. and Name	Existing Architectural Barrier and Proposed Solution	Codes / Mitigation Info	Qty	Unit	Cost	Total
<u>Door Closer</u>						
878	<ul style="list-style-type: none"> As-Built Description: Excessive force required to open door. As-Built: 10 lbs Proposed Solution: Adjust regular door closer to accessible standards (5 lbs max). 	PCODE ID03 ADAAG 4.13.11 ADA 2010 404.2.9 CBC 2010 1133B.2.5 CBC 2013 11B-404.2.9 Priority 1 Severity 4 FY 23-24 Maintenance Work	2	JOB	\$25	\$50

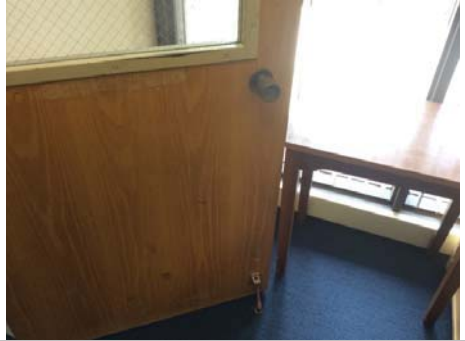
<u>Door Hardware</u>						
886	<ul style="list-style-type: none"> As-Built Description: Door does not have accessible operating hardware. As-Built: purchasing Proposed Solution: Provide lever handle or other accessible hardware. 	PCODE ID07 ADAAG 4.13.9 ADA 2010 404.2.7 CBC 2010 1133B.2.5.2 CBC 2013 11B-404.2.7 Priority 1 Severity 3 FY 23-24 Maintenance Work	1	JOB	\$250	\$250
