Facility: **WOMENS INFANTS & CHILDREN**

Address: 330 HARRIS ST.

Facility: **LEMORE HEALTH CLINIC**
 Address: 229 C ST.

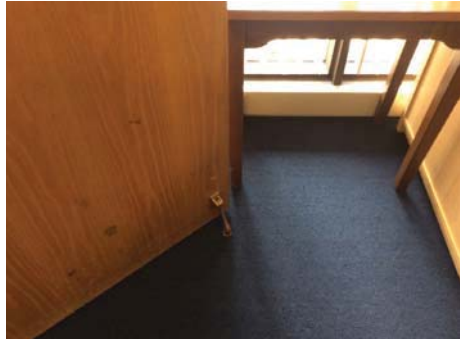
<u>Door Stopper</u>						
887	<ul style="list-style-type: none"> As-Built Description: At push side of door on accessible route, bottom 10" does not have a smooth, uninterrupted surface. As-Built: purchasing Proposed Solution: Remove door stopper when altering area. Provide rubber wedge. 	PCODE ID06A ADA 2010 404.2.10 CBC 2010 1133B.2.6 CBC 2013 11B-404.2.10 Priority 1 Severity 3 FY 23-24 Maintenance Work	1	JOB	\$25	\$25

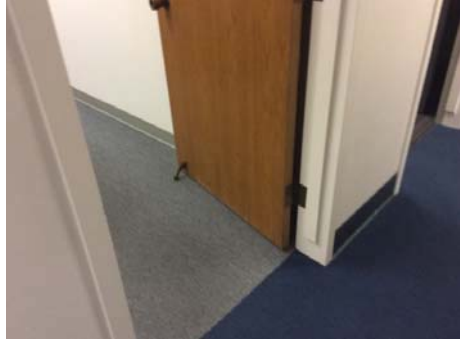
Item No. and Name	Existing Architectural Barrier and Proposed Solution	Codes / Mitigation Info	Qty	Unit	Cost	Total
891	<ul style="list-style-type: none"> <i>As-Built Description:</i> At push side of door on accessible route, bottom 10" does not have a smooth, uninterrupted surface. <i>Proposed Solution:</i> Remove door stopper when altering area. Provide rubber wedge. 	PCODE ID06A ADA 2010 404.2.10 CBC 2010 1133B.2.6 CBC 2013 11B-404.2.10 Priority 1 Severity 3 FY 23-24 Maintenance Work	4	JOB	\$25	\$100

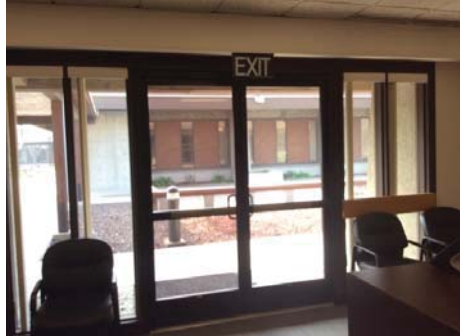
880	<ul style="list-style-type: none"> <i>As-Built Description:</i> At final exit door to exterior: Where required exit signs are installed, signs to provide exiting information for people with vision impairment are not provided. <i>Proposed Solution:</i> Provide raised letter/Braille "EXIT" sign at door. 	PCODE SA10A ADAAG 4.1.3(16) ADA 2010 216.4.1 CBC 2010 1011.3 CBC 2013 11B-216.4.1 Priority 1 Severity 3 FY 23-24 Maintenance Work	1	JOB	\$90	\$90

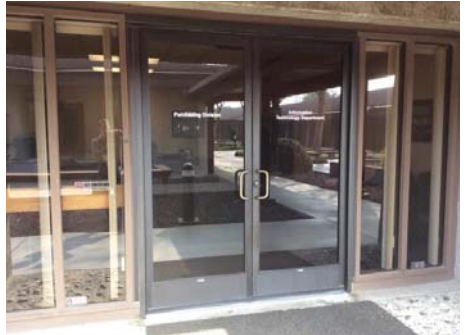
879	<ul style="list-style-type: none"> <i>As-Built Description:</i> Existing sign designating permanent room or space is noncompliant. <i>Proposed Solution:</i> Provide compliant signage. 	PCODE SA13 ADAAG 4.1.3(16)(a) ADA 2010 216.2 CBC 2010 1117B.5 CBC 2013 11B-216.2 Priority 1 Severity 4 FY 23-24 Maintenance Work	2	JOB	\$150	\$300

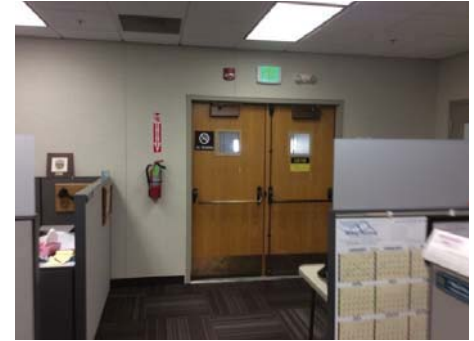
Item No. and Name	Existing Architectural Barrier and Proposed Solution	Codes / Mitigation Info	Qty	Unit	Cost	Total
Signage						
906	<ul style="list-style-type: none"> <i>As-Built Description:</i> At door leading into exit corridor: Where required exit signs are installed, signs to provide exiting information for people with vision impairment are not provided. <i>Proposed Solution:</i> Provide raised letter/Braille "EXIT ROUTE" sign at door. 	PCODE SA10D ADAAG 4.1.3(16) ADA 2010 216.4.1 CBC 2010 1011.3 CBC 2013 11B-216.4.1 Priority 1 Severity 3 FY 23-24 Maintenance Work	1	JOB	\$90	\$90

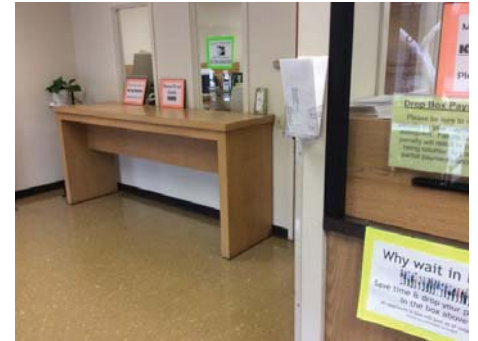
Brochure Bins

581	<ul style="list-style-type: none"> As-Built Description: Information brochure bins mounted above accessible height of 48". As-Built: 57" Proposed Solution: Relocate/remount bins at accessible height. 	<p>PCODE IN08</p> <p>ADAAG 4.2.5 & 6</p> <p>ADA 2010 308.2.1</p> <p>CBC 2010 1118B.5</p> <p>CBC 2013 11B-308.2.1</p> <p>Priority 1</p> <p>Severity 3</p> <p>FY 23-24 Maintenance Work</p>	1	JOB	\$100	\$100
-----	--	---	---	-----	-------	-------

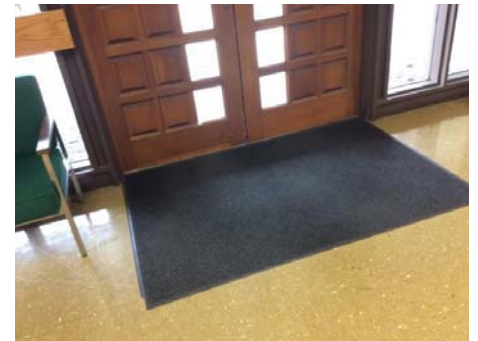
Door

579	<ul style="list-style-type: none"> As-Built Description: At push side of door on accessible route, bottom 10" does not have a smooth, uninterrupted surface. As-Built: 8.5" Proposed Solution: Provide 10" min. "kick plate" covering width of door when altering area. 	<p>PCODE ID06</p> <p>ADA 2010 404.2.10</p> <p>CBC 2010 1133B.2.6</p> <p>CBC 2013 11B-404.2.10</p> <p>Priority 1</p> <p>Severity 3</p> <p>FY 23-24 Maintenance Work</p>	4	JOB	\$100	\$400
-----	--	---	---	-----	-------	-------

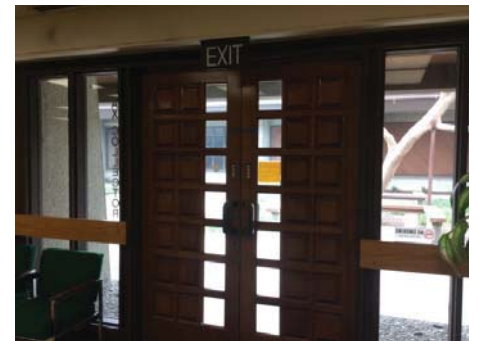
Door Closer

578	<ul style="list-style-type: none"> As-Built Description: Excessive force required to open door. As-Built: 9-10 lbs Proposed Solution: Adjust regular door closer to accessible standards (5 lbs max). 	<p>PCODE ID03</p> <p>ADAAG 4.13.11</p> <p>ADA 2010 404.2.9</p> <p>CBC 2010 1133B.2.5</p> <p>CBC 2013 11B-404.2.9</p> <p>Priority 1</p> <p>Severity 4</p> <p>FY 23-24 Maintenance Work</p>	4	JOB	\$25	\$100
-----	--	---	---	-----	------	-------

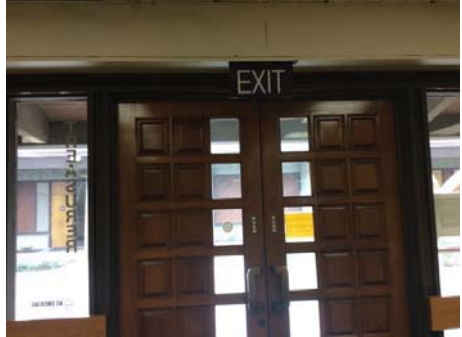
Item No. and Name	Existing Architectural Barrier and Proposed Solution	Codes / Mitigation Info	Qty	Unit	Cost	Total
Signage						
574	<ul style="list-style-type: none"> <i>As-Built Description:</i> At final exit door to exterior: Where required exit signs are installed, signs to provide exiting information for people with vision impairment are not provided. <i>Proposed Solution:</i> Provide raised letter/Braille "EXIT" sign at door. 	PCODE SA10A ADAAG 4.1.3(16) ADA 2010 216.4.1 CBC 2010 1011.3 CBC 2013 11B-216.4.1 Priority 1 Severity 3 FY 23-24 Maintenance Work	2	JOB	\$90	\$180

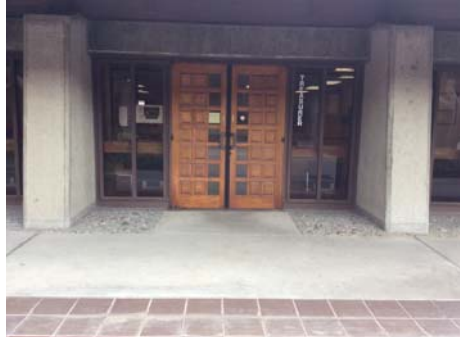
573	<ul style="list-style-type: none"> <i>As-Built Description:</i> Existing sign designating permanent room or space is noncompliant. <i>Proposed Solution:</i> Provide compliant signage and ISA. 	PCODE SA13 ADAAG 4.1.3(16)(a) ADA 2010 216.2 CBC 2010 1117B.5 CBC 2013 11B-216.2 Priority 1 Severity 4 FY 23-24 Maintenance Work	2	JOB	\$150	\$300

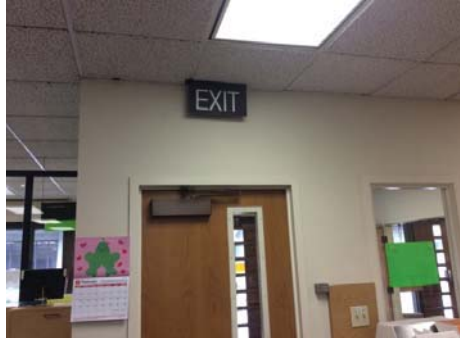
Signage						
587	<ul style="list-style-type: none"> <i>As-Built Description:</i> At door leading into exit corridor: Where required exit signs are installed, signs to provide exiting information for people with vision impairment are not provided. <i>Proposed Solution:</i> Provide raised letter/Braille "EXIT ROUTE" sign at door. 	PCODE SA10D ADAAG 4.1.3(16) ADA 2010 216.4.1 CBC 2010 1011.3 CBC 2013 11B-216.4.1 Priority 1 Severity 3 FY 23-24 Maintenance Work	1	JOB	\$90	\$90

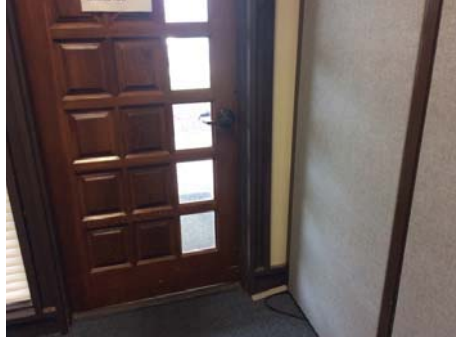
Item No. and Name	Existing Architectural Barrier and Proposed Solution	Codes / Mitigation Info	Qty	Unit	Cost	Total
<u>Door Swing</u>						
603	<ul style="list-style-type: none"> • <i>As-Built Description:</i> Front approach: At push side, door does not have clear and level maneuvering space measuring door width x 48" (door width plus 12" if door has both, latch and closer). • <i>As-Built:</i> 9" • <i>Proposed Solution:</i> Remove or relocate furniture or storage items. 	PCODE ID24A ADAAG Fig. 25(a) ADA 2010 404.2.4 CBC 2010 11B-26A(a) CBC 2013 11B-404.2.4 Priority 1 Severity 4 FY 23-24 Maintenance Work	1	JOB	\$50	\$50

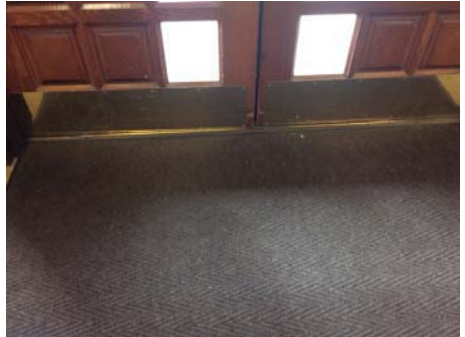
<u>Door</u>						
613	<ul style="list-style-type: none"> • <i>As-Built Description:</i> At push side of door on accessible route, bottom 10" does not have a smooth, uninterrupted surface. • <i>As-Built:</i> 8.5" • <i>Proposed Solution:</i> Provide 10" min. "kick plate" covering width of door when altering area. 	PCODE ID06 ADA 2010 404.2.10 CBC 2010 1133B.2.6 CBC 2013 11B-404.2.10 Priority 1 Severity 3 FY 23-24 Maintenance Work	1	JOB	\$100	\$100

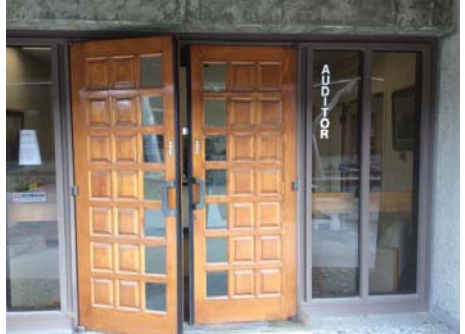
<u>Door Closer</u>						
615	<ul style="list-style-type: none"> • <i>As-Built Description:</i> Excessive force required to open door. • <i>As-Built:</i> 10 lbs • <i>Proposed Solution:</i> Adjust regular door closer to accessible standards (5 lbs max). 	PCODE ID03 ADAAG 4.13.11 ADA 2010 404.2.9 CBC 2010 1133B.2.5 CBC 2013 11B-404.2.9 Priority 1 Severity 4 FY 23-24 Maintenance Work	1	JOB	\$25	\$25

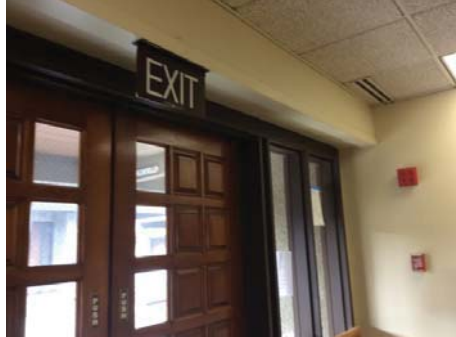
Item No. and Name	Existing Architectural Barrier and Proposed Solution	Codes / Mitigation Info	Qty	Unit	Cost	Total
Signage						
610	<ul style="list-style-type: none"> <i>As-Built Description:</i> At final exit door to exterior: Where required exit signs are installed, signs to provide exiting information for people with vision impairment are not provided. <i>Proposed Solution:</i> Provide raised letter/Braille "EXIT" sign at door. 	PCODE SA10A ADAAG 4.1.3(16) ADA 2010 216.4.1 CBC 2010 1011.3 CBC 2013 11B-216.4.1 Priority 1 Severity 3 FY 23-24 Maintenance Work	1	JOB	\$90	\$90

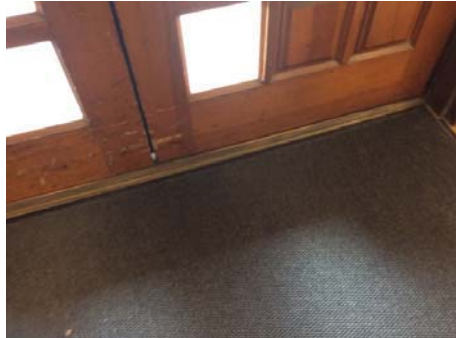
Door						
620	<ul style="list-style-type: none"> <i>As-Built Description:</i> At push side of door on accessible route, bottom 10" does not have a smooth, uninterrupted surface. <i>As-Built:</i> 8.5" <i>Proposed Solution:</i> Provide 10" min. "kick plate" covering width of door when altering area. 	PCODE ID06 ADA 2010 404.2.10 CBC 2010 1133B.2.6 CBC 2013 11B-404.2.10 Priority 1 Severity 3 FY 23-24 Maintenance Work	2	JOB	\$100	\$200

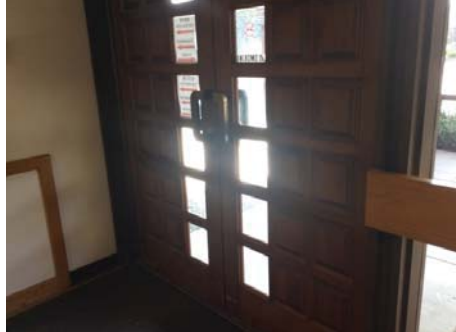
Door Closer						
621	<ul style="list-style-type: none"> <i>As-Built Description:</i> Excessive force required to open door. <i>As-Built:</i> 12 lbs <i>Proposed Solution:</i> Adjust regular door closer to accessible standards (5 lbs max). 	PCODE ID03 ADAAG 4.13.11 ADA 2010 404.2.9 CBC 2010 1133B.2.5 CBC 2013 11B-404.2.9 Priority 1 Severity 3 FY 23-24 Maintenance Work	2	JOB	\$25	\$50

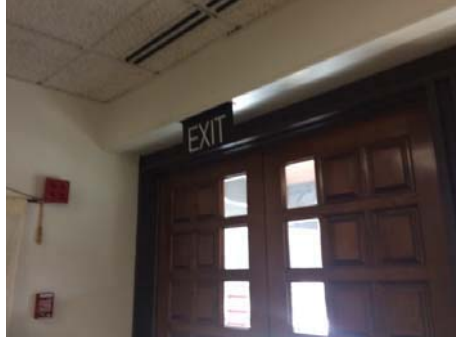
Item No. and Name	Existing Architectural Barrier and Proposed Solution	Codes / Mitigation Info	Qty	Unit	Cost	Total
Signage						
622	<ul style="list-style-type: none"> <i>As-Built Description:</i> At final exit door to exterior: Where required exit signs are installed, signs to provide exiting information for people with vision impairment are not provided. <i>Proposed Solution:</i> Provide raised letter/Braille "EXIT" sign at door. 	PCODE SA10A ADAAG 4.1.3(16) ADA 2010 216.4.1 CBC 2010 1011.3 CBC 2013 11B-216.4.1 Priority 1 Severity 3 FY 23-24 Maintenance Work	1	JOB	\$90	\$90

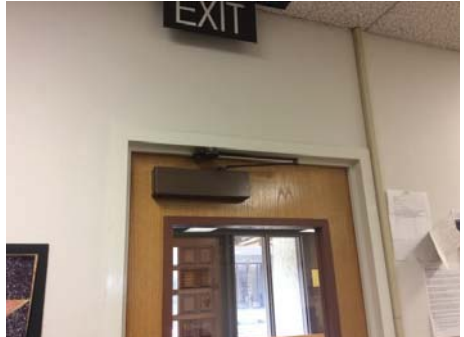
Signage						
629	<ul style="list-style-type: none"> <i>As-Built Description:</i> At door leading into exit corridor: Where required exit signs are installed, signs to provide exiting information for people with vision impairment are not provided. <i>Proposed Solution:</i> Provide raised letter/Braille "EXIT ROUTE" sign at door. 	PCODE SA10D ADAAG 4.1.3(16) ADA 2010 216.4.1 CBC 2010 1011.3 CBC 2013 11B-216.4.1 Priority 1 Severity 3 FY 23-24 Maintenance Work	1	JOB	\$90	\$90

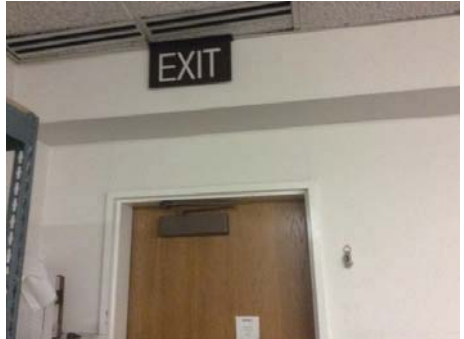
632	<ul style="list-style-type: none"> <i>As-Built Description:</i> At door leading into exit corridor: Where required exit signs are installed, signs to provide exiting information for people with vision impairment are not provided. <i>Proposed Solution:</i> Provide raised letter/Braille "EXIT ROUTE" sign at door. 	PCODE SA10D ADAAG 4.1.3(16) ADA 2010 216.4.1 CBC 2010 1011.3 CBC 2013 11B-216.4.1 Priority 1 Severity 3 FY 23-24 Maintenance Work	1	JOB	\$90	\$90

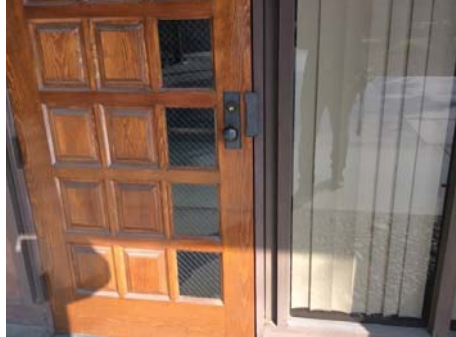
Item No. and Name	Existing Architectural Barrier and Proposed Solution	Codes / Mitigation Info	Qty	Unit	Cost	Total
<u>Door Hardware</u>						
643	<ul style="list-style-type: none"> • <i>As-Built Description:</i> Door does not have accessible operating hardware. • <i>Proposed Solution:</i> Provide lever handle or other accessible hardware. 	<p>PCODE ID07 ADAAG 4.13.9 ADA 2010 404.2.7 CBC 2010 1133B.2.5.2 CBC 2013 11B-404.2.7 Priority 1 Severity 3 FY 23-24 Maintenance Work</p>	1	JOB	\$250	\$250

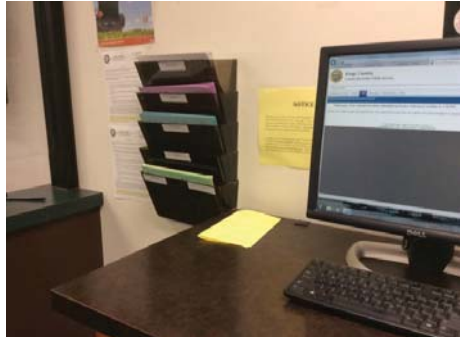
<u>Brochure Bins</u>						
649	<ul style="list-style-type: none"> • <i>As-Built Description:</i> Information brochure bins mounted above accessible height of 48". • <i>As-Built:</i> 48"-71" difficult to reach • <i>Proposed Solution:</i> Relocate/remount bins at accessible height. 	<p>PCODE IN08 ADAAG 4.2.5 & 6 ADA 2010 308.2.1 CBC 2010 1118B.5 CBC 2013 11B-308.2.1 Priority 1 Severity 1 FY 23-24 Maintenance Work</p>	1	JOB	\$100	\$100

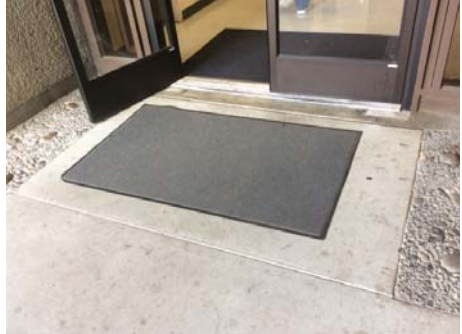
<u>Carpet/Doormat</u>						
644	<ul style="list-style-type: none"> • <i>As-Built Description:</i> Doormat not securely attached to ground or floor structure. • <i>Proposed Solution:</i> Attach doormat to floor surface or remove doormat. 	<p>PCODE ID05A ADAAG 4.5.3 ADA 2010 302.2 CBC 2010 1124B.3 CBC 2013 11B-302.2 Priority 1 Severity 3 FY 23-24 Maintenance Work</p>	2	JOB	\$75	\$150

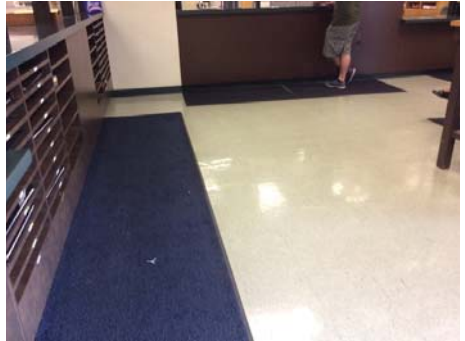
Item No. and Name	Existing Architectural Barrier and Proposed Solution	Codes / Mitigation Info	Qty	Unit	Cost	Total
646	<ul style="list-style-type: none"> <i>As-Built Description:</i> Doormat not securely attached to ground or floor structure. <i>As-Built:</i> General mats <i>Proposed Solution:</i> Attach doormat to floor surface or remove doormat. 	<p>PCODE ID05A ADAAG 4.5.3 ADA 2010 302.2 CBC 2010 1124B.3 CBC 2013 11B-302.2 Priority 1 Severity 3 FY 23-24 Maintenance Work</p>	4	JOB	\$75	\$300

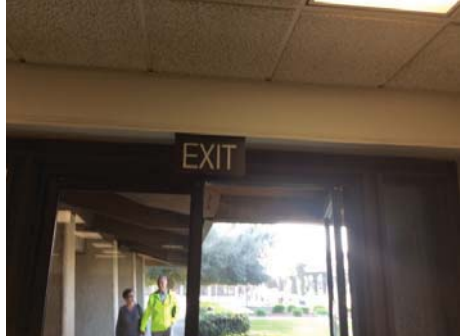
647	<ul style="list-style-type: none"> <i>As-Built Description:</i> At final exit door to exterior: Where required exit signs are installed, signs to provide exiting information for people with vision impairment are not provided. <i>Proposed Solution:</i> Provide raised letter/Braille "EXIT" sign at door. 	<p>PCODE SA10A ADAAG 4.1.3(16) ADA 2010 216.4.1 CBC 2010 1011.3 CBC 2013 11B-216.4.1 Priority 1 Severity 3 FY 23-24 Maintenance Work</p>	1	JOB	\$90	\$90

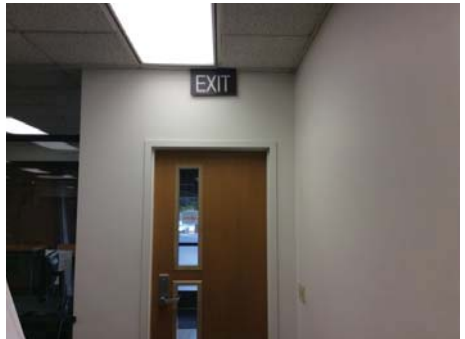
698	<ul style="list-style-type: none"> <i>As-Built Description:</i> At door leading into exit corridor: Where required exit signs are installed, signs to provide exiting information for people with vision impairment are not provided. <i>Proposed Solution:</i> Provide raised letter/Braille "EXIT ROUTE" sign at door. 	<p>PCODE SA10D ADAAG 4.1.3(16) ADA 2010 216.4.1 CBC 2010 1011.3 CBC 2013 11B-216.4.1 Priority 1 Severity 3 FY 23-24 Maintenance Work</p>	1	JOB	\$90	\$90

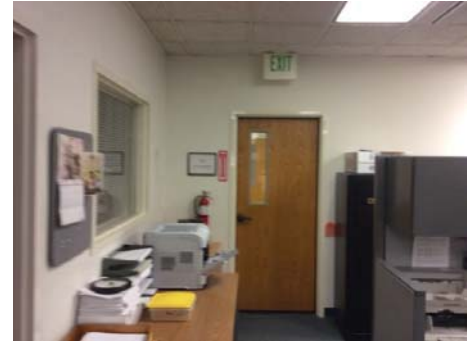
Item No. and Name	Existing Architectural Barrier and Proposed Solution	Codes / Mitigation Info	Qty	Unit	Cost	Total
708	<ul style="list-style-type: none"> <i>As-Built Description:</i> At door leading into exit corridor: Where required exit signs are installed, signs to provide exiting information for people with vision impairment are not provided. <i>Proposed Solution:</i> Provide raised letter/Braille "EXIT ROUTE" sign at door. 	PCODE SA10D ADAAG 4.1.3(16) ADA 2010 216.4.1 CBC 2010 1011.3 CBC 2013 11B-216.4.1 Priority 1 Severity 3 FY 23-24 Maintenance Work	1	JOB	\$90	\$90

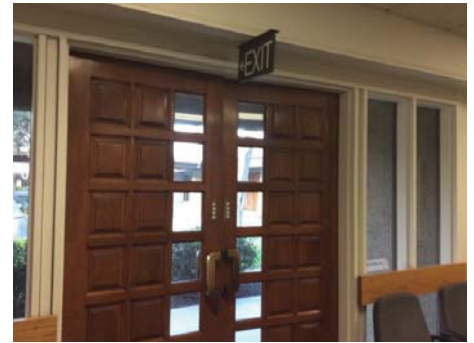
Door Closer

735	<ul style="list-style-type: none"> <i>As-Built Description:</i> Excessive force required to open door. <i>As-Built:</i> 12 lbs <i>Proposed Solution:</i> Adjust regular door closer to accessible standards (5 lbs max). 	PCODE ID03 ADAAG 4.13.11 ADA 2010 404.2.9 CBC 2010 1133B.2.5 CBC 2013 11B-404.2.9 Priority 1 Severity 3 FY 23-24 Maintenance Work	2	JOB	\$25	\$50
-----	---	--	---	-----	------	------

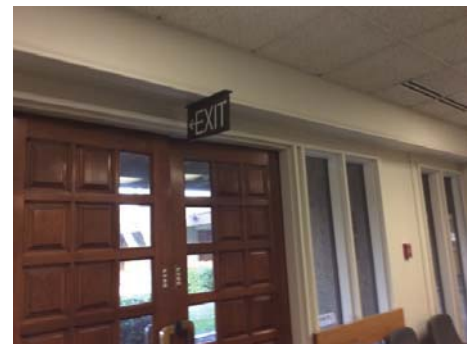
736	<ul style="list-style-type: none"> <i>As-Built Description:</i> At final exit door to exterior: Where required exit signs are installed, signs to provide exiting information for people with vision impairment are not provided. <i>Proposed Solution:</i> Provide raised letter/Braille "EXIT" sign at door. 	PCODE SA10A ADAAG 4.1.3(16) ADA 2010 216.4.1 CBC 2010 1011.3 CBC 2013 11B-216.4.1 Priority 1 Severity 3 FY 23-24 Maintenance Work	1	JOB	\$90	\$90
-----	--	--	---	-----	------	------

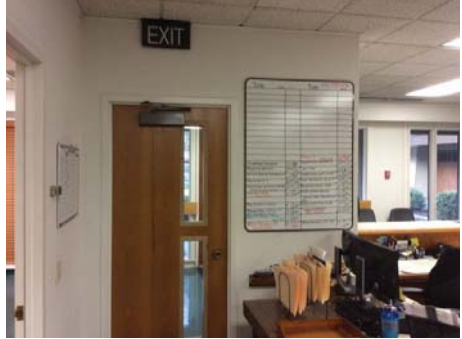
Item No. and Name	Existing Architectural Barrier and Proposed Solution	Codes / Mitigation Info	Qty	Unit	Cost	Total
Signage						
752	<ul style="list-style-type: none"> <i>As-Built Description:</i> At door leading into exit corridor: Where required exit signs are installed, signs to provide exiting information for people with vision impairment are not provided. <i>Proposed Solution:</i> Provide raised letter/Braille "EXIT ROUTE" sign at door. 	PCODE SA10D ADAAG 4.1.3(16) ADA 2010 216.4.1 CBC 2010 1011.3 CBC 2013 11B-216.4.1 Priority 1 Severity 3 FY 23-24 Maintenance Work	1	JOB	\$90	\$90

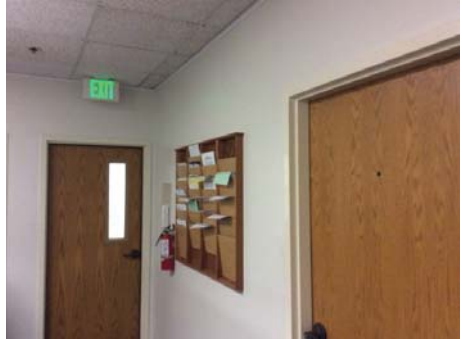
757	<ul style="list-style-type: none"> <i>As-Built Description:</i> At door leading into exit corridor: Where required exit signs are installed, signs to provide exiting information for people with vision impairment are not provided. <i>Proposed Solution:</i> Provide raised letter/Braille "EXIT ROUTE" sign at door. 	PCODE SA10D ADAAG 4.1.3(16) ADA 2010 216.4.1 CBC 2010 1011.3 CBC 2013 11B-216.4.1 Priority 1 Severity 3 FY 23-24 Maintenance Work	1	JOB	\$90	\$90

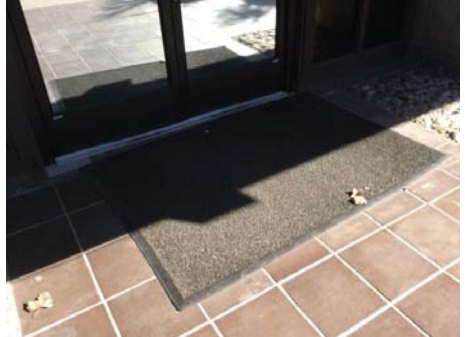
Item No. and Name	Existing Architectural Barrier and Proposed Solution	Codes / Mitigation Info	Qty	Unit	Cost	Total
<u>Carpet/Doormat</u>						
1559	<ul style="list-style-type: none"> <i>As-Built Description:</i> Doormat not securely attached to ground or floor structure. <i>Proposed Solution:</i> Attach doormat to floor surface or remove doormat. 	PCODE ID05A ADAAG 4.5.3 ADA 2010 302.2 CBC 2010 1124B.3 CBC 2013 11B-302.2 Priority 1 Severity 3 FY 23-24 Maintenance Work	2	JOB	\$75	\$150

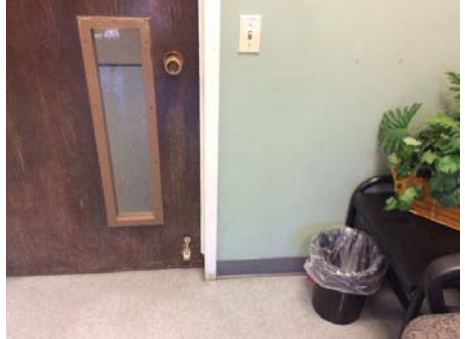
<u>Door Hardware</u>						
1561	<ul style="list-style-type: none"> <i>As-Built Description:</i> Door does not have accessible operating hardware. <i>Proposed Solution:</i> Provide lever handle or other accessible hardware. 	PCODE ID07 ADAAG 4.13.9 ADA 2010 404.2.7 CBC 2010 1133B.2.5.2 CBC 2013 11B-404.2.7 Priority 1 Severity 3 FY 23-24 Maintenance Work	1	JOB	\$250	\$250

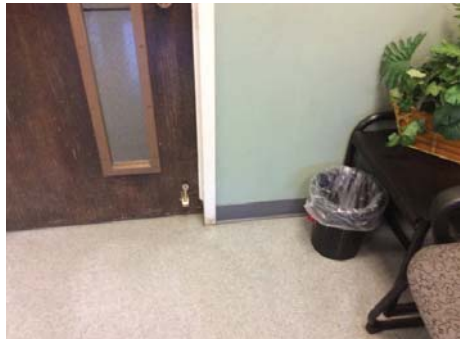
<u>Door Stopper</u>						
1562	<ul style="list-style-type: none"> <i>As-Built Description:</i> At push side of door on accessible route, bottom 10" does not have a smooth, uninterrupted surface. <i>Proposed Solution:</i> Remove door stopper when altering area. Provide rubber wedge. 	PCODE ID06A ADA 2010 404.2.10 CBC 2010 1133B.2.6 CBC 2013 11B-404.2.10 Priority 1 Severity 3 FY 23-24 Maintenance Work	1	JOB	\$25	\$25

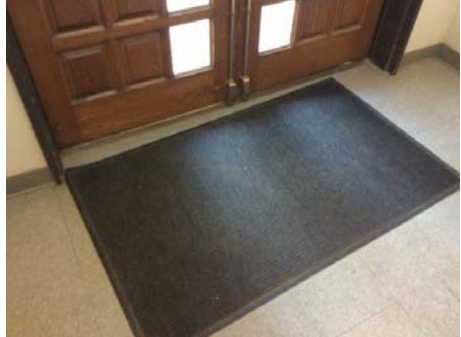
Item No. and Name	Existing Architectural Barrier and Proposed Solution	Codes / Mitigation Info	Qty	Unit	Cost	Total
<u>Carpet/Doormat</u>						
1570	<ul style="list-style-type: none"> <i>As-Built Description:</i> Doormat not securely attached to ground or floor structure. <i>Proposed Solution:</i> Attach doormat to floor surface or remove doormat. 	PCODE ID05A ADAAG 4.5.3 ADA 2010 302.2 CBC 2010 1124B.3 CBC 2013 11B-302.2 Priority 1 Severity 3 FY 23-24 Maintenance Work	1	JOB	\$75	\$75

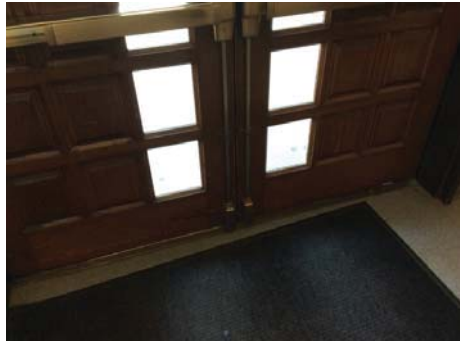
<u>Door</u>						
1568	<ul style="list-style-type: none"> <i>As-Built Description:</i> At push side of door on accessible route, bottom 10" does not have a smooth, uninterrupted surface. <i>Proposed Solution:</i> Install kick plate at bottom 10" of door to cover floor latch and floor latch rods. 	PCODE ID06ANT ADA 2010 404.2.10 CBC 2010 1133B.2.6 CBC 2013 11B-404.2.10 Priority 1 Severity 3 FY 23-24 Maintenance Work	1	JOB	\$200	\$200

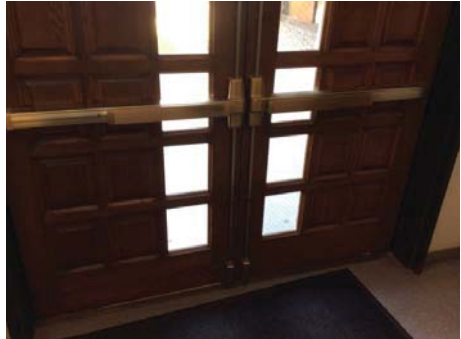
<u>Door Closer</u>						
1569	<ul style="list-style-type: none"> <i>As-Built Description:</i> Excessive force required to open door. <i>As-Built:</i> 16 lbs <i>Proposed Solution:</i> Adjust regular door closer to accessible standards (5 lbs max). 	PCODE ID03 ADAAG 4.13.11 ADA 2010 404.2.9 CBC 2010 1133B.2.5 CBC 2013 11B-404.2.9 Priority 1 Severity 2 FY 23-24 Maintenance Work	2	JOB	\$25	\$50

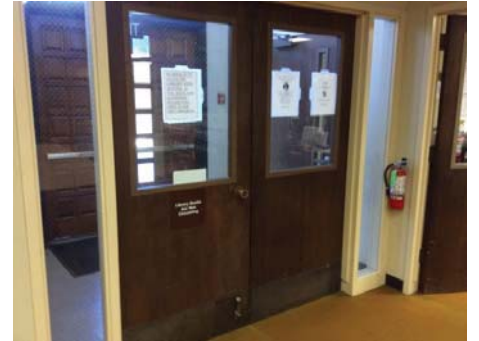
Item No. and Name	Existing Architectural Barrier and Proposed Solution	Codes / Mitigation Info	Qty	Unit	Cost	Total
1574	<ul style="list-style-type: none"> As-Built Description: Excessive force required to open door. As-Built: 17 lbs Proposed Solution: Adjust regular door closer to accessible standards (5 lbs max). 	PCODE ID03 ADAAG 4.13.11 ADA 2010 404.2.9 CBC 2010 1133B.2.5 CBC 2013 11B-404.2.9 Priority 1 Severity 2 FY 23-24 Maintenance Work	2	JOB	\$25	\$50

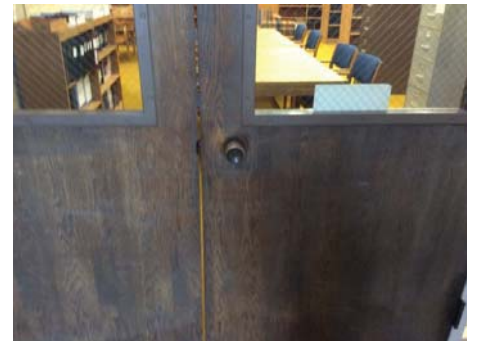
1572	<ul style="list-style-type: none"> As-Built Description: Door does not have accessible operating hardware. Proposed Solution: Provide lever handle or other accessible hardware. 	PCODE ID07 ADAAG 4.13.9 ADA 2010 404.2.7 CBC 2010 1133B.2.5.2 CBC 2013 11B-404.2.7 Priority 1 Severity 3 FY 23-24 Maintenance Work	1	JOB	\$250	\$250
------	--	---	---	-----	-------	-------

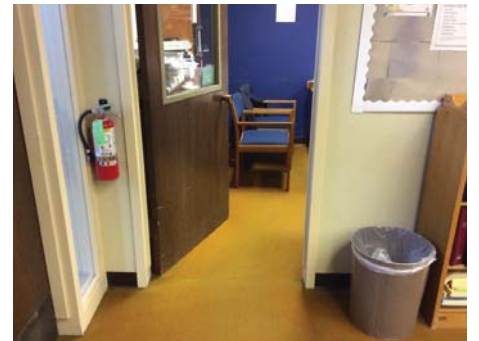
1580	<ul style="list-style-type: none"> As-Built Description: Door does not have accessible operating hardware. Proposed Solution: Provide lever handle or other accessible hardware. 	PCODE ID07 ADAAG 4.13.9 ADA 2010 404.2.7 CBC 2010 1133B.2.5.2 CBC 2013 11B-404.2.7 Priority 1 Severity 3 FY 23-24 Maintenance Work	1	JOB	\$250	\$250
------	--	---	---	-----	-------	-------

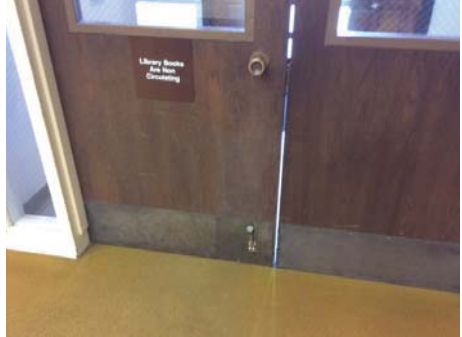
Item No. and Name	Existing Architectural Barrier and Proposed Solution	Codes / Mitigation Info	Qty	Unit	Cost	Total
<u>Door Stopper</u>						
1573	<ul style="list-style-type: none"> <i>As-Built Description:</i> At push side of door on accessible route, bottom 10" does not have a smooth, uninterrupted surface. <i>Proposed Solution:</i> Remove door stopper when altering area. Provide rubber wedge. 	PCODE ID06A ADA 2010 404.2.10 CBC 2010 1133B.2.6 CBC 2013 11B-404.2.10 Priority 1 Severity 3 FY 23-24 Maintenance Work	1	JOB	\$25	\$25

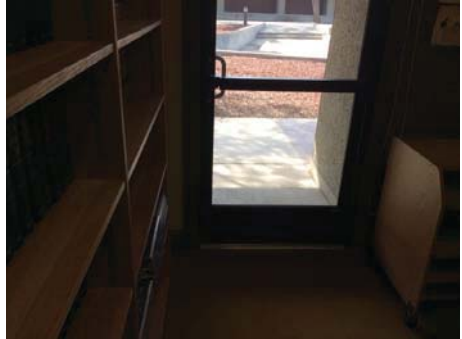
<u>Door Swing</u>						
1578	<ul style="list-style-type: none"> <i>As-Built Description:</i> Front approach: At push side, door does not have clear and level maneuvering space measuring door width x 48" (door width plus 12" if door has both, latch and closer). <i>As-Built:</i> 6" <i>Proposed Solution:</i> Remove or relocate furniture or storage items. 	PCODE ID24A ADAAG Fig. 25(a) ADA 2010 404.2.4 CBC 2010 11B-26A(a) CBC 2013 11B-404.2.4 Priority 1 Severity 3 FY 23-24 Maintenance Work	1	JOB	\$50	\$50

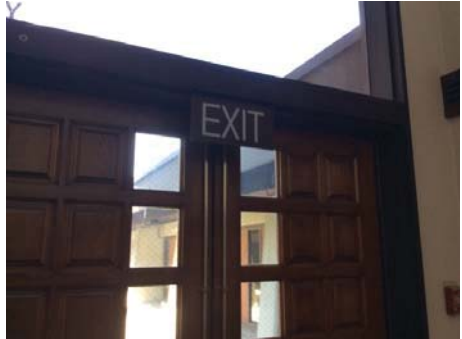
<u>Signage</u>						
1571	<ul style="list-style-type: none"> <i>As-Built Description:</i> At final exit door to exterior: Where required exit signs are installed, signs to provide exiting information for people with vision impairment are not provided. <i>Proposed Solution:</i> Provide raised letter/Braille "EXIT" sign at door. 	PCODE SA10A ADAAG 4.1.3(16) ADA 2010 216.4.1 CBC 2010 1011.3 CBC 2013 11B-216.4.1 Priority 1 Severity 3 FY 23-24 Maintenance Work	1	JOB	\$90	\$90

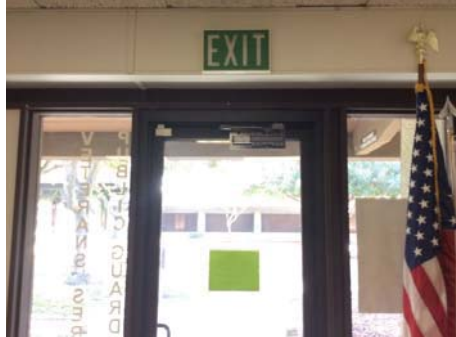
Item No. and Name	Existing Architectural Barrier and Proposed Solution	Codes / Mitigation Info	Qty	Unit	Cost	Total
Signage						
1586	<ul style="list-style-type: none"> <i>As-Built Description:</i> At final exit door to exterior: Where required exit signs are installed, signs to provide exiting information for people with vision impairment are not provided. <i>Proposed Solution:</i> Provide raised letter/Braille "EXIT" sign at door. 	PCODE SA10A ADAAG 4.1.3(16) ADA 2010 216.4.1 CBC 2010 1011.3 CBC 2013 11B-216.4.1 Priority 1 Severity 3 FY 23-24 Maintenance Work	1	JOB	\$90	\$90

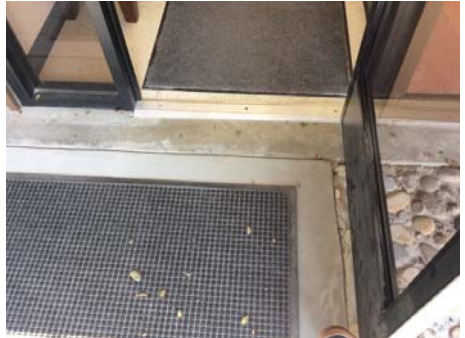
1597	<ul style="list-style-type: none"> <i>As-Built Description:</i> Doormat not securely attached to ground or floor structure. <i>Proposed Solution:</i> Attach doormat to floor surface or remove doormat. 	PCODE ID05A ADAAG 4.5.3 ADA 2010 302.2 CBC 2010 1124B.3 CBC 2013 11B-302.2 Priority 1 Severity 3 FY 23-24 Maintenance Work	2	JOB	\$75	\$150

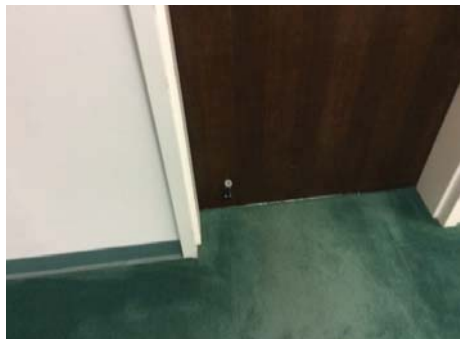
1611	<ul style="list-style-type: none"> <i>As-Built Description:</i> At push side of door on accessible route, bottom 10" does not have a smooth, uninterrupted surface. <i>Proposed Solution:</i> Remove door stopper when altering area. Provide rubber wedge. 	PCODE ID06A ADA 2010 404.2.10 CBC 2010 1133B.2.6 CBC 2013 11B-404.2.10 Priority 1 Severity 3 FY 23-24 Maintenance Work	1	JOB	\$25	\$25

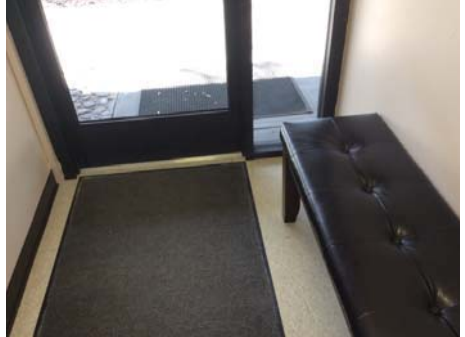
Item No. and Name	Existing Architectural Barrier and Proposed Solution	Codes / Mitigation Info	Qty	Unit	Cost	Total
<u>Door Swing</u>						
1598	<ul style="list-style-type: none"> • <i>As-Built Description:</i> Front approach: At push side, door does not have clear and level maneuvering space measuring door width x 48" (door width plus 12" if door has both, latch and closer). • <i>As-Built:</i> 2" to bench • <i>Proposed Solution:</i> Remove or relocate furniture or storage items. 	<p>PCODE ID24A ADAAG Fig. 25(a) ADA 2010 404.2.4 CBC 2010 11B-26A(a) CBC 2013 11B-404.2.4 Priority 1 Severity 2 FY 23-24 Maintenance Work</p>	1	JOB	\$50	\$50

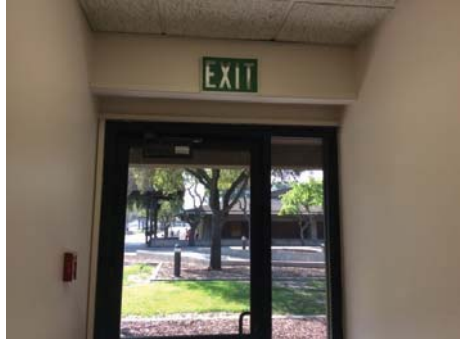
<u>Signage</u>						
1600	<ul style="list-style-type: none"> • <i>As-Built Description:</i> At final exit door to exterior: Where required exit signs are installed, signs to provide exiting information for people with vision impairment are not provided. • <i>Proposed Solution:</i> Provide raised letter/Braille "EXIT" sign at door. 	<p>PCODE SA10A ADAAG 4.1.3(16) ADA 2010 216.4.1 CBC 2010 1011.3 CBC 2013 11B-216.4.1 Priority 1 Severity 3 FY 23-24 Maintenance Work</p>	1	JOB	\$90	\$90

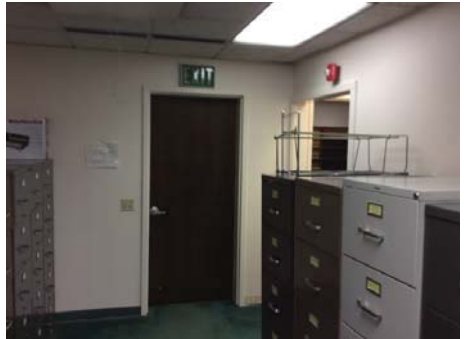
1610	<ul style="list-style-type: none"> • <i>As-Built Description:</i> At door leading into exit corridor: Where required exit signs are installed, signs to provide exiting information for people with vision impairment are not provided. • <i>Proposed Solution:</i> Provide raised letter/Braille "EXIT ROUTE" sign at door. 	<p>PCODE SA10D ADAAG 4.1.3(16) ADA 2010 216.4.1 CBC 2010 1011.3 CBC 2013 11B-216.4.1 Priority 1 Severity 3 FY 23-24 Maintenance Work</p>	1	JOB	\$90	\$90

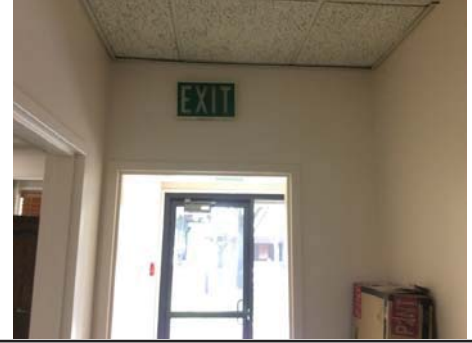
Item No. and Name	Existing Architectural Barrier and Proposed Solution	Codes / Mitigation Info	Qty	Unit	Cost	Total
1612	<ul style="list-style-type: none"> <i>As-Built Description:</i> At door leading to horizontal exit: Where required exit signs are installed, signs to provide exiting information for people with vision impairment are not provided. <i>Proposed Solution:</i> Provide raised letter/Braille "TO EXIT" sign at door. 	PCODE SA10E ADAAG 4.1.3(16) ADA 2010 216.4.1 CBC 2010 1011.3 CBC 2013 11B-216.4.1 Priority 1 Severity 3 FY 23-24 Maintenance Work	1	JOB	\$90	\$90

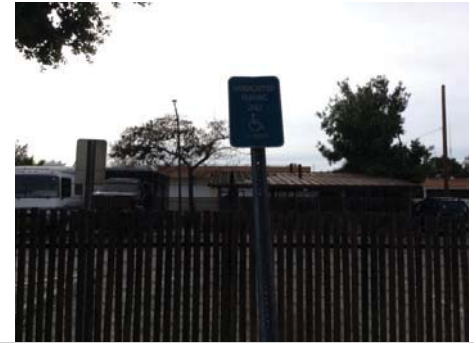
2616	<ul style="list-style-type: none"> <i>As-Built Description:</i> No van parking provided (one in every 6 or fraction of 6 accessible spaces, but not less than one. <i>Proposed Solution:</i> Provide van parking space(s) by restriping; provide van sign. 	<p>PCODE EA07 ADAAG 4.1.2(5)(b) ADA 2010 208.2; 502.1 CBC 2010 1129B.3.2 CBC 2013 11B-208.2.4 Priority 1 Severity 2 FY 23-24 Maintenance Work</p>	1	JOB	\$350	\$350
------	--	--	---	-----	-------	-------

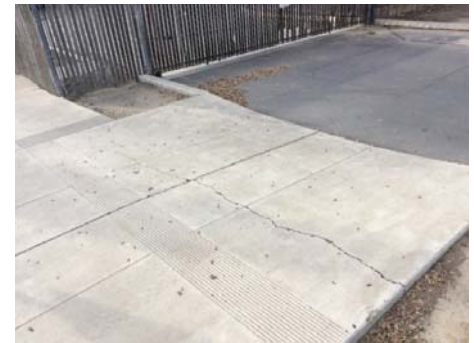
2620	<ul style="list-style-type: none"> <i>As-Built Description:</i> Detectable warning not provided where pedestrian crosses vehicular area. <i>Proposed Solution:</i> Provide detectable warning surface (i.e. in-line truncated domes) at regular curb ramp. 	<p>PCODE EH07A ADAAG 4.7.7 ADA 2010 705.1 CBC 2010 1127B.5.7 CBC 2013 11B-705.1.2.2 Priority 1 Severity 3 FY 23-24 Maintenance Work</p>	1	JOB	\$250	\$250
------	--	--	---	-----	-------	-------

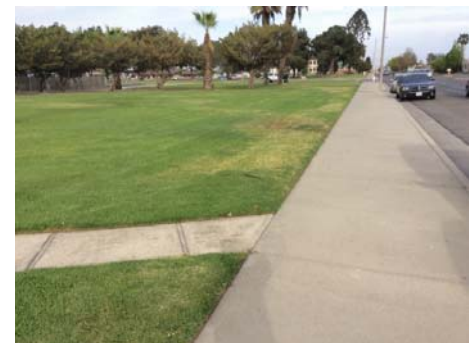
2646	<ul style="list-style-type: none"> <i>As-Built Description:</i> No sign by inaccessible route directing persons to an accessible route. <i>Proposed Solution:</i> Provide directional sign. 	<p>PCODE SA20 ADAAG 35.163(b) ADA 2010 216.3 CBC 2010 1127B.3 CBC 2013 11B-216.3 Priority 1 Severity 3 FY 23-24 Maintenance Work</p>	1	JOB	\$170	\$170
------	---	---	---	-----	-------	-------

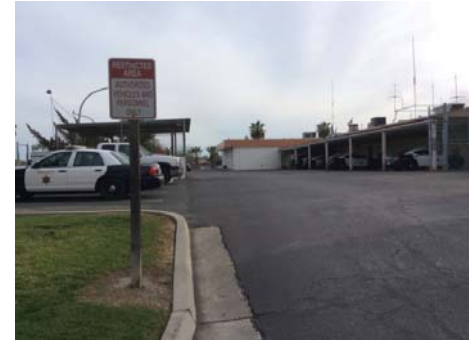
Item No. and Name	Existing Architectural Barrier and Proposed Solution	Codes / Mitigation Info	Qty	Unit	Cost	Total
<u>Minimum Number</u>						
2652	<ul style="list-style-type: none"> <i>As-Built Description:</i> At parking lot with 26-50 spaces, the number of accessible spaces is less than required by code; 2 spaces required. <i>As-Built:</i> 0 spaces <i>Proposed Solution:</i> Provide required accessible parking spaces with signs including a minimum of one van space. 	PCODE EA01B ADAAG 4.1.2(5)* ADA 2010 208.2 CBC 2010 Tbl. 11B-6 CBC 2013 11B-208.2 Tbl. 11B-208.2 Priority 1 Severity 2 FY 23-24 Maintenance Work	1	JOB	\$300	\$300

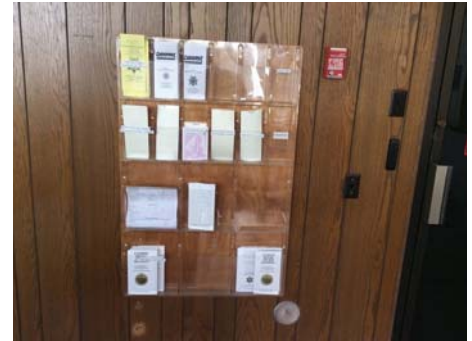
Brochure Bins

1743	<ul style="list-style-type: none"> • <i>As-Built Description:</i> Information brochure bins mounted above accessible height of 48". • <i>As-Built:</i> 27"-60" • <i>Proposed Solution:</i> Relocate/remount bins at accessible height. 	<p>PCODE IN08</p> <p>ADAAG 4.2.5 & 6</p> <p>ADA 2010 308.2.1</p> <p>CBC 2010 1118B.5</p> <p>CBC 2013 11B-308.2.1</p> <p>Priority 1</p> <p>Severity 2</p> <p>FY 23-24 Maintenance Work</p>	1	JOB	\$100	\$100
------	---	---	---	-----	-------	-------

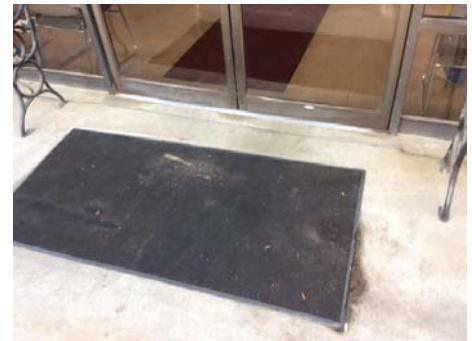
Carpet/Doormat

1733	<ul style="list-style-type: none"> • <i>As-Built Description:</i> Doormat not securely attached to ground or floor structure. • <i>Proposed Solution:</i> Attach doormat to floor surface or remove doormat. 	<p>PCODE ID05A</p> <p>ADAAG 4.5.3</p> <p>ADA 2010 302.2</p> <p>CBC 2010 1124B.3</p> <p>CBC 2013 11B-302.2</p> <p>Priority 1</p> <p>Severity 3</p> <p>FY 23-24 Maintenance Work</p>	2	JOB	\$75	\$150
------	--	--	---	-----	------	-------

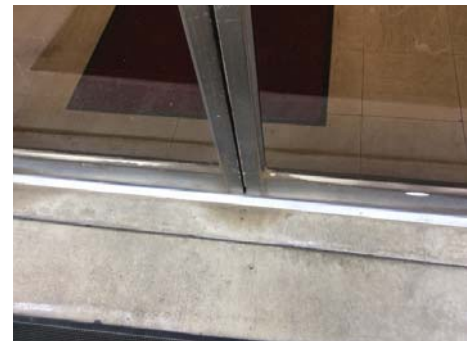
Door

1734	<ul style="list-style-type: none"> • <i>As-Built Description:</i> At push side of door on accessible route, bottom 10" does not have a smooth, uninterrupted surface. • <i>As-Built:</i> 4" • <i>Proposed Solution:</i> Provide 10" min. "kick plate" covering width of door when altering area. 	<p>PCODE ID06</p> <p>ADA 2010 404.2.10</p> <p>CBC 2010 1133B.2.6</p> <p>CBC 2013 11B-404.2.10</p> <p>Priority 1</p> <p>Severity 3</p> <p>FY 23-24 Maintenance Work</p>	1	JOB	\$100	\$100
------	---	---	---	-----	-------	-------

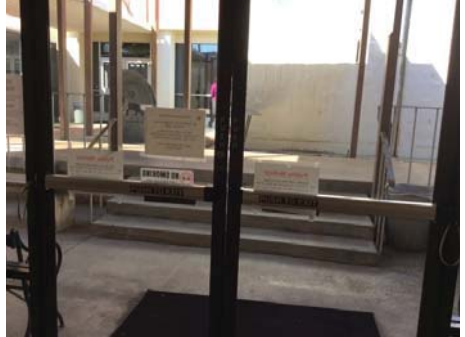
Item No. and Name	Existing Architectural Barrier and Proposed Solution	Codes / Mitigation Info	Qty	Unit	Cost	Total
<u>Door Closer</u>						
1735	<ul style="list-style-type: none"> <i>As-Built Description:</i> Excessive force required to open door. <i>As-Built:</i> 13 lbs <i>Proposed Solution:</i> Adjust regular door closer to accessible standards (5 lbs max). 	PCODE ID03 ADAAG 4.13.11 ADA 2010 404.2.9 CBC 2010 1133B.2.5 CBC 2013 11B-404.2.9 Priority 1 Severity 3 FY 23-24 Maintenance Work	1	JOB	\$25	\$25

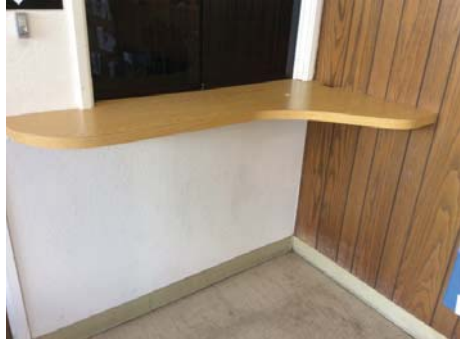
<u>Protrusion Limits</u>						
1740	<ul style="list-style-type: none"> <i>As-Built Description:</i> Protruding objects more than 4" from wall, when bottom of object more than 27" or less than 80" above finished floor. <i>As-Built:</i> 12" protrusion at 42" <i>Proposed Solution:</i> Provide cane-detectable railing to mark area of low clearance. 	PCODE EG04A ADAAG 4.4.1 ADA 2010 307.2 CBC 2010 1133B.8.6.1 CBC 2013 11B-307.2 Priority 1 Severity 1 FY 23-24 Maintenance Work	4"	LF	\$100	\$400

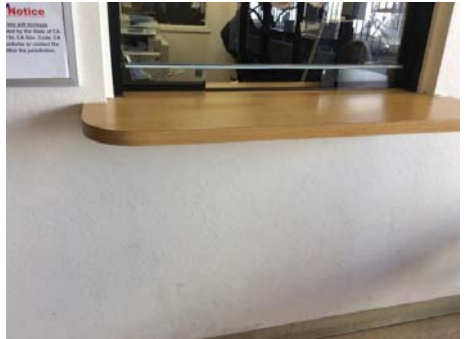
1738	<ul style="list-style-type: none"> <i>As-Built Description:</i> Protruding objects more than 4" from wall, when bottom of object more than 27" or less than 80" above finished floor. <i>As-Built:</i> 11.5" protrusion at 43.5" <i>Proposed Solution:</i> Provide cane-detectable railing to mark area of low clearance. 	PCODE EG04A ADAAG 4.4.1 ADA 2010 307.2 CBC 2010 1133B.8.6.1 CBC 2013 11B-307.2 Priority 1 Severity 2 FY 23-24 Maintenance Work	4	LF	\$100	\$400

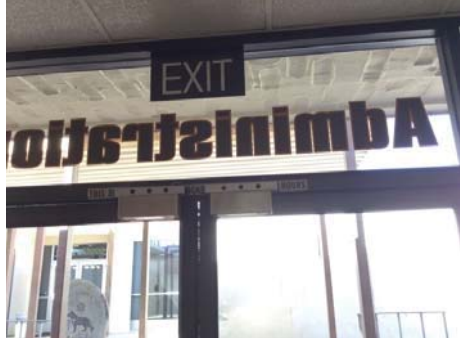
Item No. and Name	Existing Architectural Barrier and Proposed Solution	Codes / Mitigation Info	Qty	Unit	Cost	Total
Signage						
1736	<ul style="list-style-type: none"> <i>As-Built Description:</i> At final exit door to exterior: Where required exit signs are installed, signs to provide exiting information for people with vision impairment are not provided. <i>Proposed Solution:</i> Provide raised letter/Braille "EXIT" sign at door. 	PCODE SA10A ADAAG 4.1.3(16) ADA 2010 216.4.1 CBC 2010 1011.3 CBC 2013 11B-216.4.1 Priority 1 Severity 3 FY 23-24 Maintenance Work	1	JOB	\$90	\$90

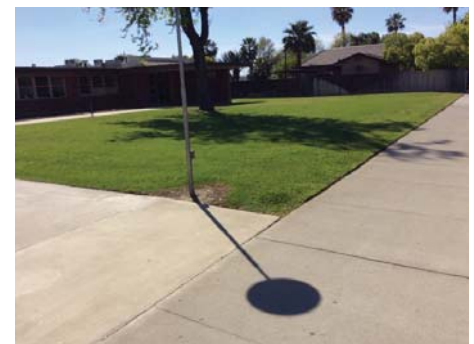
Route Sign

- *As-Built Description:*
No sign by inaccessible route directing persons to an accessible route.
- *Proposed Solution:*
Provide directional sign.
- **Notes:**
Directional sign recommended.

PCODE SA20
 ADAAG 35.163(b)
 ADA 2010 216.3
 CBC 2010 1127B.3
 CBC 2013 11B-216.3
 Priority 1
 Severity 3
 FY 23-24 Maintenance Work

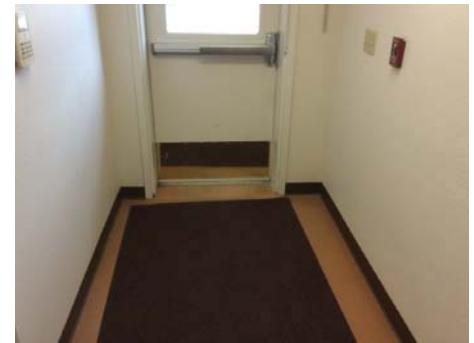
Carpet/Doormat

2529	<ul style="list-style-type: none"> <i>As-Built Description:</i> Doormat not securely attached to ground or floor structure. <i>Proposed Solution:</i> Attach doormat to floor surface or remove doormat. 	PCODE ID05A ADAAG 4.5.3 ADA 2010 302.2 CBC 2010 1124B.3 CBC 2013 11B-302.2 Priority 1 Severity 3 FY 23-24 Maintenance Work	1	JOB	\$75	\$75
------	--	---	---	-----	------	------

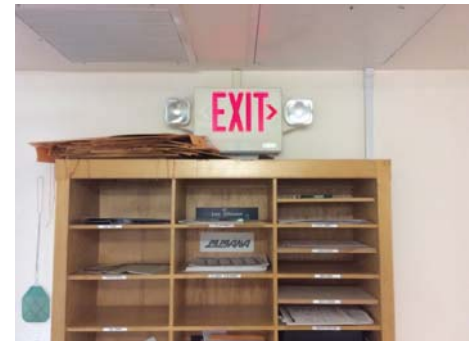
Signage

2526	<ul style="list-style-type: none"> <i>As-Built Description:</i> At door leading into exit corridor: Where required exit signs are installed, signs to provide exiting information for people with vision impairment are not provided. <i>Proposed Solution:</i> Provide raised letter/Braille "EXIT ROUTE" sign at door. 	PCODE SA10D ADAAG 4.13(16) ADA 2010 216.4.1 CBC 2010 10113 CBC 2013 11B-216.4.1 Priority 1 Severity 3 FY 23-24 Maintenance Work	1	JOB	\$90	\$90
------	--	--	---	-----	------	------

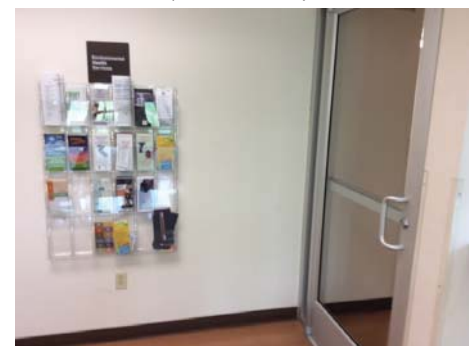
7 Environmental Health Lobby

2584	<ul style="list-style-type: none"> <i>As-Built Description:</i> Information brochure bins mounted above accessible height of 48". <i>As-Built:</i> 32"-62" <i>Proposed Solution:</i> Relocate/remount bins at accessible height. 	PCODE IN08 ADAAG 4.2.5 & 6 ADA 2010 308.2.1 CBC 2010 1118B.5 CBC 2013 11B-308.2.1 Priority 1 Severity 2 FY 23-24 Maintenance Work	1	JOB	\$100	\$100
------	---	--	---	-----	-------	-------

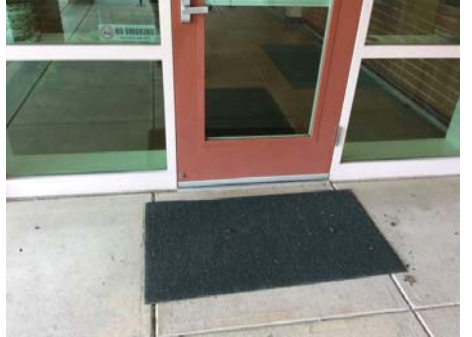
Item No. and Name	Existing Architectural Barrier and Proposed Solution	Codes / Mitigation Info	Qty	Unit	Cost	Total
<u>Carpet/Doormat</u>						
2578	<ul style="list-style-type: none"> <i>As-Built Description:</i> Doormat not securely attached to ground or floor structure. <i>Proposed Solution:</i> Attach doormat to floor surface or remove doormat. 	PCODE ID05A ADAAG 4.5.3 ADA 2010 302.2 CBC 2010 1124B.3 CBC 2013 11B-302.2 Priority 1 Severity 3 FY 23-24 Maintenance Work	1	JOB	\$75	\$75

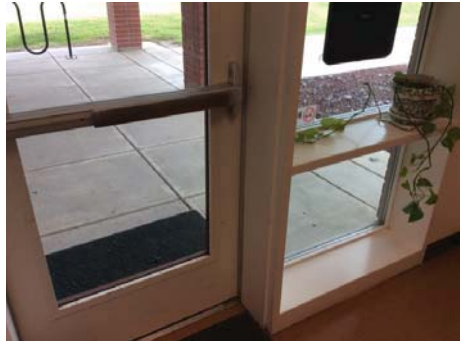
<u>Door Swing</u>							
2581	<ul style="list-style-type: none"> <i>As-Built Description:</i> Front approach: At push side, door does not have clear and level maneuvering space measuring door width x 48" (door width plus 12" if door has both, latch and closer). <i>As-Built:</i> 10" deep <i>Proposed Solution:</i> Provide door operator. 	PCODE ID24CREF ADAAG Fig. 25(a) ADA 2010 404.2.4 CBC 2010 11B-26A(a) CBC 2013 11B-404.2.4 Priority 1 Severity 2 FY 23-24 Maintenance Work	REF

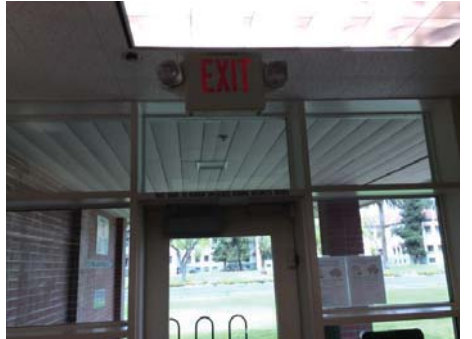
<u>Signage</u>						
2582	<ul style="list-style-type: none"> <i>As-Built Description:</i> At final exit door to exterior: Where required exit signs are installed, signs to provide exiting information for people with vision impairment are not provided. <i>Proposed Solution:</i> Provide raised letter/Braille "EXIT" sign at door. 	PCODE SA10A ADAAG 4.1.3(16) ADA 2010 216.4.1 CBC 2010 1011.3 CBC 2013 11B-216.4.1 Priority 1 Severity 3 FY 23-24 Maintenance Work	1	JOB	\$90	\$90

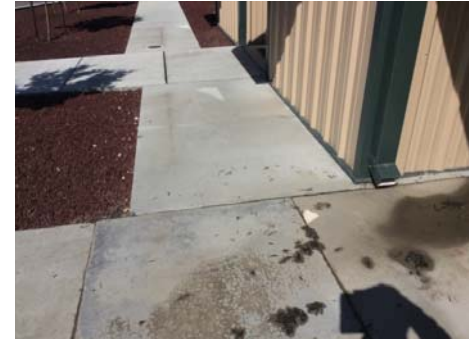
Item No. and Name	Existing Architectural Barrier and Proposed Solution	Codes / Mitigation Info	Qty	Unit	Cost	Total
3578	<ul style="list-style-type: none"> <i>As-Built Description:</i> 36" wide band of truncated domes not provided at walkway or crossing adjoining a vehicular way, if surfaces are not separated by a curb, railing, or other element. <i>Proposed Solution:</i> Provide 36" wide, contrasting color, band of truncated domes between pedestrian and vehicular area. 	PCODE EG09REF ADAAG 4.29.5 CBC 2010 1133B.8.5 CBC 2013 11B-705.1.2.5 Priority 1 Severity 3 FY 23-24 Maintenance Work	5	REF

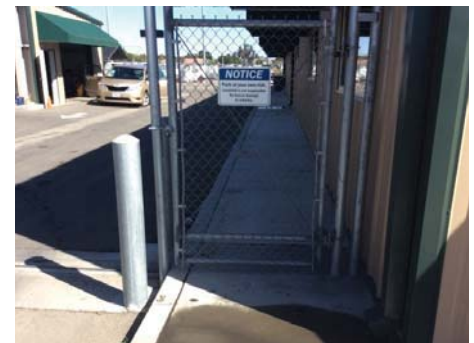
Gate

3581	<ul style="list-style-type: none"> <i>As-Built Description:</i> 10" min kick-plate/accessible operating hardware at gate not provided on push-side of gate and/or gap between floor surface and bottom of gate exceeds 3" max. (required in CA only). <i>Proposed Solution:</i> Provide accessible operating hardware and 10" min. "kick plate" covering width of gate when altering area. <i>Notes:</i> Not Acc. route. also no pull side landing. locked. 	PCODE ID06BREF ADA 2010 404.2.10 CBC 2010 1133B.2.6 CBC 2013 11B-404.2.10 Priority 1 Severity 3 FY 23-24 Maintenance Work		REF		
------	---	--	--	-----	--	--

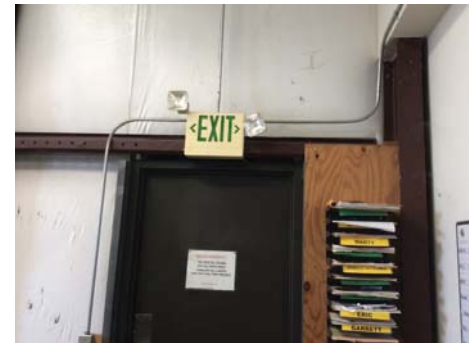
Signage

3495	<ul style="list-style-type: none"> <i>As-Built Description:</i> At final exit door to exterior: Where required exit signs are installed, signs to provide exiting information for people with vision impairment are not provided. <i>Proposed Solution:</i> Provide raised letter/Braille "EXIT" sign at door. 	<p>PCODE SA10A ADAAG 4.1.3(16) ADA 2010 216.4.1 CBC 2010 1011.3 CBC 2013 11B-216.4.1 Priority 1 Severity 3 FY 23-24 Maintenance Work</p>	2	JOB	\$90	\$180
------	--	---	---	-----	------	-------

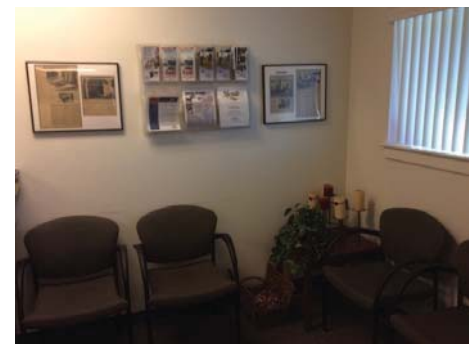
5 CalVans Main Entrance

3540	<ul style="list-style-type: none"> <i>As-Built Description:</i> Information brochure bins mounted above accessible height of 48". <i>As-Built:</i> 74" <i>Proposed Solution:</i> Relocate/remount bins at accessible height. <i>Notes:</i> provide same at lower. 	<p>PCODE IN08 ADAAG 4.2.5 & 6 ADA 2010 308.2.1 CBC 2010 1118B.5 CBC 2013 11B-308.2.1 Priority 1 Severity 1 FY 23-24 Maintenance Work</p>	1	JOB	\$100	\$100
------	---	---	---	-----	-------	-------

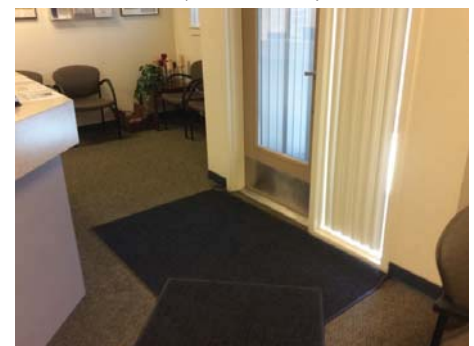
Carpet/Doormat

3523	<ul style="list-style-type: none"> <i>As-Built Description:</i> Doormat not securely attached to ground or floor structure. <i>Proposed Solution:</i> Attach doormat to floor surface or remove doormat. 	<p>PCODE ID05A ADAAG 4.5.3 ADA 2010 302.2 CBC 2010 1124B.3 CBC 2013 11B-302.2 Priority 1 Severity 3 FY 23-24 Maintenance Work</p>	1	JOB	\$75	\$75
------	--	--	---	-----	------	------

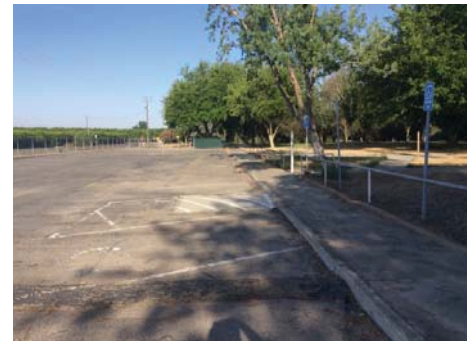
Minimum Number

- 4912
- As-Built Description:**
At parking lot with 76-100 spaces, the number of accessible spaces is less than required by code; 4 spaces required.
 - Proposed Solution:**
Provide required accessible parking spaces with signs including a minimum of one van space.
 - Notes:**
Approx. 80 spaces
2 Acc
0 van

PCODE EA01D
 ADAAG 4.1.2(5)*
 ADA 2010 208.2
 CBC 2010 Tbl. 11B-6
 CBC 2013 11B-208.2 Tbl. 11B-208.2
 Priority 1
 Severity 2
 FY 23-24 Maintenance Work

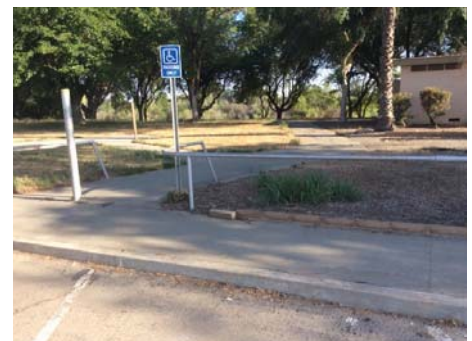
Parking

- 4907
- As-Built Description:**
No van parking provided (one in every 6 or fraction of 6 accessible spaces, but not less than one).
 - Proposed Solution:**
Provide van parking space(s) by restriping; provide van sign.

PCODE EA07
 ADAAG 4.1.2(5)(b)
 ADA 2010 208.2; 502.1
 CBC 2010 1129B.3.2
 CBC 2013 11B-208.2.4
 Priority 1
 Severity 2
 FY 23-24 Maintenance Work

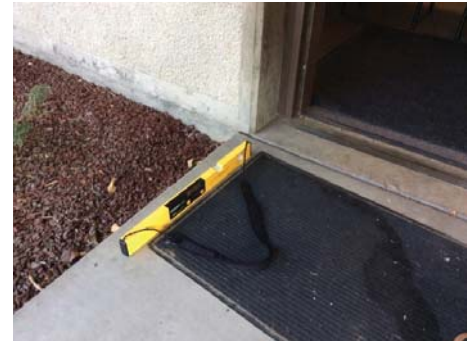
349	<ul style="list-style-type: none"> <i>As-Built Description:</i> Surface of required maneuvering clearance at door slopes more than 1/4":12" (2.0%). <i>As-Built:</i> 2.6% at SW exit door <i>Proposed Solution:</i> Modify surface slope at door. 	PCODE ID11REF ADAAG 4.13.6 ADA 2010 404.2.4.4 CBC 2010 1133B.2.4 CBC 2013 11B-404.2.4 Priority 2 Severity 4 FY 24-25 Contract Work				
-----	--	---	--	--	--	--
