Facility: **WOMENS INFANTS & CHILDREN**

Address: 330 HARRIS ST.

Facility: **LEMORE HEALTH CLINIC**
 Address: 229 C ST.

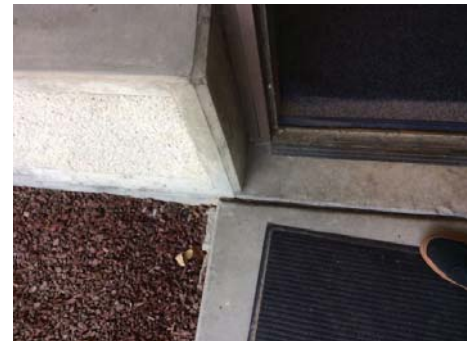
Door Swing

344	<ul style="list-style-type: none"> <i>As-Built Description:</i> Front approach: At pull side, door does not have clear and level maneuvering space measuring door width plus 18"(CA only: 24" at exterior doors)x 60". <i>As-Built:</i> Exterior: Door width + 6" <i>Proposed Solution:</i> Extend maneuvering space. 	PCODE ID23D ADAAG Fig. 25(a) ADA 2010 404.2.4 CBC 2010 11B-26A(a) CBC 2013 11B-404.2.4 Priority 2 Severity 3 FY 24-25 Contract Work	1	JOB	\$800	\$800
-----	--	--	---	-----	-------	-------

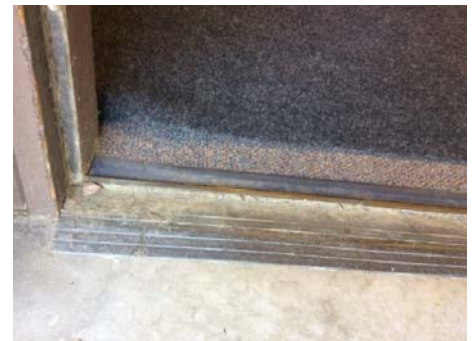
Door Threshold

345	<ul style="list-style-type: none"> <i>As-Built Description:</i> Existing threshold at door is 1/2" high or less but without a beveled edge on both sides. <i>As-Built:</i> No bevel <i>Proposed Solution:</i> Modify threshold to have beveled edge on each side. 	PCODE ID02 ADAAG 4.1.6(3)(d)(ii) ADA 2010 404.2.5 CBC 2010 1133B.2.4.1 CBC 2013 11B-404.2.5 Priority 2 Severity 4 FY 24-25 Contract Work	2	JOB	\$250	\$500
-----	--	---	---	-----	-------	-------

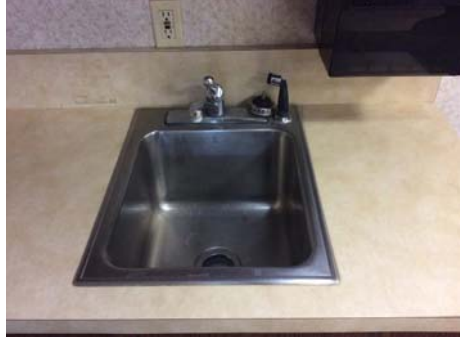
Item No. and Name	Existing Architectural Barrier and Proposed Solution	Codes / Mitigation Info	Qty	Unit	Cost	Total
Sink						
354	<ul style="list-style-type: none"> As-Built Description: Sink is more than 6 1/2" deep. As-Built: 10" deep Proposed Solution: Provide new sink remodel and cabinet as needed. 	PCODE IN06BREF ADAAG 4.24.4 CBC 2010 1115B.4.7.1 CBC 2013 11B-606.7 Priority 2 Severity 3 FY 24-25 Contract Work				
						REF

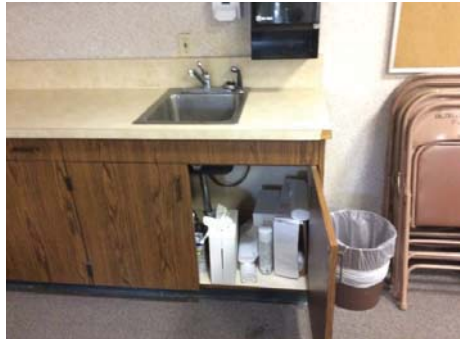
353	<ul style="list-style-type: none"> As-Built Description: Sink rim higher than 34" above floor. As-Built: 36" Proposed Solution: Remodel sink cabinet to lower sink. 	PCODE IN06REF ADAAG 4.24.2 ADA 2010 606.3 CBC 2010 1115B.4.7.1 CBC 2013 11B-606.3 Priority 2 Severity 4 FY 24-25 Contract Work				
						REF

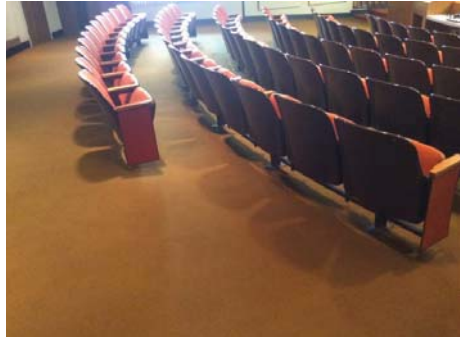
Disabled Seating

419	<ul style="list-style-type: none"> As-Built Description: Wheelchair space (33"x48") not provided at fixed seating with forward or rear approach. (NOTE: Space must be adjacent to regular seating; can provide easily removable fixed seat). As-Built: 7.5-7.1% slope Proposed Solution: Remove fixed seating and provide wheelchair space plus necessary maneuvering clearance. Notes: 73 seats. Modify flooring 	PCODE GB01A ADAAG 4.1.3(19)(a) ADA 2010 221.2 CBC 2010 1104B.3.6 CBC 2013 11B-221.2 Priority 2 Severity 3 FY 24-25 Contract Work	2	JOB	\$450	\$900

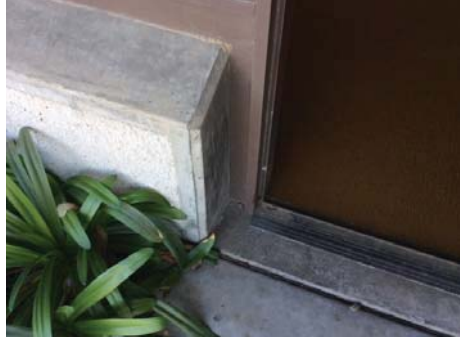
Item No. and Name	Existing Architectural Barrier and Proposed Solution	Codes / Mitigation Info	Qty	Unit	Cost	Total
<u>Door Swing</u>						
414	<ul style="list-style-type: none"> <i>As-Built Description:</i> Front approach: At pull side, door does not have clear and level maneuvering space measuring door width plus 18"(CA only: 24" at exterior doors)x 60". <i>As-Built:</i> Exterior 10" <i>Proposed Solution:</i> Extend maneuvering space. 	PCODE ID23D ADAAG Fig. 25(a) ADA 2010 404.2.4 CBC 2010 11B-26A(a) CBC 2013 11B-404.2.4 Priority 2 Severity 3 FY 24-25 Contract Work	1	JOB	\$800	\$800

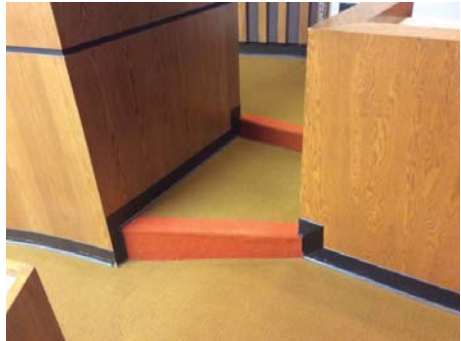
<u>Stairway</u>						
425	<ul style="list-style-type: none"> <i>As-Built Description:</i> Stair tread width less than 11", measured horizontally from nosing to nosing. <i>As-Built:</i> Nonuniform <i>Proposed Solution:</i> Rebuild stair as needed. 	PCODE II02E ADAAG 4.9.2 ADA 2010 504.2 CBC 2010 1133B.4.5.3 CBC 2013 11B-504.2 Priority 2 Severity 3 FY 24-25 Contract Work	1	JOB	\$2,000	\$2,000

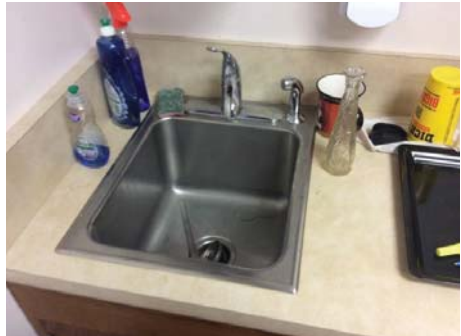
<u>Sink</u>							
458	<ul style="list-style-type: none"> <i>As-Built Description:</i> Sink is more than 6 1/2" deep. <i>As-Built:</i> 10" <i>Proposed Solution:</i> Provide new sink remodel and cabinet as needed. 	PCODE IN06BREF ADAAG 4.24.4 CBC 2010 1115B.4.7.1 CBC 2013 11B-606.7 Priority 2 Severity 3 FY 24-25 Contract Work	REF

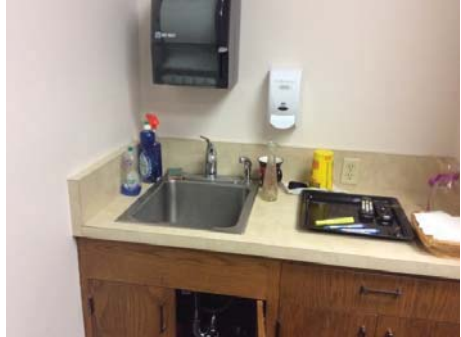
Item No. and Name	Existing Architectural Barrier and Proposed Solution	Codes / Mitigation Info	Qty	Unit	Cost	Total
457	<ul style="list-style-type: none"> As-Built Description: Sink rim higher than 34" above floor. As-Built: 35.75" Proposed Solution: Remodel sink cabinet to lower sink. 	PCODE IN06REF ADAAG 4.24.2 ADA 2010 606.3 CBC 2010 1115B.4.7.1 CBC 2013 11B-606.3 Priority 2 Severity 4 FY 24-25 Contract Work				
						REF

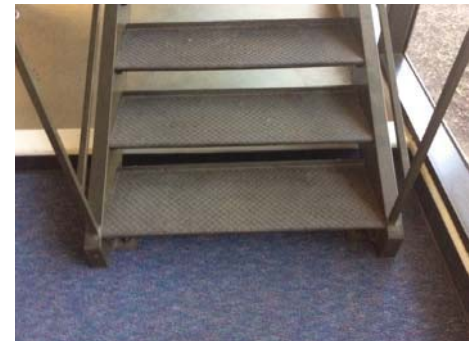
Stairway

- 2993
- *As-Built Description:*
The leading 2" of the tread does not have visual contrast of dark-on-light or light-on-dark from the remainder of the tread.
 - *Proposed Solution:*
Provide 2" wide contrasting color strip 1" max. from nosing on top & bottom treads when altering area.
 - *Notes:*
Both sets of stairs

PCODE **II02B**
 ADA 2010 **504.4**
 CBC 2010 **1133B.4.4**
 CBC 2013 **11B-504.4.1**
 Priority **2**
 Severity **3**
 FY 24-25 **Contract Work**

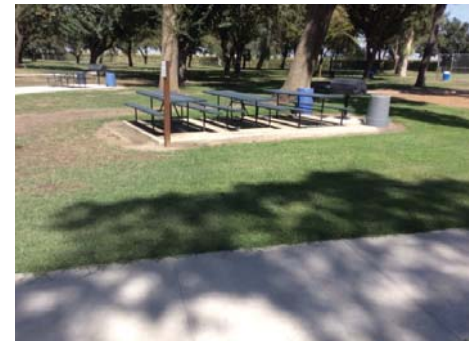
Accessible Route

PCODE EF13
 ADAAG 4.3.2
 ADA 2010 206.1
 CBC 2010 1114B.1.2
 CBC 2013 11B-206.1
 Priority 2
 Severity 3
 FY 24-25 Contract Work

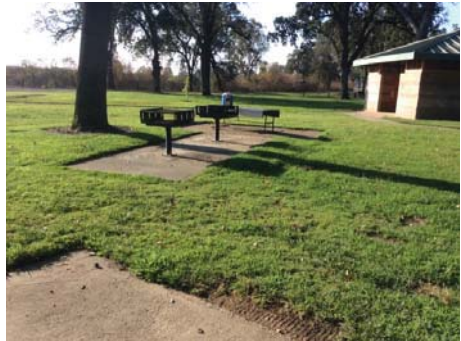
Accessible Route

5040	<ul style="list-style-type: none"> As-Built Description: No walk / sidewalk provided to connect accessible facilities or elements that are on the same site. Proposed Solution: Provide new 48" wide walk / sidewalk. 	<p>PCODE EF13 ADAAG 4.3.2 ADA 2010 206.1 CBC 2010 1114B.1.2 CBC 2013 11B-206.1 Priority 2 Severity 3 FY 24-25 Contract Work</p>	10	LF	\$45	\$450
------	---	--	----	----	------	--------------

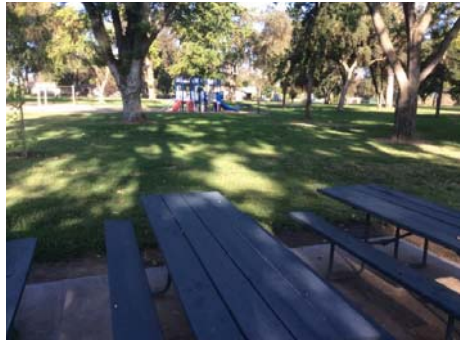
5044	<ul style="list-style-type: none"> As-Built Description: No walk / sidewalk provided to connect accessible facilities or elements that are on the same site. Proposed Solution: Provide new 48" wide walk / sidewalk. Notes: To play area and horse shoe area 	<p>PCODE EF13 ADAAG 4.3.2 ADA 2010 206.1 CBC 2010 1114B.1.2 CBC 2013 11B-206.1 Priority 2 Severity 3 FY 24-25 Contract Work</p>	90	LF	\$45	\$4,050
------	--	--	----	----	------	----------------

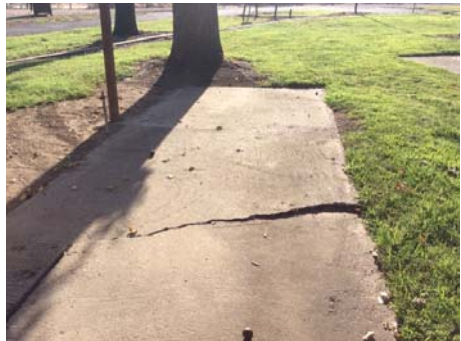
Changes in Level

5036	<ul style="list-style-type: none"> As-Built Description: Walk: Pavement dislocation creates abrupt change in level exceeding 1/2" in accessible route. As-Built: 1.5" Proposed Solution: Remove, replace or repair area of pavement sufficient to correct abrupt change in level. 	<p>PCODE EF03 ADAAG 4.3.8 ADA 2010 403.4 CBC 2010 1133B.7.4 CBC 2013 11B-403.4 Priority 2 Severity 3 FY 24-25 Contract Work</p>	4	SF	\$21	\$84
------	---	--	---	----	------	-------------

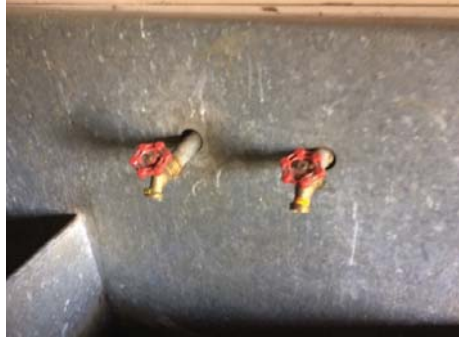
Item No. and Name	Existing Architectural Barrier and Proposed Solution	Codes / Mitigation Info	Qty	Unit	Cost	Total
Sink						
5238	<ul style="list-style-type: none"> <i>As-Built Description:</i> Sink faucet controls not accessible. <i>Proposed Solution:</i> Provide accessible sink faucet controls. 	PCODE IN07 ADAAG 4.24.7 ADA 2010 606.4 CBC 2010 1115B.4.7.1 CBC 2013 11B-606.4 Priority 2 Severity 3 FY 24-25 Contract Work	1	JOB	\$600	\$600

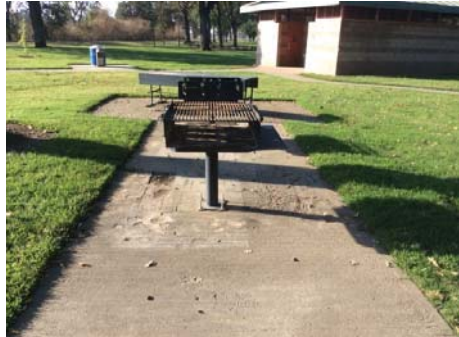
Walk						
5042	<ul style="list-style-type: none"> <i>As-Built Description:</i> Walk more than 36" but less than 48" wide (required in CA only). <i>As-Built:</i> 31" <i>Proposed Solution:</i> Enlarge width of walk to 48". 	PCODE EF08 CBC 2010 1133B.7.1 CBC 2013 11B-403.5.1.3 Priority 2 Severity 2 FY 24-25 Contract Work	96	SF	\$45	\$4,320

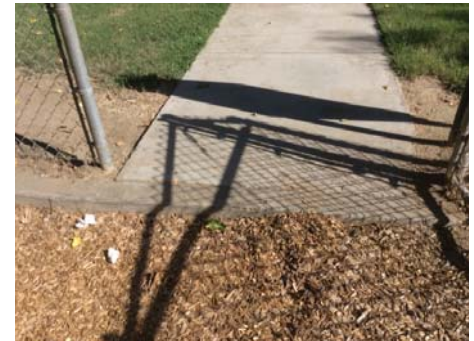
- 5078
- *As-Built Description:*
Walk: Pavement dislocation creates abrupt change in level exceeding 1/2" in accessible route.
 - *As-Built:* 3"
 - *Proposed Solution:*
Remove, replace or repair area of pavement sufficient to correct abrupt change in level.

PCODE EF03REF
 ADAAG 4.3.8
 ADA 2010 403.4
 CBC 2010 1133B.7.4
 CBC 2013 11B-403.4
 Priority 2
 Severity 2
 FY 24-25 Contract Work

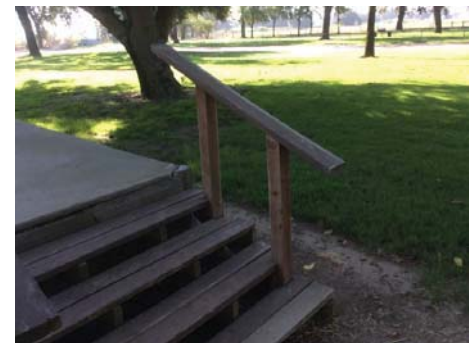
Height

- 5062
- *As-Built Description:*
Handrail gripping surface top not mounted between 34" and 38" above ramp surface or stair nosings.
 - *As-Built:* 32"
 - *Proposed Solution:*
Remove existing and provide new handrail.

PCODE ED02REF
 ADAAG 4.9.4(5)
 ADA 2010 505.4
 CBC 2010 1133B.4.2.1 &
 CBC 2013 11B-505.4
 Priority 2
 Severity 3
 FY 24-25 Contract Work

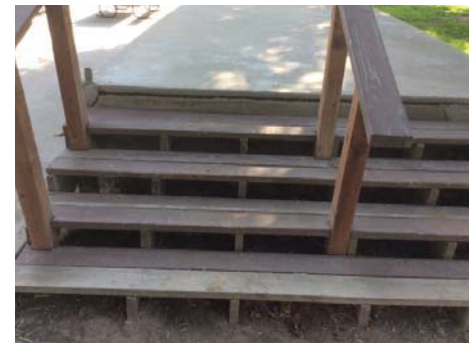
Open Risers

- 5063
- *As-Built Description:*
Stair does not have closed risers.
 - *Proposed Solution:*
Modify stair to have closed risers

PCODE EC03
 ADAAG 4.9.2
 ADA 2010 504.3
 CBC 2010 1133B.4.5.3
 CBC 2013 11B-504.3
 Priority 2
 Severity 3
 FY 24-25 Contract Work

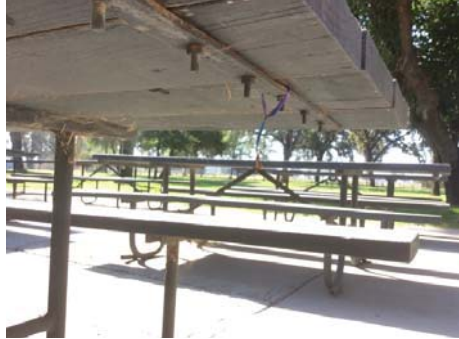
Item No. and Name	Existing Architectural Barrier and Proposed Solution	Codes / Mitigation Info	Qty	Unit	Cost	Total
<u>Picnic Area</u>						
5074	<ul style="list-style-type: none"> <i>As-Built Description:</i> Knee clearance at minimums 27" high, 30" wide, and 19" deep is not provided. <i>As-Built:</i> Tables ok but bolts may scratch wheelchair user. <i>Proposed Solution:</i> Modify picnic table as required to provide knee clearance. <i>Notes:</i> Ensure that designated Acc. tables do not have sharp abrasive surfaces below. 	PCODE NH11A ADAAG 16.5.4. ADA 2010 902.2 CBC 2010 1132B.1 CBC 2013 11-902.2 Priority 2 Severity 2 FY 24-25 Contract Work	1	JOB	\$850	\$850

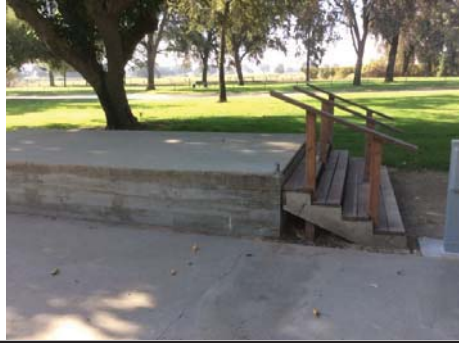
<u>Ramps</u>						
5059	<ul style="list-style-type: none"> <i>As-Built Description:</i> Ramp needed to provide disabled access at steps or change of level along path of travel. <i>Proposed Solution:</i> Provide new concrete ramp with handrails [slope more than 1:20 (5.0%) needed]. <i>Notes:</i> 27" high 	PCODE EB01A ADAAG 4.1.1 ADA 2010 303.4 CBC 2010 1127B.1 CBC 2013 11B-303.4 Priority 2 Severity 3 FY 24-25 Contract Work	108	SF	\$100	\$10,800

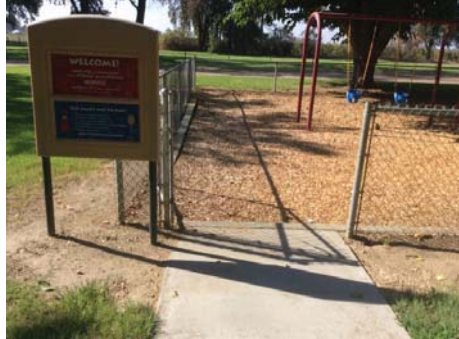
<u>Surfacing</u>						
5077	<ul style="list-style-type: none"> <i>As-Built Description:</i> Accessible route within 8'-0" of play equipment is not firm, resilient safety surfacing. <i>Proposed Solution:</i> Provide 8'-0" resilient surfacing around play structure. 	PCODE OA01 ADAAG 36 CFR Part 1191 ADA 2010 1008.2.6 CBC 2010 DSA 99-02 CBC 2013 11B-1008.2.6 Priority 2 Severity 3 FY 24-25 Contract Work	400	SF	\$9	\$3,600

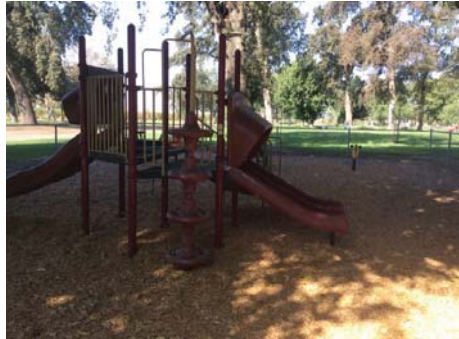
Item No. and Name	Existing Architectural Barrier and Proposed Solution	Codes / Mitigation Info	Qty	Unit	Cost	Total
5079	<ul style="list-style-type: none"> <i>As-Built Description:</i> Accessible route within 8'-0" of play equipment is not firm, resilient safety surfacing. <i>Proposed Solution:</i> Provide 8'-0" resilient surfacing around play structure. 	PCODE OA01REF ADAAG 36 CFR Part 1191 ADA 2010 1008.2.6 CBC 2010 DSA 99-02 CBC 2013 11B-1008.2.6 Priority 2 Severity 3 FY 24-25 Contract Work				
			REF

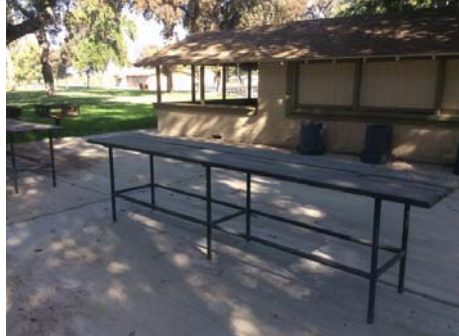
Table

5066	<ul style="list-style-type: none"> <i>As-Built Description:</i> Prep counter (top 28" to 34" high; knee space at least 27" high x 19" deep x 30" wide) not provided. <i>As-Built:</i> Top 36" prep table. no knee space. <i>Proposed Solution:</i> Modify table 	PCODE IN02 ADAAG 4.32.3 & .4 ADA 2010 306.1 CBC 2010 1122B.3 & 4 CBC 2013 11B-306.1 Priority 2 Severity 2 FY 24-25 Contract Work	1	JOB	\$2,500	\$2,500

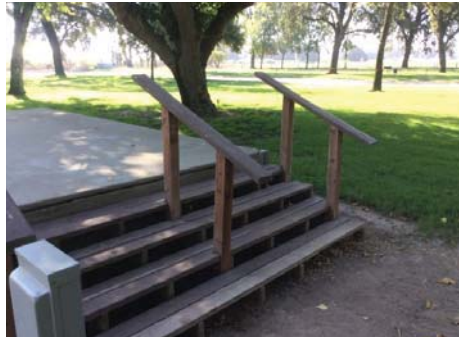
Top & Bottom Extension at Stairs

5060	<ul style="list-style-type: none"> <i>As-Built Description:</i> Stair handrail does not extend horizontally 12" minimum beyond top nosing, and one tread width sloped, plus 12" minimum horizontally beyond the bottom nosing. <i>Proposed Solution:</i> Extend stair handrail at top and bottom (cost for each extension piece). 	PCODE ED06REF ADAAG 4.9.4(2) ADA 2010 505.10.2; 505.10.3 CBC 2010 1133B.4.2.2 CBC 2013 11B-505.10.2; 11B-505.10.3 Priority 2 Severity 2 FY 24-25 Contract Work				
			REF

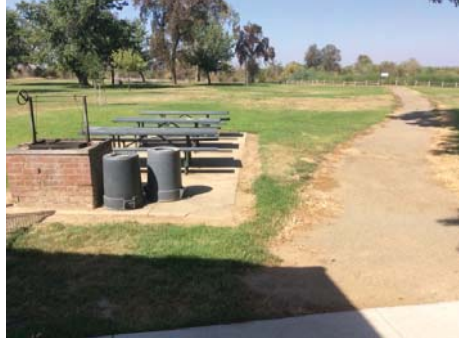
Item No. and Name	Existing Architectural Barrier and Proposed Solution	Codes / Mitigation Info	Qty	Unit	Cost	Total
<u>Accessible Route</u>						
5112	<ul style="list-style-type: none"> <i>As-Built Description:</i> No walk / sidewalk provided to connect accessible facilities or elements that are on the same site. <i>Proposed Solution:</i> Provide new 48" wide walk / sidewalk. <i>Notes:</i> recommen providing picnic areas due to proximity of Acc. parking and restrooms. Areas H,G,F, and or V 	PCODE EF13 ADAAG 4.3.2 ADA 2010 206.1 CBC 2010 1114B.1.2 CBC 2013 11B-206.1 Priority 2 Severity 3 FY 24-25 Contract Work	150	LF	\$45	\$6,750

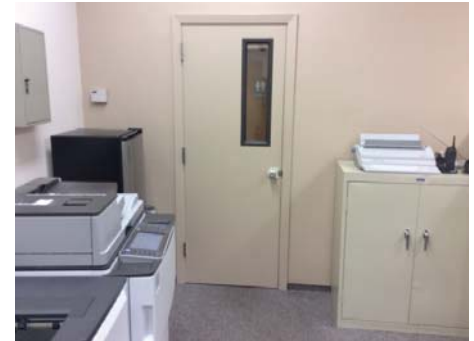
3601	<ul style="list-style-type: none"> <i>As-Built Description:</i> Door does not have accessible operating hardware. <i>Proposed Solution:</i> Provide lever handle or other accessible hardware. 	PCODE ID07 ADAAG 4.13.9 ADA 2010 404.2.7 CBC 2010 1133B.2.5.2 CBC 2013 11B-404.2.7 Priority 2 Severity 3 FY 24-25 Maintenance Work	1	JOB	\$250	\$250
------	--	---	---	-----	-------	-------

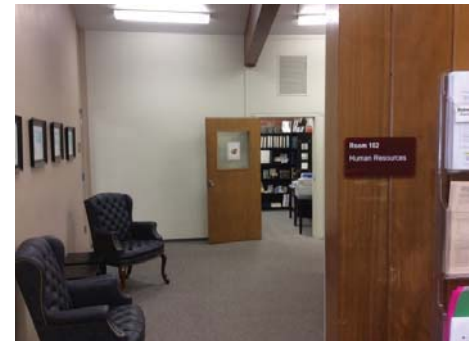
3598	<ul style="list-style-type: none"> <i>As-Built Description:</i> Sign designating a permanent room or space does not include Grade 2 Braille. <i>Proposed Solution:</i> Provide new compliant signage including California Grade 2 Braille (1/10" on center dots with 2/10" space between cells). <i>Notes:</i> Lacks braille and tactile letters 	PCODE SA07A ADAAG 4.30.4 ADA 2010 703.2 CBC 2010 1117B.5.6 CBC 2013 11B-703.3 Priority 2 Severity 3 FY 24-25 Maintenance Work	1	JOB	\$90	\$90
------	--	--	---	-----	------	------

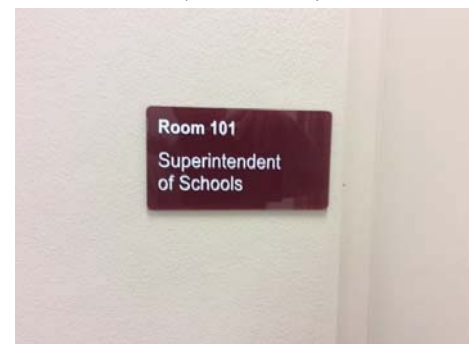
3609	<ul style="list-style-type: none"> <i>As-Built Description:</i> Sign designating a permanent room or space does not include Grade 2 Braille. <i>Proposed Solution:</i> Provide new compliant signage including California Grade 2 Braille (1/10" on center dots with 2/10" space between cells). <i>Notes:</i> Lacks braille and tactile letters. Also has glare. 	PCODE SA07A ADAAG 4.30.4 ADA 2010 703.2 CBC 2010 1117B.5.6 CBC 2013 11B-703.3 Priority 2 Severity 3 FY 24-25 Maintenance Work	1	JOB	\$90	\$90
------	---	--	---	-----	------	------

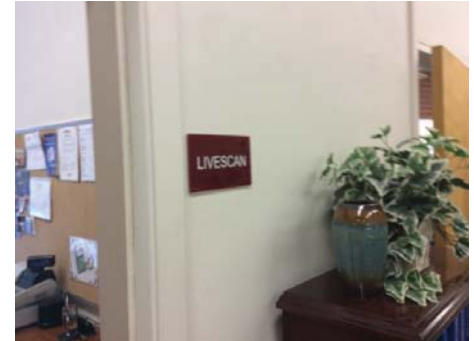
Item No. and Name	Existing Architectural Barrier and Proposed Solution	Codes / Mitigation Info	Qty	Unit	Cost	Total
3611	<ul style="list-style-type: none"> <i>As-Built Description:</i> Sign designating a permanent room or space does not include Grade 2 Braille. <i>Proposed Solution:</i> Provide new compliant signage including California Grade 2 Braille (1/10" on center dots with 2/10" space between cells). 	PCODE SA07A ADAAG 4.30.4 ADA 2010 703.2 CBC 2010 1117B.5.6 CBC 2013 11B-703.3 Priority 2 Severity 3 FY 24-25 Maintenance Work	1	JOB	\$90	\$90

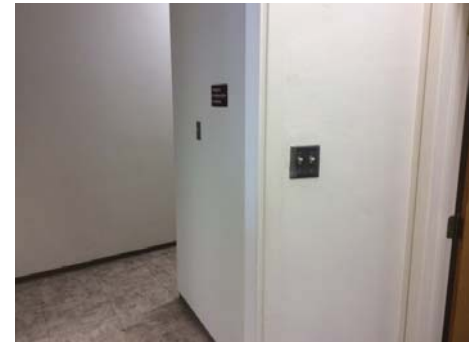
3619	<ul style="list-style-type: none"> <i>As-Built Description:</i> Electric switch or control mounted less than 36" or more than 48" above floor to center. <i>As-Built:</i> Light switch: 54" <i>Proposed Solution:</i> Relocate light switches or control to between 36" and 48" height. 	PCODE IC01 ADAAG 4.2.5 & 6 ADA 2010 308.2.1 & 308.2.2 CBC 2010 1117B.6.3 CBC 2013 11B-308.2.1 & 11B-308.2.2 Priority 2 Severity 3 FY 24-25 Maintenance Work	3	JOB	\$300	\$900
------	--	--	---	-----	-------	-------

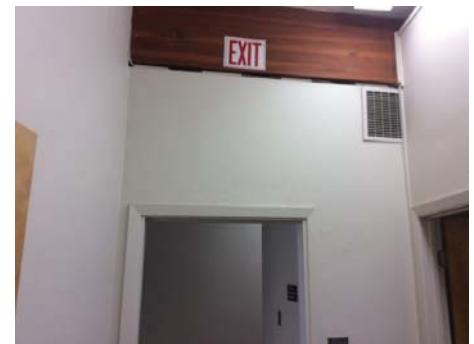
3627	<ul style="list-style-type: none"> <i>As-Built Description:</i> At door leading into exit corridor: Where required exit signs are installed, signs to provide exiting information for people with vision impairment are not provided. <i>Proposed Solution:</i> Provide raised letter/Braille "EXIT ROUTE" sign at door. 	PCODE SA10D ADAAG 4.1.3(16) ADA 2010 216.4.1 CBC 2010 1011.3 CBC 2013 11B-216.4.1 Priority 2 Severity 3 FY 24-25 Maintenance Work	1	JOB	\$90	\$90
------	--	--	---	-----	------	------

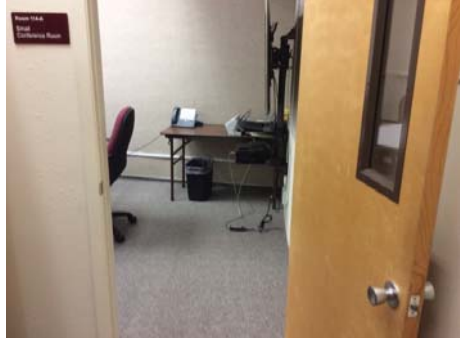
Item No. and Name	Existing Architectural Barrier and Proposed Solution	Codes / Mitigation Info	Qty	Unit	Cost	Total
<u>Door Hardware</u>						
3620	<ul style="list-style-type: none"> <i>As-Built Description:</i> Door does not have accessible operating hardware. <i>Proposed Solution:</i> Provide lever handle or other accessible hardware. 	PCODE ID07REF ADAAG 4.13.9 ADA 2010 404.2.7 CBC 2010 1133B.2.5.2 CBC 2013 11B-404.2.7 Priority 2 Severity 3 FY 24-25 Maintenance Work				
						REF

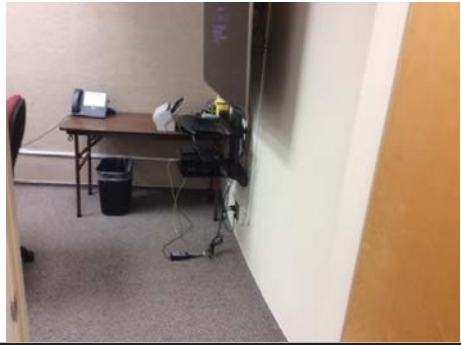
<u>Protrusion Limits</u>						
3625	<ul style="list-style-type: none"> <i>As-Built Description:</i> Protruding objects more than 4" from wall, when bottom of object more than 27" or less than 80" above finished floor. <i>As-Built:</i> TV: 9" protrusion at 44" and in clear space of door. <i>Proposed Solution:</i> Remove/relocate protruding object. Patch existing surface. 	PCODE EG04 ADAAG 4.4.1 ADA 2010 307.2 CBC 2010 1133B.8.6.1 CBC 2013 11B-307.2 Priority 2 Severity 2 FY 24-25 Maintenance Work	1	JOB	\$100	\$100

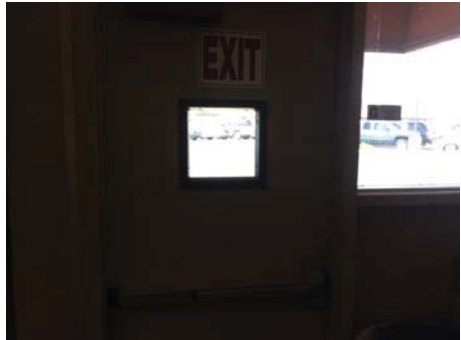
<u>Door</u>						
3642	<ul style="list-style-type: none"> <i>As-Built Description:</i> Vision Light at door that permits viewing, does not have bottom of at least one glazed panel located 43 inches maximum above the finish floor. (Exception: More than 66" above finished floor.) <i>As-Built:</i> 55" <i>Proposed Solution:</i> Provide new door with vision panel at 43" max. 	PCODE ID06C ADA 2010 404.2.11 CBC 2013 11B-404.2.11 Priority 2 Severity 2 FY 24-25 Maintenance Work	1	JOB	\$2,500	\$2,500

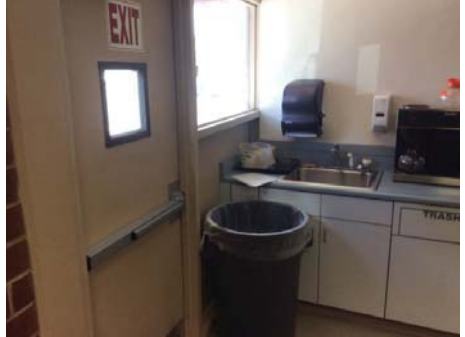
Item No. and Name	Existing Architectural Barrier and Proposed Solution	Codes / Mitigation Info	Qty	Unit	Cost	Total
<u>Door Closer</u>						
3645	<ul style="list-style-type: none"> <i>As-Built Description:</i> Excessive force required to open door. <i>As-Built:</i> 13 lbs <i>Proposed Solution:</i> Adjust regular door closer to accessible standards (5 lbs max). 	PCODE ID03 ADAAG 4.13.11 ADA 2010 404.2.9 CBC 2010 1133B.2.5 CBC 2013 11B-404.2.9 Priority 2 Severity 3 FY 24-25 Maintenance Work	1	JOB	\$25	\$25

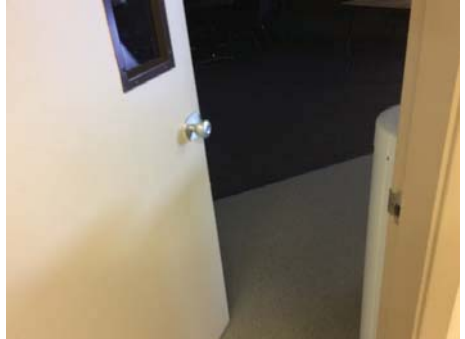
<u>Door Hardware</u>						
3634	<ul style="list-style-type: none"> <i>As-Built Description:</i> Door does not have accessible operating hardware. <i>Proposed Solution:</i> Provide lever handle or other accessible hardware. 	PCODE ID07 ADAAG 4.13.9 ADA 2010 404.2.7 CBC 2010 1133B.2.5.2 CBC 2013 11B-404.2.7 Priority 2 Severity 3 FY 24-25 Maintenance Work	1	JOB	\$250	\$250

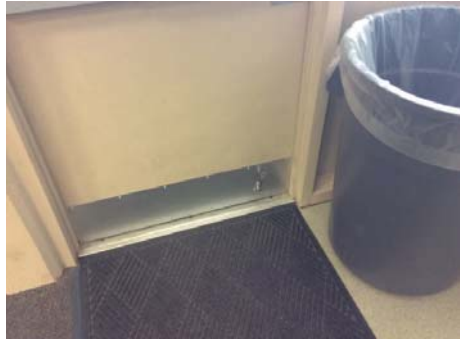
<u>Door Stopper</u>						
3643	<ul style="list-style-type: none"> <i>As-Built Description:</i> At push side of door on accessible route, bottom 10" does not have a smooth, uninterrupted surface. <i>Proposed Solution:</i> Remove door stopper when altering area. Provide rubber wedge. 	PCODE ID06A ADA 2010 404.2.10 CBC 2010 1133B.2.6 CBC 2013 11B-404.2.10 Priority 2 Severity 3 FY 24-25 Maintenance Work	1	JOB	\$25	\$25

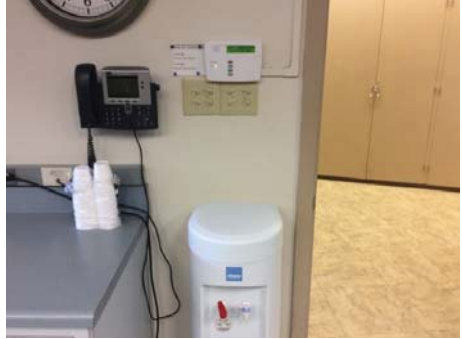
Item No. and Name	Existing Architectural Barrier and Proposed Solution	Codes / Mitigation Info	Qty	Unit	Cost	Total
Electrical						
3636	<ul style="list-style-type: none"> <i>As-Built Description:</i> Electric switch or control mounted less than 36" or more than 48" above floor to center. <i>As-Built:</i> 55"-58" various items <i>Proposed Solution:</i> Relocate light switches or control to between 36" and 48" height. 	PCODE IC01 ADAAG 4.2.5 & 6 ADA 2010 308.2.1 & 308.2.2 CBC 2010 1117B.6.3 CBC 2013 11B-308.2.1 & 11B-308.2.2 Priority 2 Severity 3 FY 24-25 Maintenance Work	4	JOB	\$300	\$1,200

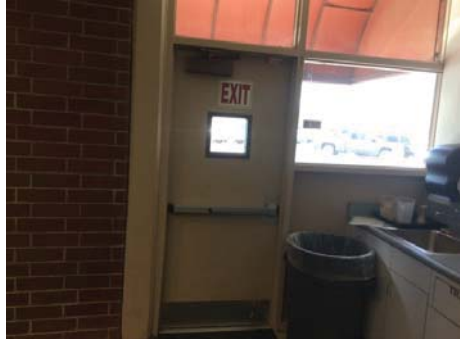
Signage						
3641	<ul style="list-style-type: none"> <i>As-Built Description:</i> At final exit door to exterior: Where required exit signs are installed, signs to provide exiting information for people with vision impairment are not provided. <i>Proposed Solution:</i> Provide raised letter/Braille "EXIT" sign at door. 	PCODE SA10A ADAAG 4.1.3(16) ADA 2010 216.4.1 CBC 2010 1011.3 CBC 2013 11B-216.4.1 Priority 2 Severity 3 FY 24-25 Maintenance Work	1	JOB	\$90	\$90

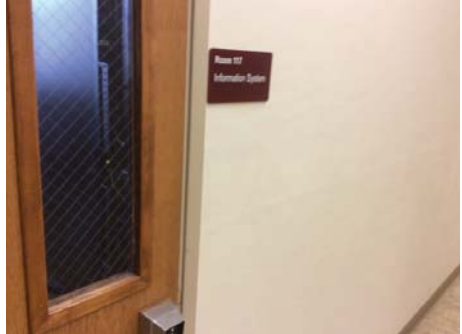
Signage						
3647	<ul style="list-style-type: none"> <i>As-Built Description:</i> Sign designating a permanent room or space does not include Grade 2 Braille. <i>Proposed Solution:</i> Provide new compliant signage including California Grade 2 Braille (1/10" on center dots with 2/10" space between cells). 	PCODE SA07ANT ADAAG 4.30.4 ADA 2010 703.2 CBC 2010 1117B.5.6 CBC 2013 11B-703.3 Priority 2 Severity 3 FY 24-25 Maintenance Work	1	JOB	\$150	\$150

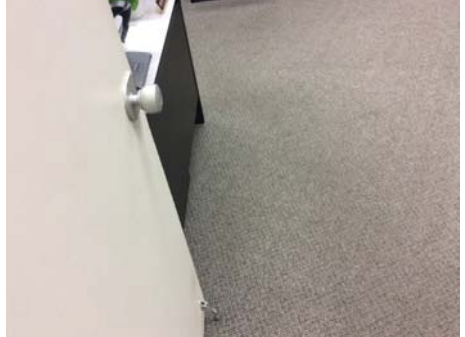
Item No. and Name	Existing Architectural Barrier and Proposed Solution	Codes / Mitigation Info	Qty	Unit	Cost	Total
<u>Door Hardware</u>						
3695	<ul style="list-style-type: none"> <i>As-Built Description:</i> Door does not have accessible operating hardware. <i>Proposed Solution:</i> Provide lever handle or other accessible hardware. 	PCODE ID07 ADAAG 4.13.9 ADA 2010 404.2.7 CBC 2010 1133B.2.5.2 CBC 2013 11B-404.2.7 Priority 2 Severity 3 FY 24-25 Maintenance Work	1	JOB	\$250	\$250

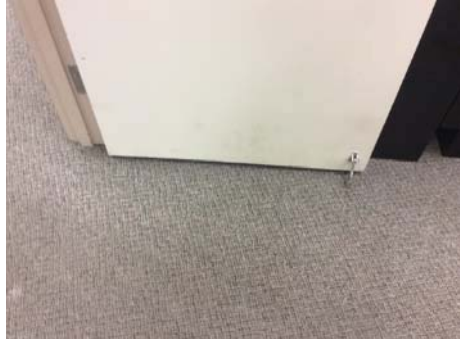
<u>Door Stopper</u>						
3696	<ul style="list-style-type: none"> <i>As-Built Description:</i> At push side of door on accessible route, bottom 10" does not have a smooth, uninterrupted surface. <i>Proposed Solution:</i> Remove door stopper when altering area. Provide rubber wedge. 	PCODE ID06A ADA 2010 404.2.10 CBC 2010 1133B.2.6 CBC 2013 11B-404.2.10 Priority 2 Severity 3 FY 24-25 Maintenance Work	1	JOB	\$25	\$25

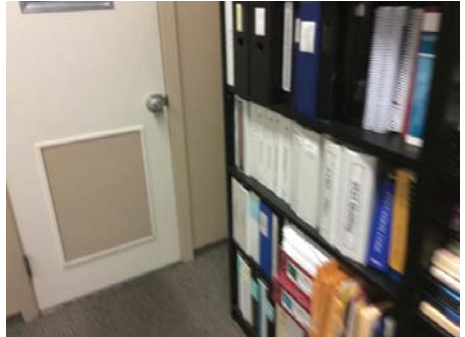
<u>Door Swing</u>						
3699	<ul style="list-style-type: none"> <i>As-Built Description:</i> Front approach: At pull side, door does not have clear and level maneuvering space measuring door width plus 18" x 60". <i>As-Built:</i> 20" to book shelf <i>Proposed Solution:</i> Remove or relocate furniture or storage items. 	PCODE ID23A ADAAG Fig. 25(a) ADA 2010 404.2.4 CBC 2010 11B-26A(a) CBC 2013 11B-404.2.4 Priority 2 Severity 2 FY 24-25 Maintenance Work	1	JOB	\$50	\$50

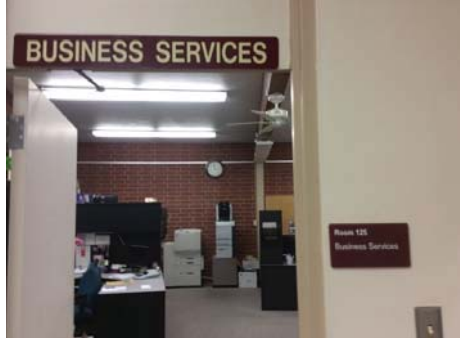
Item No. and Name	Existing Architectural Barrier and Proposed Solution	Codes / Mitigation Info	Qty	Unit	Cost	Total
Signage						
3694	<ul style="list-style-type: none"> <i>As-Built Description:</i> Sign designating a permanent room or space does not include Grade 2 Braille. <i>Proposed Solution:</i> Provide new compliant signage including California Grade 2 Braille (1/10" on center dots with 2/10" space between cells). 	PCODE SA07A ADAAG 4.30.4 ADA 2010 703.2 CBC 2010 1117B.5.6 CBC 2013 11B-703.3 Priority 2 Severity 3 FY 24-25 Maintenance Work	1	JOB	\$90	\$90

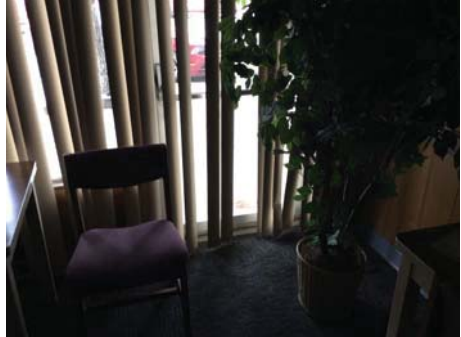
Item No. and Name	Existing Architectural Barrier and Proposed Solution	Codes / Mitigation Info	Qty	Unit	Cost	Total
<u>Door Swing</u>						
3843	<ul style="list-style-type: none"> <i>As-Built Description:</i> Front approach: At push side, door does not have clear and level maneuvering space measuring door width x 48" (door width plus 12" if door has both, latch and closer). <i>As-Built:</i> Door blocked and stuck. <i>Proposed Solution:</i> Remove or relocate furniture or storage items. 	PCODE ID24A ADAAG Fig. 25(a) ADA 2010 404.2.4 CBC 2010 11B-26A(a) CBC 2013 11B-404.2.4 Priority 2 Severity 2 FY 24-25 Maintenance Work	1	JOB	\$50	\$50

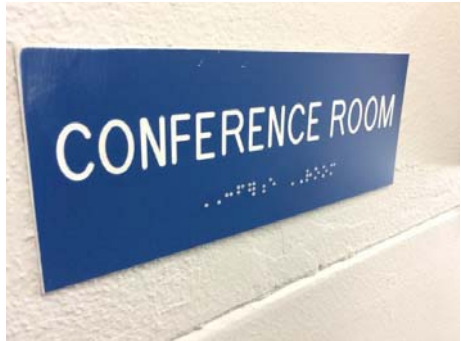
<u>Signage</u>						
3840	<ul style="list-style-type: none"> <i>As-Built Description:</i> Sign designating a permanent room or space does not include Grade 2 Braille. <i>As-Built:</i> characters not raised <i>Proposed Solution:</i> Provide new compliant signage including California Grade 2 Braille (1/10" on center dots with 2/10" space between cells). 	PCODE SA07AREF ADAAG 4.30.4 ADA 2010 703.2 CBC 2010 1117B.5.6 CBC 2013 11B-703.3 Priority 2 Severity 3 FY 24-25 Maintenance Work	REF

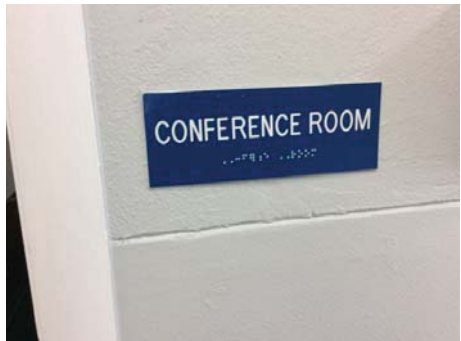
3839	<ul style="list-style-type: none"> <i>As-Built Description:</i> Braille symbols: dots are not 1/10" on centers in each cell with 2/10" space between cells. <i>Proposed Solution:</i> CA only - Provide new compliant signage including Contracted Grade 2 Braille with Title 24 spacing requirements - 1/10" on center dots with 2/10" space between cells. 	PCODE SA07C ADA 2010 703.3 CBC 2010 1117B.5.6 CBC 2013 11B-703.3 Priority 2 Severity 3 FY 24-25 Maintenance Work	1	JOB	\$150	\$150

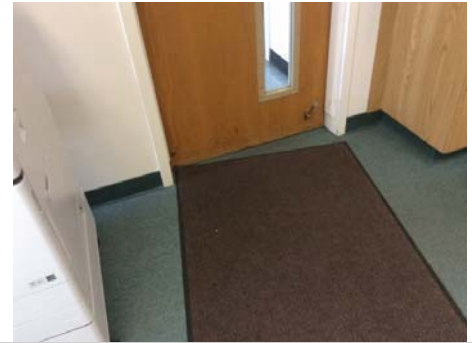
959	<ul style="list-style-type: none"> <i>As-Built Description:</i> Doormat not securely attached to ground or floor structure. <i>Proposed Solution:</i> Attach doormat to floor surface or remove doormat. 	PCODE ID05A ADAAG 4.5.3 ADA 2010 302.2 CBC 2010 1124B.3 CBC 2013 11B-302.2 Priority 2 Severity 3 FY 24-25 Maintenance Work	1	JOB	\$75	\$75
-----	--	---	---	-----	------	------

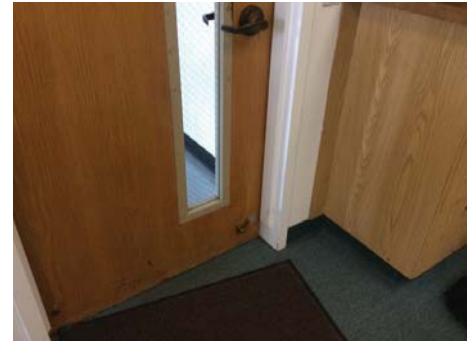
958	<ul style="list-style-type: none"> <i>As-Built Description:</i> At push side of door on accessible route, bottom 10" does not have a smooth, uninterrupted surface. <i>Proposed Solution:</i> Remove door stopper when altering area. Provide rubber wedge. 	PCODE ID06A ADA 2010 404.2.10 CBC 2010 1133B.2.6 CBC 2013 11B-404.2.10 Priority 2 Severity 3 FY 24-25 Maintenance Work	1	JOB	\$25	\$25
-----	---	--	---	-----	------	------

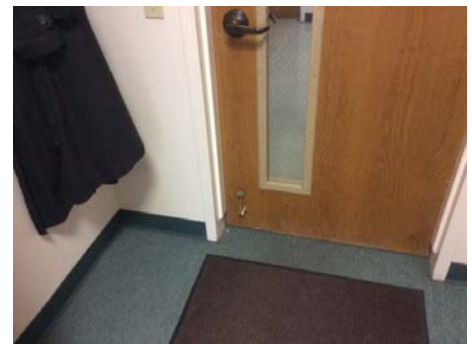
963	<ul style="list-style-type: none"> <i>As-Built Description:</i> At push side of door on accessible route, bottom 10" does not have a smooth, uninterrupted surface. <i>Proposed Solution:</i> Remove door stopper when altering area. Provide rubber wedge. 	PCODE ID06A ADA 2010 404.2.10 CBC 2010 1133B.2.6 CBC 2013 11B-404.2.10 Priority 2 Severity 3 FY 24-25 Maintenance Work	1	JOB	\$25	\$25
-----	---	--	---	-----	------	------

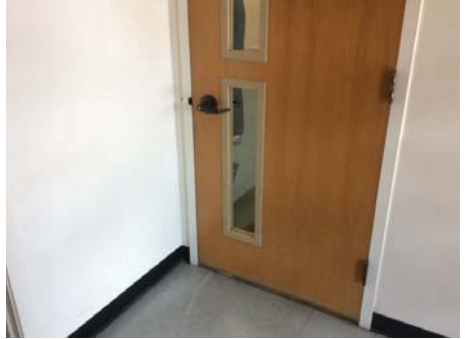
Item No. and Name	Existing Architectural Barrier and Proposed Solution	Codes / Mitigation Info	Qty	Unit	Cost	Total
<u>Door Swing</u>						
957	<ul style="list-style-type: none"> <i>As-Built Description:</i> Front approach: At pull side, door does not have clear and level maneuvering space measuring door width plus 18" x 60". <i>As-Built:</i> Door width plus 4.5" <i>Proposed Solution:</i> Change door swing. Latch to hinge side. 	PCODE ID23 ADAAG Fig. 25(a) ADA 2010 404.2.4 CBC 2010 11B-26A(a) CBC 2013 11B-404.2.4 Priority 2 Severity 2 FY 24-25 Maintenance Work	1	JOB	\$500	\$500

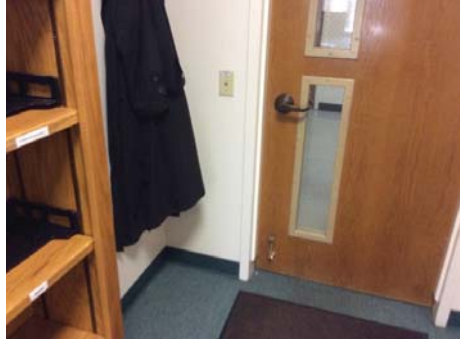
967	<ul style="list-style-type: none"> <i>As-Built Description:</i> Front approach: At push side, door does not have clear and level maneuvering space measuring door width x 48" (door width plus 12" if door has both, latch and closer). <i>As-Built:</i> 36" to shelving <i>Proposed Solution:</i> Remove or relocate furniture or storage items. 	PCODE ID24A ADAAG Fig. 25(a) ADA 2010 404.2.4 CBC 2010 11B-26A(a) CBC 2013 11B-404.2.4 Priority 2 Severity 3 FY 24-25 Maintenance Work	1	JOB	\$50	\$50

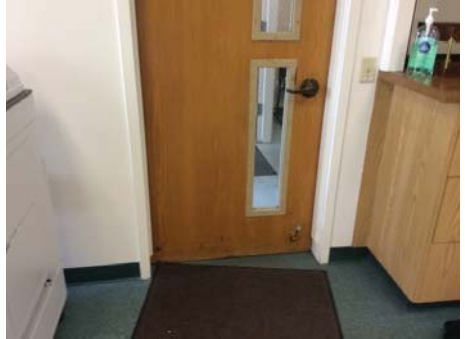
960	<ul style="list-style-type: none"> <i>As-Built Description:</i> Front approach: At push side, door does not have clear and level maneuvering space measuring door width x 48" (door width plus 12" if door has both, latch and closer). <i>As-Built:</i> 8-11" <i>Proposed Solution:</i> Change door swing. Latch to hinge side. 	PCODE ID24REF ADAAG Fig. 25(a) ADA 2010 404.2.4 CBC 2010 11B-26A(a) CBC 2013 11B-404.2.4 Priority 2 Severity 3 FY 24-25 Maintenance Work	REF

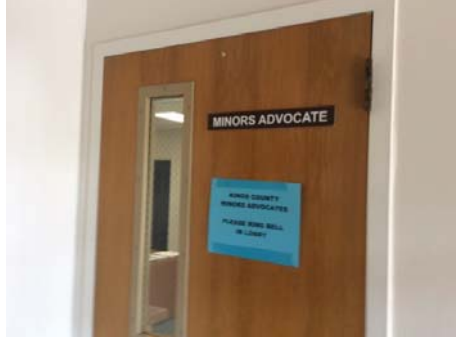
Item No. and Name	Existing Architectural Barrier and Proposed Solution	Codes / Mitigation Info	Qty	Unit	Cost	Total
Signage						
956	<ul style="list-style-type: none"> <i>As-Built Description:</i> Sign not located on latch side of door and/or not located at 48" min. above to baseline of the lowest Braille cells and 60" max. to baseline of the highest line of raised characters. <i>Proposed Solution:</i> Provide compliant signage including tactile characters and Grade II Braille on latch side of door located 60" on center from floor. 	PCODE SA07 ADAAG 4.30.6 ADA 2010 703.4.1 CBC 2010 1117B.5.7 CBC 2013 11B-703.4.1 Priority 2 Severity 3 FY 24-25 Maintenance Work	1	JOB	\$50	\$50

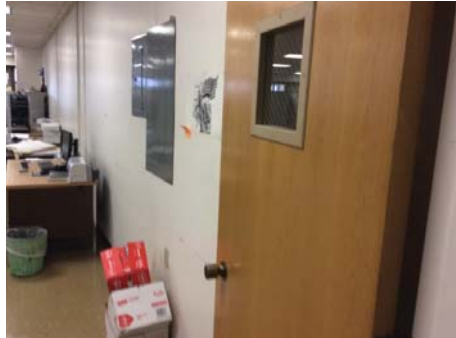
970	<ul style="list-style-type: none"> <i>As-Built Description:</i> Vision Light at door that permits viewing, does not have bottom of at least one glazed panel located 43 inches maximum above the finish floor. (Exception: More than 66" above finished floor.) <i>As-Built:</i> 60" <i>Proposed Solution:</i> Provide new door with vision panel at 43" max. 	PCODE ID06C ADA 2010 404.2.11 CBC 2013 11B-404.2.11 Priority 2 Severity 1 FY 24-25 Maintenance Work	1	JOB	\$2,500	\$2,500

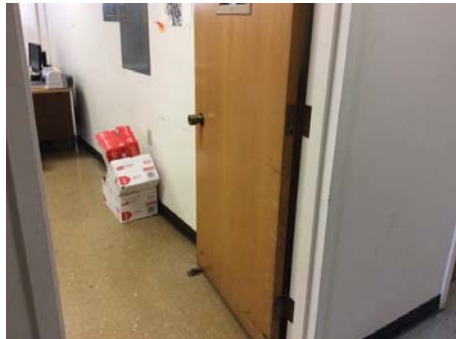
969	<ul style="list-style-type: none"> <i>As-Built Description:</i> Door does not have accessible operating hardware. <i>Proposed Solution:</i> Provide lever handle or other accessible hardware. 	PCODE ID07 ADAAG 4.13.9 ADA 2010 404.2.7 CBC 2010 1133B.2.5.2 CBC 2013 11B-404.2.7 Priority 2 Severity 3 FY 24-25 Maintenance Work	1	JOB	\$250	\$250

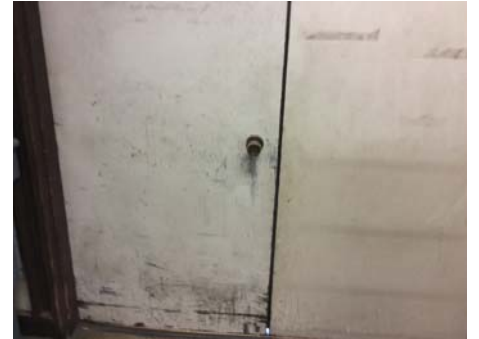
Item No. and Name	Existing Architectural Barrier and Proposed Solution	Codes / Mitigation Info	Qty	Unit	Cost	Total
980	<ul style="list-style-type: none"> <i>As-Built Description:</i> Door does not have accessible operating hardware. <i>Proposed Solution:</i> Provide lever handle or other accessible hardware. 	PCODE ID07 ADAAG 4.13.9 ADA 2010 404.2.7 CBC 2010 1133B.2.5.2 CBC 2013 11B-404.2.7 Priority 2 Severity 3 FY 24-25 Maintenance Work	1	JOB	\$250	\$250

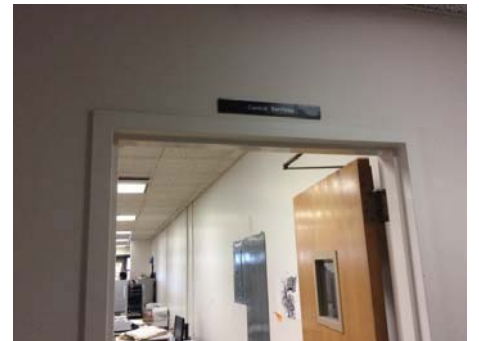
968	<ul style="list-style-type: none"> <i>As-Built Description:</i> Sign not located on latch side of door and/or not located at 48" min. above to baseline of the lowest Braille cells and 60" max. to baseline of the highest line of raised characters. <i>Proposed Solution:</i> Provide compliant signage including tactile characters and Grade II Braille on latch side of door located 60" on center from floor. 	PCODE SA07 ADAAG 4.30.6 ADA 2010 703.4.1 CBC 2010 1117B.5.7 CBC 2013 11B-703.4.1 Priority 2 Severity 3 FY 24-25 Maintenance Work	1	JOB	\$50	\$50
-----	--	---	---	-----	------	------

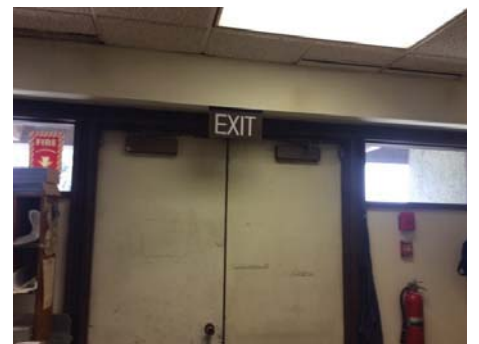
979	<ul style="list-style-type: none"> <i>As-Built Description:</i> At final exit door to exterior: Where required exit signs are installed, signs to provide exiting information for people with vision impairment are not provided. <i>Proposed Solution:</i> Provide raised letter/Braille "EXIT" sign at door. 	PCODE SA10A ADAAG 4.1.3(16) ADA 2010 216.4.1 CBC 2010 1011.3 CBC 2013 11B-216.4.1 Priority 2 Severity 3 FY 24-25 Maintenance Work	1	JOB	\$90	\$90
-----	--	--	---	-----	------	------

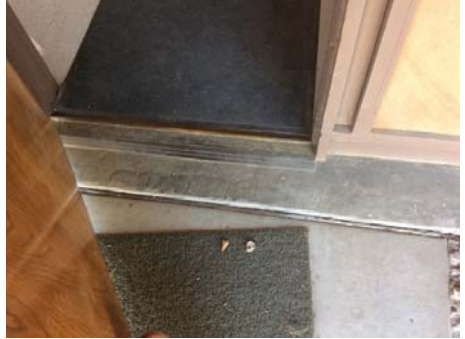
Item No. and Name	Existing Architectural Barrier and Proposed Solution	Codes / Mitigation Info	Qty	Unit	Cost	Total
<u>Carpet/Doormat</u>						
996	<ul style="list-style-type: none"> <i>As-Built Description:</i> Doormat not securely attached to ground or floor structure. <i>Proposed Solution:</i> Attach doormat to floor surface or remove doormat. 	PCODE ID05A ADAAG 4.5.3 ADA 2010 302.2 CBC 2010 1124B.3 CBC 2013 11B-302.2 Priority 2 Severity 3 FY 24-25 Maintenance Work	1	JOB	\$75	\$75

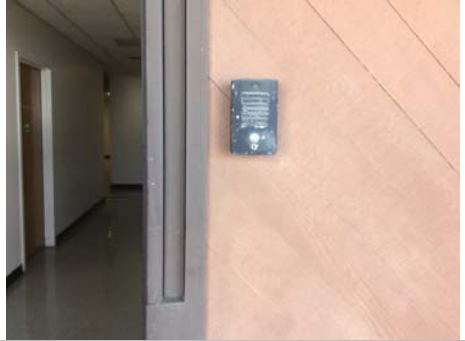
<u>Reach Range</u>						
997	<ul style="list-style-type: none"> <i>As-Built Description:</i> Reach height to control or access point, where only forward approach is available, exceeds 48" or is less than 15". <i>As-Built:</i> Doorbell: 58" <i>Proposed Solution:</i> Modify equipment or mounting. 	PCODE IE01 ADAAG 4.2.5 ADA 2010 308.2.1 CBC 2010 1118B.5 CBC 2013 11B-308.2.1 Priority 2 Severity 3 FY 24-25 Maintenance Work	1	JOB	\$100	\$100

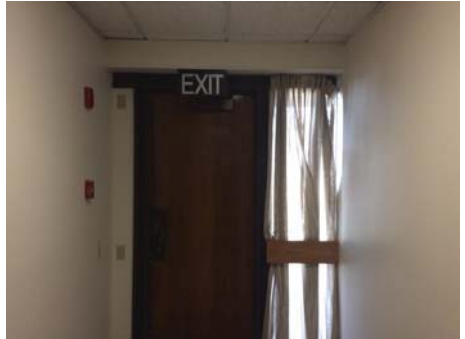
<u>Signage</u>						
999	<ul style="list-style-type: none"> <i>As-Built Description:</i> At final exit door to exterior: Where required exit signs are installed, signs to provide exiting information for people with vision impairment are not provided. <i>Proposed Solution:</i> Provide raised letter/Braille "EXIT" sign at door. 	PCODE SA10A ADAAG 4.1.3(16) ADA 2010 216.4.1 CBC 2010 1011.3 CBC 2013 11B-216.4.1 Priority 2 Severity 3 FY 24-25 Maintenance Work	1	JOB	\$90	\$90

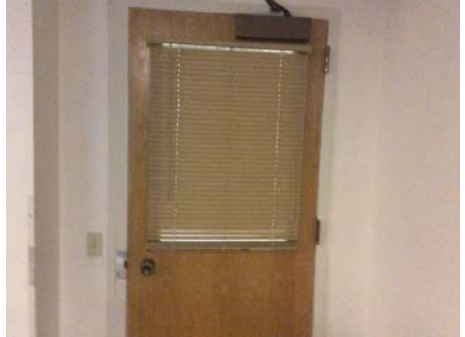
Item No. and Name	Existing Architectural Barrier and Proposed Solution	Codes / Mitigation Info	Qty	Unit	Cost	Total
<u>Door Closer</u>						
1053	<ul style="list-style-type: none"> As-Built Description: Excessive force required to open door. As-Built: 13 lbs Proposed Solution: Adjust regular door closer to accessible standards (5 lbs max). 	PCODE ID03 ADAAG 4.13.11 ADA 2010 404.2.9 CBC 2010 1133B.2.5 CBC 2013 11B-404.2.9 Priority 2 Severity 3 FY 24-25 Maintenance Work	1	JOB	\$25	\$25

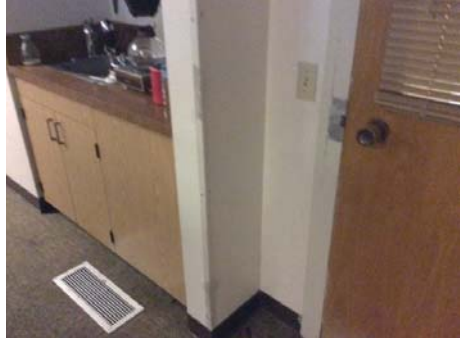
1054	<ul style="list-style-type: none"> As-Built Description: Excessive force required to open door. As-Built: 12 lbs Proposed Solution: Adjust regular door closer to accessible standards (5 lbs max). 	PCODE ID03 ADAAG 4.13.11 ADA 2010 404.2.9 CBC 2010 1133B.2.5 CBC 2013 11B-404.2.9 Priority 2 Severity 3 FY 24-25 Maintenance Work	1	JOB	\$25	\$25

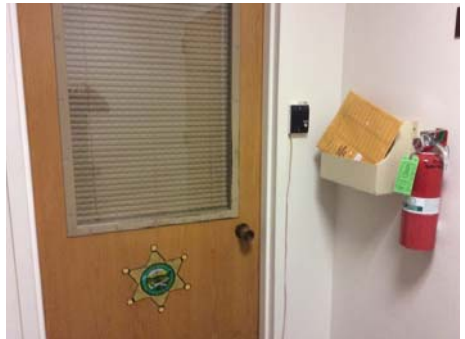
<u>Door Hardware</u>						
1047	<ul style="list-style-type: none"> As-Built Description: Door does not have accessible operating hardware. Proposed Solution: Provide lever handle or other accessible hardware. 	PCODE ID07 ADAAG 4.13.9 ADA 2010 404.2.7 CBC 2010 1133B.2.5.2 CBC 2013 11B-404.2.7 Priority 2 Severity 3 FY 24-25 Maintenance Work	1	JOB	\$250	\$250

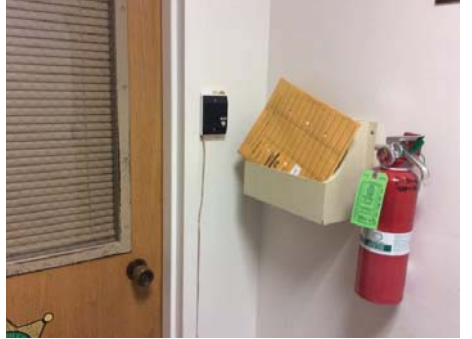
Item No. and Name	Existing Architectural Barrier and Proposed Solution	Codes / Mitigation Info	Qty	Unit	Cost	Total
Reach Range						
1049	<ul style="list-style-type: none"> As-Built Description: Reach height to control or access point, where only forward approach is available, exceeds 48" or is less than 15". As-Built: Doorbell & drop box: 56" and 52" Proposed Solution: Modify equipment or mounting. 	PCODE IE01 ADAAG 4.2.5 ADA 2010 308.2.1 CBC 2010 1118B.5 CBC 2013 11B-308.2.1 Priority 2 Severity 3 FY 24-25 Maintenance Work	1	JOB	\$100	\$100

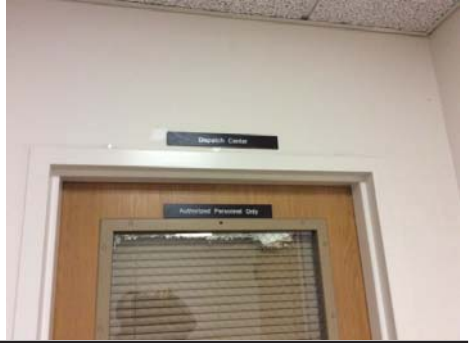
Signage						
1048	<ul style="list-style-type: none"> As-Built Description: Sign not located on latch side of door and/or not located at 48" min. above to baseline of the lowest Braille cells and 60" max. to baseline of the highest line of raised characters. Proposed Solution: Provide compliant signage including tactile characters and Grade II Braille on latch side of door located 60" on center from floor. 	PCODE SA07 ADAAG 4.30.6 ADA 2010 703.4.1 CBC 2010 1117B.5.7 CBC 2013 11B-703.4.1 Priority 2 Severity 3 FY 24-25 Maintenance Work	1	JOB	\$50	\$50

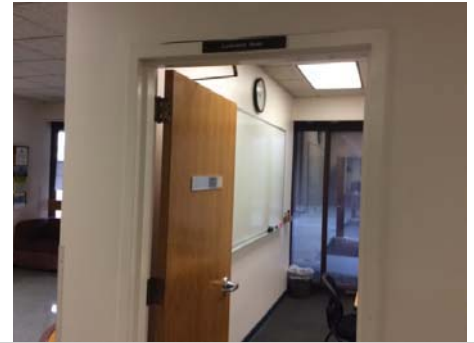
777	<ul style="list-style-type: none"> <i>As-Built Description:</i> Excessive force required to open door. <i>As-Built:</i> 12 lbs <i>Proposed Solution:</i> Adjust regular door closer to accessible standards (5 lbs max). 	<p>PCODE ID03 ADAAG 4.13.11 ADA 2010 404.2.9 CBC 2010 1133B.2.5 CBC 2013 11B-404.2.9 Priority 2 Severity 3 FY 24-25 Maintenance Work</p>	2	JOB	\$25	\$50
-----	---	--	---	-----	------	------

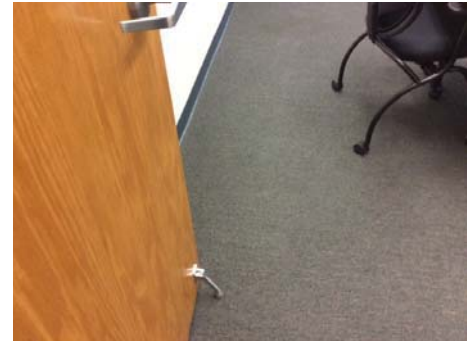
776	<ul style="list-style-type: none"> <i>As-Built Description:</i> At push side of door on accessible route, bottom 10" does not have a smooth, uninterrupted surface. <i>Proposed Solution:</i> Remove door stopper when altering area. Provide rubber wedge. 	<p>PCODE ID06A ADA 2010 404.2.10 CBC 2010 1133B.2.6 CBC 2013 11B-404.2.10 Priority 2 Severity 3 FY 24-25 Maintenance Work</p>	2	JOB	\$25	\$50
-----	---	---	---	-----	------	------

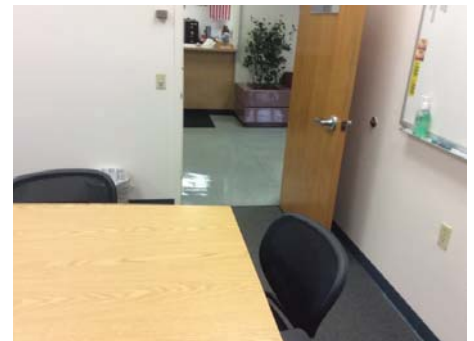
780	<ul style="list-style-type: none"> <i>As-Built Description:</i> Front approach: At pull side, door does not have clear and level maneuvering space measuring door width plus 18"(CA only: 24" at exterior doors)x 60". <i>As-Built:</i> 58" to table <i>Proposed Solution:</i> Remove or relocate furniture or storage items. 	<p>PCODE ID23A ADAAG Fig. 25(a) ADA 2010 404.2.4 CBC 2010 11B-26A(a) CBC 2013 11B-404.2.4 Priority 2 Severity 2 FY 24-25 Maintenance Work</p>	1	JOB	\$50	\$50
-----	--	---	---	-----	------	------

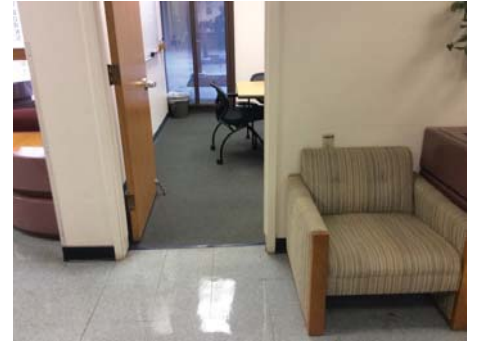
Item No. and Name	Existing Architectural Barrier and Proposed Solution	Codes / Mitigation Info	Qty	Unit	Cost	Total
778	<ul style="list-style-type: none"> As-Built Description: Front approach: At push side, door does not have clear and level maneuvering space measuring door width x 48" (door width plus 12" if door has both, latch and closer). As-Built: 5" to chair Proposed Solution: Remove or relocate furniture or storage items. 	PCODE ID24A ADAAG Fig. 25(a) ADA 2010 404.2.4 CBC 2010 11B-26A(a) CBC 2013 11B-404.2.4 Priority 2 Severity 2 FY 24-25 Maintenance Work	1	JOB	\$50	\$50

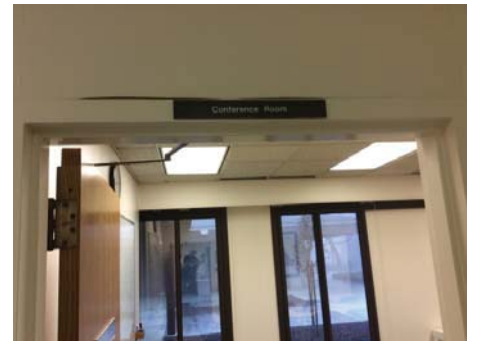
775	<ul style="list-style-type: none"> As-Built Description: Sign not located on latch side of door and/or not located at 48" min. above to baseline of the lowest Braille cells and 60" max. to baseline of the highest line of raised characters. Proposed Solution: Provide compliant signage including tactile characters and Grade II Braille on latch side of door located 60" on center from floor. 	PCODE SA07 ADAAG 4.30.6 ADA 2010 703.4.1 CBC 2010 1117B.5.7 CBC 2013 11B-703.4.1 Priority 2 Severity 3 FY 24-25 Maintenance Work	2	JOB	\$50	\$100
-----	--	---	---	-----	------	-------

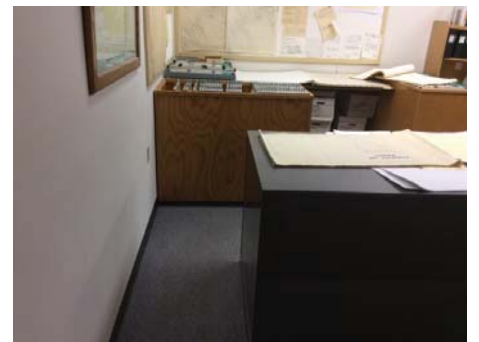
814	<ul style="list-style-type: none"> As-Built Description: Corridor, for occupant load less than 10, less than 36" wide. As-Built: 32-36" Proposed Solution: Remove or relocate furniture and storage items. 	PCODE IH03A ADAAG 4.3.3 ADA 2010 403.5.1 CBC 2010 1133B.3.1 CBC 2013 11B-403.5.1 Priority 2 Severity 2 FY 24-25 Maintenance Work	1	JOB	\$50	\$50
-----	---	---	---	-----	------	------

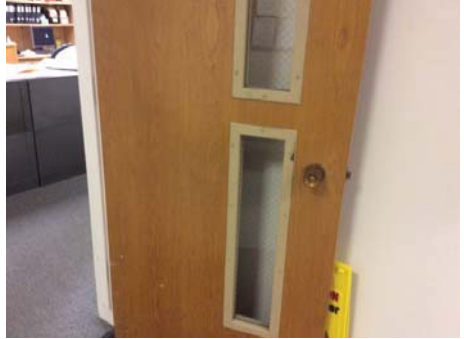
812	<ul style="list-style-type: none"> • <i>As-Built Description:</i> Door does not have accessible operating hardware. • <i>Proposed Solution:</i> Provide lever handle or other accessible hardware. 	<p>PCODE ID07 ADAAG 4.13.9 ADA 2010 404.2.7 CBC 2010 1133B.2.5.2 CBC 2013 11B-404.2.7 Priority 2 Severity 3 FY 24-25 Maintenance Work</p>	1	JOB	\$250	\$250
-----	--	--	---	-----	-------	-------

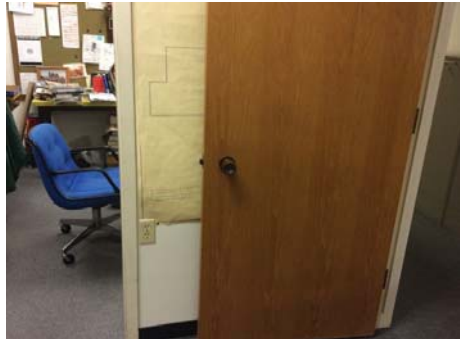
819	<ul style="list-style-type: none"> • <i>As-Built Description:</i> Door does not have accessible operating hardware. • <i>Proposed Solution:</i> Provide lever handle or other accessible hardware. 	<p>PCODE ID07 ADAAG 4.13.9 ADA 2010 404.2.7 CBC 2010 1133B.2.5.2 CBC 2013 11B-404.2.7 Priority 2 Severity 3 FY 24-25 Maintenance Work</p>	1	JOB	\$250	\$250
-----	--	--	---	-----	-------	-------
