Facility: **WOMENS INFANTS & CHILDREN**

Address: 330 HARRIS ST.

Facility: **LEMORE HEALTH CLINIC**
 Address: 229 C ST.

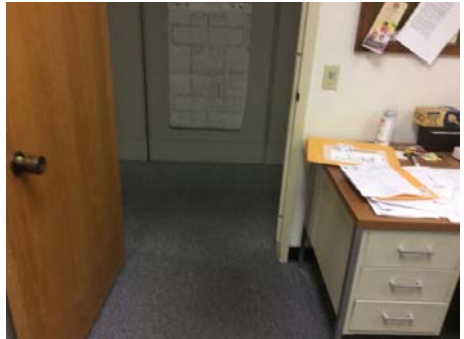
820	<ul style="list-style-type: none"> • <i>As-Built Description:</i> Front approach: At pull side, door does not have clear and level maneuvering space measuring door width plus 18" x 60". • <i>As-Built:</i> 5" to desk • <i>Proposed Solution:</i> Remove or relocate furniture or storage items. 	<p>PCODE ID23A ADAAG Fig. 25(a) ADA 2010 404.2.4 CBC 2010 11B-26A(a) CBC 2013 11B-404.2.4 Priority 2 Severity 2 FY 24-25 Maintenance Work</p>	1	JOB	\$50	\$50
-----	---	--	---	-----	------	------

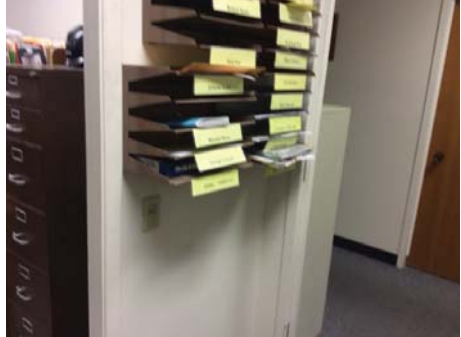
Item No. and Name	Existing Architectural Barrier and Proposed Solution	Codes / Mitigation Info	Qty	Unit	Cost	Total
<u>Protrusion Limits</u>						
843	<ul style="list-style-type: none"> <i>As-Built Description:</i> Protruding objects more than 4" from wall, when bottom of object more than 27" or less than 80" above finished floor. <i>As-Built:</i> File trays: 9" protrusion at 48" AFF <i>Proposed Solution:</i> Remove/relocate protruding object. Patch existing surface. <i>Notes:</i> Copy room 	<p>PCODE EG04 ADAAG 4.4.1 ADA 2010 307.2 CBC 2010 1133B.8.6.1 CBC 2013 11B-307.2 Priority 2 Severity 2 FY 24-25 Maintenance Work</p>	1	JOB	\$100	\$100

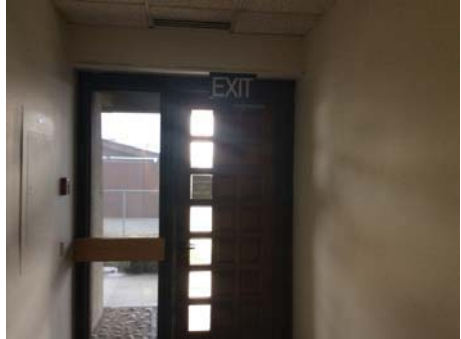
9 Planning Offices

<u>Signage</u>						
833	<ul style="list-style-type: none"> <i>As-Built Description:</i> At final exit door to exterior: Where required exit signs are installed, signs to provide exiting information for people with vision impairment are not provided. <i>Proposed Solution:</i> Provide raised letter/Braille "EXIT" sign at door. 	<p>PCODE SA10A ADAAG 4.1.3(16) ADA 2010 216.4.1 CBC 2010 1011.3 CBC 2013 11B-216.4.1 Priority 2 Severity 3 FY 24-25 Maintenance Work</p>	1	JOB	\$90	\$90

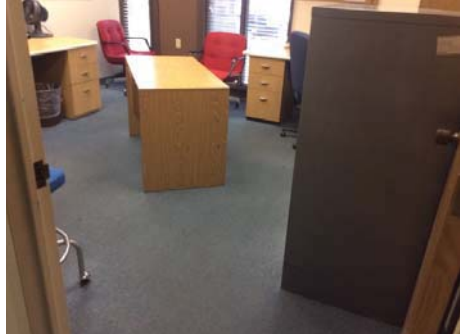
11 Planning Office Print Room

<u>Door Swing</u>						
859	<ul style="list-style-type: none"> <i>As-Built Description:</i> Front approach: At pull side, door does not have clear and level maneuvering space measuring door width plus 18" x 60". <i>As-Built:</i> 37" to cabinet <i>Proposed Solution:</i> Remove or relocate furniture or storage items. <i>Notes:</i> Ensure clearances where public may have access. 	<p>PCODE ID23A ADAAG Fig. 25(a) ADA 2010 404.2.4 CBC 2010 11B-26A(a) CBC 2013 11B-404.2.4 Priority 2 Severity 2 FY 24-25 Maintenance Work</p>	1	JOB	\$50	\$50

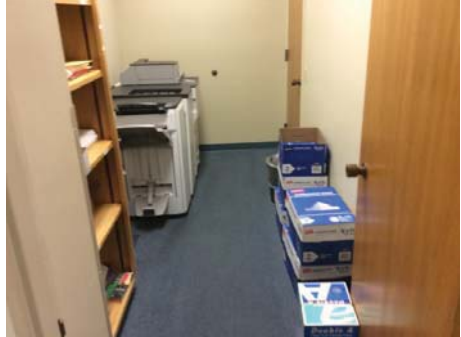
Item No. and Name	Existing Architectural Barrier and Proposed Solution	Codes / Mitigation Info	Qty	Unit	Cost	Total
<u>Door Swing</u>						
875	<ul style="list-style-type: none"> • <i>As-Built Description:</i> Front approach: At push side, door does not have clear and level maneuvering space measuring door width x 48" (door width plus 12" if door has both, latch and closer). • <i>As-Built:</i> 40" to copy machine • <i>Proposed Solution:</i> Remove or relocate furniture or storage items. 	PCODE ID24A ADAAG Fig. 25(a) ADA 2010 404.2.4 CBC 2010 11B-26A(a) CBC 2013 11B-404.2.4 Priority 2 Severity 3 FY 24-25 Maintenance Work	1	JOB	\$50	\$50

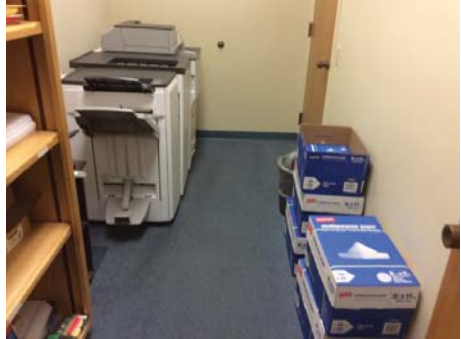
12 IT & Purchasing Lobby

<u>Turn Space</u>						
874	<ul style="list-style-type: none"> • <i>As-Built Description:</i> Less than 60" diameter or T-shaped space provided for wheelchair turns. • <i>Proposed Solution:</i> Remove or relocate storage items or furniture. 	PCODE IN04A ADAAG 4.2.3 ADA 2010 304.1 CBC 2010 1118B.3 CBC 2013 11B-304.1 Priority 2 Severity 2 FY 24-25 Maintenance Work	1	JOB	\$50	\$50

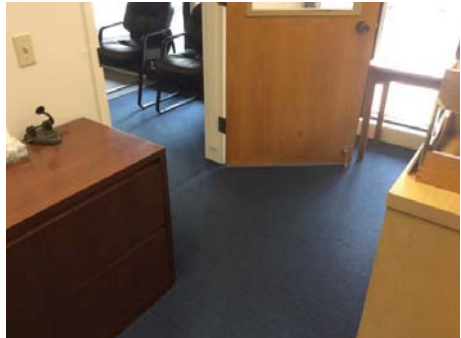
<u>Door Swing</u>						
888	<ul style="list-style-type: none"> • <i>As-Built Description:</i> Front approach: At pull side, door does not have clear and level maneuvering space measuring door width plus 18" x 60". • <i>As-Built:</i> 6" and 56.5" • <i>Proposed Solution:</i> Remove or relocate furniture or storage items. 	PCODE ID23A ADAAG Fig. 25(a) ADA 2010 404.2.4 CBC 2010 11B-26A(a) CBC 2013 11B-404.2.4 Priority 2 Severity 3 FY 24-25 Maintenance Work	1	JOB	\$50	\$50

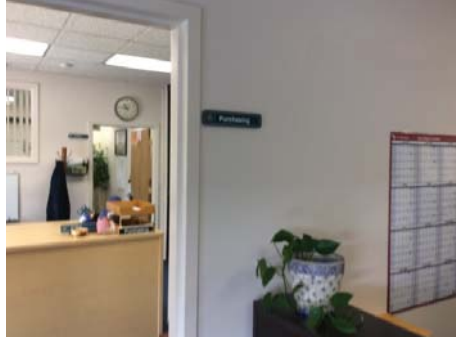
13 IT Offices

Item No. and Name	Existing Architectural Barrier and Proposed Solution	Codes / Mitigation Info	Qty	Unit	Cost	Total
Signage						
884	<ul style="list-style-type: none"> <i>As-Built Description:</i> Sign not located on latch side of door and/or not located at 48" min. above to baseline of the lowest Braille cells and 60" max. to baseline of the highest line of raised characters. <i>Proposed Solution:</i> Provide compliant signage including tactile characters and Grade II Braille on latch side of door located 60" on center from floor. 	PCODE SA07 ADAAG 4.30.6 ADA 2010 703.4.1 CBC 2010 1117B.5.7 CBC 2013 11B-703.4.1 Priority 2 Severity 3 FY 24-25 Maintenance Work	1	JOB	\$50	\$50

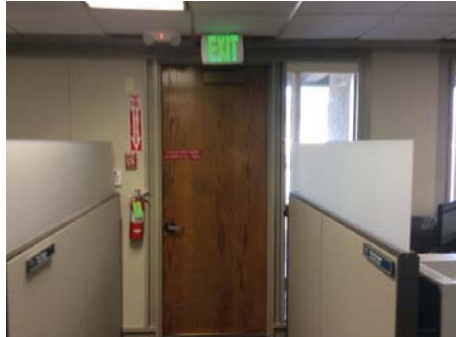
14 Server Room & Offices

Signage						
901	<ul style="list-style-type: none"> <i>As-Built Description:</i> At final exit door to exterior: Where required exit signs are installed, signs to provide exiting information for people with vision impairment are not provided. <i>Proposed Solution:</i> Provide raised letter/Braille "EXIT" sign at door. 	PCODE SA10A ADAAG 4.1.3(16) ADA 2010 216.4.1 CBC 2010 1011.3 CBC 2013 11B-216.4.1 Priority 2 Severity 3 FY 24-25 Maintenance Work	1	JOB	\$90	\$90

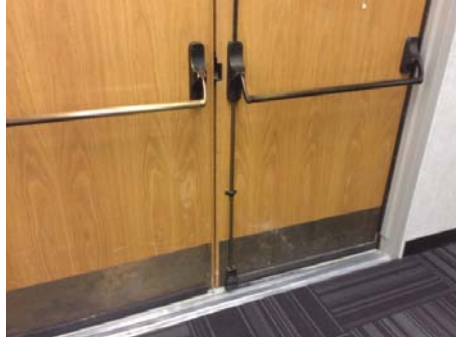
Door						
907	<ul style="list-style-type: none"> <i>As-Built Description:</i> At push side of door on accessible route, bottom 10" does not have a smooth, uninterrupted surface. <i>Proposed Solution:</i> Install kick plate at bottom 10" of door to cover floor latch and floor latch rods. 	PCODE ID06ANT ADA 2010 404.2.10 CBC 2010 1133B.2.6 CBC 2013 11B-404.2.10 Priority 2 Severity 3 FY 24-25 Maintenance Work	1	JOB	\$200	\$200

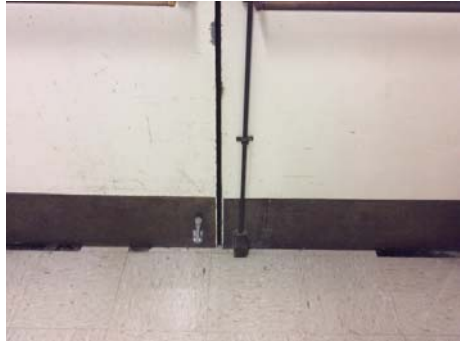
Item No. and Name	Existing Architectural Barrier and Proposed Solution	Codes / Mitigation Info	Qty	Unit	Cost	Total
914	<ul style="list-style-type: none"> <i>As-Built Description:</i> At push side of door on accessible route, bottom 10" does not have a smooth, uninterrupted surface. <i>Proposed Solution:</i> Install kick plate at bottom 10" of door to cover floor latch and floor latch rods. <i>Notes:</i> And remove stopper. 	PCODE ID06ANT ADA 2010 404.2.10 CBC 2010 1133B.2.6 CBC 2013 11B-404.2.10 Priority 2 Severity 3 FY 24-25 Maintenance Work	1	JOB	\$200	\$200

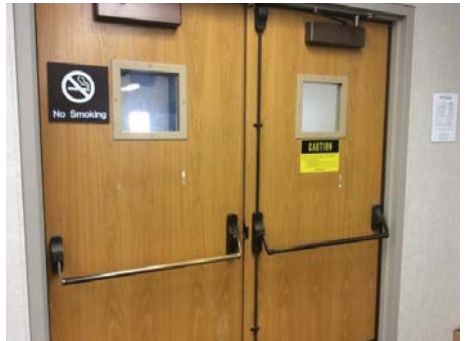
910	<ul style="list-style-type: none"> <i>As-Built Description:</i> Vision Light at door that permits viewing, does not have bottom of at least one glazed panel located 43 inches maximum above the finish floor. (Exception: More than 66" above finished floor.) <i>As-Built:</i> 60.5" <i>Proposed Solution:</i> Provide new door with vision panel at 43" max. 	PCODE ID06C ADA 2010 404.2.11 CBC 2013 11B-404.2.11 Priority 2 Severity 1 FY 24-25 Maintenance Work	2	JOB	\$2,500	\$5,000

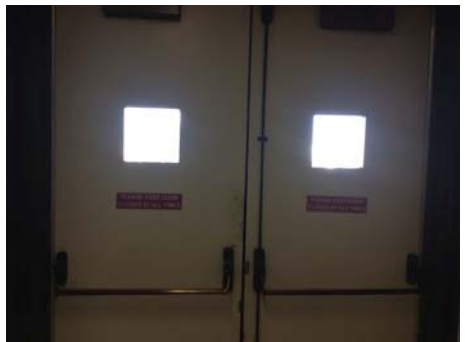
917	<ul style="list-style-type: none"> <i>As-Built Description:</i> Vision Light at door that permits viewing, does not have bottom of at least one glazed panel located 43 inches maximum above the finish floor. (Exception: More than 66" above finished floor.) <i>As-Built:</i> 60.5" <i>Proposed Solution:</i> Provide new door with vision panel at 43" max. 	PCODE ID06C ADA 2010 404.2.11 CBC 2013 11B-404.2.11 Priority 2 Severity 1 FY 24-25 Maintenance Work	2	JOB	\$2,500	\$5,000

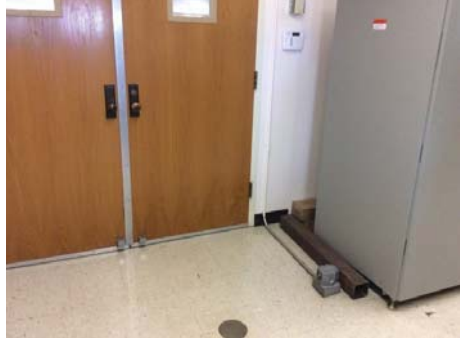
Item No. and Name	Existing Architectural Barrier and Proposed Solution	Codes / Mitigation Info	Qty	Unit	Cost	Total
<u>Door Hardware</u>						
911	<ul style="list-style-type: none"> As-Built Description: Door does not have accessible operating hardware. Proposed Solution: Provide lever handle or other accessible hardware. 	PCODE ID07 ADAAG 4.13.9 ADA 2010 404.2.7 CBC 2010 1133B.2.5.2 CBC 2013 11B-404.2.7 Priority 2 Severity 3 FY 24-25 Maintenance Work	2	JOB	\$250	\$500

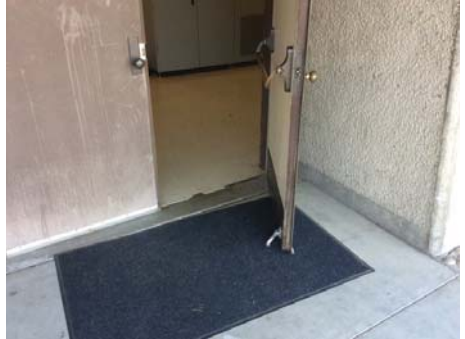
916	<ul style="list-style-type: none"> As-Built Description: Door does not have accessible operating hardware. Proposed Solution: Provide lever handle or other accessible hardware. 	PCODE ID07 ADAAG 4.13.9 ADA 2010 404.2.7 CBC 2010 1133B.2.5.2 CBC 2013 11B-404.2.7 Priority 2 Severity 3 FY 24-25 Maintenance Work	2	JOB	\$250	\$500

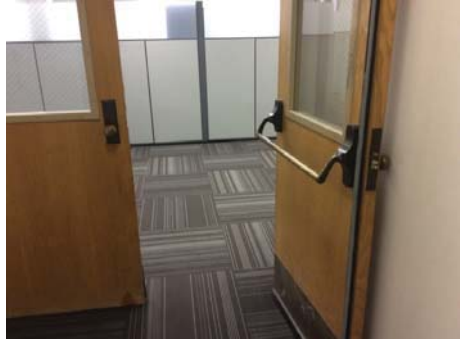
922	<ul style="list-style-type: none"> As-Built Description: Door does not have accessible operating hardware. Proposed Solution: Provide lever handle or other accessible hardware. 	PCODE ID07 ADAAG 4.13.9 ADA 2010 404.2.7 CBC 2010 1133B.2.5.2 CBC 2013 11B-404.2.7 Priority 2 Severity 3 FY 24-25 Maintenance Work	2	JOB	\$250	\$500

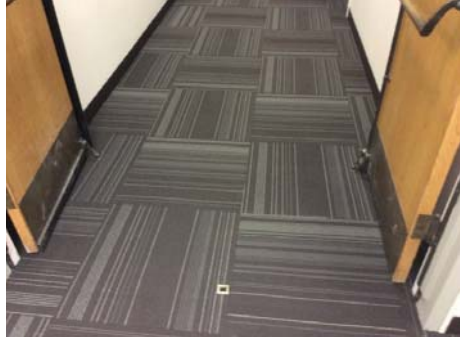
Item No. and Name	Existing Architectural Barrier and Proposed Solution	Codes / Mitigation Info	Qty	Unit	Cost	Total
Door Stopper						
919	<ul style="list-style-type: none"> <i>As-Built Description:</i> At push side of door on accessible route, bottom 10" does not have a smooth, uninterrupted surface. <i>Proposed Solution:</i> Remove door stopper when altering area. Provide rubber wedge. <i>Notes:</i> And provide latch cover plate. 	<p>PCODE ID06A</p> <p>ADA 2010 404.2.10</p> <p>CBC 2010 1133B.2.6</p> <p>CBC 2013 11B-404.2.10</p> <p>Priority 2</p> <p>Severity 3</p> <p>FY 24-25 Maintenance Work</p>	2	JOB	\$25	\$50

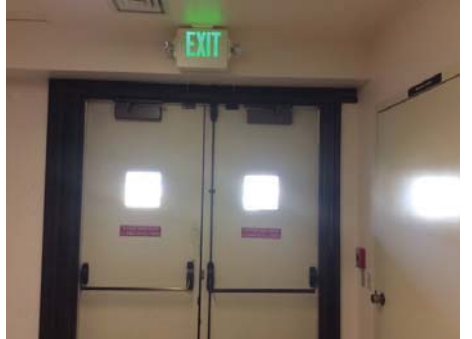
Signage						
913	<ul style="list-style-type: none"> <i>As-Built Description:</i> At final exit door to exterior: Where required exit signs are installed, signs to provide exiting information for people with vision impairment are not provided. <i>Proposed Solution:</i> Provide raised letter/Braille "EXIT" sign at door. 	<p>PCODE SA10A</p> <p>ADAAG 4.1.3(16)</p> <p>ADA 2010 216.4.1</p> <p>CBC 2010 1011.3</p> <p>CBC 2013 11B-216.4.1</p> <p>Priority 2</p> <p>Severity 3</p> <p>FY 24-25 Maintenance Work</p>	1	JOB	\$90	\$90

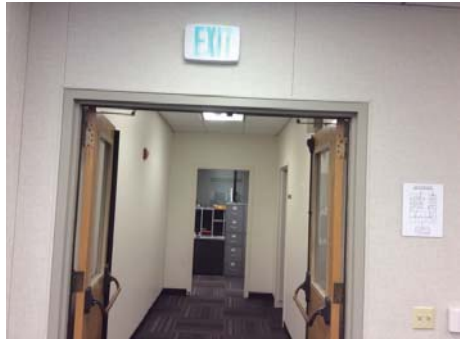
15 Programming Conference Room

918	<ul style="list-style-type: none"> <i>As-Built Description:</i> At door leading into exit corridor: Where required exit signs are installed, signs to provide exiting information for people with vision impairment are not provided. <i>Proposed Solution:</i> Provide raised letter/Braille "EXIT ROUTE" sign at door. 	<p>PCODE SA10D</p> <p>ADAAG 4.1.3(16)</p> <p>ADA 2010 216.4.1</p> <p>CBC 2010 1011.3</p> <p>CBC 2013 11B-216.4.1</p> <p>Priority 2</p> <p>Severity 3</p> <p>FY 24-25 Maintenance Work</p>	1	JOB	\$90	\$90

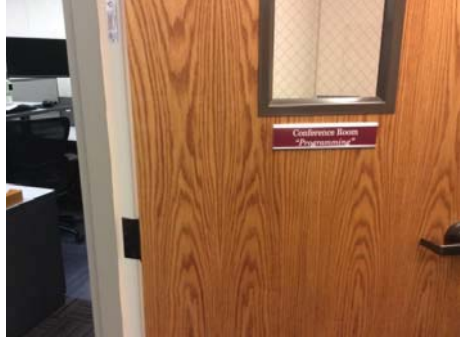
Item No. and Name	Existing Architectural Barrier and Proposed Solution	Codes / Mitigation Info	Qty	Unit	Cost	Total
<u>Door</u>						
926	<ul style="list-style-type: none"> As-Built Description: Vision Light at door that permits viewing, does not have bottom of at least one glazed panel located 43 inches maximum above the finish floor. (Exception: More than 66" above finished floor.) As-Built: 54" Proposed Solution: Provide new door with vision panel at 43" max. 	PCODE ID06C ADA 2010 404.2.11 CBC 2013 11B-404.2.11 Priority 2 Severity 2 FY 24-25 Maintenance Work	2	JOB	\$2,500	\$5,000

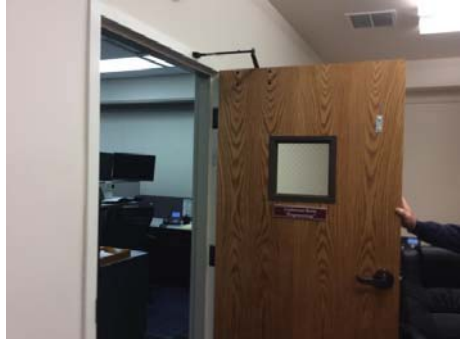
<u>Door Closer</u>						
928	<ul style="list-style-type: none"> As-Built Description: Excessive force required to open door. As-Built: 11 lbs Proposed Solution: Adjust regular door closer to accessible standards (5 lbs max). 	PCODE ID03 ADAAG 4.13.11 ADA 2010 404.2.9 CBC 2010 1133B.2.5 CBC 2013 11B-404.2.9 Priority 2 Severity 3 FY 24-25 Maintenance Work	2	JOB	\$25	\$50

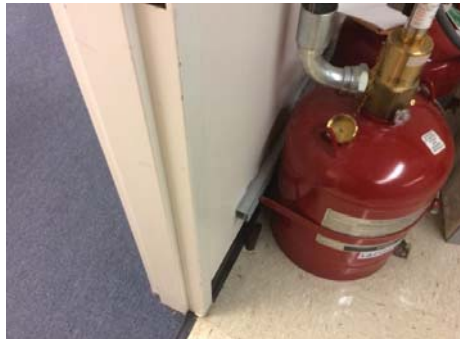
<u>Door Swing</u>						
930	<ul style="list-style-type: none"> As-Built Description: Front approach: At pull side, door does not have clear and level maneuvering space measuring door width plus 18" x 60". As-Built: 11" to sapphire Proposed Solution: Remove or relocate furniture or storage items. 	PCODE ID23ANT ADAAG Fig. 25(a) ADA 2010 404.2.4 CBC 2010 11B-26A(a) CBC 2013 11B-404.2.4 Priority 2 Severity 3 FY 24-25 Maintenance Work	1	JOB	\$50	\$50

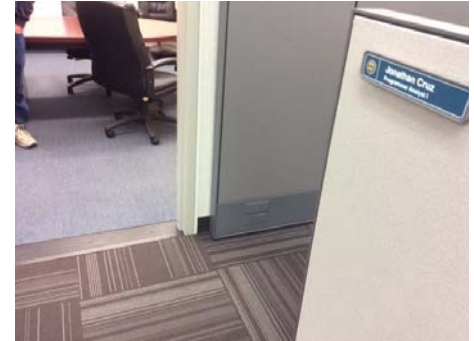
Item No. and Name	Existing Architectural Barrier and Proposed Solution	Codes / Mitigation Info	Qty	Unit	Cost	Total
927	<ul style="list-style-type: none"> <i>As-Built Description:</i> Front approach: At push side, door does not have clear and level maneuvering space measuring door width x 48" (door width plus 12" if door has both, latch and closer). <i>As-Built:</i> 39" to cubicle wing, within 12" <i>Proposed Solution:</i> Remove or relocate furniture or storage items. 	<p>PCODE ID24A</p> <p>ADAAG Fig. 25(a)</p> <p>ADA 2010 404.2.4</p> <p>CBC 2010 11B-26A(a)</p> <p>CBC 2013 11B-404.2.4</p> <p>Priority 2</p> <p>Severity 3</p> <p>FY 24-25 Maintenance Work</p>	1	JOB	\$50	\$50

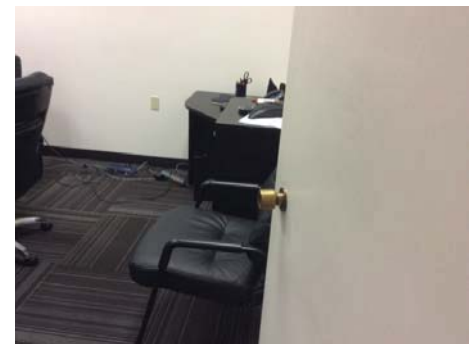
933	<ul style="list-style-type: none"> <i>As-Built Description:</i> Door does not have accessible operating hardware. <i>Proposed Solution:</i> Provide lever handle or other accessible hardware. 	<p>PCODE ID07</p> <p>ADAAG 4.13.9</p> <p>ADA 2010 404.2.7</p> <p>CBC 2010 1133B.2.5.2</p> <p>CBC 2013 11B-404.2.7</p> <p>Priority 2</p> <p>Severity 3</p> <p>FY 24-25 Maintenance Work</p>	1	JOB	\$250	\$250
-----	--	--	---	-----	-------	-------

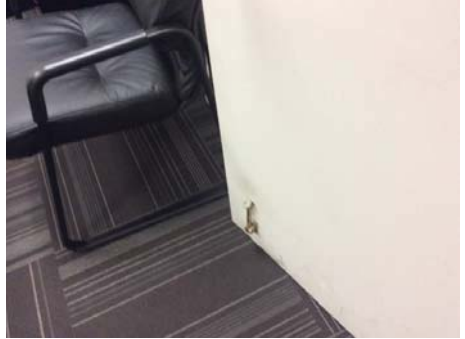
Item No. and Name	Existing Architectural Barrier and Proposed Solution	Codes / Mitigation Info	Qty	Unit	Cost	Total
<u>Door Stopper</u>						
934	<ul style="list-style-type: none"> <i>As-Built Description:</i> At push side of door on accessible route, bottom 10" does not have a smooth, uninterrupted surface. <i>Proposed Solution:</i> Remove door stopper when altering area. Provide rubber wedge. 	PCODE ID06A ADA 2010 404.2.10 CBC 2010 1133B.2.6 CBC 2013 11B-404.2.10 Priority 2 Severity 3 FY 24-25 Maintenance Work	1	JOB	\$25	\$25

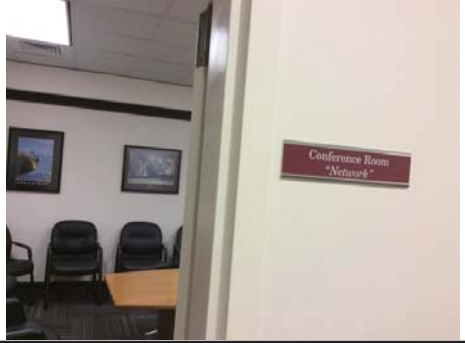
<u>Signage</u>						
932	<ul style="list-style-type: none"> <i>As-Built Description:</i> Sign not located on latch side of door and/or not located at 48" min. above to baseline of the lowest Braille cells and 60" max. to baseline of the highest line of raised characters. <i>Proposed Solution:</i> Provide compliant signage including tactile characters and Grade II Braille on latch side of door located 60" on center from floor. 	PCODE SA07 ADAAG 4.30.6 ADA 2010 703.4.1 CBC 2010 1117B.5.7 CBC 2013 11B-703.4.1 Priority 2 Severity 3 FY 24-25 Maintenance Work	1	JOB	\$50	\$50

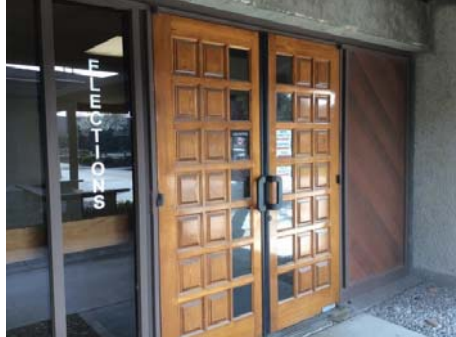
7 Elections Staff Area

Item No. and Name	Existing Architectural Barrier and Proposed Solution	Codes / Mitigation Info	Qty	Unit	Cost	Total
Signage						
618	<ul style="list-style-type: none"> <i>As-Built Description:</i> Existing sign designating permanent room or space is noncompliant. <i>Proposed Solution:</i> Provide compliant signage. 	PCODE SA13 ADAAG 4.1.3(16)(a) ADA 2010 216.2 CBC 2010 1117B.5 CBC 2013 11B-216.2 Priority 1 Severity 4 FY 24-25 Maintenance Work	1	JOB	\$150	\$150

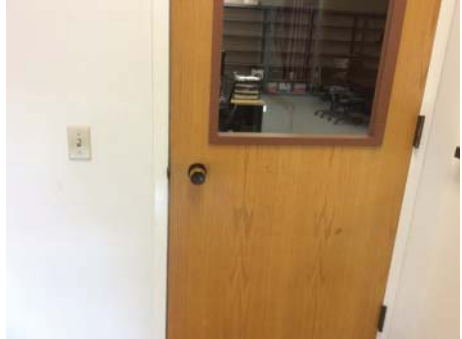
626	<ul style="list-style-type: none"> <i>As-Built Description:</i> Door does not have accessible operating hardware. <i>Proposed Solution:</i> Provide lever handle or other accessible hardware. 	PCODE ID07 ADAAG 4.13.9 ADA 2010 404.2.7 CBC 2010 1133B.2.5.2 CBC 2013 11B-404.2.7 Priority 2 Severity 3 FY 24-25 Maintenance Work	1	JOB	\$250	\$250

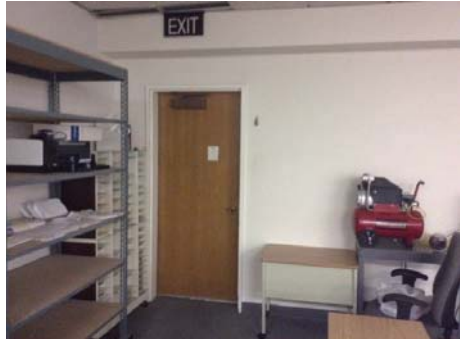
633	<ul style="list-style-type: none"> <i>As-Built Description:</i> Door does not have accessible operating hardware. <i>As-Built:</i> exit door <i>Proposed Solution:</i> Provide lever handle or other accessible hardware. 	PCODE ID07 ADAAG 4.13.9 ADA 2010 404.2.7 CBC 2010 1133B.2.5.2 CBC 2013 11B-404.2.7 Priority 2 Severity 3 FY 24-25 Maintenance Work	1	JOB	\$250	\$250

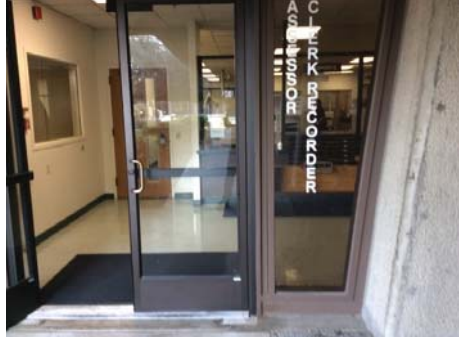
10 Assessor Lobby

Item No. and Name	Existing Architectural Barrier and Proposed Solution	Codes / Mitigation Info	Qty	Unit	Cost	Total
Signage						
645	<ul style="list-style-type: none"> <i>As-Built Description:</i> Existing sign designating permanent room or space is noncompliant. <i>Proposed Solution:</i> Provide compliant signage and ISA. 	PCODE SA13 ADAAG 4.1.3(16)(a) ADA 2010 216.2 CBC 2010 1117B.5 CBC 2013 11B-216.2 Priority 1 Severity 4 FY 24-25 Maintenance Work	1	JOB	\$150	\$150

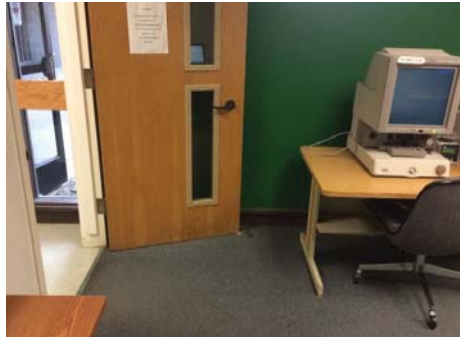
11 Records Room

657	<ul style="list-style-type: none"> <i>As-Built Description:</i> Front approach: At pull side, door does not have clear and level maneuvering space measuring door width plus 18" x 60". <i>As-Built:</i> 53" to desk. <i>Proposed Solution:</i> Remove or relocate furniture or storage items. 	PCODE ID23A ADAAG Fig. 25(a) ADA 2010 404.2.4 CBC 2010 11B-26A(a) CBC 2013 11B-404.2.4 Priority 2 Severity 3 FY 24-25 Maintenance Work	1	JOB	\$50	\$50

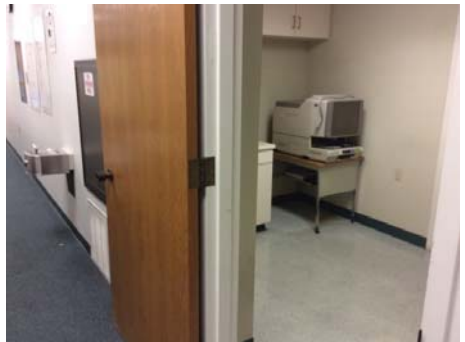
15 Assessors Office - Staff

704	<ul style="list-style-type: none"> <i>As-Built Description:</i> Door does not have accessible operating hardware. <i>Proposed Solution:</i> Provide lever handle or other accessible hardware. 	PCODE ID07 ADAAG 4.13.9 ADA 2010 404.2.7 CBC 2010 1133B.2.5.2 CBC 2013 11B-404.2.7 Priority 2 Severity 3 FY 24-25 Maintenance Work	1	JOB	\$250	\$250

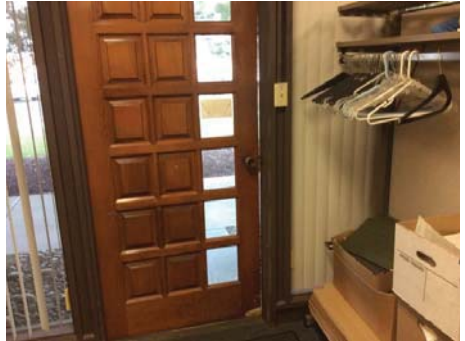
Item No. and Name	Existing Architectural Barrier and Proposed Solution	Codes / Mitigation Info	Qty	Unit	Cost	Total
712	<ul style="list-style-type: none"> • <i>As-Built Description:</i> Door does not have accessible operating hardware. • <i>Proposed Solution:</i> Provide lever handle or other accessible hardware. 	<p>PCODE ID07 ADAAG 4.13.9 ADA 2010 404.2.7 CBC 2010 1133B.2.5.2 CBC 2013 11B-404.2.7 Priority 2 Severity 3 FY 24-25 Maintenance Work</p>	1	JOB	\$250	\$250

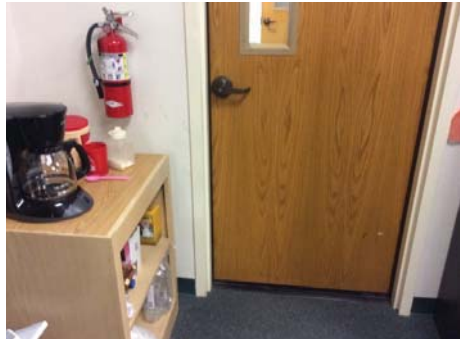
709	<ul style="list-style-type: none"> • <i>As-Built Description:</i> Front approach: At push side, door does not have clear and level maneuvering space measuring door width x 48" (door width plus 12" if door has both, latch and closer). • <i>As-Built:</i> 4.5" to cabinet • <i>Proposed Solution:</i> Remove or relocate furniture or storage items. 	<p>PCODE ID24A ADAAG Fig. 25(a) ADA 2010 404.2.4 CBC 2010 11B-26A(a) CBC 2013 11B-404.2.4 Priority 2 Severity 2 FY 24-25 Maintenance Work</p>	1	JOB	\$50	\$50
-----	--	--	---	-----	------	------

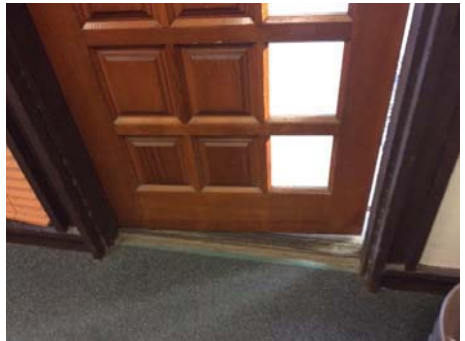
17 Shared Conference Room

728	<ul style="list-style-type: none"> • <i>As-Built Description:</i> At push side of door on accessible route, bottom 10" does not have a smooth, uninterrupted surface. • <i>As-Built:</i> 8.5" • <i>Proposed Solution:</i> Provide 10" min. "kick plate" covering width of door when altering area. 	<p>PCODE ID06 ADA 2010 404.2.10 CBC 2010 1133B.2.6 CBC 2013 11B-404.2.10 Priority 2 Severity 3 FY 24-25 Maintenance Work</p>	1	JOB	\$100	\$100
-----	---	--	---	-----	-------	-------

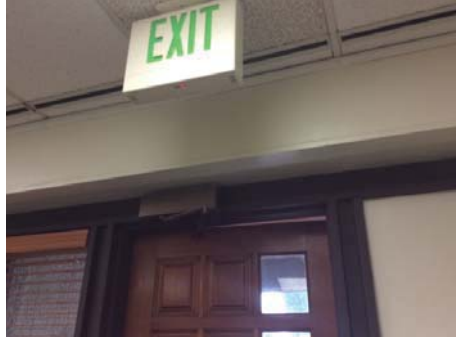
Item No. and Name	Existing Architectural Barrier and Proposed Solution	Codes / Mitigation Info	Qty	Unit	Cost	Total
Signage						
727	<ul style="list-style-type: none"> <i>As-Built Description:</i> At final exit door to exterior: Where required exit signs are installed, signs to provide exiting information for people with vision impairment are not provided. <i>Proposed Solution:</i> Provide raised letter/Braille "EXIT" sign at door. 	PCODE SA10A ADAAG 4.1.3(16) ADA 2010 216.4.1 CBC 2010 1011.3 CBC 2013 11B-216.4.1 Priority 2 Severity 3 FY 24-25 Maintenance Work	1	JOB	\$90	\$90

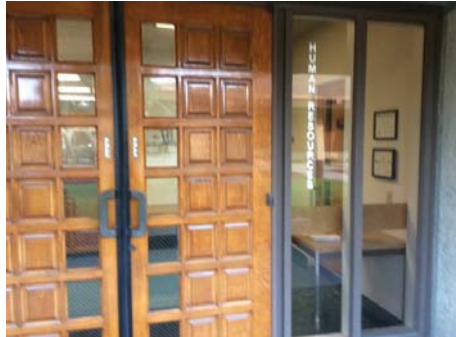
18 HR Lobby

Signage						
733	<ul style="list-style-type: none"> <i>As-Built Description:</i> Existing sign designating permanent room or space is noncompliant. <i>Proposed Solution:</i> Provide compliant signage. 	PCODE SA13 ADAAG 4.1.3(16)(a) ADA 2010 216.2 CBC 2010 1117B.5 CBC 2013 11B-216.2 Priority 1 Severity 4 FY 24-25 Maintenance Work	1	JOB	\$150	\$150

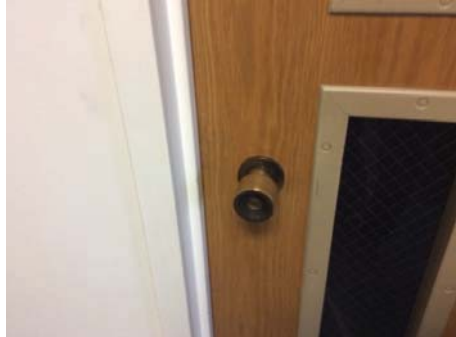
19 Training Testing Room

Door Hardware						
741	<ul style="list-style-type: none"> <i>As-Built Description:</i> Door does not have accessible operating hardware. <i>Proposed Solution:</i> Provide lever handle or other accessible hardware. 	PCODE ID07 ADAAG 4.13.9 ADA 2010 404.2.7 CBC 2010 1133B.2.5.2 CBC 2013 11B-404.2.7 Priority 2 Severity 3 FY 24-25 Maintenance Work	2	JOB	\$250	\$500

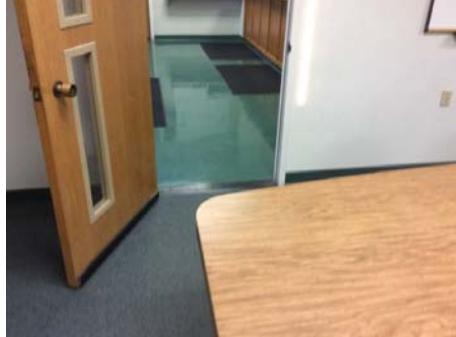
Item No. and Name	Existing Architectural Barrier and Proposed Solution	Codes / Mitigation Info	Qty	Unit	Cost	Total
<u>Door Swing</u>						
743	<ul style="list-style-type: none"> As-Built Description: Front approach: At pull side, door does not have clear and level maneuvering space measuring door width plus 18" x 60". As-Built: 51" to table Proposed Solution: Remove or relocate furniture or storage items. 	PCODE ID23A ADAAG Fig. 25(a) ADA 2010 404.2.4 CBC 2010 11B-26A(a) CBC 2013 11B-404.2.4 Priority 2 Severity 3 FY 24-25 Maintenance Work	1	JOB	\$50	\$50

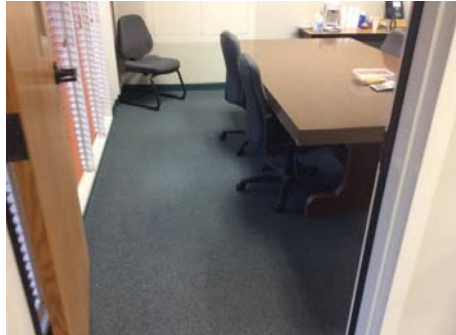
20 Training Testing Room

<u>Door Swing</u>						
745	<ul style="list-style-type: none"> As-Built Description: Front approach: At pull side, door does not have clear and level maneuvering space measuring door width plus 18" x 60". As-Built: 30" & 41" Proposed Solution: Remove or relocate furniture or storage items. 	PCODE ID23A ADAAG Fig. 25(a) ADA 2010 404.2.4 CBC 2010 11B-26A(a) CBC 2013 11B-404.2.4 Priority 2 Severity 2 FY 24-25 Maintenance Work	1	JOB	\$50	\$50

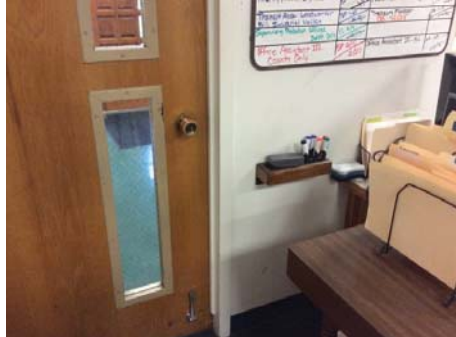
21 Staff Offices

<u>Door Hardware</u>						
753	<ul style="list-style-type: none"> As-Built Description: Door does not have accessible operating hardware. Proposed Solution: Provide lever handle or other accessible hardware. 	PCODE ID07 ADAAG 4.13.9 ADA 2010 404.2.7 CBC 2010 1133B.2.5.2 CBC 2013 11B-404.2.7 Priority 2 Severity 3 FY 24-25 Maintenance Work	1	JOB	\$250	\$250

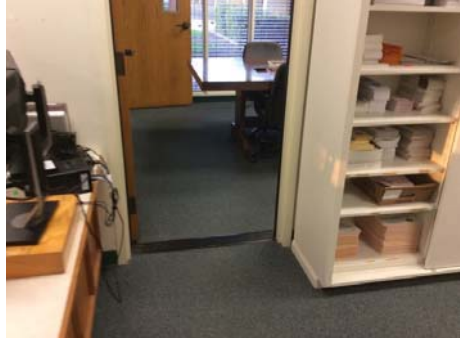
Item No. and Name	Existing Architectural Barrier and Proposed Solution	Codes / Mitigation Info	Qty	Unit	Cost	Total
Door Swing						
749	<ul style="list-style-type: none"> As-Built Description: Front approach: At push side, door does not have clear and level maneuvering space measuring door width x 48" (door width plus 12" if door has both, latch and closer). As-Built: 2" Proposed Solution: Remove or relocate furniture or storage items. 	PCODE ID24A ADAAG Fig. 25(a) ADA 2010 404.2.4 CBC 2010 11B-26A(a) CBC 2013 11B-404.2.4 Priority 2 Severity 2 FY 24-25 Maintenance Work	1	JOB	\$50	\$50

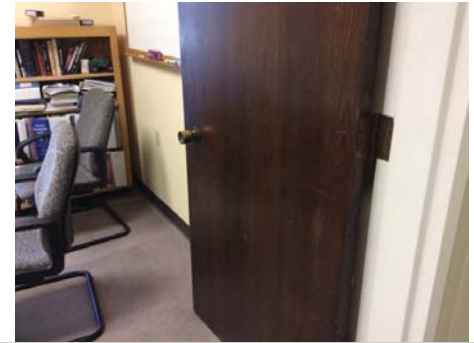
1464	<ul style="list-style-type: none"> <i>As-Built Description:</i> Door does not have accessible operating hardware. <i>Proposed Solution:</i> Provide lever handle or other accessible hardware. 	<p>PCODE ID07 ADAAG 4.13.9 ADA 2010 404.2.7 CBC 2010 1133B.2.5.2 CBC 2013 11B-404.2.7 Priority 2 Severity 3 FY 24-25 Maintenance Work</p>	20	JOB	\$250	\$5,000
------	--	--	----	-----	-------	---------

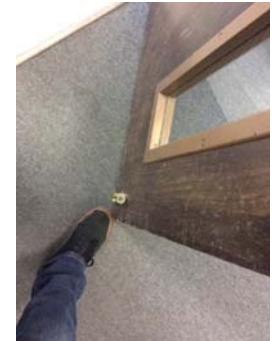
1467	<ul style="list-style-type: none"> <i>As-Built Description:</i> At push side of door on accessible route, bottom 10" does not have a smooth, uninterrupted surface. <i>Proposed Solution:</i> Remove door stopper when altering area. Provide rubber wedge. 	<p>PCODE ID06A ADA 2010 404.2.10 CBC 2010 1133B.2.6 CBC 2013 11B-404.2.10 Priority 2 Severity 3 FY 24-25 Maintenance Work</p>	1	JOB	\$25	\$25
------	---	---	---	-----	------	------

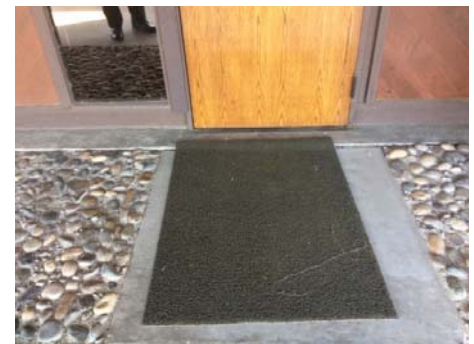
2 DA Offices - Conference Room

1470	<ul style="list-style-type: none"> <i>As-Built Description:</i> Doormat not securely attached to ground or floor structure. <i>Proposed Solution:</i> Attach doormat to floor surface or remove doormat. 	<p>PCODE ID05A ADAAG 4.5.3 ADA 2010 302.2 CBC 2010 1124B.3 CBC 2013 11B-302.2 Priority 2 Severity 3 FY 24-25 Maintenance Work</p>	1	JOB	\$75	\$75
------	--	--	---	-----	------	------

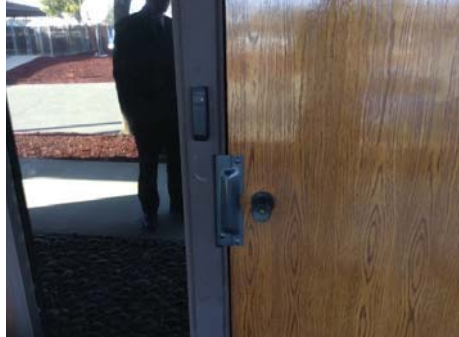
Item No. and Name	Existing Architectural Barrier and Proposed Solution	Codes / Mitigation Info	Qty	Unit	Cost	Total
<u>Door Hardware</u>						
1469	<ul style="list-style-type: none"> <i>As-Built Description:</i> Door does not have accessible operating hardware. <i>Proposed Solution:</i> Provide lever handle or other accessible hardware. 	PCODE ID07 ADAAG 4.13.9 ADA 2010 404.2.7 CBC 2010 1133B.2.5.2 CBC 2013 11B-404.2.7 Priority 2 Severity 3 FY 24-25 Maintenance Work	1	JOB	\$250	\$250

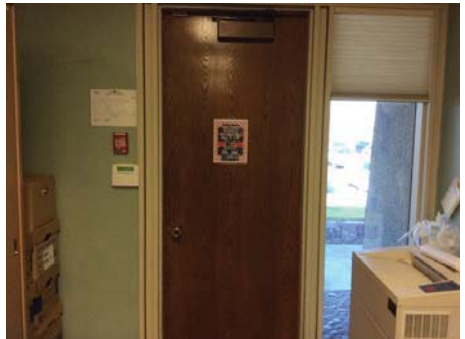
4 Staff Office West

<u>Door Hardware</u>						
1482	<ul style="list-style-type: none"> <i>As-Built Description:</i> Door does not have accessible operating hardware. <i>Proposed Solution:</i> Provide lever handle or other accessible hardware. 	PCODE ID07 ADAAG 4.13.9 ADA 2010 404.2.7 CBC 2010 1133B.2.5.2 CBC 2013 11B-404.2.7 Priority 2 Severity 3 FY 24-25 Maintenance Work	1	JOB	\$250	\$250

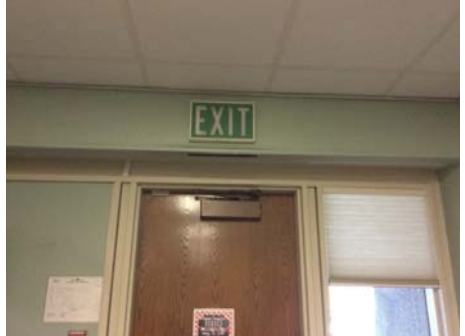
<u>Signage</u>						
1483	<ul style="list-style-type: none"> <i>As-Built Description:</i> At final exit door to exterior: Where required exit signs are installed, signs to provide exiting information for people with vision impairment are not provided. <i>Proposed Solution:</i> Provide raised letter/Braille "EXIT" sign at door. 	PCODE SA10A ADAAG 4.1.3(16) ADA 2010 216.4.1 CBC 2010 1011.3 CBC 2013 11B-216.4.1 Priority 2 Severity 3 FY 24-25 Maintenance Work	1	JOB	\$90	\$90

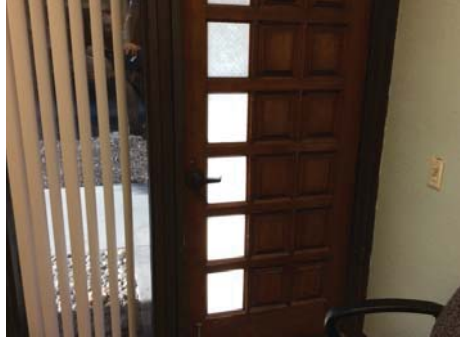
Item No. and Name	Existing Architectural Barrier and Proposed Solution	Codes / Mitigation Info	Qty	Unit	Cost	Total
<u>Door Closer</u>						
1496	<ul style="list-style-type: none"> • <i>As-Built Description:</i> Excessive force required to open door. • <i>As-Built:</i> 7 lbs • <i>Proposed Solution:</i> Adjust regular door closer to accessible standards (5 lbs max). 	PCODE ID03 ADAAG 4.13.11 ADA 2010 404.2.9 CBC 2010 1133B.2.5 CBC 2013 11B-404.2.9 Priority 1 Severity 4 FY 24-25 Maintenance Work	1	JOB	\$25	\$25

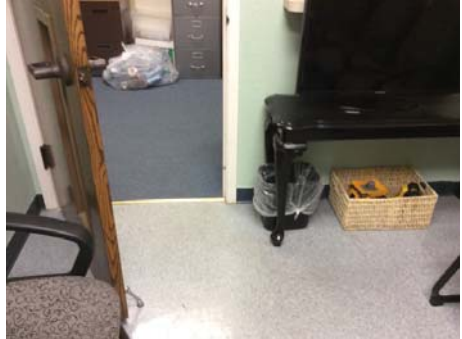
<u>Door Swing</u>						
1499	<ul style="list-style-type: none"> • <i>As-Built Description:</i> Front approach: At pull side, door does not have clear and level maneuvering space measuring door width plus 18" x 60". • <i>As-Built:</i> 7" to table • <i>Proposed Solution:</i> Remove or relocate furniture or storage items. 	PCODE ID23A ADAAG Fig. 25(a) ADA 2010 404.2.4 CBC 2010 11B-26A(a) CBC 2013 11B-404.2.4 Priority 2 Severity 3 FY 24-25 Maintenance Work	1	JOB	\$50	\$50

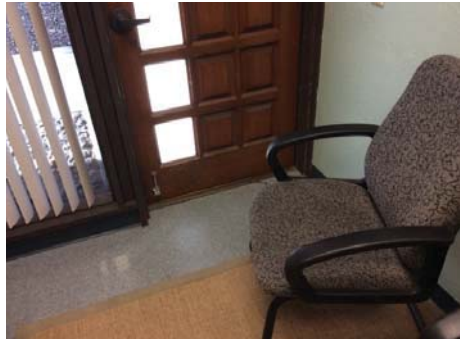
1498	<ul style="list-style-type: none"> • <i>As-Built Description:</i> Front approach: At push side, door does not have clear and level maneuvering space measuring door width x 48" (door width plus 12" if door has both, latch and closer). • <i>Proposed Solution:</i> Remove or relocate furniture or storage items. 	PCODE ID24A ADAAG Fig. 25(a) ADA 2010 404.2.4 CBC 2010 11B-26A(a) CBC 2013 11B-404.2.4 Priority 1 Severity 4 FY 24-25 Maintenance Work	1	JOB	\$50	\$50

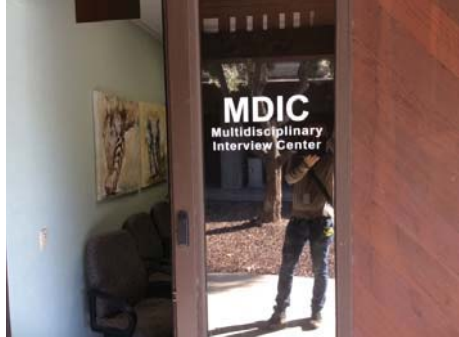
Item No. and Name	Existing Architectural Barrier and Proposed Solution	Codes / Mitigation Info	Qty	Unit	Cost	Total
Signage						
1493	<ul style="list-style-type: none"> <i>As-Built Description:</i> Existing sign designating permanent room or space is noncompliant. <i>Proposed Solution:</i> Provide compliant signage. 	PCODE SA13 ADAAG 4.1.3(16)(a) ADA 2010 216.2 CBC 2010 1117B.5 CBC 2013 11B-216.2 Priority 1 Severity 4 FY 24-25 Maintenance Work	1	JOB	\$150	\$150

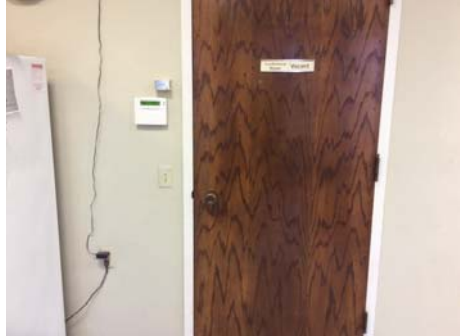
8 DA Staff Conference Room

1508	<ul style="list-style-type: none"> <i>As-Built Description:</i> Door does not have accessible operating hardware. <i>Proposed Solution:</i> Provide lever handle or other accessible hardware. 	PCODE ID07 ADAAG 4.13.9 ADA 2010 404.2.7 CBC 2010 1133B.2.5.2 CBC 2013 11B-404.2.7 Priority 2 Severity 3 FY 24-25 Maintenance Work	1	JOB	\$250	\$250

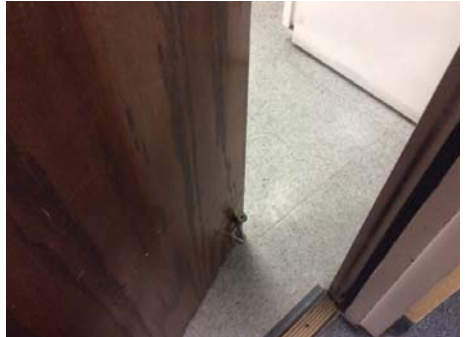
1510	<ul style="list-style-type: none"> <i>As-Built Description:</i> At push side of door on accessible route, bottom 10" does not have a smooth, uninterrupted surface. <i>Proposed Solution:</i> Remove door stopper when altering area. Provide rubber wedge. 	PCODE ID06A ADA 2010 404.2.10 CBC 2010 1133B.2.6 CBC 2013 11B-404.2.10 Priority 2 Severity 3 FY 24-25 Maintenance Work	1	JOB	\$25	\$25

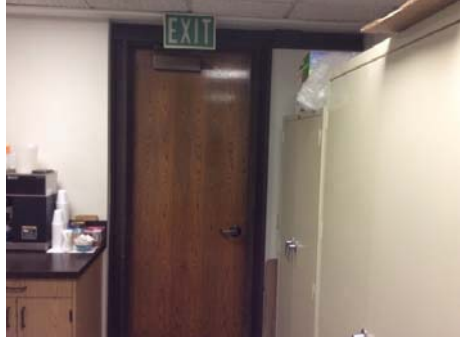
Item No. and Name	Existing Architectural Barrier and Proposed Solution	Codes / Mitigation Info	Qty	Unit	Cost	Total
Door Swing						
1527	<ul style="list-style-type: none"> As-Built Description: Front approach: At push side, door does not have clear and level maneuvering space measuring door width x 48" (door width plus 12" if door has both, latch and closer). As-Built: 6" to cabinets Proposed Solution: Remove or relocate furniture or storage items. 	PCODE ID24A ADAAG Fig. 25(a) ADA 2010 404.2.4 CBC 2010 11B-26A(a) CBC 2013 11B-404.2.4 Priority 2 Severity 3 FY 24-25 Maintenance Work	1	JOB	\$50	\$50

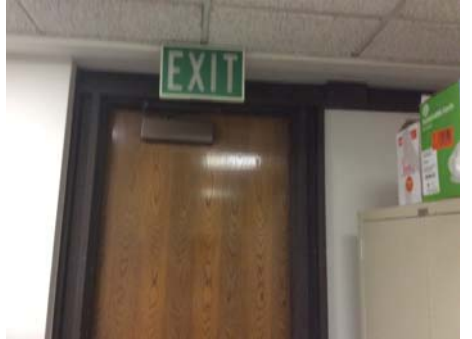
Signage						
1528	<ul style="list-style-type: none"> As-Built Description: At final exit door to exterior: Where required exit signs are installed, signs to provide exiting information for people with vision impairment are not provided. Proposed Solution: Provide raised letter/Braille "EXIT" sign at door. 	PCODE SA10A ADAAG 4.1.3(16) ADA 2010 216.4.1 CBC 2010 1011.3 CBC 2013 11B-216.4.1 Priority 2 Severity 3 FY 24-25 Maintenance Work	1	JOB	\$90	\$90

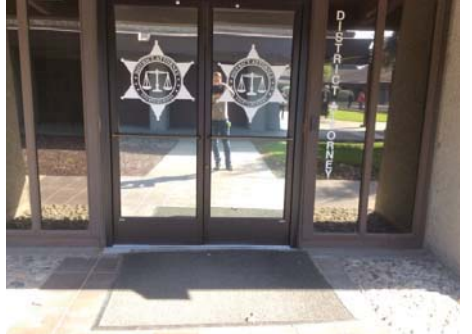
13 DA Lobby

Signage						
1558	<ul style="list-style-type: none"> As-Built Description: Existing sign designating permanent room or space is noncompliant. Proposed Solution: Provide compliant signage. 	PCODE SA13 ADAAG 4.1.3(16)(a) ADA 2010 216.2 CBC 2010 1117B.5 CBC 2013 11B-216.2 Priority 1 Severity 4 FY 24-25 Maintenance Work	1	JOB	\$150	\$150

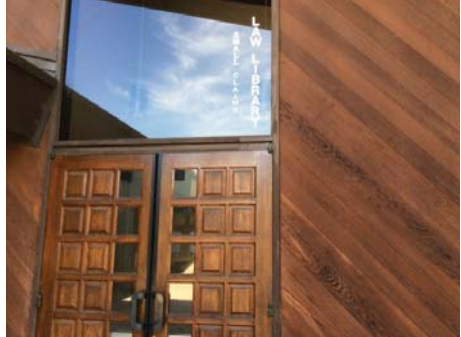
14 Law Library

Item No. and Name	Existing Architectural Barrier and Proposed Solution	Codes / Mitigation Info	Qty	Unit	Cost	Total
Signage						
1567	<ul style="list-style-type: none"> <i>As-Built Description:</i> Existing sign designating permanent room or space is noncompliant. <i>Proposed Solution:</i> Provide compliant signage. 	PCODE SA13 ADAAG 4.1.3(16)(a) ADA 2010 216.2 CBC 2010 1117B.5 CBC 2013 11B-216.2 Priority 1 Severity 4 FY 24-25 Maintenance Work	1	JOB	\$150	\$150

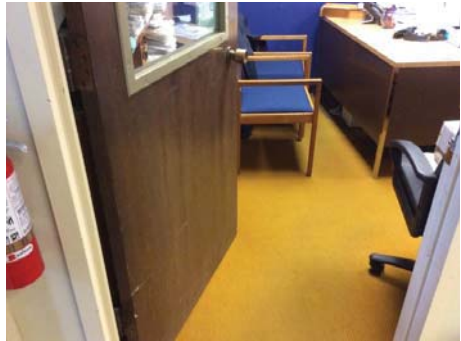
Turn Space							
1581	<ul style="list-style-type: none"> <i>As-Built Description:</i> Less than 60" diameter or T-shaped space provided for wheelchair turns. <i>Proposed Solution:</i> Remove or relocate storage items or furniture. Notes: If accessed by public. 	PCODE IN04AREF ADAAG 4.2.3 ADA 2010 304.1 CBC 2010 1118B.3 CBC 2013 11B-304.1 Priority 2 Severity 2 FY 24-25 Maintenance Work	REF

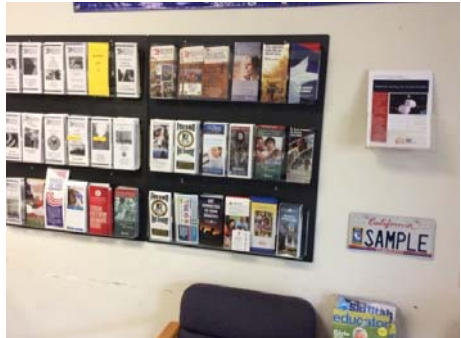
15 Veterans Services

Brochure Bins						
1585	<ul style="list-style-type: none"> <i>As-Built Description:</i> Information brochure bins mounted above accessible height of 48". <i>As-Built:</i> 47"-70" <i>Proposed Solution:</i> Relocate/remount bins at accessible height. 	PCODE IN08 ADAAG 4.2.5 & 6 ADA 2010 308.2.1 CBC 2010 1118B.5 CBC 2013 11B-308.2.1 Priority 2 Severity 1 FY 24-25 Maintenance Work	1	JOB	\$100	\$100

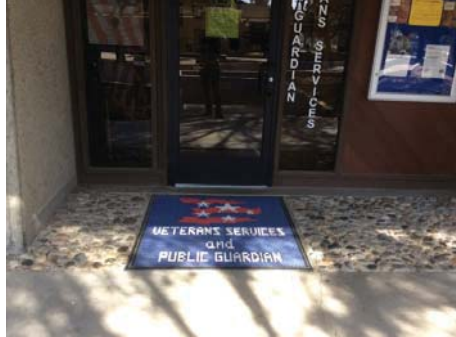
Item No. and Name	Existing Architectural Barrier and Proposed Solution	Codes / Mitigation Info	Qty	Unit	Cost	Total
Signage						
1583	<ul style="list-style-type: none"> <i>As-Built Description:</i> Existing sign designating permanent room or space is noncompliant. <i>Proposed Solution:</i> Provide compliant signage. 	PCODE SA13 ADAAG 4.1.3(16)(a) ADA 2010 216.2 CBC 2010 1117B.5 CBC 2013 11B-216.2 Priority 1 Severity 4 FY 24-25 Maintenance Work	1	JOB	\$150	\$150

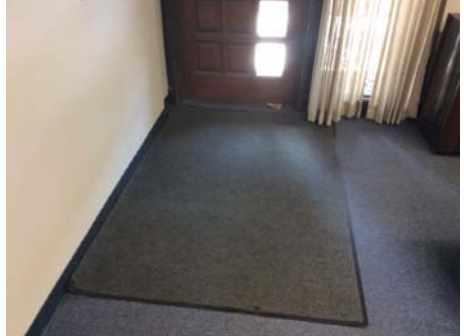
16 Veterans Services Offices

Carpet/Doormat

1593	<ul style="list-style-type: none"> <i>As-Built Description:</i> Doormat not securely attached to ground or floor structure. <i>Proposed Solution:</i> Attach doormat to floor surface or remove doormat. <i>Notes:</i> Exit door 	PCODE ID05A ADAAG 4.5.3 ADA 2010 302.2 CBC 2010 1124B.3 CBC 2013 11B-302.2 Priority 2 Severity 3 FY 24-25 Maintenance Work	1	JOB	\$75	\$75

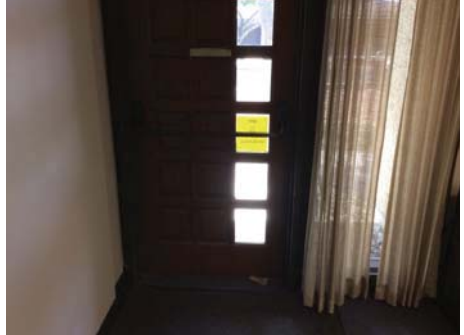
Door Closer

1592	<ul style="list-style-type: none"> <i>As-Built Description:</i> Excessive force required to open door. <i>As-Built:</i> 9 lbs <i>Proposed Solution:</i> Adjust regular door closer to accessible standards (5 lbs max). <i>Notes:</i> Exit door 	PCODE ID03 ADAAG 4.13.11 ADA 2010 404.2.9 CBC 2010 1133B.2.5 CBC 2013 11B-404.2.9 Priority 1 Severity 4 FY 24-25 Maintenance Work	1	JOB	\$25	\$25

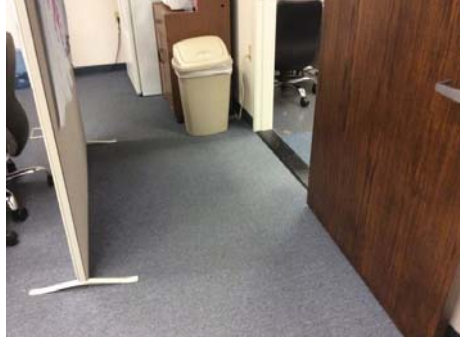
Item No. and Name	Existing Architectural Barrier and Proposed Solution	Codes / Mitigation Info	Qty	Unit	Cost	Total
Door Swing						
1594	<ul style="list-style-type: none"> <i>As-Built Description:</i> Front approach: At pull side, door does not have clear and level maneuvering space measuring door width plus 18" x 60". <i>As-Built:</i> 46" <i>Proposed Solution:</i> Remove or relocate furniture or storage items. <i>Notes:</i> Door is kept open 	<p>PCODE ID23A ADAAG Fig. 25(a) ADA 2010 404.2.4 CBC 2010 11B-26A(a) CBC 2013 11B-404.2.4 Priority 2 Severity 3 FY 24-25 Maintenance Work</p>	1	JOB	\$50	\$50

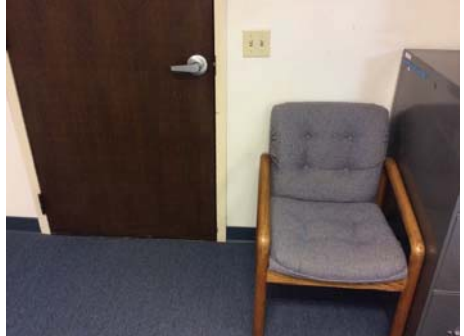
1595	<ul style="list-style-type: none"> <i>As-Built Description:</i> Front approach: At pull side, door does not have clear and level maneuvering space measuring door width plus 18" x 60". <i>As-Built:</i> 8" to chair <i>Proposed Solution:</i> Remove or relocate furniture or storage items. <i>Notes:</i> To restrooms 	<p>PCODE ID23A ADAAG Fig. 25(a) ADA 2010 404.2.4 CBC 2010 11B-26A(a) CBC 2013 11B-404.2.4 Priority 2 Severity 3 FY 24-25 Maintenance Work</p>	1	JOB	\$50	\$50

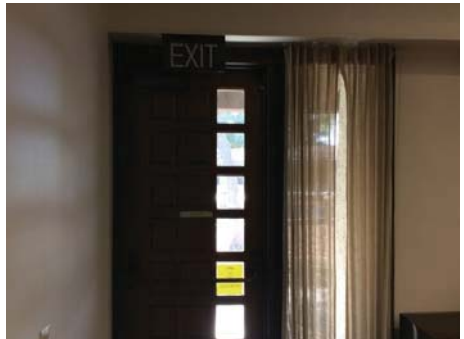
Signage						
1591	<ul style="list-style-type: none"> <i>As-Built Description:</i> At final exit door to exterior: Where required exit signs are installed, signs to provide exiting information for people with vision impairment are not provided. <i>Proposed Solution:</i> Provide raised letter/Braille "EXIT" sign at door. 	<p>PCODE SA10A ADAAG 4.1.3(16) ADA 2010 216.4.1 CBC 2010 1011.3 CBC 2013 11B-216.4.1 Priority 2 Severity 3 FY 24-25 Maintenance Work</p>	1	JOB	\$90	\$90

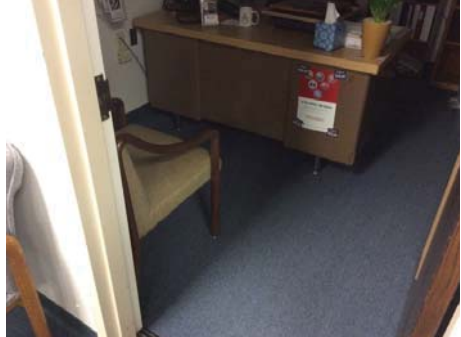
Item No. and Name	Existing Architectural Barrier and Proposed Solution	Codes / Mitigation Info	Qty	Unit	Cost	Total
<u>Turn Space</u>						
1590	<ul style="list-style-type: none"> <i>As-Built Description:</i> Less than 60" diameter or T-shaped space provided for wheelchair turns. <i>Proposed Solution:</i> Remove or relocate storage items or furniture. <i>Notes:</i> When needed if public access 	PCODE IN04A ADAAG 4.2.3 ADA 2010 304.1 CBC 2010 1118B.3 CBC 2013 11B-304.1 Priority 2 Severity 2 FY 24-25 Maintenance Work	1	JOB	\$50	\$50

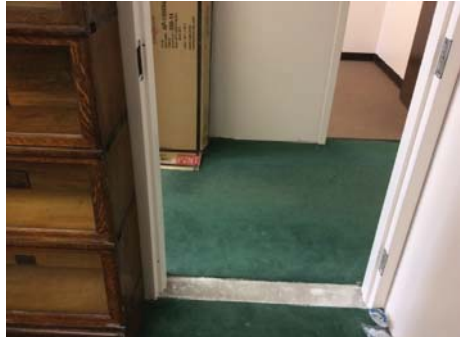
17 County Council

<u>Door Swing</u>						
1602	<ul style="list-style-type: none"> <i>As-Built Description:</i> Front approach: At pull side, door does not have clear and level maneuvering space measuring door width plus 18" x 60". <i>As-Built:</i> 2" to cabinet <i>Proposed Solution:</i> Remove or relocate furniture or storage items. <i>Notes:</i> If door is added 	PCODE ID23A ADAAG Fig. 25(a) ADA 2010 404.2.4 CBC 2010 11B-26A(a) CBC 2013 11B-404.2.4 Priority 2 Severity 2 FY 24-25 Maintenance Work	1	JOB	\$50	\$50

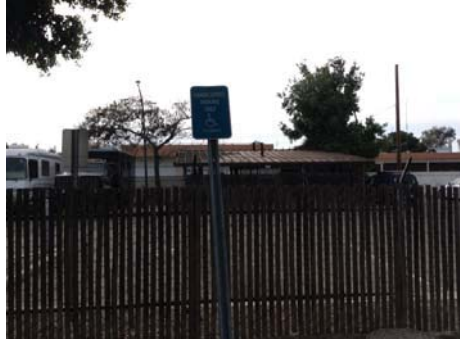
Parking Signage

2614	<ul style="list-style-type: none"> <i>As-Built Description:</i> Sign relating to parking privileges for disabled persons is non-compliant. <i>As-Built:</i> Wording <i>Proposed Solution:</i> Provide compliant parking signage that does not contain the word "handicapped". 	PCODE EA04F ADA 2010 502.6 CBC 2010 VC \$22511.9. CBC 2013 11B-502.6 Priority 1 Severity 4 FY 24-25 Maintenance Work	1	JOB	\$100	\$100
------	--	--	---	-----	-------	-------

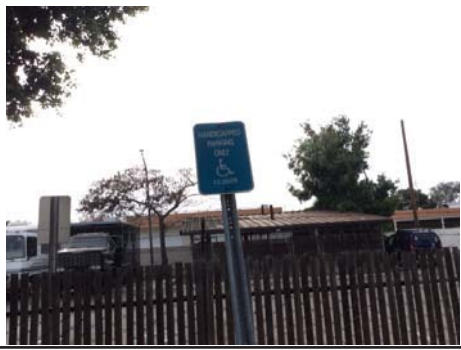
2615	<ul style="list-style-type: none"> <i>As-Built Description:</i> CA only: Additional Sign or additional language below the symbol of accessibility stating "Minimum Fine \$250" not provided. <i>Proposed Solution:</i> Provide compliant parking signage that includes fine information. 	PCODE EA04G CBC 2010 1129B.4 CBC 2013 11B-502.6.2 Priority 1 Severity 4 FY 24-25 Maintenance Work	1	JOB	\$100	\$100
------	--	--	---	-----	-------	-------

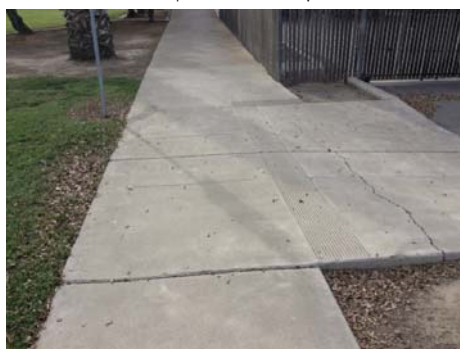
2 POT from Driveway to Admin Buildings

Changes in Level

2619	<ul style="list-style-type: none"> <i>As-Built Description:</i> Walk: Pavement dislocation creates vertical change in level between 1/4" and 1/2" in accessible route. <i>As-Built:</i> 0.5" <i>Proposed Solution:</i> Grind or fill pavement dislocation to create beveled transition. 	PCODE EF03A ADAAG 4.3.8 ADA 2010 403.4 CBC 2010 1133B.7.4 CBC 2013 11B-403.4 Priority 1 Severity 4 FY 24-25 Maintenance Work	4	SF	\$21	\$84
------	--	---	---	----	------	------

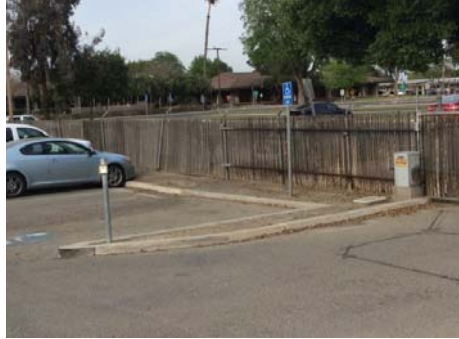
5 Accessible Space in Secured Staff Lot

Item No. and Name	Existing Architectural Barrier and Proposed Solution	Codes / Mitigation Info	Qty	Unit	Cost	Total
<u>Parking Signage</u>						
2650	<ul style="list-style-type: none"> <i>As-Built Description:</i> CA only: Additional Sign or additional language below the symbol of accessibility stating "Minimum Fine \$250" not provided. <i>Proposed Solution:</i> Provide compliant parking signage that includes fine information. 	<p>PCODE EA04G</p> <p>CBC 2010 1129B.4</p> <p>CBC 2013 11B-502.6.2</p> <p>Priority 1</p> <p>Severity 4</p> <p>FY 24-25 Maintenance Work</p>	1	JOB	\$100	\$100

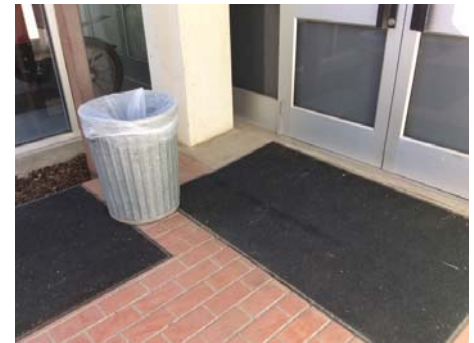
Carpet/Doormat

1809	<ul style="list-style-type: none"> <i>As-Built Description:</i> Doormat not securely attached to ground or floor structure. <i>As-Built:</i> Meeting room doors <i>Proposed Solution:</i> Attach doormat to floor surface or remove doormat. 	PCODE ID05A	2	JOB	\$75	\$150
		ADAAG 4.5.3				
		ADA 2010 302.2				
		CBC 2010 1124B.3				
		CBC 2013 11B-302.2				
		Priority 2				
		Severity 3				
		FY 24-25 Maintenance Work

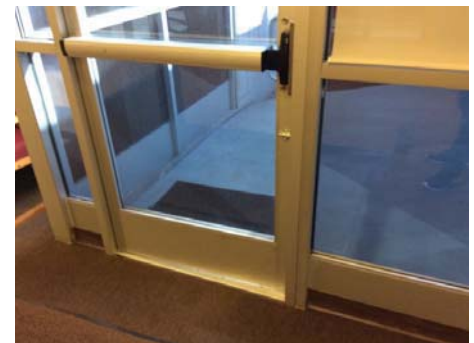
Door Closer

1810	<ul style="list-style-type: none"> <i>As-Built Description:</i> Excessive force required to open door. <i>As-Built:</i> 8 lbs <i>Proposed Solution:</i> Adjust regular door closer to accessible standards (5 lbs max). 	PCODE ID03	1	JOB	\$25	\$25
		ADAAG 4.13.11				
		ADA 2010 404.2.9				
		CBC 2010 1133B.2.5				
		CBC 2013 11B-404.2.9				
		Priority 1				
		Severity 4				
		FY 24-25 Maintenance Work

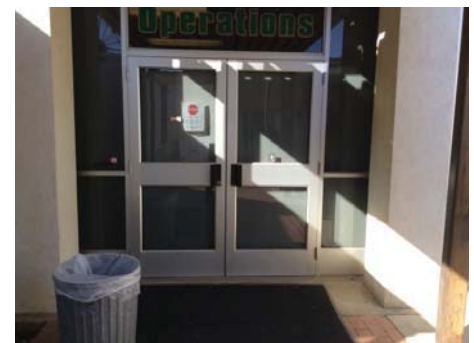
Signage

1807	<ul style="list-style-type: none"> <i>As-Built Description:</i> Existing sign designating permanent room or space is noncompliant. <i>Proposed Solution:</i> Provide compliant signage. 	PCODE SA13	1	JOB	\$150	\$150
		ADAAG 4.1.3(16)(a)				
		ADA 2010 216.2				
		CBC 2010 1117B.5				
		CBC 2013 11B-216.2				
		Priority 1				
		Severity 4				
		FY 24-25 Maintenance Work

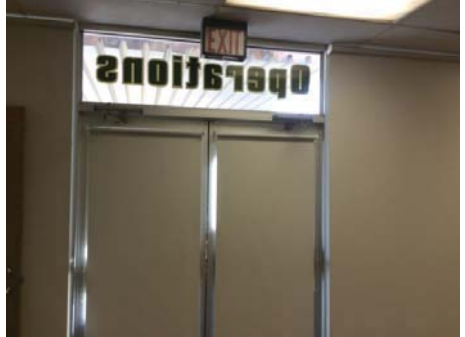
2 Large Meeting Room

Item No. and Name	Existing Architectural Barrier and Proposed Solution	Codes / Mitigation Info	Qty	Unit	Cost	Total
<u>Door Closer</u>						
1812	<ul style="list-style-type: none"> • <i>As-Built Description:</i> Excessive force required to open door. • <i>As-Built:</i> 12 lbs • <i>Proposed Solution:</i> Adjust regular door closer to accessible standards (5 lbs max). 	<p>PCODE ID03</p> <p>ADAAG 4.13.11</p> <p>ADA 2010 404.2.9</p> <p>CBC 2010 1133B.2.5</p> <p>CBC 2013 11B-404.2.9</p> <p>Priority 2</p> <p>Severity 3</p> <p>FY 24-25 Maintenance Work</p>	2	JOB	\$25	\$50
