Facility: **WOMENS INFANTS & CHILDREN**

Address: 330 HARRIS ST.

Facility: **LEMORE HEALTH CLINIC**
 Address: 229 C ST.

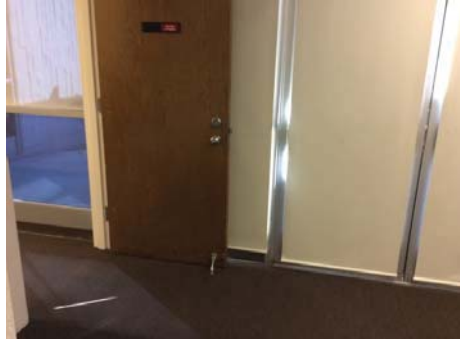
<u>Door Hardware</u>						
1813	<ul style="list-style-type: none"> • <i>As-Built Description:</i> Door does not have accessible operating hardware. • <i>Proposed Solution:</i> Provide lever handle or other accessible hardware. 	<p>PCODE ID07</p> <p>ADAAG 4.13.9</p> <p>ADA 2010 404.2.7</p> <p>CBC 2010 1133B.2.5.2</p> <p>CBC 2013 11B-404.2.7</p> <p>Priority 2</p> <p>Severity 3</p> <p>FY 24-25 Maintenance Work</p>	1	JOB	\$250	\$250

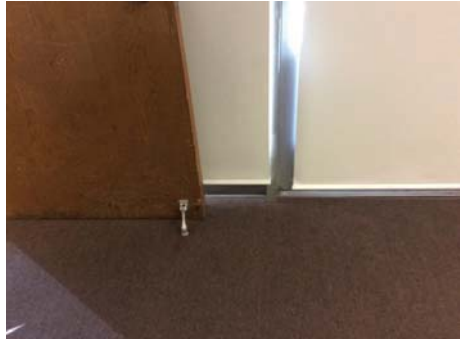
<u>Door Stopper</u>						
1814	<ul style="list-style-type: none"> • <i>As-Built Description:</i> At push side of door on accessible route, bottom 10" does not have a smooth, uninterrupted surface. • <i>Proposed Solution:</i> Remove door stopper when altering area. Provide rubber wedge. 	<p>PCODE ID06A</p> <p>ADA 2010 404.2.10</p> <p>CBC 2010 1133B.2.6</p> <p>CBC 2013 11B-404.2.10</p> <p>Priority 2</p> <p>Severity 3</p> <p>FY 24-25 Maintenance Work</p>	2	JOB	\$25	\$50

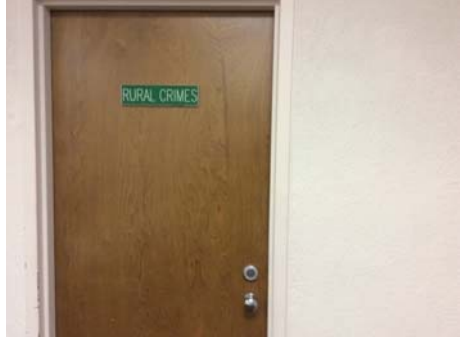
Item No. and Name	Existing Architectural Barrier and Proposed Solution	Codes / Mitigation Info	Qty	Unit	Cost	Total
Signage						
1817	<ul style="list-style-type: none"> <i>As-Built Description:</i> Sign not located on latch side of door and/or not located at 48" min. above to baseline of the lowest Braille cells and 60" max. to baseline of the highest line of raised characters. <i>Proposed Solution:</i> Provide compliant signage including tactile characters and Grade II Braille on latch side of door located 60" on center from floor. 	PCODE SA07 ADAAG 4.30.6 ADA 2010 703.4.1 CBC 2010 1117B.5.7 CBC 2013 11B-703.4.1 Priority 2 Severity 3 FY 24-25 Maintenance Work	1	JOB	\$50	\$50

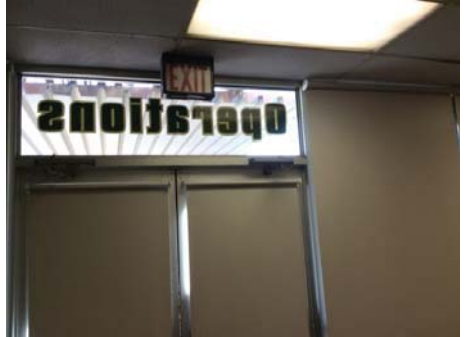
1816	<ul style="list-style-type: none"> <i>As-Built Description:</i> At final exit door to exterior: Where required exit signs are installed, signs to provide exiting information for people with vision impairment are not provided. <i>Proposed Solution:</i> Provide raised letter/Braille "EXIT" sign at door. 	PCODE SA10A ADAAG 4.1.3(16) ADA 2010 216.4.1 CBC 2010 1011.3 CBC 2013 11B-216.4.1 Priority 2 Severity 3 FY 24-25 Maintenance Work	1	JOB	\$90	\$90

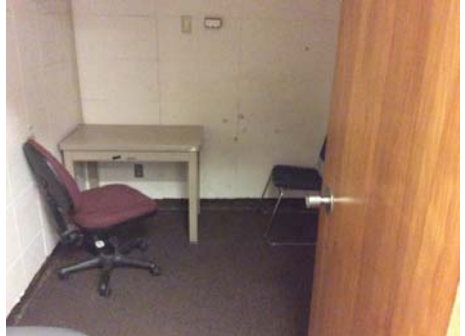
5 Interrogation Room

Door Hardware						
1858	<ul style="list-style-type: none"> <i>As-Built Description:</i> Door does not have accessible operating hardware. <i>Proposed Solution:</i> Provide lever handle or other accessible hardware. 	PCODE ID07 ADAAG 4.13.9 ADA 2010 404.2.7 CBC 2010 1133B.2.5.2 CBC 2013 11B-404.2.7 Priority 2 Severity 3 FY 24-25 Maintenance Work	1	JOB	\$250	\$250

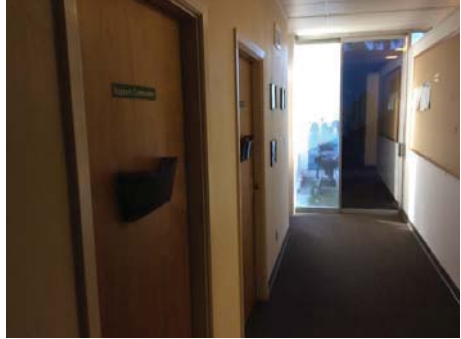
6 General Staff Corridors

Item No. and Name	Existing Architectural Barrier and Proposed Solution	Codes / Mitigation Info	Qty	Unit	Cost	Total
Signage						
1864	<ul style="list-style-type: none"> <i>As-Built Description:</i> Sign not located on latch side of door and/or not located at 48" min. above to baseline of the lowest Braille cells and 60" max. to baseline of the highest line of raised characters. <i>Proposed Solution:</i> Provide compliant signage including tactile characters and Grade II Braille on latch side of door located 60" on center from floor. 	PCODE SA07 ADAAG 4.30.6 ADA 2010 703.4.1 CBC 2010 1117B.5.7 CBC 2013 11B-703.4.1 Priority 2 Severity 3 FY 24-25 Maintenance Work	8	JOB	\$50	\$400

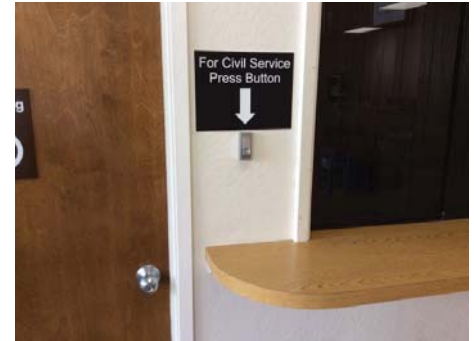
Reach Range

1741	<ul style="list-style-type: none"> <i>As-Built Description:</i> Reach height to control or access point, where only forward approach is available, exceeds 48" or is less than 15". <i>As-Built:</i> Call button: 53" <i>Proposed Solution:</i> Modify equipment or mounting. 	<p>PCODE IE01 ADAAG 4.2.5 ADA 2010 308.2.1 CBC 2010 1118B.5 CBC 2013 11B-308.2.1 Priority 1 Severity 4 FY 24-25 Maintenance Work</p>	1	JOB	\$100	\$100
------	--	--	---	-----	-------	-------

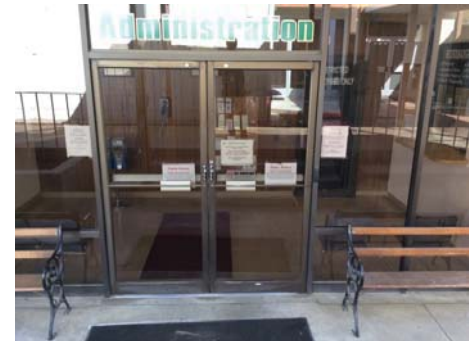
1731	<ul style="list-style-type: none"> <i>As-Built Description:</i> Existing sign designating permanent room or space is noncompliant. <i>Proposed Solution:</i> Provide compliant signage. 	<p>PCODE SA13 ADAAG 4.1.3(16)(a) ADA 2010 216.2 CBC 2010 1117B.5 CBC 2013 11B-216.2 Priority 1 Severity 4 FY 24-25 Maintenance Work</p>	1	JOB	\$150	\$150
------	---	---	---	-----	-------	-------

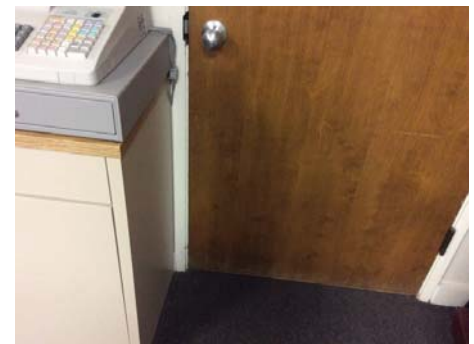
5 Civil Office

1766	<ul style="list-style-type: none"> <i>As-Built Description:</i> Front approach: At pull side, door does not have clear and level maneuvering space measuring door width plus 18" x 60". <i>As-Built:</i> 2" to counter. <i>Proposed Solution:</i> Remove or relocate furniture or storage items. 	<p>PCODE ID23A ADAAG Fig. 25(a) ADA 2010 404.2.4 CBC 2010 11B-26A(a) CBC 2013 11B-404.2.4 Priority 2 Severity 2 FY 24-25 Maintenance Work</p>	1	JOB	\$50	\$50
------	---	---	---	-----	------	------

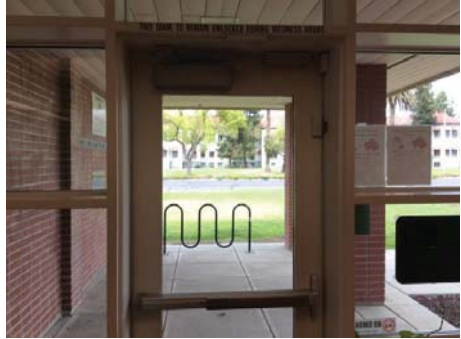
Item No. and Name	Existing Architectural Barrier and Proposed Solution	Codes / Mitigation Info	Qty	Unit	Cost	Total
<u>Door Closer</u>						
2580	<ul style="list-style-type: none"> As-Built Description: Excessive force required to open door. As-Built: 9 lbs Proposed Solution: Adjust regular door closer to accessible standards (5 lbs max). 	PCODE ID03 ADAAG 4.13.11 ADA 2010 404.2.9 CBC 2010 1133B.2.5 CBC 2013 11B-404.2.9 Priority 1 Severity 4 FY 24-25 Maintenance Work	1	JOB	\$25	\$25

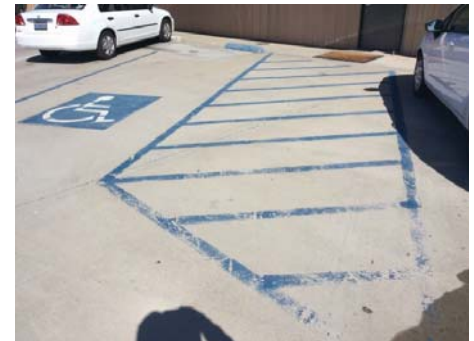
3575	<ul style="list-style-type: none"> As-Built Description: The words "NO PARKING" not painted on the ground within loading and unloading access aisle (12" min high white letters), located so that it is visible to traffic enforcement officials (required in CA only). Proposed Solution: Provide the words "NO PARKING" in each access aisle, painted in 12" high letters, when altering area. 	PCODE EA04D CBC 2010 1129B.3.1 CBC 2013 11B-502.3.3 Priority 1 Severity 4 FY 24-25 Maintenance Work	1	JOB	\$100	\$100
------	--	--	---	-----	-------	-------

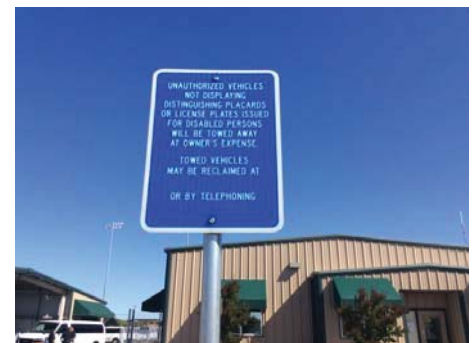
3574	<ul style="list-style-type: none"> As-Built Description: No "Tow Away" sign provided at parking lot entrance does not include retrieval contact information (required in CA only). As-Built: No contact information Proposed Solution: Provide compliant "Tow Away" sign at parking lot entrance when altering area. 	PCODE EA04CNT CBC 2010 1129B.4 CBC 2013 11B-502.8.2 Priority 1 Severity 4 FY 24-25 Maintenance Work	1	JOB	\$325	\$325
------	--	--	---	-----	-------	-------

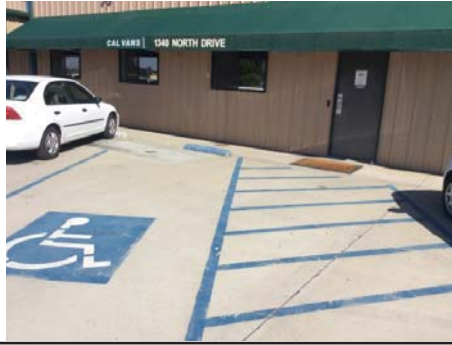
Item No. and Name	Existing Architectural Barrier and Proposed Solution	Codes / Mitigation Info	Qty	Unit	Cost	Total
3573	<ul style="list-style-type: none"> <i>As-Built Description:</i> CA only: Additional Sign or additional language below the symbol of accessibility stating "Minimum Fine \$250" not provided. <i>Proposed Solution:</i> Provide compliant parking signage that includes fine information. 	PCODE EA04GREF CBC 2010 1129B.4 CBC 2013 11B-502.6.2 Priority 1 Severity 4 FY 24-25 Maintenance Work				
						REF

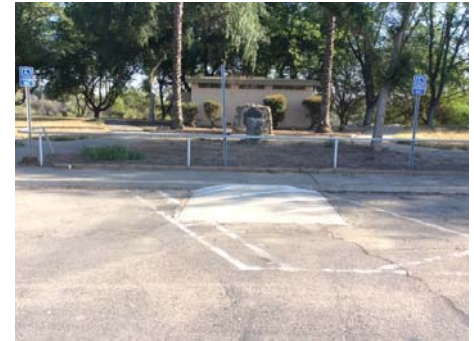
4910	<ul style="list-style-type: none"> <i>As-Built Description:</i> The words "NO PARKING" not painted on the ground within loading and unloading access aisle (12" min high white letters), located so that it is visible to traffic enforcement officials (required in CA only). <i>Proposed Solution:</i> Provide the words "NO PARKING" in each access aisle, painted in 12" high letters, when altering area. 	<p>PCODE EA04D</p> <p>CBC 2010 1129B.3.1</p> <p>CBC 2013 11B-502.3.3</p> <p>Priority 1</p> <p>Severity 4</p> <p>FY 24-25 Maintenance Work</p>	1	JOB	\$100	\$100
------	--	---	---	-----	-------	-------

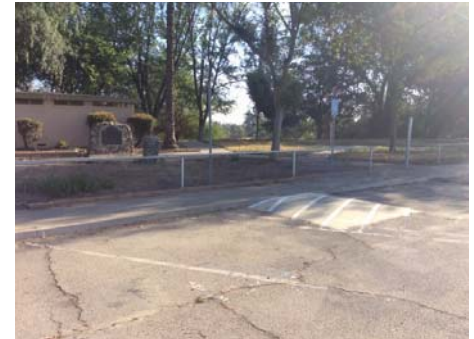
4911	<ul style="list-style-type: none"> <i>As-Built Description:</i> No "Tow Away" sign at parking lot entrance (required in CA only). <i>Proposed Solution:</i> Provide "Tow Away" sign at parking lot entrance when altering area. 	<p>PCODE EA04C</p> <p>CBC 2010 1129B.4</p> <p>CBC 2013 11B-502.8.2</p> <p>Priority 1</p> <p>Severity 4</p> <p>FY 24-25 Maintenance Work</p>	1	JOB	\$325	\$325
------	---	---	---	-----	-------	-------

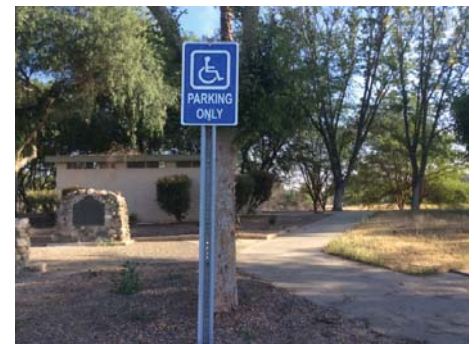
4905	<ul style="list-style-type: none"> <i>As-Built Description:</i> CA only: Additional Sign or additional language below the symbol of accessibility stating "Minimum Fine \$250" not provided. <i>Proposed Solution:</i> Provide compliant parking signage that includes fine information. 	<p>PCODE EA04G</p> <p>CBC 2010 1129B.4</p> <p>CBC 2013 11B-502.6.2</p> <p>Priority 1</p> <p>Severity 4</p> <p>FY 24-25 Maintenance Work</p>	2	JOB	\$100	\$200
------	--	---	---	-----	-------	-------

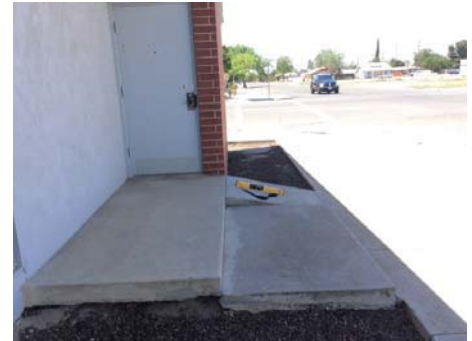
- 4733
- As-Built Description:**
Slope greater than 1:12 (8.3%).
 - As-Built:** 25.2%
 - Proposed Solution:**
Demolish existing and provide new ramp with handrails.
 - Notes:**
14" high

PCODE **EB02**
 ADAAG **4.8.2**
 ADA 2010 **405.2**
 CBC 2010 **1133B.5.3**
 CBC 2013 **11B-405.2**
 Priority **3**
 Severity **1**
 FY 25-26 **Contract Work**

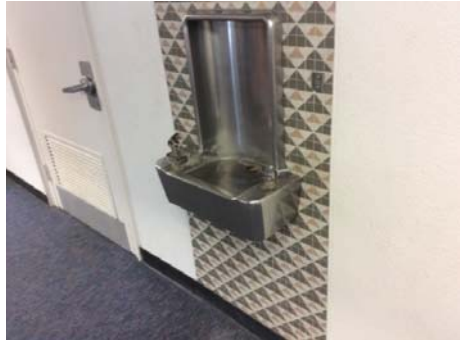
<p>4741</p> <ul style="list-style-type: none"> As-Built Description: Where only one drinking fountain is provided per floor: Fountain is not accessible to individuals who use wheelchairs, or to those who have difficulty bending or stooping. Proposed Solution: Provide additional fountain or hi-lo combination fountain. 	<p>PCODE IA01A ADAAG 4.1.3(10)(a) ADA 2010 211.1 CBC 2010 1115B.4.6.1 CBC 2013 11B-211.1 Priority 3 Severity 2 FY 25-26 Contract Work</p>	<p>1 JOB \$2,000 \$2,000</p>

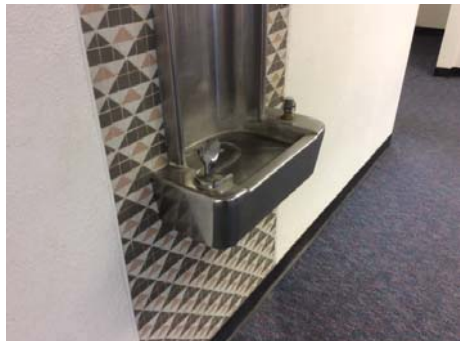
<p>4740</p> <ul style="list-style-type: none"> As-Built Description: Drinking fountain is not 18" - 19" in depth. As-Built: 8" - 12" deep Proposed Solution: Provide new, accessible fountain. 	<p>PCODE IA02B ADAAG 4.15.5(1) ADA 2010 602.8 CBC 2010 1115B.4.6.2 CBC 2013 11B-602.8 Priority 3 Severity 1 FY 25-26 Contract Work</p>	<p>1 JOB \$3,200 \$3,200</p>

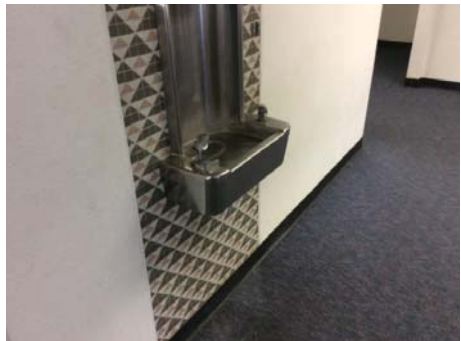
<p>4739</p> <ul style="list-style-type: none"> As-Built Description: CA only: Drinking fountain not located in an alcove (min. 32" wide x 18" deep) or otherwise encroaches into pedestrian way. Proposed Solution: Provide new alcove for drinking fountain, or, if unreasonable hardship is determined, provide wing walls or cane-detectable railings on each side of the drinking fountain. The wings must project out from the supporting wall at least as far as the drinking fountain to within 6" of the surface of the circulation path, but cannot reduce the required clear width of the adjacent accessible route. 	<p>PCODE IA04 CBC 2010 1115B.4.6.3; Fig. CBC 2013 11B-602.9 Priority 3 Severity 2 FY 25-26 Contract Work</p>	<p>1 JOB \$3,000 \$3,000</p>

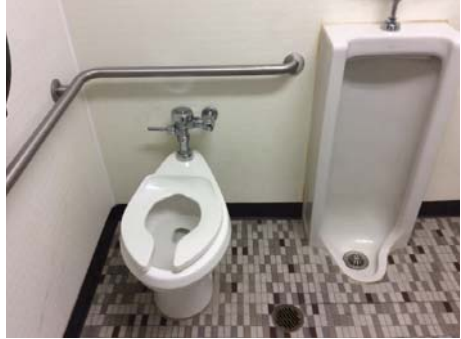
Item No. and Name	Existing Architectural Barrier and Proposed Solution	Codes / Mitigation Info	Qty	Unit	Cost	Total
<u>Toilet Stall</u>						
4761	<ul style="list-style-type: none"> <i>As-Built Description:</i> The lavatory or other unintended fixture, encroaches on the necessary clearance around a water closet (60" x 56"). <i>As-Built:</i> 14" to urinal, 38" to side wall <i>Proposed Solution:</i> Remove adjacent fixture and provide new enclosure at accessible water closet. 	PCODE WB01A ADA 2010 604.3.1; 604.3.2 CBC 2013 11B-604.3.1; 11B-604.3.2 Priority 3 Severity 1 FY 25-26 Contract Work	1	JOB	\$2,000	\$2,000

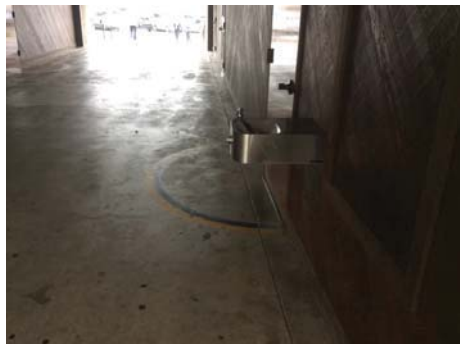
512	<ul style="list-style-type: none"> As-Built Description: CA only: Drinking fountain not located in an alcove (min. 32" wide x 18" deep) or otherwise encroaches into pedestrian way. Proposed Solution: Provide new alcove for drinking fountain, or, if unreasonable hardship is determined, provide wing walls or cane-detectable railings on each side of the drinking fountain. The wings must project out from the supporting wall at least as far as the drinking fountain to within 6" of the surface of the circulation path, but cannot reduce the required clear width of the adjacent accessible route. 	PCODE IA04 CBC 2010 1115B.4.6.3; Fig. CBC 2013 11B-602.9 Priority 3 Severity 2 FY 25-26 Contract Work	1	JOB	\$3,000	\$3,000

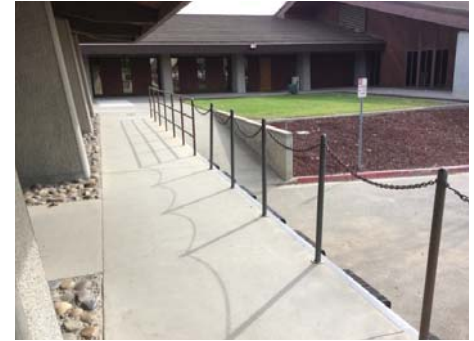
2593 • *As-Built Description:*
 Guards (42" high) not provided at side of ramp or landing where drop-off to adjacent grade or floor exceeds 30" height (California building code requirement only).
 • *Proposed Solution:*
 Provide new guards along drop-off area.
 • *Notes:*
43" drop at loading zone, extreme hazard

PCODE **ED08B**
CBC 2010 **1013.1**
CBC 2013 **Section 1013.2;**
1013.3
Priority **3**
Severity **2**
FY 25-26 Contract Work

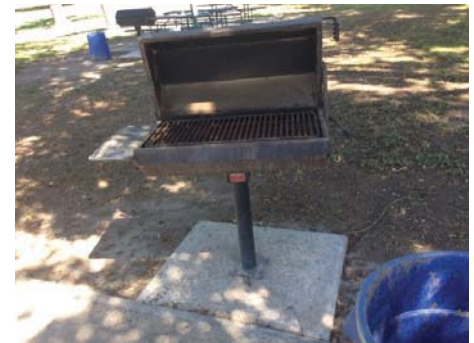
- 4944
- *As-Built Description:*
Single cook surface height is not between 28" and 34" above ground surface.
 - *As-Built:* 35"
 - *Proposed Solution:*
Replace with new cook surface.
 - *Notes:*
Adjust. also difficult to open and close

PCODE NJ01A
 ADAAG 16.7.3
 ADA 2010 804.3.2
 CBC 2010 1132B.1
 CBC 2013 11B-804.3.2
 Priority 2
 Severity 4
 FY 25-26 Contract Work

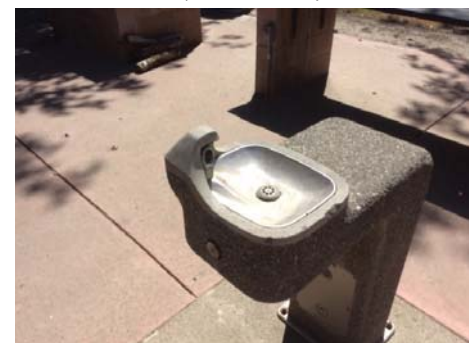
- 5140
- *As-Built Description:*
Drinking fountain water flow less than 4" high; unit in good condition.
 - *As-Built:* 0"
 - *Proposed Solution:*
Adjust water flow.

PCODE IA03D
 ADAAG 4.15.3
 ADA 2010 602.6
 CBC 2010 1115B.4.6.5
 CBC 2013 11B-602.6
 Priority 3
 Severity 1
 FY 25-26 Contract Work

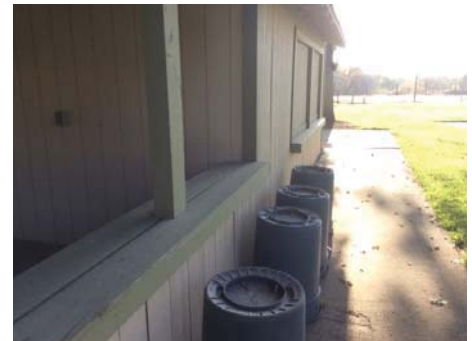
5033	<ul style="list-style-type: none"> <i>As-Built Description:</i> Service counter (stand-up): Accessible section min. 36" length and 36" max. height (in CA: 28" to 34" high) not provided. <i>As-Built:</i> 38" <i>Proposed Solution:</i> Provide auxiliary shelf, clipboard, or table as equivalent facilitation. <i>Notes:</i> 34" lower counter provided at side hatch counter. 	PCODE IN03 ADAAG 7.2(2) ADA 2010 904.4 CBC 2010 1122B.4 CBC 2013 11B-904.4 Priority 2 Severity 4 FY 25-26 Contract Work	1	JOB	\$150	\$150
------	--	--	---	-----	-------	-------

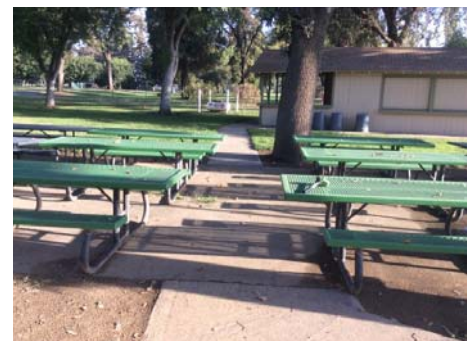
5032	<ul style="list-style-type: none"> <i>As-Built Description:</i> Walk more than 36" but less than 48" wide (required in CA only). <i>As-Built:</i> 40" wide and tables protrude into path. <i>Proposed Solution:</i> Enlarge width of walk to 48". <i>Notes:</i> Acc tables provided along main path. clearance between tables not provided. 	PCODE EF08REF ADA 2010 403.5 CBC 2010 1133B.7.1 CBC 2013 11B-403.5.1.3 Priority 2 Severity 4 FY 25-26 Contract Work		REF		
------	--	---	--	-----	--	--

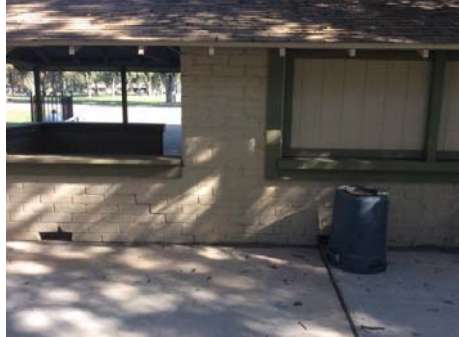
3 Accessible Parking & Picnic Area Y

Item No. and Name	Existing Architectural Barrier and Proposed Solution	Codes / Mitigation Info	Qty	Unit	Cost	Total
<u>Public Counter</u>						
5067	<ul style="list-style-type: none"> <i>As-Built Description:</i> Service counter (stand-up): Accessible section min. 36" length and 36" max. height (in CA: 28" to 34" high) not provided. <i>As-Built:</i> 36" counters. <i>Proposed Solution:</i> Provide auxiliary shelf, clipboard, or table as equivalent facilitation. 	PCODE IN03 ADAAG 7.2(2) ADA 2010 904.4 CBC 2010 1122B.4 CBC 2013 11B-904.4 Priority 2 Severity 4 FY 25-26 Contract Work	1	JOB	\$150	\$150

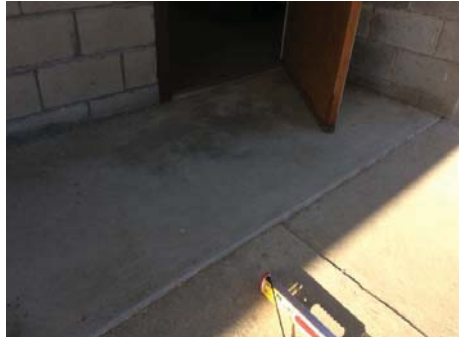
7 Museum Wagon Barn

<u>Changes in Level</u>						
5198	<ul style="list-style-type: none"> <i>As-Built Description:</i> Walk: Pavement dislocation creates abrupt change in level exceeding 1/2" in accessible route. <i>As-Built:</i> 1" <i>Proposed Solution:</i> Remove, replace or repair area of pavement sufficient to correct abrupt change in level. 	PCODE EF03REF ADAAG 4.3.8 ADA 2010 403.4 CBC 2010 1133B.7.4 CBC 2013 11B-403.4 Priority 2 Severity 4 FY 25-26 Contract Work	REF

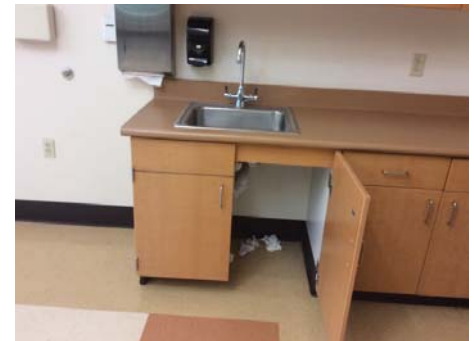
- 5206
- *As-Built Description:*
Sink rim higher than 34" above floor.
 - *As-Built:* 34.25"-34.5" to sink rim
 - *Proposed Solution:*
Remodel sink cabinet to lower sink.

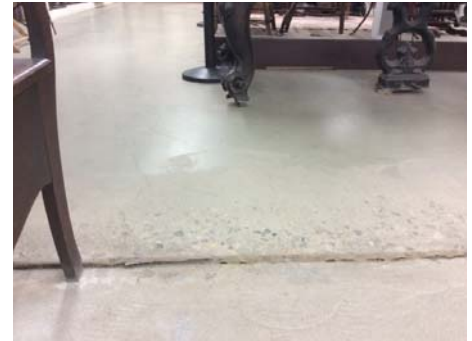
- *As-Built Description:*
 Walk: Pavement dislocation creates abrupt change in level exceeding 1/2" in accessible route.
- *As-Built:* 0.5"
- *Proposed Solution:*
 Remove, replace or repair area of pavement sufficient to correct abrupt change in level.
- **Notes:**
Maintain transitions.

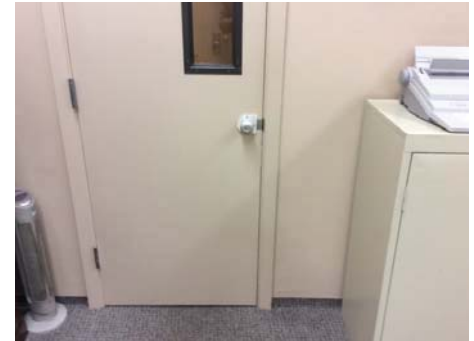
Door

3602	<ul style="list-style-type: none"> <i>As-Built Description:</i> Vision Light at door that permits viewing, does not have bottom of at least one glazed panel located 43 inches maximum above the finish floor. (Exception: More than 66" above finished floor.) <i>As-Built:</i> 47.25" <i>Proposed Solution:</i> Provide new door with vision panel at 43" max. 	<p>PCODE ID06C ADA 2010 404.2.11 CBC 2013 11B-404.2.11 Priority 2 Severity 4 FY 25-26 Maintenance Work</p>	1	JOB	\$2,500	\$2,500
------	---	---	---	-----	---------	---------

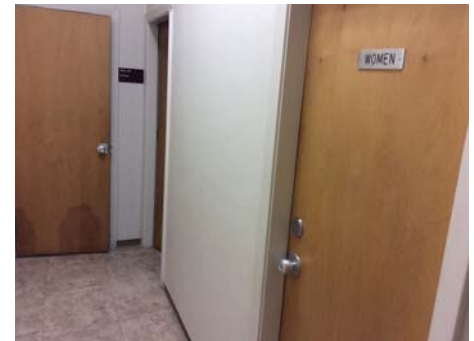
3 Restroom Corridor & Credentials

3613	<ul style="list-style-type: none"> <i>As-Built Description:</i> Door does not have accessible operating hardware. <i>Proposed Solution:</i> Provide lever handle or other accessible hardware. 	<p>PCODE ID07 ADAAG 4.13.9 ADA 2010 404.2.7 CBC 2010 1133B.2.5.2 CBC 2013 11B-404.2.7 Priority 3 Severity 3 FY 25-26 Maintenance Work</p>	5	JOB	\$250	\$1,250
------	--	--	---	-----	-------	---------

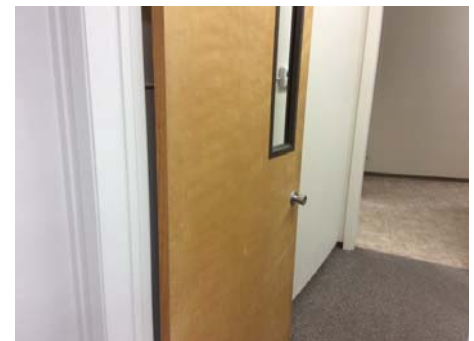
4 Conference Room

3621	<ul style="list-style-type: none"> <i>As-Built Description:</i> Vision Light at door that permits viewing, does not have bottom of at least one glazed panel located 43 inches maximum above the finish floor. (Exception: More than 66" above finished floor.) <i>As-Built:</i> 47" <i>Proposed Solution:</i> Provide new door with vision panel at 43" max. 	<p>PCODE ID06C ADA 2010 404.2.11 CBC 2013 11B-404.2.11 Priority 2 Severity 4 FY 25-26 Maintenance Work</p>	1	JOB	\$2,500	\$2,500
------	--	---	---	-----	---------	---------

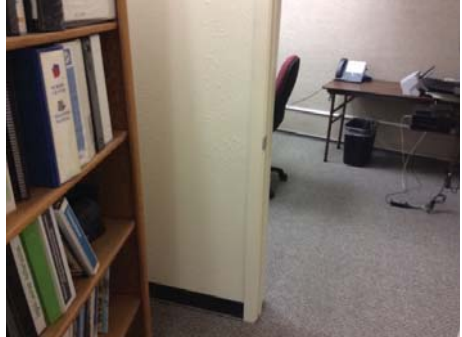
Item No. and Name	Existing Architectural Barrier and Proposed Solution	Codes / Mitigation Info	Qty	Unit	Cost	Total
Door Swing						
3624	<ul style="list-style-type: none"> <i>As-Built Description:</i> Front approach: At pull side, door does not have clear and level maneuvering space measuring door width plus 18" x 60". <i>As-Built:</i> DW + 12" <i>Proposed Solution:</i> Remove or relocate furniture or storage items. 	PCODE ID23A ADAAG Fig. 25(a) ADA 2010 404.2.4 CBC 2010 11B-26A(a) CBC 2013 11B-404.2.4 Priority 2 Severity 4 FY 25-26 Maintenance Work	1	JOB	\$50	\$50

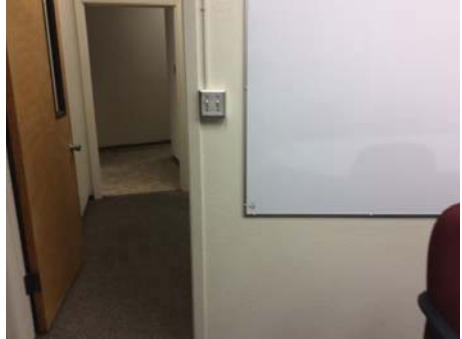
Electrical						
3623	<ul style="list-style-type: none"> <i>As-Built Description:</i> Electric switch or control mounted less than 36" or more than 48" above floor to center. <i>As-Built:</i> Light switch: 53" <i>Proposed Solution:</i> Relocate light switches or control to between 36" and 48" height. 	PCODE IC01 ADAAG 4.2.5 & 6 ADA 2010 308.2.1 & 308.2.2 CBC 2010 1117B.6.3 CBC 2013 11B-308.2.1 & 11B-308.2.2 Priority 2 Severity 4 FY 25-26 Maintenance Work	1	JOB	\$300	\$300

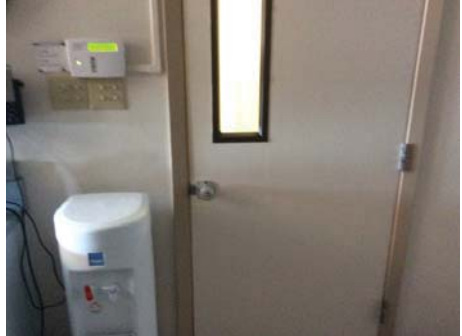
6 Large Conference Room

Door						
3635	<ul style="list-style-type: none"> <i>As-Built Description:</i> Vision Light at door that permits viewing, does not have bottom of at least one glazed panel located 43 inches maximum above the finish floor. (Exception: More than 66" above finished floor.) <i>As-Built:</i> 47.5" <i>Proposed Solution:</i> Provide new door with vision panel at 43" max. 	PCODE ID06C ADA 2010 404.2.11 CBC 2013 11B-404.2.11 Priority 2 Severity 4 FY 25-26 Maintenance Work	1	JOB	\$2,500	\$2,500

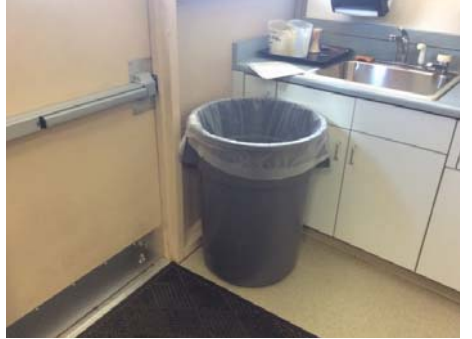
Item No. and Name	Existing Architectural Barrier and Proposed Solution	Codes / Mitigation Info	Qty	Unit	Cost	Total
<u>Door Swing</u>						
3646	<ul style="list-style-type: none"> <i>As-Built Description:</i> Front approach: At push side, door does not have clear and level maneuvering space measuring door width x 48" (door width plus 12" if door has both, latch and closer). <i>As-Built:</i> Trash bin <i>Proposed Solution:</i> Remove or relocate furniture or storage items. 	PCODE ID24A ADAAG Fig. 25(a) ADA 2010 404.2.4 CBC 2010 11B-26A(a) CBC 2013 11B-404.2.4 Priority 2 Severity 4 FY 25-26 Maintenance Work	1	JOB	\$50	\$50

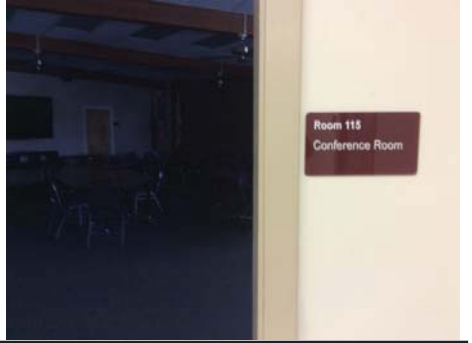
<u>Signage</u>						
3633	<ul style="list-style-type: none"> <i>As-Built Description:</i> Sign designating a permanent room or space is not centered at 60" above the finished floor. <i>Proposed Solution:</i> Remount signage to 60" o.c., remodel wall as needed. 	PCODE SA07B ADAAG 4.30.6 ADA 2010 703.4.1 CBC 2010 1117B.5.7 CBC 2013 11B-703.4.1 Priority 2 Severity 4 FY 25-26 Maintenance Work	1	JOB	\$150	\$150

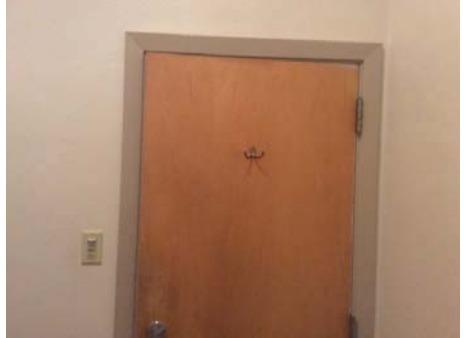
8 Unisex Staff RR

<u>Coat Hook</u>						
3653	<ul style="list-style-type: none"> <i>As-Built Description:</i> Accessible coat hook not within reach range. <i>As-Built:</i> 67" <i>Proposed Solution:</i> Adjust existing or provide new coat hook at maximum 48" height. 	PCODE WG03A ADAAG 4.2.5 ADA 2010 603.4 CBC 2010 1118B.5 CBC 2013 11B-603.4 Priority 3 Severity 1 FY 25-26 Maintenance Work	1	JOB	\$50	\$50

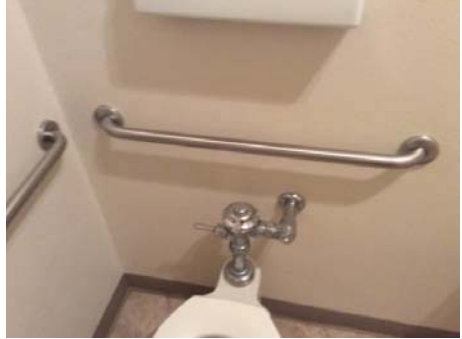
Item No. and Name	Existing Architectural Barrier and Proposed Solution	Codes / Mitigation Info	Qty	Unit	Cost	Total
Grab Bars						
3663	<ul style="list-style-type: none"> <i>As-Built Description:</i> The rear wall grab is less than 36" min. or does not extend from the centerline of the water closet 12" min. on one side and 24" min. on the other side. <i>As-Built:</i> 30" RGB <i>Proposed Solution:</i> Provide or relocate accessible rear grab bar. 	PCODE WB07B ADAAG 4.17.6 ADA 2010 604.5.2 CBC 2010 1115B.4.1.3.2 CBC 2013 11B-604.5.2 Priority 3 Severity 2 FY 25-26 Maintenance Work	1	JOB	\$340	\$340

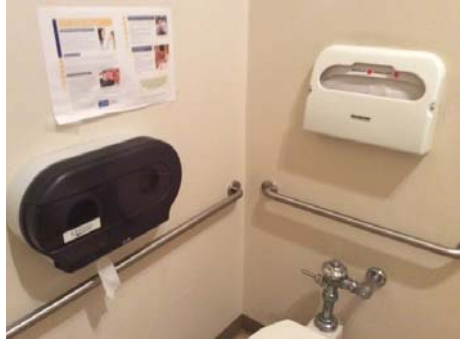
3660	<ul style="list-style-type: none"> <i>As-Built Description:</i> Accessories/dispensers in accessible stall located closer than 1-1/2" below or 12" above grab bar impedes its use. <i>As-Built:</i> TPD: 4" <i>Proposed Solution:</i> Relocate accessories/dispensers to be no closer than 1-1/2" below and 12" above grab bars (except if accessories are recessed, flush with wall, and have no sharp edges). 	PCODE WB07I ADAAG 4.26.2 ADA 2010 609.3 CBC 2010 1133B.4.2.5 CBC 2013 11B-609.3 Priority 3 Severity 2 FY 25-26 Maintenance Work	1	JOB	\$75	\$75

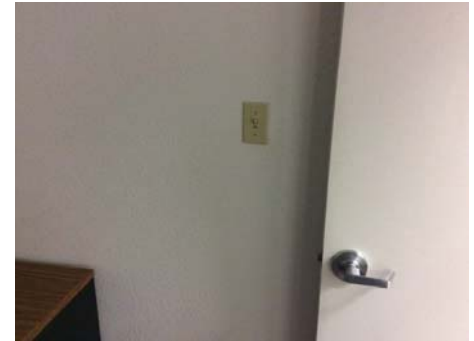
Electrical

3878	<ul style="list-style-type: none"> <i>As-Built Description:</i> Electric switch or control mounted less than 36" or more than 48" above floor to center. <i>As-Built:</i> Light switch: 50" <i>Proposed Solution:</i> Relocate light switches or control to between 36" and 48" height. 	<p>PCODE IC01 ADAAG 4.2.5 & 6 ADA 2010 308.2.1 & 308.2.2 CBC 2010 1117B.6.3 CBC 2013 11B-308.2.1 & 11B-308.2.2 Priority 2 Severity 4 FY 25-26 Maintenance Work</p>	1	JOB	\$300	\$300
------	--	---	---	-----	-------	-------

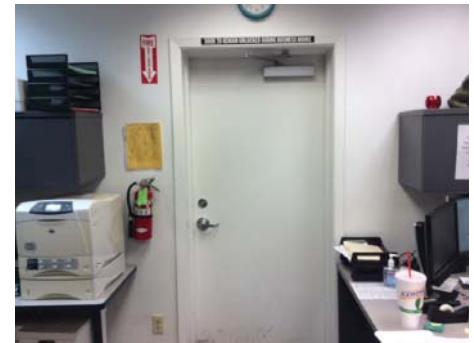
17 JTO Staff Offices

3882	<ul style="list-style-type: none"> <i>As-Built Description:</i> Front approach: At push side, door does not have clear and level maneuvering space measuring door width x 48" (door width plus 12" if door has both, latch and closer). <i>Proposed Solution:</i> Remove or relocate furniture or storage items. <i>Notes:</i> Leads to a non marked exit. verify with fire marshal and provide accessible route and door landings etc. 	<p>PCODE ID24A ADAAG Fig. 25(a) ADA 2010 404.2.4 CBC 2010 11B-26A(a) CBC 2013 11B-404.2.4 Priority 2 Severity 4 FY 25-26 Maintenance Work</p>	1	JOB	\$50	\$50
------	--	--	---	-----	------	------

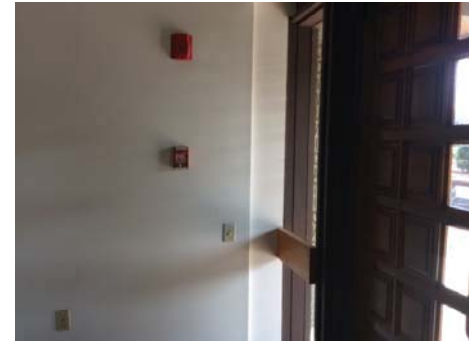
Fire Alarm

945	<ul style="list-style-type: none"> • <i>As-Built Description:</i> Fire alarm pull stations not 48" from floor to center. Note: Required only at new construction, or where mounting location was or is to be remodeled. • <i>As-Built:</i> 61" • <i>Proposed Solution:</i> Remount fire alarm station to be 48" from floor to center. 	PCODE IC03 ADAAG 4.2.5 ADA 2010 308.2.1 CBC 2010 907.4.2 CBC 2013 907.4.2.2 Priority 3 Severity 2 FY 25-26 Maintenance Work	1	JOB	\$275	\$275
-----	--	--	---	-----	-------	-------

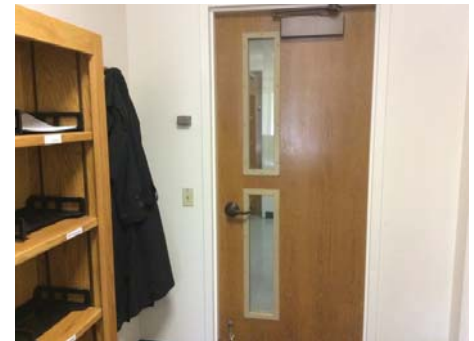
3 Minors Advocates Offices

966	<ul style="list-style-type: none"> • <i>As-Built Description:</i> Excessive force required to open door. • <i>As-Built:</i> 9 lbs • <i>Proposed Solution:</i> Adjust regular door closer to accessible standards (5 lbs max). 	PCODE ID03 ADAAG 4.13.11 ADA 2010 404.2.9 CBC 2010 1133B.2.5 CBC 2013 11B-404.2.9 Priority 2 Severity 4 FY 25-26 Maintenance Work	1	JOB	\$25	\$25
-----	--	--	---	-----	------	------

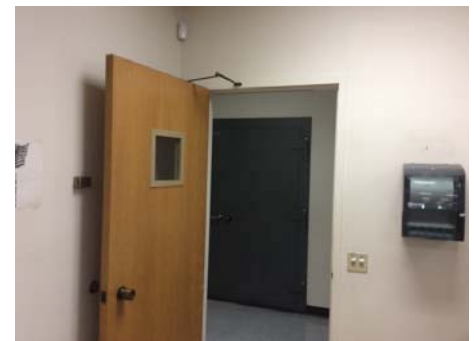
4 Central Services Office

971	<ul style="list-style-type: none"> • <i>As-Built Description:</i> Excessive force required to open door. • <i>As-Built:</i> 9 lbs • <i>Proposed Solution:</i> Adjust regular door closer to accessible standards (5 lbs max). 	PCODE ID03 ADAAG 4.13.11 ADA 2010 404.2.9 CBC 2010 1133B.2.5 CBC 2013 11B-404.2.9 Priority 2 Severity 4 FY 25-26 Maintenance Work	1	JOB	\$25	\$25
-----	--	--	---	-----	------	------

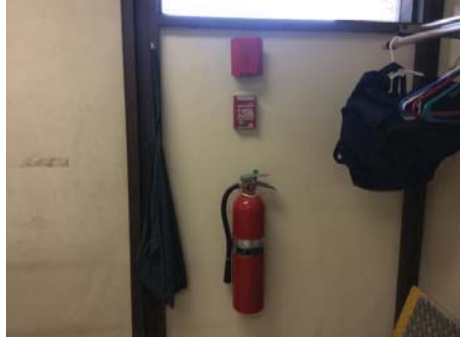
Item No. and Name	Existing Architectural Barrier and Proposed Solution	Codes / Mitigation Info	Qty	Unit	Cost	Total
<u>Fire Alarm</u>						
981	<ul style="list-style-type: none"> As-Built Description: Fire alarm pull stations not 48" from floor to center. Note: Required only at new construction, or where mounting location was or is to be remodeled. As-Built: 62" Proposed Solution: Remount fire alarm station to be 48" from floor to center. 	PCODE IC03 ADAAG 4.2.5 ADA 2010 308.2.1 CBC 2010 907.4.2 CBC 2013 907.4.2.2 Priority 3 Severity 2 FY 25-26 Maintenance Work	1	JOB	\$275	\$275

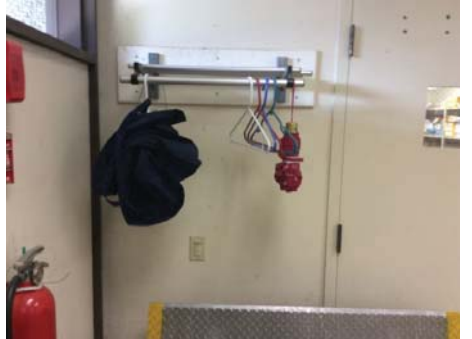
<u>Reach Range</u>						
982	<ul style="list-style-type: none"> As-Built Description: Reach height to control or access point, where only forward approach is available, exceeds 48" or is less than 15". As-Built: CH: 69" Proposed Solution: Modify equipment or mounting. 	PCODE IE01 ADAAG 4.2.5 ADA 2010 308.2.1 CBC 2010 1118B.5 CBC 2013 11B-308.2.1 Priority 3 Severity 1 FY 25-26 Maintenance Work	1	JOB	\$100	\$100

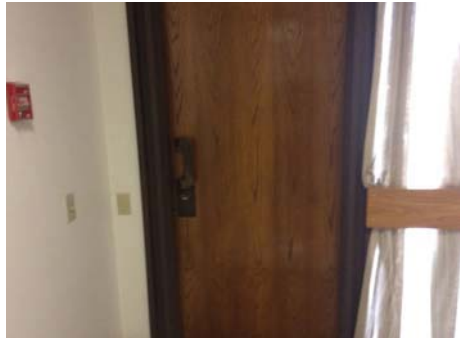
7 Corridors

<u>Door Closer</u>						
998	<ul style="list-style-type: none"> As-Built Description: Excessive force required to open door. As-Built: 9 lbs Proposed Solution: Adjust regular door closer to accessible standards (5 lbs max). 	PCODE ID03 ADAAG 4.13.11 ADA 2010 404.2.9 CBC 2010 1133B.2.5 CBC 2013 11B-404.2.9 Priority 2 Severity 4 FY 25-26 Maintenance Work	1	JOB	\$25	\$25

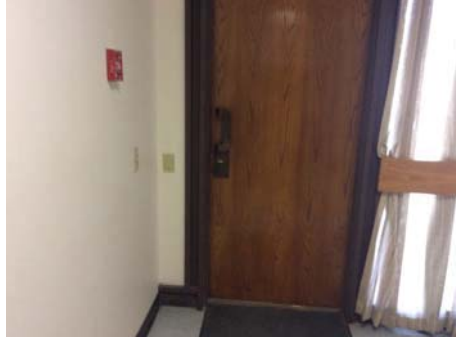
Item No. and Name	Existing Architectural Barrier and Proposed Solution	Codes / Mitigation Info	Qty	Unit	Cost	Total
<u>Fire Alarm</u>						
994	<ul style="list-style-type: none"> <i>As-Built Description:</i> Fire alarm pull stations not 48" from floor to center. Note: Required only at new construction, or where mounting location was or is to be remodeled. <i>As-Built:</i> 61" <i>Proposed Solution:</i> Remount fire alarm station to be 48" from floor to center. 	PCODE IC03 ADAAG 4.2.5 ADA 2010 308.2.1 CBC 2010 907.4.2 CBC 2013 907.4.2.2 Priority 3 Severity 2 FY 25-26 Maintenance Work	1	JOB	\$275	\$275

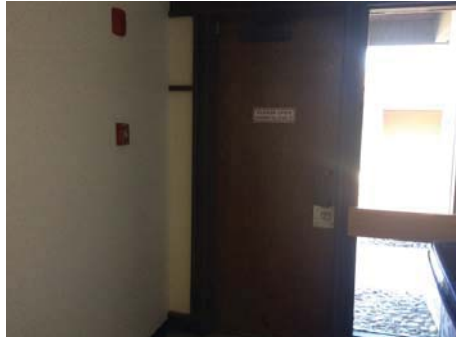
<u>Fire Alarm</u>						
1006	<ul style="list-style-type: none"> <i>As-Built Description:</i> Fire alarm pull stations not 48" from floor to center. Note: Required only at new construction, or where mounting location was or is to be remodeled. <i>As-Built:</i> 61" <i>Proposed Solution:</i> Remount fire alarm station to be 48" from floor to center. 	PCODE IC03 ADAAG 4.2.5 ADA 2010 308.2.1 CBC 2010 907.4.2 CBC 2013 907.4.2.2 Priority 3 Severity 2 FY 25-26 Maintenance Work	1	JOB	\$275	\$275

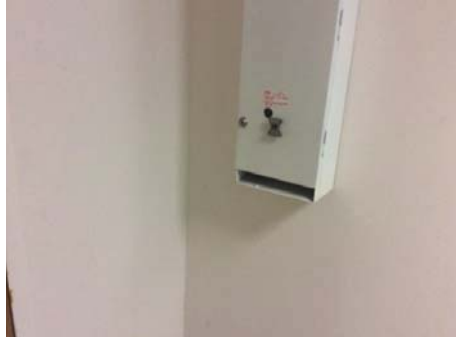
9 Women's Restroom

<u>Accessories</u>						
1015	<ul style="list-style-type: none"> <i>As-Built Description:</i> Dispensers in sanitary facilities, such as for towels, soap, sanitary napkins, seat covers, etc., and waste receptacles more than 48" (CA only: 40") from floor to highest operating slot or control. <i>As-Built:</i> FND: 52" <i>Proposed Solution:</i> Relocate existing restroom accessories. 	PCODE WG01A ADAAG 4.23.7 ADA 2010 308.2.1 CBC 2010 1115B.8.3 CBC 2013 11B-603.5 Priority 3 Severity 2 FY 25-26 Maintenance Work	1	JOB	\$100	\$100

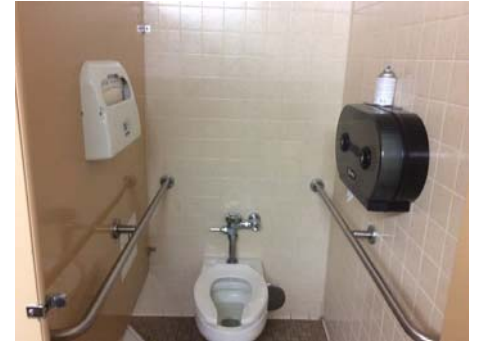
Item No. and Name	Existing Architectural Barrier and Proposed Solution	Codes / Mitigation Info	Qty	Unit	Cost	Total
1027	<ul style="list-style-type: none"> <i>As-Built Description:</i> Dispensers in sanitary facilities, such as for towels, soap, sanitary napkins, seat covers, etc., and waste receptacles more than 48" (CA only: 40") from floor to highest operating slot or control. <i>As-Built:</i> SCD: 54" <i>Proposed Solution:</i> Relocate existing restroom accessories. 	PCODE WG01A ADAAG 4.23.7 ADA 2010 308.2.1 CBC 2010 1115B.8.3 CBC 2013 11B-603.5 Priority 3 Severity 2 FY 25-26 Maintenance Work	1	JOB	\$100	\$100

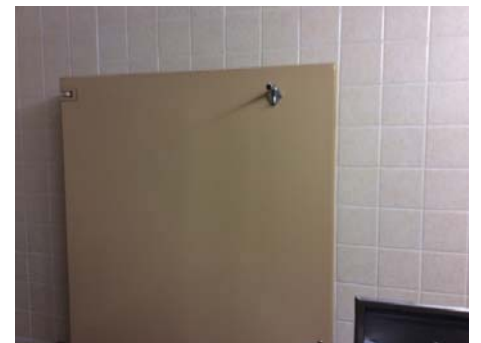
Coat Hook

1026	<ul style="list-style-type: none"> <i>As-Built Description:</i> Accessible coat hook not within reach range. <i>As-Built:</i> 68" <i>Proposed Solution:</i> Adjust existing or provide new coat hook at maximum 48" height. 	PCODE WG03A ADAAG 4.2.5 ADA 2010 603.4 CBC 2010 1118B.5 CBC 2013 11B-603.4 Priority 3 Severity 1 FY 25-26 Maintenance Work	1	JOB	\$50	\$50
------	--	---	---	-----	------	------

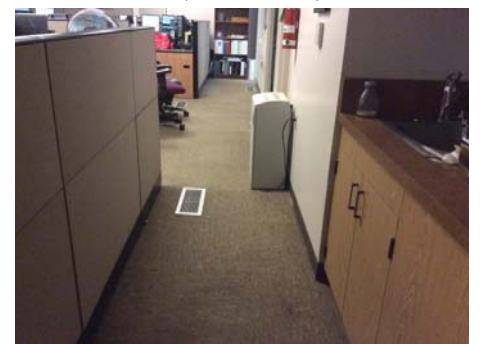
1055	<ul style="list-style-type: none"> <i>As-Built Description:</i> Corridor less than 44" wide when occupant load 10 or more. <i>As-Built:</i> 40" <i>Proposed Solution:</i> Remove or relocate furniture and storage items. 	PCODE IH01A ADAAG 4.3.3 CBC 2010 1133B.3.1 CBC 2013 11B-403.5.1 Priority 2 Severity 4 FY 25-26 Maintenance Work	1	JOB	\$50	\$50
------	--	--	---	-----	------	------

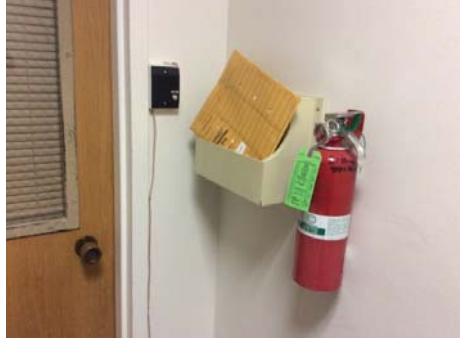
Item No. and Name	Existing Architectural Barrier and Proposed Solution	Codes / Mitigation Info	Qty	Unit	Cost	Total
<u>Protrusion Limits</u>						
1050	<ul style="list-style-type: none"> <i>As-Built Description:</i> Protruding objects more than 4" from wall, when bottom of object more than 27" or less than 80" above finished floor. <i>As-Built:</i> Drop box: 5.75" protrusion at 49" <i>Proposed Solution:</i> Remove/relocate protruding object. Patch existing surface. 	PCODE EG04REF ADAAG 4.4.1 ADA 2010 307.2 CBC 2010 1133B.8.6.1 CBC 2013 11B-307.2 Priority 2 Severity 4 FY 25-26 Maintenance Work				
				REF

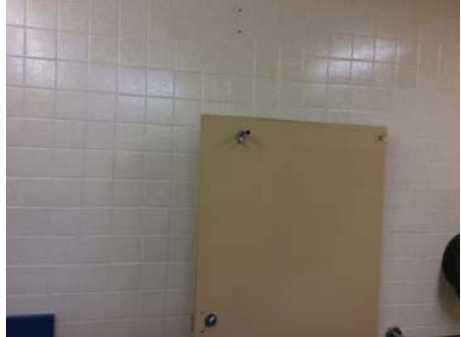
Item No. and Name	Existing Architectural Barrier and Proposed Solution	Codes / Mitigation Info	Qty	Unit	Cost	Total
<u>Coat Hook</u>						
805	<ul style="list-style-type: none"> As-Built Description: Accessible coat hook not within reach range. As-Built: 67" Proposed Solution: Adjust existing or provide new coat hook at maximum 48" height. 	PCODE WG03A ADAAG 4.2.5 ADA 2010 603.4 CBC 2010 1118B.5 CBC 2013 11B-603.4 Priority 3 Severity 1 FY 25-26 Maintenance Work	1	JOB	\$50	\$50

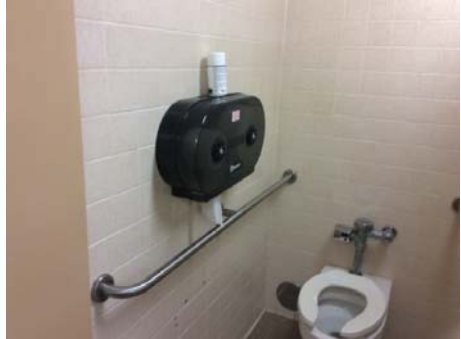
<u>Grab Bars</u>						
801	<ul style="list-style-type: none"> As-Built Description: Accessories/dispensers in accessible stall located closer than 1-1/2" below or 12" above grab bar impedes its use. As-Built: TPD: 6" Proposed Solution: Relocate accessories/dispensers to be no closer than 1-1/2" below and 12" above grab bars (except if accessories are recessed, flush with wall, and have no sharp edges). 	PCODE WB07I ADAAG 4.26.2 ADA 2010 609.3 CBC 2010 1133B.4.2.5 CBC 2013 11B-609.3 Priority 3 Severity 2 FY 25-26 Maintenance Work	1	JOB	\$75	\$75

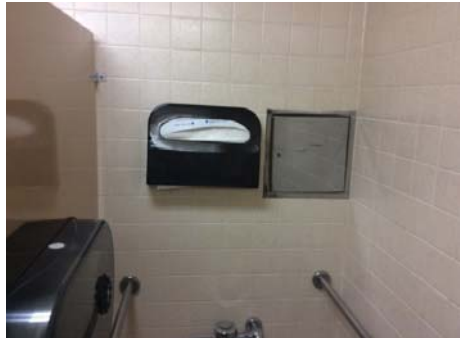
5 Men's Public Restroom

<u>Accessories</u>						
824	<ul style="list-style-type: none"> As-Built Description: Dispensers in sanitary facilities, such as for towels, soap, sanitary napkins, seat covers, etc., and waste receptacles more than 48" (CA only: 40") from floor to highest operating slot or control. As-Built: SCD: 57" Proposed Solution: Relocate existing restroom accessories. 	PCODE WG01A ADAAG 4.23.7 ADA 2010 308.2.1 CBC 2010 1115B.8.3 CBC 2013 11B-603.5 Priority 3 Severity 2 FY 25-26 Maintenance Work	1	JOB	\$100	\$100

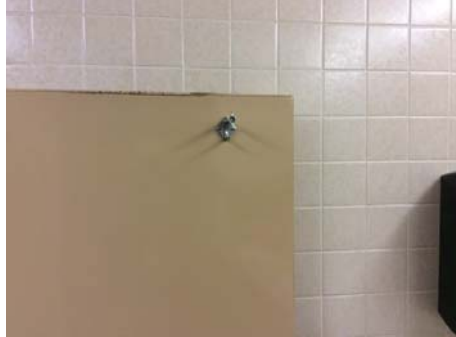
Item No. and Name	Existing Architectural Barrier and Proposed Solution	Codes / Mitigation Info	Qty	Unit	Cost	Total
<u>Coat Hook</u>						
827	<ul style="list-style-type: none"> As-Built Description: Accessible coat hook not within reach range. As-Built: 67" Proposed Solution: Adjust existing or provide new coat hook at maximum 48" height. 	PCODE WG03A ADAAG 4.2.5 ADA 2010 603.4 CBC 2010 1118B.5 CBC 2013 11B-603.4 Priority 3 Severity 1 FY 25-26 Maintenance Work	1	JOB	\$50	\$50

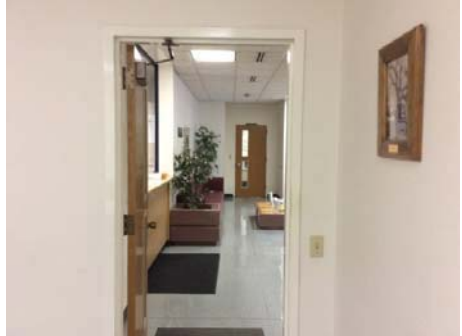
Door Closer

815	<ul style="list-style-type: none"> As-Built Description: Excessive force required to open door. As-Built: 7 lbs Proposed Solution: Adjust regular door closer to accessible standards (5 lbs max). 	PCODE ID03 ADAAG 4.13.11 ADA 2010 404.2.9 CBC 2010 1133B.2.5 CBC 2013 11B-404.2.9 Priority 2 Severity 4 FY 25-26 Maintenance Work	1	JOB	\$25	\$25

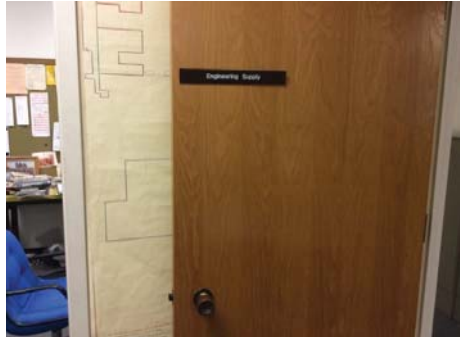
Signage

818	<ul style="list-style-type: none"> As-Built Description: Existing sign designating permanent room or space is noncompliant. Proposed Solution: Provide compliant signage. 	PCODE SA13 ADAAG 4.1.3(16)(a) ADA 2010 216.2 CBC 2010 1117B.5 CBC 2013 11B-216.2 Priority 2 Severity 4 FY 25-26 Maintenance Work	1	JOB	\$150	\$150

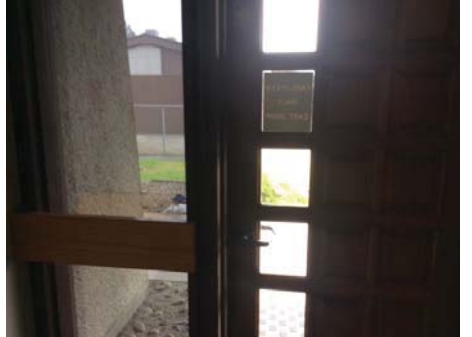
Item No. and Name	Existing Architectural Barrier and Proposed Solution	Codes / Mitigation Info	Qty	Unit	Cost	Total
<u>Door Closer</u>						
838	<ul style="list-style-type: none"> As-Built Description: Excessive force required to open door. As-Built: 10 lbs Proposed Solution: Adjust regular door closer to accessible standards (5 lbs max). 	PCODE ID03 ADAAG 4.13.11 ADA 2010 404.2.9 CBC 2010 1133B.2.5 CBC 2013 11B-404.2.9 Priority 2 Severity 4 FY 25-26 Maintenance Work	1	JOB	\$25	\$25

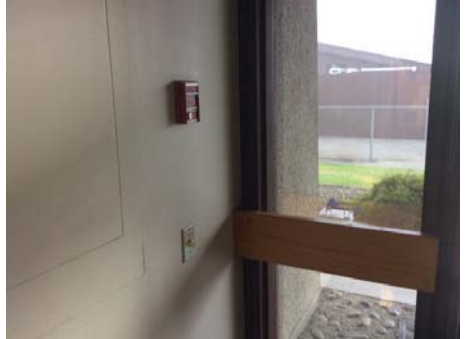
<u>Fire Alarm</u>						
834	<ul style="list-style-type: none"> As-Built Description: Fire alarm pull stations not 48" from floor to center. Note: Required only at new construction, or where mounting location was or is to be remodeled. As-Built: 61" Proposed Solution: Remount fire alarm station to be 48" from floor to center. 	PCODE IC03 ADAAG 4.2.5 ADA 2010 308.2.1 CBC 2010 907.4.2 CBC 2013 907.4.2.2 Priority 3 Severity 2 FY 25-26 Maintenance Work	1	JOB	\$275	\$275

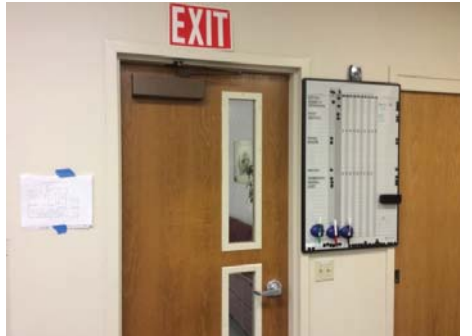
9 Planning Offices

<u>Door Closer</u>						
856	<ul style="list-style-type: none"> As-Built Description: Excessive force required to open door. As-Built: 8 lbs Proposed Solution: Adjust regular door closer to accessible standards (5 lbs max). 	PCODE ID03 ADAAG 4.13.11 ADA 2010 404.2.9 CBC 2010 1133B.2.5 CBC 2013 11B-404.2.9 Priority 2 Severity 4 FY 25-26 Maintenance Work	1	JOB	\$25	\$25

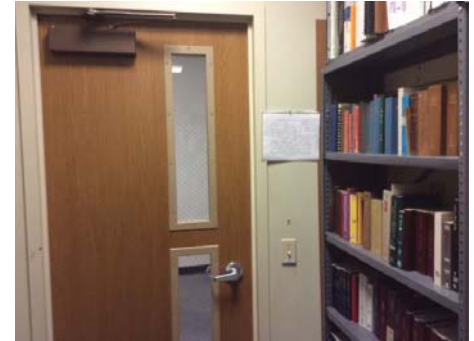
Item No. and Name	Existing Architectural Barrier and Proposed Solution	Codes / Mitigation Info	Qty	Unit	Cost	Total
861	<ul style="list-style-type: none"> As-Built Description: Excessive force required to open door. As-Built: 9 lbs Proposed Solution: Adjust regular door closer to accessible standards (5 lbs max). 	PCODE ID03 ADAAG 4.13.11 ADA 2010 404.2.9 CBC 2010 1133B.2.5 CBC 2013 11B-404.2.9 Priority 2 Severity 4 FY 25-26 Maintenance Work	1	JOB	\$25	\$25

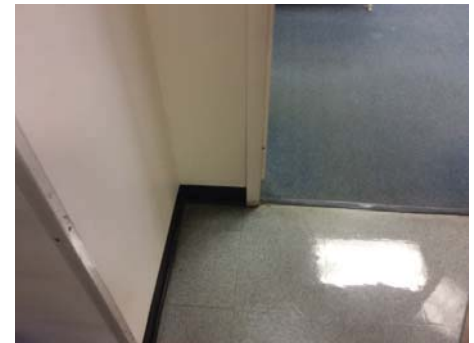
Door Swing

855	<ul style="list-style-type: none"> As-Built Description: Front approach: At pull side, door does not have clear and level maneuvering space measuring door width plus 18" x 60". As-Built: 12" Proposed Solution: Provide power door operator. 	PCODE ID23C ADAAG Fig. 25(a) ADA 2010 404.2.4 CBC 2010 11B-26A(a) CBC 2013 11B-404.2.4 Priority 2 Severity 4 FY 25-26 Maintenance Work	1	JOB	\$5,000	\$5,000
-----	---	---	---	-----	---------	---------

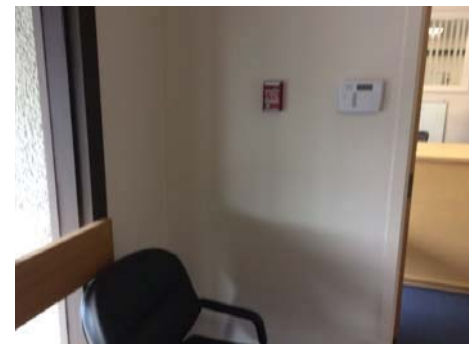
Fire Alarm

882	<ul style="list-style-type: none"> As-Built Description: Fire alarm pull stations not 48" from floor to center. Note: Required only at new construction, or where mounting location was or is to be remodeled. As-Built: 61" Proposed Solution: Remount fire alarm station to be 48" from floor to center. 	PCODE IC03 ADAAG 4.2.5 ADA 2010 308.2.1 CBC 2010 907.4.2 CBC 2013 907.4.2.2 Priority 3 Severity 2 FY 25-26 Maintenance Work	1	JOB	\$275	\$275
-----	---	--	---	-----	-------	-------

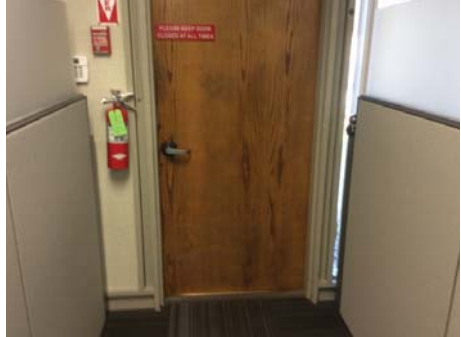
Item No. and Name	Existing Architectural Barrier and Proposed Solution	Codes / Mitigation Info	Qty	Unit	Cost	Total
<u>Door Closer</u>						
904	<ul style="list-style-type: none"> As-Built Description: Excessive force required to open door. As-Built: 7 lbs Proposed Solution: Adjust regular door closer to accessible standards (5 lbs max). 	PCODE ID03 ADAAG 4.13.11 ADA 2010 404.2.9 CBC 2010 1133B.2.5 CBC 2013 11B-404.2.9 Priority 2 Severity 4 FY 25-26 Maintenance Work	1	JOB	\$25	\$25

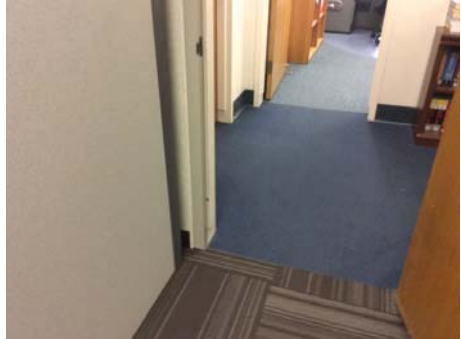
<u>Door Swing</u>						
894	<ul style="list-style-type: none"> As-Built Description: Front approach: At pull side, door does not have clear and level maneuvering space measuring door width plus 18" x 60". As-Built: 3" Proposed Solution: Remove or relocate furniture or storage items. 	PCODE ID23A ADAAG Fig. 25(a) ADA 2010 404.2.4 CBC 2010 11B-26A(a) CBC 2013 11B-404.2.4 Priority 3 Severity 2 FY 25-26 Maintenance Work	1	JOB	\$50	\$50

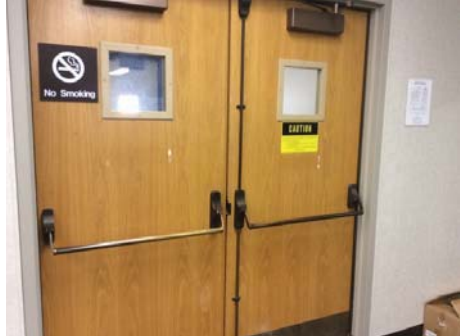
14 Server Room & Offices

<u>Door Closer</u>						
909	<ul style="list-style-type: none"> As-Built Description: Excessive force required to open door. As-Built: 9 lbs Proposed Solution: Adjust regular door closer to accessible standards (5 lbs max). 	PCODE ID03 ADAAG 4.13.11 ADA 2010 404.2.9 CBC 2010 1133B.2.5 CBC 2013 11B-404.2.9 Priority 2 Severity 4 FY 25-26 Maintenance Work	2	JOB	\$25	\$50

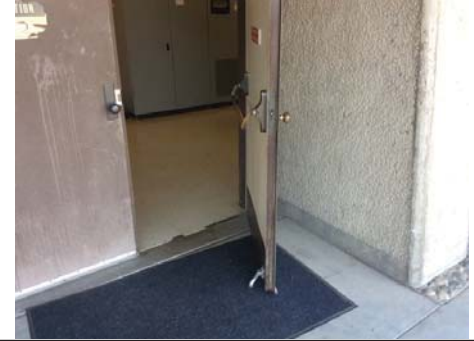
Item No. and Name	Existing Architectural Barrier and Proposed Solution	Codes / Mitigation Info	Qty	Unit	Cost	Total
915	<ul style="list-style-type: none"> As-Built Description: Excessive force required to open door. As-Built: 8 lbs Proposed Solution: Adjust regular door closer to accessible standards (5 lbs max). 	PCODE ID03 ADAAG 4.13.11 ADA 2010 404.2.9 CBC 2010 1133B.2.5 CBC 2013 11B-404.2.9 Priority 2 Severity 4 FY 25-26 Maintenance Work	2	JOB	\$25	\$50

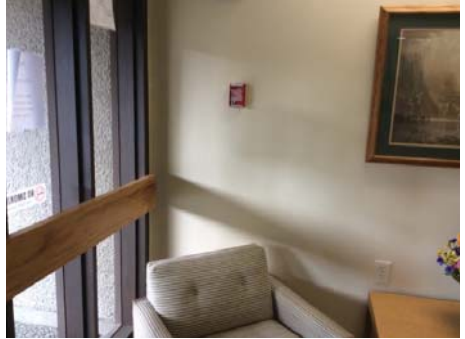
Item No. and Name	Existing Architectural Barrier and Proposed Solution	Codes / Mitigation Info	Qty	Unit	Cost	Total
<u>Fire Alarm</u>						
611	<ul style="list-style-type: none"> • <i>As-Built Description:</i> Fire alarm pull stations not 48" from floor to center. Note: Required only at new construction, or where mounting location was or is to be remodeled. • <i>As-Built:</i> 61" • <i>Proposed Solution:</i> Remount fire alarm station to be 48" from floor to center. 	PCODE IC03 ADAAG 4.2.5 ADA 2010 308.2.1 CBC 2010 907.4.2 CBC 2013 907.4.2.2 Priority 3 Severity 2 FY 25-26 Maintenance Work	1	JOB	\$275	\$275
