Facility: **WOMENS INFANTS & CHILDREN**

Address: 330 HARRIS ST.

Facility: **LEMORE HEALTH CLINIC**
 Address: 229 C ST.

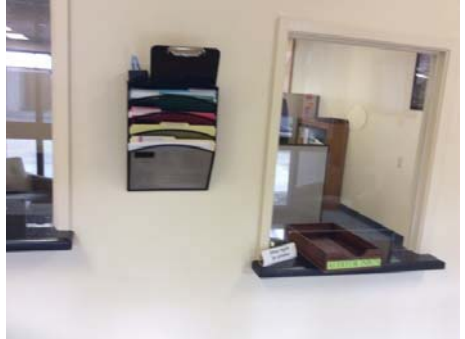
<u>Reach Range</u>						
617	<ul style="list-style-type: none"> • <i>As-Built Description:</i> Reach height to control or access point, where only forward approach is available, exceeds 48" or is less than 15". • <i>As-Built:</i> Folders bin: 54"-64" • <i>Proposed Solution:</i> Modify equipment or mounting. 	PCODE IE01 ADAAG 4.2.5 ADA 2010 308.2.1 CBC 2010 1118B.5 CBC 2013 11B-308.2.1 Priority 3 Severity 2 FY 25-26 Maintenance Work	1	JOB	\$100	\$100

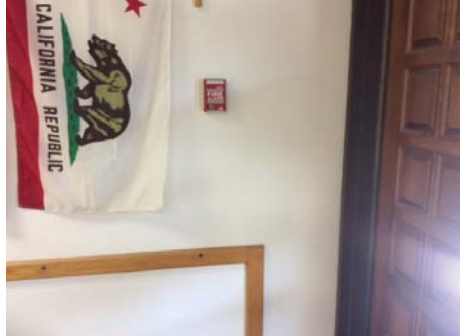
6 Elections Lobby

<u>Fire Alarm</u>						
624	<ul style="list-style-type: none"> • <i>As-Built Description:</i> Fire alarm pull stations not 48" from floor to center. Note: Required only at new construction, or where mounting location was or is to be remodeled. • <i>As-Built:</i> 61" • <i>Proposed Solution:</i> Remount fire alarm station to be 48" from floor to center. 	PCODE IC03 ADAAG 4.2.5 ADA 2010 308.2.1 CBC 2010 907.4.2 CBC 2013 907.4.2.2 Priority 3 Severity 2 FY 25-26 Maintenance Work	1	JOB	\$275	\$275

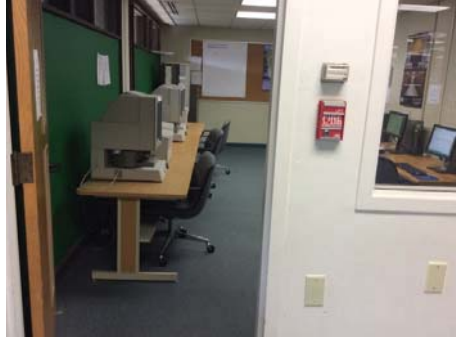
Item No. and Name	Existing Architectural Barrier and Proposed Solution	Codes / Mitigation Info	Qty	Unit	Cost	Total
<u>Fire Alarm</u>						
651	<ul style="list-style-type: none"> As-Built Description: Fire alarm pull stations not 48" from floor to center. Note: Required only at new construction, or where mounting location was or is to be remodeled. As-Built: 61" Proposed Solution: Remount fire alarm station to be 48" from floor to center. 	PCODE IC03 ADAAG 4.2.5 ADA 2010 308.2.1 CBC 2010 907.4.2 CBC 2013 907.4.2.2 Priority 3 Severity 2 FY 25-26 Maintenance Work	1	JOB	\$275	\$275

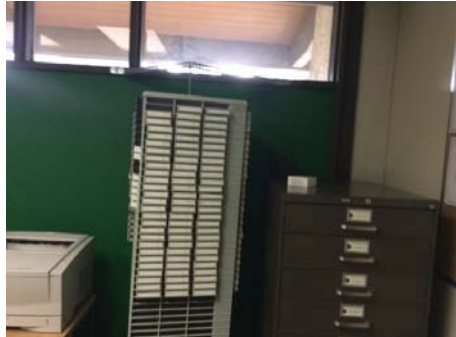
11 Records Room

<u>Reach Range</u>						
656	<ul style="list-style-type: none"> As-Built Description: Reach height to operable part exceeds 48" AFF. As-Built: Micro film: 64" AFF Proposed Solution: Modify equipment or mounting. 	PCODE IE01NT ADAAG 4.2.5 ADA 2010 308.2.1 CBC 2010 1118B.5 CBC 2013 11B-308.2.1 Priority 3 Severity 2 FY 25-26 Maintenance Work	1	JOB	\$350	\$350

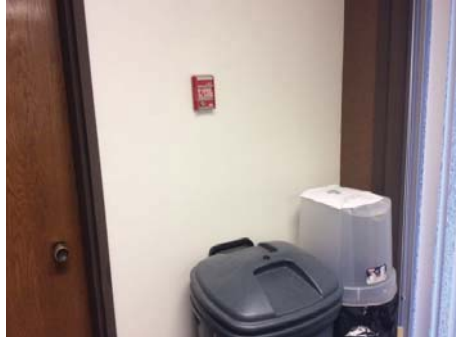
16 Assessors Office - Staff Break Room

<u>Fire Alarm</u>						
722	<ul style="list-style-type: none"> As-Built Description: Fire alarm pull stations not 48" from floor to center. Note: Required only at new construction, or where mounting location was or is to be remodeled. As-Built: 61" Proposed Solution: Remount fire alarm station to be 48" from floor to center. 	PCODE IC03 ADAAG 4.2.5 ADA 2010 308.2.1 CBC 2010 907.4.2 CBC 2013 907.4.2.2 Priority 3 Severity 2 FY 25-26 Maintenance Work	1	JOB	\$275	\$275

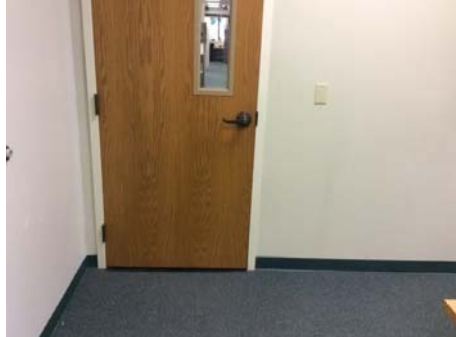
17 Shared Conference Room

Item No. and Name	Existing Architectural Barrier and Proposed Solution	Codes / Mitigation Info	Qty	Unit	Cost	Total
<u>Door</u>						
732	<ul style="list-style-type: none"> As-Built Description: Vision Light at door that permits viewing, does not have bottom of at least one glazed panel located 43 inches maximum above the finish floor. (Exception: More than 66" above finished floor.) As-Built: 47" Proposed Solution: Provide new door with vision panel at 43" max. 	PCODE ID06C ADA 2010 404.2.11 CBC 2013 11B-404.2.11 Priority 2 Severity 4 FY 25-26 Maintenance Work	2	JOB	\$2,500	\$5,000

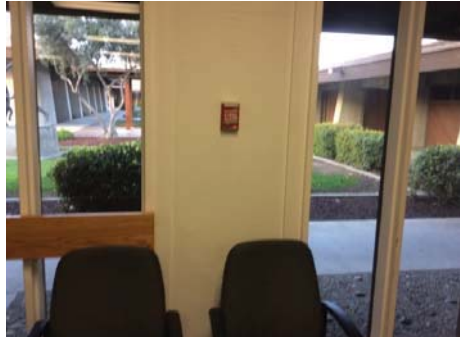
18 HR Lobby

<u>Fire Alarm</u>						
738	<ul style="list-style-type: none"> As-Built Description: Fire alarm pull stations not 48" from floor to center. Note: Required only at new construction, or where mounting location was or is to be remodeled. As-Built: 61" and obstructed Proposed Solution: Remount fire alarm station to be 48" from floor to center. 	PCODE IC03 ADAAG 4.2.5 ADA 2010 308.2.1 CBC 2010 907.4.2 CBC 2013 907.4.2.2 Priority 3 Severity 2 FY 25-26 Maintenance Work	1	JOB	\$275	\$275

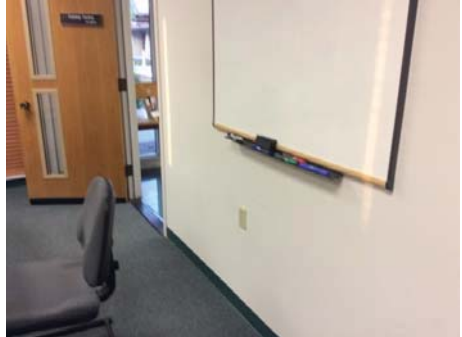
19 Training Testing Room

<u>Reach Range</u>							
744	<ul style="list-style-type: none"> As-Built Description: Reach height to control or access point, where only forward approach is available, exceeds 48" or is less than 15". As-Built: White board: 43" Proposed Solution: Modify equipment or mounting. 	PCODE IE01REF ADAAG 4.2.5 ADA 2010 308.2.1 CBC 2010 1118B.5 CBC 2013 11B-308.2.1 Priority 2 Severity 4 FY 25-26 Maintenance Work	REF

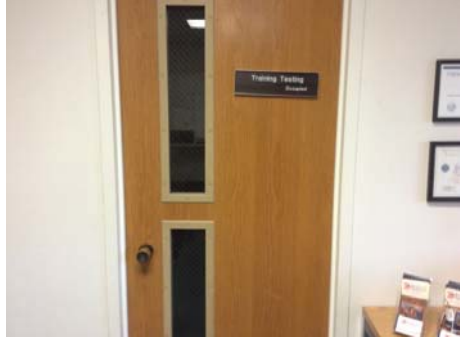
Item No. and Name	Existing Architectural Barrier and Proposed Solution	Codes / Mitigation Info	Qty	Unit	Cost	Total
Signage						
740	<ul style="list-style-type: none"> As-Built Description: Existing sign designating permanent room or space is noncompliant. Proposed Solution: Provide compliant signage. 	PCODE SA13 ADAAG 4.1.3(16)(a) ADA 2010 216.2 CBC 2010 1117B.5 CBC 2013 11B-216.2 Priority 2 Severity 4 FY 25-26 Maintenance Work	2	JOB	\$150	\$300

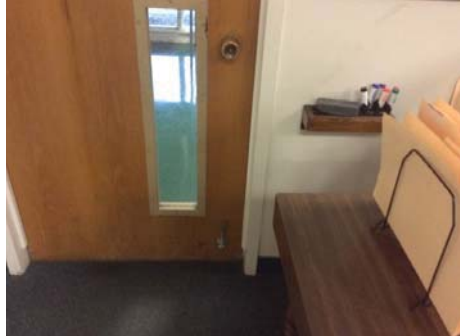
21 Staff Offices

755	<ul style="list-style-type: none"> As-Built Description: Front approach: At push side, door does not have clear and level maneuvering space measuring door width x 48" (door width plus 12" if door has both, latch and closer). As-Built: 17" to table Proposed Solution: Remove or relocate furniture or storage items. 	PCODE ID24A ADAAG Fig. 25(a) ADA 2010 404.2.4 CBC 2010 11B-26A(a) CBC 2013 11B-404.2.4 Priority 2 Severity 4 FY 25-26 Maintenance Work	1	JOB	\$50	\$50

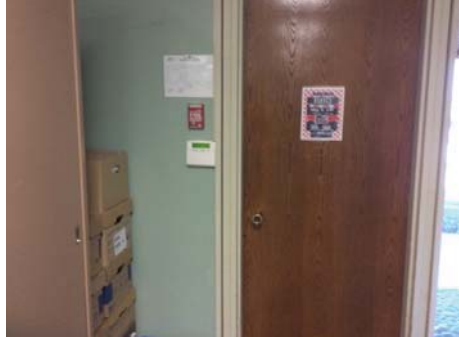
4 Staff Office West

Item No. and Name	Existing Architectural Barrier and Proposed Solution	Codes / Mitigation Info	Qty	Unit	Cost	Total
<u>Fire Alarm</u>						
1484	<ul style="list-style-type: none"> As-Built Description: Fire alarm pull stations not 48" from floor to center. Note: Required only at new construction, or where mounting location was or is to be remodeled. As-Built: 60" Proposed Solution: Remount fire alarm station to be 48" from floor to center. 	PCODE IC03 ADAAG 4.2.5 ADA 2010 308.2.1 CBC 2010 907.4.2 CBC 2013 907.4.2.2 Priority 3 Severity 2 FY 25-26 Maintenance Work	1	JOB	\$275	\$275

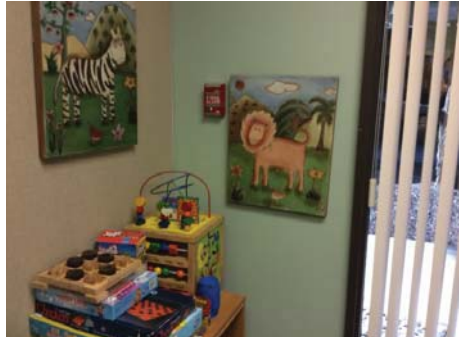
6 Sexual Assault Lobby

<u>Fire Alarm</u>						
1501	<ul style="list-style-type: none"> As-Built Description: Fire alarm pull stations not 48" from floor to center. Note: Required only at new construction, or where mounting location was or is to be remodeled. As-Built: 60" Proposed Solution: Remount fire alarm station to be 48" from floor to center. 	PCODE IC03 ADAAG 4.2.5 ADA 2010 308.2.1 CBC 2010 907.4.2 CBC 2013 907.4.2.2 Priority 3 Severity 2 FY 25-26 Maintenance Work	1	JOB	\$275	\$275

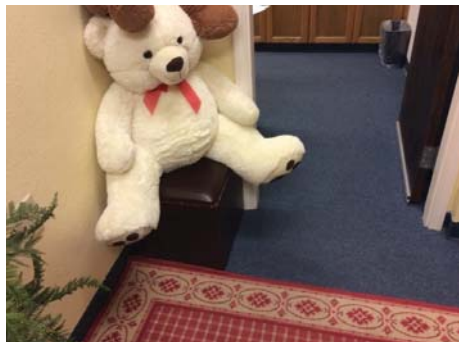
7 Sexual Assault Interview Room

<u>Door Swing</u>						
1506	<ul style="list-style-type: none"> As-Built Description: Front approach: At push side, door does not have clear and level maneuvering space measuring door width x 48" (door width plus 12" if door has both, latch and closer). Proposed Solution: Remove or relocate furniture or storage items. 	PCODE ID24A ADAAG Fig. 25(a) ADA 2010 404.2.4 CBC 2010 11B-26A(a) CBC 2013 11B-404.2.4 Priority 2 Severity 4 FY 25-26 Maintenance Work	1	JOB	\$50	\$50

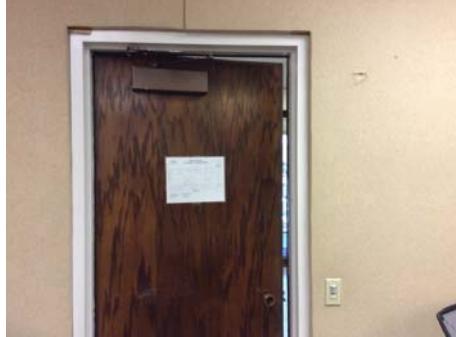
8 DA Staff Conference Room

Item No. and Name	Existing Architectural Barrier and Proposed Solution	Codes / Mitigation Info	Qty	Unit	Cost	Total
<u>Door Closer</u>						
1511	<ul style="list-style-type: none"> As-Built Description: Excessive force required to open door. As-Built: 8 lbs Proposed Solution: Adjust regular door closer to accessible standards (5 lbs max). 	PCODE ID03 ADAAG 4.13.11 ADA 2010 404.2.9 CBC 2010 1133B.2.5 CBC 2013 11B-404.2.9 Priority 2 Severity 4 FY 25-26 Maintenance Work	1	JOB	\$25	\$25

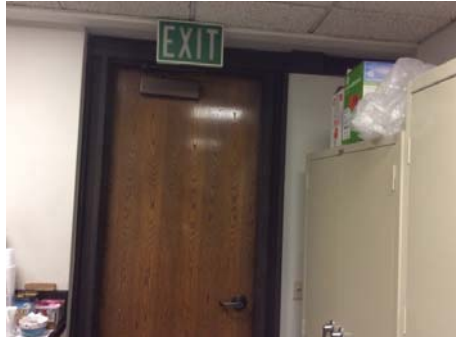
10 DA Restroom Corridor - Kitchenette

<u>Door Closer</u>						
1530	<ul style="list-style-type: none"> As-Built Description: Excessive force required to open door. As-Built: 9 lbs Proposed Solution: Adjust regular door closer to accessible standards (5 lbs max). 	PCODE ID03 ADAAG 4.13.11 ADA 2010 404.2.9 CBC 2010 1133B.2.5 CBC 2013 11B-404.2.9 Priority 2 Severity 4 FY 25-26 Maintenance Work	1	JOB	\$25	\$25

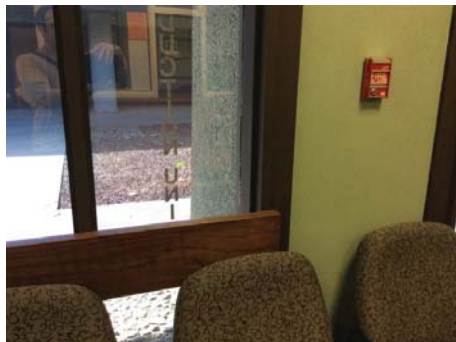
13 DA Lobby

<u>Fire Alarm</u>						
1566	<ul style="list-style-type: none"> As-Built Description: Fire alarm pull stations not 48" from floor to center. Note: Required only at new construction, or where mounting location was or is to be remodeled. As-Built: 60" Proposed Solution: Remount fire alarm station to be 48" from floor to center. 	PCODE IC03 ADAAG 4.2.5 ADA 2010 308.2.1 CBC 2010 907.4.2 CBC 2013 907.4.2.2 Priority 3 Severity 2 FY 25-26 Maintenance Work	1	JOB	\$275	\$275

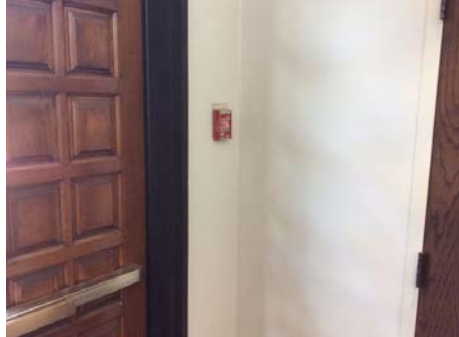
14 Law Library

Item No. and Name	Existing Architectural Barrier and Proposed Solution	Codes / Mitigation Info	Qty	Unit	Cost	Total
<u>Fire Alarm</u>						
1582	<ul style="list-style-type: none"> As-Built Description: Fire alarm pull stations not 48" from floor to center. Note: Required only at new construction, or where mounting location was or is to be remodeled. As-Built: 61" Proposed Solution: Remount fire alarm station to be 48" from floor to center. 	PCODE IC03 ADAAG 4.2.5 ADA 2010 308.2.1 CBC 2010 907.4.2 CBC 2013 907.4.2.2 Priority 3 Severity 2 FY 25-26 Maintenance Work	1	JOB	\$275	\$275

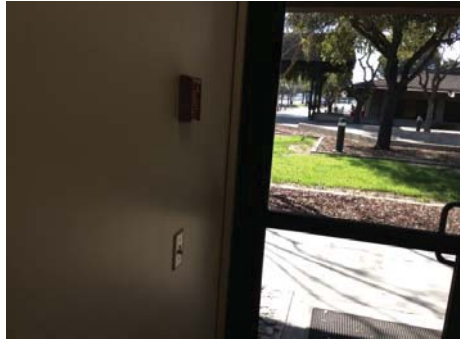
17 County Council

<u>Fire Alarm</u>						
1599	<ul style="list-style-type: none"> As-Built Description: Fire alarm pull stations not 48" from floor to center. Note: Required only at new construction, or where mounting location was or is to be remodeled. As-Built: 61" Proposed Solution: Remount fire alarm station to be 48" from floor to center. 	PCODE IC03 ADAAG 4.2.5 ADA 2010 308.2.1 CBC 2010 907.4.2 CBC 2013 907.4.2.2 Priority 3 Severity 2 FY 25-26 Maintenance Work	1	JOB	\$275	\$275

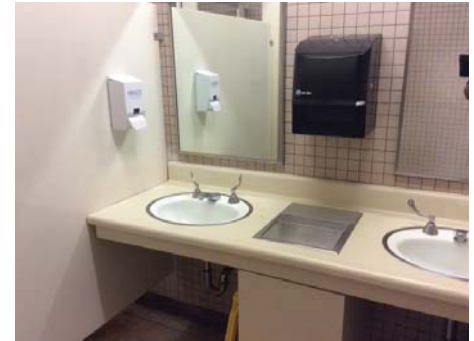
1824	<ul style="list-style-type: none"> • <i>As-Built Description:</i> Dispensers in sanitary facilities, such as for towels, soap, sanitary napkins, seat covers, etc., and waste receptacles more than 48" (CA only: 40") from floor to highest operating slot or control. • <i>As-Built:</i> PTD: 53" SD: 48" • <i>Proposed Solution:</i> Relocate existing restroom accessories. 	<p>PCODE WG01A ADAAG 4.23.7 ADA 2010 308.2.1 CBC 2010 1115B.8.3 CBC 2013 11B-603.5 Priority 3 Severity 2 FY 25-26 Maintenance Work</p>	2	JOB	\$100	\$200
------	--	---	---	-----	-------	-------

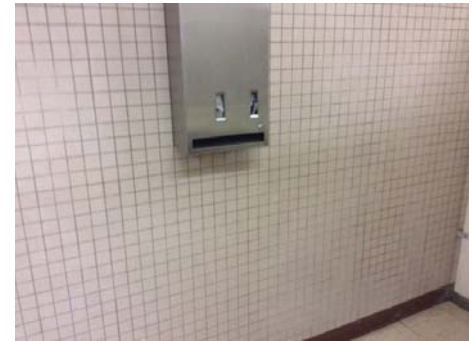
1825	<ul style="list-style-type: none"> • <i>As-Built Description:</i> Dispensers in sanitary facilities, such as for towels, soap, sanitary napkins, seat covers, etc., and waste receptacles more than 48" from floor to highest operating slot or control. • <i>As-Built:</i> FND: 53" • <i>Proposed Solution:</i> Relocate existing restroom accessories. 	<p>PCODE WG01AREF ADAAG 4.23.7 ADA 2010 308.2.1 CBC 2010 1115B.8.3 CBC 2013 11B-603.5 Priority 3 Severity 2 FY 25-26 Maintenance Work</p>	REF			
------	---	--	-----	--	--	--

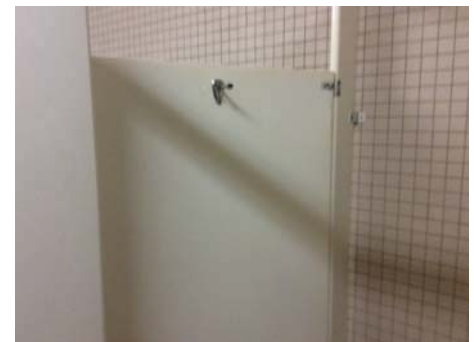
1830	<ul style="list-style-type: none"> • <i>As-Built Description:</i> Accessible coat hook not within reach range. • <i>As-Built:</i> 67" • <i>Proposed Solution:</i> Adjust existing or provide new coat hook at maximum 48" height. 	<p>PCODE WG03A ADAAG 4.2.5 ADA 2010 603.4 CBC 2010 1118B.5 CBC 2013 11B-603.4 Priority 3 Severity 1 FY 25-26 Maintenance Work</p>	1	JOB	\$50	\$50
------	--	--	---	-----	------	------

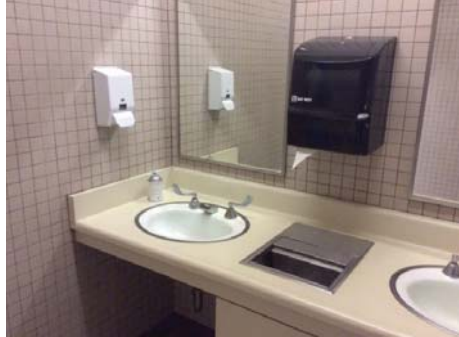
4 Men's Restroom

Item No. and Name	Existing Architectural Barrier and Proposed Solution	Codes / Mitigation Info	Qty	Unit	Cost	Total
Accessories						
1846	<ul style="list-style-type: none"> <i>As-Built Description:</i> Dispensers in sanitary facilities, such as for towels, soap, sanitary napkins, seat covers, etc., and waste receptacles more than 48" (CA only: 40") from floor to highest operating slot or control. <i>As-Built:</i> SD: 48" PTD: 53" <i>Proposed Solution:</i> Relocate existing restroom accessories. 	PCODE WG01A ADAAG 4.23.7 ADA 2010 308.2.1 CBC 2010 1115B.8.3 CBC 2013 11B-603.5 Priority 3 Severity 2 FY 25-26 Maintenance Work	1	JOB	\$100	\$100

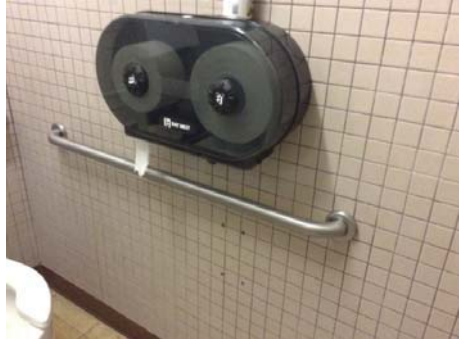
Grab Bars						
1853	<ul style="list-style-type: none"> <i>As-Built Description:</i> Accessories/dispensers in accessible stall located closer than 1-1/2" below or 12" above grab bar impedes its use. <i>As-Built:</i> TPD: 5" <i>Proposed Solution:</i> Relocate accessories/dispensers to be no closer than 1-1/2" below and 12" above grab bars (except if accessories are recessed, flush with wall, and have no sharp edges). 	PCODE WB07I ADAAG 4.26.2 ADA 2010 609.3 CBC 2010 1133B.4.2.5 CBC 2013 11B-609.3 Priority 3 Severity 2 FY 25-26 Maintenance Work	1	JOB	\$75	\$75

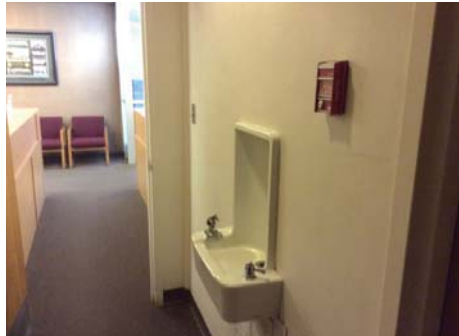
9 Restroom Corridor

Fire Alarm						
1886	<ul style="list-style-type: none"> <i>As-Built Description:</i> Fire alarm pull stations not 48" from floor to center. Note: Required only at new construction, or where mounting location was or is to be remodeled. <i>As-Built:</i> 61" <i>Proposed Solution:</i> Remount fire alarm station to be 48" from floor to center. 	PCODE IC03 ADAAG 4.2.5 ADA 2010 308.2.1 CBC 2010 907.4.2 CBC 2013 907.4.2.2 Priority 3 Severity 2 FY 25-26 Maintenance Work	1	JOB	\$275	\$275

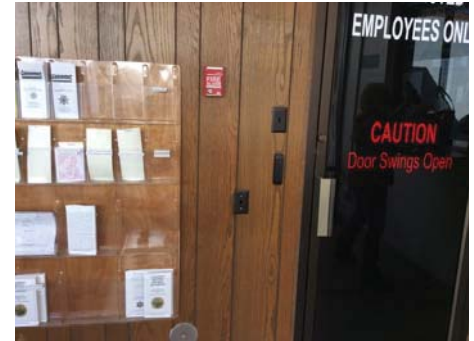
1744	<ul style="list-style-type: none"> <i>As-Built Description:</i> Fire alarm pull stations not 48" from floor to center. Note: Required only at new construction, or where mounting location was or is to be remodeled. <i>As-Built:</i> 62" <i>Proposed Solution:</i> Remount fire alarm station to be 48" from floor to center. 	<p>PCODE IC03 ADAAG 4.2.5 ADA 2010 308.2.1 CBC 2010 907.4.2 CBC 2013 907.4.2.2 Priority 3 Severity 2 FY 25-26 Maintenance Work</p>	1	JOB	\$275	\$275
------	--	---	---	-----	-------	-------

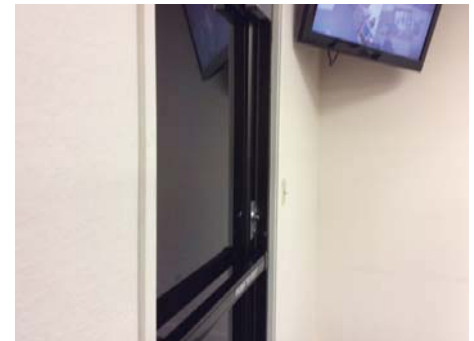
1747	<ul style="list-style-type: none"> <i>As-Built Description:</i> Excessive force required to open door. <i>As-Built:</i> 10 lbs <i>Proposed Solution:</i> Adjust regular door closer to accessible standards (5 lbs max). 	<p>PCODE ID03 ADAAG 4.13.11 ADA 2010 404.2.9 CBC 2010 1133B.2.5 CBC 2013 11B-404.2.9 Priority 2 Severity 4 FY 25-26 Maintenance Work</p>	1	JOB	\$25	\$25
------	---	---	---	-----	------	------

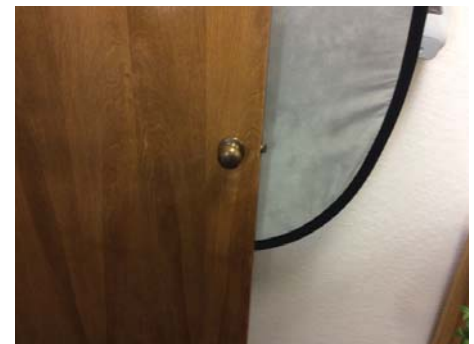
1748	<ul style="list-style-type: none"> <i>As-Built Description:</i> Door does not have accessible operating hardware. <i>As-Built:</i> 5" <i>Proposed Solution:</i> Provide lever handle or other accessible hardware. 	<p>PCODE ID07 ADAAG 4.13.9 ADA 2010 404.2.7 CBC 2010 1133B.2.5.2 CBC 2013 11B-404.2.7 Priority 2 Severity 3 FY 25-26 Maintenance Work</p>	1	JOB	\$250	\$250
------	---	--	---	-----	-------	-------

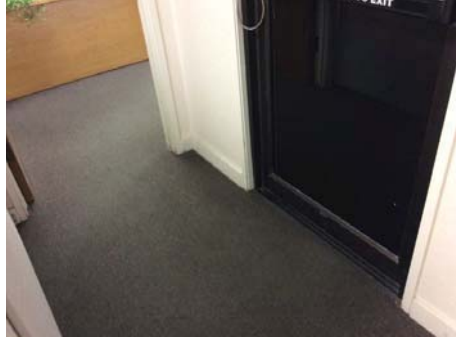
2 Records & Background

Item No. and Name	Existing Architectural Barrier and Proposed Solution	Codes / Mitigation Info	Qty	Unit	Cost	Total
Door Swing						
1746	<ul style="list-style-type: none"> <i>As-Built Description:</i> Latch approach: At push side, door does not have clear and level maneuvering space measuring door width plus 24" (starting at hinge) x 42", or 48" if door has closer. <i>As-Built:</i> 45" <i>Proposed Solution:</i> Change door swing. 	PCODE ID28 ADAAG Fig. 25(c) ADA 2010 404.2.4 CBC 2010 11B-26A(c) CBC 2013 11B-404.2.4 Priority 2 Severity 4 FY 25-26 Maintenance Work	1	JOB	\$500	\$500

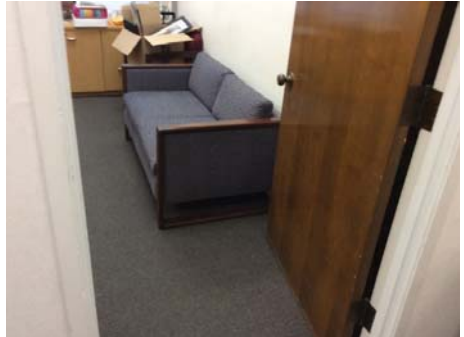
3 General Staff Office Area

Door Swing						
1752	<ul style="list-style-type: none"> <i>As-Built Description:</i> Front approach: At pull side, door does not have clear and level maneuvering space measuring door width plus 18" x 60". <i>As-Built:</i> Provide one meeting room with Acc clearances for wheelchair users. <i>Proposed Solution:</i> Remove or relocate furniture or storage items. 	PCODE ID23A ADAAG Fig. 25(a) ADA 2010 404.2.4 CBC 2010 11B-26A(a) CBC 2013 11B-404.2.4 Priority 2 Severity 4 FY 25-26 Maintenance Work	1	JOB	\$50	\$50

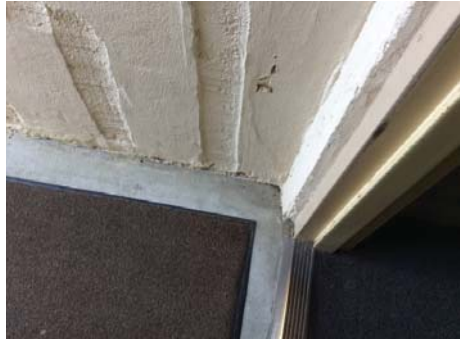
1758	<ul style="list-style-type: none"> <i>As-Built Description:</i> Front approach: At pull side, door does not have clear and level maneuvering space measuring door width plus 18" x 60". <i>As-Built:</i> 6.5" <i>Proposed Solution:</i> Provide power door operator. 	PCODE ID23CREF ADAAG Fig. 25(a) ADA 2010 404.2.4 CBC 2010 11B-26A(a) CBC 2013 11B-404.2.4 Priority 2 Severity 3 FY 25-26 Maintenance Work	REF

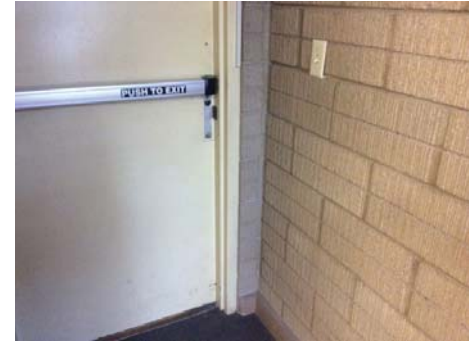
Item No. and Name	Existing Architectural Barrier and Proposed Solution	Codes / Mitigation Info	Qty	Unit	Cost	Total
1757	<ul style="list-style-type: none"> <i>As-Built Description:</i> Front approach: At push side, door does not have clear and level maneuvering space measuring door width x 48" (door width plus 12" if door has both, latch and closer). <i>As-Built:</i> 6.5" <i>Proposed Solution:</i> Provide door operator. 	<p>PCODE ID24C</p> <p>ADAAG Fig. 25(a)</p> <p>ADA 2010 404.2.4</p> <p>CBC 2010 11B-26A(a)</p> <p>CBC 2013 11B-404.2.4</p> <p>Priority 2</p> <p>Severity 3</p> <p>FY 25-26 Maintenance Work</p>	1	JOB	\$5,000	\$5,000

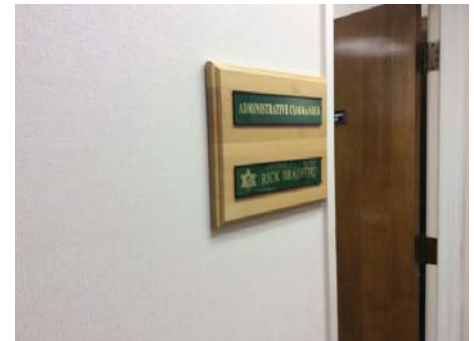
1753	<ul style="list-style-type: none"> <i>As-Built Description:</i> Sign not located on latch side of door and/or not located at 48" min. above to baseline of the lowest Braille cells and 60" max. to baseline of the highest line of raised characters. <i>Proposed Solution:</i> Provide compliant signage including tactile characters and Grade II Braille on latch side of door located 60" on center from floor. 	<p>PCODE SA07</p> <p>ADAAG 4.30.6</p> <p>ADA 2010 703.4.1</p> <p>CBC 2010 1117B.5.7</p> <p>CBC 2013 11B-703.4.1</p> <p>Priority 2</p> <p>Severity 3</p> <p>FY 25-26 Maintenance Work</p>	5	JOB	\$50	\$250
------	--	--	---	-----	------	-------

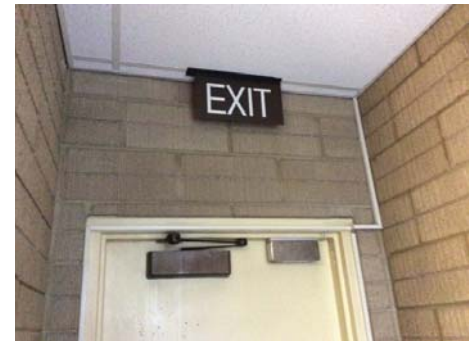
1756	<ul style="list-style-type: none"> <i>As-Built Description:</i> At final exit door to exterior: Where required exit signs are installed, signs to provide exiting information for people with vision impairment are not provided. <i>Proposed Solution:</i> Provide raised letter/Braille "EXIT" sign at door. 	<p>PCODE SA10A</p> <p>ADAAG 4.1.3(16)</p> <p>ADA 2010 216.4.1</p> <p>CBC 2010 1011.3</p> <p>CBC 2013 11B-216.4.1</p> <p>Priority 2</p> <p>Severity 3</p> <p>FY 25-26 Maintenance Work</p>	1	JOB	\$90	\$90
------	--	---	---	-----	------	------

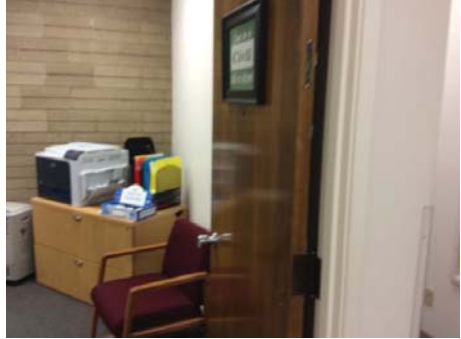
Item No. and Name	Existing Architectural Barrier and Proposed Solution	Codes / Mitigation Info	Qty	Unit	Cost	Total
<u>Door Hardware</u>						
1764	<ul style="list-style-type: none"> <i>As-Built Description:</i> Door does not have accessible operating hardware. <i>Proposed Solution:</i> Provide lever handle or other accessible hardware. <i>Notes:</i> And signage 	<p>PCODE ID07REF ADAAG 4.13.9 ADA 2010 404.2.7 CBC 2010 1133B.2.5.2 CBC 2013 11B-404.2.7 Priority 2 Severity 3 FY 25-26 Maintenance Work</p>				
						REF

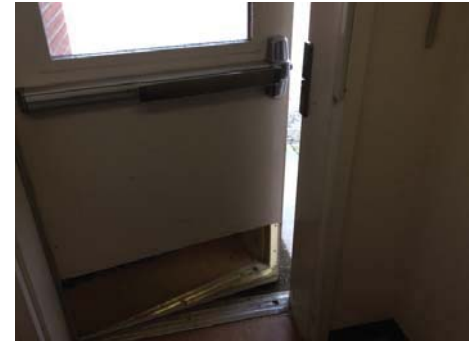
2531	<ul style="list-style-type: none"> <i>As-Built Description:</i> Excessive force required to open door. <i>As-Built:</i> 8 lbs <i>Proposed Solution:</i> Adjust regular door closer to accessible standards (5 lbs max). 	<p>PCODE ID03 ADAAG 4.13.11 ADA 2010 404.2.9 CBC 2010 1133B.2.5 CBC 2013 11B-404.2.9 Priority 2 Severity 4 FY 25-26 Maintenance Work</p>	1	JOB	\$25	\$25
------	--	---	---	-----	------	------

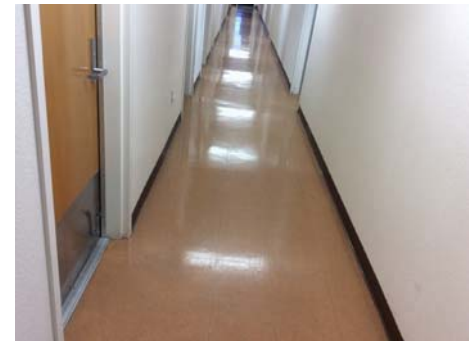
2527	<ul style="list-style-type: none"> <i>As-Built Description:</i> At push side of door on accessible route, bottom 10" does not have a smooth, uninterrupted surface. <i>Proposed Solution:</i> Remove door stopper when altering area. Provide rubber wedge. 	<p>PCODE ID06A ADA 2010 404.2.10 CBC 2010 1133B.2.6 CBC 2013 11B-404.2.10 Priority 2 Severity 3 FY 25-26 Maintenance Work</p>	8	JOB	\$25	\$200
------	---	---	---	-----	------	-------

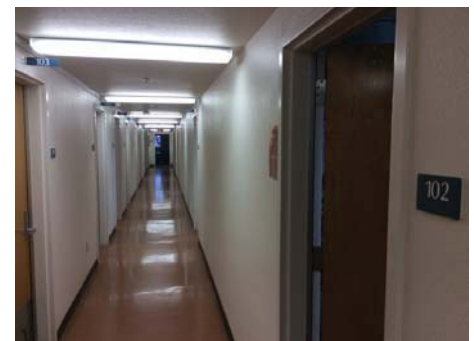
2528	<ul style="list-style-type: none"> <i>As-Built Description:</i> Braille symbols: dots are not 1/10" on centers in each cell with 2/10" space between cells. <i>Proposed Solution:</i> CA only - Provide new compliant signage including Contracted Grade 2 Braille with Title 24 spacing requirements - 1/10" on center dots with 2/10" space between cells. 	<p>PCODE SA07C ADA 2010 703.3 CBC 2010 1117B.5.6 CBC 2013 11B-703.3 Priority 2 Severity 3 FY 25-26 Maintenance Work</p>	10	JOB	\$150	\$1,500
------	--	---	----	-----	-------	---------

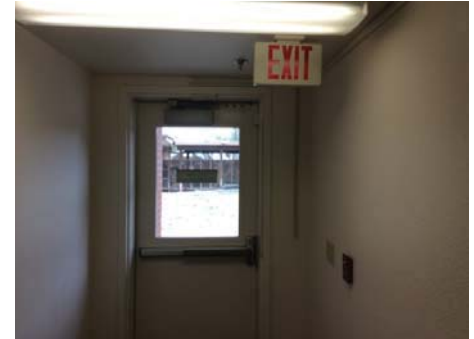
Item No. and Name	Existing Architectural Barrier and Proposed Solution	Codes / Mitigation Info	Qty	Unit	Cost	Total
2530	<ul style="list-style-type: none"> <i>As-Built Description:</i> At final exit door to exterior: Where required exit signs are installed, signs to provide exiting information for people with vision impairment are not provided. <i>Proposed Solution:</i> Provide raised letter/Braille "EXIT" sign at door. 	PCODE SA10A ADAAG 4.13(16) ADA 2010 216.4.1 CBC 2010 10113 CBC 2013 11B-216.4.1 Priority 2 Severity 3 FY 25-26 Maintenance Work	1	JOB	\$90	\$90

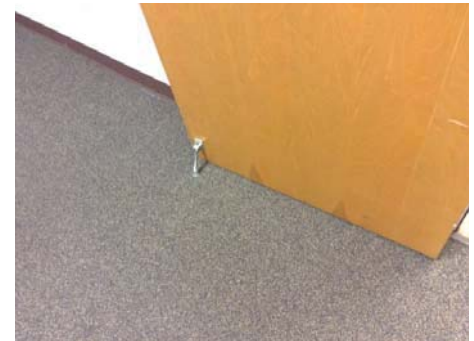
2533	<ul style="list-style-type: none"> <i>As-Built Description:</i> At push side of door on accessible route, bottom 10" does not have a smooth, uninterrupted surface. <i>Proposed Solution:</i> Remove door stopper when altering area. Provide rubber wedge. 	PCODE ID06A ADA 2010 404.2.10 CBC 2010 1133B.2.6 CBC 2013 11B-404.2.10 Priority 2 Severity 3 FY 25-26 Maintenance Work	1	JOB	\$25	\$25
------	---	--	---	-----	------	------

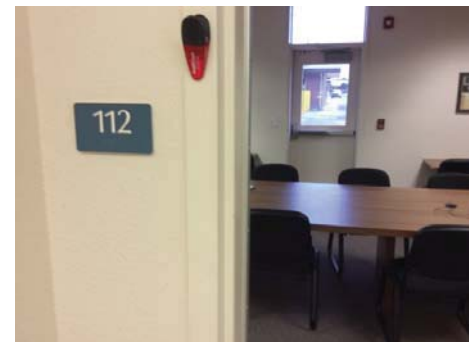
2532	<ul style="list-style-type: none"> <i>As-Built Description:</i> Braille symbols: dots are not 1/10" on centers in each cell with 2/10" space between cells. <i>Proposed Solution:</i> CA only - Provide new compliant signage including Contracted Grade 2 Braille with Title 24 spacing requirements - 1/10" on center dots with 2/10" space between cells. 	PCODE SA07C ADA 2010 703.3 CBC 2010 1117B.5.6 CBC 2013 11B-703.3 Priority 2 Severity 3 FY 25-26 Maintenance Work	1	JOB	\$150	\$150
------	--	--	---	-----	-------	-------

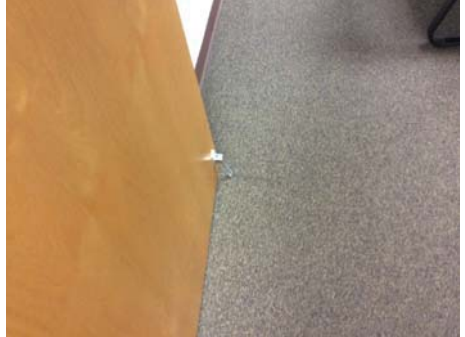
Item No. and Name	Existing Architectural Barrier and Proposed Solution	Codes / Mitigation Info	Qty	Unit	Cost	Total
<u>Door Stopper</u>						
2539	<ul style="list-style-type: none"> <i>As-Built Description:</i> At push side of door on accessible route, bottom 10" does not have a smooth, uninterrupted surface. <i>Proposed Solution:</i> Remove door stopper when altering area. Provide rubber wedge. 	PCODE ID06A ADA 2010 404.2.10 CBC 2010 1133B.2.6 CBC 2013 11B-404.2.10 Priority 2 Severity 3 FY 25-26 Maintenance Work	1	JOB	\$25	\$25

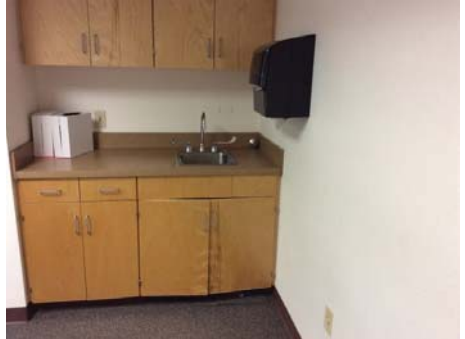
<u>Protrusion Limits</u>						
2545	<ul style="list-style-type: none"> <i>As-Built Description:</i> Protruding objects more than 4" from wall, when bottom of object more than 27" or less than 80" above finished floor. <i>As-Built:</i> PTD: 8.5" protrusion at 50" <i>Proposed Solution:</i> Remove/relocate protruding object. Patch existing surface. 	PCODE EG04REF ADAAG 4.4.1 ADA 2010 307.2 CBC 2010 1133B.8.6.1 CBC 2013 11B-307.2 Priority 2 Severity 3 FY 25-26 Maintenance Work	REF

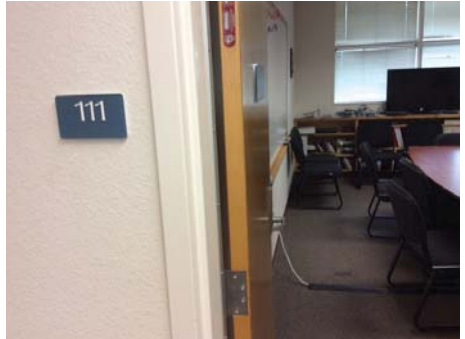
<u>Signage</u>						
2538	<ul style="list-style-type: none"> <i>As-Built Description:</i> Sign not located on latch side of door and/or not located at 48" min. above to baseline of the lowest Braille cells and 60" max. to baseline of the highest line of raised characters. <i>As-Built:</i> Latch side <i>Proposed Solution:</i> Provide compliant signage including tactile characters and Grade II Braille on latch side of door located 60" on center from floor. 	PCODE SA07 ADAAG 4.30.6 ADA 2010 703.4.1 CBC 2010 1117B.5.7 CBC 2013 11B-703.4.1 Priority 2 Severity 3 FY 25-26 Maintenance Work	1	JOB	\$50	\$50

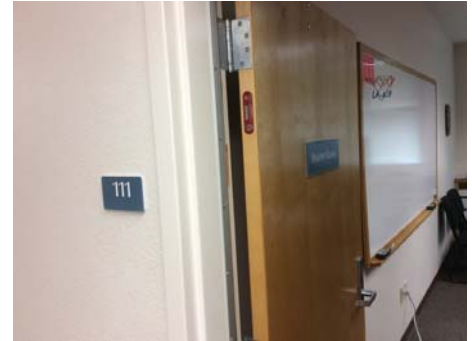
Item No. and Name	Existing Architectural Barrier and Proposed Solution	Codes / Mitigation Info	Qty	Unit	Cost	Total
2537	<ul style="list-style-type: none"> <i>As-Built Description:</i> Braille symbols: dots are not 1/10" on centers in each cell with 2/10" space between cells. <i>Proposed Solution:</i> CA only - Provide new compliant signage including Contracted Grade 2 Braille with Title 24 spacing requirements - 1/10" on center dots with 2/10" space between cells. 	PCODE SA07C ADA 2010 703.3 CBC 2010 1117B.5.6 CBC 2013 11B-703.3 Priority 2 Severity 3 FY 25-26 Maintenance Work	1	JOB	\$150	\$150

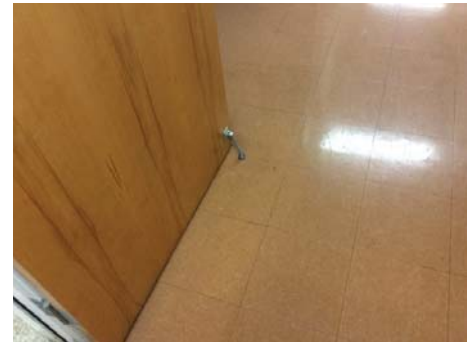
2548	<ul style="list-style-type: none"> <i>As-Built Description:</i> At push side of door on accessible route, bottom 10" does not have a smooth, uninterrupted surface. <i>Proposed Solution:</i> Remove door stopper when altering area. Provide rubber wedge. 	PCODE ID06A ADA 2010 404.2.10 CBC 2010 1133B.2.6 CBC 2013 11B-404.2.10 Priority 2 Severity 3 FY 25-26 Maintenance Work	1	JOB	\$25	\$25
------	---	--	---	-----	------	------

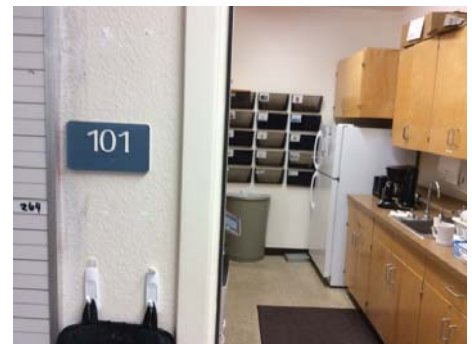
2546	<ul style="list-style-type: none"> <i>As-Built Description:</i> Braille symbols: dots are not 1/10" on centers in each cell with 2/10" space between cells. <i>Proposed Solution:</i> CA only - Provide new compliant signage including Contracted Grade 2 Braille with Title 24 spacing requirements - 1/10" on center dots with 2/10" space between cells. 	PCODE SA07C ADA 2010 703.3 CBC 2010 1117B.5.6 CBC 2013 11B-703.3 Priority 2 Severity 3 FY 25-26 Maintenance Work	1	JOB	\$150	\$150
------	--	--	---	-----	-------	-------

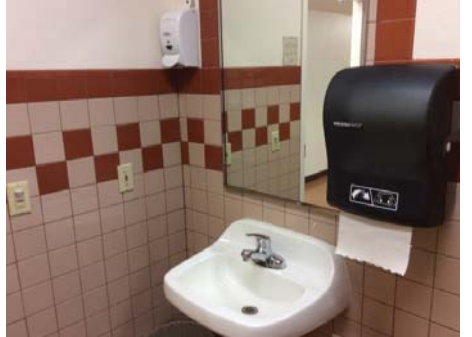
Item No. and Name	Existing Architectural Barrier and Proposed Solution	Codes / Mitigation Info	Qty	Unit	Cost	Total
Accessories						
2562	<ul style="list-style-type: none"> <i>As-Built Description:</i> Dispensers in sanitary facilities, such as for towels, soap, sanitary napkins, seat covers, etc., and waste receptacles more than 48" (CA only: 40") from floor to highest operating slot or control. <i>As-Built:</i> PTD: 44" SD: 62" <i>Proposed Solution:</i> Relocate existing restroom accessories. 	PCODE WG01A ADAAG 4.23.7 ADA 2010 308.2.1 CBC 2010 1115B.8.3 CBC 2013 11B-603.5 Priority 3 Severity 1 FY 25-26 Maintenance Work	1	JOB	\$100	\$100

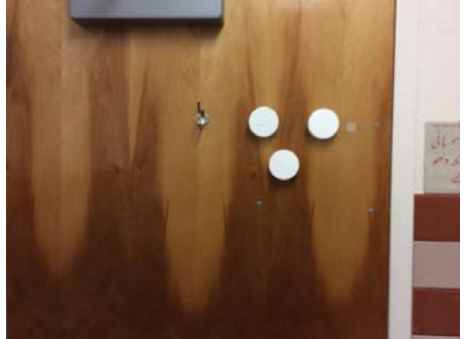
Coat Hook						
2560	<ul style="list-style-type: none"> <i>As-Built Description:</i> Accessible coat hook not within reach range. <i>As-Built:</i> 68" <i>Proposed Solution:</i> Adjust existing or provide new coat hook at maximum 48" height. 	PCODE WG03A ADAAG 4.2.5 ADA 2010 603.4 CBC 2010 1118B.5 CBC 2013 11B-603.4 Priority 3 Severity 1 FY 25-26 Maintenance Work	1	JOB	\$50	\$50

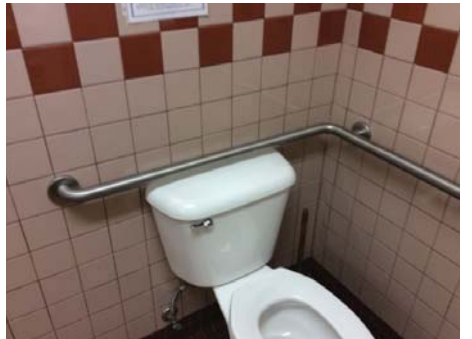
Grab Bars						
2564	<ul style="list-style-type: none"> <i>As-Built Description:</i> The rear wall grab is less than 36" min. or does not extend from the centerline of the water closet 12" min. on one side and 24" min. on the other side. <i>As-Built:</i> 18" & 18" <i>Proposed Solution:</i> Provide or relocate accessible rear grab bar. 	PCODE WB07B ADAAG 4.17.6 ADA 2010 604.5.2 CBC 2010 1115B.4.1.3.2 CBC 2013 11B-604.5.2 Priority 3 Severity 2 FY 25-26 Maintenance Work	1	JOB	\$340	\$340

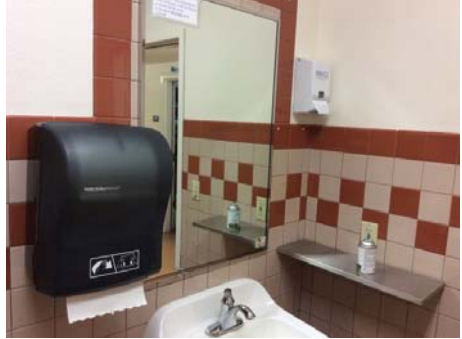
Item No. and Name	Existing Architectural Barrier and Proposed Solution	Codes / Mitigation Info	Qty	Unit	Cost	Total
<u>Accessories</u>						
2572	<ul style="list-style-type: none"> <i>As-Built Description:</i> Dispensers in sanitary facilities, such as for towels, soap, sanitary napkins, seat covers, etc., and waste receptacles more than 48" (CA only: 40") from floor to highest operating slot or control. <i>As-Built:</i> PTD: 64" SD: 45" <i>Proposed Solution:</i> Relocate existing restroom accessories. 	PCODE WG01A ADAAG 4.23.7 ADA 2010 308.2.1 CBC 2010 1115B.8.3 CBC 2013 11B-603.5 Priority 3 Severity 1 FY 25-26 Maintenance Work	1	JOB	\$100	\$100

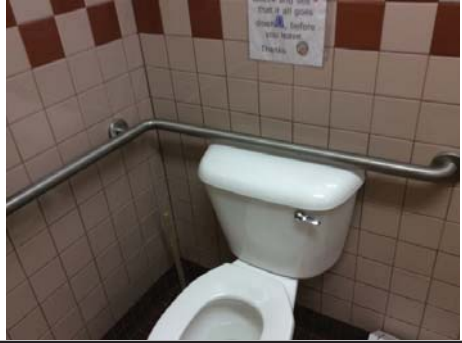
<u>Grab Bars</u>						
2575	<ul style="list-style-type: none"> <i>As-Built Description:</i> The rear wall grab is less than 36" min. or does not extend from the centerline of the water closet 12" min. on one side and 24" min. on the other side. <i>As-Built:</i> 19" & 17" <i>Proposed Solution:</i> Provide or relocate accessible rear grab bar. 	PCODE WB07B ADAAG 4.17.6 ADA 2010 604.5.2 CBC 2010 1115B.4.1.3.2 CBC 2013 11B-604.5.2 Priority 3 Severity 2 FY 25-26 Maintenance Work	1	JOB	\$340	\$340

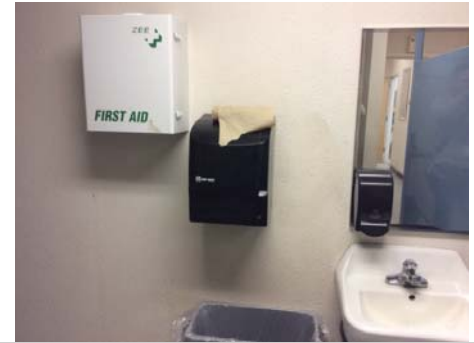
3511	<ul style="list-style-type: none"> <i>As-Built Description:</i> Dispensers in sanitary facilities, such as for towels, soap, sanitary napkins, seat covers, etc., and waste receptacles more than 48" (CA only: 40") from floor to highest operating slot or control. <i>As-Built:</i> PTD: 47" First Aid Kit: 68" <i>Proposed Solution:</i> Relocate existing restroom accessories. 	<p>PCODE WG01A ADAAG 4.23.7 ADA 2010 308.2.1 CBC 2010 1115B.8.3 CBC 2013 11B-603.5 Priority 3 Severity 1 FY 25-26 Maintenance Work</p>	1	JOB	\$100	\$100
------	---	---	---	-----	-------	-------

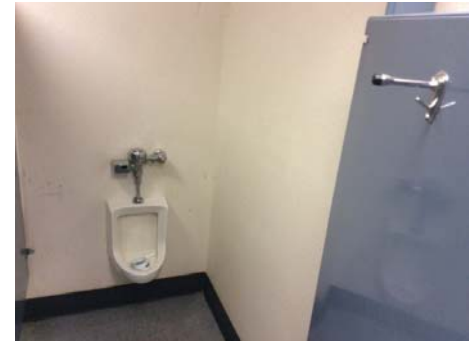
3507	<ul style="list-style-type: none"> <i>As-Built Description:</i> Accessible coat hook not within reach range. <i>As-Built:</i> 66" <i>Proposed Solution:</i> Adjust existing or provide new coat hook at maximum 48" height. 	<p>PCODE WG03A ADAAG 4.2.5 ADA 2010 603.4 CBC 2010 1118B.5 CBC 2013 11B-603.4 Priority 3 Severity 1 FY 25-26 Maintenance Work</p>	1	JOB	\$50	\$50
------	--	--	---	-----	------	------

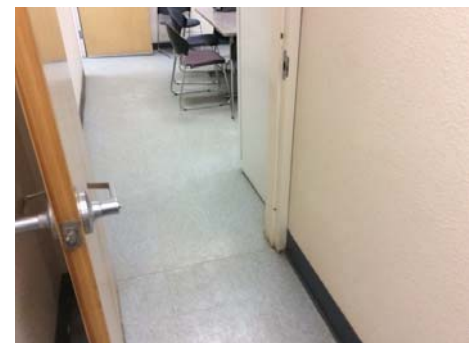
3504	<ul style="list-style-type: none"> <i>As-Built Description:</i> Front approach: At pull side, door does not have clear and level maneuvering space measuring door width plus 18" x 60". <i>As-Built:</i> 2" <i>Proposed Solution:</i> Provide power door operator or relocate fridge and swing door out. 	<p>PCODE ID23C ADAAG Fig. 25(a) ADA 2010 404.2.4 CBC 2010 11B-26A(a) CBC 2013 11B-404.2.4 Priority 3 Severity 2 FY 25-26 Maintenance Work</p>	1	JOB	\$5,000	\$5,000
------	---	--	---	-----	---------	---------

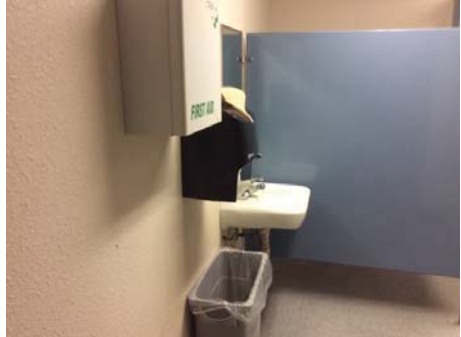
Item No. and Name	Existing Architectural Barrier and Proposed Solution	Codes / Mitigation Info	Qty	Unit	Cost	Total
<u>Protrusion Limits</u>						
3512	<ul style="list-style-type: none"> <i>As-Built Description:</i> Protruding objects more than 4" from wall, when bottom of object more than 27" or less than 80" above finished floor. <i>As-Built:</i> First Aid: 7.5" protrusion at 55" PTD: 9" protrusion at 42" <i>Proposed Solution:</i> Remove/relocate protruding object. Patch existing surface. 	PCODE EG04REF ADAAG 4.4.1 ADA 2010 307.2 CBC 2010 1133B.8.6.1 CBC 2013 11B-307.2 Priority 3 Severity 2 FY 25-26 Maintenance Work	1	REF

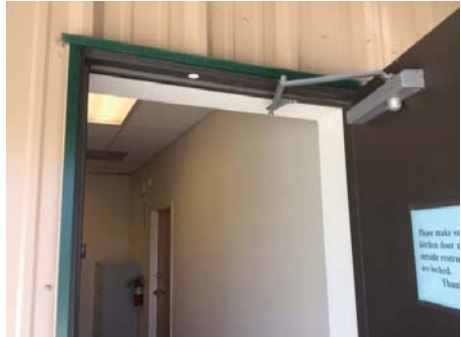
<u>Door Closer</u>						
3527	<ul style="list-style-type: none"> <i>As-Built Description:</i> Excessive force required to open door. <i>As-Built:</i> 15 lbs <i>Proposed Solution:</i> Adjust regular door closer to accessible standards (5 lbs max). 	PCODE ID03 ADAAG 4.13.11 ADA 2010 404.2.9 CBC 2010 1133B.2.5 CBC 2013 11B-404.2.9 Priority 2 Severity 3 FY 25-26 Maintenance Work	1	JOB	\$25	\$25

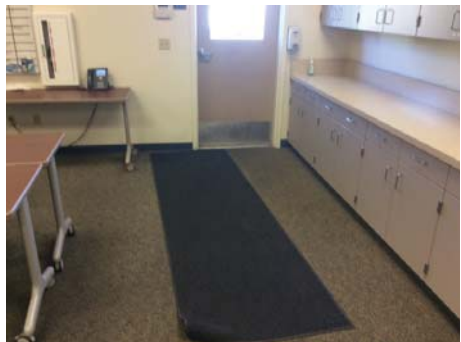
<u>Carpet/Doormat</u>						
3541	<ul style="list-style-type: none"> <i>As-Built Description:</i> Doormat not securely attached to ground or floor structure. <i>Proposed Solution:</i> Attach doormat to floor surface or remove doormat. 	PCODE ID05A ADAAG 4.5.3 ADA 2010 302.2 CBC 2010 1124B.3 CBC 2013 11B-302.2 Priority 2 Severity 3 FY 25-26 Maintenance Work	2	JOB	\$75	\$150

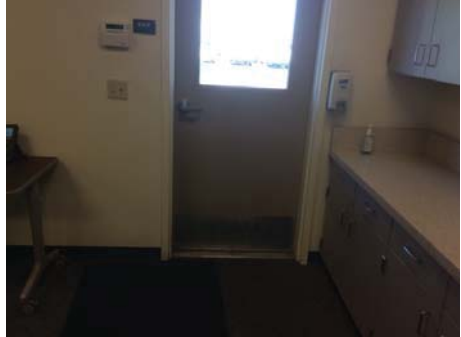
Item No. and Name	Existing Architectural Barrier and Proposed Solution	Codes / Mitigation Info	Qty	Unit	Cost	Total
<u>Door</u>						
3543	<ul style="list-style-type: none"> As-Built Description: Vision Light at door that permits viewing, does not have bottom of at least one glazed panel located 43 inches maximum above the finish floor. (Exception: More than 66" above finished floor.) As-Built: 47.5" Proposed Solution: Provide new door with vision panel at 43" max. 	PCODE ID06C ADA 2010 404.2.11 CBC 2013 11B-404.2.11 Priority 2 Severity 4 FY 25-26 Maintenance Work	1	JOB	\$2,500	\$2,500

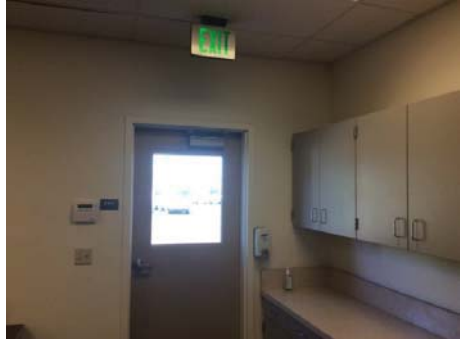
<u>Door Closer</u>						
3542	<ul style="list-style-type: none"> As-Built Description: Excessive force required to open door. As-Built: 10 lbs Proposed Solution: Adjust regular door closer to accessible standards (5 lbs max). 	PCODE ID03 ADAAG 4.13.11 ADA 2010 404.2.9 CBC 2010 1133B.2.5 CBC 2013 11B-404.2.9 Priority 2 Severity 4 FY 25-26 Maintenance Work	1	JOB	\$25	\$25

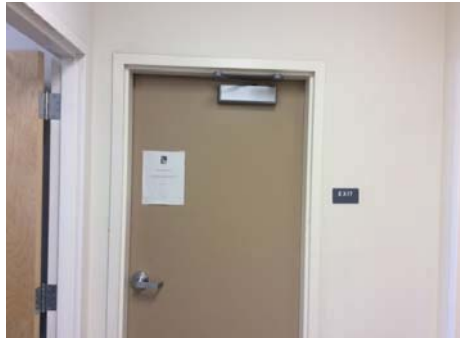
11 CalVans Restroom Corridor

<u>Door Closer</u>						
3553	<ul style="list-style-type: none"> As-Built Description: Excessive force required to open door. As-Built: 16 lbs Proposed Solution: Adjust regular door closer to accessible standards (5 lbs max). 	PCODE ID03 ADAAG 4.13.11 ADA 2010 404.2.9 CBC 2010 1133B.2.5 CBC 2013 11B-404.2.9 Priority 3 Severity 2 FY 25-26 Maintenance Work	1	JOB	\$25	\$25

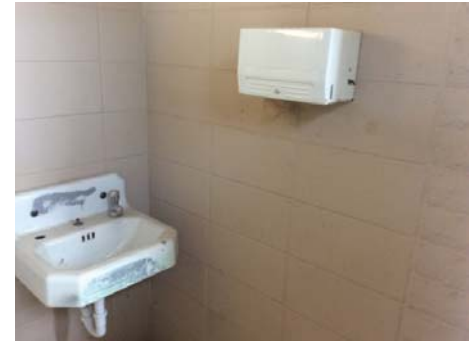
4885	<ul style="list-style-type: none"> <i>As-Built Description:</i> Dispensers in sanitary facilities, such as for towels, soap, sanitary napkins, seat covers, etc., and waste receptacles more than 48" (CA only: 40") from floor to highest operating slot or control. <i>As-Built:</i> PTD: 55" <i>Proposed Solution:</i> Relocate existing restroom accessories. 	PCODE WG01A ADAAG 4.23.7 ADA 2010 308.2.1 CBC 2010 1115B.8.3 CBC 2013 11B-603.5 Priority 3 Severity 2 FY 25-26 Maintenance Work	1	JOB	\$100	\$100
------	--	--	---	-----	-------	-------

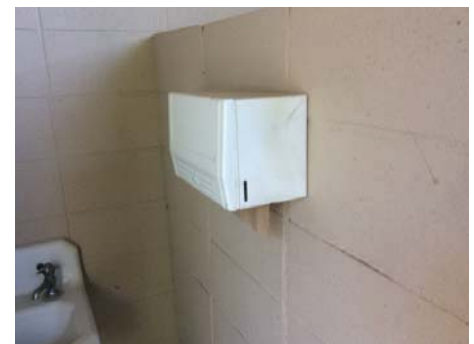
2 Women's Restroom

4898	<ul style="list-style-type: none"> <i>As-Built Description:</i> Dispensers in sanitary facilities, such as for towels, soap, sanitary napkins, seat covers, etc., and waste receptacles more than 48" (CA only: 40") from floor to highest operating slot or control. <i>As-Built:</i> PTD: 50" <i>Proposed Solution:</i> Relocate existing restroom accessories. 	PCODE WG01A ADAAG 4.23.7 ADA 2010 308.2.1 CBC 2010 1115B.8.3 CBC 2013 11B-603.5 Priority 3 Severity 2 FY 25-26 Maintenance Work	1	JOB	\$100	\$100
------	--	--	---	-----	-------	-------

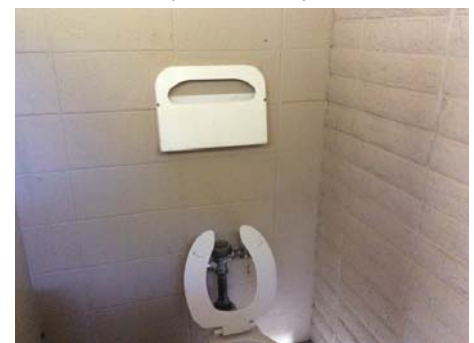
4899	<ul style="list-style-type: none"> <i>As-Built Description:</i> Dispensers in sanitary facilities, such as for towels, soap, sanitary napkins, seat covers, etc., and waste receptacles more than 48" (CA only: 40") from floor to highest operating slot or control. <i>As-Built:</i> SCD: 51" <i>Proposed Solution:</i> Relocate existing restroom accessories. 	PCODE WG01A ADAAG 4.23.7 ADA 2010 308.2.1 CBC 2010 1115B.8.3 CBC 2013 11B-603.5 Priority 3 Severity 2 FY 25-26 Maintenance Work	1	JOB	\$100	\$100
------	--	--	---	-----	-------	-------

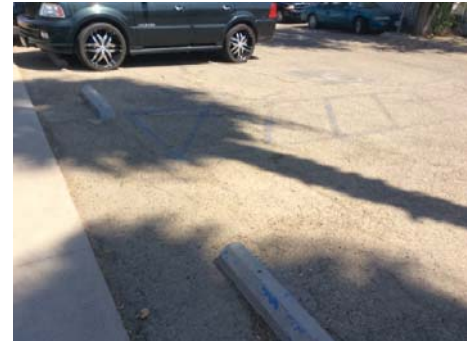
5011	<ul style="list-style-type: none"> <i>As-Built Description:</i> Accessible parking space has slope greater than 1/4":12" (2%). <i>As-Built:</i> Highly irregular surface. and striping is faded <i>Proposed Solution:</i> Modify slope at accessible parking space. 	<p>PCODE EA05 ADAAG 4.6.3 ADA 2010 502.4 CBC 2010 1129B.3.3 CBC 2013 11B-502.4 Priority 1 Severity 4 TBD Contract Work</p>
------	--	---

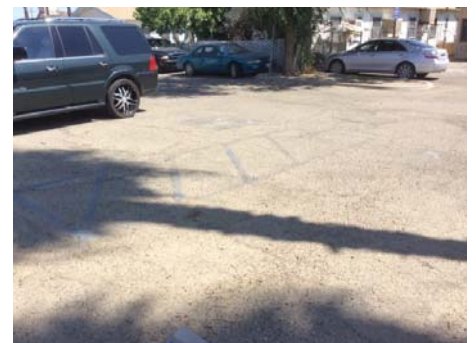
5015	<ul style="list-style-type: none"> <i>As-Built Description:</i> Accessible parking space smaller than 8' wide (CA only: 9' x 18'). <i>As-Built:</i> Faded <i>Proposed Solution:</i> Modify parking space(s) to create accessible space. <i>Notes:</i> Provide Van space with 8' aisle 	<p>PCODE EA02AREF ADAAG 4.6.3 ADA 2010 502.2 CBC 2010 1129B.3.1 CBC 2013 11B-502.2 Priority 1 Severity 4 TBD Contract Work</p>
------	--	---

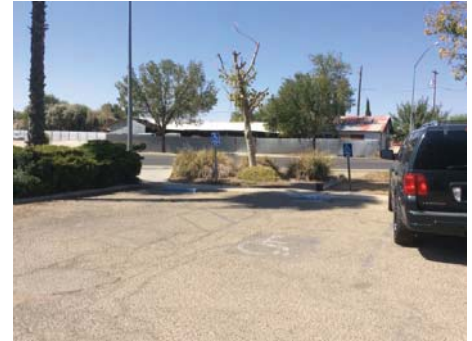
Item No. and Name	Existing Architectural Barrier and Proposed Solution	Codes / Mitigation Info	Qty	Unit	Cost	Total
5009	<ul style="list-style-type: none"> <i>As-Built Description:</i> Accessible parking space(s) not located close to the nearest possible entrance on an accessible route. <i>Proposed Solution:</i> Relocate accessible parking space(s). <i>Notes:</i> 2 Acc. 13 total 	PCODE EA06 ADAAG 4.6.2 ADA 2010 208.3 CBC 2010 1129B.1 CBC 2013 11B-208.3.1 Priority 1 Severity 3 TBD Contract Work	1	JOB	\$350	\$350

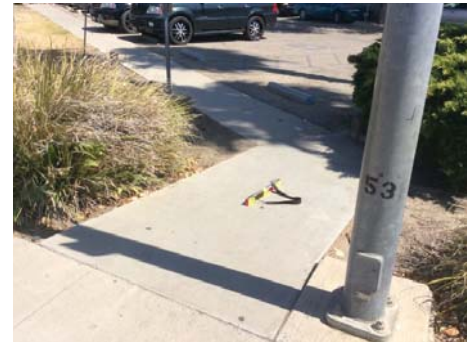
2 Site a entry Near Acc Parking

5016	<ul style="list-style-type: none"> <i>As-Built Description:</i> Slope greater than 1:12 (8.3%). <i>As-Built:</i> 10.1-11.2% <i>Proposed Solution:</i> Demolish existing and provide new ramp with handrails. <i>Notes:</i> Interim. Provide directional signage. 	PCODE EB02 ADAAG 4.8.2 ADA 2010 405.2 CBC 2010 1133B.5.3 CBC 2013 11B-405.2 Priority 1 Severity 3 TBD Contract Work	60	SF	\$100	\$6,000
------	---	--	----	----	-------	---------

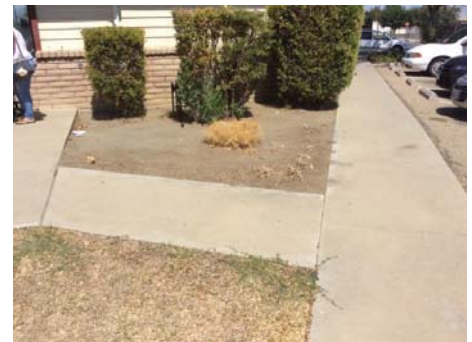
3 POT from Parking to Entrance

5018	<ul style="list-style-type: none"> <i>As-Built Description:</i> Walk: Slope greater than 1:20 (5.0%), and walk does not comply with requirements for ramps. <i>As-Built:</i> 9.8%-10.2% <i>Proposed Solution:</i> Modify walk/sidewalk slope to 1:20 or less. 	PCODE EF01 ADAAG 4.3.7 ADA 2010 403.3 CBC 2010 1133B.7.3 CBC 2013 11B-403.3 Priority 1 Severity 3 TBD Contract Work	60	SF	\$25	\$1,500
------	--	--	----	----	------	---------

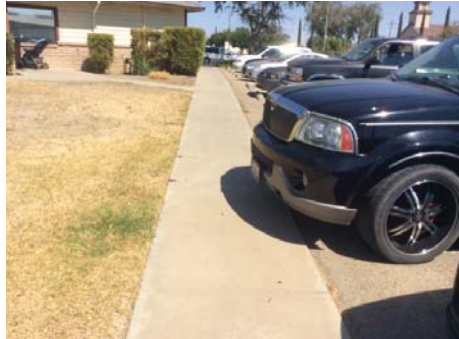
Item No. and Name	Existing Architectural Barrier and Proposed Solution	Codes / Mitigation Info	Qty	Unit	Cost	Total
5017	<ul style="list-style-type: none"> • <i>As-Built Description:</i> Walk more than 36" but less than 48" wide (required in CA only). • <i>As-Built:</i> Re-set wheel stop. 35" • <i>Proposed Solution:</i> Enlarge width of walk to 48". 	PCODE EF08REF ADA 2010 403.5 CBC 2010 1133B.7.1 CBC 2013 11B-403.5.1.3 Priority 1 Severity 3 TBD Contract Work				
			REF

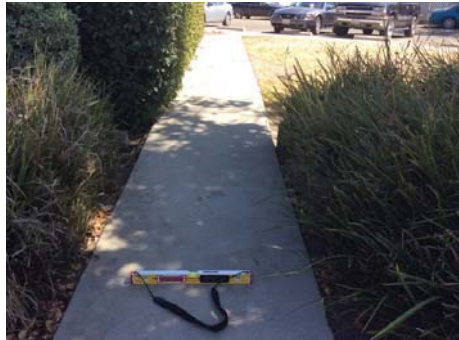
4 POT from Sidewalk to Entrance

5019	<ul style="list-style-type: none"> • <i>As-Built Description:</i> Cross slope more than 1":48" (2.083%). • <i>As-Built:</i> 2.7-3.1% • <i>Proposed Solution:</i> Modify cross slope. 	PCODE EF07 ADAAG 4.3.7 ADA 2010 403.3 CBC 2010 1133B.7.1.3 CBC 2013 11B-403.3 Priority 1 Severity 4 TBD Contract Work	100	SF	\$25	\$2,500

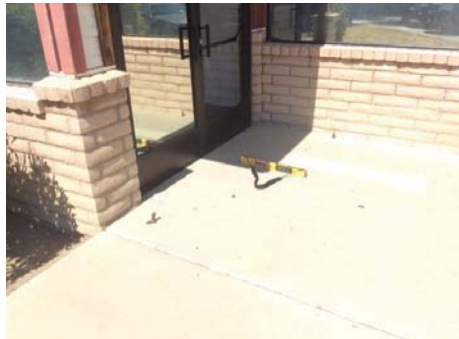
5020	<ul style="list-style-type: none"> • <i>As-Built Description:</i> Surface of required maneuvering clearance at door slopes more than 1/4":12" (2.0%). • <i>As-Built:</i> 2.8% • <i>Proposed Solution:</i> Modify surface slope at door. 	PCODE ID11 ADAAG 4.13.6 ADA 2010 404.2.4.4 CBC 2010 1133B.2.4 CBC 2013 11B-404.2.4 Priority 1 Severity 4 TBD Contract Work	30	SF	\$40	\$1,200

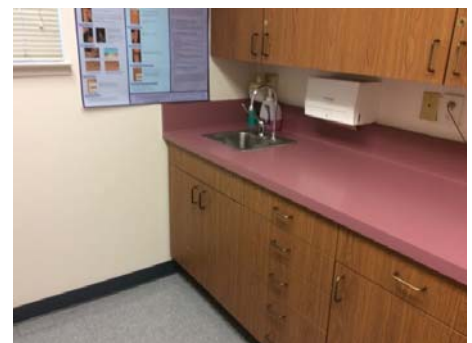
- 4962
- *As-Built Description:*
Sink does not have knee space min. 27" high x 19" deep x 30" wide.
 - *Proposed Solution:*
Remodel sink cabinet.
 - *Notes:*
Staff Only

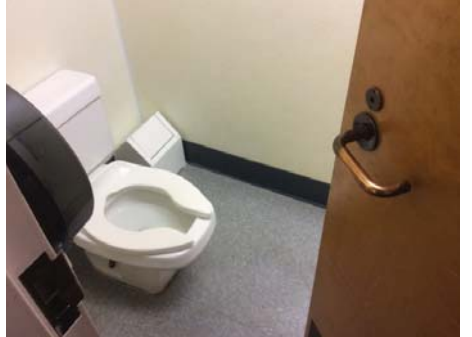
Item No. and Name	Existing Architectural Barrier and Proposed Solution	Codes / Mitigation Info	Qty	Unit	Cost	Total
<u>Door Clearance</u>						
4966	<ul style="list-style-type: none"> <i>As-Built Description:</i> Door on accessible route has less than 32" clear and 80" (78" min. to closer if provided) opening width when 90° open. <i>As-Built:</i> 27" <i>Proposed Solution:</i> Provide new, larger door and frame with new accessible hardware. 	PCODE ID01REF ADAAG 4.13.5 ADA 2010 404.2.3 CBC 2010 1133B.1.1.1.1 CBC 2013 11B-404.2.3 Priority 4 Severity 2 TBD Contract Work				
						REF

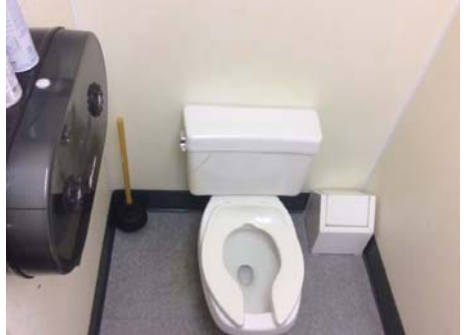
<u>Restroom</u>						
4967	<ul style="list-style-type: none"> <i>As-Built Description:</i> Single accommodation restroom not accessible; multiple compliance violations. <i>As-Built:</i> 45" wide <i>Proposed Solution:</i> Remodel area to provide single-occupant accessible restroom. 	PCODE WA01 ADAAG 4.22 ADA 2010 603 CBC 2010 1115B.3.2 CBC 2013 11B-603 Priority 4 Severity 2 TBD Contract Work	1	JOB	\$30,000	\$30,000
