Facility: **WOMENS INFANTS & CHILDREN**

Address: 330 HARRIS ST.

Facility: **LEMORE HEALTH CLINIC**
 Address: 229 C ST.

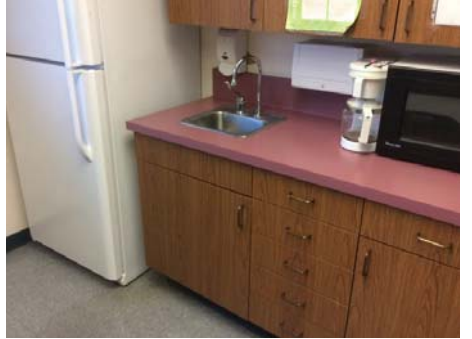
Item No. and Name	Existing Architectural Barrier and Proposed Solution	Codes / Mitigation Info	Qty	Unit	Cost	Total
Sink						
4970	<ul style="list-style-type: none"> As-Built Description: Sink rim higher than 34" above floor. As-Built: 37" Proposed Solution: Remodel sink cabinet to lower sink. 	PCODE IN06 ADAAG 4.24.2 ADA 2010 606.3 CBC 2010 1115B.4.7.1 CBC 2013 11B-606.3 Priority 4 Severity 4 TBD Contract Work	1	JOB	\$1,750	\$1,750

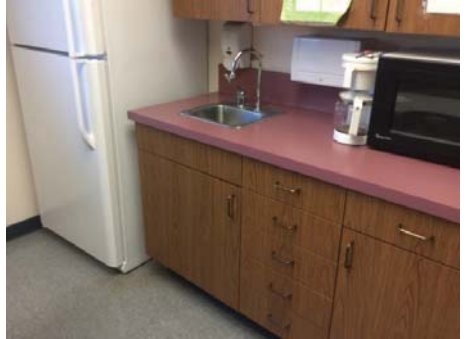
4971	<ul style="list-style-type: none"> As-Built Description: Sink does not have knee space min. 27" high x 19" deep x 30" wide. Proposed Solution: Remodel sink cabinet. 	PCODE IN06AREF ADAAG 4.24.3 ADA 2010 606.2 CBC 2010 1115B.4.7.1 CBC 2013 11B-606.2 Priority 4 Severity 2 TBD Contract Work	REF

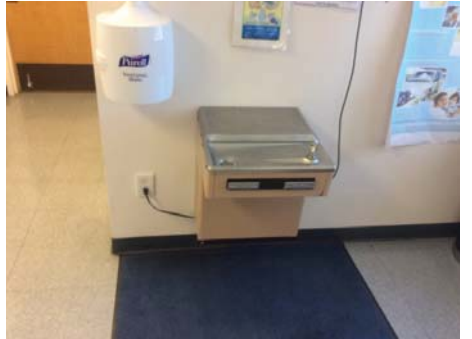
6 Entrance Lobby

4978	<ul style="list-style-type: none"> As-Built Description: Where only one drinking fountain is provided per floor: Fountain is not accessible to individuals who use wheelchairs, or to those who have difficulty bending or stooping. Proposed Solution: Provide additional fountain or hi-lo combination fountain. Notes: Children ht. 	PCODE IA01A ADAAG 4.1.3(10)(a) ADA 2010 211.1 CBC 2010 1115B.4.6.1 CBC 2013 11B-211.1 Priority 3 Severity 4 TBD Contract Work	1	JOB	\$2,000	\$2,000

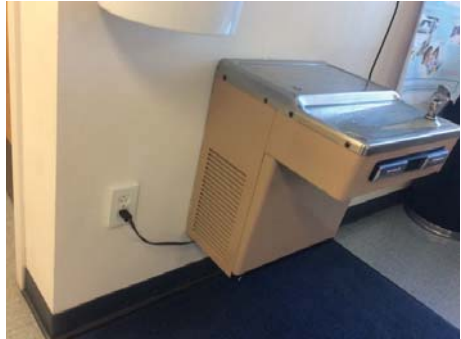
Item No. and Name	Existing Architectural Barrier and Proposed Solution	Codes / Mitigation Info	Qty	Unit	Cost	Total
4979	<ul style="list-style-type: none"> <i>As-Built Description:</i> Wall- and post-mounted cantilevered units: Knee space not provided at drinking fountain (27" high, 8" deep, 30" wide from front of drinking fountain). <i>As-Built:</i> 25.5" <i>Proposed Solution:</i> Provide new, accessible fountain. 	PCODE IA02 ADAAG 4.15.5(1) ADA 2010 602.2 CBC 2010 1115B.4.6.2 CBC 2013 11B-602.2 Priority 3 Severity 2 TBD Contract Work	1	JOB	\$3,200	\$3,200

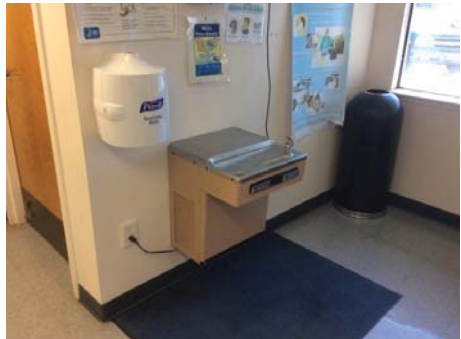
4977	<ul style="list-style-type: none"> <i>As-Built Description:</i> CA only: Drinking fountain not located in an alcove (min. 32" wide x 18" deep) or otherwise encroaches into pedestrian way. <i>Proposed Solution:</i> Provide new alcove for drinking fountain, or, if unreasonable hardship is determined, provide wing walls or cane-detectable railings on each side of the drinking fountain. The wings must project out from the supporting wall at least as far as the drinking fountain to within 6" of the surface of the circulation path, but cannot reduce the required clear width of the adjacent accessible route. 	PCODE IA04 CBC 2010 1115B.4.6.3; Fig. CBC 2013 11B-602.9 Priority 3 Severity 2 TBD Contract Work	1	JOB	\$3,000	\$3,000

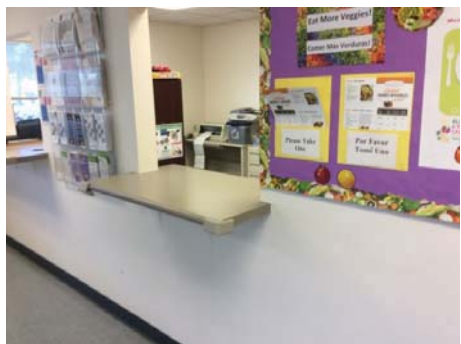
Public Counter						
4976	<ul style="list-style-type: none"> <i>As-Built Description:</i> Service counter (stand-up): Accessible section min. 36" length and 36" max. height (in CA: 28" to 34" high) not provided. <i>As-Built:</i> 41" AFF <i>Proposed Solution:</i> Provide auxiliary shelf, clipboard, or table as equivalent facilitation. 	PCODE IN03 ADAAG 7.2(2) ADA 2010 904.4 CBC 2010 1122B.4 CBC 2013 11B-904.4 Priority 1 Severity 3 TBD Contract Work	1	JOB	\$150	\$150

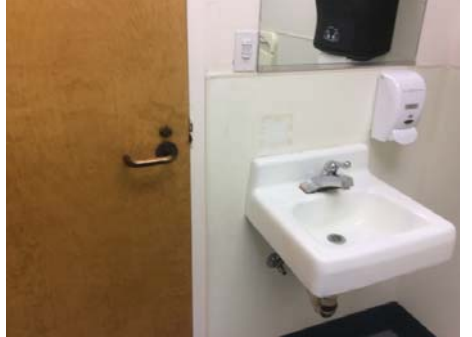
7 Men's Restroom

Item No. and Name	Existing Architectural Barrier and Proposed Solution	Codes / Mitigation Info	Qty	Unit	Cost	Total
<u>Door Swing</u>						
4987	<ul style="list-style-type: none"> <i>As-Built Description:</i> Front approach: At pull side, door does not have clear and level maneuvering space measuring door width plus 18" x 60". <i>As-Built:</i> 7.5" to lav <i>Proposed Solution:</i> Provide relocated new door and frame; remodel walls as needed. 	PCODE ID23B ADAAG Fig. 25(a) ADA 2010 404.2.4 CBC 2010 11B-26A(a) CBC 2013 11B-404.2.4 Priority 3 Severity 3 TBD Contract Work	1	JOB	\$2,600	\$2,600

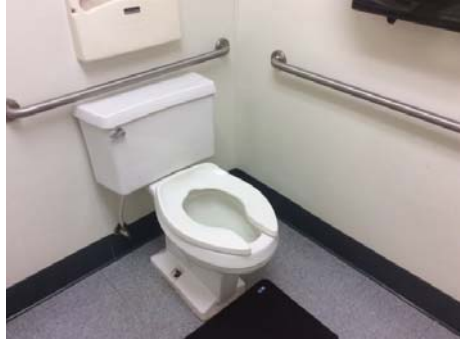
<u>Water Closet</u>						
4992	<ul style="list-style-type: none"> <i>As-Built Description:</i> More than 18" from near side wall to centerline of water closet. <i>As-Built:</i> 22" <i>Proposed Solution:</i> Provide new accessible water closet and relocate plumbing. 	PCODE WB02A ADAAG Fig. 28 ADA 2010 604.2 CBC 2010 1115B.4.1.1 CBC 2013 11B-604.2 Priority 3 Severity 3 TBD Contract Work	1	JOB	\$4,500	\$4,500

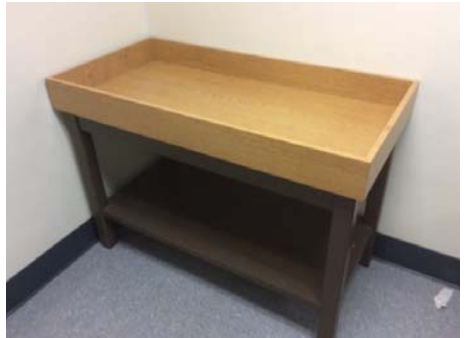
<u>Desk</u>						
5001	<ul style="list-style-type: none"> <i>As-Built Description:</i> Accessible fixed table or desk (top 28" to 34" high; knee space at least 27" high x 19" deep x 30" wide) not provided. <i>Proposed Solution:</i> Provide new fixed accessible table or desk. Notes: Modify 	PCODE IN02 ADAAG 4.32.3 & .4 ADA 2010 306.1 CBC 2010 1122B.3 & 4 CBC 2013 11B-306.1 Priority 3 Severity 2 TBD Contract Work	1	JOB	\$2,500	\$2,500

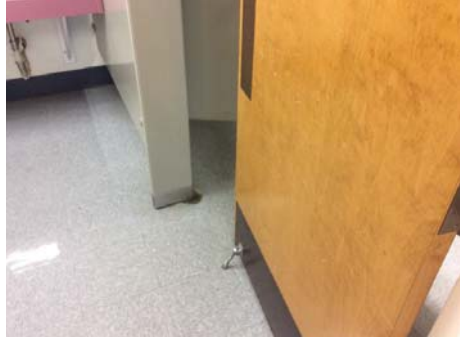
Item No. and Name	Existing Architectural Barrier and Proposed Solution	Codes / Mitigation Info	Qty	Unit	Cost	Total
<u>Door Swing</u>						
4998	<ul style="list-style-type: none"> • <i>As-Built Description:</i> Front approach: At pull side, door does not have clear and level maneuvering space measuring door width plus 18" x 60". • <i>As-Built:</i> 50" to stall • <i>Proposed Solution:</i> Provide relocated new door and frame; remodel walls as needed. 	PCODE ID23B ADAAG Fig. 25(a) ADA 2010 404.2.4 CBC 2010 11B-26A(a) CBC 2013 11B-404.2.4 Priority 3 Severity 3 TBD Contract Work	1	JOB	\$2,600	\$2,600

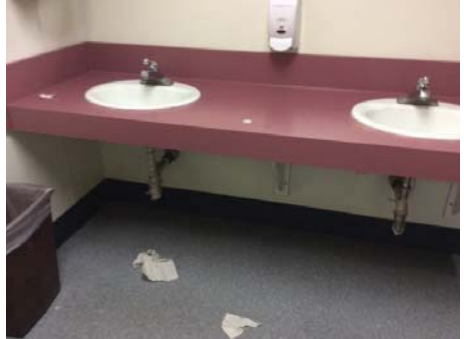
<u>Lavatory</u>						
5000	<ul style="list-style-type: none"> • <i>As-Built Description:</i> Wheelchair clearance under lavatory apron or lavatory counter front edge less than 29" high. • <i>As-Built:</i> 28.25" • <i>Proposed Solution:</i> Provide new accessible lavatory. Remodel restroom as needed. 	PCODE WD03 ADAAG 4.19.2 ADA 2010 606.3 CBC 2010 1115B.4.3.3 CBC 2013 11B-606.3 Priority 3 Severity 2 TBD Contract Work	1	JOB	\$3,400	\$3,400

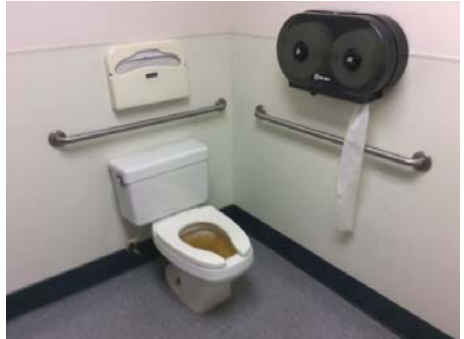
<u>Water Closet</u>						
5005	<ul style="list-style-type: none"> • <i>As-Built Description:</i> More than 18" from near side wall to centerline of water closet. • <i>As-Built:</i> 22" • <i>Proposed Solution:</i> Provide new accessible water closet and relocate plumbing. 	PCODE WB02A ADAAG Fig. 28 ADA 2010 604.2 CBC 2010 1115B.4.1.1 CBC 2013 11B-604.2 Priority 3 Severity 3 TBD Contract Work	1	JOB	\$4,500	\$4,500

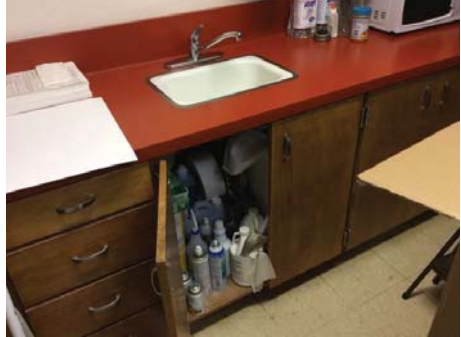
Item No. and Name	Existing Architectural Barrier and Proposed Solution	Codes / Mitigation Info	Qty	Unit	Cost	Total
Sink						
4519	<ul style="list-style-type: none"> As-Built Description: Sink does not have knee space min. 27" high x 19" deep x 30" wide. Proposed Solution: Remodel sink cabinet. 	PCODE IN06A ADAAG 4.24.3 ADA 2010 606.2 CBC 2010 1115B.4.7.1 CBC 2013 11B-606.2 Priority 4 Severity 2 TBD Contract Work	1	JOB	\$1,750	\$1,750

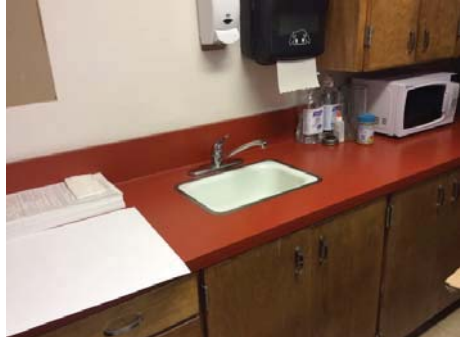
4520	<ul style="list-style-type: none"> As-Built Description: Sink rim higher than 34" above floor. As-Built: 35" Proposed Solution: Remodel sink cabinet to lower sink. 	PCODE IN06REF ADAAG 4.24.2 ADA 2010 606.3 CBC 2010 1115B.4.7.1 CBC 2013 11B-606.3 Priority 4 Severity 4 TBD Contract Work	REF

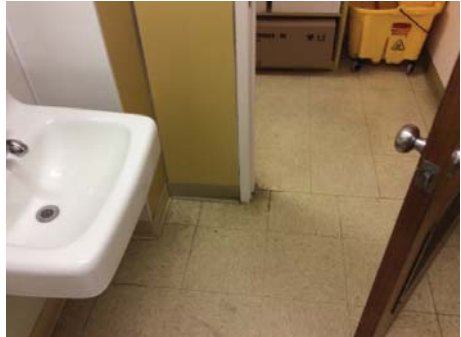
4512	<ul style="list-style-type: none"> As-Built Description: Front approach: At pull side, door does not have clear and level maneuvering space measuring door width plus 18" x 60". As-Built: 7"-14" Proposed Solution: Remodel as needed. 	PCODE ID23BREF ADAAG Fig. 25(a) ADA 2010 404.2.4 CBC 2010 11B-26A(a) CBC 2013 11B-404.2.4 Priority 4 Severity 3 TBD Contract Work	REF

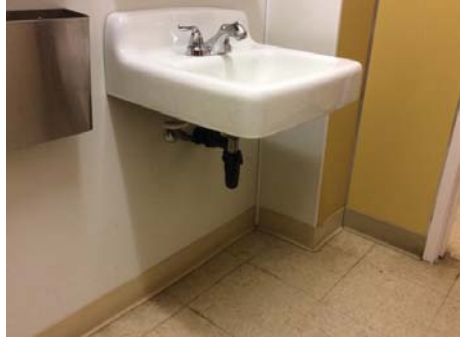
Item No. and Name	Existing Architectural Barrier and Proposed Solution	Codes / Mitigation Info	Qty	Unit	Cost	Total
<u>Lavatory</u>						
4513	<ul style="list-style-type: none"> As-Built Description: Wheelchair clearance under lavatory apron or lavatory counter front edge less than 29" high. As-Built: 26" Proposed Solution: Provide new accessible lavatory. Remodel restroom as needed. 	PCODE WD03REF ADAAG 4.19.2 ADA 2010 606.3 CBC 2010 1115B.4.3.3 CBC 2013 11B-606.3 Priority 4 Severity 3 TBD Contract Work				
						REF

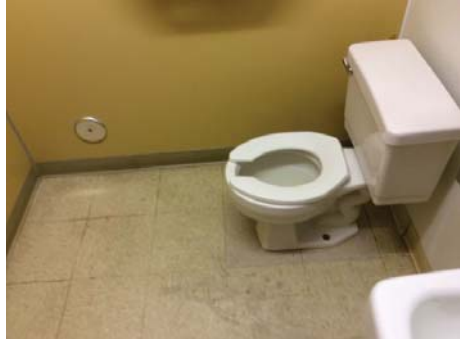
<u>Restroom</u>						
4511	<ul style="list-style-type: none"> As-Built Description: Single accommodation restroom not accessible; multiple compliance violations. Proposed Solution: Remodel area to provide single-occupant accessible restroom. 	PCODE WA01 ADAAG 4.22 ADA 2010 603 CBC 2010 1115B.3.2 CBC 2013 11B-603 Priority 4 Severity 2 TBD Contract Work	1	JOB	\$30,000	\$30,000

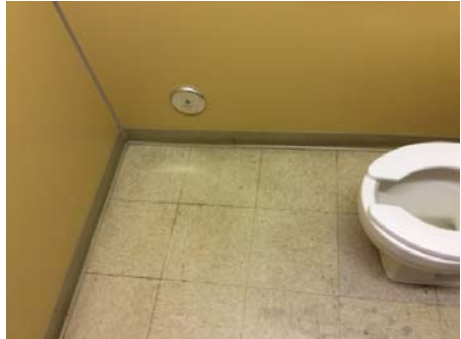
<u>Water Closet</u>						
4514	<ul style="list-style-type: none"> As-Built Description: CA only: In single-accommodation restroom less than 48" in front of water closet provided. As-Built: 36.5" Proposed Solution: Remodel restroom to provide at least 48" in front of water closet. Notes: 79" x 65" 	PCODE WB03AREF CBC 2010 1115B.3.2.1 CBC 2013 11B-604.3.1 Priority 4 Severity 3 TBD Contract Work				
						REF

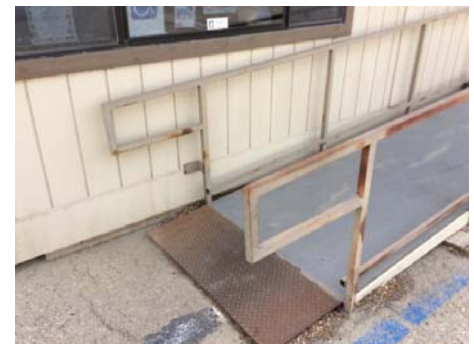
- *As-Built Description:*
Walk: Pavement dislocation creates abrupt change in level exceeding 1/2" in accessible route.
- *As-Built:* Due to metal grate on ramp.
- *Proposed Solution:*
Remove, replace or repair area of pavement sufficient to correct abrupt change in level.

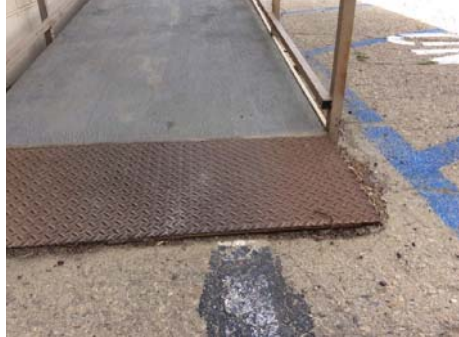
Item No. and Name	Existing Architectural Barrier and Proposed Solution	Codes / Mitigation Info	Qty	Unit	Cost	Total
Ramps						
4475	<ul style="list-style-type: none"> <i>As-Built Description:</i> Ramp: Pavement dislocation creates abrupt change in level exceeding 1/2" in ramp. <i>As-Built:</i> 0.5" <i>Proposed Solution:</i> Remove, replace or repair area of pavement sufficient to correct abrupt change in level. 	PCODE EB04 ADAAG 4.5.2 ADA 2010 303.4 CBC 2010 1133B.7.1 CBC 2013 11B-405.4 Priority 3 Severity 4 TBD Contract Work	10	SF	\$9	\$90

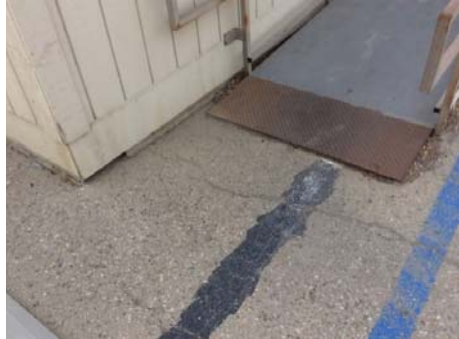
Slope						
4477	<ul style="list-style-type: none"> <i>As-Built Description:</i> Level 2% max. landing for ramp not provided. <i>As-Built:</i> 2.8% <i>Proposed Solution:</i> Rebuild ramp to provide landings for each ramp run with slopes no greater than 2% 	PCODE EB05A ADAAG 4.8.4 ADA 2010 405.7.1 CBC 2010 1133B.5.4.1 CBC 2013 11B-405.7.1 Priority 3 Severity 4 TBD Contract Work	30	SF	\$100	\$3,000

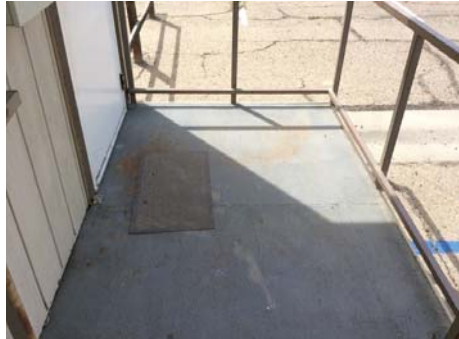
Walk						
4478	<ul style="list-style-type: none"> <i>As-Built Description:</i> Walk (not ramp): Level areas at doors not 60"x60" at swing side or 48"x44" at push side (required in CA only; for ADA requirement see door codes). <i>As-Built:</i> 59" to wheel guide <i>Proposed Solution:</i> Enlarge level areas; demolish existing surface, provide new surface. 	PCODE EF06 ADA 2010 404.2.4 CBC 2010 1133B.7.5 CBC 2013 11B-404.2.4 Priority 3 Severity 4 TBD Contract Work	25	SF	\$45	\$1,125

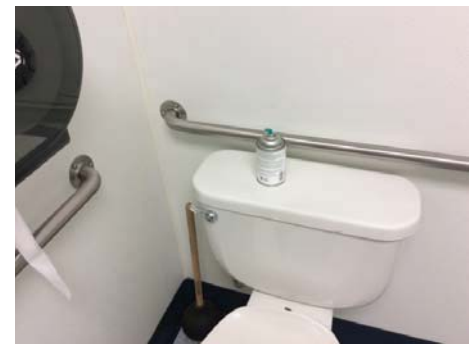
- 4463
- *As-Built Description:*
 Flush Control: Operating handle not mounted toward wide side of stall.
 - *Proposed Solution:*
 Replace flush control with properly mounted accessible type, or install sensor flush.

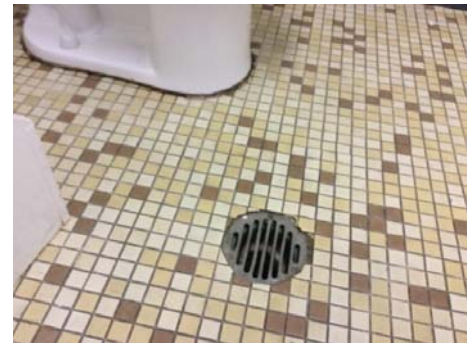
- 4749
- *As-Built Description:*
 Drain opening in floor produces a non-flush surface within the water closet.
 - *As-Built:* Not flush
 - *Proposed Solution:*
 Modify drain to be flush with the floor surface.

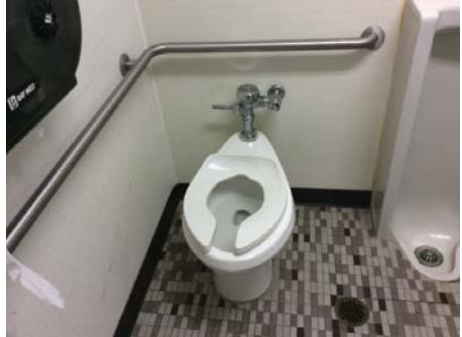
Item No. and Name	Existing Architectural Barrier and Proposed Solution	Codes / Mitigation Info	Qty	Unit	Cost	Total
<u>Water Closet</u>						
4762	<ul style="list-style-type: none"> <i>As-Built Description:</i> Water closet not 17"-18" from near side wall to center line of water closet (2010 ADAS: 16"-18"). <i>As-Built:</i> 16.5" o.c. <i>Proposed Solution:</i> Relocate existing water closet and plumbing, remount with offset closet flange to provide 17"-18" from side wall. 	PCODE WB02C ADAAG Fig. 28 ADA 2010 604.2 CBC 2010 1115B.4.1.1 CBC 2013 11B-604.2 Priority 3 Severity 4 TBD Contract Work	1	JOB	\$500	\$500

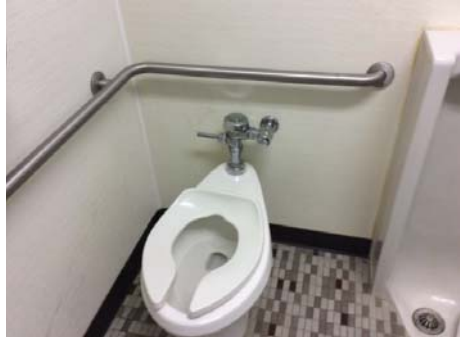
4758	<ul style="list-style-type: none"> <i>As-Built Description:</i> Flush Control: Operating handle not mounted toward wide side of stall. <i>Proposed Solution:</i> Replace flush control with properly mounted accessible type, or install sensor flush. 	PCODE WB10 ADAAG 4.16.5 ADA 2010 604.6 CBC 2010 1115B.4.1.5 CBC 2013 11B-604.6 Priority 3 Severity 3 TBD Contract Work	1	JOB	\$500	\$500

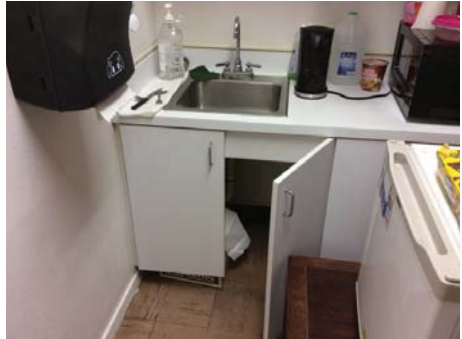
4771	<ul style="list-style-type: none"> <i>As-Built Description:</i> Sink rim higher than 34" above floor. <i>As-Built:</i> 34.75" <i>Proposed Solution:</i> Remodel sink cabinet to lower sink. 	PCODE IN06 ADAAG 4.24.2 ADA 2010 606.3 CBC 2010 1115B.4.7.1 CBC 2013 11B-606.3 Priority 4 Severity 4 TBD Contract Work	1	JOB	\$1,750	\$1,750

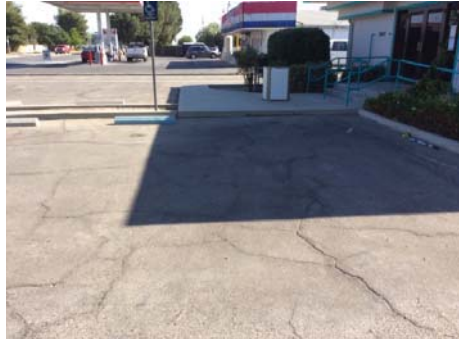
Item No. and Name	Existing Architectural Barrier and Proposed Solution	Codes / Mitigation Info	Qty	Unit	Cost	Total
4340	<ul style="list-style-type: none"> <i>As-Built Description:</i> International Symbol of Accessibility (36" square, in white on blue) is not painted on the pavement near the rear end of the parking space (required in CA only). <i>Proposed Solution:</i> Apply symbol on parking space pavement when altering area. 	PCODE EA04AREF CBC 2010 1129B.4 CBC 2013 11B-502.6.4 Priority 1 Severity 4 TBD Contract Work				
			REF

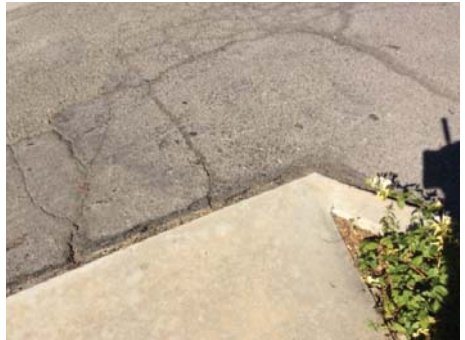
4359	<ul style="list-style-type: none"> <i>As-Built Description:</i> Walk: Pavement dislocation creates abrupt change in level exceeding 1/2" in accessible route. <i>As-Built:</i> 1" <i>Proposed Solution:</i> Remove, replace or repair area of pavement sufficient to correct abrupt change in level. 	PCODE EF03 ADAAG 4.3.8 ADA 2010 403.4 CBC 2010 1133B.7.4 CBC 2013 11B-403.4 Priority 1 Severity 4 TBD Contract Work	4	SF	\$21	\$84
			REF

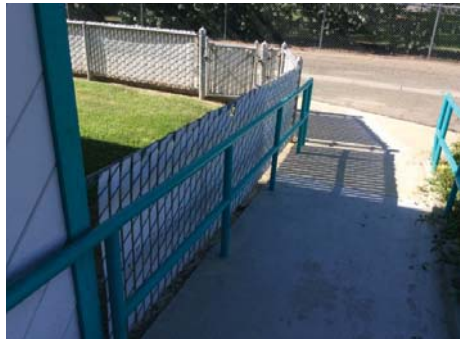
4346	<ul style="list-style-type: none"> <i>As-Built Description:</i> Ramp: No curb (2" minimum height) or wheel guide (centered approx. 3" above surface of ramp) at sides of ramp. <i>Proposed Solution:</i> Provide 2" minimum curb or wheel guide. 	PCODE EB14REF ADAAG 4.8.7 ADA 2010 405.9.2 CBC 2010 1133B.5.6 CBC 2013 11B-405.9.2 Priority 1 Severity 2 TBD Contract Work				
			REF

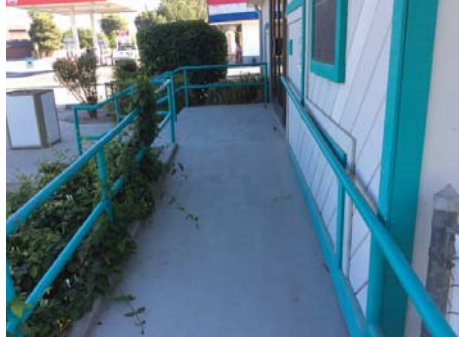
Item No. and Name	Existing Architectural Barrier and Proposed Solution	Codes / Mitigation Info	Qty	Unit	Cost	Total
Height						
4345	<ul style="list-style-type: none"> <i>As-Built Description:</i> Handrail gripping surface top not mounted between 34" and 38" above ramp surface or stair nosings. <i>As-Built:</i> 32" <i>Proposed Solution:</i> Remove existing and provide new handrail. 	PCODE ED02 ADAAG 4.9.4(5) ADA 2010 505.4 CBC 2010 1133B.4.2.1 & CBC 2013 11B-505.4 Priority 1 Severity 4 TBD Contract Work	50	LF	\$75	\$3,750

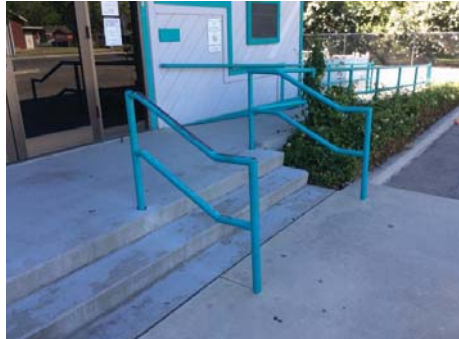
Top & Bottom Extension at Stairs

4348	<ul style="list-style-type: none"> <i>As-Built Description:</i> Stair handrail does not extend horizontally 12" minimum beyond top nosing, and one tread width sloped, plus 12" minimum horizontally beyond the bottom nosing. <i>As-Built:</i> 5"-11" <i>Proposed Solution:</i> Extend stair handrail at top and bottom (cost for each extension piece). 	PCODE ED06 ADAAG 4.9.4(2) ADA 2010 505.10.2; 505.10.3 CBC 2010 1133B.4.2.2 CBC 2013 11B-505.10.2; 11B-505.10.3 Priority 4 Severity 4 TBD Contract Work	4	JOB	\$170	\$680

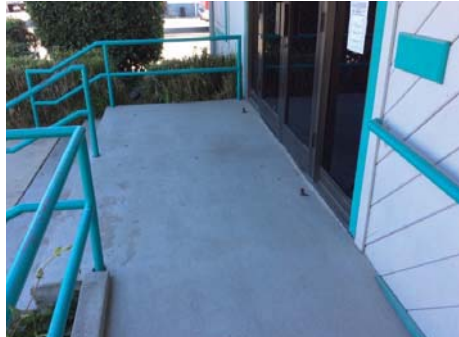
Top and Bottom Extension at Ramps

4347	<ul style="list-style-type: none"> <i>As-Built Description:</i> Ramp handrail does not extend horizontally 12" past top and / or bottom of ramp. <i>Proposed Solution:</i> Provide ramp handrail extension (cost for each extension piece). 	PCODE ED05REF ADAAG 4.8.5(2) ADA 2010 505.10.1 CBC 2010 1133B.4.2.2 & CBC 2013 11B-505.10.1 Priority 1 Severity 2 TBD Contract Work	REF

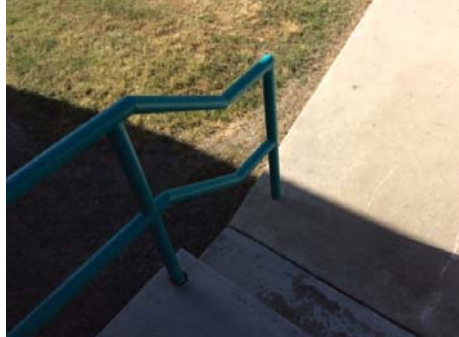
Item No. and Name	Existing Architectural Barrier and Proposed Solution	Codes / Mitigation Info	Qty	Unit	Cost	Total
<u>Top & Bottom Extension at Stairs</u>						
4351	<ul style="list-style-type: none"> <i>As-Built Description:</i> Stair handrail does not extend horizontally 12" minimum beyond top nosing, and one tread width sloped, plus 12" minimum horizontally beyond the bottom nosing. <i>As-Built:</i> 11" <i>Proposed Solution:</i> Extend stair handrail at top and bottom (cost for each extension piece). 	PCODE ED06 ADAAG 4.9.4(2) ADA 2010 505.10.2; 505.10.3 CBC 2010 1133B.4.2.2 CBC 2013 11B-505.10.2; 11B-505.10.3 Priority 3 Severity 4 TBD Contract Work	1	JOB	\$170	\$170

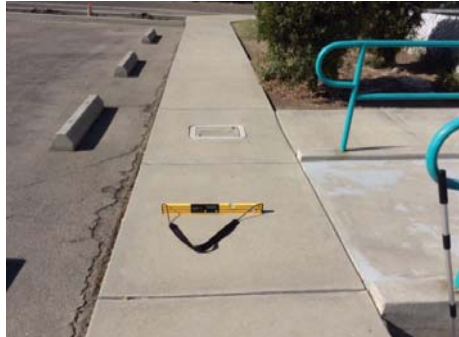
<u>Cross Slope</u>						
4357	<ul style="list-style-type: none"> <i>As-Built Description:</i> Cross slope more than 1":48" (2.083%). <i>As-Built:</i> 4.3% <i>Proposed Solution:</i> Modify cross slope. Notes: Not a ramp. <5% 	PCODE EF07 ADAAG 4.3.7 ADA 2010 403.3 CBC 2010 1133B.7.1.3 CBC 2013 11B-403.3 Priority 1 Severity 3 TBD Contract Work	16	SF	\$25	\$400

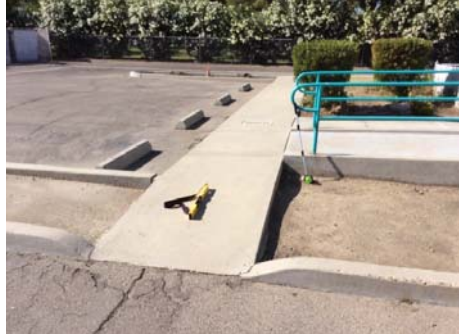
<u>Curb Ramp</u>						
4355	<ul style="list-style-type: none"> <i>As-Built Description:</i> Slope greater than 1:12 (8.3%). <i>As-Built:</i> 10.2% <i>Proposed Solution:</i> Demolish existing and provide new curb ramp. 	PCODE EH02A ADAAG 4.7.2 ADA 2010 406.1 CBC 2010 1127B.5.3 CBC 2013 11B-406.2.1 Priority 1 Severity 4 TBD Contract Work	1	JOB	\$2,500	\$2,500

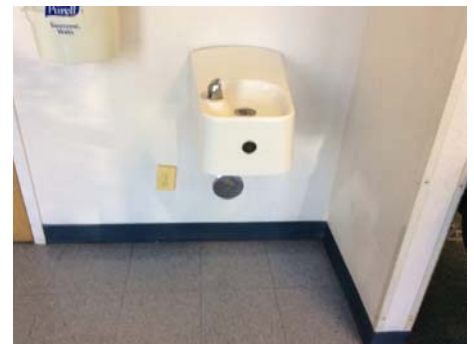
- *As-Built Description:*
 Wall- and post-mounted cantilevered units: Knee space not provided at drinking fountain (27" high, 8" deep, 30" wide from front of drinking fountain). Unit in good condition.
- *As-Built:* 26.5"
- *Proposed Solution:*
 Remount fountain at accessible height.

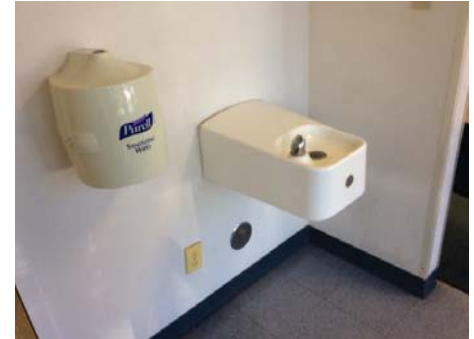
Item No. and Name	Existing Architectural Barrier and Proposed Solution	Codes / Mitigation Info	Qty	Unit	Cost	Total
4260	<ul style="list-style-type: none"> <i>As-Built Description:</i> CA only: Drinking fountain not located in an alcove (min. 32" wide x 18" deep) or otherwise encroaches into pedestrian way. <i>Proposed Solution:</i> Provide new alcove for drinking fountain, or, if unreasonable hardship is determined, provide wing walls or cane-detectable railings on each side of the drinking fountain. The wings must project out from the supporting wall at least as far as the drinking fountain to within 6" of the surface of the circulation path, but cannot reduce the required clear width of the adjacent accessible route. 	PCODE IA04 CBC 2010 1115B.4.6.3; Fig. CBC 2013 11B-602.9 Priority 3 Severity 2 TBD Contract Work	1	JOB	\$3,000	\$3,000

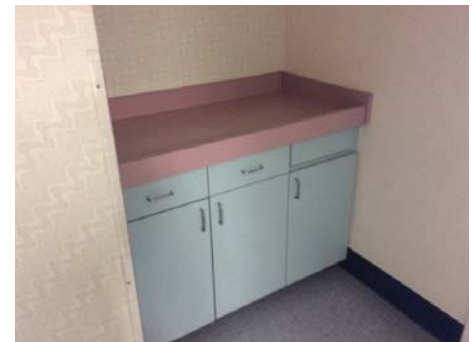
Counter

4267	<ul style="list-style-type: none"> <i>As-Built Description:</i> Accessible counter (top 28" to 34" high; knee space at least 27" high x 19" deep x 30" wide) not provided. <i>As-Built:</i> BCS: no knee space, 37.5" top <i>Proposed Solution:</i> Provide new section of counter at 34" high max. 	PCODE IN02B ADAAG 4.32.3 & .4 ADA 2010 902.3 CBC 2010 1122B.3 & 4 CBC 2013 11B-902.3 Priority 3 Severity 2 TBD Contract Work	1	JOB	\$2,500	\$2,500
------	--	---	---	-----	---------	---------

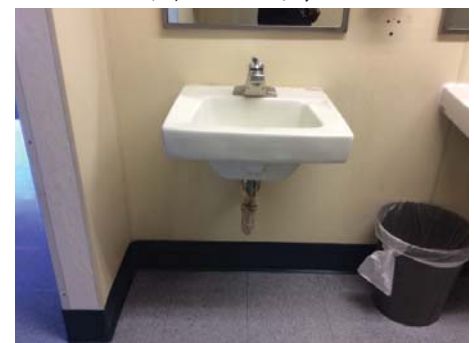
Lavatory

4272	<ul style="list-style-type: none"> <i>As-Built Description:</i> Knee clearance 27" min. high starting 8" back from the front edge of the lavatory towards the wall is not provided. <i>As-Built:</i> 24.25" <i>Proposed Solution:</i> Provide new accessible lavatory. Remodel restroom as needed. 	PCODE WD04 ADAAG Fig. 31 ADA 2010 606.3 CBC 2010 1115B.4.3 CBC 2013 11B-306.3.3 Priority 3 Severity 2 TBD Contract Work	1	JOB	\$3,400	\$3,400
------	---	--	---	-----	---------	---------

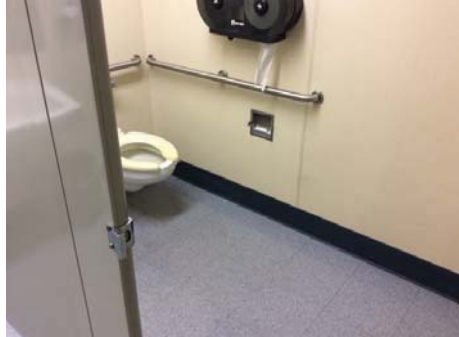
Item No. and Name	Existing Architectural Barrier and Proposed Solution	Codes / Mitigation Info	Qty	Unit	Cost	Total
<u>Toilet Stall</u>						
4275	<ul style="list-style-type: none"> As-Built Description: Toilet stall less than 60" wide. As-Built: 58" Proposed Solution: Provide new accessible stall. 	PCODE WB06 ADAAG 4.17.3 ADA 2010 604.8.1.1 CBC 2010 1115B.3.1.4.1 CBC 2013 11B-604.8.1.1 Priority 3 Severity 4 TBD Contract Work	1	JOB	\$1,500	\$1,500

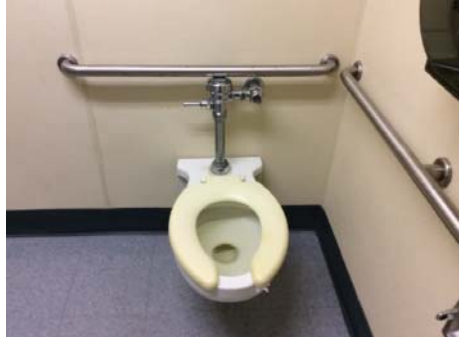
<u>Water Closet</u>						
4281	<ul style="list-style-type: none"> As-Built Description: Water closet not 17"-18" from near side wall to center line of water closet (2010 ADAS: 16"-18"). As-Built: 18.75" o.c. Proposed Solution: Relocate existing water closet and plumbing, remount with offset closet flange to provide 17"-18" from side wall. 	PCODE WB02C ADAAG Fig. 28 ADA 2010 604.2 CBC 2010 1115B.4.1.1 CBC 2013 11B-604.2 Priority 3 Severity 4 TBD Contract Work	1	JOB	\$500	\$500

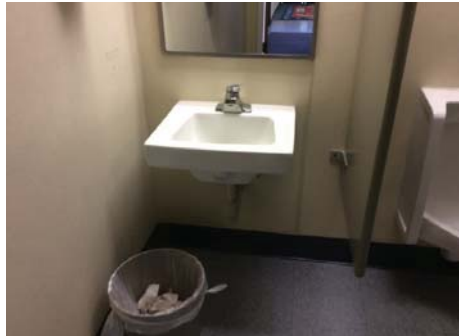
<u>Lavatory</u>						
4288	<ul style="list-style-type: none"> As-Built Description: Knee clearance 27" min. high starting 8" back from the front edge of the lavatory towards the wall is not provided. As-Built: 24.5" Proposed Solution: Provide new accessible lavatory. Remodel restroom as needed. 	PCODE WD04 ADAAG Fig. 31 ADA 2010 606.3 CBC 2010 1115B.4.3 CBC 2013 11B-306.3.3 Priority 3 Severity 2 TBD Contract Work	1	JOB	\$3,400	\$3,400

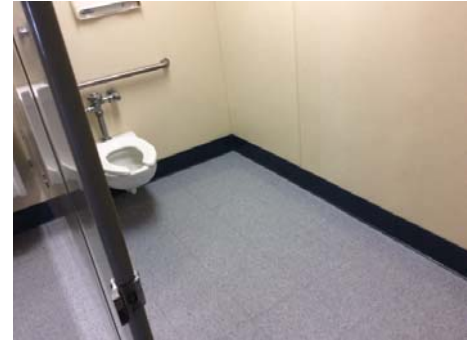
Toilet Stall

4297	<ul style="list-style-type: none"> • <i>As-Built Description:</i> Toilet stall less than 60" wide. • <i>As-Built:</i> 58" • <i>Proposed Solution:</i> Provide new accessible stall. 	PCODE WB06 ADAAG 4.17.3 ADA 2010 604.8.1.1 CBC 2010 1115B.3.1.4.1 CBC 2013 11B-604.8.1.1 Priority 3 Severity 4 TBD Contract Work	1	JOB	\$1,500	\$1,500
------	--	---	---	-----	---------	----------------

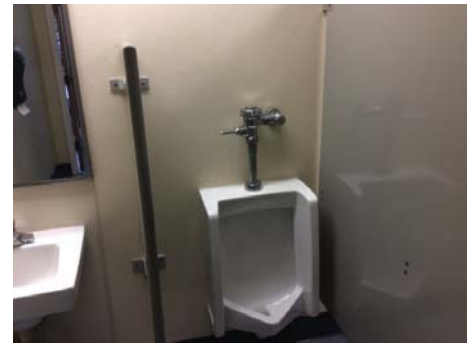
4293	<ul style="list-style-type: none"> • <i>As-Built Description:</i> Urinal flush control lever more than 48" above floor (CA only: 44" max.). • <i>As-Built:</i> 45" • <i>Proposed Solution:</i> Provide accessible urinal flush control. 	PCODE WE03 ADAAG 4.18.4 ADA 2010 605.4 CBC 2010 1115B.4.2.2 CBC 2013 11B-605.4 Priority 3 Severity 4 TBD Contract Work	1	JOB	\$500	\$500
------	--	---	---	-----	-------	--------------

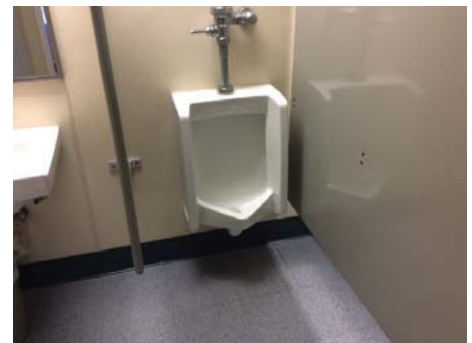
4292	<ul style="list-style-type: none"> • <i>As-Built Description:</i> 30" x 48" clear floor space in front of accessible urinal not provided. • <i>As-Built:</i> 29.5" wide • <i>Proposed Solution:</i> Provide clear floor space in front of accessible urinal. Remodel restroom as needed. • Notes: 12" o.c. 	PCODE WE04 ADAAG 4.18.3 ADA 2010 605.3 CBC 2010 1115B.4.2.3 CBC 2013 11B-605.3 Priority 3 Severity 2 TBD Contract Work	1	JOB	\$1,500	\$1,500
------	--	---	---	-----	---------	----------------

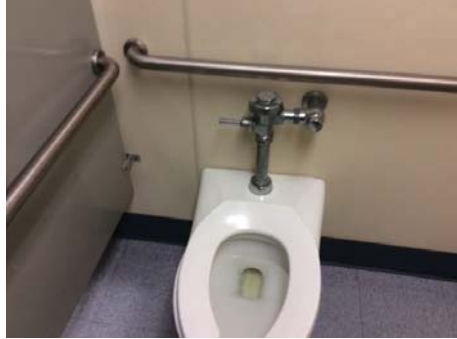
Item No. and Name	Existing Architectural Barrier and Proposed Solution	Codes / Mitigation Info	Qty	Unit	Cost	Total
<u>Water Closet</u>						
4298	<ul style="list-style-type: none"> <i>As-Built Description:</i> Flush Control: Operating handle not mounted toward wide side of stall. <i>Proposed Solution:</i> Replace flush control with properly mounted accessible type, or install sensor flush. 	PCODE WB10 ADAAG 4.16.5 ADA 2010 604.6 CBC 2010 1115B.4.1.5 CBC 2013 11B-604.6 Priority 3 Severity 3 TBD Contract Work	1	JOB	\$500	\$500

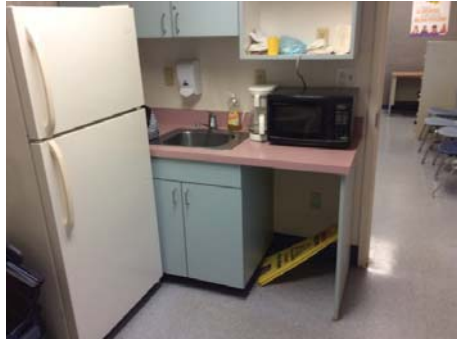
<u>Sink</u>						
4303	<ul style="list-style-type: none"> <i>As-Built Description:</i> Sink does not have knee space min. 27" high x 19" deep x 30" wide. <i>Proposed Solution:</i> Remodel sink cabinet. <i>Notes:</i> Also fridge 	PCODE IN06A ADAAG 4.24.3 ADA 2010 606.2 CBC 2010 1115B.4.7.1 CBC 2013 11B-606.2 Priority 4 Severity 2 TBD Contract Work	1	JOB	\$1,750	\$1,750

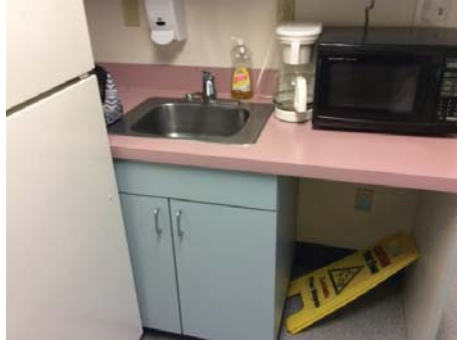
4304	<ul style="list-style-type: none"> <i>As-Built Description:</i> Sink rim higher than 34" above floor. <i>As-Built:</i> 35.75" <i>Proposed Solution:</i> Remodel sink cabinet to lower sink. 	PCODE IN06REF ADAAG 4.24.2 ADA 2010 606.3 CBC 2010 1115B.4.7.1 CBC 2013 11B-606.3 Priority 4 Severity 4 TBD Contract Work	REF

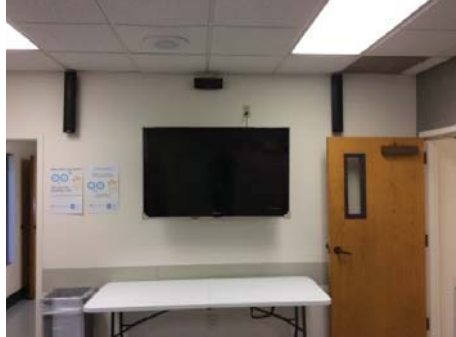
Item No. and Name	Existing Architectural Barrier and Proposed Solution	Codes / Mitigation Info	Qty	Unit	Cost	Total
<u>Assistive Listening</u>						
4309	<ul style="list-style-type: none"> <i>As-Built Description:</i> No portable assistive listening system provided for small meeting room. <i>Proposed Solution:</i> Share existing portable assistive listening system from other facility if needed. 	PCODE GI01E ADAAG 4.1.3(19)(b) & 4.33.7 ADA 2010 219.1 & 706.1 CBC 2010 1104B.2 CBC 2013 11B-219.2 Priority 3 Severity 3 TBD Contract Work				
						REF

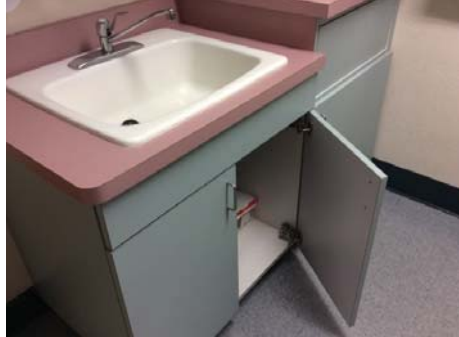
Item No. and Name	Existing Architectural Barrier and Proposed Solution	Codes / Mitigation Info	Qty	Unit	Cost	Total
Sink						
4330	<ul style="list-style-type: none"> <i>As-Built Description:</i> Sink does not have knee space min. 27" high x 19" deep x 30" wide. <i>Proposed Solution:</i> Remodel sink cabinet. <i>Notes:</i> Top 36" 	PCODE IN06A ADAAG 4.24.3 ADA 2010 606.2 CBC 2010 1115B.4.7.1 CBC 2013 11B-606.2 Priority 2 Severity 2 TBD Contract Work	1	JOB	\$1,750	\$1,750

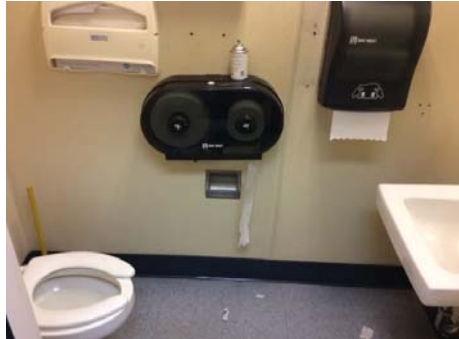
Item No. and Name	Existing Architectural Barrier and Proposed Solution	Codes / Mitigation Info	Qty	Unit	Cost	Total
Restroom						
4336	<ul style="list-style-type: none"> <i>As-Built Description:</i> Single accommodation restroom not accessible; multiple compliance violations. <i>Proposed Solution:</i> Remodel area to provide single-occupant accessible restroom. <i>Notes:</i> 39.5"x80" 	PCODE WA01 ADAAG 4.22 ADA 2010 603 CBC 2010 1115B.3.2 CBC 2013 11B-603 Priority 4 Severity 2 TBD Contract Work	1	JOB	\$30,000	\$30,000

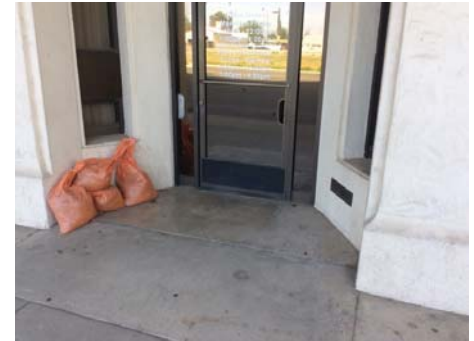
Door

4587	<ul style="list-style-type: none"> <i>As-Built Description:</i> Surface of required maneuvering clearance at door slopes more than 1/4":12" (2.0%). <i>As-Built:</i> 6.0% at 39" from door <i>Proposed Solution:</i> Modify surface slope at door. 	PCODE ID11 ADAAG 4.13.6 ADA 2010 404.2.4.4 CBC 2010 1133B.2.4 CBC 2013 11B-404.2.4 Priority 1 Severity 3 TBD Contract Work	30	SF	\$40	\$1,200
------	---	---	----	----	------	---------

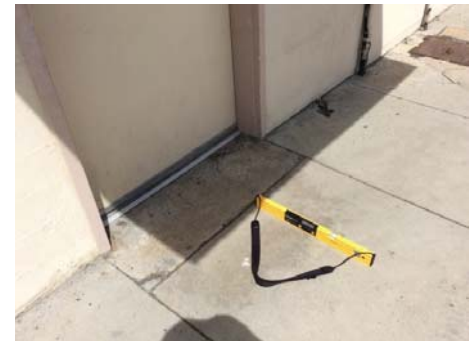
Door

4711	<ul style="list-style-type: none"> <i>As-Built Description:</i> Surface of required maneuvering clearance at door slopes more than 1/4":12" (2.0%). <i>As-Built:</i> 3.3% <i>Proposed Solution:</i> Modify surface slope at door. 	PCODE ID11 ADAAG 4.13.6 ADA 2010 404.2.4.4 CBC 2010 1133B.2.4 CBC 2013 11B-404.2.4 Priority 1 Severity 4 TBD Contract Work	30	SF	\$40	\$1,200
------	--	---	----	----	------	---------

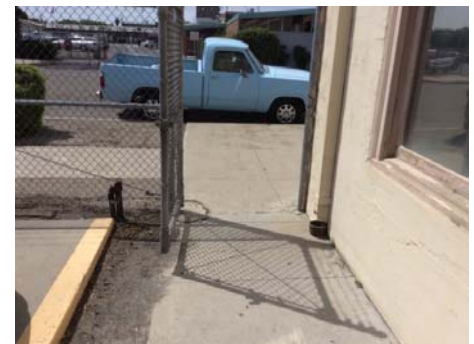
Door Swing

4710	<ul style="list-style-type: none"> <i>As-Built Description:</i> Front approach: At pull side, door does not have clear and level maneuvering space measuring door width plus 18"(CA only: 24" at exterior doors)x 60". <i>As-Built:</i> 3" <i>Proposed Solution:</i> Extend maneuvering space. 	PCODE ID23D ADAAG Fig. 25(a) ADA 2010 404.2.4 CBC 2010 11B-26A(a) CBC 2013 11B-404.2.4 Priority 1 Severity 2 TBD Contract Work	1	JOB	\$800	\$800
------	---	---	---	-----	-------	-------

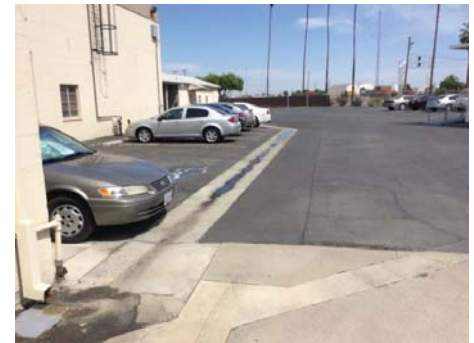
Parking

4714 • *As-Built Description:*
 Disabled persons must wheel or walk behind parked car(s) other than their own.

• *Notes:*
Recommend using main entrance at street for Bldg 2

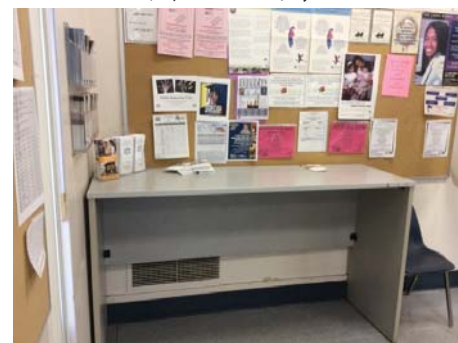
Non-Fixed Desk

- 4593
- *As-Built Description:*
Accessible non-fixed table or desk (top 28" to 34" high; knee space at least 27" high x 19" deep x 30" wide) not provided.
 - *As-Built:* 42" top
 - *Proposed Solution:*
Provide table or desk with accessible dimensions when purchasing new furniture.

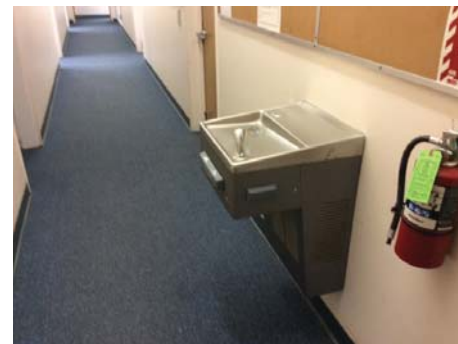
Drinking Fountain

Item No. and Name	Existing Architectural Barrier and Proposed Solution	Codes / Mitigation Info	Qty	Unit	Cost	Total
4602	<ul style="list-style-type: none"> As-Built Description: CA only: Drinking fountain not located in an alcove (min. 32" wide x 18" deep) or otherwise encroaches into pedestrian way. Proposed Solution: Provide new alcove for drinking fountain, or, if unreasonable hardship is determined, provide wing walls or cane-detectable railings on each side of the drinking fountain. The wings must project out from the supporting wall at least as far as the drinking fountain to within 6" of the surface of the circulation path, but cannot reduce the required clear width of the adjacent accessible route. 	PCODE IA04 CBC 2010 1115B.4.6.3; Fig. CBC 2013 11B-602.9 Priority 3 Severity 2 TBD Contract Work	1	JOB	\$3,000	\$3,000

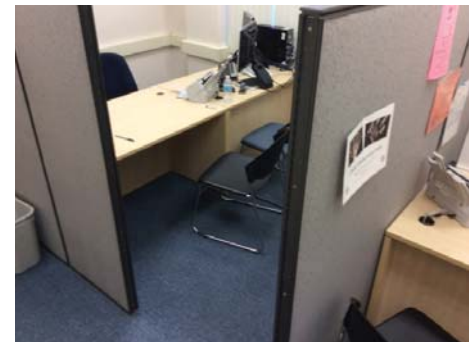
Non-Fixed Desk

4615	<ul style="list-style-type: none"> As-Built Description: Accessible non-fixed table or desk (top 28" to 34" high; knee space at least 27" high x 19" deep x 30" wide) not provided. As-Built: No knee clearances Proposed Solution: Provide table or desk with accessible dimensions when purchasing new furniture. Notes: Use booth 2. or reverse one desk at booth 6 	PCODE IN02A ADAAG 4.32.3 & .4 ADA 2010 306.1 CBC 2010 1122B.3 & 4 CBC 2013 11B-306.1 & 11B-902.3 Priority 2 Severity 2 TBD Contract Work	1	JOB	\$1,600	\$1,600
------	--	---	---	-----	---------	---------

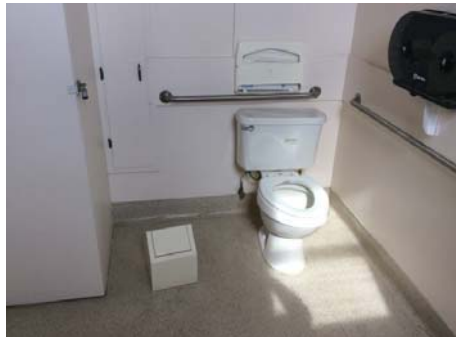
<u>Water Closet</u>						
4621	<ul style="list-style-type: none"> <i>As-Built Description:</i> Water closet not 17"-18" from near side wall to center line of water closet (2010 ADAS: 16"-18"). <i>As-Built:</i> 19" o.c. <i>Proposed Solution:</i> Relocate existing water closet and plumbing, remount with offset closet flange to provide 17"-18" from side wall. 	PCODE WB02C ADAAG Fig. 28 ADA 2010 604.2 CBC 2010 1115B.4.1.1 CBC 2013 11B-604.2 Priority 3 Severity 4 TBD Contract Work	1	JOB	\$500	\$500

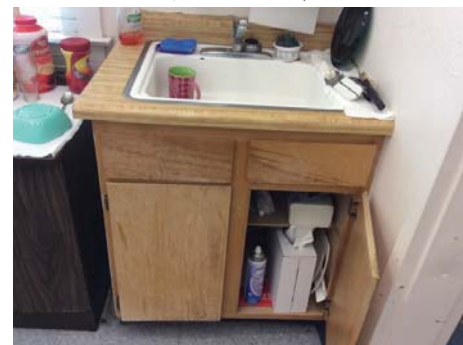
Item No. and Name	Existing Architectural Barrier and Proposed Solution	Codes / Mitigation Info	Qty	Unit	Cost	Total
4630	<ul style="list-style-type: none"> As-Built Description: Sink rim higher than 34" above floor. As-Built: 35.5" Proposed Solution: Remodel sink cabinet to lower sink. 	PCODE IN06REF ADAAG 4.24.2 ADA 2010 606.3 CBC 2010 1115B.4.7.1 CBC 2013 11B-606.3 Priority 4 Severity 4 TBD Contract Work

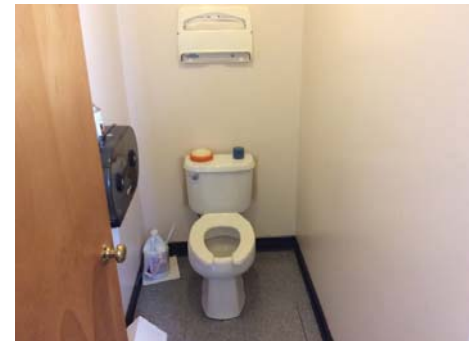
4633 • *As-Built Description:*
 Single accommodation restroom not accessible; multiple compliance violations.

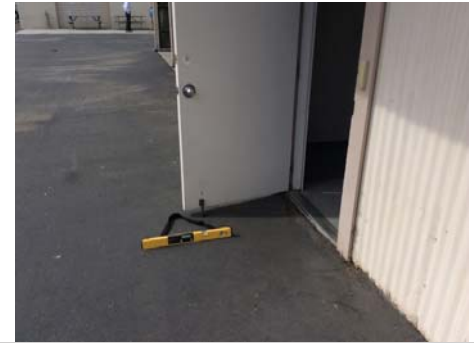
Door

4647	<ul style="list-style-type: none"> <i>As-Built Description:</i> Surface of required maneuvering clearance at door slopes more than 1/4":12" (2.0%). <i>As-Built:</i> 3.2% <i>Proposed Solution:</i> Modify surface slope at door. 	PCODE ID11 ADAAG 4.13.6 ADA 2010 404.2.4.4 CBC 2010 1133B.2.4 CBC 2013 11B-404.2.4 Priority 1 Severity 4 TBD Contract Work	30	SF	\$40	\$1,200
------	--	---	----	----	------	---------

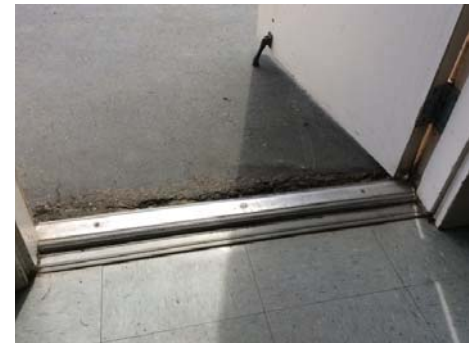
Door Threshold

4649	<ul style="list-style-type: none"> <i>As-Built Description:</i> Existing threshold at door is 1/2" high or less but without a beveled edge on both sides. <i>As-Built:</i> 0.75" <i>Proposed Solution:</i> Modify threshold to have beveled edge on each side. 	PCODE ID02 ADAAG 4.1.6(3)(d)(ii) ADA 2010 404.2.5 CBC 2010 1133B.2.4.1 CBC 2013 11B-404.2.5 Priority 1 Severity 4 TBD Contract Work	1	JOB	\$250	\$250
------	---	--	---	-----	-------	-------

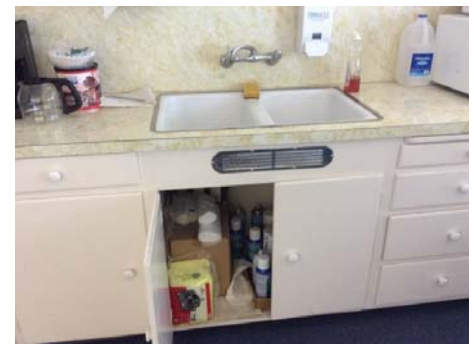
4654	<ul style="list-style-type: none"> <i>As-Built Description:</i> Sink does not have knee space min. 27" high x 19" deep x 30" wide. <i>Proposed Solution:</i> Remodel sink cabinet. 	PCODE IN06A ADAAG 4.24.3 ADA 2010 606.2 CBC 2010 1115B.4.7.1 CBC 2013 11B-606.2 Priority 2 Severity 2 TBD Contract Work	1	JOB	\$1,750	\$1,750
------	--	--	---	-----	---------	---------

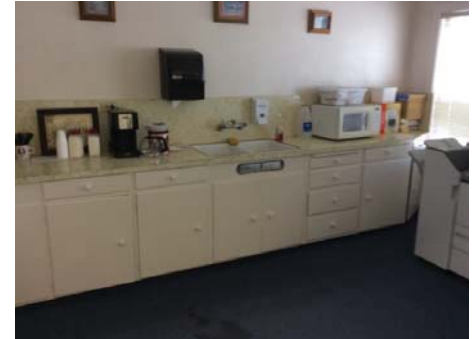
Item No. and Name	Existing Architectural Barrier and Proposed Solution	Codes / Mitigation Info	Qty	Unit	Cost	Total
4653	<ul style="list-style-type: none"> • <i>As-Built Description:</i> Sink rim higher than 34" above floor. • <i>As-Built:</i> 35.5" • <i>Proposed Solution:</i> Remodel sink cabinet to lower sink. 	PCODE IN06REF ADAAG 4.24.2 ADA 2010 606.3 CBC 2010 1115B.4.7.1 CBC 2013 11B-606.3 Priority 3 Severity 4 TBD Contract Work

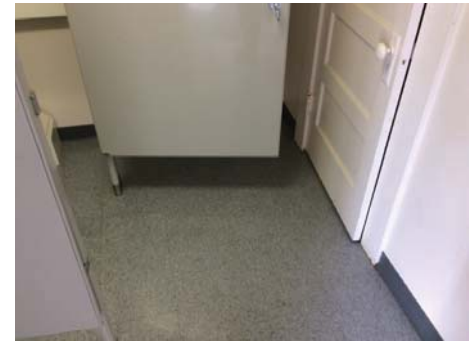
Door Swing

4666	<ul style="list-style-type: none"> • <i>As-Built Description:</i> Latch approach: At pull side, door does not have clear and level maneuvering space measuring door width plus 24" x 48" or 54" if door has closer (CA only: door width plus 24" x 60"). • <i>As-Built:</i> Stall 45" to wall • <i>Proposed Solution:</i> Remodel restroom as needed. 	PCODE ID27BNT ADAAG Fig. 25(c) ADA 2010 404.2.4 CBC 2010 11B-26A(c) CBC 2013 11B-404.2.4 Priority 3 Severity 4 TBD Contract Work	1	JOB	\$1,600	\$1,600
------	--	---	---	-----	---------	----------------

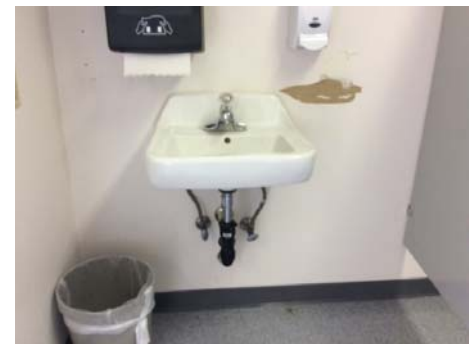
Lavatory

4663	<ul style="list-style-type: none"> • <i>As-Built Description:</i> Lavatory: Fixture rim or counter height more than 34" above floor. • <i>As-Built:</i> 34.75" • <i>Proposed Solution:</i> Remount compliant fixture at accessible height. 	PCODE WD02A ADAAG 4.19.2 ADA 2010 606.3 CBC 2010 1115B.4.3 CBC 2013 11B-606.3 Priority 3 Severity 4 TBD Contract Work	1	JOB	\$900	\$900
------	---	--	---	-----	-------	--------------

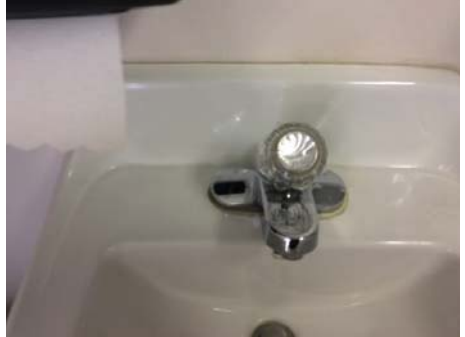
Item No. and Name	Existing Architectural Barrier and Proposed Solution	Codes / Mitigation Info	Qty	Unit	Cost	Total
<u>Lavatory</u>						
4662	<ul style="list-style-type: none"> <i>As-Built Description:</i> Lavatory: Accessible faucet (lever-operated, push-type or electronically controlled) not provided at otherwise accessible lavatory. <i>Proposed Solution:</i> Provide accessible faucet at accessible lavatory. 	PCODE WD06 ADAAG 4.19.5 ADA 2010 606.4 CBC 2010 1115B.4.3 CBC 2013 11B-606.4 Priority 3 Severity 3 TBD Contract Work	1	JOB	\$600	\$600

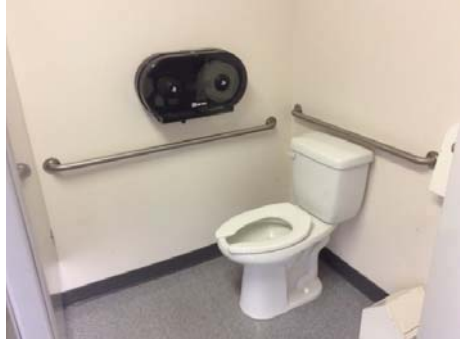
<u>Restroom</u>							
4656	<ul style="list-style-type: none"> <i>As-Built Description:</i> Multiple accommodation restroom not accessible; multiple compliance violations. <i>Proposed Solution:</i> Remodel area to provide accessible restroom with one accessible stall, lavatory (and one urinal at Mens). 	PCODE WA01AREF ADAAG 4.22 ADA 2010 603 CBC 2010 1115B.3.1 CBC 2013 11B-603 Priority 3 Severity 1 TBD Contract Work	REF

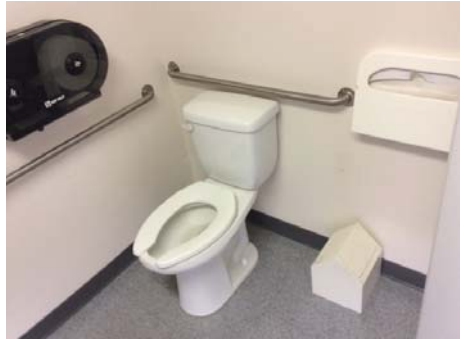
<u>Toilet Stall</u>						
4670	<ul style="list-style-type: none"> <i>As-Built Description:</i> Toilet stall less than 60" wide. <i>As-Built:</i> 57.5" <i>Proposed Solution:</i> Provide new accessible stall. 	PCODE WB06 ADAAG 4.17.3 ADA 2010 604.8.1.1 CBC 2010 1115B.3.1.4.1 CBC 2013 11B-604.8.1.1 Priority 3 Severity 4 TBD Contract Work	1	JOB	\$1,500	\$1,500

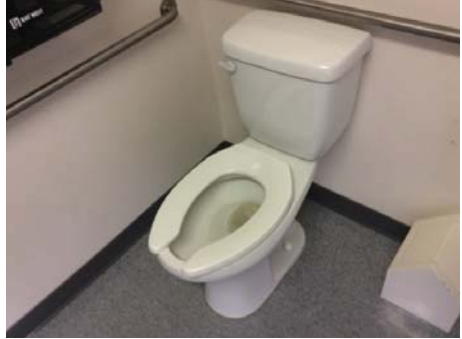
Item No. and Name	Existing Architectural Barrier and Proposed Solution	Codes / Mitigation Info	Qty	Unit	Cost	Total
<u>Water Closet</u>						
4672	<ul style="list-style-type: none"> <i>As-Built Description:</i> Water closet not 17"-18" from near side wall to center line of water closet (2010 ADAS: 16"-18"). <i>As-Built:</i> 19" o.c. <i>Proposed Solution:</i> Relocate existing water closet and plumbing, remount with offset closet flange to provide 17"-18" from side wall. 	PCODE WB02C ADAAG Fig. 28 ADA 2010 604.2 CBC 2010 1115B.4.1.1 CBC 2013 11B-604.2 Priority 3 Severity 4 TBD Contract Work	1	JOB	\$500	\$500

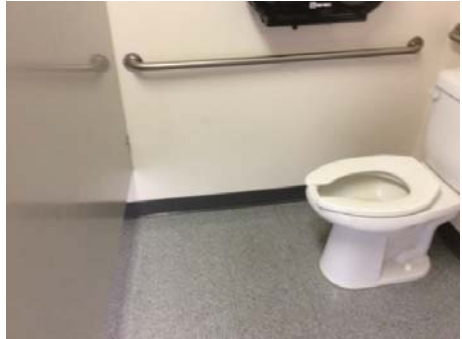
4667	<ul style="list-style-type: none"> <i>As-Built Description:</i> CA only: In single-accommodation restroom less than 48" in front of water closet provided. <i>As-Built:</i> 28" <i>Proposed Solution:</i> Remodel restroom to provide at least 48" in front of water closet. <i>Notes:</i> out swing door 	PCODE WB03A CBC 2010 1115B.3.2.1 CBC 2013 11B-604.3.1 Priority 3 Severity 1 TBD Contract Work	1	JOB	\$5,000	\$5,000

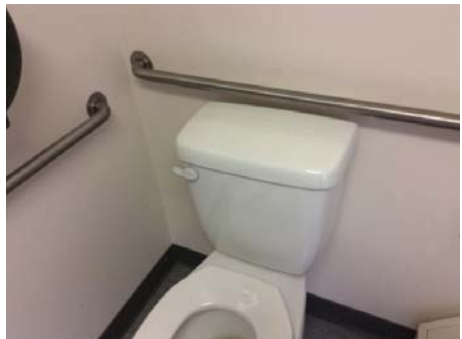
4671	<ul style="list-style-type: none"> <i>As-Built Description:</i> Flush Control: Operating handle not mounted toward wide side of stall. <i>Proposed Solution:</i> Replace flush control with properly mounted accessible type, or install sensor flush. 	PCODE WB10 ADAAG 4.16.5 ADA 2010 604.6 CBC 2010 1115B.4.1.5 CBC 2013 11B-604.6 Priority 3 Severity 3 TBD Contract Work	1	JOB	\$500	\$500

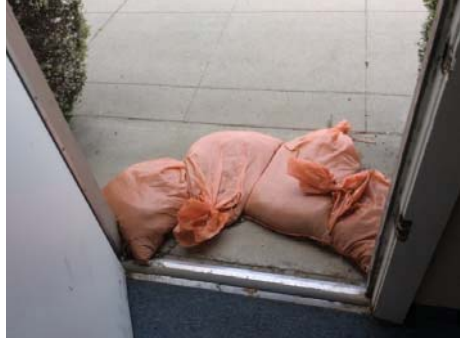
Item No. and Name	Existing Architectural Barrier and Proposed Solution	Codes / Mitigation Info	Qty	Unit	Cost	Total
<u>Door Threshold</u>						
4682	<ul style="list-style-type: none"> As-Built Description: Door inaccessible due to threshold or step at door exceeding 1/2". As-Built: sandbags Proposed Solution: Modify threshold to be no more than 1/2" by removing existing paving at door and providing landing with edge ramping (slope 1:20 max). 	PCODE ID02A ADAAG 4.13.8 ADA 2010 404.2.5 CBC 2010 1133B.2.4.1 CBC 2013 11B-404.2.5 Priority 2 Severity 4 TBD Contract Work	1	JOB	\$400	\$400

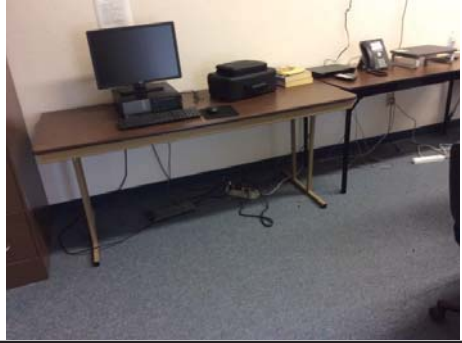
<u>Non-Fixed Desk</u>						
4685	<ul style="list-style-type: none"> As-Built Description: Accessible non-fixed table or desk (top 28" to 34" high; knee space at least 27" high x 19" deep x 30" wide) not provided. As-Built: 26.5" Proposed Solution: Provide table or desk with accessible dimensions when purchasing new furniture. 	PCODE IN02A ADAAG 4.32.3 & .4 ADA 2010 306.1 CBC 2010 1122B.3 & 4 CBC 2013 11B-306.1 & 11B-902.3 Priority 2 Severity 2 TBD Contract Work	1	JOB	\$1,600	\$1,600

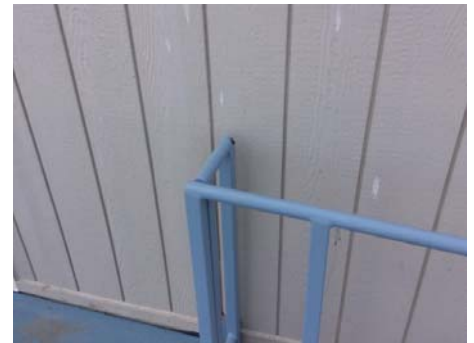
Top and Bottom Extension at Ramps

PCODE **ED05**
 ADAAG **4.8.5(2)**
 ADA 2010 **505.10.1**
 CBC 2010 **1133B.4.2.2 &**
 CBC 2013 **11B-505.10.1**
 Priority **1**
 Severity **2**
TBD Contract Work

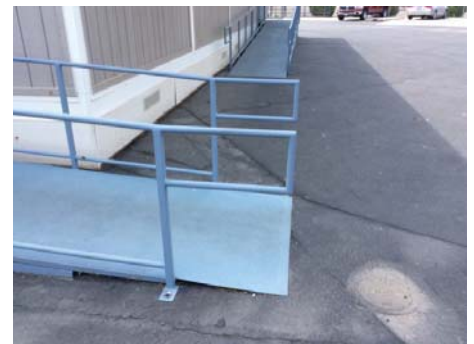
- *As-Built Description:*
Ramp handrail does not extend horizontally 12" past top and / or bottom of ramp.
- *As-Built:* Not at landing
- *Proposed Solution:*
Provide ramp handrail extension (cost for each extension piece).
- *Notes:*
Provide landing at bottom and feather out
