Facility: **WOMENS INFANTS & CHILDREN**

Address: 330 HARRIS ST.

Facility: **LEMORE HEALTH CLINIC**
 Address: 229 C ST.

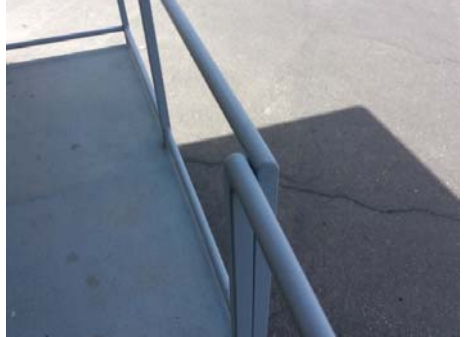
Item No. and Name	Existing Architectural Barrier and Proposed Solution	Codes / Mitigation Info	Qty	Unit	Cost	Total
<u>Handrail</u>						
4692	<ul style="list-style-type: none"> <i>As-Built Description:</i> Handrail: Gripping surface (rail top and sides) interrupted by support or other obstruction. <i>As-Built:</i> Not continuous <i>Proposed Solution:</i> Provide additional handrail as needed. <i>Notes:</i> This interruption was done to provide 60" for door clearance 	PCODE ED10 ADAAG 4.9.4(4) ADA 2010 505.3 CBC 2010 1133B.4.2.6 CBC 2013 11B-505.3 Priority 1 Severity 3 TBD Contract Work	5	LF	\$75	\$375

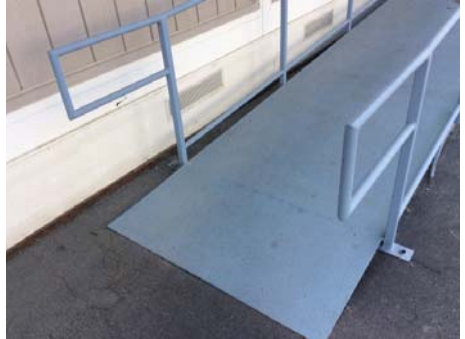
<u>Slope</u>						
4690	<ul style="list-style-type: none"> <i>As-Built Description:</i> Slope greater than 1:12 (8.3%). <i>As-Built:</i> 9.8% <i>Proposed Solution:</i> Demolish existing and provide new ramp with handrails. <i>Notes:</i> Provide landing at bottom and feather out 	PCODE EB02 ADAAG 4.8.2 ADA 2010 405.2 CBC 2010 1133B.5.3 CBC 2013 11B-405.2 Priority 1 Severity 4 TBD Contract Work	24	SF	\$100	\$2,400

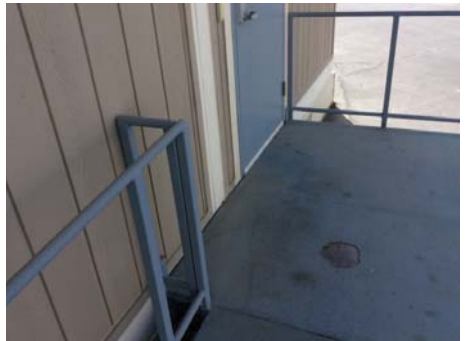
<u>Top and Bottom Extension at Ramps</u>						
4691	<ul style="list-style-type: none"> <i>As-Built Description:</i> Ramp handrail does not extend horizontally 12" past top and / or bottom of ramp. <i>Proposed Solution:</i> Provide ramp handrail extension (cost for each extension piece). 	PCODE ED05 ADAAG 4.8.5(2) ADA 2010 505.10.1 CBC 2010 1133B.4.2.2 & CBC 2013 11B-505.10.1 Priority 1 Severity 2 TBD Contract Work	1	JOB	\$170	\$170

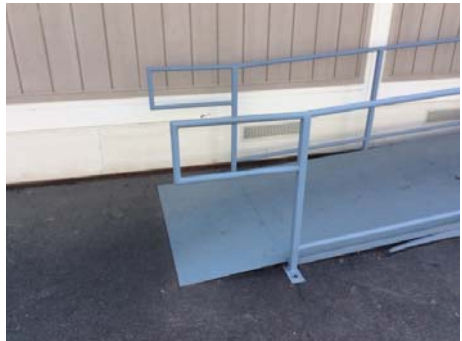
Item No. and Name	Existing Architectural Barrier and Proposed Solution	Codes / Mitigation Info	Qty	Unit	Cost	Total
4689	<ul style="list-style-type: none"> <i>As-Built Description:</i> Ramp handrail does not extend horizontally 12" past top and / or bottom of ramp. <i>As-Built:</i> Not at landing <i>Proposed Solution:</i> Provide ramp handrail extension (cost for each extension piece). 	PCODE ED05REF ADAAG 4.8.5(2) ADA 2010 505.10.1 CBC 2010 1133B.4.2.2 & CBC 2013 11B-505.10.1 Priority 1 Severity 4 TBD Contract Work

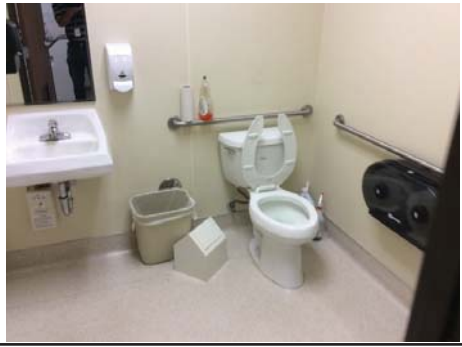
Toilet Stall

4706	<ul style="list-style-type: none"> <i>As-Built Description:</i> The lavatory or other unintended fixture, encroaches on the necessary clearance around a water closet (60" x 56"). <i>As-Built:</i> 30" to lavatory, 54" to side wall <i>Proposed Solution:</i> Remove adjacent fixture and provide new enclosure at accessible water closet. 	PCODE WB01A ADA 2010 604.3.1; 604.3.2 CBC 2013 11B-604.3.1; 11B-604.3.2 Priority 4 Severity 4 TBD Contract Work	1	JOB	\$2,000	\$2,000
------	--	--	---	-----	---------	---------

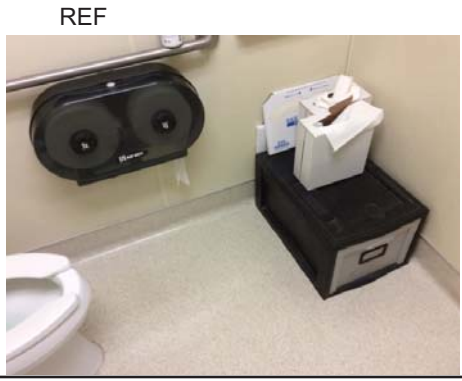
Water Closet

4708	<ul style="list-style-type: none"> <i>As-Built Description:</i> CA only: In single-accommodation restroom less than 48" in front of water closet provided. <i>As-Built:</i> storage items 30" <i>Proposed Solution:</i> Remodel restroom to provide at least 48" in front of water closet. <i>Notes:</i> relocate items if requested 	PCODE WB03AREF CBC 2010 1115B.3.2.1 CBC 2013 11B-604.3.1 Priority 4 Severity 1 TBD Contract Work				
------	--	---	--	--	--	--

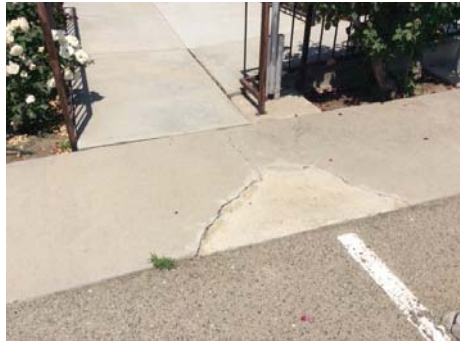
Changes in Level

4212	<ul style="list-style-type: none"> <i>As-Built Description:</i> Walk: Pavement dislocation creates abrupt change in level exceeding 1/2" in accessible route. <i>As-Built:</i> 0.5" <i>Proposed Solution:</i> Remove, replace or repair area of pavement sufficient to correct abrupt change in level. 	PCODE EF03 ADAAG 4.3.8 ADA 2010 403.4 CBC 2010 1133B.7.4 CBC 2013 11B-403.4 Priority 1 Severity 4 TBD Contract Work	4	SF	\$21	\$84
------	---	--	---	----	------	------

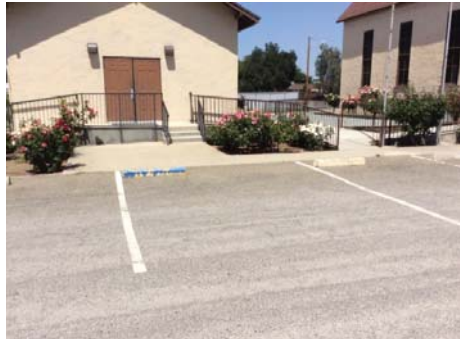
Parking

4209	<ul style="list-style-type: none"> <i>As-Built Description:</i> Accessible parking space does not have 5' wide access aisle; 8' wide for van accessible aisle. <i>Proposed Solution:</i> Modify parking aisle(s) to create accessible space by restriping. 	PCODE EA02B ADAAG 4.6.3 ADA 2010 502.3 CBC 2010 1129B.3.1 CBC 2013 11B-502.2; 11B-502.3.1 Priority 1 Severity 1 TBD Contract Work	1	JOB	\$200	\$200
------	--	--	---	-----	-------	-------

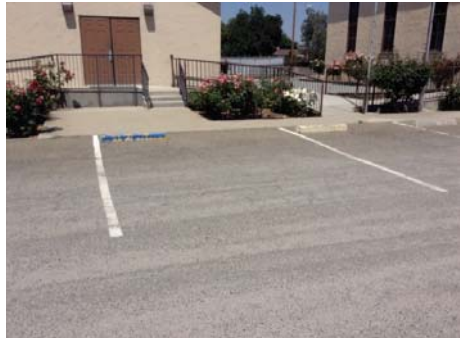
4210	<ul style="list-style-type: none"> <i>As-Built Description:</i> International Symbol of Accessibility (36" square, in white on blue) is not painted on the pavement near the rear end of the parking space (required in CA only). <i>Proposed Solution:</i> Apply symbol on parking space pavement when altering area. 	PCODE EA04A CBC 2010 1129B.4 CBC 2013 11B-502.6.4 Priority 1 Severity 4 TBD Contract Work	1	JOB	\$120	\$120
------	--	--	---	-----	-------	-------

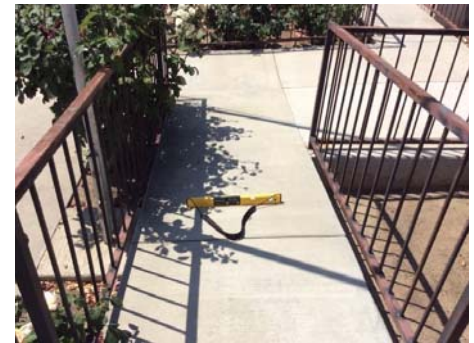
Cross Slope

- 4216
- *As-Built Description:*
 Ramp: Cross slope more than 1/4":12" (2%).
 - *As-Built:* 4.2%
 - *Proposed Solution:*
 Modify ramp's cross slope.

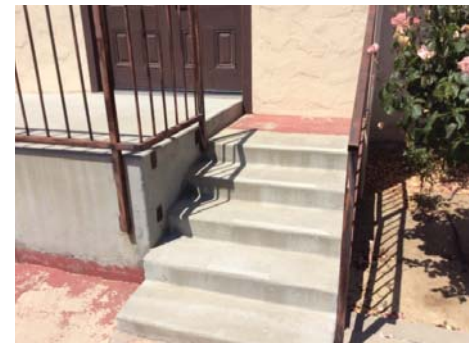
Handrails

- 4219
- *As-Built Description:*
 Handrail not provided at stairs or ramp, required on both sides (not required at curb ramps or adjacent to seating areas).
 - *Proposed Solution:*
 Provide new handrail for each side including extensions.

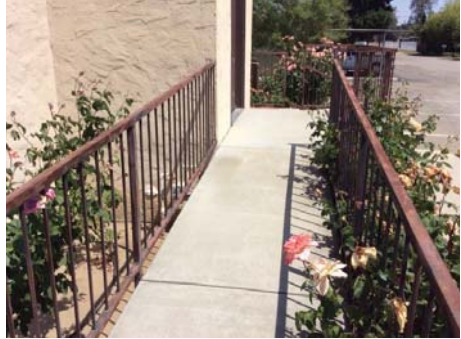
Item No. and Name	Existing Architectural Barrier and Proposed Solution	Codes / Mitigation Info	Qty	Unit	Cost	Total
Height						
4217	<ul style="list-style-type: none"> As-Built Description: Handrail gripping surface top not mounted between 34" and 38" above ramp surface or stair nosings. As-Built: 38.5" Proposed Solution: Remove existing and provide new handrail. 	PCODE ED02 ADAAG 4.9.4(5) ADA 2010 505.4 CBC 2010 1133B.4.2.1 & CBC 2013 11B-505.4 Priority 1 Severity 4 TBD Contract Work	68	LF	\$75	\$5,100

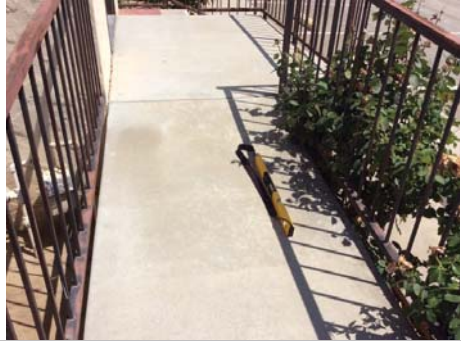
Slope						
4215	<ul style="list-style-type: none"> As-Built Description: Slope greater than 1:12 (8.3%). As-Built: 8.7% upper part of ramp Proposed Solution: Demolish existing and provide new ramp with handrails. 	PCODE EB02 ADAAG 4.8.2 ADA 2010 405.2 CBC 2010 1133B.5.3 CBC 2013 11B-405.2 Priority 1 Severity 4 TBD Contract Work	32	SF	\$100	\$3,200

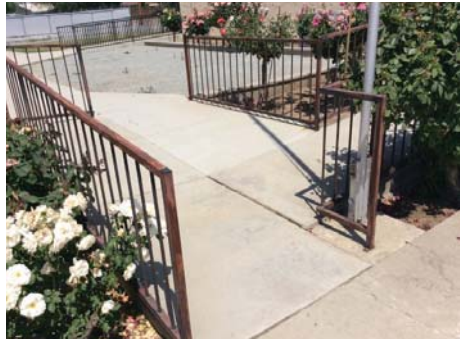
4213	<ul style="list-style-type: none"> As-Built Description: Level 2% max. landing for ramp not provided. As-Built: 3.9-4.9% Proposed Solution: Rebuild ramp to provide landings for each ramp run with slopes no greater than 2% 	PCODE EB05A ADAAG 4.8.4 ADA 2010 405.7.1 CBC 2010 1133B.5.4.1 CBC 2013 11B-405.7.1 Priority 1 Severity 3 TBD Contract Work	126	SF	\$100	\$12,600

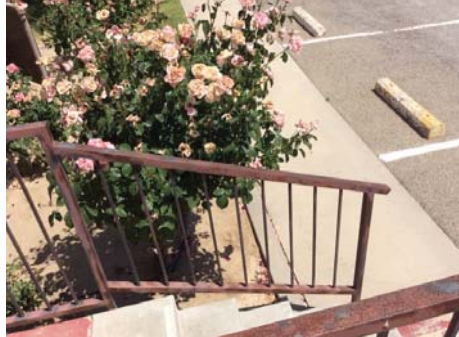
Item No. and Name	Existing Architectural Barrier and Proposed Solution	Codes / Mitigation Info	Qty	Unit	Cost	Total
<u>Top & Bottom Extension at Stairs</u>						
4220	<ul style="list-style-type: none"> <i>As-Built Description:</i> Stair handrail does not extend horizontally 12" minimum beyond top nosing, and one tread width sloped, plus 12" minimum horizontally beyond the bottom nosing. <i>Proposed Solution:</i> Extend stair handrail at top and bottom (cost for each extension piece). 	PCODE ED06 ADAAG 4.9.4(2) ADA 2010 505.10.2; 505.10.3 CBC 2010 1133B.4.2.2 CBC 2013 11B-505.10.2; 11B-505.10.3 Priority 4 Severity 2 TBD Contract Work	1	JOB	\$170	\$170

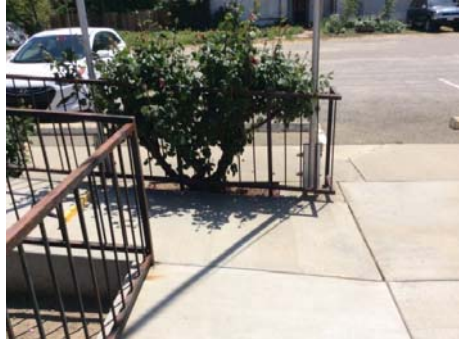
<u>Top and Bottom Extension at Ramps</u>						
4218	<ul style="list-style-type: none"> <i>As-Built Description:</i> Ramp handrail does not extend horizontally 12" past top and / or bottom of ramp. <i>Proposed Solution:</i> Provide ramp handrail extension (cost for each extension piece). 	PCODE ED05REF ADAAG 4.8.5(2) ADA 2010 505.10.1 CBC 2010 1133B.4.2.2 & CBC 2013 11B-505.10.1 Priority 1 Severity 2 TBD Contract Work	REF

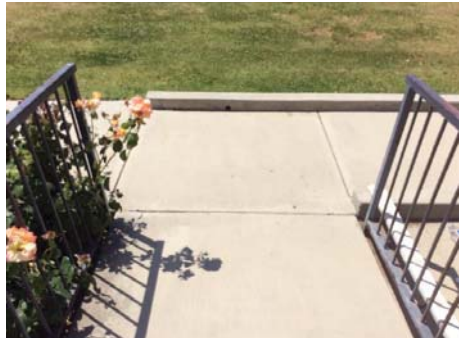
<u>Change in Direction</u>						
4227	<ul style="list-style-type: none"> <i>As-Built Description:</i> Landing at change of direction not 60" minimum by 72" minimum in the direction of downward travel from the upper ramp run. <i>As-Built:</i> 54" <i>Proposed Solution:</i> Modify landing at change of direction to 60" x 72". 	PCODE EB08REF ADAAG 4.8.4(3) ADA 2010 405.7.4 CBC 2010 1133B.5.4 CBC 2013 11B-405.7.4 Priority 1 Severity 3 TBD Contract Work	REF

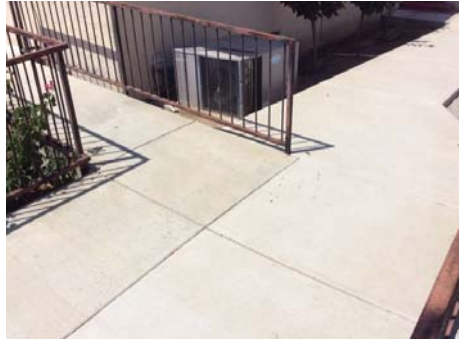
Item No. and Name	Existing Architectural Barrier and Proposed Solution	Codes / Mitigation Info	Qty	Unit	Cost	Total
4222	<ul style="list-style-type: none"> • <i>As-Built Description:</i> Landing at change of direction not 60" minimum by 72" minimum in the direction of downward travel from the upper ramp run. • <i>As-Built:</i> 57" • <i>Proposed Solution:</i> Modify landing at change of direction to 60" x 72". 	PCODE EB08REF ADAAG 4.8.4(3) ADA 2010 405.7.4 CBC 2010 1133B.5.4 CBC 2013 11B-405.7.4 Priority 1 Severity 4 TBD Contract Work				
			REF

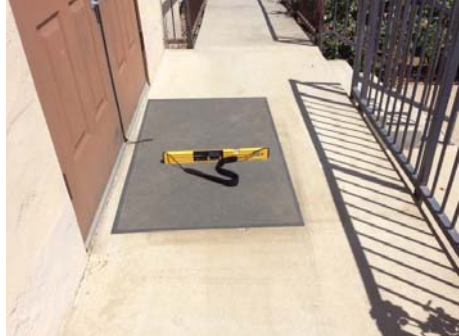
Door

4230	<ul style="list-style-type: none"> • <i>As-Built Description:</i> Surface of required maneuvering clearance at door slopes more than 1/4":12" (2.0%). • <i>As-Built:</i> 2.4% • <i>Proposed Solution:</i> Modify surface slope at door. 	PCODE ID11 ADAAG 4.13.6 ADA 2010 404.2.4.4 CBC 2010 1133B.2.4 CBC 2013 11B-404.2.4 Priority 1 Severity 4 TBD Contract Work	60	SF	\$40	\$2,400

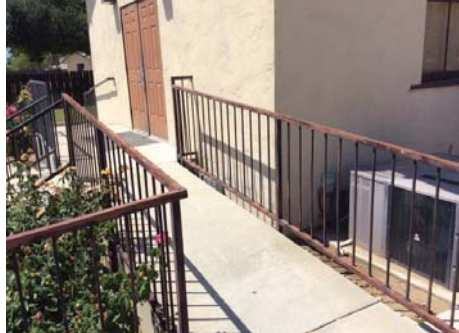
Height

4224	<ul style="list-style-type: none"> • <i>As-Built Description:</i> Handrail gripping surface top not mounted between 34" and 38" above ramp surface or stair nosings. • <i>As-Built:</i> 38.5" • <i>Proposed Solution:</i> Remove existing and provide new handrail. 	PCODE ED02 ADAAG 4.9.4(5) ADA 2010 505.4 CBC 2010 1133B.4.2.1 & CBC 2013 11B-505.4 Priority 1 Severity 4 TBD Contract Work	30	LF	\$75	\$2,250

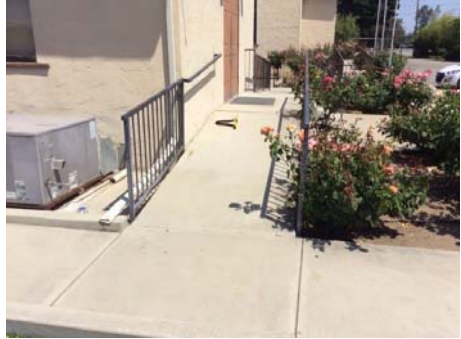
Item No. and Name	Existing Architectural Barrier and Proposed Solution	Codes / Mitigation Info	Qty	Unit	Cost	Total
Slope						
4226	<ul style="list-style-type: none"> <i>As-Built Description:</i> Slope greater than 1:12 (8.3%). <i>As-Built:</i> Left Ramp 12.7% <i>Proposed Solution:</i> Demolish existing and provide new ramp with handrails. <i>Notes:</i> Provide directional sign to other ramp. 	PCODE EB02 ADAAG 4.8.2 ADA 2010 405.2 CBC 2010 1133B.5.3 CBC 2013 11B-405.2 Priority 1 Severity 3 TBD Contract Work	48	SF	\$100	\$4,800

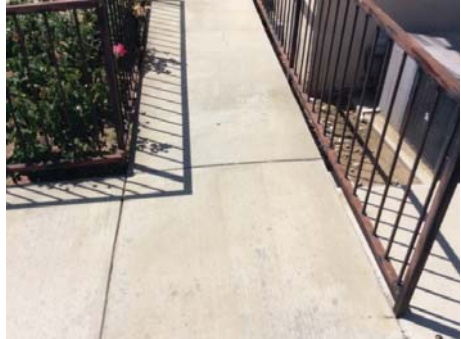
4223	<ul style="list-style-type: none"> <i>As-Built Description:</i> Level 2% max. landing for ramp not provided. <i>As-Built:</i> 5.4% <i>Proposed Solution:</i> Rebuild ramp to provide landings for each ramp run with slopes no greater than 2% 	PCODE EB05AREF ADAAG 4.8.4 ADA 2010 405.7.1 CBC 2010 1133B.5.4.1 CBC 2013 11B-405.7.1 Priority 1 Severity 3 TBD Contract Work	REF

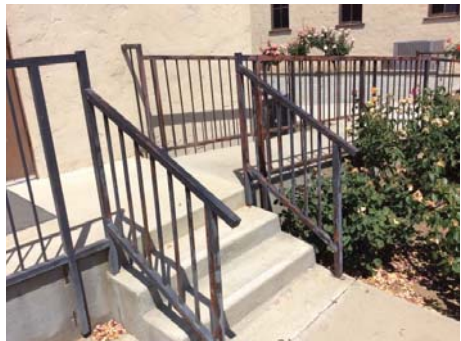
Top & Bottom Extension at Stairs

4232	<ul style="list-style-type: none"> <i>As-Built Description:</i> Stair handrail does not extend horizontally 12" minimum beyond top nosing, and one tread width sloped, plus 12" minimum horizontally beyond the bottom nosing. <i>Proposed Solution:</i> Extend stair handrail at top and bottom (cost for each extension piece). 	PCODE ED06 ADAAG 4.9.4(2) ADA 2010 505.10.2; 505.10.3 CBC 2010 1133B.4.2.2 CBC 2013 11B-505.10.2; 11B-505.10.3 Priority 4 Severity 2 TBD Contract Work	1	JOB	\$170	\$170

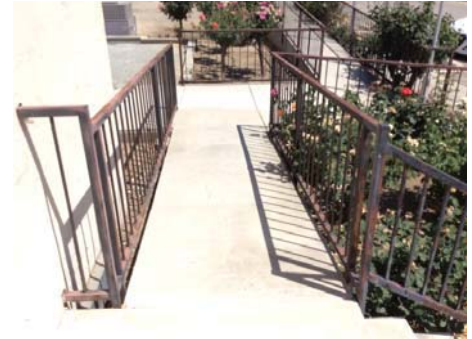
- 4228
- *As-Built Description:*
Ramp handrail does not extend horizontally 12" past top and / or bottom of ramp.
 - *Proposed Solution:*
Provide ramp handrail extension (cost for each extension piece).

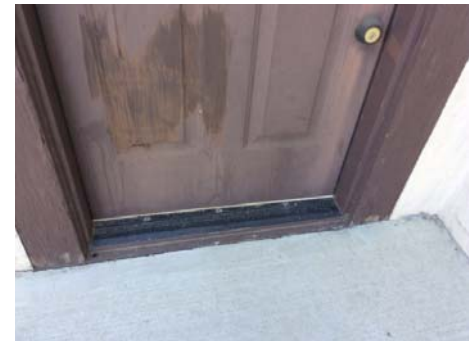
Door Threshold

4234 • *As-Built Description:*
 Door inaccessible due to threshold or step at door exceeding 1/2".
 • *As-Built:* 1.25"
 • *Proposed Solution:*
 Modify threshold to be no more than 1/2" by removing existing paving at door and providing landing with edge ramping (slope 1:20 max).

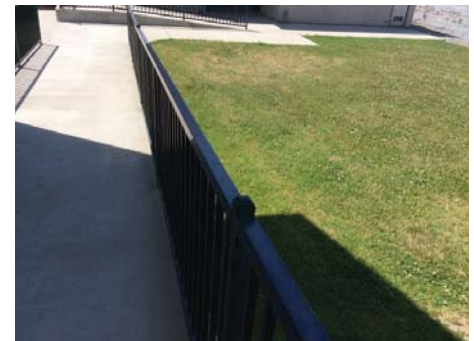
Handrail

4237 • *As-Built Description:*
 Handrail: Gripping surface (rail top and sides) interrupted by support or other obstruction.
 • *As-Built:* Gripping surface has interruptions
 • *Proposed Solution:*
 Provide additional handrail as needed.

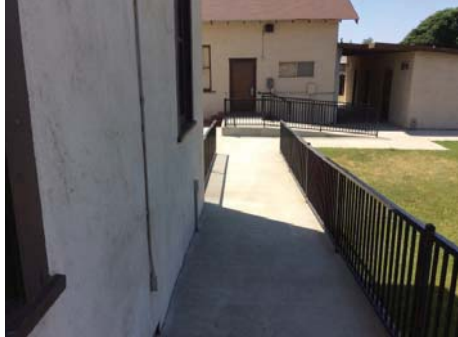
Item No. and Name	Existing Architectural Barrier and Proposed Solution	Codes / Mitigation Info	Qty	Unit	Cost	Total
<u>Handrails</u>						
4236	<ul style="list-style-type: none"> <i>As-Built Description:</i> Handrail not provided at stairs or ramp, required on both sides (not required at curb ramps or adjacent to seating areas). <i>Proposed Solution:</i> Provide new handrail for each side including extensions. <i>Notes:</i> Handrails abruptly end on one side 	PCODE ED01 ADAAG 4.8.5 & 4.9.4 ADA 2010 505.2 CBC 2010 1133B.4.1.1 & .5.5 CBC 2013 11B-505.2 Priority 3 Severity 2 TBD Contract Work	23	LF	\$95	\$2,185

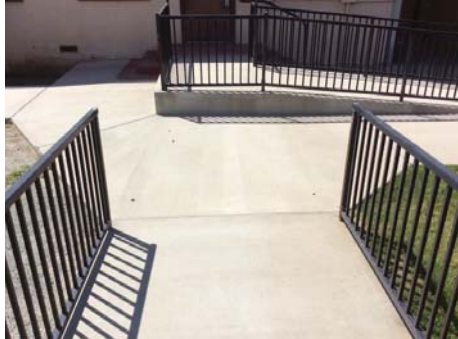
<u>Top and Bottom Extension at Ramps</u>						
4238	<ul style="list-style-type: none"> <i>As-Built Description:</i> Ramp handrail does not extend horizontally 12" past top and / or bottom of ramp. <i>Proposed Solution:</i> Provide ramp handrail extension (cost for each extension piece). 	PCODE ED05 ADAAG 4.8.5(2) ADA 2010 505.10.1 CBC 2010 1133B.4.2.2 & CBC 2013 11B-505.10.1 Priority 3 Severity 2 TBD Contract Work	1	JOB	\$170	\$170

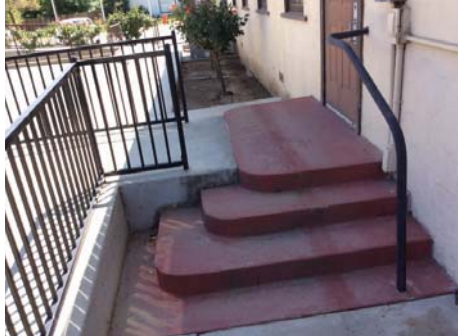
<u>Handrails</u>						
4243	<ul style="list-style-type: none"> <i>As-Built Description:</i> Handrail not provided at stairs or ramp, required on both sides (not required at curb ramps or adjacent to seating areas). <i>Proposed Solution:</i> Provide new handrail for each side including extensions. 	PCODE ED01 ADAAG 4.8.5 & 4.9.4 ADA 2010 505.2 CBC 2010 1133B.4.1.1 & .5.5 CBC 2013 11B-505.2 Priority 2 Severity 2 TBD Contract Work	12	LF	\$95	\$1,140

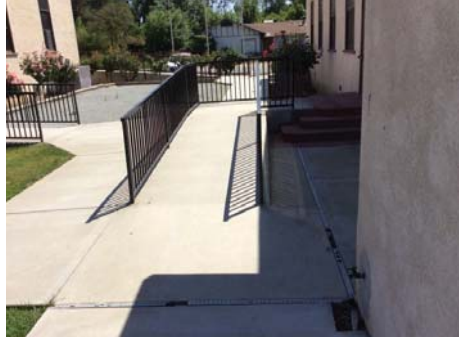
Item No. and Name	Existing Architectural Barrier and Proposed Solution	Codes / Mitigation Info	Qty	Unit	Cost	Total
<u>Slope</u>						
4240	<ul style="list-style-type: none"> <i>As-Built Description:</i> Slope greater than 1:12 (8.3%). <i>As-Built:</i> 9.1-10.1% <i>Proposed Solution:</i> Demolish existing and provide new ramp with handrails. 	PCODE EB02 ADAAG 4.8.2 ADA 2010 405.2 CBC 2010 1133B.5.3 CBC 2013 11B-405.2 Priority 2 Severity 4 TBD Contract Work	48	SF	\$100	\$4,800

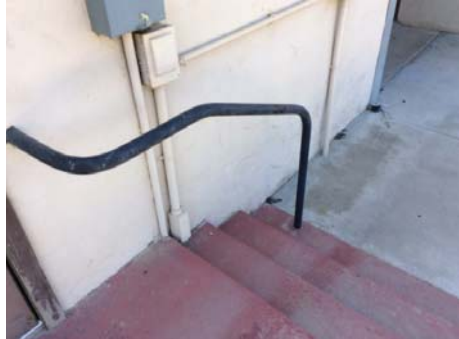
<u>Top & Bottom Extension at Stairs</u>						
4245	<ul style="list-style-type: none"> <i>As-Built Description:</i> Stair handrail does not extend horizontally 12" minimum beyond top nosing, and one tread width sloped, plus 12" minimum horizontally beyond the bottom nosing. <i>As-Built:</i> lower <i>Proposed Solution:</i> Extend stair handrail at top and bottom (cost for each extension piece). 	PCODE ED06 ADAAG 4.9.4(2) ADA 2010 505.10.2; 505.10.3 CBC 2010 1133B.4.2.2 CBC 2013 11B-505.10.2; 11B-505.10.3 Priority 2 Severity 2 TBD Contract Work	1	JOB	\$170	\$170

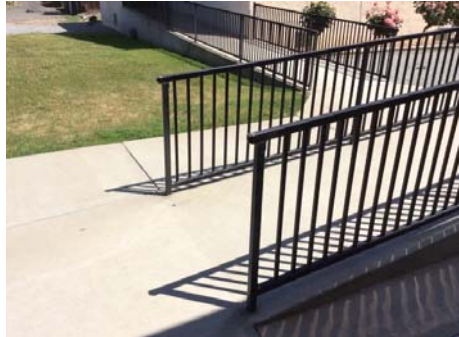
<u>Top and Bottom Extension at Ramps</u>						
4241	<ul style="list-style-type: none"> <i>As-Built Description:</i> Ramp handrail does not extend horizontally 12" past top and / or bottom of ramp. <i>Proposed Solution:</i> Provide ramp handrail extension (cost for each extension piece). 	PCODE ED05REF ADAAG 4.8.5(2) ADA 2010 505.10.1 CBC 2010 1133B.4.2.2 & CBC 2013 11B-505.10.1 Priority 2 Severity 2 TBD Contract Work	REF

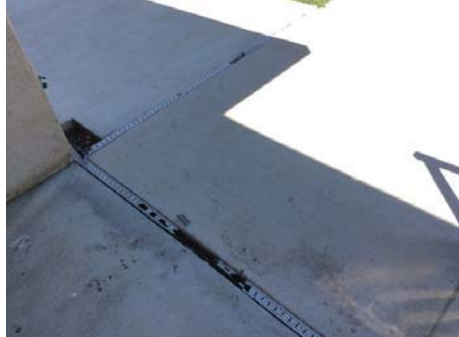
Item No. and Name	Existing Architectural Barrier and Proposed Solution	Codes / Mitigation Info	Qty	Unit	Cost	Total
<u>Changes in Level</u>						
4242	<ul style="list-style-type: none"> <i>As-Built Description:</i> Walk: Pavement dislocation creates abrupt change in level exceeding 1/2" in accessible route. <i>As-Built:</i> 1.5" <i>Proposed Solution:</i> Remove, replace or repair area of pavement sufficient to correct abrupt change in level. 	PCODE EF03 ADAAG 4.3.8 ADA 2010 403.4 CBC 2010 1133B.7.4 CBC 2013 11B-403.4 Priority 3 Severity 3 TBD Contract Work	4	SF	\$21	\$84

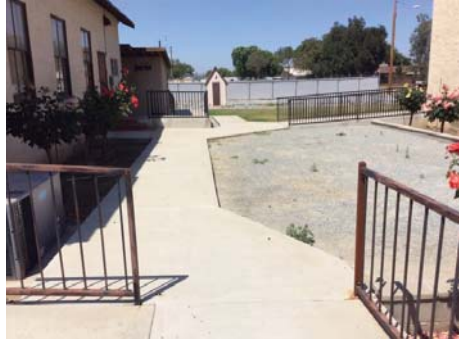
<u>Cross Slope</u>						
4239	<ul style="list-style-type: none"> <i>As-Built Description:</i> Cross slope more than 1":48" (2.083%). <i>As-Built:</i> 3.2%-5.4% <i>Proposed Solution:</i> Modify cross slope. 	PCODE EF07 ADAAG 4.3.7 ADA 2010 403.3 CBC 2010 1133B.7.1.3 CBC 2013 11B-403.3 Priority 3 Severity 3 TBD Contract Work	224	SF	\$25	\$5,600

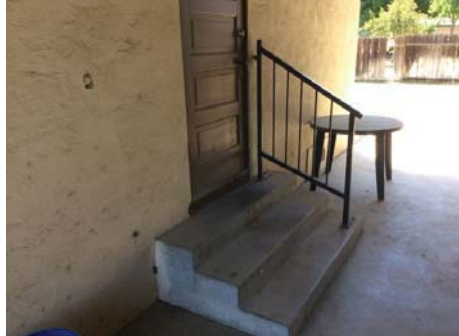
<u>Handrails</u>						
4248	<ul style="list-style-type: none"> <i>As-Built Description:</i> Handrail not provided at stairs or ramp, required on both sides (not required at curb ramps or adjacent to seating areas). <i>Proposed Solution:</i> Provide new handrail for each side including extensions. 	PCODE ED01 ADAAG 4.8.5 & 4.9.4 ADA 2010 505.2 CBC 2010 1133B.4.1.1 & .5.5 CBC 2013 11B-505.2 Priority 3 Severity 2 TBD Contract Work	5	LF	\$95	\$475

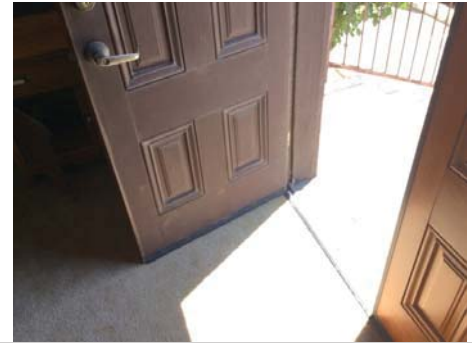
Door Pair

<p>4153</p> <ul style="list-style-type: none"> <i>As-Built Description:</i> Pair of doors on accessible route has less than 32" clear opening width with one leaf open 90°. <i>As-Built:</i> 27.5" <i>Proposed Solution:</i> Provide new door leaves, unequal in width, to existing frame for pair of doors. <i>Notes:</i> two door vestibule 	<p><i>PCODE</i> ID08A <i>ADAAG</i> 4.13.4 <i>ADA 2010</i> 404.2.2 <i>CBC 2010</i> 1133B.2.3.1 <i>CBC 2013</i> 11B-404.2.2 Priority 1 Severity 2 TBD Contract Work</p>	<p>2 JOB \$1,500 \$3,000</p>
--	--	-------------------------------------

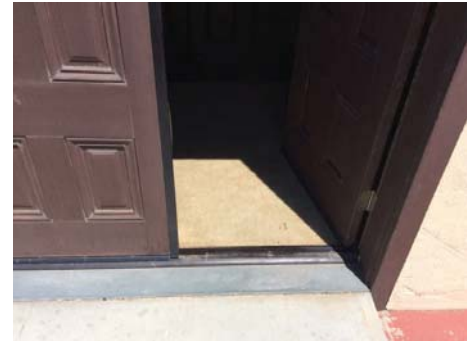
Door Threshold

<p>4152</p> <ul style="list-style-type: none"> <i>As-Built Description:</i> Door inaccessible due to threshold or step at door exceeding 1/2". <i>As-Built:</i> 0.75" <i>Proposed Solution:</i> Modify threshold to be no more than 1/2" by removing existing paving at door and providing landing with edge ramping (slope 1:20 max). 	<p><i>PCODE</i> ID02A <i>ADAAG</i> 4.13.8 <i>ADA 2010</i> 404.2.5 <i>CBC 2010</i> 1133B.2.4.1 <i>CBC 2013</i> 11B-404.2.5 Priority 1 Severity 4 TBD Contract Work</p>	<p>1 JOB \$400 \$400</p>
---	--	---------------------------------

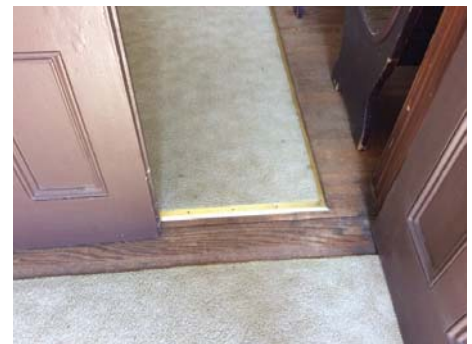
<p>4156</p> <ul style="list-style-type: none"> <i>As-Built Description:</i> Door inaccessible due to threshold or step at door exceeding 1/2". <i>As-Built:</i> 0.75" <i>Proposed Solution:</i> Modify threshold to be no more than 1/2" by removing existing paving at door and providing landing with edge ramping (slope 1:20 max). 	<p><i>PCODE</i> ID02A <i>ADAAG</i> 4.13.8 <i>ADA 2010</i> 404.2.5 <i>CBC 2010</i> 1133B.2.4.1 <i>CBC 2013</i> 11B-404.2.5 Priority 1 Severity 4 TBD Contract Work</p>	<p>1 JOB \$400 \$400</p>
---	--	---------------------------------

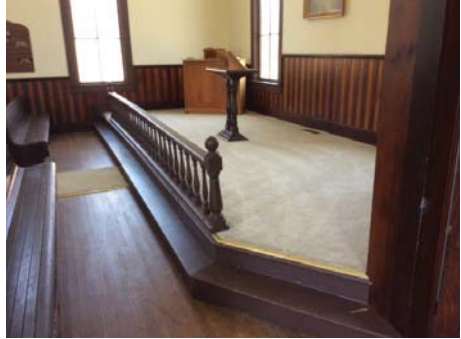
Item No. and Name	Existing Architectural Barrier and Proposed Solution	Codes / Mitigation Info	Qty	Unit	Cost	Total
Ramps						
4158	<ul style="list-style-type: none"> <i>As-Built Description:</i> Ramp needed to provide disabled access at steps or change of level along path of travel. <i>As-Built:</i> 12" rise <i>Proposed Solution:</i> Provide new concrete ramp with handrails [slope more than 1:20 (5.0%) needed]. 	PCODE EB01A ADAAG 4.1.1 ADA 2010 303.4 CBC 2010 1127B.1 CBC 2013 11B-303.4 Priority 2 Severity 1 TBD Contract Work	48	SF	\$100	\$4,800

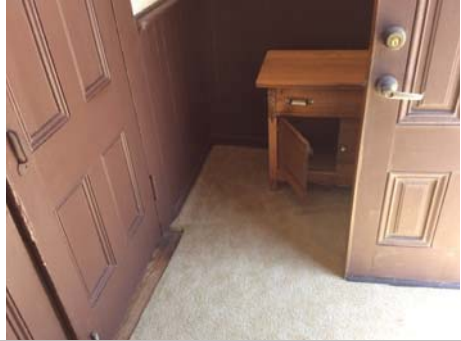
Vestibule						
4154	<ul style="list-style-type: none"> <i>As-Built Description:</i> Vestibule length in direction of travel less than width(es) of door(s) swinging into vestibule, plus 48". <i>As-Built:</i> DW + 36" <i>Proposed Solution:</i> At vestibule with standard pairs of doors, remodel area to provide required length. Notes: vestibule 	PCODE IF02A ADAAG 4.13.7 ADA 2010 404.2.6 CBC 2010 1133B.2.4.4 CBC 2013 11B-404.2.6 Priority 1 Severity 2 TBD Contract Work	1	JOB	\$5,000	\$5,000

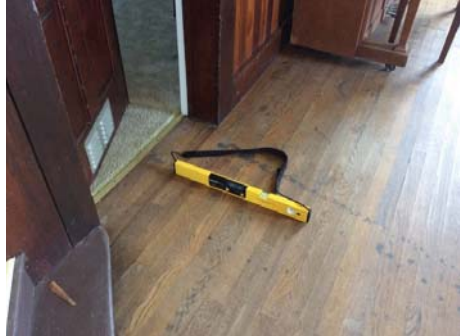
Door						
4161	<ul style="list-style-type: none"> <i>As-Built Description:</i> Surface of required maneuvering clearance at door slopes more than 1/4":12" (2.0%). <i>As-Built:</i> 5.8% <i>Proposed Solution:</i> Modify surface slope at door. 	PCODE ID11 ADAAG 4.13.6 ADA 2010 404.2.4.4 CBC 2010 1133B.2.4 CBC 2013 11B-404.2.4 Priority 1 Severity 3 TBD Contract Work	30	SF	\$40	\$1,200

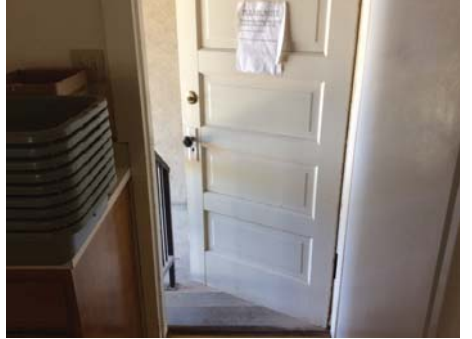
Item No. and Name	Existing Architectural Barrier and Proposed Solution	Codes / Mitigation Info	Qty	Unit	Cost	Total
<u>Door Clearance</u>						
4175	<ul style="list-style-type: none"> <i>As-Built Description:</i> Door on accessible route has less than 32" clear and 80" (78" min. to closer if provided) opening width when 90° open. <i>As-Built:</i> 29.5" <i>Proposed Solution:</i> Provide new, larger door and frame with new accessible hardware. <i>Notes:</i> Provide directional sign to Acc exit. to restrooms 	PCODE ID01 ADAAG 4.13.5 ADA 2010 404.2.3 CBC 2010 1133B.1.1.1.1 CBC 2013 11B-404.2.3 Priority 2 Severity 3 TBD Contract Work	1	JOB	\$2,600	\$2,600

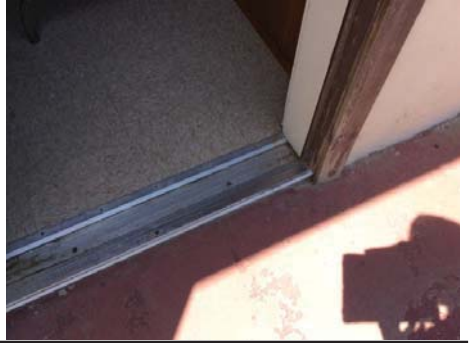
<u>Door Threshold</u>						
4168	<ul style="list-style-type: none"> <i>As-Built Description:</i> Door inaccessible due to threshold or step at door exceeding 1/2". <i>As-Built:</i> 1.5" <i>Proposed Solution:</i> Modify threshold to be no more than 1/2" by removing existing paving at door and providing landing with edge ramping (slope 1:20 max). 	PCODE ID02A ADAAG 4.13.8 ADA 2010 404.2.5 CBC 2010 1133B.2.4.1 CBC 2013 11B-404.2.5 Priority 1 Severity 4 TBD Contract Work	1	JOB	\$400	\$400

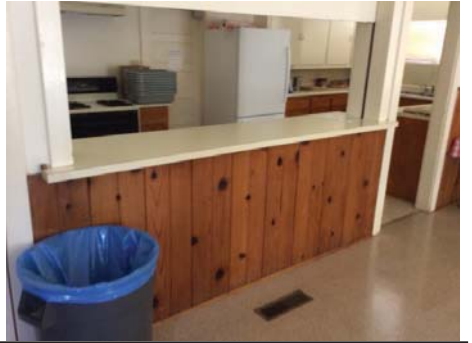
<u>Public Counter</u>						
4166	<ul style="list-style-type: none"> <i>As-Built Description:</i> Service counter (stand-up): Accessible section min. 36" length and 36" max. height (in CA: 28" to 34" high) not provided. <i>As-Built:</i> 40" <i>Proposed Solution:</i> Provide auxiliary shelf, clipboard, or table as equivalent facilitation. 	PCODE IN03 ADAAG 7.2(2) ADA 2010 904.4 CBC 2010 1122B.4 CBC 2013 11B-904.4 Priority 1 Severity 3 TBD Contract Work	1	JOB	\$150	\$150

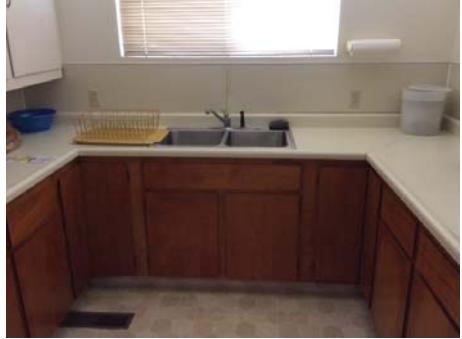
Item No. and Name	Existing Architectural Barrier and Proposed Solution	Codes / Mitigation Info	Qty	Unit	Cost	Total
Sink						
4169	<ul style="list-style-type: none"> <i>As-Built Description:</i> Sink does not have knee space min. 27" high x 19" deep x 30" wide. <i>Proposed Solution:</i> Remodel sink cabinet. 	PCODE IN06A ADAAG 4.24.3 ADA 2010 606.2 CBC 2010 1115B.4.7.1 CBC 2013 11B-606.2 Priority 2 Severity 2 TBD Contract Work	1	JOB	\$1,750	\$1,750

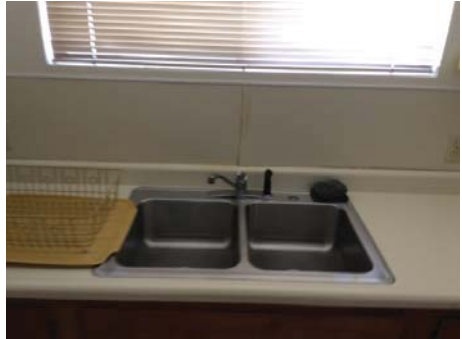
4177	<ul style="list-style-type: none"> <i>As-Built Description:</i> Sink is more than 6 1/2" deep. <i>As-Built:</i> 7" <i>Proposed Solution:</i> Provide new sink remodel and cabinet as needed. 	PCODE IN06BREF ADAAG 4.24.4 CBC 2010 1115B.4.7.1 CBC 2013 11B-606.7 Priority 3 Severity 4 TBD Contract Work				REF

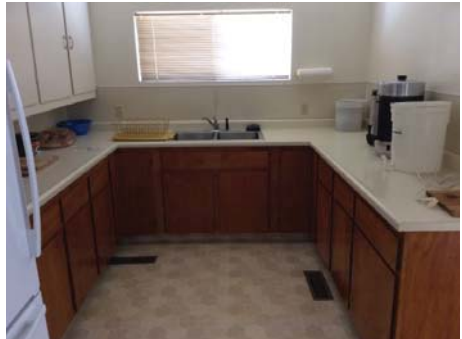
4170	<ul style="list-style-type: none"> <i>As-Built Description:</i> Sink rim higher than 34" above floor. <i>As-Built:</i> 36" <i>Proposed Solution:</i> Remodel sink cabinet to lower sink. 	PCODE IN06REF ADAAG 4.24.2 ADA 2010 606.3 CBC 2010 1115B.4.7.1 CBC 2013 11B-606.3 Priority 3 Severity 4 TBD Contract Work				REF

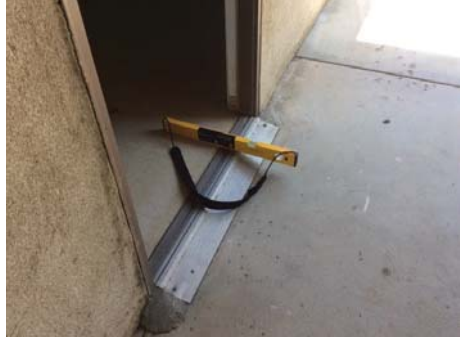
Item No. and Name	Existing Architectural Barrier and Proposed Solution	Codes / Mitigation Info	Qty	Unit	Cost	Total
<u>Door Threshold</u>						
4182	<ul style="list-style-type: none"> As-Built Description: Door inaccessible due to threshold or step at door exceeding 1/2". As-Built: 2" Proposed Solution: Modify threshold to be no more than 1/2" by removing existing paving at door and providing landing with edge ramping (slope 1:20 max). 	PCODE ID02A ADAAG 4.13.8 ADA 2010 404.2.5 CBC 2010 1133B.2.4.1 CBC 2013 11B-404.2.5 Priority 3 Severity 2 TBD Contract Work	1	JOB	\$400	\$400

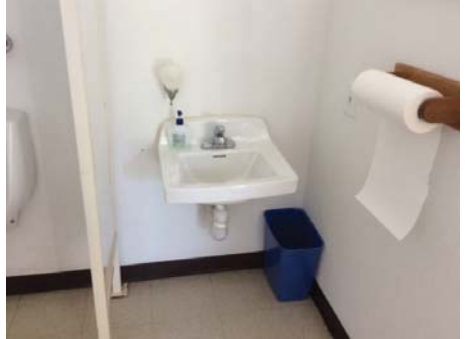
<u>Lavatory</u>						
4185	<ul style="list-style-type: none"> As-Built Description: Knee clearance 27" min. high starting 8" back from the front edge of the lavatory towards the wall is not provided. As-Built: 23.5" Proposed Solution: Remount compliant fixture to accessible height. 	PCODE WD04A ADAAG Fig. 31 ADA 2010 606.3 CBC 2010 1115B.4.3 CBC 2013 11B-306.3.3 Priority 3 Severity 2 TBD Contract Work	1	JOB	\$1,500	\$1,500

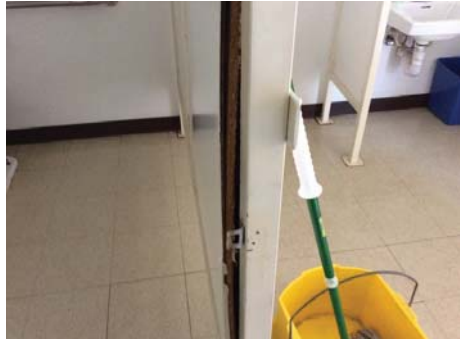
<u>Toilet Stall</u>						
4188	<ul style="list-style-type: none"> As-Built Description: Toilet stall less than 60" wide. As-Built: 59.5" Proposed Solution: Provide new accessible stall (alternate stalls 36" x 69" or 48" x 69" not recommended). Notes: Repair partition 	PCODE WB06NT ADAAG 4.17.3 ADA 2010 604.8.1.1 CBC 2010 1115B.3.1.4.1 CBC 2013 11B-604.8.1.1 Priority 3 Severity 4 TBD Contract Work	1	JOB	\$150	\$150

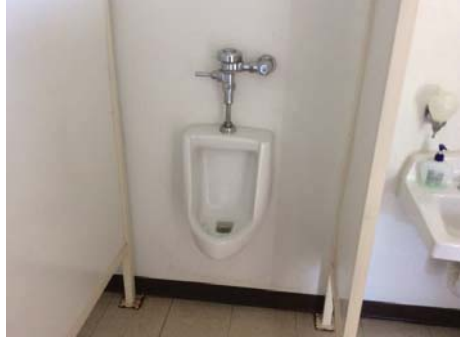
Item No. and Name	Existing Architectural Barrier and Proposed Solution	Codes / Mitigation Info	Qty	Unit	Cost	Total
Urinal						
4187	<ul style="list-style-type: none"> <i>As-Built Description:</i> Fixture mounted with rim more than 17" above floor. <i>As-Built:</i> 24" <i>Proposed Solution:</i> Provide accessible urinal. Remodel restroom as needed. <i>Notes:</i> Flush 45.5" 	PCODE WE02 ADAAG 4.18.2 ADA 2010 605.2 CBC 2010 1115B.4.2.1 CBC 2013 11B-605.2 Priority 3 Severity 2 TBD Contract Work	1	JOB	\$2,400	\$2,400

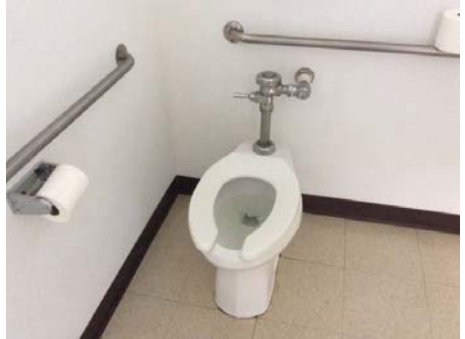
Water Closet						
4193	<ul style="list-style-type: none"> <i>As-Built Description:</i> Water closet not 17"-18" from near side wall to center line of water closet (2010 ADAS: 16"-18"). <i>As-Built:</i> 18.5" o.c. <i>Proposed Solution:</i> Relocate existing water closet and plumbing, remount with offset closet flange to provide 17"-18" from side wall. 	PCODE WB02C ADAAG Fig. 28 ADA 2010 604.2 CBC 2010 1115B.4.1.1 CBC 2013 11B-604.2 Priority 3 Severity 4 TBD Contract Work	1	JOB	\$500	\$500

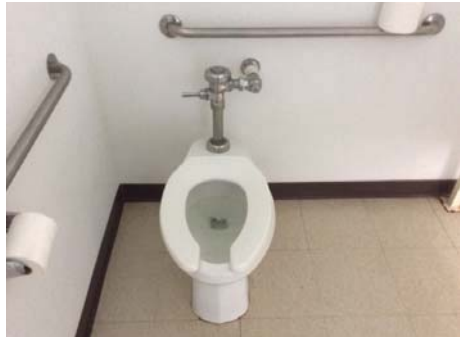
4189	<ul style="list-style-type: none"> <i>As-Built Description:</i> Flush Control: Operating handle not mounted toward wide side of stall. <i>Proposed Solution:</i> Replace flush control with properly mounted accessible type, or install sensor flush. 	PCODE WB10 ADAAG 4.16.5 ADA 2010 604.6 CBC 2010 1115B.4.1.5 CBC 2013 11B-604.6 Priority 3 Severity 3 TBD Contract Work	1	JOB	\$500	\$500

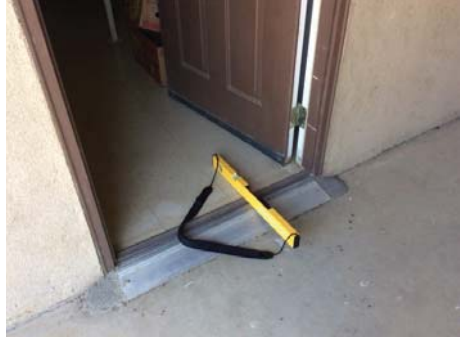
Item No. and Name	Existing Architectural Barrier and Proposed Solution	Codes / Mitigation Info	Qty	Unit	Cost	Total
<u>Door Threshold</u>						
4197	<ul style="list-style-type: none"> <i>As-Built Description:</i> Existing threshold at door is 1/2" high or less but without a beveled edge on both sides. <i>As-Built:</i> 2" <i>Proposed Solution:</i> Modify threshold to have beveled edge on each side. 	PCODE ID02 ADAAG 4.1.6(3)(d)(ii) ADA 2010 404.2.5 CBC 2010 1133B.2.4.1 CBC 2013 11B-404.2.5 Priority 3 Severity 2 TBD Contract Work	1	JOB	\$250	\$250

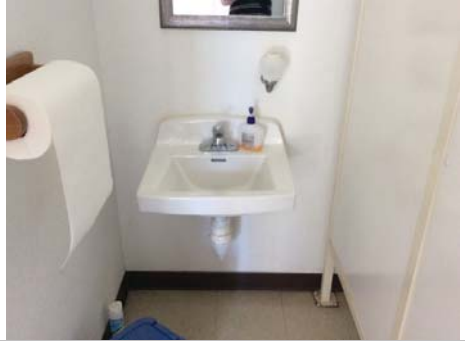
<u>Lavatory</u>						
4201	<ul style="list-style-type: none"> <i>As-Built Description:</i> Wheelchair clearance under lavatory apron or lavatory counter front edge less than 29" high. <i>As-Built:</i> 27.5" <i>Proposed Solution:</i> Remount compliant fixture to accessible height. 	PCODE WD03A ADAAG 4.19.2 ADA 2010 606.3 CBC 2010 1115B.4.3.3 CBC 2013 11B-306.3.1 Priority 3 Severity 3 TBD Contract Work	1	JOB	\$1,500	\$1,500

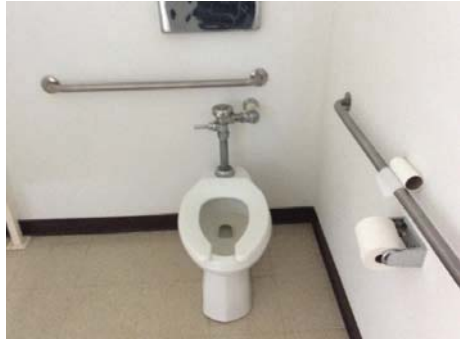
<u>Water Closet</u>						
4206	<ul style="list-style-type: none"> <i>As-Built Description:</i> Water closet not 17"-18" from near side wall to center line of water closet (2010 ADAS: 16"-18"). <i>As-Built:</i> 19" o.c. <i>Proposed Solution:</i> Relocate existing water closet and plumbing, remount with offset closet flange to provide 17"-18" from side wall. 	PCODE WB02C ADAAG Fig. 28 ADA 2010 604.2 CBC 2010 1115B.4.1.1 CBC 2013 11B-604.2 Priority 3 Severity 4 TBD Contract Work	1	JOB	\$500	\$500

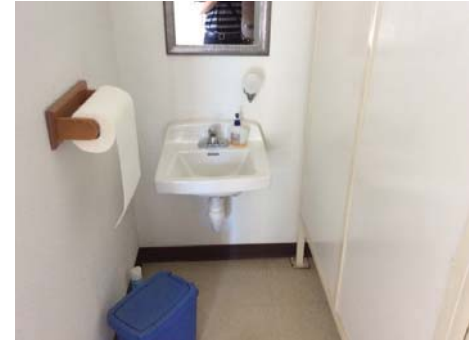
4199	<ul style="list-style-type: none"> • <i>As-Built Description:</i> Clear passage width (except doorways) from rest room entry to accessible water closet compartment less than 36" (CA only: 44" wide). • <i>As-Built:</i> 36" wide to lavatory • <i>Proposed Solution:</i> Modify facility passage to be min. 44" wide. Demolish existing partition and replace. 	<p>PCODE WC02A ADAAG 4.3.3 ADA 2010 403.5.1 CBC 2010 1115B.3.2.4 CBC 2013 11B-403.5.1 Priority 3 Severity 2 TBD Contract Work</p>	5	LF	\$170	\$850
------	---	--	---	----	-------	-------

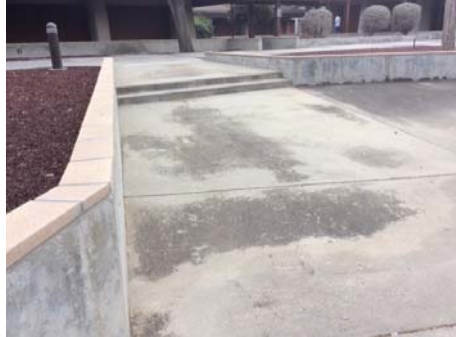
Item No. and Name	Existing Architectural Barrier and Proposed Solution	Codes / Mitigation Info	Qty	Unit	Cost	Total
Handrails						
571	<ul style="list-style-type: none"> <i>As-Built Description:</i> Handrail not provided at stairs or ramp, required on both sides (not required at curb ramps or adjacent to seating areas). <i>Proposed Solution:</i> Provide new handrail for each side including extensions. 	PCODE ED01 ADAAG 4.8.5 & 4.9.4 ADA 2010 505.2 CBC 2010 1133B.4.1.1 & .5.5 CBC 2013 11B-505.2 Priority 4 Severity 2 TBD Contract Work	12	LF	\$95	\$1,140

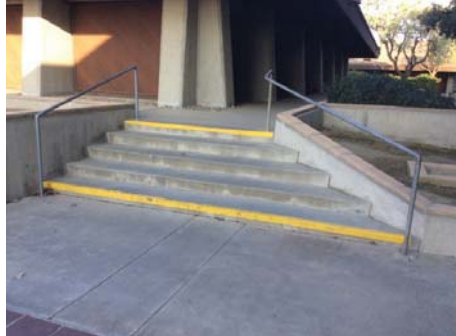
1088	<ul style="list-style-type: none"> <i>As-Built Description:</i> Stair handrail does not extend horizontally 12" minimum beyond top nosing, and one tread width sloped, plus 12" minimum horizontally beyond the bottom nosing. <i>Proposed Solution:</i> Extend stair handrail at top and bottom (cost for each extension piece). 	PCODE ED06 ADAAG 4.9.4(2) ADA 2010 505.10.2; 505.10.3 CBC 2010 1133B.4.2.2 CBC 2013 11B-505.10.2; 11B-505.10.3 Priority 4 Severity 2 TBD Contract Work	4	JOB	\$170	\$680

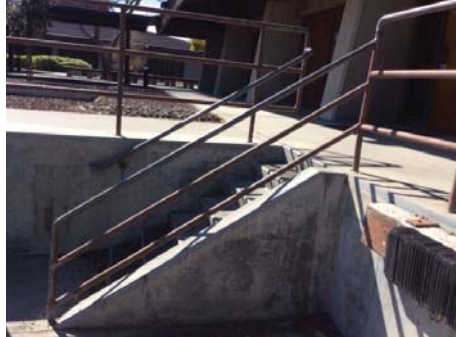
1709	<ul style="list-style-type: none"> <i>As-Built Description:</i> Handrail gripping surface top not mounted between 34" and 38" above ramp surface or stair nosings. <i>As-Built:</i> 32" <i>Proposed Solution:</i> Remove existing and provide new handrail. 	PCODE ED02 ADAAG 4.9.4(5) ADA 2010 505.4 CBC 2010 1133B.4.2.1 & CBC 2013 11B-505.4 Priority 4 Severity 4 TBD Contract Work	18	LF	\$75	\$1,350

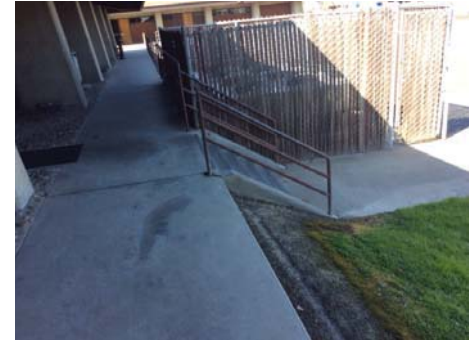
1704	<ul style="list-style-type: none"> <i>As-Built Description:</i> Stair handrail does not extend horizontally 12" minimum beyond top nosing, and one tread width sloped, plus 12" minimum horizontally beyond the bottom nosing. <i>Proposed Solution:</i> Extend stair handrail at top and bottom (cost for each extension piece). 	PCODE ED06	4	JOB	\$170	\$680
		ADAAG 4.9.4(2)				
		ADA 2010 505.10.2; 505.10.3				
		CBC 2010 1133B.4.2.2				
		CBC 2013 11B-505.10.2; 11B-505.10.3				
		Priority 4				
		Severity 2

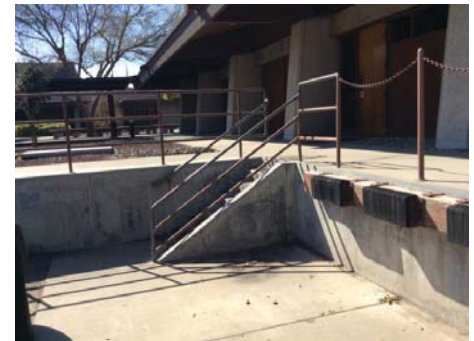
1707	<ul style="list-style-type: none"> <i>As-Built Description:</i> Stair handrail does not extend horizontally 12" minimum beyond top nosing, and one tread width sloped, plus 12" minimum horizontally beyond the bottom nosing. <i>Proposed Solution:</i> Extend stair handrail at top and bottom (cost for each extension piece). 	PCODE ED06REF				
		ADAAG 4.9.4(2)				
		ADA 2010 505.10.2; 505.10.3				
		CBC 2010 1133B.4.2.2				
		CBC 2013 11B-505.10.2; 11B-505.10.3				
		Priority 4				
		Severity 2

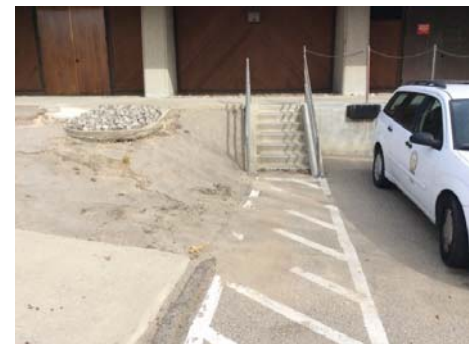
2587	<ul style="list-style-type: none"> <i>As-Built Description:</i> Handrail gripping surface top not mounted between 34" and 38" above ramp surface or stair nosings. <i>As-Built:</i> 33" <i>Proposed Solution:</i> Remove existing and provide new handrail. 	PCODE ED02	20	LF	\$75	\$1,500
		ADAAG 4.9.4(5)				
		ADA 2010 505.4				
		CBC 2010 1133B.4.2.1 &				
		CBC 2013 11B-505.4				
		Priority 4				
		Severity 4

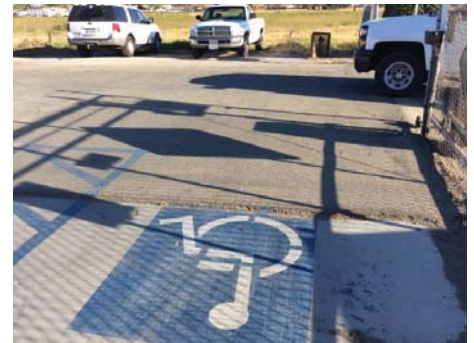
- 2840
- As-Built Description:**
Walk: Pavement dislocation creates abrupt change in level exceeding 1/2" in accessible route.
 - As-Built:** 1"
 - Proposed Solution:**
Remove, replace or repair area of pavement sufficient to correct abrupt change in level.
 - Notes:**
Extend concrete to 18'

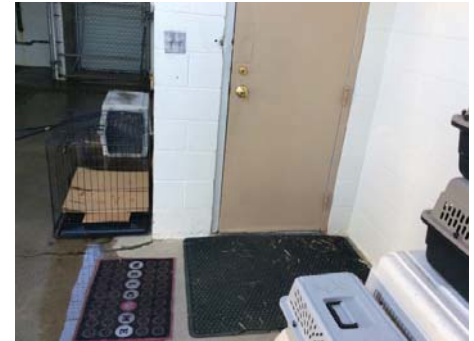
2849	<ul style="list-style-type: none"> <i>As-Built Description:</i> Surface of required maneuvering clearance at door slopes more than 1/4":12" (2.0%). <i>As-Built:</i> 4.6% <i>Proposed Solution:</i> Modify surface slope at door. 	PCODE ID11 ADAAG 4.13.6 ADA 2010 404.2.4.4 CBC 2010 1133B.2.4 CBC 2013 11B-404.2.4 Priority 1 Severity 3 TBD Contract Work	30	SF	\$40	\$1,200
------	--	---	----	----	------	---------

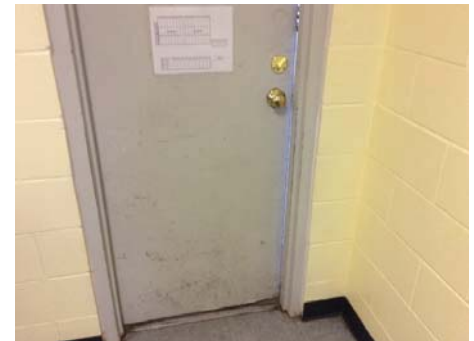
2847	<ul style="list-style-type: none"> <i>As-Built Description:</i> Door on accessible route has less than 32" clear and 80" (78" min. to closer if provided) opening width when 90° open. <i>As-Built:</i> 27" <i>Proposed Solution:</i> Provide new, larger door and frame with new accessible hardware. 	PCODE ID01 ADAAG 4.13.5 ADA 2010 404.2.3 CBC 2010 1133B.1.1.1.1 CBC 2013 11B-404.2.3 Priority 1 Severity 2 TBD Contract Work	1	JOB	\$2,600	\$2,600
------	---	---	---	-----	---------	---------

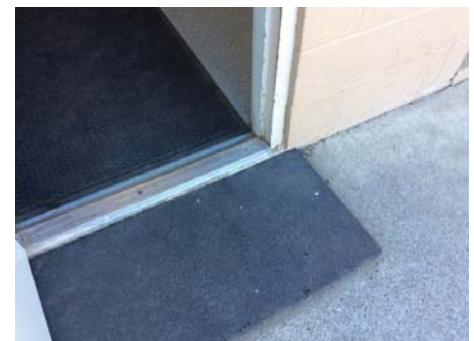
2843	<ul style="list-style-type: none"> <i>As-Built Description:</i> Door inaccessible due to threshold or step at door exceeding 1/2". <i>As-Built:</i> 1" <i>Proposed Solution:</i> Modify threshold to be no more than 1/2" by removing existing paving at door and providing landing with edge ramping (slope 1:20 max). 	PCODE ID02A ADAAG 4.13.8 ADA 2010 404.2.5 CBC 2010 1133B.2.4.1 CBC 2013 11B-404.2.5 Priority 1 Severity 4 TBD Contract Work	1	JOB	\$400	\$400
------	--	--	---	-----	-------	-------

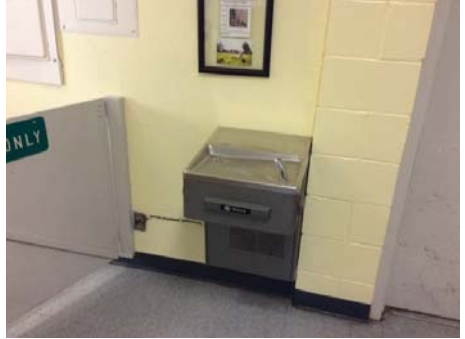
Item No. and Name	Existing Architectural Barrier and Proposed Solution	Codes / Mitigation Info	Qty	Unit	Cost	Total
<u>Drinking Fountain</u>						
2850	<ul style="list-style-type: none"> <i>As-Built Description:</i> Where only one drinking fountain is provided per floor: Fountain is not accessible to individuals who use wheelchairs, or to those who have difficulty bending or stooping. <i>Proposed Solution:</i> Provide additional fountain or hi-lo combination fountain. 	PCODE IA01A ADAAG 4.1.3(10)(a) ADA 2010 211.1 CBC 2010 1115B.4.6.1 CBC 2013 11B-211.1 Priority 3 Severity 2 TBD Contract Work	1	JOB	\$2,000	\$2,000

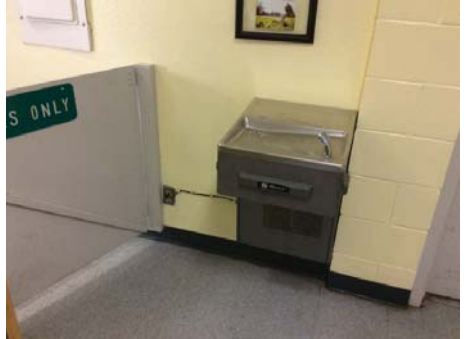
2851	<ul style="list-style-type: none"> <i>As-Built Description:</i> Wall- and post-mounted cantilevered units: Knee space not provided at drinking fountain (27" high, 8" deep, 30" wide from front of drinking fountain). Unit in good condition. <i>As-Built:</i> 25.25" <i>Proposed Solution:</i> Remount fountain at accessible height. 	PCODE IA02A ADAAG 4.15.5(1) ADA 2010 602.2 CBC 2010 1115B.4.6.2 CBC 2013 11B-602.2 Priority 3 Severity 2 TBD Contract Work	1	JOB	\$1,200	\$1,200

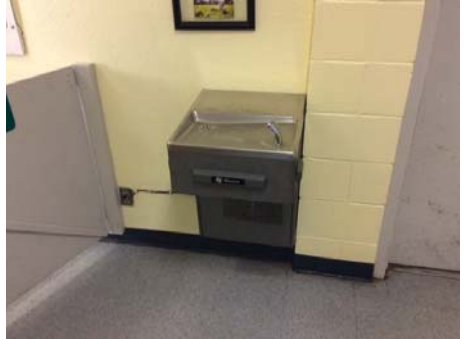
2852	<ul style="list-style-type: none"> <i>As-Built Description:</i> CA only: Drinking fountain not located in an alcove (min. 32" wide x 18" deep) or otherwise encroaches into pedestrian way. <i>Proposed Solution:</i> Provide new alcove for drinking fountain, or, if unreasonable hardship is determined, provide wing walls or cane-detectable railings on each side of the drinking fountain. The wings must project out from the supporting wall at least as far as the drinking fountain to within 6" of the surface of the circulation path, but cannot reduce the required clear width of the adjacent accessible route. 	PCODE IA04 CBC 2010 1115B.4.6.3; Fig. CBC 2013 11B-602.9 Priority 3 Severity 2 TBD Contract Work	1	JOB	\$3,000	\$3,000

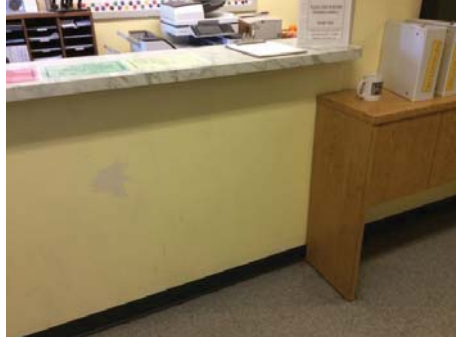
Item No. and Name	Existing Architectural Barrier and Proposed Solution	Codes / Mitigation Info	Qty	Unit	Cost	Total
Public Counter						
2844	<ul style="list-style-type: none"> <i>As-Built Description:</i> Service counter (stand-up): Accessible section min. 36" length and 36" max. height (in CA: 28" to 34" high) not provided. <i>As-Built:</i> 45" <i>Proposed Solution:</i> Provide auxiliary shelf, clipboard, or table as equivalent facilitation. 	PCODE IN03 ADAAG 7.2(2) ADA 2010 904.4 CBC 2010 1122B.4 CBC 2013 11B-904.4 Priority 1 Severity 3 TBD Contract Work	1	JOB	\$150	\$150

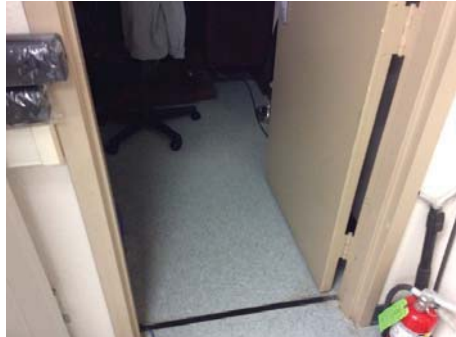
Door Clearance						
2869	<ul style="list-style-type: none"> <i>As-Built Description:</i> Door on accessible route has less than 32" clear and 80" (78" min. to closer if provided) opening width when 90° open. <i>As-Built:</i> 27" <i>Proposed Solution:</i> Provide new, larger door and frame with new accessible hardware. 	PCODE ID01 ADAAG 4.13.5 ADA 2010 404.2.3 CBC 2010 1133B.1.1.1.1 CBC 2013 11B-404.2.3 Priority 4 Severity 2 TBD Contract Work	1	JOB	\$2,600	\$2,600

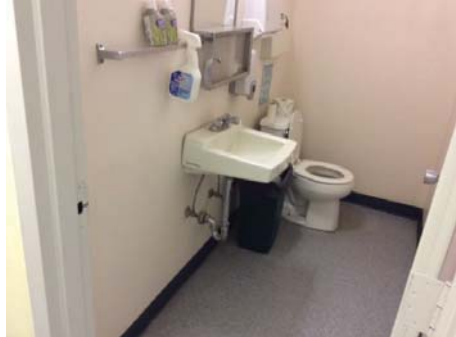
Door Clearance							
2861	<ul style="list-style-type: none"> <i>As-Built Description:</i> Door on accessible route has less than 32" clear and 80" (78" min. to closer if provided) opening width when 90° open. <i>As-Built:</i> 27" <i>Proposed Solution:</i> Provide new, larger door and frame with new accessible hardware. 	PCODE ID01REF ADAAG 4.13.5 ADA 2010 404.2.3 CBC 2010 1133B.1.1.1.1 CBC 2013 11B-404.2.3 Priority 3 Severity 2 TBD Contract Work	REF

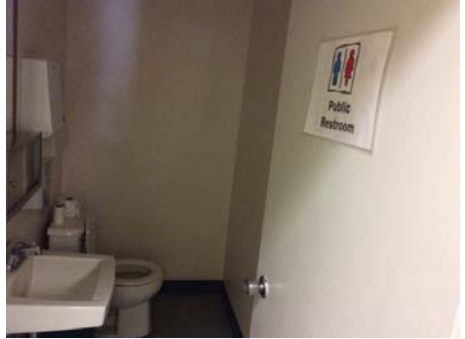
Item No. and Name	Existing Architectural Barrier and Proposed Solution	Codes / Mitigation Info	Qty	Unit	Cost	Total
<u>Restroom</u>						
2860	<ul style="list-style-type: none"> <i>As-Built Description:</i> Single accommodation restroom not accessible; multiple compliance violations. <i>Proposed Solution:</i> Remodel area to provide single-occupant accessible restroom. 	PCODE WA01 ADAAG 4.22 ADA 2010 603 CBC 2010 1115B.3.2 CBC 2013 11B-603 Priority 3 Severity 2 TBD Contract Work	1	JOB	\$30,000	\$30,000

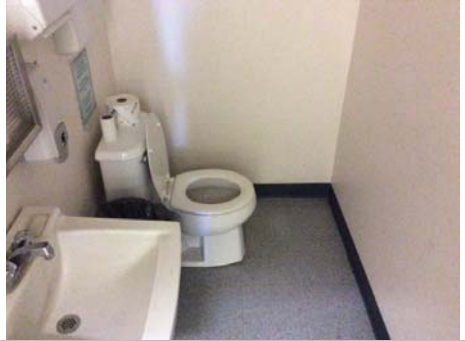
<u>Turning Space</u>							
2862	<ul style="list-style-type: none"> <i>As-Built Description:</i> Wheelchair clearance: Clear space, floor to 27" high with a diameter of 60", not provided (space 56" x 63" acceptable). <i>As-Built:</i> 47.5" <i>Proposed Solution:</i> Provide wheelchair clearance space in restroom. 	PCODE WC01REF ADAAG 4.22.3 ADA 2010 603.2.1 CBC 2010 1115B.3.2 CBC 2013 11B-603.2.1; 11B-304.3 Priority 3 Severity 2 TBD Contract Work	REF

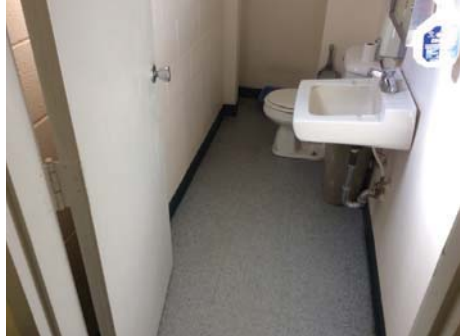
4 Staff Restroom

<u>Door Clearance</u>							
2865	<ul style="list-style-type: none"> <i>As-Built Description:</i> Door on accessible route has less than 32" clear and 80" (78" min. to closer if provided) opening width when 90° open. <i>As-Built:</i> 27.5" <i>Proposed Solution:</i> Provide new, larger door and frame with new accessible hardware. 	PCODE ID01REF ADAAG 4.13.5 ADA 2010 404.2.3 CBC 2010 1133B.1.1.1.1 CBC 2013 11B-404.2.3 Priority 4 Severity 2 TBD Contract Work	REF

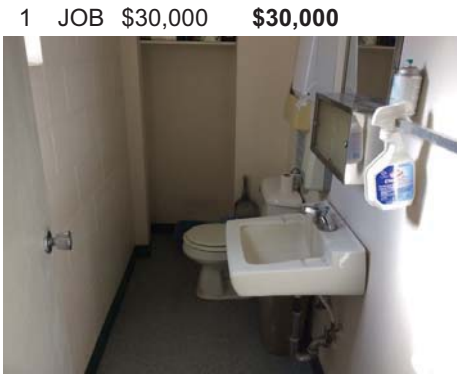
2866 • *As-Built Description:*
 Single accommodation restroom not accessible; multiple compliance violations.

• *Proposed Solution:*
 Remodel area to provide single-occupant accessible restroom.
