Facility: **WOMENS INFANTS & CHILDREN**

Address: 330 HARRIS ST.

Facility: **LEMORE HEALTH CLINIC**
 Address: 229 C ST.

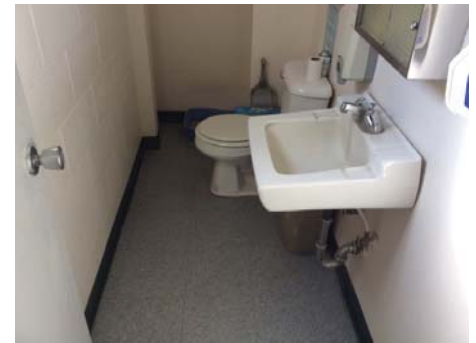
• *Proposed Solution:*
 Provide wheelchair clearance space in restroom.

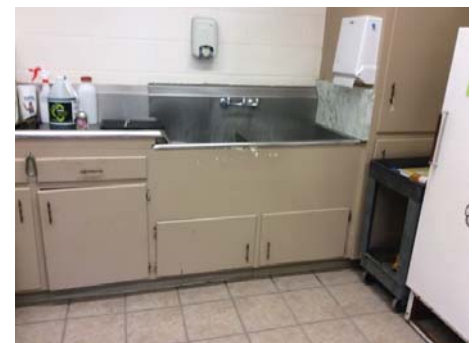
5 Intake Room

• *Proposed Solution:*
 Remodel sink cabinet.

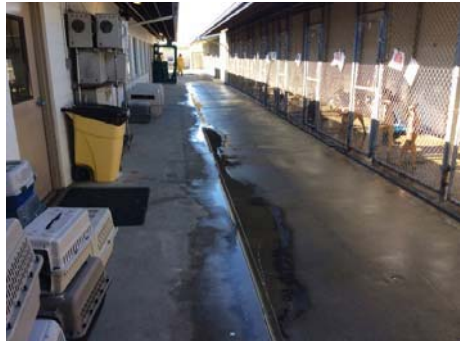
2878	<ul style="list-style-type: none"> As-Built Description: Cross slope more than 1":48" (2.083%). As-Built: 2.9-9.5% Proposed Solution: Modify cross slope. 	PCODE EF07 ADAAG 4.3.7 ADA 2010 403.3 CBC 2010 1133B.7.1.3 CBC 2013 11B-403.3 Priority 1 Severity 2 TBD Contract Work	400	SF	\$25	\$10,000

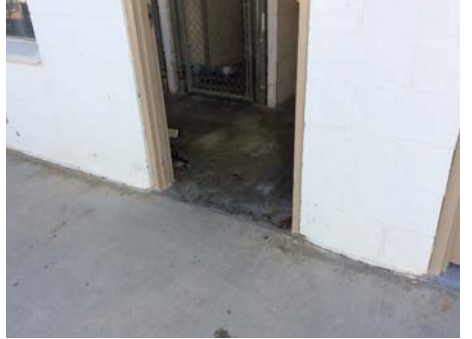
7 Bite Ward

Item No. and Name	Existing Architectural Barrier and Proposed Solution	Codes / Mitigation Info	Qty	Unit	Cost	Total
Door						
2882	<ul style="list-style-type: none"> As-Built Description: Surface of required maneuvering clearance at door slopes more than 1/4":12" (2.0%). As-Built: 8.3% Proposed Solution: Modify surface slope at door. Notes: Staff Only 	PCODE ID11REF ADAAG 4.13.6 ADA 2010 404.2.4.4 CBC 2010 1133B.2.4 CBC 2013 11B-404.2.4 Priority 4 Severity 2 TBD Contract Work				
						REF

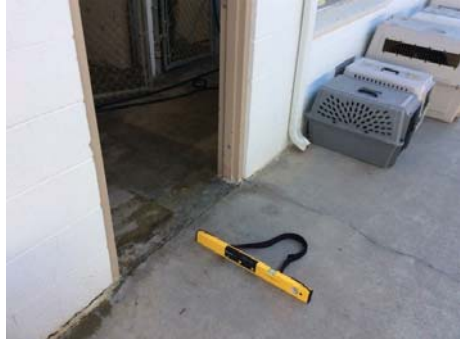
2879	<ul style="list-style-type: none"> As-Built Description: Surface of required maneuvering clearance at door slopes more than 1/4":12" (2.0%). As-Built: 4.3% Proposed Solution: Modify surface slope at door. Notes: Staff Only 	PCODE ID11REF ADAAG 4.13.6 ADA 2010 404.2.4.4 CBC 2010 1133B.2.4 CBC 2013 11B-404.2.4 Priority 4 Severity 3 TBD Contract Work				
						REF

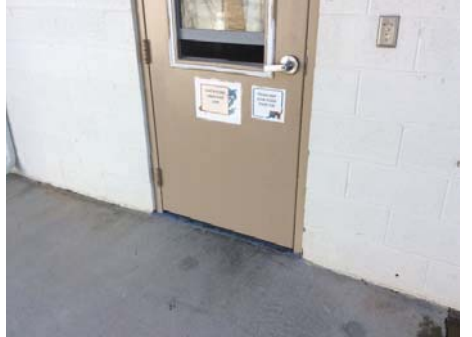
9 Lost & Found Cats

Item No. and Name	Existing Architectural Barrier and Proposed Solution	Codes / Mitigation Info	Qty	Unit	Cost	Total
Door						
2884	<ul style="list-style-type: none"> As-Built Description: Surface of required maneuvering clearance at door slopes more than 1/4":12" (2.0%). As-Built: 5.8% Proposed Solution: Modify surface slope at door. 	PCODE ID11REF ADAAG 4.13.6 ADA 2010 404.2.4.4 CBC 2010 1133B.2.4 CBC 2013 11B-404.2.4 Priority 2 Severity 3 TBD Contract Work				
						REF

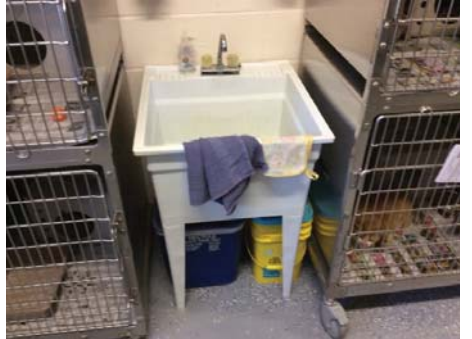
Sink						
2891	<ul style="list-style-type: none"> As-Built Description: Sink does not have knee space min. 27" high x 19" deep x 30" wide. Proposed Solution: Remodel sink cabinet. 	PCODE IN06A ADAAG 4.24.3 ADA 2010 606.2 CBC 2010 1115B.4.7.1 CBC 2013 11B-606.2 Priority 2 Severity 2 TBD Contract Work	1	JOB	\$1,750	\$1,750

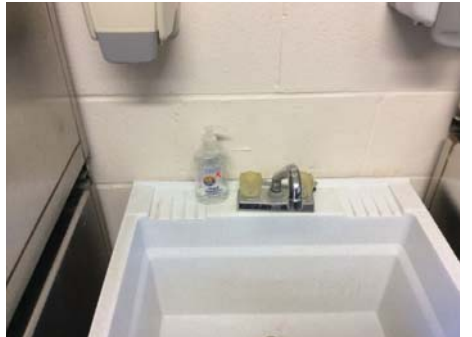
2892	<ul style="list-style-type: none"> As-Built Description: Sink faucet controls not accessible. Proposed Solution: Provide accessible sink faucet controls. 	PCODE IN07 ADAAG 4.24.7 ADA 2010 606.4 CBC 2010 1115B.4.7.1 CBC 2013 11B-606.4 Priority 3 Severity 2 TBD Contract Work	1	JOB	\$600	\$600

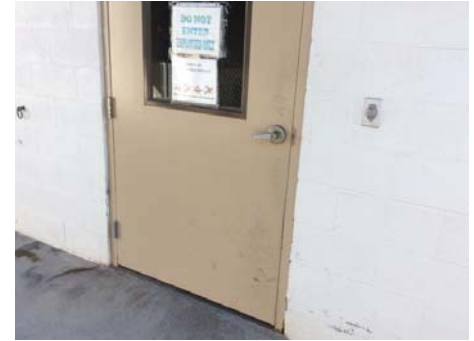
10 Staff Only Holding Room

PCODE ID11REF
 ADAAG 4.13.6
 ADA 2010 404.2.4.4
 CBC 2010 1133B.2.4
 CBC 2013 11B-404.2.4
 Priority 2
 Severity 2
 TBD Contract Work

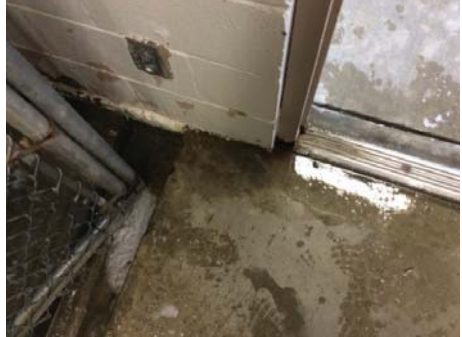
Item No. and Name	Existing Architectural Barrier and Proposed Solution	Codes / Mitigation Info	Qty	Unit	Cost	Total
Door Swing						
2905	<ul style="list-style-type: none"> As-Built Description: Front approach: At pull side, door does not have clear and level maneuvering space measuring door width plus 18" x 60". As-Built: 13" to drainage Proposed Solution: Provide grating along drainage extending 60" back. Notes: Provide grating extending 60" back. 	PCODE ID23BNT ADAAG Fig. 25(a) ADA 2010 404.2.4 CBC 2010 11B-26A(a) CBC 2013 11B-404.2.4 Priority 2 Severity 4 TBD Contract Work	1	JOB	\$1,600	\$1,600

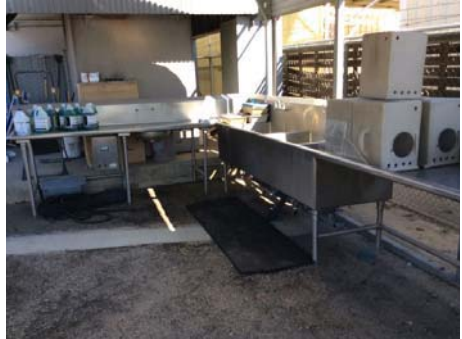
Sink						
2909	<ul style="list-style-type: none"> As-Built Description: Sink does not have knee space min. 27" high x 19" deep x 30" wide. Proposed Solution: Remodel sink cabinet. Notes: Staff Only 	PCODE IN06A ADAAG 4.24.3 ADA 2010 606.2 CBC 2010 1115B.4.7.1 CBC 2013 11B-606.2 Priority 4 Severity 2 TBD Contract Work	1	JOB	\$1,750	\$1,750

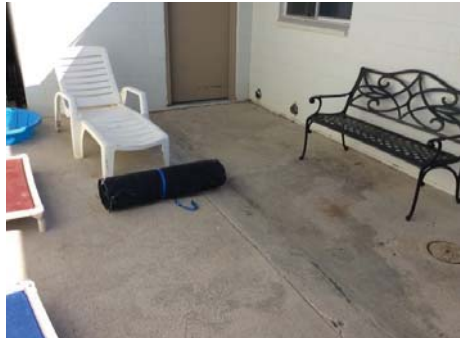
12 Play Area

Cross Slope						
2901	<ul style="list-style-type: none"> As-Built Description: Cross slope more than 1":48" (2.083%). As-Built: 13.5% Proposed Solution: Modify cross slope. 	PCODE EF07 ADAAG 4.3.7 ADA 2010 403.3 CBC 2010 1133B.7.1.3 CBC 2013 11B-403.3 Priority 2 Severity 1 TBD Contract Work	100	SF	\$25	\$2,500

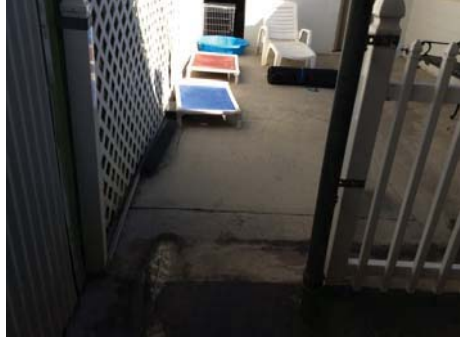
Item No. and Name	Existing Architectural Barrier and Proposed Solution	Codes / Mitigation Info	Qty	Unit	Cost	Total
Door						
2902	<ul style="list-style-type: none"> <i>As-Built Description:</i> Surface of required maneuvering clearance at door slopes more than 1/4":12" (2.0%). <i>As-Built:</i> 13.8% <i>Proposed Solution:</i> Modify surface slope at door. 	PCODE ID11REF ADAAG 4.13.6 ADA 2010 404.2.4.4 CBC 2010 1133B.2.4 CBC 2013 11B-404.2.4 Priority 2 Severity 1 TBD Contract Work				
						REF

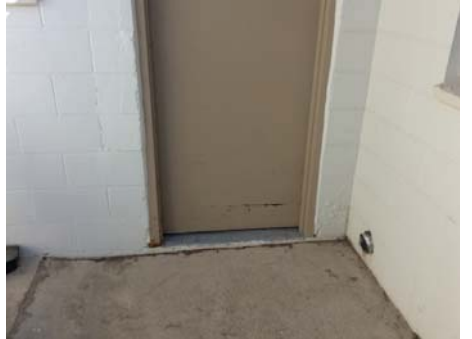
Door Threshold						
2903	<ul style="list-style-type: none"> <i>As-Built Description:</i> Existing threshold at door is 1/2" high or less but without a beveled edge on both sides. <i>As-Built:</i> 1.5" <i>Proposed Solution:</i> Modify threshold to have beveled edge on each side. Notes: No door hardware 	PCODE ID02 ADAAG 4.1.6(3)(d)(ii) ADA 2010 404.2.5 CBC 2010 1133B.2.4.1 CBC 2013 11B-404.2.5 Priority 2 Severity 4 TBD Contract Work	1	JOB	\$250	\$250

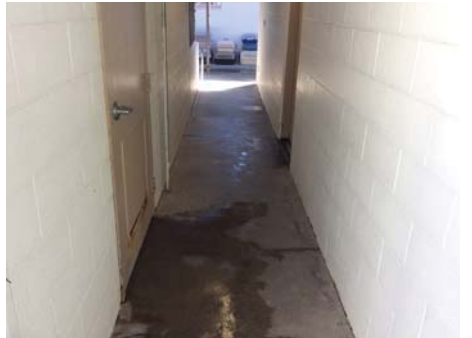
13 Puppy Ward

Door Swing						
2904	<ul style="list-style-type: none"> <i>As-Built Description:</i> Latch approach: At pull side, door does not have clear and level maneuvering space measuring door width plus 24" x 48" or 54" if door has closer (CA only: door width plus 24" x 60"). <i>As-Built:</i> 47.5" <i>Proposed Solution:</i> Provide relocated new door and frame; remodel walls as needed. Notes: Staff Only 	PCODE ID27B ADAAG Fig. 25(c) ADA 2010 404.2.4 CBC 2010 11B-26A(c) CBC 2013 11B-404.2.4 Priority 4 Severity 4 TBD Contract Work	1	JOB	\$2,600	\$2,600

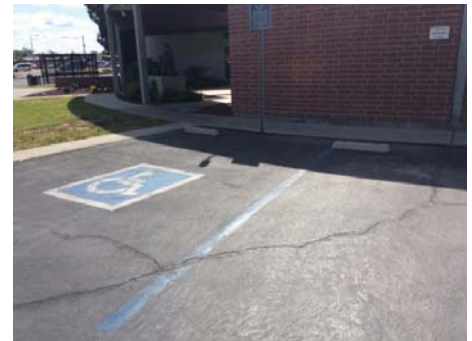
3701	<ul style="list-style-type: none"> <i>As-Built Description:</i> Accessible parking space does not have 5' wide access aisle; 8' wide for van accessible aisle. <i>Proposed Solution:</i> Modify parking aisle(s) to create accessible space by restriping. 	PCODE EA02B ADAAG 4.6.3 ADA 2010 502.3 CBC 2010 1129B.3.1 CBC 2013 11B-502.2; 11B-502.3.1 Priority 1 Severity 1 TBD Contract Work	1	JOB	\$200	\$200
------	--	--	---	-----	-------	--------------

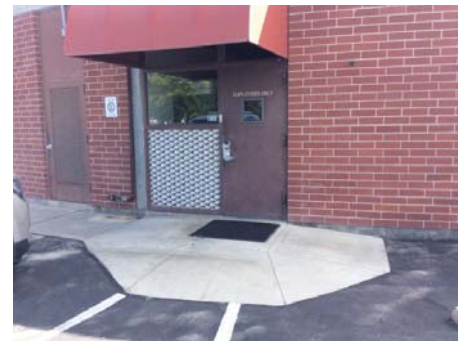
3709	<ul style="list-style-type: none"> As-Built Description: Slope greater than 1:12 (8.3%). As-Built: 9.4% Proposed Solution: Demolish existing and provide new curb ramp. 	PCODE EH02A ADAAG 4.7.2 ADA 2010 406.1 CBC 2010 1127B.5.3 CBC 2013 11B-406.2.1 Priority 1 Severity 4 TBD Contract Work	1	JOB	\$2,500	\$2,500
------	--	---	---	-----	---------	---------

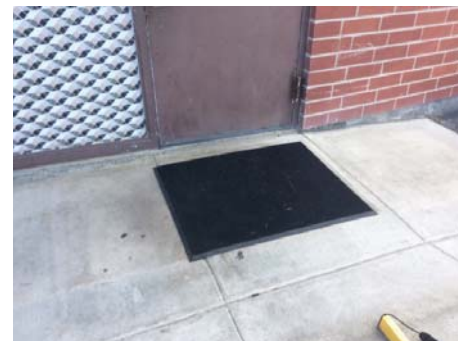
3711	<ul style="list-style-type: none"> As-Built Description: Front approach: At pull side, door does not have clear and level maneuvering space measuring door width plus 18"(CA only: 24" at exterior doors)x 60". As-Built: 2" x 47" not level. Proposed Solution: Provide and extend level maneuvering space. 	PCODE ID23D ADAAG Fig. 25(a) ADA 2010 404.2.4 CBC 2010 11B-26A(a) CBC 2013 11B-404.2.4 Priority 4 Severity 2 TBD Contract Work	1	JOB	\$800	\$800
------	---	---	---	-----	-------	-------

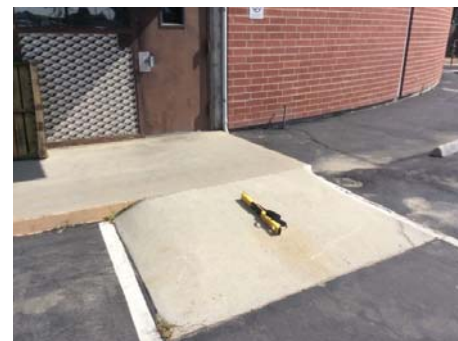
5 Conference Room Door

3712	<ul style="list-style-type: none"> As-Built Description: Slope greater than 1:12 (8.3%). As-Built: 13.1% Proposed Solution: Demolish existing and provide new curb ramp. 	PCODE EH02A ADAAG 4.7.2 ADA 2010 406.1 CBC 2010 1127B.5.3 CBC 2013 11B-406.2.1 Priority 1 Severity 3 TBD Contract Work	1	JOB	\$2,500	\$2,500
------	---	---	---	-----	---------	---------

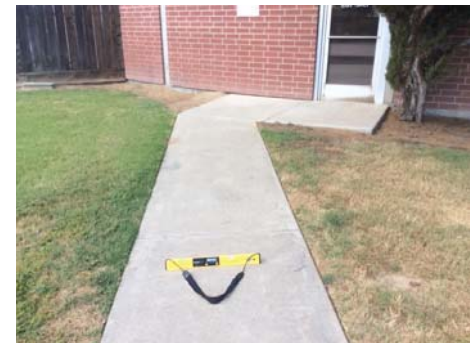
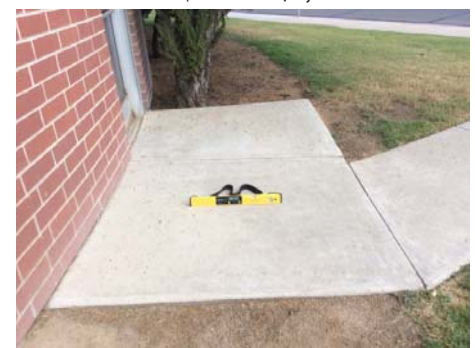
3716	<ul style="list-style-type: none"> <i>As-Built Description:</i> Cross slope more than 1":48" (2.083%). <i>As-Built:</i> 2.8% <i>Proposed Solution:</i> Modify cross slope. 	PCODE EF07 ADAAG 4.3.7 ADA 2010 403.3 CBC 2010 1133B.7.1.3 CBC 2013 11B-403.3 Priority 2 Severity 4 TBD Contract Work	20	SF	\$25	\$500
3717	<ul style="list-style-type: none"> <i>As-Built Description:</i> Cross slope more than 1":48" (2.083%). <i>As-Built:</i> 3.5% <i>Proposed Solution:</i> Modify cross slope. 	PCODE EF07 ADAAG 4.3.7 ADA 2010 403.3 CBC 2010 1133B.7.1.3 CBC 2013 11B-403.3 Priority 2 Severity 4 TBD Contract Work	60	SF	\$25	\$1,500

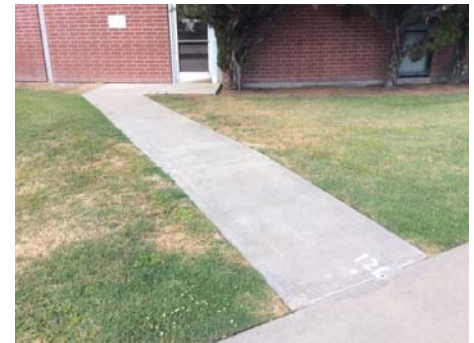
3715 • *As-Built Description:*
 Walk: Slope greater than 1:20 (5.0%), and walk does not comply with requirements for ramps.
 • *As-Built:* 6.9-8.1%
 • *Proposed Solution:*
 Modify walk/sidewalk slope to 1:20 or less.

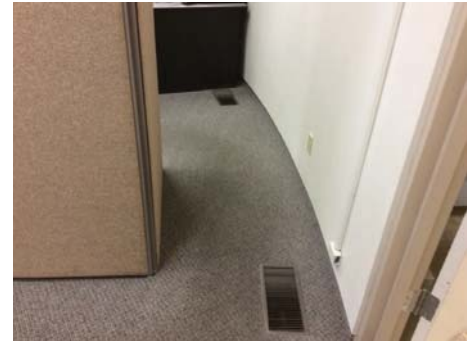
3628	<ul style="list-style-type: none"> <i>As-Built Description:</i> Corridor less than 36" wide. <i>As-Built:</i> 32" <i>Proposed Solution:</i> Enlarge corridor to 36" wide; relocate stud wall. 	PCODE IH03 ADAAG 4.3.3 ADA 2010 403.5.1 CBC 2010 1133B.3.1 CBC 2013 11B-403.5.1 Priority 1 Severity 2 TBD Contract Work	4	LF	\$140	\$560
------	--	---	---	----	-------	-------

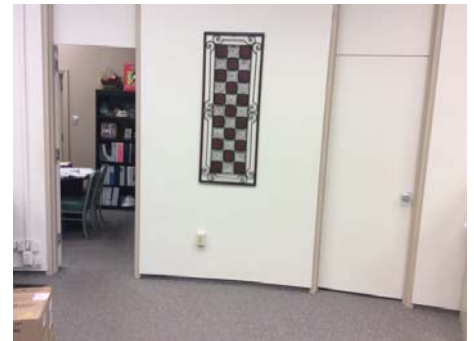
3596	<ul style="list-style-type: none"> <i>As-Built Description:</i> Door on accessible route has less than 32" clear and 80" (78" min. to closer if provided) opening width when 90° open. <i>As-Built:</i> Offices: 28.75" <i>Proposed Solution:</i> Provide new, larger door and frame with new accessible hardware. 	PCODE ID01 ADAAG 4.13.5 ADA 2010 404.2.3 CBC 2010 1133B.1.1.1.1 CBC 2013 11B-404.2.3 Priority 1 Severity 3 TBD Contract Work	2	JOB	\$2,600	\$5,200
------	---	--	---	-----	---------	---------

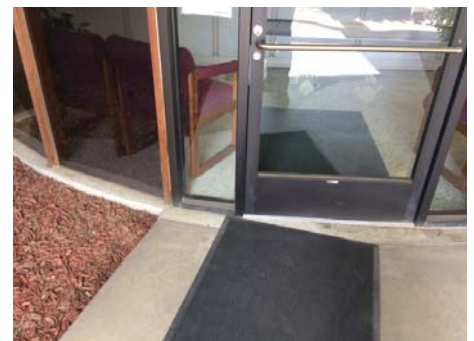
3585	<ul style="list-style-type: none"> <i>As-Built Description:</i> Front approach: At pull side, door does not have clear and level maneuvering space measuring door width plus 18"(CA only: 24" at exterior doors)x 60". <i>As-Built:</i> 18" <i>Proposed Solution:</i> Extend maneuvering space. 	PCODE ID23D ADAAG Fig. 25(a) ADA 2010 404.2.4 CBC 2010 11B-26A(a) CBC 2013 11B-404.2.4 Priority 1 Severity 4 TBD Contract Work	1	JOB	\$800	\$800
------	--	--	---	-----	-------	-------

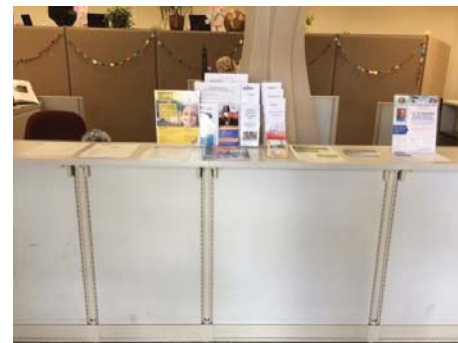
- 3588
- *As-Built Description:*
Service counter (stand-up): Accessible section min. 36" length and 36" max. height (in CA: 28" to 34" high) not provided.
 - *As-Built:* 42"
 - *Proposed Solution:*
Provide auxiliary shelf, clipboard, or table as equivalent facilitation.

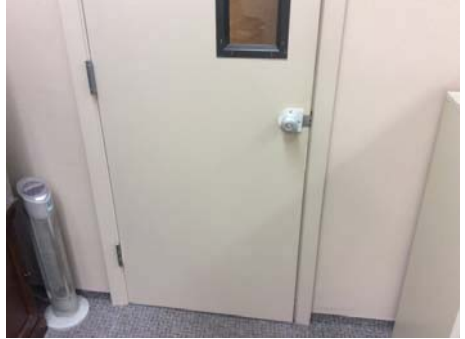
Item No. and Name	Existing Architectural Barrier and Proposed Solution	Codes / Mitigation Info	Qty	Unit	Cost	Total
Door Clearance						
3603	<ul style="list-style-type: none"> <i>As-Built Description:</i> Door on accessible route has less than 32" clear and 80" (78" min. to closer if provided) opening width when 90° open. <i>As-Built:</i> 27" <i>Proposed Solution:</i> Provide new, larger door and frame with new accessible hardware. 	PCODE ID01 ADAAG 4.13.5 ADA 2010 404.2.3 CBC 2010 1133B.1.1.1.1 CBC 2013 11B-404.2.3 Priority 2 Severity 2 TBD Contract Work	1	JOB	\$2,600	\$2,600

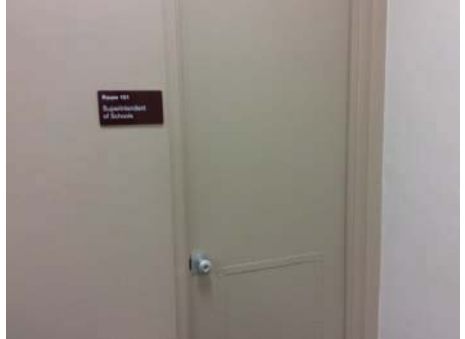
3610	<ul style="list-style-type: none"> <i>As-Built Description:</i> Door on accessible route has less than 32" clear and 80" (78" min. to closer if provided) opening width when 90° open. <i>As-Built:</i> 27" <i>Proposed Solution:</i> Provide new, larger door and frame with new accessible hardware. 	PCODE ID01 ADAAG 4.13.5 ADA 2010 404.2.3 CBC 2010 1133B.1.1.1.1 CBC 2013 11B-404.2.3 Priority 2 Severity 2 TBD Contract Work	1	JOB	\$2,600	\$2,600

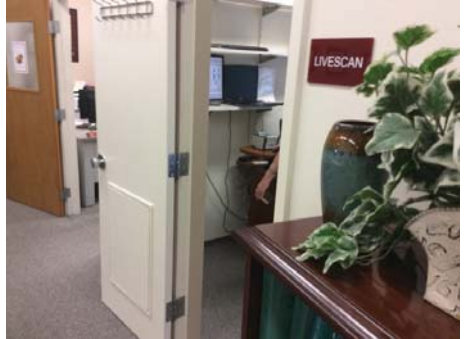
3612	<ul style="list-style-type: none"> <i>As-Built Description:</i> Door on accessible route has less than 32" clear and 80" (78" min. to closer if provided) opening width when 90° open. <i>As-Built:</i> Live scan: 28" <i>Proposed Solution:</i> Provide new, larger door and frame with new accessible hardware. 	PCODE ID01 ADAAG 4.13.5 ADA 2010 404.2.3 CBC 2010 1133B.1.1.1.1 CBC 2013 11B-404.2.3 Priority 2 Severity 2 TBD Contract Work	1	JOB	\$2,600	\$2,600

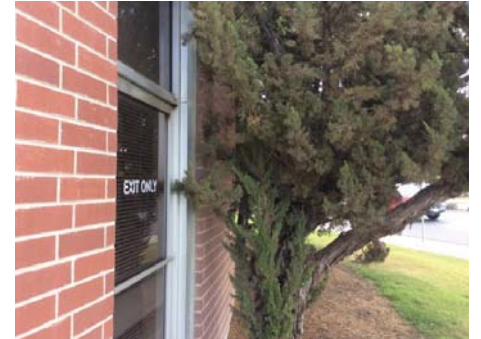
Item No. and Name	Existing Architectural Barrier and Proposed Solution	Codes / Mitigation Info	Qty	Unit	Cost	Total
3607	<ul style="list-style-type: none"> <i>As-Built Description:</i> Door on accessible route has less than 32" clear and 80" (78" min. to closer if provided) opening width when 90° open. <i>As-Built:</i> Door does not open all the way due to tree <i>Proposed Solution:</i> Remove tree. 	PCODE ID01NT ADAAG 4.13.5 ADA 2010 404.2.3 CBC 2010 1133B.1.1.1.1 CBC 2013 11B-404.2.3 Priority 1 Severity 4 TBD Contract Work	1	JOB	\$2,600	\$2,600

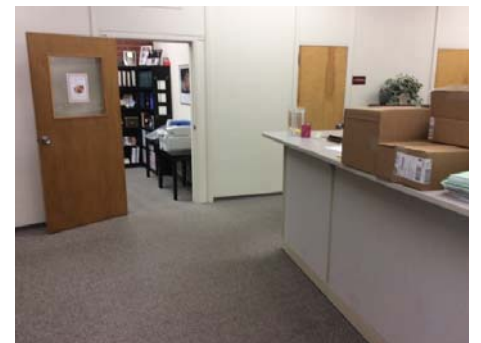
Public Counter

3599	<ul style="list-style-type: none"> <i>As-Built Description:</i> Service counter (stand-up): Accessible section min. 36" length and 36" max. height (in CA: 28" to 34" high) not provided. <i>As-Built:</i> 43.25" <i>Proposed Solution:</i> Provide auxiliary shelf, clipboard, or table as equivalent facilitation. 	PCODE IN03 ADAAG 7.2(2) ADA 2010 904.4 CBC 2010 1122B.4 CBC 2013 11B-904.4 Priority 1 Severity 3 TBD Contract Work	1	JOB	\$150	\$150
------	---	---	---	-----	-------	-------

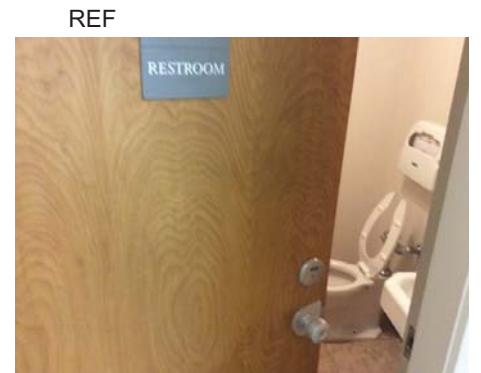
Door Clearance

3615	<ul style="list-style-type: none"> <i>As-Built Description:</i> Door on accessible route has less than 32" clear and 80" (78" min. to closer if provided) opening width when 90° open. <i>As-Built:</i> 27" <i>Proposed Solution:</i> Provide new, larger door and frame with new accessible hardware. 	PCODE ID01REF ADAAG 4.13.5 ADA 2010 404.2.3 CBC 2010 1133B.1.1.1.1 CBC 2013 11B-404.2.3 Priority 3 Severity 2 TBD Contract Work	REF			
------	---	--	-----	--	--	--

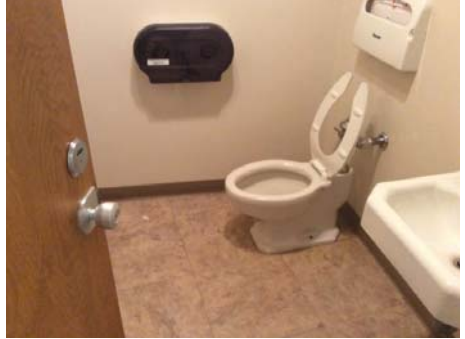
Item No. and Name	Existing Architectural Barrier and Proposed Solution	Codes / Mitigation Info	Qty	Unit	Cost	Total
<u>Restroom</u>						
3614	<ul style="list-style-type: none"> <i>As-Built Description:</i> Single accommodation restroom not accessible; multiple compliance violations. <i>Proposed Solution:</i> Remodel area to provide single-occupant accessible restroom. 	PCODE WA01 ADAAG 4.22 ADA 2010 603 CBC 2010 1115B.3.2 CBC 2013 11B-603 Priority 3 Severity 2 TBD Contract Work	2	JOB	\$30,000	\$60,000

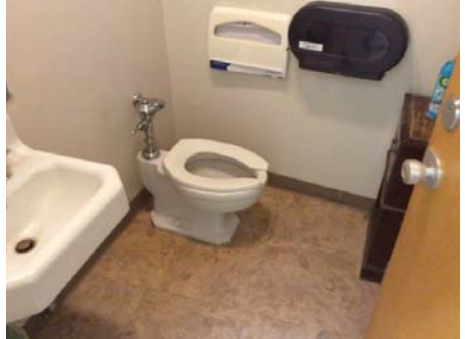
3617	<ul style="list-style-type: none"> <i>As-Built Description:</i> Single accommodation restroom not accessible; multiple compliance violations. <i>As-Built:</i> Women's <i>Proposed Solution:</i> Remodel area to provide single-occupant accessible restroom. 	PCODE WA01REF ADAAG 4.22 ADA 2010 603 CBC 2010 1115B.3.2 CBC 2013 11B-603 Priority 3 Severity 2 TBD Contract Work				
			REF

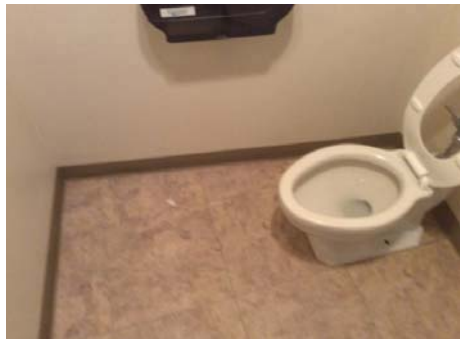
<u>Water Closet</u>						
3616	<ul style="list-style-type: none"> <i>As-Built Description:</i> CA only: In single-accommodation restroom less than 48" in front of water closet provided. <i>As-Built:</i> 34" <i>Proposed Solution:</i> Remodel restroom to provide at least 48" in front of water closet. 	PCODE WB03AREF CBC 2010 1115B.3.2.1 CBC 2013 11B-604.3.1 Priority 3 Severity 2 TBD Contract Work				
			REF

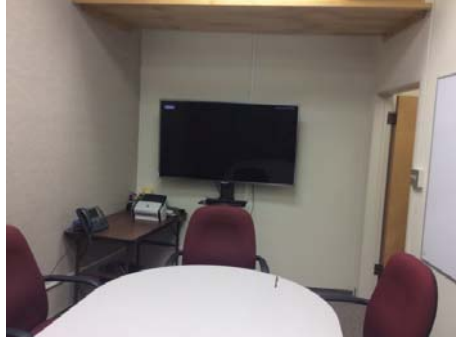
Item No. and Name	Existing Architectural Barrier and Proposed Solution	Codes / Mitigation Info	Qty	Unit	Cost	Total
<u>Assistive Listening</u>						
3622	<ul style="list-style-type: none"> <i>As-Built Description:</i> No portable assistive listening system provided for small meeting room. <i>Proposed Solution:</i> Share existing portable assistive listening system from other facility if needed. 	PCODE GI01E ADAAG 4.1.3(19)(b) & 4.33.7 ADA 2010 219.1 & 706.1 CBC 2010 1104B.2 CBC 2013 11B-219.2 Priority 3 Severity 3 TBD Contract Work				
						REF

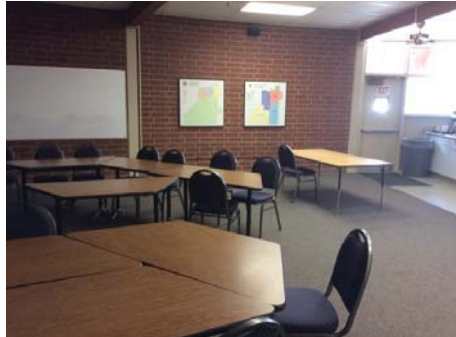
<u>Assistive Listening</u>						
3638	<ul style="list-style-type: none"> <i>As-Built Description:</i> No portable assistive listening system provided for small meeting room. <i>Proposed Solution:</i> Share existing portable assistive listening system from other facility if needed. 	PCODE GI01E ADAAG 4.1.3(19)(b) & 4.33.7 ADA 2010 219.1 & 706.1 CBC 2010 1104B.2 CBC 2013 11B-219.2 Priority 3 Severity 3 TBD Contract Work				
						REF

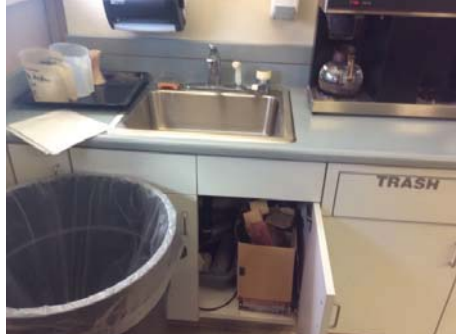
<u>Sink</u>						
3640	<ul style="list-style-type: none"> <i>As-Built Description:</i> Sink does not have knee space min. 27" high x 19" deep x 30" wide. <i>Proposed Solution:</i> Remodel sink cabinet. 	PCODE IN06A ADAAG 4.24.3 ADA 2010 606.2 CBC 2010 1115B.4.7.1 CBC 2013 11B-606.2 Priority 2 Severity 2 TBD Contract Work	1	JOB	\$1,750	\$1,750

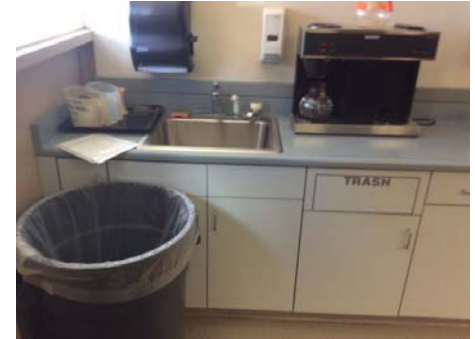
Item No. and Name	Existing Architectural Barrier and Proposed Solution	Codes / Mitigation Info	Qty	Unit	Cost	Total
3639	<ul style="list-style-type: none"> As-Built Description: Sink rim higher than 34" above floor. As-Built: 37" Proposed Solution: Remodel sink cabinet to lower sink. 	PCODE IN06REF ADAAG 4.24.2 ADA 2010 606.3 CBC 2010 1115B.4.7.1 CBC 2013 11B-606.3 Priority 3 Severity 4 TBD Contract Work

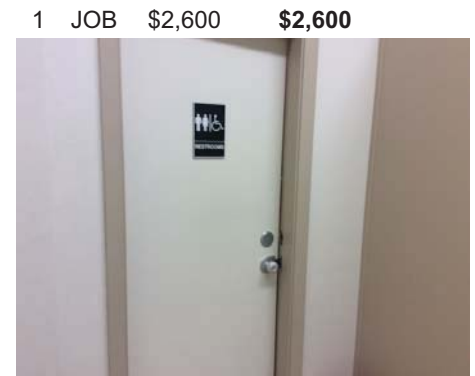
Door Clearance

3649	<ul style="list-style-type: none"> As-Built Description: Door on accessible route has less than 32" clear and 80" (78" min. to closer if provided) opening width when 90° open. As-Built: 27" Proposed Solution: Provide new, larger door and frame with new accessible hardware. 	PCODE ID01 ADAAG 4.13.5 ADA 2010 404.2.3 CBC 2010 1133B.1.1.1.1 CBC 2013 11B-404.2.3 Priority 3 Severity 2 TBD Contract Work				
------	--	---	--	--	--	--

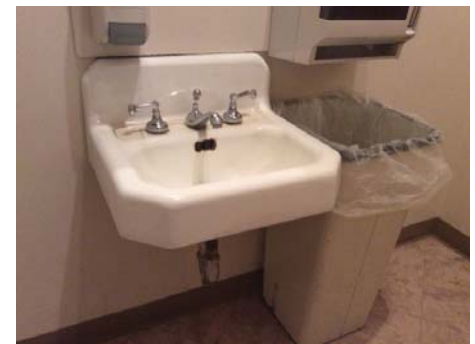
Lavatory

3657	<ul style="list-style-type: none"> As-Built Description: Wheelchair clearance under lavatory apron or lavatory counter front edge less than 29" high. As-Built: 26.75" Proposed Solution: Provide new accessible lavatory. Remodel restroom as needed. 	PCODE WD03 ADAAG 4.19.2 ADA 2010 606.3 CBC 2010 1115B.4.3.3 CBC 2013 11B-606.3 Priority 3 Severity 3 TBD Contract Work				
------	---	---	--	--	--	--

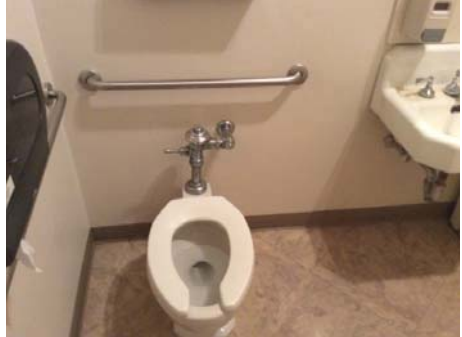
Item No. and Name	Existing Architectural Barrier and Proposed Solution	Codes / Mitigation Info	Qty	Unit	Cost	Total
<u>Toilet Stall</u>						
3659	<ul style="list-style-type: none"> • <i>As-Built Description:</i> The lavatory or other unintended fixture, encroaches on the necessary clearance around a water closet (60" x 56"). • <i>As-Built:</i> 47.5" from wall 21" from side • <i>Proposed Solution:</i> Remove adjacent fixture and provide new enclosure at accessible water closet. 	PCODE WB01A ADA 2010 604.3.1; 604.3.2 CBC 2013 11B-604.3.1; 11B-604.3.2 Priority 3 Severity 2 TBD Contract Work	1	JOB	\$2,000	\$2,000

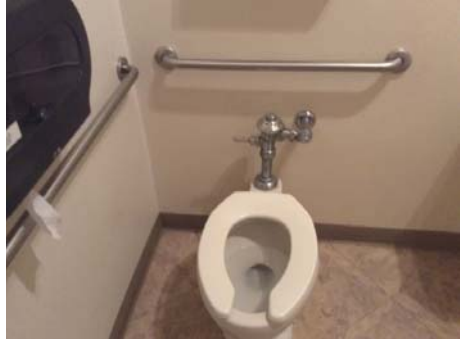
<u>Water Closet</u>						
3664	<ul style="list-style-type: none"> • <i>As-Built Description:</i> Water closet not 17"-18" from near side wall to center line of water closet (2010 ADAS: 16"-18"). • <i>As-Built:</i> 19" o.c. at front • <i>Proposed Solution:</i> Relocate existing water closet and plumbing, remount with offset closet flange to provide 17"-18" from side wall. 	PCODE WB02C ADAAG Fig. 28 ADA 2010 604.2 CBC 2010 1115B.4.1.1 CBC 2013 11B-604.2 Priority 3 Severity 4 TBD Contract Work	1	JOB	\$500	\$500

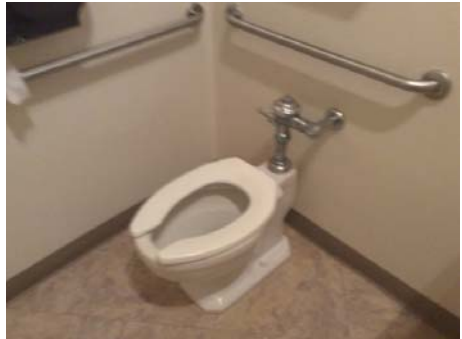
3662	<ul style="list-style-type: none"> • <i>As-Built Description:</i> Height of water closet seat less than 17" or more than 19" from floor. • <i>As-Built:</i> 16.5" AFF • <i>Proposed Solution:</i> Provide new accessible water closet. 	PCODE WB08 ADAAG 4.16.3 ADA 2010 604.4 CBC 2010 1115B.4.1.4 CBC 2013 11B-604.4 Priority 3 Severity 4 TBD Contract Work	1	JOB	\$1,400	\$1,400

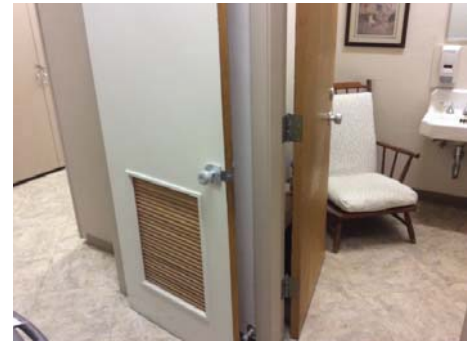
Door Clearance

3668	<ul style="list-style-type: none"> <i>As-Built Description:</i> Door on accessible route has less than 32" clear and 80" (78" min. to closer if provided) opening width when 90° open. <i>As-Built:</i> 27" <i>Proposed Solution:</i> Provide new, larger door and frame with new accessible hardware. 	PCODE ID01REF ADAAG 4.13.5 ADA 2010 404.2.3 CBC 2010 1133B.1.1.1.1 CBC 2013 11B-404.2.3 Priority 3 Severity 2 TBD Contract Work	2	REF		
------	---	--	---	-----	--	--

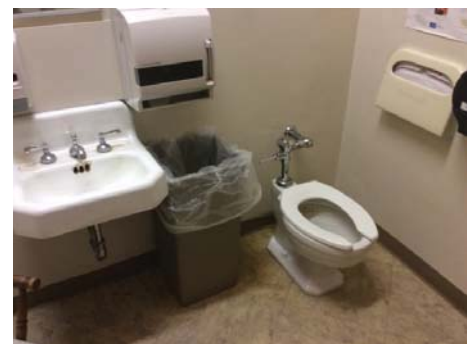
Grab Bars

3670	<ul style="list-style-type: none"> <i>As-Built Description:</i> Grab bars not provided or are not code compliant. <i>Proposed Solution:</i> Provide accessible grab bars. 	PCODE WB07REF ADAAG 4.17.6 ADA 2010 604.5 CBC 2010 1115B.4.1.3 CBC 2013 11B-604.5 Priority 3 Severity 3 TBD Contract Work		REF		
------	---	--	--	-----	--	--

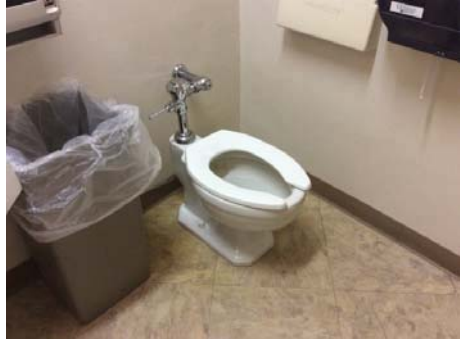
<u>Water Closet</u>						
3671	<ul style="list-style-type: none"> <i>As-Built Description:</i> Height of water closet seat less than 17" or more than 19" from floor. <i>As-Built:</i> 16.5" <i>Proposed Solution:</i> Provide new accessible water closet. 	PCODE WB08 ADAAG 4.16.3 ADA 2010 604.4 CBC 2010 1115B.4.1.4 CBC 2013 11B-604.4 Priority 3 Severity 4 TBD Contract Work	1	JOB	\$1,400	\$1,400

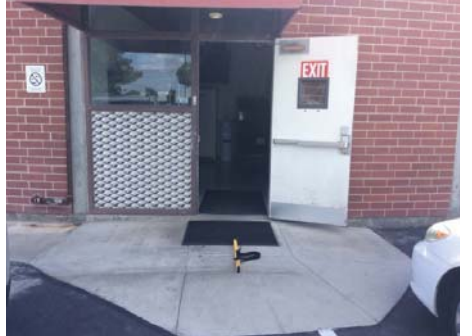
<u>Door</u>						
3691	<ul style="list-style-type: none"> <i>As-Built Description:</i> Surface of required maneuvering clearance at door slopes more than 1/4":12" (2.0%). <i>As-Built:</i> 8.2% at 49" from door <i>Proposed Solution:</i> Modify surface slope at door. 	PCODE ID11 ADAAG 4.13.6 ADA 2010 404.2.4.4 CBC 2010 1133B.2.4 CBC 2013 11B-404.2.4 Priority 4 Severity 2 TBD Contract Work	64	SF	\$40	\$2,560

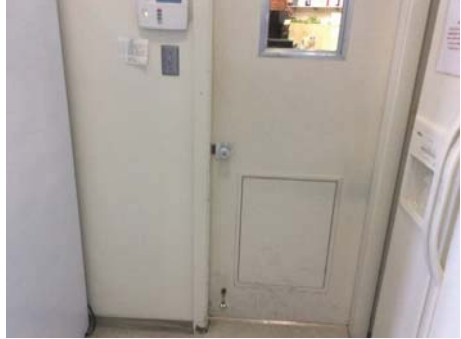
Door Clearance

3682	<ul style="list-style-type: none"> <i>As-Built Description:</i> Door on accessible route has less than 32" clear and 80" (78" min. to closer if provided) opening width when 90° open. <i>As-Built:</i> 27" <i>Proposed Solution:</i> Provide new, larger door and frame with new accessible hardware. 	PCODE ID01 ADAAG 4.13.5 ADA 2010 404.2.3 CBC 2010 1133B.1.1.1.1 CBC 2013 11B-404.2.3 Priority 4 Severity 2 TBD Contract Work	1	JOB	\$2,600	\$2,600
------	---	---	---	-----	---------	---------

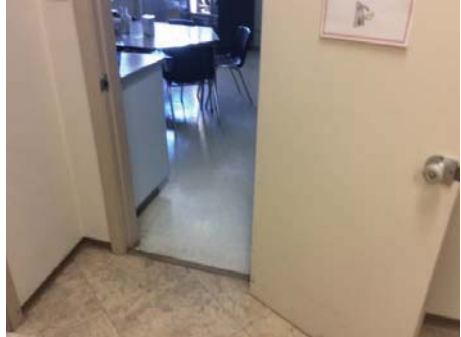
3673	<ul style="list-style-type: none"> <i>As-Built Description:</i> Door on accessible route has less than 32" clear and 80" (78" min. to closer if provided) opening width when 90° open. <i>As-Built:</i> 29" <i>Proposed Solution:</i> Provide new, larger door and frame with new accessible hardware. 	PCODE ID01 ADAAG 4.13.5 ADA 2010 404.2.3 CBC 2010 1133B.1.1.1.1 CBC 2013 11B-404.2.3 Priority 4 Severity 3 TBD Contract Work	1	JOB	\$2,600	\$2,600
------	---	---	---	-----	---------	---------

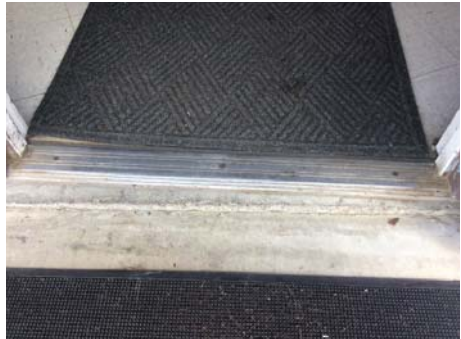
Door Threshold

3692	<ul style="list-style-type: none"> <i>As-Built Description:</i> Existing threshold at door is 1/2" high or less but without a beveled edge on both sides. <i>As-Built:</i> 0.5" <i>Proposed Solution:</i> Modify threshold to have beveled edge on each side. 	PCODE ID02REF ADAAG 4.1.6(3)(d)(ii) ADA 2010 404.2.5 CBC 2010 1133B.2.4.1 CBC 2013 11B-404.2.5 Priority 4 Severity 4 TBD Contract Work	REF			
------	--	---	-----	--	--	--

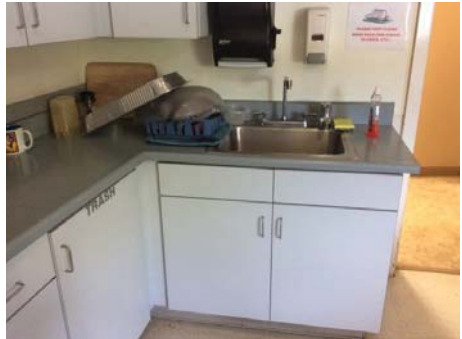
3676	<ul style="list-style-type: none"> As-Built Description: Sink rim higher than 34" above floor. As-Built: 36.5" Proposed Solution: Remodel sink cabinet to lower sink. 	PCODE IN06REF ADAAG 4.24.2 ADA 2010 606.3 CBC 2010 1115B.4.7.1 CBC 2013 11B-606.3 Priority 4 Severity 4 TBD Contract Work		REF

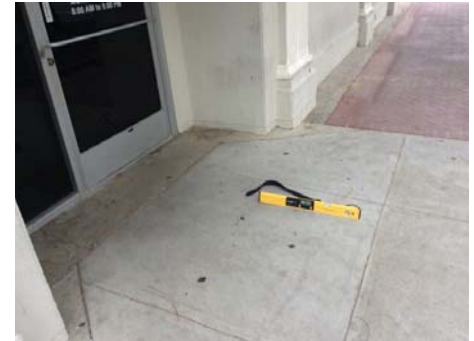
Door

3807	<ul style="list-style-type: none"> As-Built Description: Surface of required maneuvering clearance at door slopes more than 1/4":12" (2.0%). As-Built: 2.3-5.2% starting at 48" from door. Public sidewalk Proposed Solution: Modify surface slope at door. 	PCODE ID11 ADAAG 4.13.6 ADA 2010 404.2.4.4 CBC 2010 1133B.2.4 CBC 2013 11B-404.2.4 Priority 1 Severity 3 TBD Contract Work	30	SF	\$40	\$1,200
------	---	---	----	----	------	---------

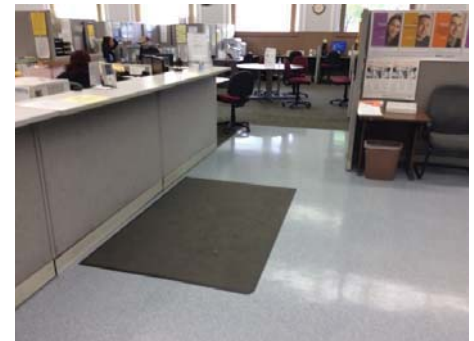
3810	<ul style="list-style-type: none"> • <i>As-Built Description:</i> Service counter (stand-up): Accessible section min. 36" length and 36" max. height (in CA: 28" to 34" high) not provided. • <i>As-Built:</i> 42" • <i>Proposed Solution:</i> Provide auxiliary shelf, clipboard, or table as equivalent facilitation. 	<p>PCODE IN03 ADAAG 7.2(2) ADA 2010 904.4 CBC 2010 1122B.4 CBC 2013 11B-904.4 Priority 1 Severity 3 TBD Contract Work</p>	1	JOB	\$150	\$150
------	--	---	---	-----	-------	-------

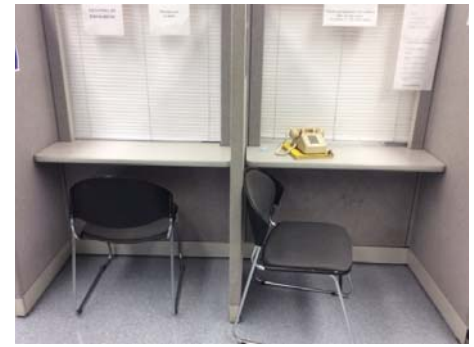
3811	<ul style="list-style-type: none"> • <i>As-Built Description:</i> Public Counter (Seated Service): Accessible section not provided (knee space min. 27" high x 19" deep x 30" wide, top 28" to 34" high, min. 36" counter wide). • <i>As-Built:</i> Testing: 12" deep • <i>Proposed Solution:</i> Retrofit existing counter to provide accessible seating section. Interim solution: Provide auxiliary counter or table. • <i>Notes:</i> Tables on other side are accessible. 	<p>PCODE IN03A ADAAG 4.32.3 & 4 ADA 2010 306.3; 904.4 CBC 2010 1122B.3 & 4 CBC 2013 11B-306.3; 11B-904.4 Priority 1 Severity 2 TBD Contract Work</p>	1	JOB	\$1,200	\$1,200
------	---	--	---	-----	---------	---------

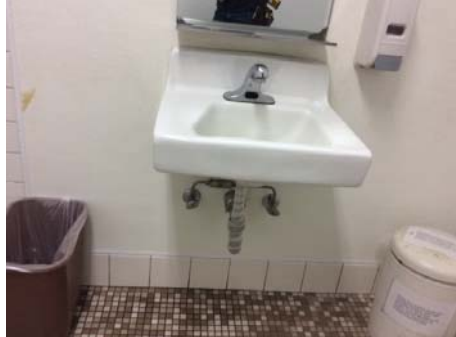
2 Lobby Restroom - Women's

Item No. and Name	Existing Architectural Barrier and Proposed Solution	Codes / Mitigation Info	Qty	Unit	Cost	Total
<u>Lavatory</u>						
3815	<ul style="list-style-type: none"> As-Built Description: Knee clearance 27" min. high starting 8" back from the front edge of the lavatory towards the wall is not provided. As-Built: 26" Proposed Solution: Provide new accessible lavatory. Remodel restroom as needed. 	PCODE WD04 ADAAG Fig. 31 ADA 2010 606.3 CBC 2010 1115B.4.3 CBC 2013 11B-306.3.3 Priority 3 Severity 2 TBD Contract Work	1	JOB	\$3,400	\$3,400

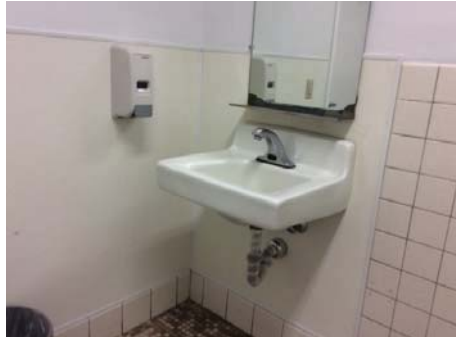
3 Lobby Restroom - Men's

<u>Lavatory</u>						
3821	<ul style="list-style-type: none"> As-Built Description: Knee clearance 27" min. high starting 8" back from the front edge of the lavatory towards the wall is not provided. As-Built: 26" Proposed Solution: Remount compliant fixture to accessible height. 	PCODE WD04A ADAAG Fig. 31 ADA 2010 606.3 CBC 2010 1115B.4.3 CBC 2013 11B-306.3.3 Priority 3 Severity 2 TBD Contract Work	1	JOB	\$1,500	\$1,500

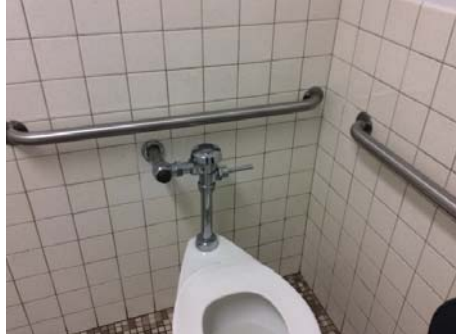
<u>Water Closet</u>						
3825	<ul style="list-style-type: none"> As-Built Description: Flush Control: Operating handle not mounted toward wide side of stall. Proposed Solution: Replace flush control with properly mounted accessible type, or install sensor flush. 	PCODE WB10 ADAAG 4.16.5 ADA 2010 604.6 CBC 2010 1115B.4.1.5 CBC 2013 11B-604.6 Priority 3 Severity 3 TBD Contract Work	1	JOB	\$500	\$500

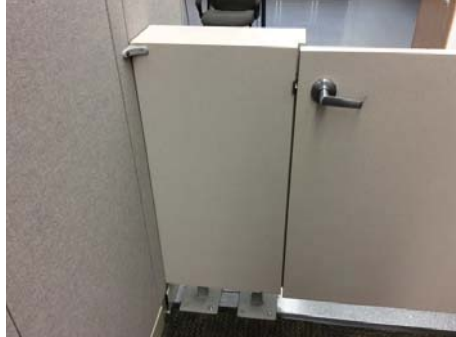
6 JTO Staff Area

Item No. and Name	Existing Architectural Barrier and Proposed Solution	Codes / Mitigation Info	Qty	Unit	Cost	Total
Door Swing						
3832	<ul style="list-style-type: none"> <i>As-Built Description:</i> Front approach: At pull side, door does not have clear and level maneuvering space measuring door width plus 18" x 60". <i>As-Built:</i> 17.5" <i>Proposed Solution:</i> Provide relocated new door and frame; remodel walls as needed. 	PCODE ID23BNT ADAAG Fig. 25(a) ADA 2010 404.2.4 CBC 2010 11B-26A(a) CBC 2013 11B-404.2.4 Priority 2 Severity 4 TBD Contract Work	1	JOB	\$2,600	\$2,600

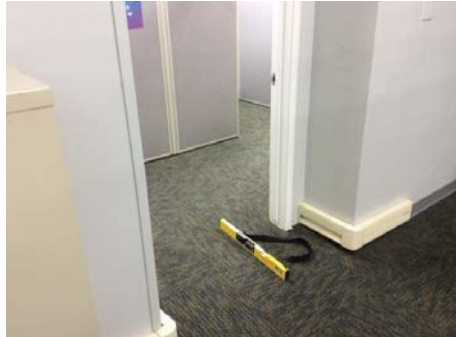
7 Youth Offices

Item No. and Name	Existing Architectural Barrier and Proposed Solution	Codes / Mitigation Info	Qty	Unit	Cost	Total
Door						
3833	<ul style="list-style-type: none"> <i>As-Built Description:</i> Surface of required maneuvering clearance at door slopes more than 1/4":12" (2.0%). <i>As-Built:</i> 10.5% <i>Proposed Solution:</i> Modify surface slope at door. <i>Notes:</i> Build up floor in corridors and provide 5% max slope in direction of travel. avoid creating x slopes along circulation path. 	PCODE ID11 ADAAG 4.13.6 ADA 2010 404.2.4.4 CBC 2010 1133B.2.4 CBC 2013 11B-404.2.4 Priority 2 Severity 1 TBD Contract Work	90	SF	\$40	\$3,600

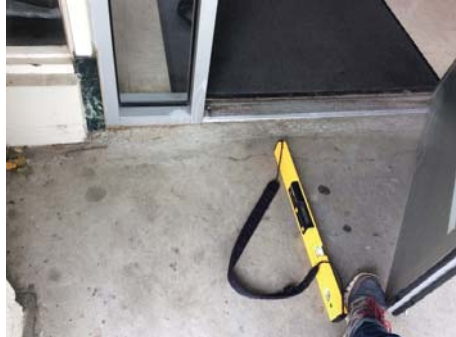
8 Staff Entrance on 7th st.

Item No. and Name	Existing Architectural Barrier and Proposed Solution	Codes / Mitigation Info	Qty	Unit	Cost	Total
Door						
3836	<ul style="list-style-type: none"> <i>As-Built Description:</i> Surface of required maneuvering clearance at door slopes more than 1/4":12" (2.0%). <i>As-Built:</i> 3.6% <i>Proposed Solution:</i> Modify surface slope at door. <i>Notes:</i> Provide door opener. 	PCODE ID11REF ADAAG 4.13.6 ADA 2010 404.2.4.4 CBC 2010 1133B.2.4 CBC 2013 11B-404.2.4 Priority 1 Severity 4 TBD Contract Work	REF

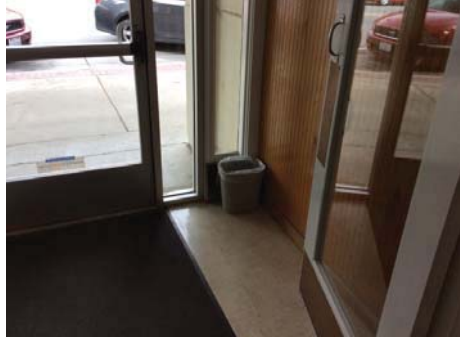
Item No. and Name	Existing Architectural Barrier and Proposed Solution	Codes / Mitigation Info	Qty	Unit	Cost	Total
<u>Vestibule</u>						
3846	<ul style="list-style-type: none"> <i>As-Built Description:</i> Vestibule length in direction of travel less than width(es) of door(s) swinging into vestibule, plus 48". <i>As-Built:</i> 40" <i>Proposed Solution:</i> At vestibule with standard pairs of doors, remodel area to provide required length. <i>Notes:</i> Remove double doors or lock open. 	PCODE IF02A ADAAG 4.13.7 ADA 2010 404.2.6 CBC 2010 1133B.2.4.4 CBC 2013 11B-404.2.6 Priority 1 Severity 2 TBD Contract Work	1	JOB	\$5,000	\$5,000

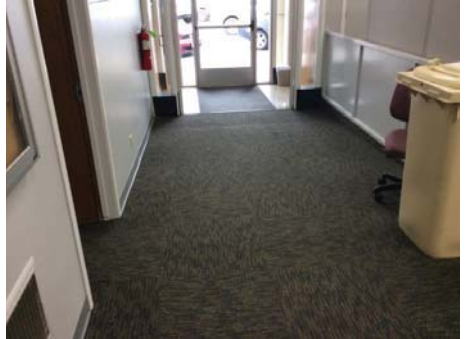
<u>Walk</u>						
3837	<ul style="list-style-type: none"> <i>As-Built Description:</i> Walk: Slope greater than 1:20 (5.0%), and walk does not comply with requirements for ramps. <i>As-Built:</i> 5.3-6.2% <i>Proposed Solution:</i> Modify walk/sidewalk slope to 1:20 or less. <i>Notes:</i> Modify area to provide 5% max slope along with compliant landing at conference door. Remove inside double doors at entrance. Use right side for sloped walk. 	PCODE EF01 ADAAG 4.3.7 ADA 2010 403.3 CBC 2010 1133B.7.3 CBC 2013 11B-403.3 Priority 1 Severity 4 TBD Contract Work	60	SF	\$25	\$1,500

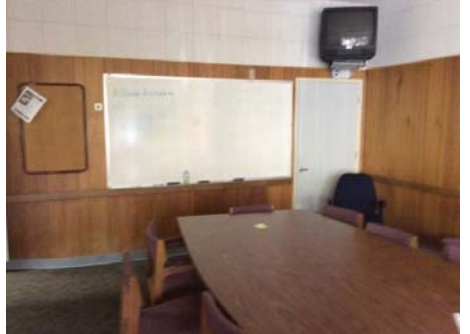
9 Conference Room

<u>Assistive Listening</u>						
3845	<ul style="list-style-type: none"> <i>As-Built Description:</i> No portable assistive listening system provided for small meeting room. <i>Proposed Solution:</i> Share existing portable assistive listening system from other facility if needed. 	PCODE GI01EREF ADAAG 4.1.3(19)(b) & 4.33.7 ADA 2010 219.1 & 706.1 CBC 2010 1104B.2 CBC 2013 11B-219.2 Priority 3 Severity 3 TBD Contract Work	REF

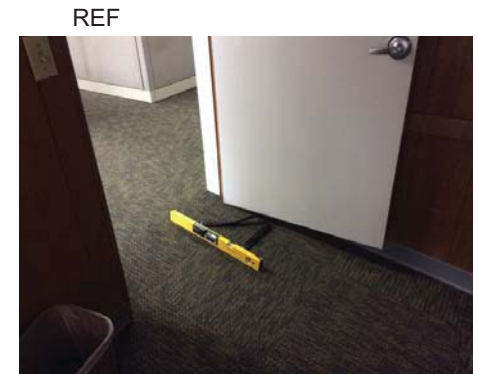
3842	<ul style="list-style-type: none"> As-Built Description: Surface of required maneuvering clearance at door slopes more than 1/4":12" (2.0%). As-Built: 13.6% Proposed Solution: Modify surface slope at door. Notes: Ramp needed: Interim solution, provide directional signage and identify street entrance as Acc. entrance with ISA. 	<p>PCODE ID11REF ADAAG 4.13.6 ADA 2010 404.2.4.4 CBC 2010 1133B.2.4 CBC 2013 11B-404.2.4 Priority 2 Severity 1 TBD Contract Work</p>				
------	--	--	--	--	--	--

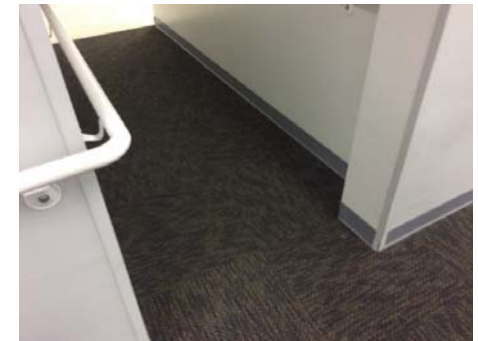
10 Staff Break Room

3847	<ul style="list-style-type: none"> As-Built Description: Concrete ramp: Width (between handrails) less than 36" min. (CA only: 48" min.) As-Built: 40" at top Proposed Solution: Modify ramp width to minimum 48" wide. Notes: Verify if structural column 	<p>PCODE EB10 ADAAG 4.8.3 ADA 2010 405.5 CBC 2010 1133B.5.2 CBC 2013 11B-405.5 Priority 4 Severity 4 TBD Contract Work</p>	1	LF	\$75	\$75
------	---	--	---	----	------	------

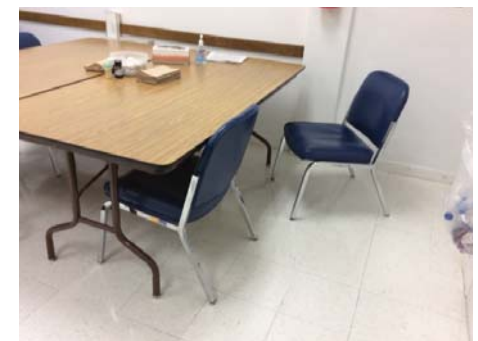
3853	<ul style="list-style-type: none"> As-Built Description: Accessible non-fixed table or desk (top 28" to 34" high; knee space at least 27" high x 19" deep x 30" wide) not provided. As-Built: 26.75" high at sides. 6" deep at ends. Proposed Solution: Provide table or desk with accessible dimensions when purchasing new furniture. 	<p>PCODE IN02A ADAAG 4.32.3 & .4 ADA 2010 306.1 CBC 2010 1122B.3 & 4 CBC 2013 11B-306.1 & 11B-902.3 Priority 4 Severity 2 TBD Contract Work</p>	1	JOB	\$1,600	\$1,600
------	---	---	---	-----	---------	---------

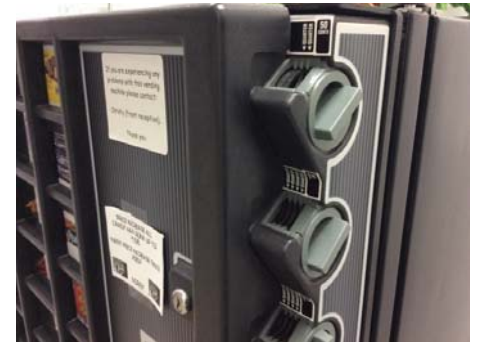
- 3851
- *As-Built Description:*
Operable part(s) require tight grasping, pinching, or twisting of the wrist with one hand.
 - *Proposed Solution:*
Modify or replace the operable part(s) to not require tight grasping, pinching, or twisting of the wrist with one hand.

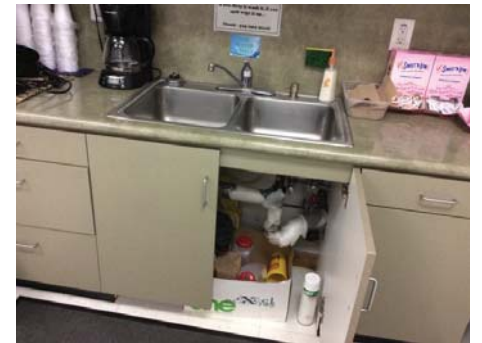
- 3852
- *As-Built Description:*
Sink does not have knee space min. 27" high x 19" deep x 30" wide.
 - *As-Built:* Storage items
 - *Proposed Solution:*
Remodel sink cabinet.
 - **Notes:**
Staff Only. if requested as reasonable accommodation. disposal 8" deep at 14" high to bottom.

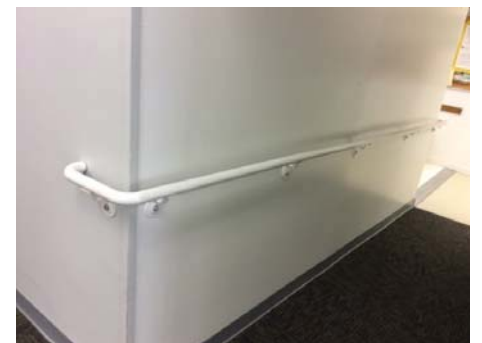
Top and Bottom Extension at Ramps

- 3848
- *As-Built Description:*
Ramp handrail does not extend horizontally 12" past top and / or bottom of ramp.
 - *Proposed Solution:*
Provide ramp handrail extension (cost for each extension piece).
 - **Notes:**
Modify slope to under 5%.

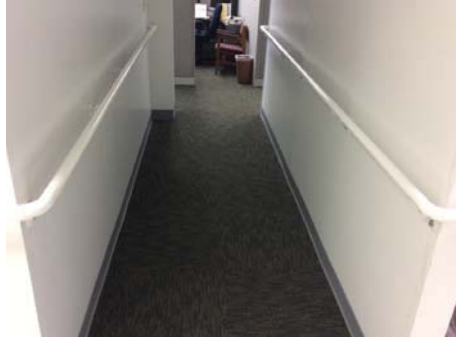
Item No. and Name	Existing Architectural Barrier and Proposed Solution	Codes / Mitigation Info	Qty	Unit	Cost	Total
Walk						
3849	<ul style="list-style-type: none"> <i>As-Built Description:</i> Walk: Slope greater than 1:20 (5.0%), and walk does not comply with requirements for ramps. <i>As-Built:</i> Upper portion: 5.5% <i>Proposed Solution:</i> Modify walk/sidewalk slope to 1:20 or less. <i>Notes:</i> Lower: 4.5% 	PCODE EF01 ADAAG 4.3.7 ADA 2010 403.3 CBC 2010 1133B.7.3 CBC 2013 11B-403.3 Priority 4 Severity 4 TBD Contract Work	20	SF	\$25	\$500

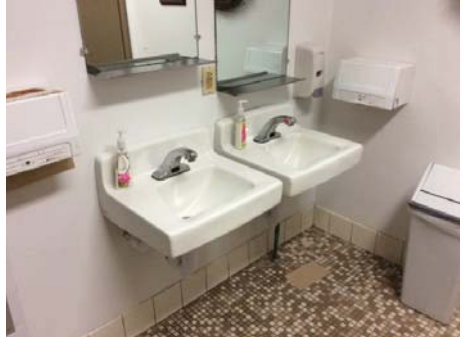
11 Staff Restroom JTO - Women's

3859	<ul style="list-style-type: none"> <i>As-Built Description:</i> Knee clearance 27" min. high starting 8" back from the front edge of the lavatory towards the wall is not provided. <i>As-Built:</i> 24" <i>Proposed Solution:</i> Remount compliant fixture to accessible height. 	PCODE WD04AREF ADAAG Fig. 31 ADA 2010 606.3 CBC 2010 1115B.4.3 CBC 2013 11B-306.3.3 Priority 4 Severity 2 TBD Contract Work	REF

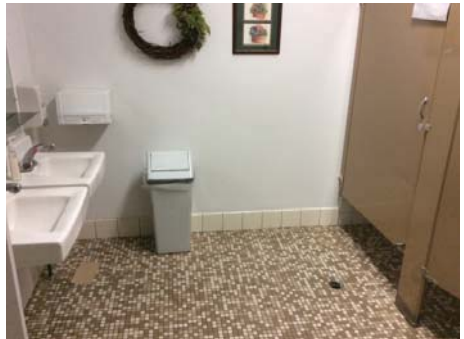
3860	<ul style="list-style-type: none"> <i>As-Built Description:</i> Multiple accommodation restroom not accessible; multiple compliance violations. <i>Proposed Solution:</i> Remodel area to provide accessible restroom with one accessible stall, lavatory (and one urinal at Mens). <i>Notes:</i> Provide directional sign as interim solution. 	PCODE WA01AREF ADAAG 4.22 ADA 2010 603 CBC 2010 1115B.3.1 CBC 2013 11B-603 Priority 4 Severity 1 TBD Contract Work	REF

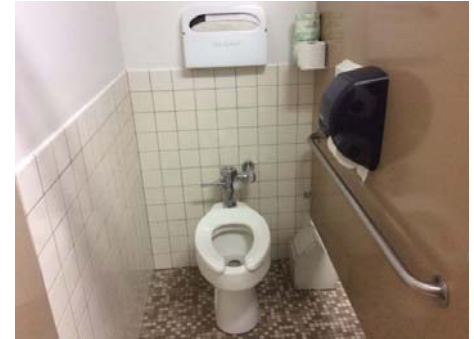
- 3857
- *As-Built Description:*
Toilet stall less than 60" wide.
 - *As-Built:* 37"
 - *Proposed Solution:*
Provide new accessible stall (alternate stalls 36" x 69" or 48" x 69" not recommended).

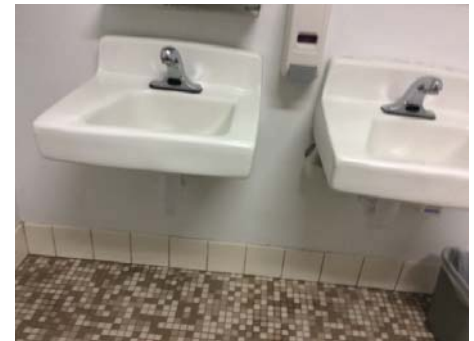
12 Staff Restroom JTO - Men's

PCODE **WD04REF**
 ADAAG **Fig. 31**
 ADA 2010 **606.3**
 CBC 2010 **1115B.4.3**
 CBC 2013 **11B-306.3.3**
 Priority **4**
 Severity **2**
 TBD **Contract Work**

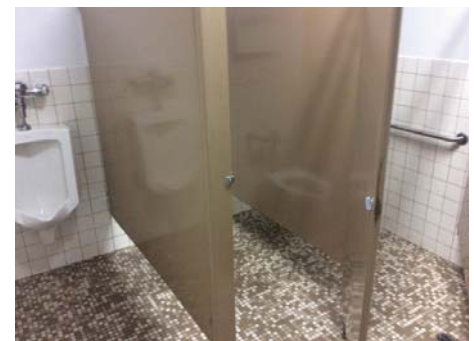
- 3861
- *As-Built Description:*
Multiple accommodation restroom not accessible; multiple compliance violations.
 - *Proposed Solution:*
Remodel area to provide accessible restroom with one accessible stall, lavatory (and one urinal at Mens).
 - *Notes:*
Provide directional sign as interim solution.

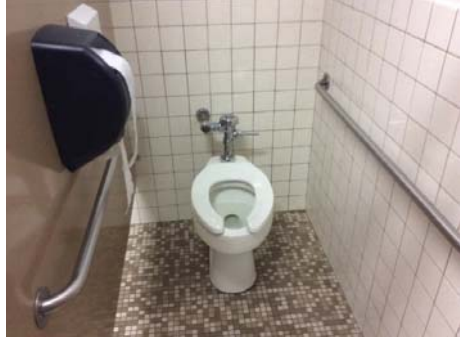
Item No. and Name	Existing Architectural Barrier and Proposed Solution	Codes / Mitigation Info	Qty	Unit	Cost	Total
<u>Toilet Stall</u>						
3865	<ul style="list-style-type: none"> • <i>As-Built Description:</i> Toilet stall less than 60" wide. • <i>As-Built:</i> 37.5" • <i>Proposed Solution:</i> Provide new accessible stall (alternate stalls 36" x 69" or 48" x 69" not recommended). 	<p>PCODE WB06REF ADAAG 4.17.3 ADA 2010 604.8.1.1 CBC 2010 1115B.3.1.4.1 CBC 2013 11B-604.8.1.1 Priority 4 Severity 2 TBD Contract Work</p>				
						REF

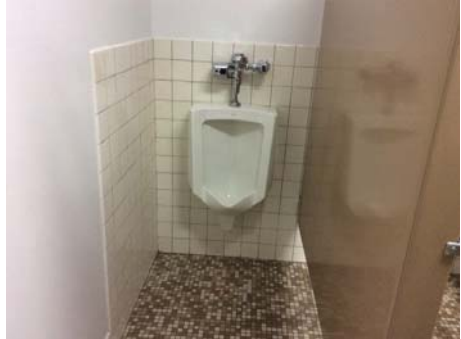
<u>Urinal</u>						
3864	<ul style="list-style-type: none"> • <i>As-Built Description:</i> Fixture mounted with rim more than 17" above floor. • <i>As-Built:</i> 20" • <i>Proposed Solution:</i> Provide accessible urinal. Remodel restroom as needed. 	<p>PCODE WE02REF ADAAG 4.18.2 ADA 2010 605.2 CBC 2010 1115B.4.2.1 CBC 2013 11B-605.2 Priority 4 Severity 3 TBD Contract Work</p>				
						REF

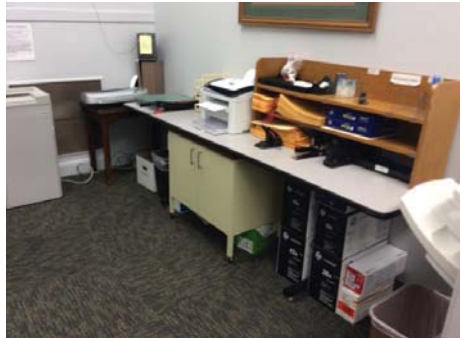
13 Copy Area

<u>Non-Fixed Desk</u>						
3868	<ul style="list-style-type: none"> • <i>As-Built Description:</i> Recommended only: Accessible non-fixed table or desk (top 28" to 34" high; knee space at least 27" high x 19" deep x 30" wide) not provided. • <i>Proposed Solution:</i> Provide table or desk with accessible dimensions when purchasing new furniture. • <i>Notes:</i> Staff Only 	<p>PCODE IN02AREF ADAAG 4.32.3 & .4 ADA 2010 306.1 CBC 2010 1122B.3 & 4 CBC 2013 11B-306.1 & 11B-902.3 Priority 4 Severity 2 TBD Contract Work</p>				
						REF
