Facility: **WOMENS INFANTS & CHILDREN**

Address: 330 HARRIS ST.

Facility: **LEMORE HEALTH CLINIC**
 Address: 229 C ST.

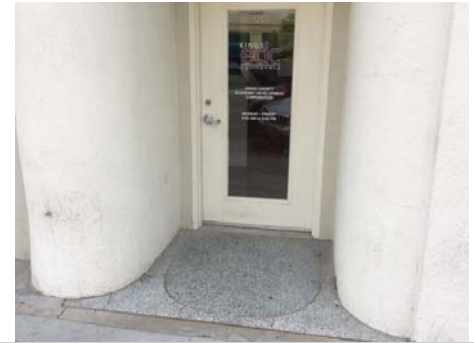
3870	<ul style="list-style-type: none"> As-Built Description: Surface of required maneuvering clearance at door slopes more than 1/4":12" (2.0%). As-Built: 3.9% Proposed Solution: Modify surface slope at door. 	<p>PCODE ID11 ADAAG 4.13.6 ADA 2010 404.2.4.4 CBC 2010 1133B.2.4 CBC 2013 11B-404.2.4 Priority 1 Severity 4 TBD Contract Work</p>	40	SF	\$40	\$1,600
------	--	--	----	----	------	---------

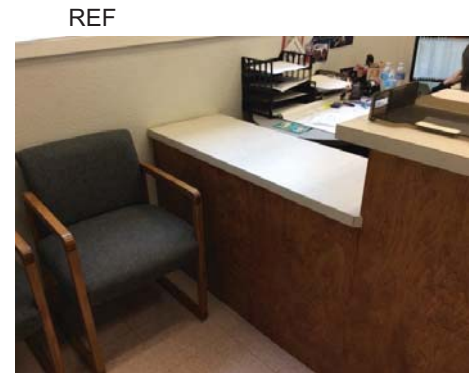
3875	<ul style="list-style-type: none"> As-Built Description: Service Counter (Stand-up): Accessible section min. 36" length and 36" max. height (in CA: 28" to 34" high) not provided. Proposed Solution: Relocate chairs to encroach into clear space of accessible counter. 	<p>PCODE IN03REF ADAAG 7.2(2) ADA 2010 904.4 CBC 2010 1122B.4 CBC 2013 11B-904.4 Priority 1 Severity 4 TBD Contract Work</p>				
------	---	---	--	--	--	--

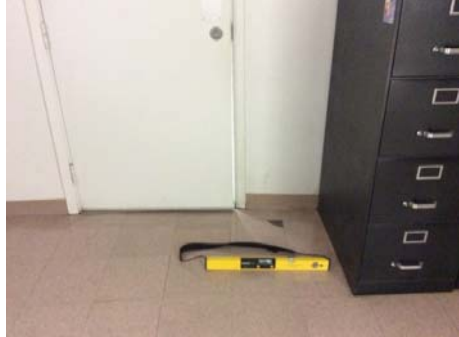
Item No. and Name	Existing Architectural Barrier and Proposed Solution	Codes / Mitigation Info	Qty	Unit	Cost	Total
Door						
3879	<ul style="list-style-type: none"> <i>As-Built Description:</i> Surface of required maneuvering clearance at door slopes more than 1/4":12" (2.0%). <i>As-Built:</i> 2.6% <i>Proposed Solution:</i> Modify surface slope at door. <i>Notes:</i> Feather out landing at door 	PCODE ID11 ADAAG 4.13.6 ADA 2010 404.2.4.4 CBC 2010 1133B.2.4 CBC 2013 11B-404.2.4 Priority 3 Severity 4 TBD Contract Work	25	SF	\$40	\$1,000

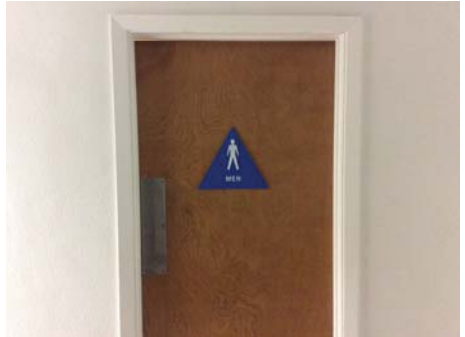
18 EDC Men's Restroom

Door Clearance						
3885	<ul style="list-style-type: none"> <i>As-Built Description:</i> Door on accessible route has less than 32" clear and 80" (78" min. to closer if provided) opening width when 90° open. <i>As-Built:</i> 30" <i>Proposed Solution:</i> Provide new, larger door and frame with new accessible hardware. 	PCODE ID01REF ADAAG 4.13.5 ADA 2010 404.2.3 CBC 2010 1133B.1.1.1.1 CBC 2013 11B-404.2.3 Priority 3 Severity 3 TBD Contract Work	REF

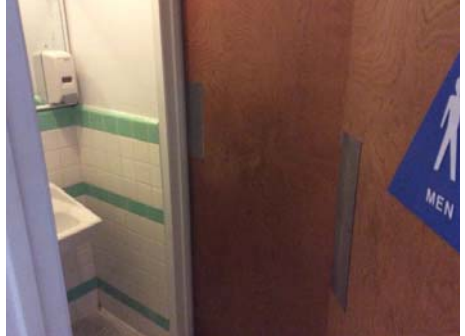
Restroom						
3883	<ul style="list-style-type: none"> <i>As-Built Description:</i> Multiple accommodation restroom not accessible; multiple compliance violations. <i>Proposed Solution:</i> Remodel area to provide accessible restroom with one accessible stall, lavatory (and one urinal at Mens). <i>Notes:</i> Interim solution provide directional sign to Acc. JToO RRs 	PCODE WA01A ADAAG 4.22 ADA 2010 603 CBC 2010 1115B.3.1 CBC 2013 11B-603 Priority 3 Severity 1 TBD Contract Work	1	JOB	\$35,000	\$35,000

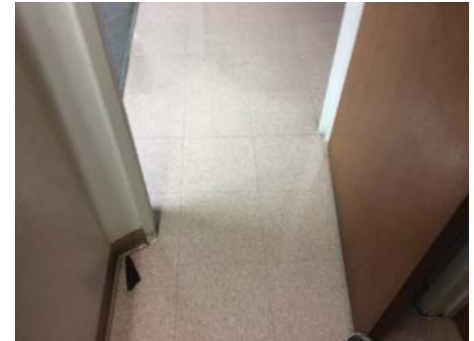
19 EDC Women's Restroom

Door Clearance

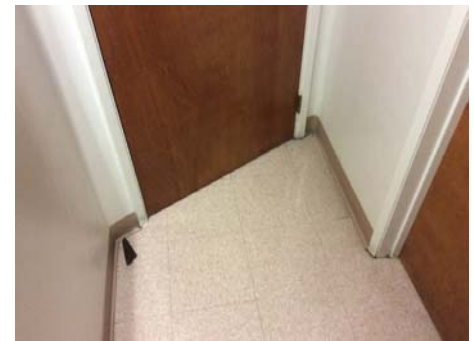
Door Swing

- 3888
- *As-Built Description:*
Front approach: At pull side, door does not have clear and level maneuvering space measuring door width plus 18" x 60".
 - *As-Built:* 27" to angled wall
 - *Proposed Solution:*
Provide relocated new door and frame; remodel walls as needed.

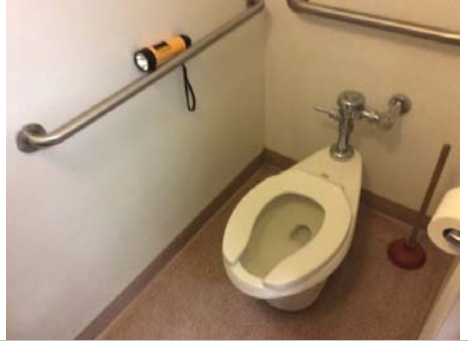
<u>Turning Space</u>						
3890	<ul style="list-style-type: none"> <i>As-Built Description:</i> Wheelchair clearance: Clear space, floor to 27" high with a diameter of 60", not provided (space 56" x 63" acceptable). <i>As-Built:</i> 36" <i>Proposed Solution:</i> Provide wheelchair clearance space in restroom. 	PCODE WC01REF ADAAG 4.22.3 ADA 2010 603.2.1 CBC 2010 1115B.3.2 CBC 2013 11B-603.2.1; 11B-304.3 Priority 3 Severity 2 TBD Contract Work	REF

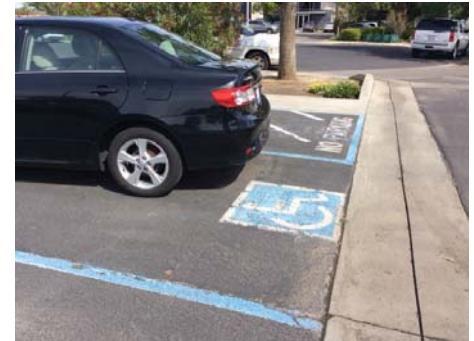
Floor or Ground Surfaces

3775	<ul style="list-style-type: none"> <i>As-Built Description:</i> Accessible parking space has slope greater than 1/4":12" (2%). <i>As-Built:</i> 2.7-3.0% along rear portion. <i>Proposed Solution:</i> Modify slope at accessible parking space. 	<p>PCODE EA05</p> <p>ADAAG 4.6.3</p> <p>ADA 2010 502.4</p> <p>CBC 2010 1129B.3.3</p> <p>CBC 2013 11B-502.4</p> <p>Priority 1</p> <p>Severity 4</p> <p>TBD Contract Work</p>	72	SF	\$12	\$864
------	---	---	----	----	------	-------

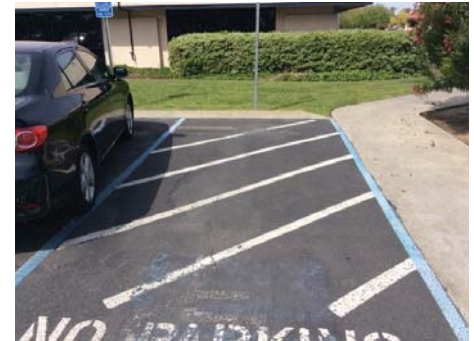
Parking

3777	<ul style="list-style-type: none"> <i>As-Built Description:</i> Accessible parking space does not have 5' wide access aisle; 8' wide for van accessible aisle. <i>As-Built:</i> 48" o.c. <i>Proposed Solution:</i> Modify parking aisle(s) to create accessible space by restriping. 	<p>PCODE EA02BNT</p> <p>ADAAG 4.6.3</p> <p>ADA 2010 502.3</p> <p>CBC 2010 1129B.3.1</p> <p>CBC 2013 11B-502.2; 11B-502.3.1</p> <p>Priority 1</p> <p>Severity 4</p> <p>TBD Contract Work</p>	1	JOB	\$200	\$200
------	---	---	---	-----	-------	-------

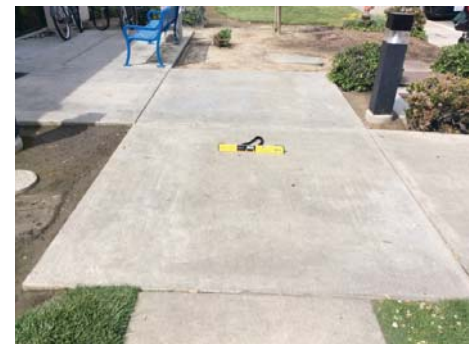
2 POT from Lot to Main Entrance

3786	<ul style="list-style-type: none"> <i>As-Built Description:</i> Cross slope more than 1":48" (2.083%). <i>As-Built:</i> 3.8% <i>Proposed Solution:</i> Modify cross slope. 	<p>PCODE EF07</p> <p>ADAAG 4.3.7</p> <p>ADA 2010 403.3</p> <p>CBC 2010 1133B.7.1.3</p> <p>CBC 2013 11B-403.3</p> <p>Priority 1</p> <p>Severity 4</p> <p>TBD Contract Work</p>	128	SF	\$25	\$3,200
------	---	---	-----	----	------	---------

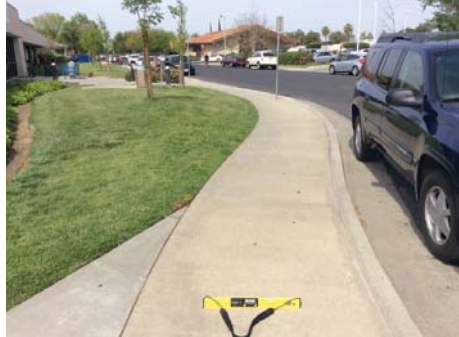
Cross Slope (PAR)

3780	<ul style="list-style-type: none"> <i>As-Built Description:</i> The cross slope of the pedestrian access route exceeds the maximum required slope (1:48 max). <i>As-Built:</i> PRow 2.4-3.0% <i>Proposed Solution:</i> Modify existing route as necessary to not exceed the required 1:48 (2%) maximum cross slope. 	<p>PCODE PR05A ADAAG 4.3.7 ADA 2010 403.3 CBC 2010 1133B.7.1.3 CBC 2013 11B-403.3 Priority 1 Severity 4 TBD Contract Work</p>	50	SF	\$40	\$2,000
------	--	--	----	----	------	---------

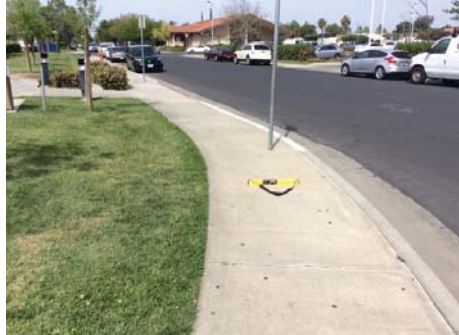
3781	<ul style="list-style-type: none"> <i>As-Built Description:</i> The cross slope of the pedestrian access route exceeds the maximum required slope (1:48 max). <i>As-Built:</i> 2.4-2.6% <i>Proposed Solution:</i> Modify existing route as necessary to not exceed the required 1:48 (2%) maximum cross slope. 	<p>PCODE PR05A ADAAG 4.3.7 ADA 2010 403.3 CBC 2010 1133B.7.1.3 CBC 2013 11B-403.3 Priority 1 Severity 4 TBD Contract Work</p>	100	SF	\$40	\$4,000
------	---	--	-----	----	------	---------

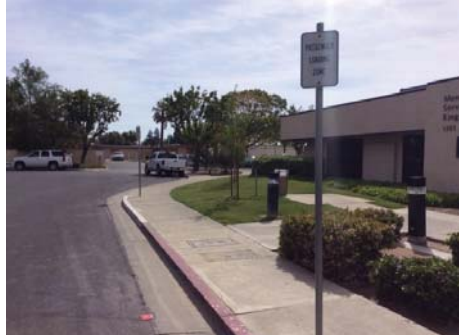
Curb Ramp

3782	<ul style="list-style-type: none"> <i>As-Built Description:</i> No curb ramp available where an accessible route crosses a curb. <i>As-Built:</i> At loading zone <i>Proposed Solution:</i> Provide new curb ramp. 	<p>PCODE EH01 ADAAG 4.7.1 ADA 2010 303.4 CBC 2010 1127B.5.1 CBC 2013 11B-402.2 Priority 1 Severity 1 TBD Contract Work</p>	1	JOB	\$2,500	\$2,500
------	---	---	---	-----	---------	---------

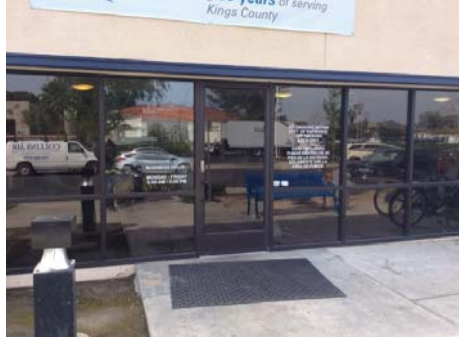
Item No. and Name	Existing Architectural Barrier and Proposed Solution	Codes / Mitigation Info	Qty	Unit	Cost	Total
<u>Door</u>						
3787	<ul style="list-style-type: none"> As-Built Description: Surface of required maneuvering clearance at door slopes more than 1/4":12" (2.0%). As-Built: 8.3% Proposed Solution: Modify surface slope at door. 	PCODE ID11 ADAAG 4.13.6 ADA 2010 404.2.4.4 CBC 2010 1133B.2.4 CBC 2013 11B-404.2.4 Priority 1 Severity 2 TBD Contract Work	64	SF	\$40	\$2,560

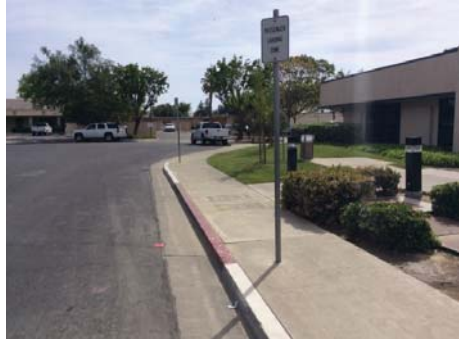
<u>Passenger Loading Zone</u>						
3783	<ul style="list-style-type: none"> As-Built Description: Aisle at passenger drop-off, adjacent to the vehicle pull-up space is not 60x 240" and/or slopes more than 1/4":12" (2%). Proposed Solution: Modify passenger drop-off such that slope does not exceed (2%) in any direction, and provide curb ramp between vehicle pull-up space and access aisle, as needed. 	PCODE PS71 ADAAG 4.6.6 ADA 2010 503.3 CBC 2010 1131B.2 CBC 2013 11B-503.3 Priority 1 Severity 3 TBD Contract Work	1	JOB	\$600	\$600

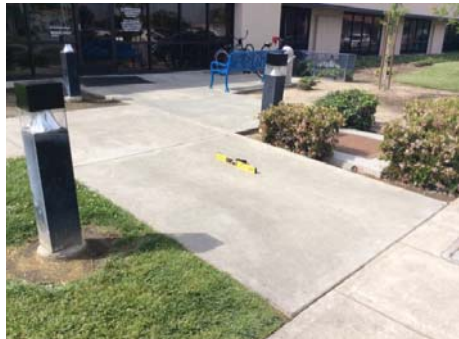
<u>Walk</u>						
3785	<ul style="list-style-type: none"> As-Built Description: Walk: Slope greater than 1:20 (5.0%), and walk does not comply with requirements for ramps. As-Built: 5.6-6.2% Proposed Solution: Modify walk/sidewalk slope to 1:20 or less. 	PCODE EF01 ADAAG 4.3.7 ADA 2010 403.3 CBC 2010 1133B.7.3 CBC 2013 11B-403.3 Priority 1 Severity 4 TBD Contract Work	72	SF	\$25	\$1,800

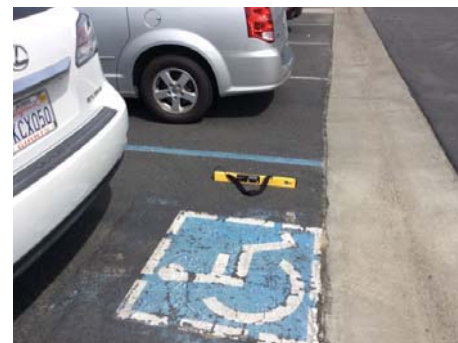
Floor or Ground Surfaces

3789	<ul style="list-style-type: none"> • <i>As-Built Description:</i> Accessible parking space has slope greater than 1/4":12" (2%). • <i>As-Built:</i> 3.2% along back • <i>Proposed Solution:</i> Modify slope at accessible parking space. 	<p>PCODE EA05 ADAAG 4.6.3 ADA 2010 502.4 CBC 2010 1129B.3.3 CBC 2013 11B-502.4 Priority 1 Severity 4 TBD Contract Work</p>	68	SF	\$12	\$816
------	--	---	----	----	------	-------

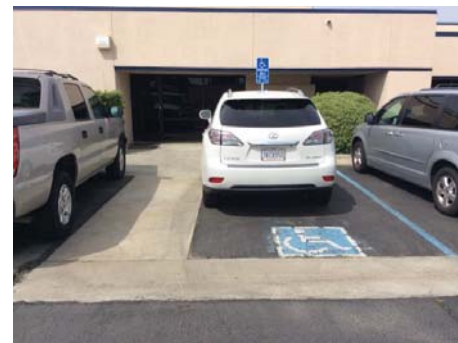
Parking

3788	<ul style="list-style-type: none"> • <i>As-Built Description:</i> Accessible parking space does not have 5' wide access aisle; 8' wide for van accessible aisle. • <i>As-Built:</i> no aisle • <i>Proposed Solution:</i> Modify parking aisle(s) to create accessible space by restriping. 	<p>PCODE EA02B ADAAG 4.6.3 ADA 2010 502.3 CBC 2010 1129B.3.1 CBC 2013 11B-502.2; 11B-502.3.1 Priority 1 Severity 1 TBD Contract Work</p>	1	JOB	\$200	\$200
------	---	---	---	-----	-------	-------

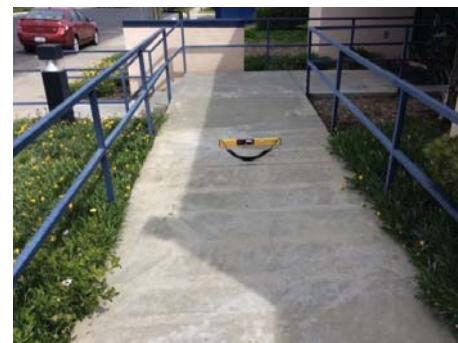
5 Staff Entrance West

3800	<ul style="list-style-type: none"> • <i>As-Built Description:</i> Cross slope more than 1":48" (2.083%). • <i>As-Built:</i> 2.7-4.0% • <i>Proposed Solution:</i> Modify cross slope. • <i>Notes:</i> Ref the railing items 	<p>PCODE EF07 ADAAG 4.3.7 ADA 2010 403.3 CBC 2010 1133B.7.1.3 CBC 2013 11B-403.3 Priority 1 Severity 3 TBD Contract Work</p>	90	SF	\$25	\$2,250
------	--	---	----	----	------	---------

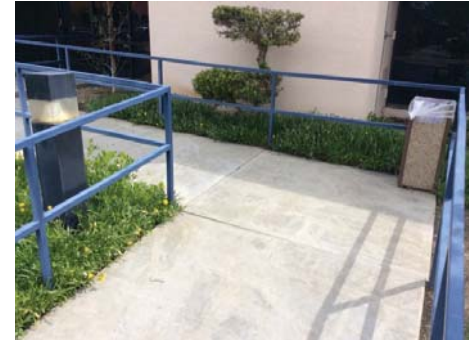
Curb or Barrier

3795	<ul style="list-style-type: none"> <i>As-Built Description:</i> No curb (2" minimum height) or wheel guide (centered approx. 3" above surface of ramp) at sides of ramp. <i>Proposed Solution:</i> Provide 2" minimum curb or wheel guide. 	PCODE EB14 ADAAG 4.8.7 ADA 2010 405.9.2 CBC 2010 1133B.5.6 CBC 2013 11B-405.9.2 Priority 1 Severity 2 TBD Contract Work	46	LF	\$17	\$782
------	--	--	----	----	------	-------

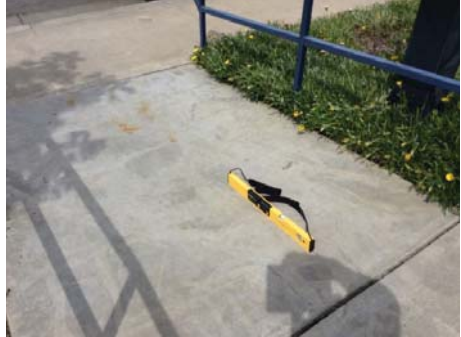
Item No. and Name	Existing Architectural Barrier and Proposed Solution	Codes / Mitigation Info	Qty	Unit	Cost	Total
Slope						
3797	<ul style="list-style-type: none"> <i>As-Built Description:</i> Slope greater than 1:12 (8.3%). <i>As-Built:</i> Lower ramp: 8.6-9.5% <i>Proposed Solution:</i> Demolish existing and provide new ramp with handrails. 	PCODE EB02 ADAAG 4.8.2 ADA 2010 405.2 CBC 2010 1133B.5.3 CBC 2013 11B-405.2 Priority 1 Severity 4 TBD Contract Work	48	SF	\$100	\$4,800

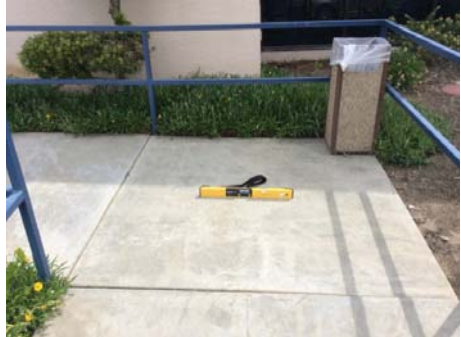
3799	<ul style="list-style-type: none"> <i>As-Built Description:</i> Level 2% max. landing for ramp not provided. <i>As-Built:</i> 3.6% <i>Proposed Solution:</i> Rebuild ramp to provide landings for each ramp run with slopes no greater than 2% 	PCODE EB05A ADAAG 4.8.4 ADA 2010 405.7.1 CBC 2010 1133B.5.4.1 CBC 2013 11B-405.7.1 Priority 1 Severity 4 TBD Contract Work	36	SF	\$100	\$3,600

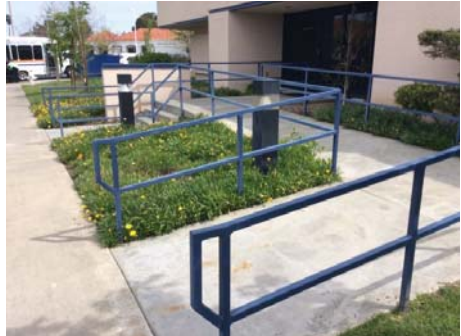
Top and Bottom Extension at Ramps

3796	<ul style="list-style-type: none"> <i>As-Built Description:</i> Ramp handrail does not extend horizontally 12" past top and / or bottom of ramp. <i>As-Built:</i> 0"-5" <i>Proposed Solution:</i> Provide ramp handrail extension (cost for each extension piece). Notes: Provide bent ext 	PCODE ED05 ADAAG 4.8.5(2) ADA 2010 505.10.1 CBC 2010 1133B.4.2.2 & CBC 2013 11B-505.10.1 Priority 1 Severity 3 TBD Contract Work	1	JOB	\$170	\$170

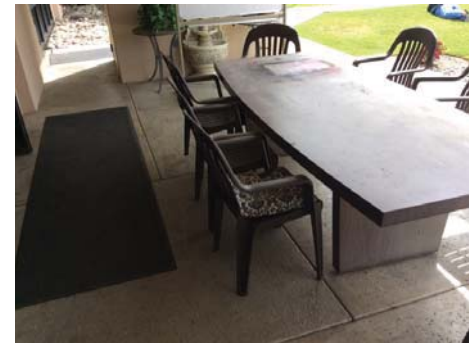
Non-Fixed Desk

- 3803
- *As-Built Description:*
Accessible non-fixed table or desk (top 28" to 34" high; knee space at least 27" high x 19" deep x 30" wide) not provided.
 - *As-Built:* 25" high knee space
 - *Proposed Solution:*
Provide table or desk with accessible dimensions when purchasing new furniture.

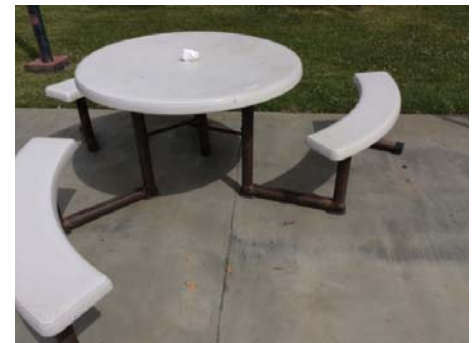
Picnic Area

- 3805
- *As-Built Description:*
Knee clearance at minimums 27" high, 30" wide, and 19" deep is not provided.
 - *As-Built:* 11" deep
 - *Proposed Solution:*
Modify picnic table as required to provide knee clearance.

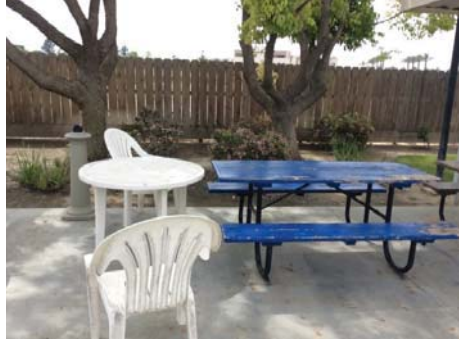
Item No. and Name	Existing Architectural Barrier and Proposed Solution	Codes / Mitigation Info	Qty	Unit	Cost	Total
3806	<ul style="list-style-type: none"> <i>As-Built Description:</i> Knee clearance at minimums 27" high, 30" wide, and 19" deep is not provided. <i>As-Built:</i> 13" deep <i>Proposed Solution:</i> Modify picnic table as required to provide knee clearance. 	<p>PCODE NH11A ADAAG 16.5.4. ADA 2010 902.2 CBC 2010 1132B.1 CBC 2013 11-902.2 Priority 2 Severity 2 TBD Contract Work</p>	1	JOB	\$850	\$850

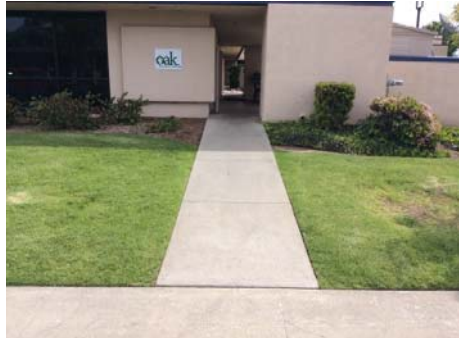
Walk

3801	<ul style="list-style-type: none"> <i>As-Built Description:</i> Walk: Slope greater than 1:20 (5.0%), and walk does not comply with requirements for ramps. <i>As-Built:</i> 8.7-9.4% <i>Proposed Solution:</i> Provide ramp with handrails on both (2) sides. Notes: And landings 	<p>PCODE EF01A ADAAG 4.8.1 ADA 2010 405.1 CBC 2010 1133B.7.3 CBC 2013 11B-405.1 Priority 1 Severity 3 TBD Contract Work</p>	30	LF	\$260	\$7,800

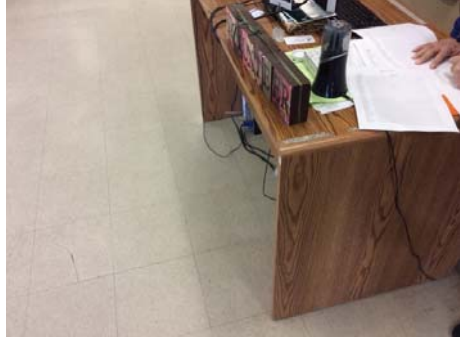
Item No. and Name	Existing Architectural Barrier and Proposed Solution	Codes / Mitigation Info	Qty	Unit	Cost	Total
Public Counter						
3723	<ul style="list-style-type: none"> <i>As-Built Description:</i> Public Counter (Seated Service): Accessible section not provided (knee space min. 27" high x 19" deep x 30" wide, top 28" to 34" high, min. 36" counter wide). <i>As-Built:</i> Sign in sheet. 6.5" deep, 30" high <i>Proposed Solution:</i> Retrofit existing counter to provide accessible seating section. Interim solution: Provide auxiliary counter or table. 	PCODE IN03A ADAAG 4.32.3 & 4 ADA 2010 306.3; 904.4 CBC 2010 1122B.3 & 4 CBC 2013 11B-306.3; 11B-904.4 Priority 1 Severity 2 TBD Contract Work	1	JOB	\$1,200	\$1,200

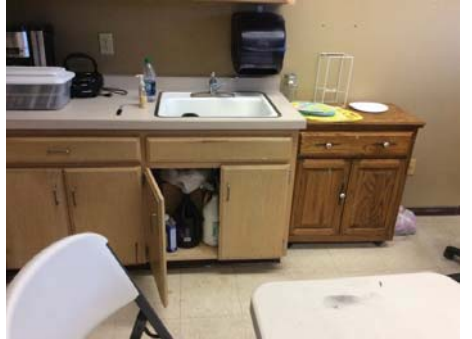
Sink						
3732	<ul style="list-style-type: none"> <i>As-Built Description:</i> Sink does not have knee space min. 27" high x 19" deep x 30" wide. <i>Proposed Solution:</i> Remodel sink cabinet. 	PCODE IN06A ADAAG 4.24.3 ADA 2010 606.2 CBC 2010 1115B.4.7.1 CBC 2013 11B-606.2 Priority 2 Severity 2 TBD Contract Work	1	JOB	\$1,750	\$1,750

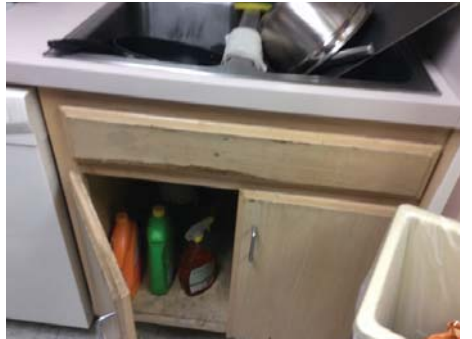
3735	<ul style="list-style-type: none"> <i>As-Built Description:</i> Sink does not have knee space min. 27" high x 19" deep x 30" wide. <i>Proposed Solution:</i> Remodel sink cabinet. 	PCODE IN06A ADAAG 4.24.3 ADA 2010 606.2 CBC 2010 1115B.4.7.1 CBC 2013 11B-606.2 Priority 2 Severity 2 TBD Contract Work	1	JOB	\$1,750	\$1,750

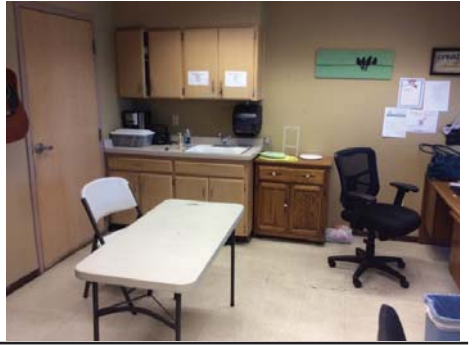
Item No. and Name	Existing Architectural Barrier and Proposed Solution	Codes / Mitigation Info	Qty	Unit	Cost	Total
3731	<ul style="list-style-type: none"> As-Built Description: Sink rim higher than 34" above floor. As-Built: 36" Proposed Solution: Remodel sink cabinet to lower sink. 	PCODE IN06REF ADAAG 4.24.2 ADA 2010 606.3 CBC 2010 1115B.4.7.1 CBC 2013 11B-606.3 Priority 3 Severity 4 TBD Contract Work				
						REF

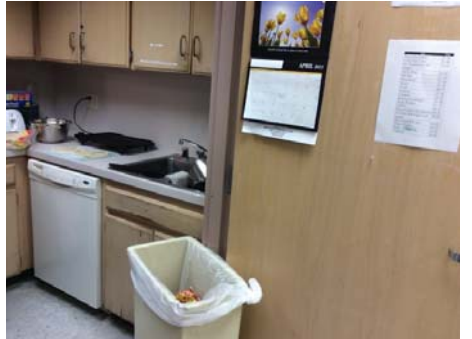
3734	<ul style="list-style-type: none"> As-Built Description: Sink rim higher than 34" above floor. As-Built: 36" Proposed Solution: Remodel sink cabinet to lower sink. 	PCODE IN06REF ADAAG 4.24.2 ADA 2010 606.3 CBC 2010 1115B.4.7.1 CBC 2013 11B-606.3 Priority 3 Severity 4 TBD Contract Work				
						REF

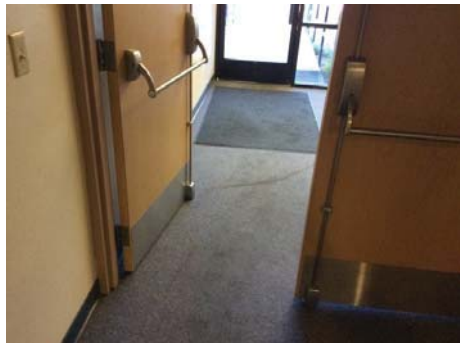
3 Oak Wellness Corridors

3743	<ul style="list-style-type: none"> As-Built Description: Pair of doors on accessible route has less than 32" clear opening width with one leaf open 90°. As-Built: 31.5" Proposed Solution: Provide new door leaves, unequal in width, to existing frame for pair of doors. 	PCODE ID08A ADAAG 4.13.4 ADA 2010 404.2.2 CBC 2010 1133B.2.3.1 CBC 2013 11B-404.2.2 Priority 2 Severity 4 TBD Contract Work	1	JOB	\$1,500	\$1,500

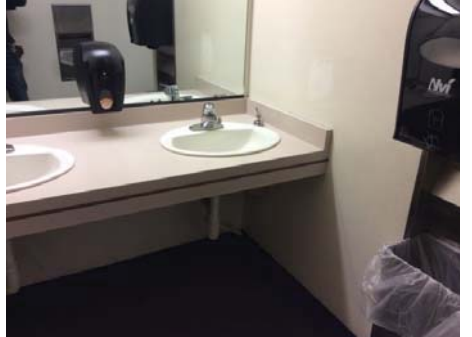
4 Women's Restroom - Oak Wellness

Item No. and Name	Existing Architectural Barrier and Proposed Solution	Codes / Mitigation Info	Qty	Unit	Cost	Total
<u>Lavatory</u>						
3749	<ul style="list-style-type: none"> As-Built Description: Lavatory: Fixture rim or counter height more than 34" above floor. As-Built: 34.25"-34.75" to rim Proposed Solution: Provide new accessible lavatory. Remodel restroom as needed. 	PCODE WD02 ADAAG 4.19.2 ADA 2010 606.3 CBC 2010 1115B.4.3 CBC 2013 11B-606.3 Priority 3 Severity 4 TBD Contract Work	1	JOB	\$3,400	\$3,400

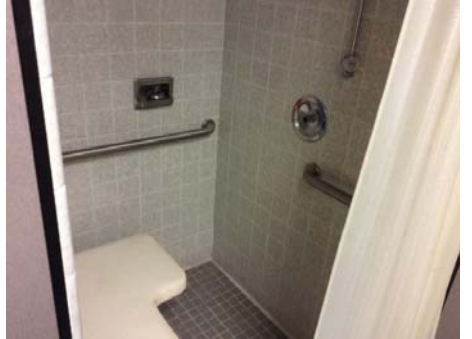
<u>Shower</u>						
3758	<ul style="list-style-type: none"> As-Built Description: Shower less than 60" x 30". As-Built: 42" x 48" Proposed Solution: Enlarge shower to compliant dimensions. Notes: Decommissioned 	PCODE WF02REF ADAAG 4.21.2 ADA 2010 608.2 CBC 2010 1115B.4.4.1 CBC 2013 11B-608.2 Priority 3 Severity 3 TBD Contract Work	REF

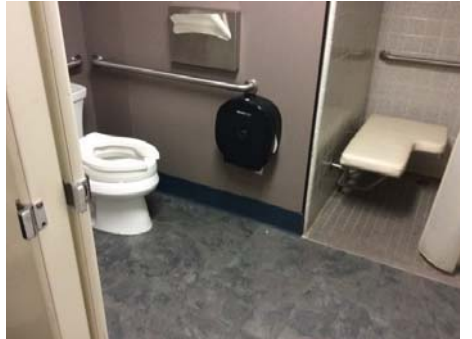
<u>Toilet Stall</u>						
3752	<ul style="list-style-type: none"> As-Built Description: Toilet stall less than 60" wide. As-Built: 57.5" Proposed Solution: Provide new accessible stall. 	PCODE WB06 ADAAG 4.17.3 ADA 2010 604.8.1.1 CBC 2010 1115B.3.1.4.1 CBC 2013 11B-604.8.1.1 Priority 3 Severity 4 TBD Contract Work	1	JOB	\$1,500	\$1,500

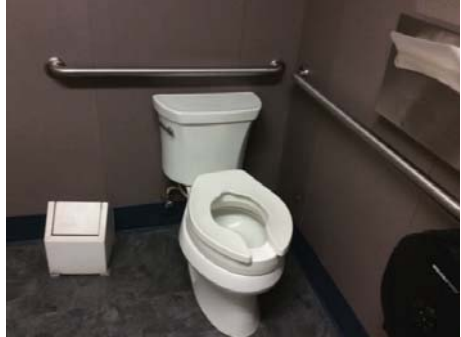
Item No. and Name	Existing Architectural Barrier and Proposed Solution	Codes / Mitigation Info	Qty	Unit	Cost	Total
<u>Water Closet</u>						
3755	<ul style="list-style-type: none"> <i>As-Built Description:</i> Water closet not 17"-18" from near side wall to center line of water closet (2010 ADAS: 16"-18"). <i>As-Built:</i> 15" o.c. <i>Proposed Solution:</i> Relocate existing water closet and plumbing, remount with offset closet flange to provide 17"-18" from side wall. 	PCODE WB02C ADAAG Fig. 28 ADA 2010 604.2 CBC 2010 1115B.4.1.1 CBC 2013 11B-604.2 Priority 3 Severity 3 TBD Contract Work	1	JOB	\$500	\$500

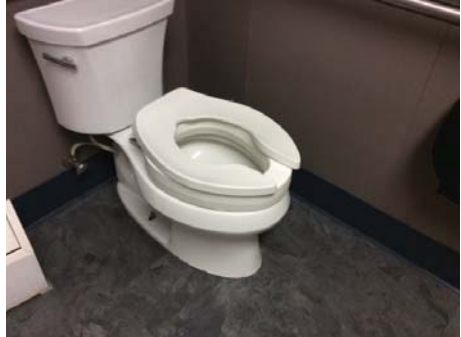
3757	<ul style="list-style-type: none"> <i>As-Built Description:</i> Height of water closet seat less than 17" or more than 19" from floor. (A 3" high seat shall be permitted only in alterations where the existing fixture is less than 15" high.) <i>As-Built:</i> 4" riser seat <i>Proposed Solution:</i> Provide new accessible water closet. <i>Notes:</i> 18.4" height is ok. 	PCODE WB08REF ADAAG 4.16.3 ADA 2010 604.4 CBC 2010 1115B.4.1.4 CBC 2013 11B-604.4 Priority 3 Severity 4 TBD Contract Work		REF

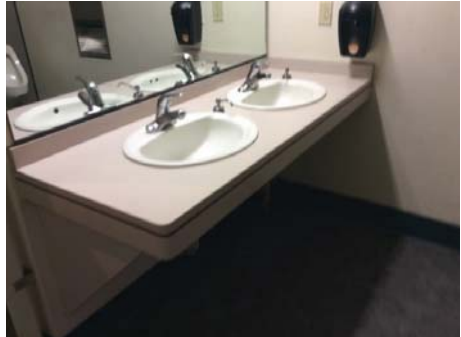
5 Men's Restroom - Oak Wellness

3761	<ul style="list-style-type: none"> <i>As-Built Description:</i> Lavatory: Fixture rim or counter height more than 34" above floor. <i>As-Built:</i> 34"-34.25" to rim <i>Proposed Solution:</i> Provide new accessible lavatory. Remodel restroom as needed. 	PCODE WD02 ADAAG 4.19.2 ADA 2010 606.3 CBC 2010 1115B.4.3 CBC 2013 11B-606.3 Priority 3 Severity 4 TBD Contract Work	1	JOB	\$3,400	\$3,400

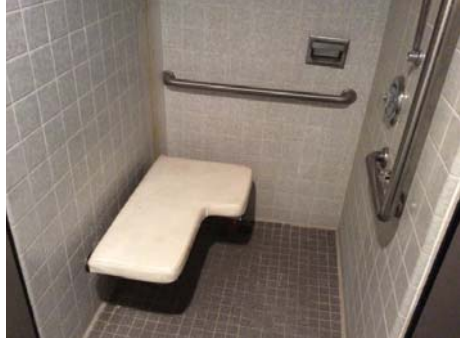
Item No. and Name	Existing Architectural Barrier and Proposed Solution	Codes / Mitigation Info	Qty	Unit	Cost	Total
Shower						
3773	<ul style="list-style-type: none"> As-Built Description: Shower less than 60" x 30". As-Built: 42" x 48" Proposed Solution: Enlarge shower to compliant dimensions. Notes: decommissioned 	PCODE WF02 ADAAG 4.21.2 ADA 2010 608.2 CBC 2010 1115B.4.4.1 CBC 2013 11B-608.2 Priority 3 Severity 1 TBD Contract Work	1	JOB	\$3,300	\$3,300

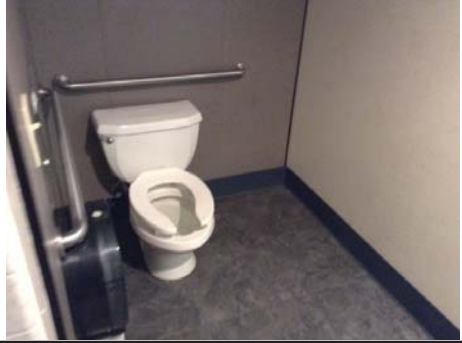
Toilet Stall						
3767	<ul style="list-style-type: none"> As-Built Description: Toilet stall less than 60" wide. As-Built: 55" Proposed Solution: Provide new accessible stall. 	PCODE WB06 ADAAG 4.17.3 ADA 2010 604.8.1.1 CBC 2010 1115B.3.1.4.1 CBC 2013 11B-604.8.1.1 Priority 3 Severity 4 TBD Contract Work	1	JOB	\$1,500	\$1,500

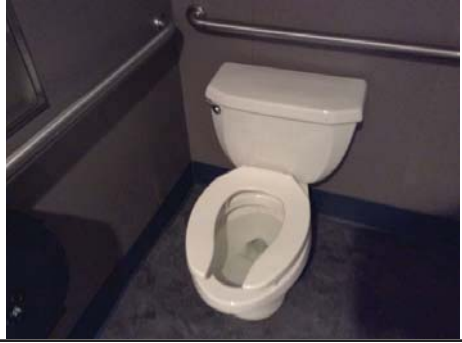
Water Closet						
3768	<ul style="list-style-type: none"> As-Built Description: Water closet not 17"-18" from near side wall to center line of water closet (2010 ADAS: 16"-18"). As-Built: 18.5" o.c. Proposed Solution: Relocate existing water closet and plumbing, remount with offset closet flange to provide 17"-18" from side wall. Notes: 3" riser 	PCODE WB02C ADAAG Fig. 28 ADA 2010 604.2 CBC 2010 1115B.4.1.1 CBC 2013 11B-604.2 Priority 3 Severity 4 TBD Contract Work	1	JOB	\$500	\$500

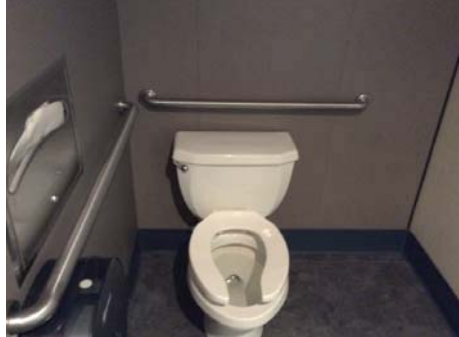
Item No. and Name	Existing Architectural Barrier and Proposed Solution	Codes / Mitigation Info	Qty	Unit	Cost	Total
3766	<ul style="list-style-type: none"> <i>As-Built Description:</i> Flush Control: Operating handle not mounted toward wide side of stall. <i>Proposed Solution:</i> Replace flush control with properly mounted accessible type, or install sensor flush. 	PCODE WB10 ADAAG 4.16.5 ADA 2010 604.6 CBC 2010 1115B.4.1.5 CBC 2013 11B-604.6 Priority 3 Severity 3 TBD Contract Work	1	JOB	\$500	\$500

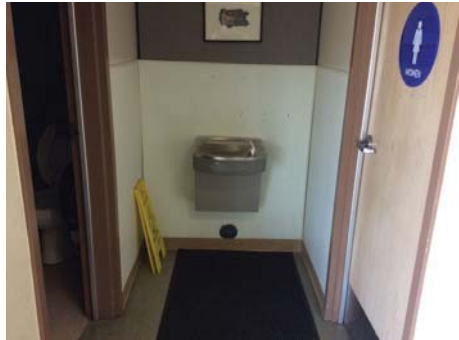
6 Main Lobby

3898	<ul style="list-style-type: none"> <i>As-Built Description:</i> Where only one drinking fountain is provided per floor: Fountain is not accessible to individuals who use wheelchairs, or to those who have difficulty bending or stooping. <i>Proposed Solution:</i> Provide additional fountain or hi-lo combination fountain. 	PCODE IA01A ADAAG 4.1.3(10)(a) ADA 2010 211.1 CBC 2010 1115B.4.6.1 CBC 2013 11B-211.1 Priority 3 Severity 2 TBD Contract Work	1	JOB	\$2,000	\$2,000
------	--	--	---	-----	---------	---------

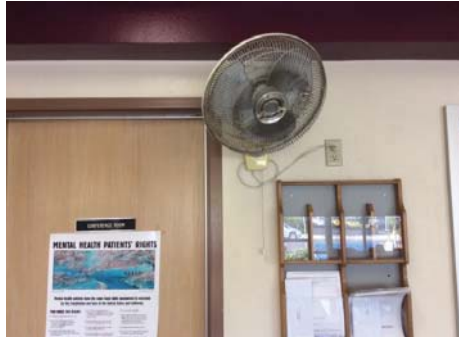
3927	<ul style="list-style-type: none"> <i>As-Built Description:</i> Overhead clearance less than 80" above finished floor. <i>As-Built:</i> Fan: 76" <i>Proposed Solution:</i> Modify overhead clearance. 	PCODE EG01 ADAAG 4.4.2 ADA 2010 307.4 CBC 2010 1133B.8.6.2 CBC 2013 11B-307.4 Priority 1 Severity 2 TBD Contract Work	1	JOB	\$60	\$60
------	--	--	---	-----	------	------

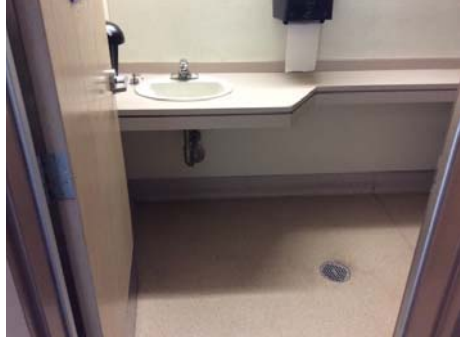
7 Main Lobby Men's Restroom

Item No. and Name	Existing Architectural Barrier and Proposed Solution	Codes / Mitigation Info	Qty	Unit	Cost	Total
<u>Door Clearance</u>						
3902	<ul style="list-style-type: none"> <i>As-Built Description:</i> Door on accessible route has less than 32" clear and 80" (78" min. to closer if provided) opening width when 90° open. <i>As-Built:</i> 30.5" <i>Proposed Solution:</i> Provide new, larger door and frame with new accessible hardware. 	PCODE ID01 ADAAG 4.13.5 ADA 2010 404.2.3 CBC 2010 1133B.1.1.1.1 CBC 2013 11B-404.2.3 Priority 3 Severity 3 TBD Contract Work	1	JOB	\$2,600	\$2,600

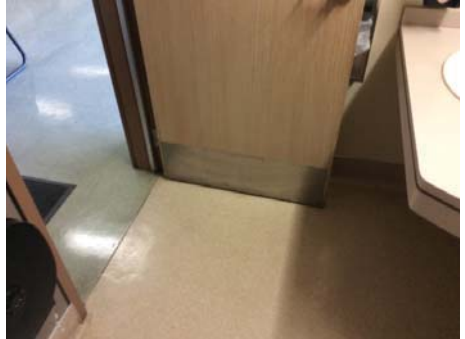
<u>Door Swing</u>						
3903	<ul style="list-style-type: none"> <i>As-Built Description:</i> Front approach: At pull side, door does not have clear and level maneuvering space measuring door width plus 18" x 60". <i>As-Built:</i> 40.5" to lav <i>Proposed Solution:</i> Remodel as needed. 	PCODE ID23B ADAAG Fig. 25(a) ADA 2010 404.2.4 CBC 2010 11B-26A(a) CBC 2013 11B-404.2.4 Priority 3 Severity 2 TBD Contract Work	1	JOB	\$2,600	\$2,600

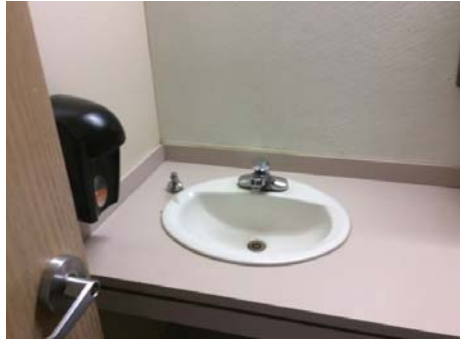
<u>Lavatory</u>						
3908	<ul style="list-style-type: none"> <i>As-Built Description:</i> Clear floor space, 30" x 48" in front of fixture, extending 19" max. under the lavatory, not provided (CA only: Less than 18" from side wall to centerline of lavatory). <i>As-Built:</i> 16" o.c. <i>Proposed Solution:</i> Provide new accessible lavatory. Remodel restroom as needed. 	PCODE WD01 ADAAG 4.19.3 ADA 2010 606.2 CBC 2010 1115B.4.3 CBC 2013 11B-606.2, 11B-606.6 Priority 3 Severity 2 TBD Contract Work	1	JOB	\$3,400	\$3,400

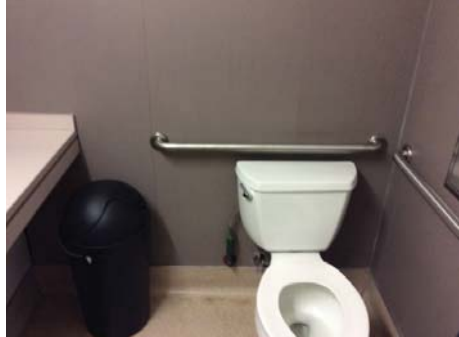
Item No. and Name	Existing Architectural Barrier and Proposed Solution	Codes / Mitigation Info	Qty	Unit	Cost	Total
<u>Toilet Stall</u>						
3911	<ul style="list-style-type: none"> <i>As-Built Description:</i> The lavatory or other unintended fixture, encroaches on the necessary clearance around a water closet (60" x 56"). <i>As-Built:</i> 53" to counter <i>Proposed Solution:</i> Remove adjacent fixture and provide new enclosure at accessible water closet. 	<p>PCODE WB01A</p> <p>ADA 2010 604.3.1; 604.3.2</p> <p>CBC 2013 11B-604.3.1; 11B-604.3.2</p> <p>Priority 3</p> <p>Severity 4</p> <p>TBD Contract Work</p>	1	JOB	\$2,000	\$2,000

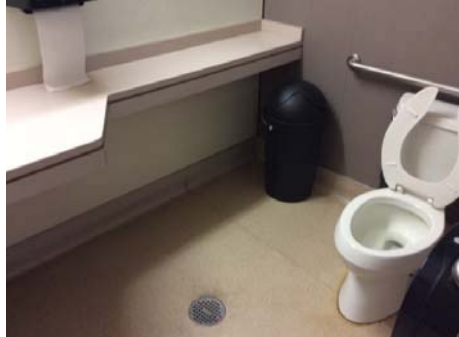
<u>Turning Space</u>						
3904	<ul style="list-style-type: none"> <i>As-Built Description:</i> Wheelchair clearance: Clear space, floor to 27" high with a diameter of 60", not provided (space 56" x 63" acceptable). <i>As-Built:</i> 53"-64" <i>Proposed Solution:</i> Provide wheelchair clearance space in restroom. 	<p>PCODE WC01</p> <p>ADAAG 4.22.3</p> <p>ADA 2010 603.2.1</p> <p>CBC 2010 1115B.3.1</p> <p>CBC 2013 11B-603.2.1; 11B-304.3</p> <p>Priority 3</p> <p>Severity 2</p> <p>TBD Contract Work</p>	1	JOB	\$1,190	\$1,190

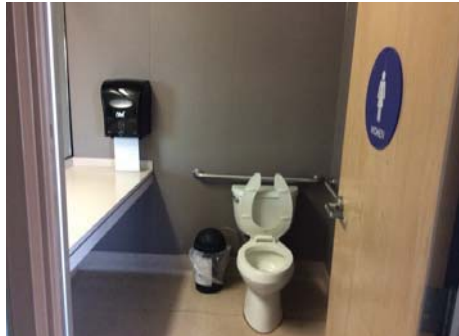
8 Main Lobby Women's Restroom

<u>Door Clearance</u>						
3916	<ul style="list-style-type: none"> <i>As-Built Description:</i> Door on accessible route has less than 32" clear and 80" (78" min. to closer if provided) opening width when 90° open. <i>As-Built:</i> 30.5" <i>Proposed Solution:</i> Provide new, larger door and frame with new accessible hardware. 	<p>PCODE ID01</p> <p>ADAAG 4.13.5</p> <p>ADA 2010 404.2.3</p> <p>CBC 2010 1133B.1.1.1.1</p> <p>CBC 2013 11B-404.2.3</p> <p>Priority 3</p> <p>Severity 3</p> <p>TBD Contract Work</p>	1	JOB	\$2,600	\$2,600

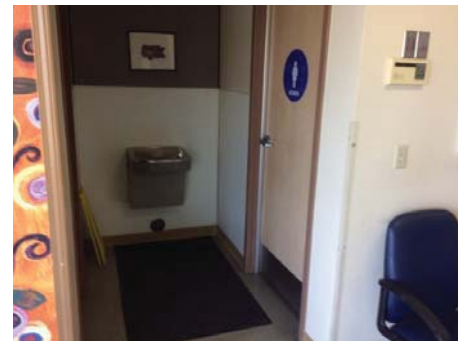
Item No. and Name	Existing Architectural Barrier and Proposed Solution	Codes / Mitigation Info	Qty	Unit	Cost	Total
Door Swing						
3915	<ul style="list-style-type: none"> <i>As-Built Description:</i> Hinge approach: At push side, door does not have clear and level maneuvering space measuring 54" width (starting at latch) x 42" deep (48" deep if door has both, latch and closer) (CA only: 54" x 44"). <i>As-Built:</i> 47" <i>Proposed Solution:</i> Provide relocated new door and frame; remodel walls as needed. <i>Notes:</i> latch only 	<p>PCODE ID26B</p> <p>ADAAG Fig. 25(b)</p> <p>ADA 2010 404.2.4</p> <p>CBC 2010 Fig. 11B-26A(b)</p> <p>CBC 2013 11B-404.2.4</p> <p>Priority 3</p> <p>Severity 4</p> <p>TBD Contract Work</p>	1	JOB	\$2,600	\$2,600

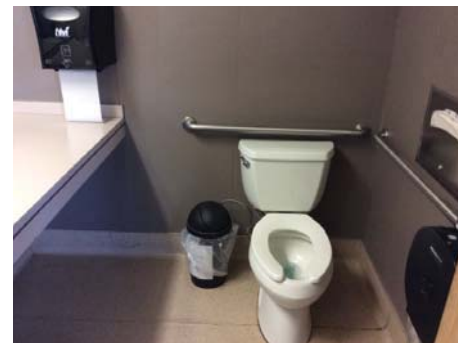
Toilet Stall						
3918	<ul style="list-style-type: none"> <i>As-Built Description:</i> The lavatory or other unintended fixture, encroaches on the necessary clearance around a water closet (60" x 56"). <i>As-Built:</i> 53.5" <i>Proposed Solution:</i> Remove adjacent fixture and provide new enclosure at accessible water closet. <i>Notes:</i> Room: 77"x87" 	<p>PCODE WB01A</p> <p>ADA 2010 604.3.1; 604.3.2</p> <p>CBC 2013 11B-604.3.1; 11B-604.3.2</p> <p>Priority 3</p> <p>Severity 4</p> <p>TBD Contract Work</p>	1	JOB	\$2,000	\$2,000

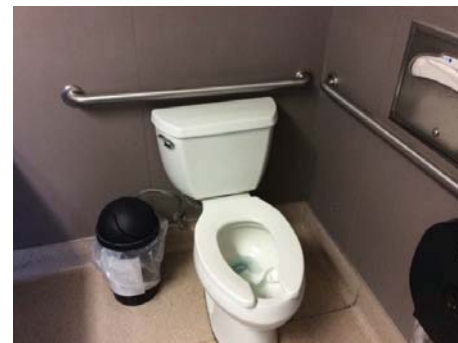
Water Closet						
3922	<ul style="list-style-type: none"> <i>As-Built Description:</i> Water closet not 17"-18" from near side wall to center line of water closet (2010 ADAS: 16"-18"). <i>As-Built:</i> 19.5" o.c. <i>Proposed Solution:</i> Relocate existing water closet and plumbing, remount with offset closet flange to provide 17"-18" from side wall. 	<p>PCODE WB02C</p> <p>ADAAG Fig. 28</p> <p>ADA 2010 604.2</p> <p>CBC 2010 1115B.4.1.1</p> <p>CBC 2013 11B-604.2</p> <p>Priority 3</p> <p>Severity 4</p> <p>TBD Contract Work</p>	1	JOB	\$500	\$500

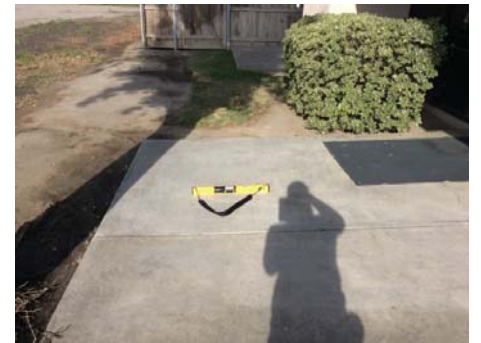
- 3935
- *As-Built Description:*
Cross slope more than 1":48" (2.083%).
 - *As-Built:* 4.3%
 - *Proposed Solution:*
Modify cross slope.

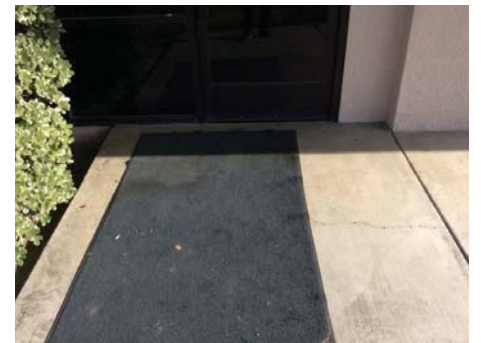
- 3933
- *As-Built Description:*
Surface of required maneuvering clearance at door slopes more than 1/4":12" (2.0%).
 - *As-Built:* 4.9%
 - *Proposed Solution:*
Modify surface slope at door.

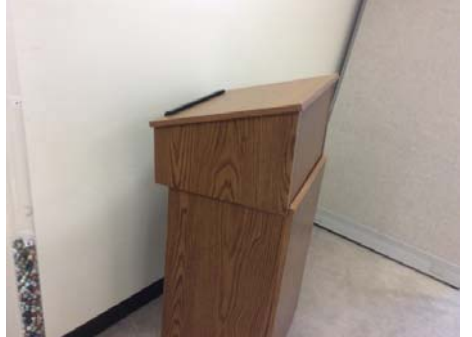
Item No. and Name	Existing Architectural Barrier and Proposed Solution	Codes / Mitigation Info	Qty	Unit	Cost	Total
<u>Non-Fixed Desk</u>						
3943	<ul style="list-style-type: none"> • <i>As-Built Description:</i> Accessible non-fixed table or desk (top 28" to 34" high; knee space at least 27" high x 19" deep x 30" wide) not provided. • <i>As-Built:</i> 41" • <i>Proposed Solution:</i> Provide table or desk with accessible dimensions when purchasing new furniture. 	<p>PCODE IN02A ADAAG 4.32.3 & .4 ADA 2010 306.1 CBC 2010 1122B.3 & 4 CBC 2013 11B-306.1 & 11B-902.3 Priority 2 Severity 2 TBD Contract Work</p>	1	JOB	\$1,600	\$1,600

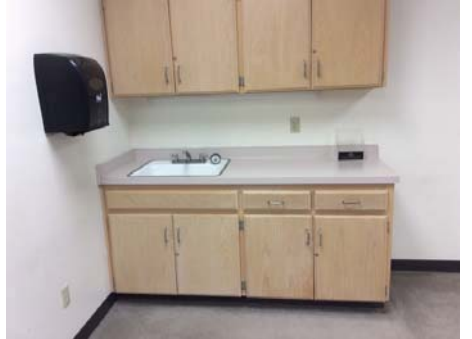
<u>Sink</u>						
3938	<ul style="list-style-type: none"> • <i>As-Built Description:</i> Sink rim higher than 34" above floor. • <i>As-Built:</i> 36" • <i>Proposed Solution:</i> Remodel sink cabinet to lower sink. 	<p>PCODE IN06 ADAAG 4.24.2 ADA 2010 606.3 CBC 2010 1115B.4.7.1 CBC 2013 11B-606.3 Priority 3 Severity 4 TBD Contract Work</p>	1	JOB	\$1,750	\$1,750

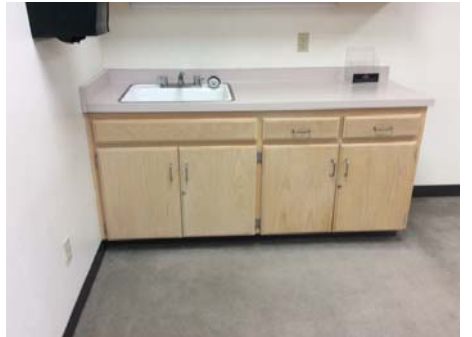
3939	<ul style="list-style-type: none"> • <i>As-Built Description:</i> Sink does not have knee space min. 27" high x 19" deep x 30" wide. • <i>Proposed Solution:</i> Remodel sink cabinet. 	<p>PCODE IN06A ADAAG 4.24.3 ADA 2010 606.2 CBC 2010 1115B.4.7.1 CBC 2013 11B-606.2 Priority 2 Severity 2 TBD Contract Work</p>	1	JOB	\$1,750	\$1,750

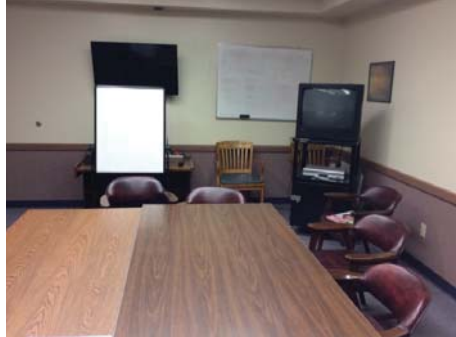
10 Group Room

Item No. and Name	Existing Architectural Barrier and Proposed Solution	Codes / Mitigation Info	Qty	Unit	Cost	Total
<u>Assistive Listening</u>						
3947	<ul style="list-style-type: none"> <i>As-Built Description:</i> No portable assistive listening system provided for small meeting room. <i>Proposed Solution:</i> Share existing portable assistive listening system from other facility if needed. 	PCODE GI01E ADAAG 4.1.3(19)(b) & 4.33.7 ADA 2010 219.1 & 706.1 CBC 2010 1104B.2 CBC 2013 11B-219.2 Priority 3 Severity 3 TBD Contract Work				
						REF

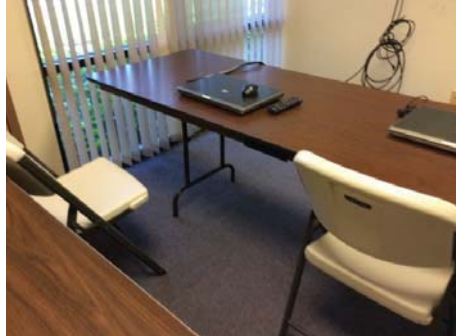
11 Small Group Room - Staff

3951	<ul style="list-style-type: none"> <i>As-Built Description:</i> Accessible non-fixed table or desk (top 28" to 34" high; knee space at least 27" high x 19" deep x 30" wide) not provided. <i>As-Built:</i> 26.5" <i>Proposed Solution:</i> Provide table or desk with accessible dimensions when purchasing new furniture. 	PCODE IN02A ADAAG 4.32.3 & .4 ADA 2010 306.1 CBC 2010 1122B.3 & 4 CBC 2013 11B-306.1 & 11B-902.3 Priority 2 Severity 2 TBD Contract Work	1	JOB	\$1,600	\$1,600

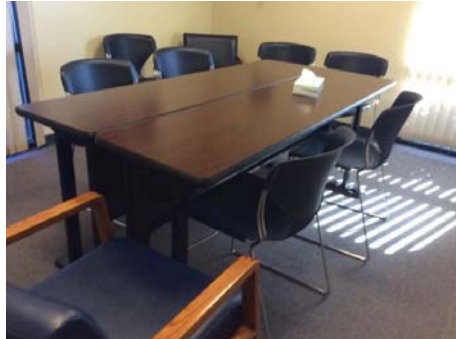
13 Medium Group Room

3960	<ul style="list-style-type: none"> <i>As-Built Description:</i> Accessible non-fixed table or desk (top 28" to 34" high; knee space at least 27" high x 19" deep x 30" wide) not provided. <i>As-Built:</i> 15" deep <i>Proposed Solution:</i> Provide table or desk with accessible dimensions when purchasing new furniture. 	PCODE IN02A ADAAG 4.32.3 & .4 ADA 2010 306.1 CBC 2010 1122B.3 & 4 CBC 2013 11B-306.1 & 11B-902.3 Priority 2 Severity 2 TBD Contract Work	1	JOB	\$1,600	\$1,600

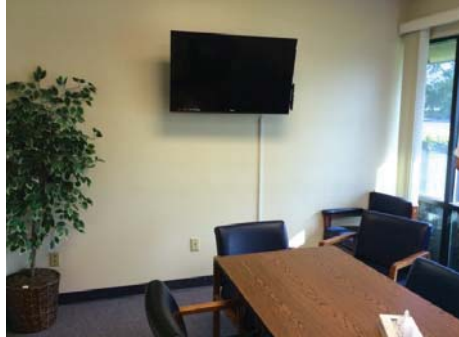
14 Medium Group Room

Item No. and Name	Existing Architectural Barrier and Proposed Solution	Codes / Mitigation Info	Qty	Unit	Cost	Total
<u>Assistive Listening</u>						
3963	<ul style="list-style-type: none"> <i>As-Built Description:</i> No portable assistive listening system provided for small meeting room. <i>Proposed Solution:</i> Share existing portable assistive listening system from other facility if needed. 	PCODE GI01E ADAAG 4.1.3(19)(b) & 4.33.7 ADA 2010 219.1 & 706.1 CBC 2010 1104B.2 CBC 2013 11B-219.2 Priority 3 Severity 3 TBD Contract Work				
						REF

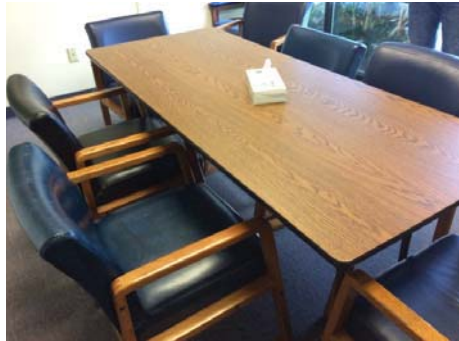
<u>Non-Fixed Desk</u>						
3965	<ul style="list-style-type: none"> <i>As-Built Description:</i> Accessible non-fixed table or desk (top 28" to 34" high; knee space at least 27" high x 19" deep x 30" wide) not provided. <i>As-Built:</i> 26.25" <i>Proposed Solution:</i> Provide table or desk with accessible dimensions when purchasing new furniture. 	PCODE IN02A ADAAG 4.32.3 & .4 ADA 2010 306.1 CBC 2010 1122B.3 & 4 CBC 2013 11B-306.1 & 11B-902.3 Priority 2 Severity 2 TBD Contract Work	1	JOB	\$1,600	\$1,600

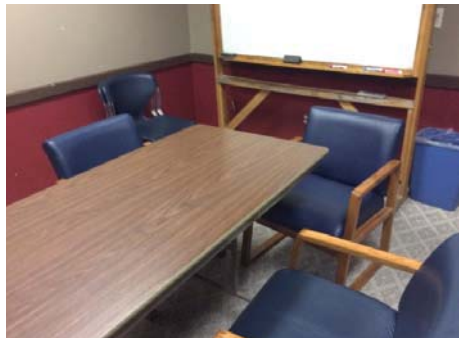
15 Medium Group Room

<u>Non-Fixed Desk</u>						
3968	<ul style="list-style-type: none"> <i>As-Built Description:</i> Accessible non-fixed table or desk (top 28" to 34" high; knee space at least 27" high x 19" deep x 30" wide) not provided. <i>As-Built:</i> 26.75" <i>Proposed Solution:</i> Provide table or desk with accessible dimensions when purchasing new furniture. 	PCODE IN02A ADAAG 4.32.3 & .4 ADA 2010 306.1 CBC 2010 1122B.3 & 4 CBC 2013 11B-306.1 & 11B-902.3 Priority 2 Severity 2 TBD Contract Work	1	JOB	\$1,600	\$1,600

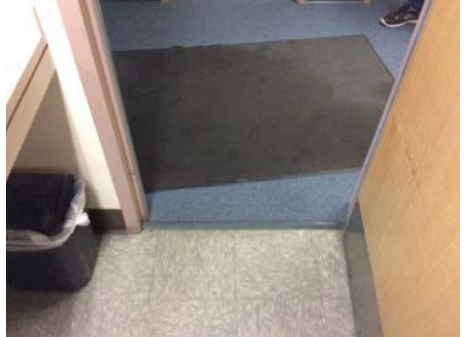
19 Children's Corridor Men's Restroom

Item No. and Name	Existing Architectural Barrier and Proposed Solution	Codes / Mitigation Info	Qty	Unit	Cost	Total
<u>Door Clearance</u>						
3995	<ul style="list-style-type: none"> <i>As-Built Description:</i> Door on accessible route has less than 32" clear and 80" (78" min. to closer if provided) opening width when 90° open. <i>As-Built:</i> 30.5" <i>Proposed Solution:</i> Provide new, larger door and frame with new accessible hardware. 	PCODE ID01 ADAAG 4.13.5 ADA 2010 404.2.3 CBC 2010 1133B.1.1.1.1 CBC 2013 11B-404.2.3 Priority 3 Severity 3 TBD Contract Work	1	JOB	\$2,600	\$2,600

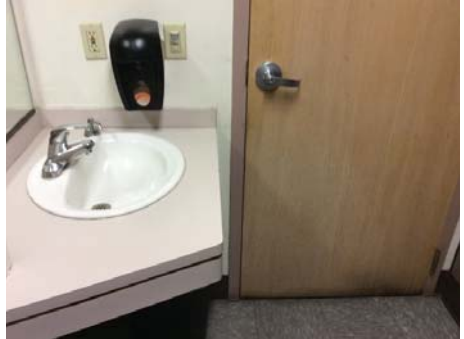
<u>Door Swing</u>						
3994	<ul style="list-style-type: none"> <i>As-Built Description:</i> Front approach: At pull side, door does not have clear and level maneuvering space measuring door width plus 18" x 60". <i>As-Built:</i> 4" to lav <i>Proposed Solution:</i> Remodel as needed. Notes: Remove urinal. provide new lav. new door and swing door out. 	PCODE ID23B ADAAG Fig. 25(a) ADA 2010 404.2.4 CBC 2010 11B-26A(a) CBC 2013 11B-404.2.4 Priority 3 Severity 2 TBD Contract Work	1	JOB	\$2,600	\$2,600

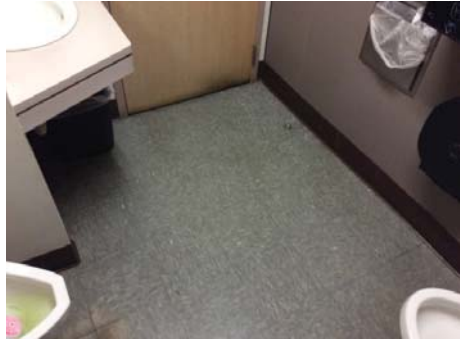
<u>Turning Space</u>						
3996	<ul style="list-style-type: none"> <i>As-Built Description:</i> Wheelchair clearance: Clear space, floor to 27" high with a diameter of 60", not provided (space 56" x 63" acceptable). <i>As-Built:</i> 38"-59" <i>Proposed Solution:</i> Provide wheelchair clearance space in restroom. 	PCODE WC01 ADAAG 4.22.3 ADA 2010 603.2.1 CBC 2010 1115B.3.1 CBC 2013 11B-603.2.1; 11B-304.3 Priority 3 Severity 2 TBD Contract Work	1	JOB	\$1,190	\$1,190

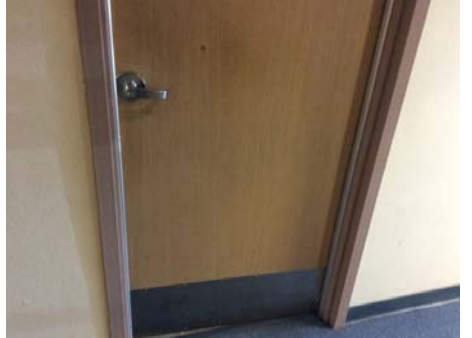
20 Children's Corridor Women's Restroom

<u>Door Clearance</u>						
4007	<ul style="list-style-type: none"> <i>As-Built Description:</i> Door on accessible route has less than 32" clear and 80" (78" min. to closer if provided) opening width when 90° open. <i>As-Built:</i> 30.5" <i>Proposed Solution:</i> Provide new, larger door and frame with new accessible hardware. 	PCODE ID01 ADAAG 4.13.5 ADA 2010 404.2.3 CBC 2010 1133B.1.1.1.1 CBC 2013 11B-404.2.3 Priority 3 Severity 3 TBD Contract Work	1	JOB	\$2,600	\$2,600

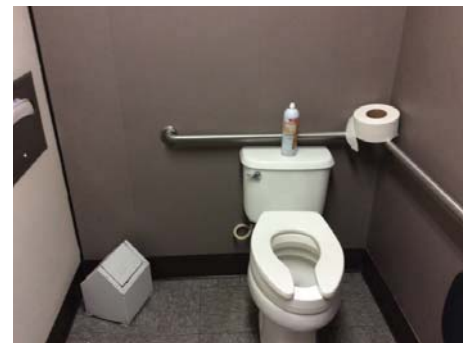
- 4015
- *As-Built Description:*
Wheelchair clearance: Clear space, floor to 27" high with a diameter of 60", not provided (space 56" x 63" acceptable).
 - *As-Built:* 59" wide
 - *Proposed Solution:*
Provide wheelchair clearance space in restroom.

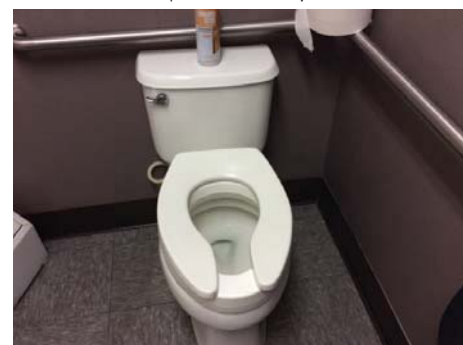
- 4017
- *As-Built Description:*
Water closet not 17"-18" from near side wall to center line of water closet (2010 ADAS: 16"-18").
 - *As-Built:* 19" o.c.
 - *Proposed Solution:*
Relocate existing water closet and plumbing, remount with offset closet flange to provide 17"-18" from side wall.

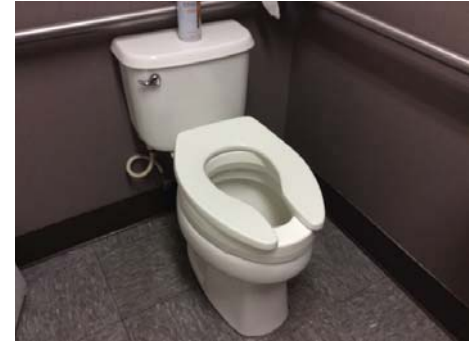
Item No. and Name	Existing Architectural Barrier and Proposed Solution	Codes / Mitigation Info	Qty	Unit	Cost	Total
4016	<ul style="list-style-type: none"> As-Built Description: Height of water closet seat less than 17" or more than 19" from floor. As-Built: 21" Proposed Solution: Remove riser seat. 	PCODE WB08 ADAAG 4.16.3 ADA 2010 604.4 CBC 2010 1115B.4.1.4 CBC 2013 11B-604.4 Priority 3 Severity 4 TBD Contract Work	1	JOB	\$80	\$80

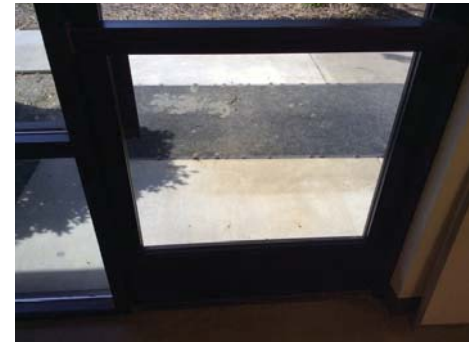
21 AOD Offices

4025	<ul style="list-style-type: none"> As-Built Description: Surface of required maneuvering clearance at door slopes more than 1/4":12" (2.0%). As-Built: 4.2% Proposed Solution: Modify surface slope at door. 	PCODE ID11 ADAAG 4.13.6 ADA 2010 404.2.4.4 CBC 2010 1133B.2.4 CBC 2013 11B-404.2.4 Priority 1 Severity 3 TBD Contract Work	72	SF	\$40	\$2,880
------	---	---	----	----	------	---------

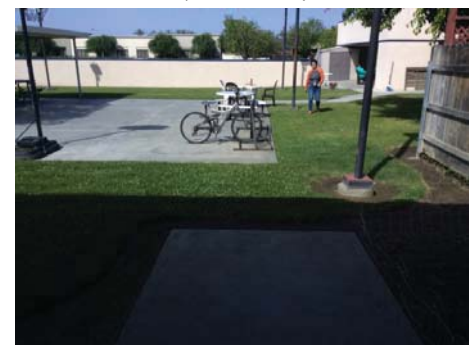
22 AOD Corridors

4029	<ul style="list-style-type: none"> As-Built Description: No walk / sidewalk provided to connect accessible facilities or elements that are on the same site. Proposed Solution: Provide new 48" wide walk / sidewalk. 	PCODE EF13 ADAAG 4.3.2 ADA 2010 206.1 CBC 2010 1114B.1.2 CBC 2013 11B-206.1 Priority 1 Severity 1 TBD Contract Work	9	LF	\$45	\$405
------	---	--	---	----	------	-------

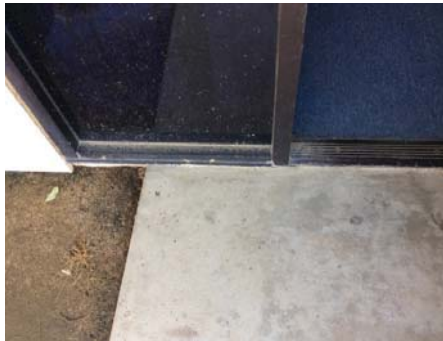
Item No. and Name	Existing Architectural Barrier and Proposed Solution	Codes / Mitigation Info	Qty	Unit	Cost	Total
Door Swing						
4031	<ul style="list-style-type: none"> <i>As-Built Description:</i> Front approach: At pull side, door does not have clear and level maneuvering space measuring door width plus 18"(CA only: 24" at exterior doors)x 60". <i>As-Built:</i> 18" <i>Proposed Solution:</i> Extend maneuvering space. 	<p>PCODE ID23D ADAAG Fig. 25(a) ADA 2010 404.2.4 CBC 2010 11B-26A(a) CBC 2013 11B-404.2.4 Priority 2 Severity 3 TBD Contract Work</p>	1	JOB	\$800	\$800

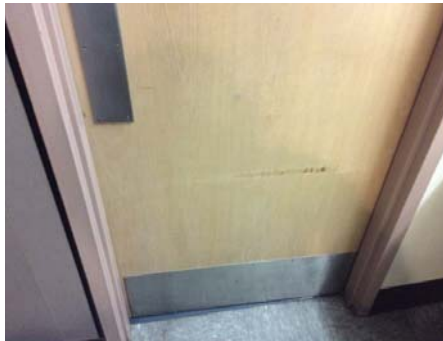
23 AOD Corridor Men's Restroom - Staff

Door Clearance						
4034	<ul style="list-style-type: none"> <i>As-Built Description:</i> Door on accessible route has less than 32" clear and 80" (78" min. to closer if provided) opening width when 90° open. <i>As-Built:</i> 31" <i>Proposed Solution:</i> Provide new, larger door and frame with new accessible hardware. 	<p>PCODE ID01 ADAAG 4.13.5 ADA 2010 404.2.3 CBC 2010 1133B.1.1.1.1 CBC 2013 11B-404.2.3 Priority 4 Severity 3 TBD Contract Work</p>	1	JOB	\$2,600	\$2,600
