Facility: **WOMENS INFANTS & CHILDREN**

Address: 330 HARRIS ST.

Facility: **LEMORE HEALTH CLINIC**
 Address: 229 C ST.

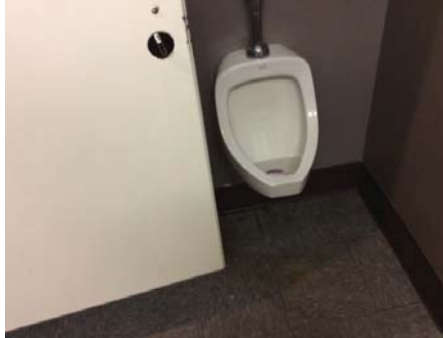
Entry Door						
4038	<ul style="list-style-type: none"> <i>As-Built Description:</i> Door swings into the clear 30x48 floor space required for any fixture. <i>As-Built:</i> Stall door swings into urinal clear space <i>Proposed Solution:</i> Modify restroom layout. Notes: Remove stall and provide single occupant restroom 	<p>PCODE WC04 ADAAG 4.22.2 ADA 2010 603.2.3 CBC 2010 1115B.3.1.2 CBC 2013 11B-603.2.3 Priority 4 Severity 2 TBD Contract Work</p>	1	JOB	\$460	\$460

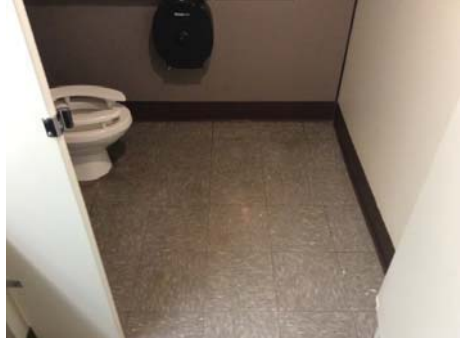
Item No. and Name	Existing Architectural Barrier and Proposed Solution	Codes / Mitigation Info	Qty	Unit	Cost	Total
<u>Toilet Stall</u>						
4040	<ul style="list-style-type: none"> <i>As-Built Description:</i> Less than 95" from back wall to front wall of side entry toilet stall when door swings inward, or less than 92" if water closet is wall-hung (CA only: Less than 60" from front of water closet to opposite wall in side entry stall). <i>As-Built:</i> 49" in front of WC. <i>Proposed Solution:</i> Provide new enclosure at existing water closet fixture. 	PCODE WB04 ADAAG 4.17.3 ADA 2010 604.8.1.1 CBC 2010 1115B.3.1.4.2 CBC 2013 11B-604.8.1.1 Priority 4 Severity 3 TBD Contract Work	1	JOB	\$1,500	\$1,500

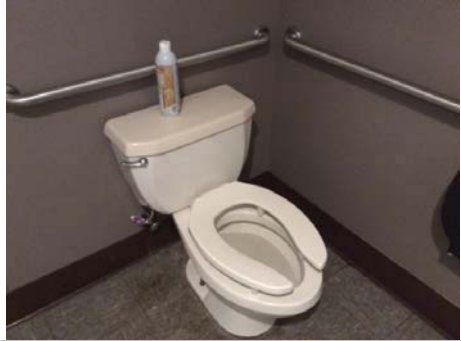
<u>Water Closet</u>						
4043	<ul style="list-style-type: none"> <i>As-Built Description:</i> More than 18" from near side wall to center line of water closet. <i>As-Built:</i> 20" o.c. <i>Proposed Solution:</i> Fur out side wall with 60" x 60" panel to provide 17"-18" dimension. Install grab bar and recess toilet paper dispenser and ensure 60" wide clear space is maintained from side wall. 	PCODE WB02BNT ADAAG Fig. 28 ADA 2010 604.2 CBC 2010 1115B.4.1.1 CBC 2013 11B-604.2 Priority 4 Severity 3 TBD Contract Work	1	JOB	\$1,500	\$1,500

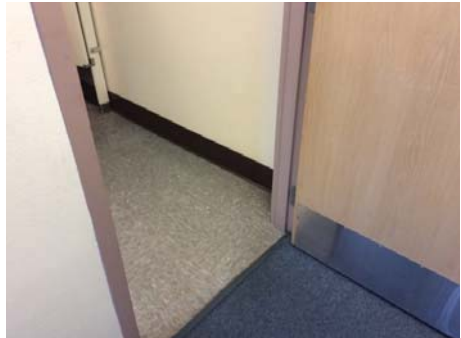
24 AOD Corridor Women's Restroom - Staff

<u>Door Clearance</u>						
4048	<ul style="list-style-type: none"> <i>As-Built Description:</i> Door on accessible route has less than 32" clear and 80" (78" min. to closer if provided) opening width when 90° open. <i>As-Built:</i> 31" <i>Proposed Solution:</i> Provide new, larger door and frame with new accessible hardware. 	PCODE ID01 ADAAG 4.13.5 ADA 2010 404.2.3 CBC 2010 1133B.1.1.1.1 CBC 2013 11B-404.2.3 Priority 4 Severity 3 TBD Contract Work	1	JOB	\$2,600	\$2,600

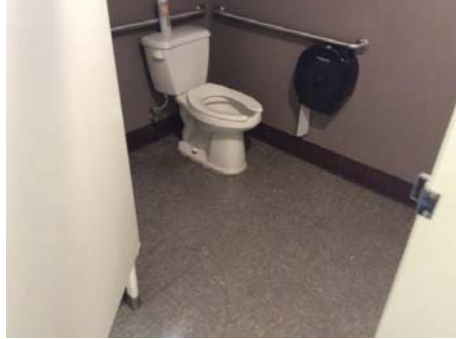
Item No. and Name	Existing Architectural Barrier and Proposed Solution	Codes / Mitigation Info	Qty	Unit	Cost	Total
<u>Toilet Stall</u>						
4054	<ul style="list-style-type: none"> As-Built Description: Less than 95" from back wall to front wall of side entry toilet stall when door swings inward, or less than 92" if water closet is wall-hung (CA only: Less than 60" from front of water closet to opposite wall in side entry stall). As-Built: 48" Proposed Solution: Provide new enclosure at existing water closet fixture. Notes: Side out swing 	PCODE WB04 ADAAG 4.17.3 ADA 2010 604.8.1.1 CBC 2010 1115B.3.1.4.2 CBC 2013 11B-604.8.1.1 Priority 4 Severity 2 TBD Contract Work	1	JOB	\$1,500	\$1,500

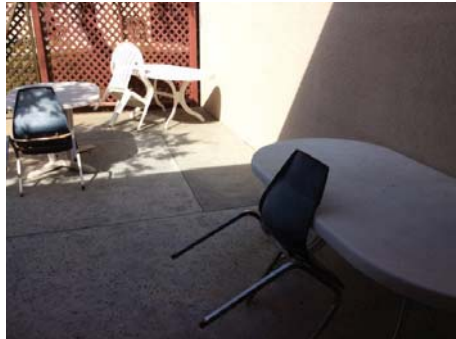
25 Staff Break Room

<u>Non-Fixed Desk</u>						
4068	<ul style="list-style-type: none"> As-Built Description: Accessible non-fixed table or desk (top 28" to 34" high; knee space at least 27" high x 19" deep x 30" wide) not provided. As-Built: 26" high knee space Proposed Solution: Provide table or desk with accessible dimensions when purchasing new furniture. 	PCODE IN02A ADAAG 4.32.3 & .4 ADA 2010 306.1 CBC 2010 1122B.3 & 4 CBC 2013 11B-306.1 & 11B-902.3 Priority 4 Severity 2 TBD Contract Work	1	JOB	\$1,600	\$1,600

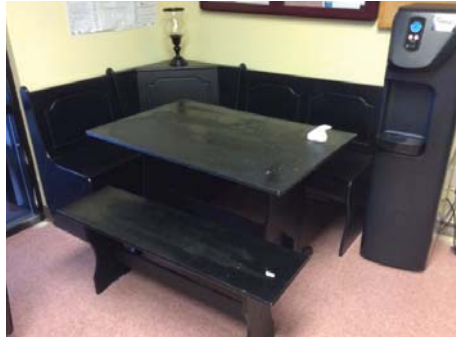
4070	<ul style="list-style-type: none"> As-Built Description: Accessible non-fixed table or desk (top 28" to 34" high; knee space at least 27" high x 19" deep x 30" wide) not provided. Proposed Solution: Provide table or desk with accessible dimensions when purchasing new furniture. 	PCODE IN02A ADAAG 4.32.3 & .4 ADA 2010 306.1 CBC 2010 1122B.3 & 4 CBC 2013 11B-306.1 & 11B-902.3 Priority 4 Severity 2 TBD Contract Work	1	JOB	\$1,600	\$1,600

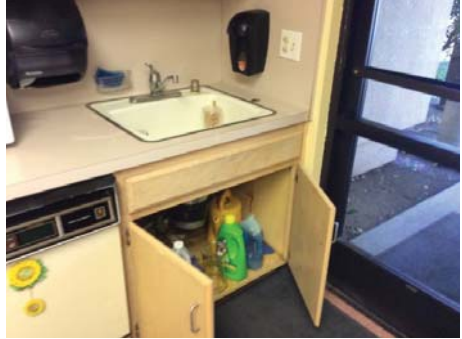
Item No. and Name	Existing Architectural Barrier and Proposed Solution	Codes / Mitigation Info	Qty	Unit	Cost	Total
Sink						
4062	<ul style="list-style-type: none"> As-Built Description: Sink does not have knee space min. 27" high x 19" deep x 30" wide. Proposed Solution: Remodel sink cabinet. 	PCODE IN06A ADAAG 4.24.3 ADA 2010 606.2 CBC 2010 1115B.4.7.1 CBC 2013 11B-606.2 Priority 4 Severity 2 TBD Contract Work	1	JOB	\$1,750	\$1,750

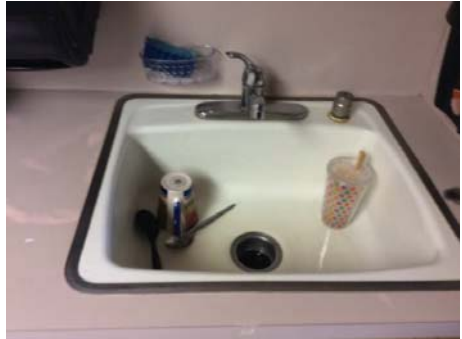
4063	<ul style="list-style-type: none"> As-Built Description: Sink is more than 6 1/2" deep. As-Built: 7" Proposed Solution: Provide new sink remodel and cabinet as needed. 	PCODE IN06BREF ADAAG 4.24.4 CBC 2010 1115B.4.7.1 CBC 2013 11B-606.7 Priority 4 Severity 4 TBD Contract Work	REF

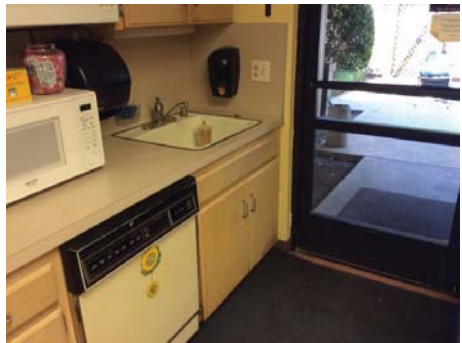
4061	<ul style="list-style-type: none"> As-Built Description: Sink rim higher than 34" above floor. As-Built: 36" Proposed Solution: Remodel sink cabinet to lower sink. 	PCODE IN06REF ADAAG 4.24.2 ADA 2010 606.3 CBC 2010 1115B.4.7.1 CBC 2013 11B-606.3 Priority 4 Severity 4 TBD Contract Work	REF

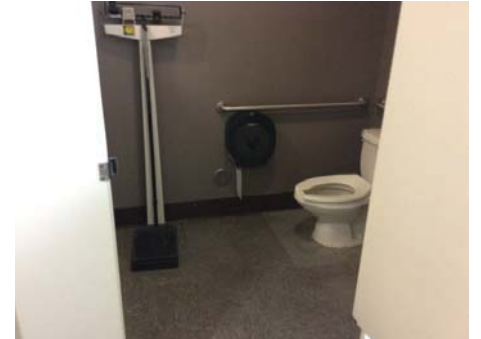
Item No. and Name	Existing Architectural Barrier and Proposed Solution	Codes / Mitigation Info	Qty	Unit	Cost	Total
<u>Toilet Stall</u>						
4085	<ul style="list-style-type: none"> <i>As-Built Description:</i> Less than 95" from back wall to front wall of side entry toilet stall when door swings inward, or less than 92" if water closet is wall-hung (CA only: Less than 60" from front of water closet to opposite wall in side entry stall). <i>As-Built:</i> 49.5" in front. also scale in s stall <i>Proposed Solution:</i> Provide new enclosure at existing water closet fixture. 	PCODE WB04 ADAAG 4.17.3 ADA 2010 604.8.1.1 CBC 2010 1115B.3.1.4.2 CBC 2013 11B-604.8.1.1 Priority 4 Severity 3 TBD Contract Work	1	JOB	\$1,500	\$1,500

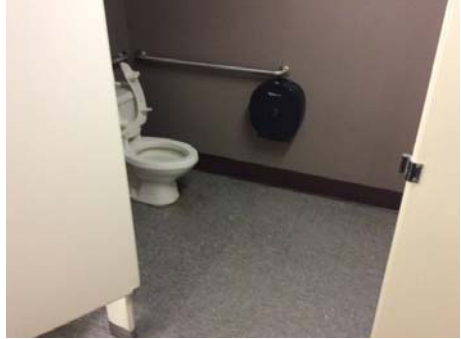
Item No. and Name	Existing Architectural Barrier and Proposed Solution	Codes / Mitigation Info	Qty	Unit	Cost	Total
<u>Toilet Stall</u>						
4099	<ul style="list-style-type: none"> <i>As-Built Description:</i> Less than 95" from back wall to front wall of side entry toilet stall when door swings inward, or less than 92" if water closet is wall-hung (CA only: Less than 60" from front of water closet to opposite wall in side entry stall). <i>As-Built:</i> 49" in front <i>Proposed Solution:</i> Provide new enclosure at existing water closet fixture. 	PCODE WB04 ADAAG 4.17.3 ADA 2010 604.8.1.1 CBC 2010 1115B.3.1.4.2 CBC 2013 11B-604.8.1.1 Priority 4 Severity 3 TBD Contract Work	1	JOB	\$1,500	\$1,500

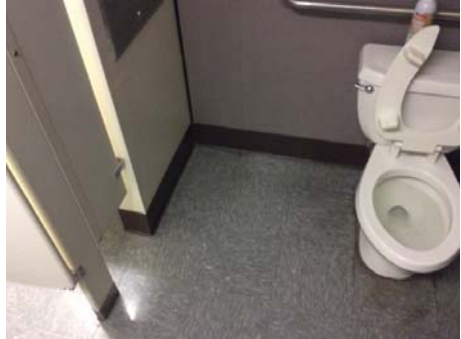
4100	<ul style="list-style-type: none"> <i>As-Built Description:</i> Toilet stall less than 60" wide. <i>As-Built:</i> 58"-59" <i>Proposed Solution:</i> Provide new accessible stall. 	PCODE WB06 ADAAG 4.17.3 ADA 2010 604.8.1.1 CBC 2010 1115B.3.1.4.1 CBC 2013 11B-604.8.1.1 Priority 4 Severity 4 TBD Contract Work	1	JOB	\$1,500	\$1,500

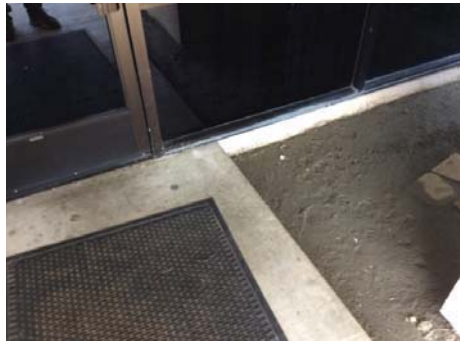
4112	<ul style="list-style-type: none"> <i>As-Built Description:</i> Front approach: At pull side, door does not have clear and level maneuvering space measuring door width plus 18"(CA only: 24" at exterior doors)x 60". <i>As-Built:</i> 13" <i>Proposed Solution:</i> Extend maneuvering space. 	PCODE ID23D ADAAG Fig. 25(a) ADA 2010 404.2.4 CBC 2010 11B-26A(a) CBC 2013 11B-404.2.4 Priority 2 Severity 4 TBD Contract Work	1	JOB	\$800	\$800

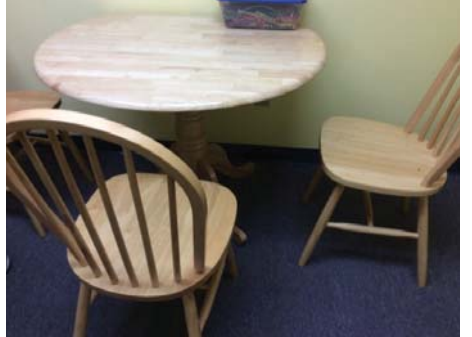
Item No. and Name	Existing Architectural Barrier and Proposed Solution	Codes / Mitigation Info	Qty	Unit	Cost	Total
<u>Non-Fixed Desk</u>						
4127	<ul style="list-style-type: none"> <i>As-Built Description:</i> Accessible non-fixed table or desk (top 28" to 34" high; knee space at least 27" high x 19" deep x 30" wide) not provided. <i>As-Built:</i> due to table legs. <i>Proposed Solution:</i> Provide table or desk with accessible dimensions when purchasing new furniture. 	PCODE IN02A ADAAG 4.32.3 & .4 ADA 2010 306.1 CBC 2010 1122B.3 & 4 CBC 2013 11B-306.1 & 11B-902.3 Priority 2 Severity 2 TBD Contract Work	1	JOB	\$1,600	\$1,600

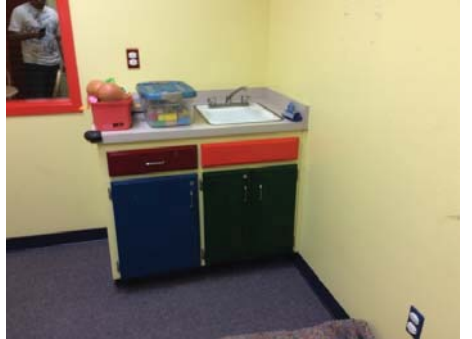
<u>Sink</u>						
4125	<ul style="list-style-type: none"> <i>As-Built Description:</i> Sink does not have knee space min. 27" high x 19" deep x 30" wide. <i>Proposed Solution:</i> Remodel sink cabinet. 	PCODE IN06A ADAAG 4.24.3 ADA 2010 606.2 CBC 2010 1115B.4.7.1 CBC 2013 11B-606.2 Priority 2 Severity 2 TBD Contract Work	1	JOB	\$1,750	\$1,750

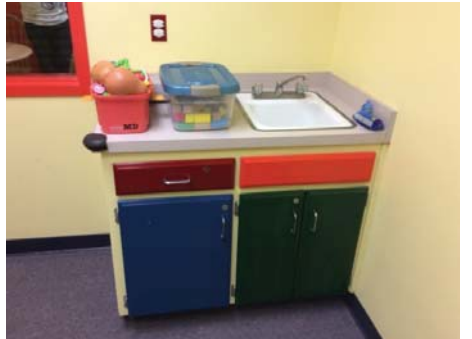
4126	<ul style="list-style-type: none"> <i>As-Built Description:</i> Sink rim higher than 34" above floor. <i>As-Built:</i> 36" <i>Proposed Solution:</i> Remodel sink cabinet to lower sink. 	PCODE IN06REF ADAAG 4.24.2 ADA 2010 606.3 CBC 2010 1115B.4.7.1 CBC 2013 11B-606.3 Priority 3 Severity 4 TBD Contract Work	REF

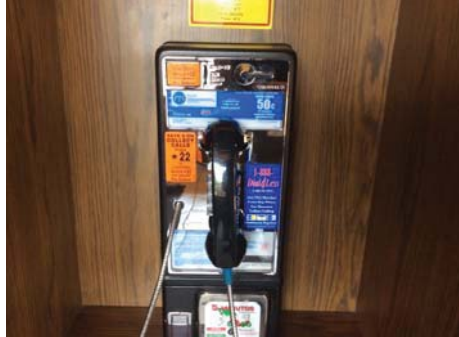
Item No. and Name	Existing Architectural Barrier and Proposed Solution	Codes / Mitigation Info	Qty	Unit	Cost	Total
Telephone						
329	<ul style="list-style-type: none"> <i>As-Built Description:</i> Telephone amplification for hearing impaired persons not provided (push button volume control). <i>Proposed Solution:</i> Provide telephone amplification for hearing impaired persons. To be provided by utility company. 	PCODE IB05 ADAAG 4.31.5 ADA 2010 704.3 CBC 2010 1117B.2.8 CBC 2013 11B-704.3 Priority 3 Severity 3 TBD Contract Work	1	JOB	\$100	\$100

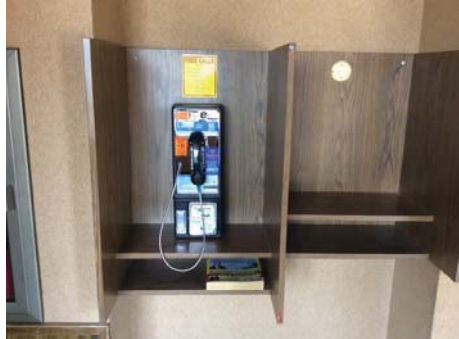
TTY						
328	<ul style="list-style-type: none"> <i>As-Built Description:</i> Interior public text telephone (TTY) not provided at type of facility required to have a public text telephone. <i>Proposed Solution:</i> Provide text telephone. 	PCODE IB10 ADAAG 4.1.3(17)(c) ADA 2010 217.4 CBC 2010 1117B.2.9.1 CBC 2013 11B-217.4 Priority 3 Severity 3 TBD Contract Work	1	JOB	\$1,150	\$1,150

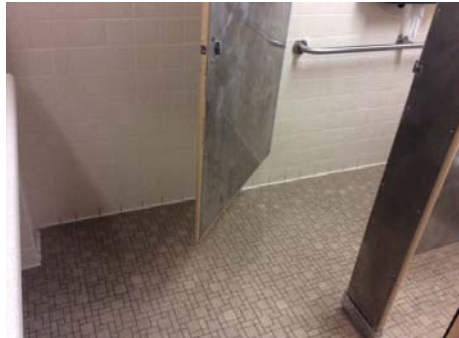
Door Swing						
373	<ul style="list-style-type: none"> <i>As-Built Description:</i> Latch approach: At pull side, door does not have clear and level maneuvering space measuring door width plus 24" x 48" or 54" if door has closer (CA only: door width plus 24" x 60"). <i>As-Built:</i> Stall door: 42.5" <i>Proposed Solution:</i> Remodel restroom as needed. 	PCODE ID27NT ADAAG Fig. 25(c) ADA 2010 404.2.4 CBC 2010 11B-26A(c) CBC 2013 11B-404.2.4 Priority 3 Severity 4 TBD Contract Work	1	JOB	\$500	\$500

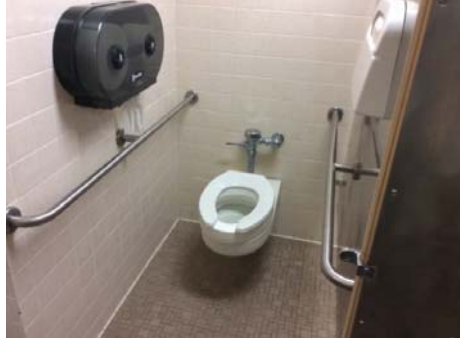
Item No. and Name	Existing Architectural Barrier and Proposed Solution	Codes / Mitigation Info	Qty	Unit	Cost	Total
<u>Toilet Stall</u>						
376	<ul style="list-style-type: none"> As-Built Description: Toilet stall less than 60" wide. As-Built: 38.5" Proposed Solution: Provide new accessible stall. 	PCODE WB06 ADAAG 4.17.3 ADA 2010 604.8.1.1 CBC 2010 1115B.3.1.4.1 CBC 2013 11B-604.8.1.1 Priority 3 Severity 2 TBD Contract Work	1	JOB	\$1,500	\$1,500

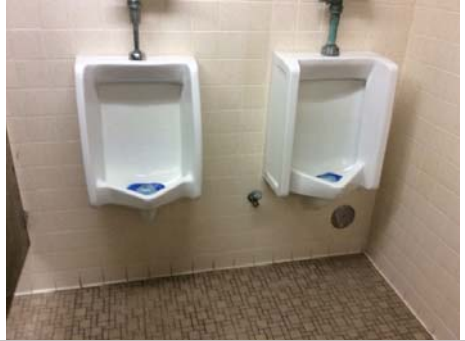
<u>Urinal</u>						
370	<ul style="list-style-type: none"> As-Built Description: Front of rim projects less than 13.5" from wall. As-Built: 12.5" Proposed Solution: Provide accessible urinal. Remodel restroom as needed. 	PCODE WE01 ADA 2010 605.2 CBC 2010 1115B.4.2.1 CBC 2013 11B-605.2 Priority 3 Severity 4 TBD Contract Work	1	JOB	\$4,000	\$4,000

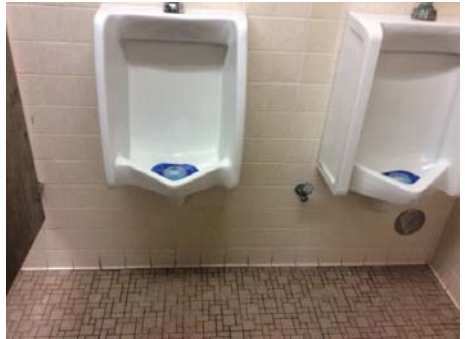
371	<ul style="list-style-type: none"> As-Built Description: Fixture mounted with rim more than 17" above floor. As-Built: 25" Proposed Solution: Provide accessible urinal. Remodel restroom as needed. 	PCODE WE02REF ADAAG 4.18.2 ADA 2010 605.2 CBC 2010 1115B.4.2.1 CBC 2013 11B-605.2 Priority 3 Severity 2 TBD Contract Work	REF

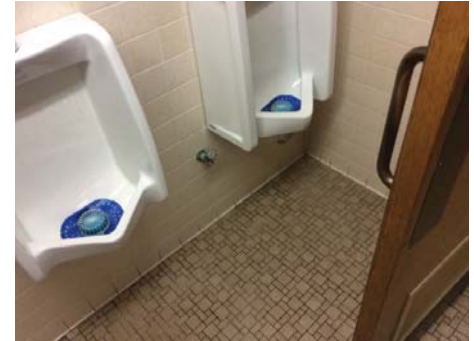
Item No. and Name	Existing Architectural Barrier and Proposed Solution	Codes / Mitigation Info	Qty	Unit	Cost	Total
372	<ul style="list-style-type: none"> <i>As-Built Description:</i> 30" x 48" clear floor space in front of accessible urinal not provided. <i>As-Built:</i> Door swing hazard. <i>Proposed Solution:</i> Provide clear floor space in front of accessible urinal. Remodel restroom as needed. 	PCODE WE04 ADAAG 4.18.3 ADA 2010 605.3 CBC 2010 1115B.4.2.3 CBC 2013 11B-605.3 Priority 3 Severity 2 TBD Contract Work	1	JOB	\$1,500	\$1,500

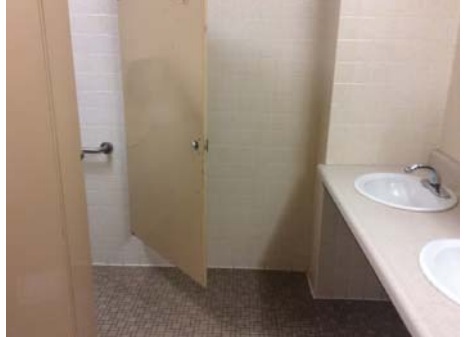
Item No. and Name	Existing Architectural Barrier and Proposed Solution	Codes / Mitigation Info	Qty	Unit	Cost	Total
Door Swing						
390	<ul style="list-style-type: none"> <i>As-Built Description:</i> Latch approach: At pull side, door does not have clear and level maneuvering space measuring door width plus 24" x 48" or 54" if door has closer (CA only: door width plus 24" x 60"). <i>As-Built:</i> Stall door: 42.5" <i>Proposed Solution:</i> Remodel restroom as needed. 	PCODE ID27BNT ADAAG Fig. 25(c) ADA 2010 404.2.4 CBC 2010 11B-26A(c) CBC 2013 11B-404.2.4 Priority 3 Severity 4 TBD Contract Work	1	JOB	\$1,600	\$1,600

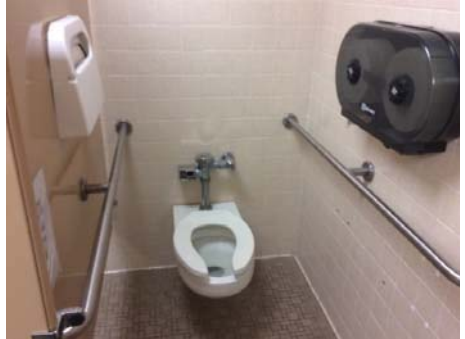
Grab Bars						
395	<ul style="list-style-type: none"> <i>As-Built Description:</i> Grab bars not provided or are not code compliant. <i>Proposed Solution:</i> Provide accessible grab bars. 	PCODE WB07REF ADAAG 4.17.6 ADA 2010 604.5 CBC 2010 1115B.4.1.3 CBC 2013 11B-604.5 Priority 3 Severity 3 TBD Contract Work	REF

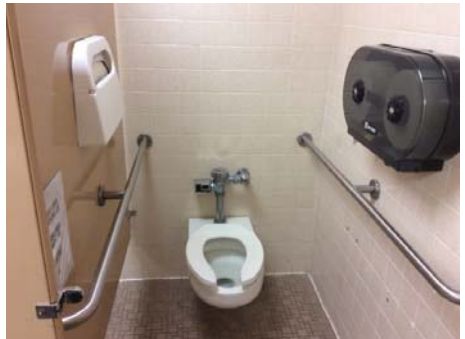
Toilet Stall						
394	<ul style="list-style-type: none"> <i>As-Built Description:</i> Toilet stall less than 60" wide. <i>As-Built:</i> 40" <i>Proposed Solution:</i> Provide new accessible stall. 	PCODE WB06 ADAAG 4.17.3 ADA 2010 604.8.1.1 CBC 2010 1115B.3.1.4.1 CBC 2013 11B-604.8.1.1 Priority 3 Severity 2 TBD Contract Work	1	JOB	\$1,500	\$1,500

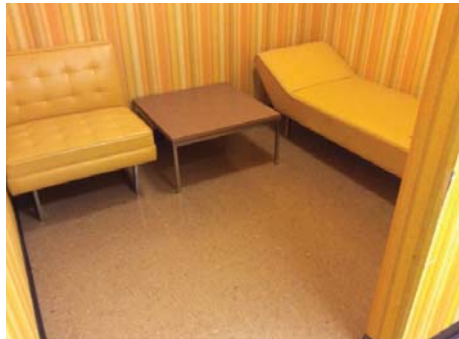
Item No. and Name	Existing Architectural Barrier and Proposed Solution	Codes / Mitigation Info	Qty	Unit	Cost	Total
<u>Turn Space</u>						
382	<ul style="list-style-type: none"> <i>As-Built Description:</i> Less than 60" diameter or T-shaped space provided for wheelchair turns. <i>As-Built:</i> 53" to chair and table <i>Proposed Solution:</i> Retrofit space to provide 60" diameter or T-turn by providing a smaller table. 	<p>PCODE IN04 ADAAG 4.2.3 ADA 2010 304.1 CBC 2010 1118B.3 CBC 2013 11B-304.1 Priority 3 Severity 2 TBD Contract Work</p>	1	JOB	\$925	\$925

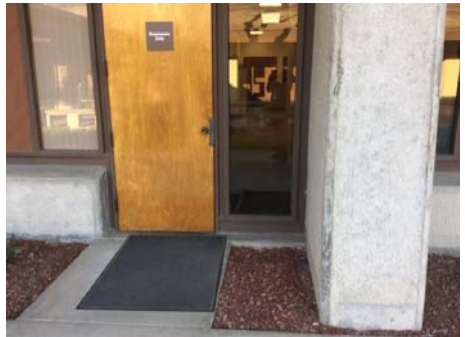
<u>Door Swing</u>						
481	<ul style="list-style-type: none"> <i>As-Built Description:</i> Front approach: At pull side, door does not have clear and level maneuvering space measuring door width plus 18"(CA only: 24" at exterior doors)x 60". <i>As-Built:</i> Exterior: DW + 7" <i>Proposed Solution:</i> Extend maneuvering space. Notes: Staff Only 	<p>PCODE ID23D ADAAG Fig. 25(a) ADA 2010 404.2.4 CBC 2010 11B-26A(a) CBC 2013 11B-404.2.4 Priority 4 Severity 3 TBD Contract Work</p>	1	JOB	\$800	\$800

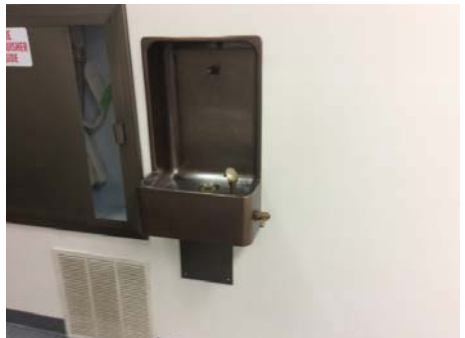
<u>Drinking Fountain</u>						
447	<ul style="list-style-type: none"> <i>As-Built Description:</i> Where only one drinking fountain is provided per floor: Fountain is not accessible to individuals who use wheelchairs, or to those who have difficulty bending or stooping. <i>Proposed Solution:</i> Provide additional fountain or hi-lo combination fountain. 	<p>PCODE IA01A ADAAG 4.1.3(10)(a) ADA 2010 211.1 CBC 2010 1115B.4.6.1 CBC 2013 11B-211.1 Priority 3 Severity 2 TBD Contract Work</p>	1	JOB	\$2,000	\$2,000

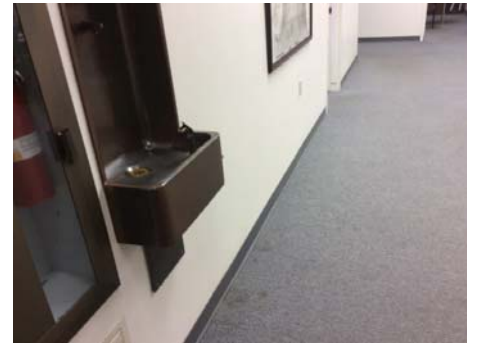
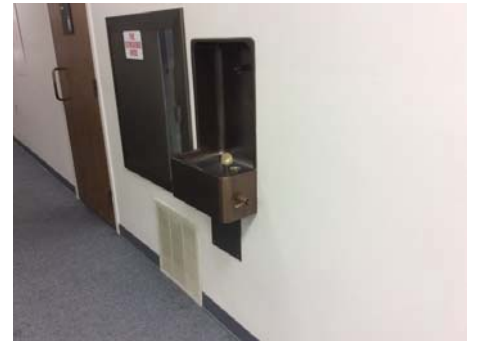
Item No. and Name	Existing Architectural Barrier and Proposed Solution	Codes / Mitigation Info	Qty	Unit	Cost	Total
449	<ul style="list-style-type: none"> • <i>As-Built Description:</i> Drinking fountain bubbler more than 36" above floor. • <i>As-Built:</i> 38" AFF • <i>Proposed Solution:</i> Provide new, accessible fountain. 	PCODE IA03BREF ADAAG 4.15.2 ADA 2010 602.4 CBC 2010 1115B.4.6.4 CBC 2013 11B-602.4 Priority 3 Severity 4 TBD Contract Work				
446	<ul style="list-style-type: none"> • <i>As-Built Description:</i> CA only: Drinking fountain not located in an alcove (min. 32" wide x 18" deep) or otherwise encroaches into pedestrian way. • <i>Proposed Solution:</i> Provide new alcove for drinking fountain, or, if unreasonable hardship is determined, provide wing walls or cane-detectable railings on each side of the drinking fountain. The wings must project out from the supporting wall at least as far as the drinking fountain to within 6" of the surface of the circulation path, but cannot reduce the required clear width of the adjacent accessible route. 	PCODE IA04 CBC 2010 1115B.4.6.3; Fig. CBC 2013 11B-602.9 Priority 3 Severity 2 TBD Contract Work	1	JOB	\$3,000	\$3,000

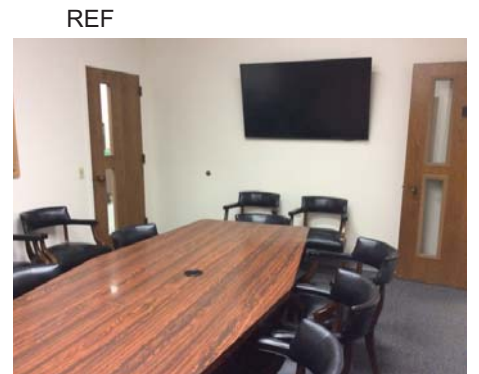
452	<ul style="list-style-type: none"> • <i>As-Built Description:</i> No portable assistive listening system provided for small meeting room. • <i>Proposed Solution:</i> Share existing portable assistive listening system from other facility if needed. 	PCODE GI01E ADAAG 4.1.3(19)(b) & 4.33.7 ADA 2010 219.1 & 706.1 CBC 2010 1104B.2 CBC 2013 11B-219.2 Priority 3 Severity 3 TBD Contract Work

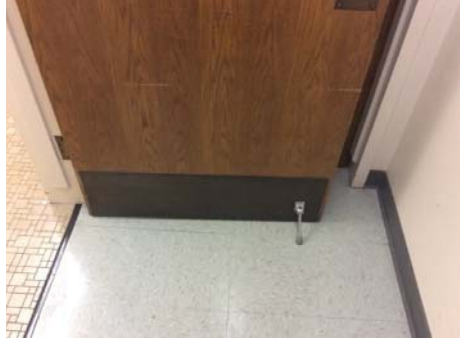
Item No. and Name	Existing Architectural Barrier and Proposed Solution	Codes / Mitigation Info	Qty	Unit	Cost	Total
Door Swing						
468	<ul style="list-style-type: none"> <i>As-Built Description:</i> Latch approach: At pull side, door does not have clear and level maneuvering space measuring door width plus 24" x 48" or 54" if door has closer (CA only: door width plus 24" x 60"). <i>As-Built:</i> 48" <i>Proposed Solution:</i> Provide relocated new door and frame; remodel walls as needed. 	PCODE ID27BREF ADAAG Fig. 25(c) ADA 2010 404.2.4 CBC 2010 11B-26A(c) CBC 2013 11B-404.2.4 Priority 4 Severity 4 TBD Contract Work				
						REF

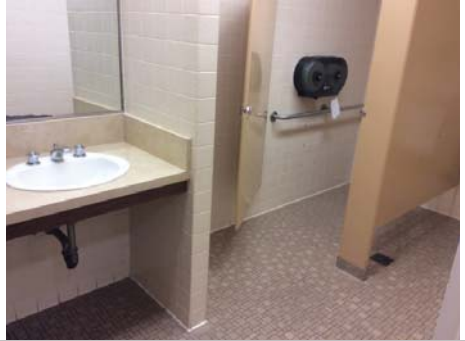
Restroom						
469	<ul style="list-style-type: none"> <i>As-Built Description:</i> Multiple accommodation restroom not accessible; multiple compliance violations. <i>Proposed Solution:</i> Remodel area to provide accessible restroom with one accessible stall, lavatory (and one urinal at Mens). 	PCODE WA01A ADAAG 4.22 ADA 2010 603 CBC 2010 1115B.3.1 CBC 2013 11B-603 Priority 4 Severity 1 TBD Contract Work	1	JOB	\$35,000	\$35,000

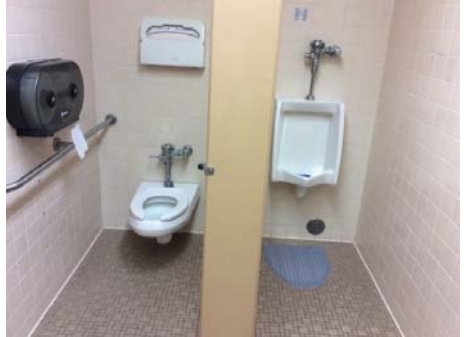
Toilet Stall						
470	<ul style="list-style-type: none"> <i>As-Built Description:</i> Toilet stall less than 60" wide. <i>As-Built:</i> 39.5" wide <i>Proposed Solution:</i> Provide new accessible stall (alternate stalls 36" x 69" or 48" x 69" not recommended). 	PCODE WB06REF ADAAG 4.17.3 ADA 2010 604.8.1.1 CBC 2010 1115B.3.1.4.1 CBC 2013 11B-604.8.1.1 Priority 4 Severity 2 TBD Contract Work				
						REF

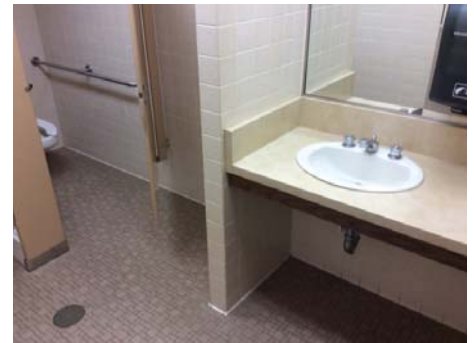
- 477
- *As-Built Description:*
 Multiple accommodation restroom not accessible; multiple compliance violations.
 - *Proposed Solution:*
 Remodel area to provide accessible restroom with one accessible stall, lavatory (and one urinal at Mens).

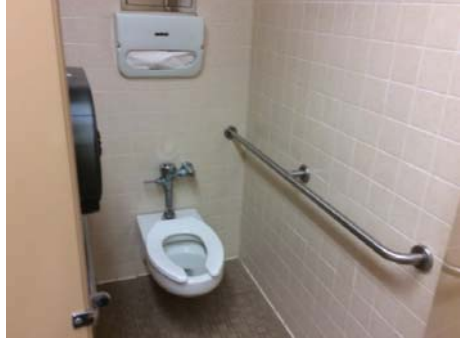
Item No. and Name	Existing Architectural Barrier and Proposed Solution	Codes / Mitigation Info	Qty	Unit	Cost	Total
<u>Toilet Stall</u>						
478	<ul style="list-style-type: none"> As-Built Description: Toilet stall less than 60" wide. As-Built: 39.5" Proposed Solution: Provide new accessible stall (alternate stalls 36" x 69" or 48" x 69" not recommended). 	PCODE WB06REF ADAAG 4.17.3 ADA 2010 604.8.1.1 CBC 2010 1115B.3.1.4.1 CBC 2013 11B-604.8.1.1 Priority 4 Severity 2 TBD Contract Work				
						REF

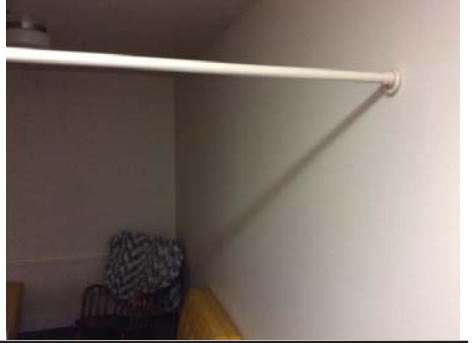
<u>Vertical Clearance</u>						
475	<ul style="list-style-type: none"> As-Built Description: Overhead clearance less than 80" above finished floor. As-Built: 77.5" Proposed Solution: Modify overhead clearance. 	PCODE EG01 ADAAG 4.4.2 ADA 2010 307.4 CBC 2010 1133B.8.6.2 CBC 2013 11B-307.4 Priority 4 Severity 2 TBD Contract Work	1	JOB	\$60	\$60

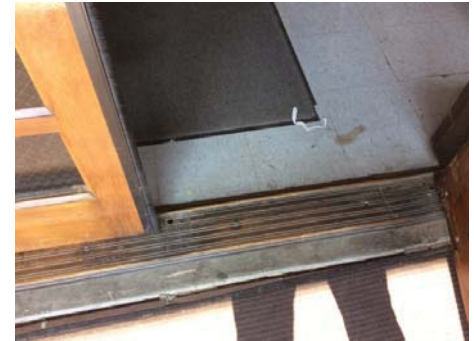
Door Threshold

942	<ul style="list-style-type: none"> <i>As-Built Description:</i> Existing threshold at door is 1/2" high or less but without a beveled edge on both sides. <i>As-Built:</i> Gap, loose plate 0.25" no bevel <i>Proposed Solution:</i> Modify threshold to have beveled edge on each side. 	PCODE ID02 ADAAG 4.1.6(3)(d)(ii) ADA 2010 404.2.5 CBC 2010 1133B.2.4.1 CBC 2013 11B-404.2.5 Priority 1 Severity 4 TBD Contract Work	1	JOB	\$250	\$250
-----	---	--	---	-----	-------	--------------

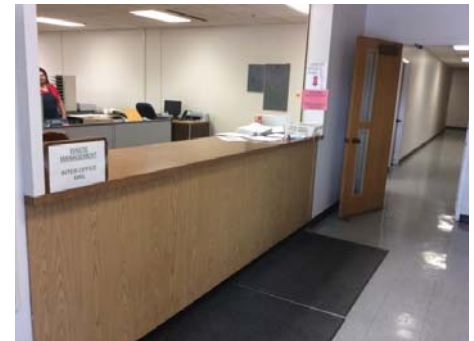
Public Counter

948	<ul style="list-style-type: none"> <i>As-Built Description:</i> Service counter (stand-up): Accessible section min. 36" length and 36" max. height (in CA: 28" to 34" high) not provided. <i>As-Built:</i> 41.75" <i>Proposed Solution:</i> Provide auxiliary shelf, clipboard, or table as equivalent facilitation. 	PCODE IN03 ADAAG 7.2(2) ADA 2010 904.4 CBC 2010 1122B.4 CBC 2013 11B-904.4 Priority 1 Severity 3 TBD Contract Work	1	JOB	\$150	\$150
-----	---	---	---	-----	-------	--------------

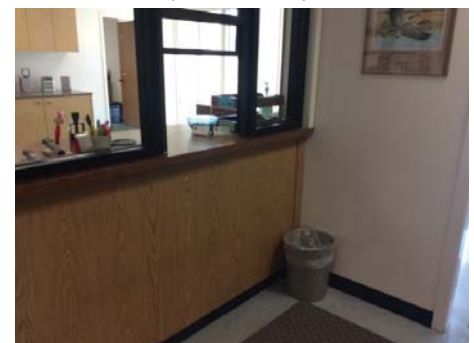
Public Counter

954	<ul style="list-style-type: none"> <i>As-Built Description:</i> Service counter (stand-up): Accessible section min. 36" length and 36" max. height (in CA: 28" to 34" high) not provided. <i>As-Built:</i> 42" <i>Proposed Solution:</i> Provide auxiliary shelf, clipboard, or table as equivalent facilitation. 	PCODE IN03 ADAAG 7.2(2) ADA 2010 904.4 CBC 2010 1122B.4 CBC 2013 11B-904.4 Priority 1 Severity 3 TBD Contract Work	1	JOB	\$150	\$150
-----	--	---	---	-----	-------	--------------

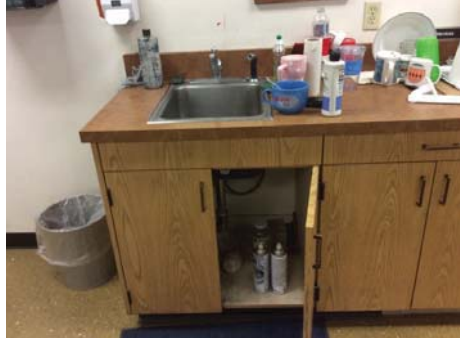
Item No. and Name	Existing Architectural Barrier and Proposed Solution	Codes / Mitigation Info	Qty	Unit	Cost	Total
Sink						
974	<ul style="list-style-type: none"> As-Built Description: Sink does not have knee space min. 27" high x 19" deep x 30" wide. Proposed Solution: Remodel sink cabinet. 	PCODE IN06A ADAAG 4.24.3 ADA 2010 606.2 CBC 2010 1115B.4.7.1 CBC 2013 11B-606.2 Priority 2 Severity 2 TBD Contract Work	1	JOB	\$1,750	\$1,750

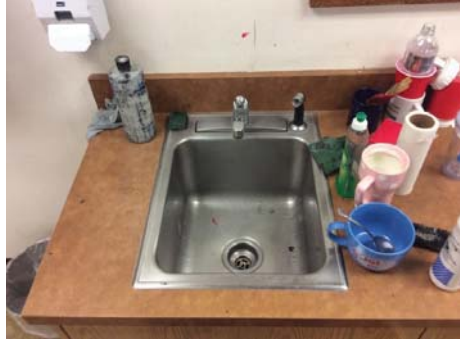
976	<ul style="list-style-type: none"> As-Built Description: Sink is more than 6 1/2" deep. Proposed Solution: Provide new sink remodel and cabinet as needed. 	PCODE IN06B ADAAG 4.24.4 CBC 2010 1115B.4.7.1 CBC 2013 11B-606.7 Priority 2 Severity 3 TBD Contract Work	1	JOB	\$1,850	\$1,850

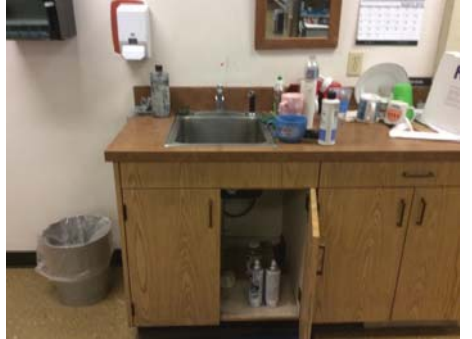
975	<ul style="list-style-type: none"> As-Built Description: Sink rim higher than 34" above floor. As-Built: 36" Proposed Solution: Remodel sink cabinet to lower sink. 	PCODE IN06REF ADAAG 4.24.2 ADA 2010 606.3 CBC 2010 1115B.4.7.1 CBC 2013 11B-606.3 Priority 2 Severity 4 TBD Contract Work		REF

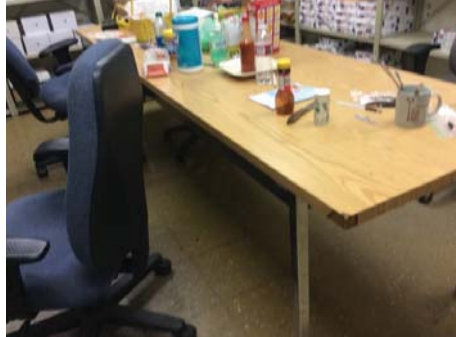
Item No. and Name	Existing Architectural Barrier and Proposed Solution	Codes / Mitigation Info	Qty	Unit	Cost	Total
<u>Non-Fixed Desk</u>						
986	<ul style="list-style-type: none"> <i>As-Built Description:</i> Accessible non-fixed table or desk (top 28" to 34" high; knee space at least 27" high x 19" deep x 30" wide) not provided. <i>As-Built:</i> 26.5" knee ht <i>Proposed Solution:</i> Provide table or desk with accessible dimensions when purchasing new furniture. 	PCODE IN02A ADAAG 4.32.3 & .4 ADA 2010 306.1 CBC 2010 1122B.3 & 4 CBC 2013 11B-306.1 & 11B-902.3 Priority 4 Severity 2 TBD Contract Work	1	JOB	\$1,600	\$1,600

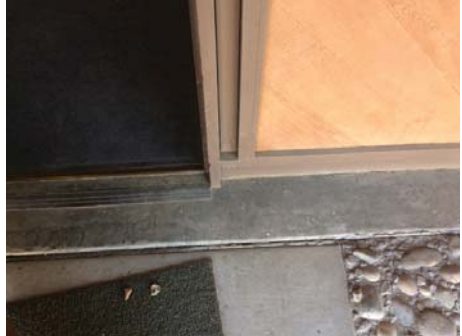
Door

995	<ul style="list-style-type: none"> <i>As-Built Description:</i> Surface of required maneuvering clearance at door slopes more than 1/4":12" (2.0%). <i>As-Built:</i> 14" to irregular surface within DW + 24" at exterior door. <i>Proposed Solution:</i> Modify surface slope at door. 	PCODE ID11 ADAAG 4.13.6 ADA 2010 404.2.4.4 CBC 2010 1133B.2.4 CBC 2013 11B-404.2.4 Priority 2 Severity 1 TBD Contract Work	10	SF	\$40	\$400

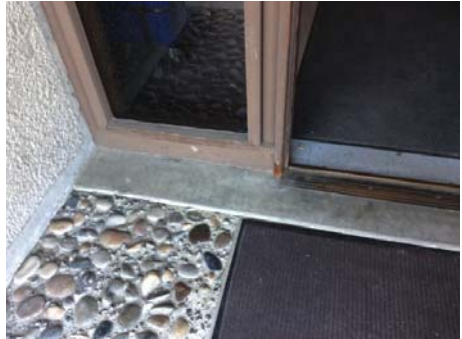
Door

1009	<ul style="list-style-type: none"> <i>As-Built Description:</i> Surface of required maneuvering clearance at door slopes more than 1/4":12" (2.0%). <i>As-Built:</i> 5" to irregular surface within DW + 24" at exterior door. <i>Proposed Solution:</i> Modify surface slope at door. 	PCODE ID11 ADAAG 4.13.6 ADA 2010 404.2.4.4 CBC 2010 1133B.2.4 CBC 2013 11B-404.2.4 Priority 3 Severity 1 TBD Contract Work	10	SF	\$40	\$400

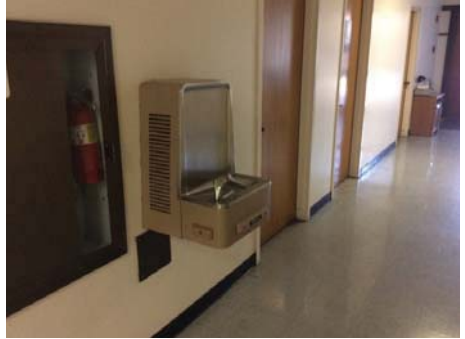
Item No. and Name	Existing Architectural Barrier and Proposed Solution	Codes / Mitigation Info	Qty	Unit	Cost	Total
<u>Drinking Fountain</u>						
1003	<ul style="list-style-type: none"> <i>As-Built Description:</i> Where only one drinking fountain is provided per floor: Fountain is not accessible to individuals who use wheelchairs, or to those who have difficulty bending or stooping. <i>Proposed Solution:</i> Provide additional fountain or hi-lo combination fountain. 	PCODE IA01A ADAAG 4.1.3(10)(a) ADA 2010 211.1 CBC 2010 1115B.4.6.1 CBC 2013 11B-211.1 Priority 3 Severity 2 TBD Contract Work	1	JOB	\$2,000	\$2,000

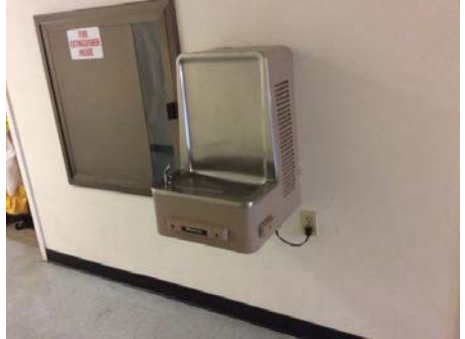
1002	<ul style="list-style-type: none"> <i>As-Built Description:</i> Drinking fountain bubbler more than 36" above floor. <i>As-Built:</i> 36.5" <i>Proposed Solution:</i> Provide new, accessible fountain. 	PCODE IA03B ADAAG 4.15.2 ADA 2010 602.4 CBC 2010 1115B.4.6.4 CBC 2013 11B-602.4 Priority 3 Severity 4 TBD Contract Work	1	JOB	\$3,200	\$3,200

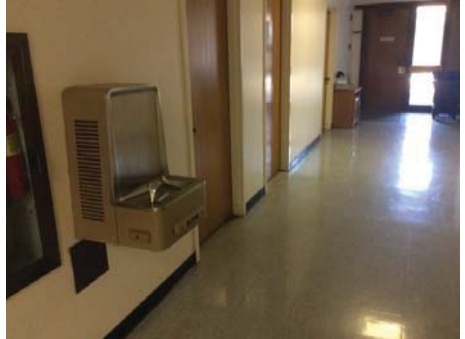
1001	<ul style="list-style-type: none"> <i>As-Built Description:</i> CA only: Drinking fountain not located in an alcove (min. 32" wide x 18" deep) or otherwise encroaches into pedestrian way. <i>Proposed Solution:</i> Provide new alcove for drinking fountain, or, if unreasonable hardship is determined, provide wing walls or cane-detectable railings on each side of the drinking fountain. The wings must project out from the supporting wall at least as far as the drinking fountain to within 6" of the surface of the circulation path, but cannot reduce the required clear width of the adjacent accessible route. 	PCODE IA04 CBC 2010 1115B.4.6.3; Fig. CBC 2013 11B-602.9 Priority 3 Severity 2 TBD Contract Work	1	JOB	\$3,000	\$3,000

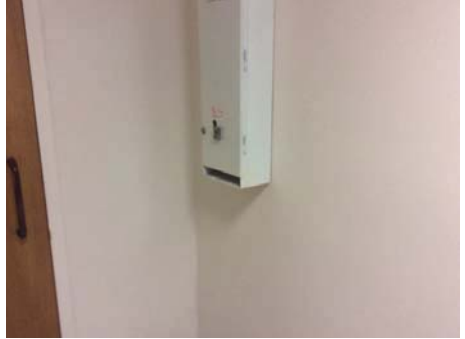
Item No. and Name	Existing Architectural Barrier and Proposed Solution	Codes / Mitigation Info	Qty	Unit	Cost	Total
<u>Accessories</u>						
1014	<ul style="list-style-type: none"> As-Built Description: Dispensers in sanitary facilities, such as for towels, soap, sanitary napkins, seat covers, etc., and waste receptacles not accessible or more than 40" from floor to highest operating slot or control. As-Built: FND: 5.5" @ 45" Proposed Solution: Provide specific restroom accessories. 	PCODE WG01REF ADAAG 4.23.7 ADA 2010 308.2.1 CBC 2010 1115B.8.3 CBC 2013 11B-603.5 Priority 3 Severity 3 TBD Contract Work				
						REF

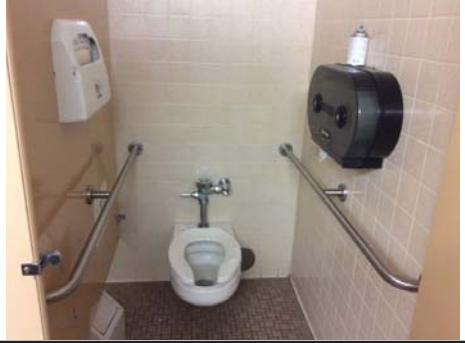
<u>Grab Bars</u>						
1025	<ul style="list-style-type: none"> As-Built Description: Grab bars not provided or are not code compliant. Proposed Solution: Provide accessible grab bars. 	PCODE WB07 ADAAG 4.17.6 ADA 2010 604.5 CBC 2010 1115B.4.1.3 CBC 2013 11B-604.5 Priority 3 Severity 3 TBD Contract Work	1	JOB	\$500	\$500

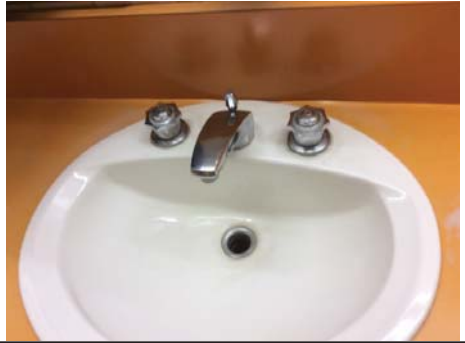
<u>Lavatory</u>						
1022	<ul style="list-style-type: none"> As-Built Description: Lavatory: Accessible faucet (lever-operated, push-type or electronically controlled) not provided at otherwise accessible lavatory. Proposed Solution: Provide accessible faucet at accessible lavatory. 	PCODE WD06 ADAAG 4.19.5 ADA 2010 606.4 CBC 2010 1115B.4.3 CBC 2013 11B-606.4 Priority 3 Severity 3 TBD Contract Work	1	JOB	\$600	\$600

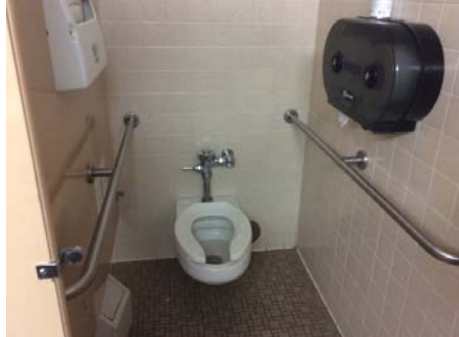
Item No. and Name	Existing Architectural Barrier and Proposed Solution	Codes / Mitigation Info	Qty	Unit	Cost	Total
<u>Toilet Stall</u>						
1029	<ul style="list-style-type: none"> As-Built Description: Toilet stall less than 60" wide. As-Built: 40.5" Proposed Solution: Provide new accessible stall. 	PCODE WB06 ADAAG 4.17.3 ADA 2010 604.8.1.1 CBC 2010 1115B.3.1.4.1 CBC 2013 11B-604.8.1.1 Priority 3 Severity 2 TBD Contract Work	1	JOB	\$1,500	\$1,500

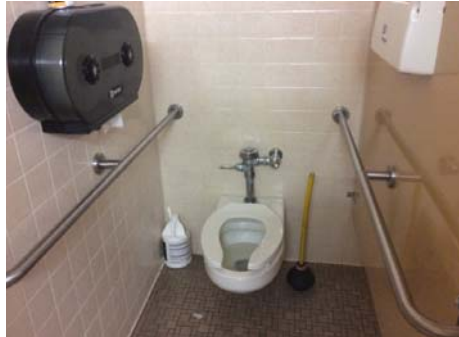
<u>Grab Bars</u>						
1042	<ul style="list-style-type: none"> As-Built Description: Grab bars not provided or are not code compliant. Proposed Solution: Provide accessible grab bars. 	PCODE WB07 ADAAG 4.17.6 ADA 2010 604.5 CBC 2010 1115B.4.1.3 CBC 2013 11B-604.5 Priority 4 Severity 3 TBD Contract Work	1	JOB	\$500	\$500

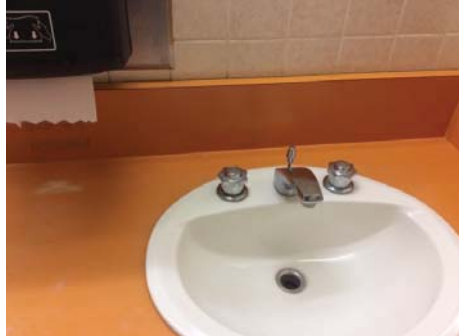
<u>Lavatory</u>						
1035	<ul style="list-style-type: none"> As-Built Description: Lavatory: Accessible faucet (lever-operated, push-type or electronically controlled) not provided at otherwise accessible lavatory. Proposed Solution: Provide accessible faucet at accessible lavatory. 	PCODE WD06 ADAAG 4.19.5 ADA 2010 606.4 CBC 2010 1115B.4.3 CBC 2013 11B-606.4 Priority 4 Severity 3 TBD Contract Work	1	JOB	\$600	\$600

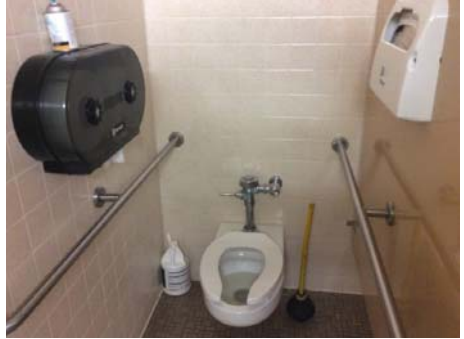
Item No. and Name	Existing Architectural Barrier and Proposed Solution	Codes / Mitigation Info	Qty	Unit	Cost	Total
Toilet Stall						
1043	<ul style="list-style-type: none"> As-Built Description: Toilet stall less than 60" wide. As-Built: 39.5" Proposed Solution: Provide new accessible stall. 	PCODE WB06 ADAAG 4.17.3 ADA 2010 604.8.1.1 CBC 2010 1115B.3.1.4.1 CBC 2013 11B-604.8.1.1 Priority 4 Severity 2 TBD Contract Work	1	JOB	\$1,500	\$1,500

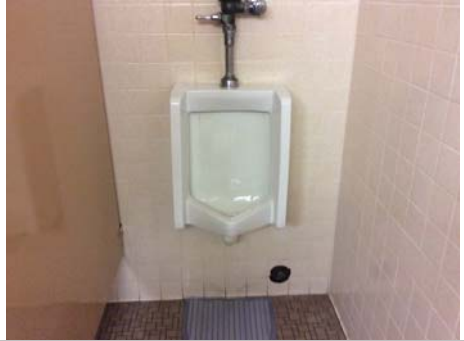
Urinal						
1036	<ul style="list-style-type: none"> As-Built Description: Fixture mounted with rim more than 17" above floor. As-Built: 24" Proposed Solution: Provide accessible urinal. Remodel restroom as needed. 	PCODE WE02 ADAAG 4.18.2 ADA 2010 605.2 CBC 2010 1115B.4.2.1 CBC 2013 11B-605.2 Priority 4 Severity 2 TBD Contract Work	1	JOB	\$2,400	\$2,400

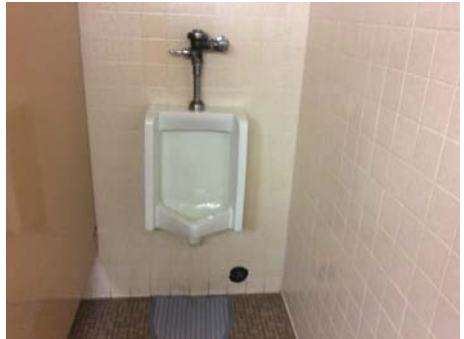
1037	<ul style="list-style-type: none"> As-Built Description: Urinal flush control lever more than 48" above floor (CA only: 44" max.). As-Built: 54" Proposed Solution: Provide accessible urinal flush control. 	PCODE WE03 ADAAG 4.18.4 ADA 2010 605.4 CBC 2010 1115B.4.2.2 CBC 2013 11B-605.4 Priority 4 Severity 3 TBD Contract Work	1	JOB	\$500	\$500

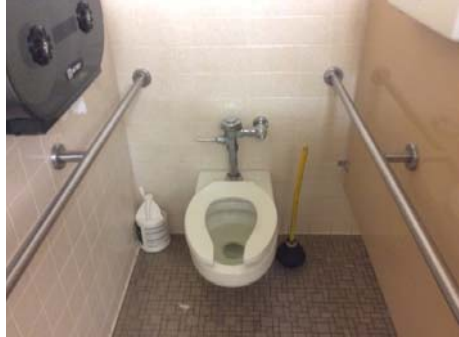
Item No. and Name	Existing Architectural Barrier and Proposed Solution	Codes / Mitigation Info	Qty	Unit	Cost	Total
<u>Water Closet</u>						
1046	<ul style="list-style-type: none"> <i>As-Built Description:</i> Flush Control: Operating handle not mounted toward wide side of stall. <i>Proposed Solution:</i> Replace flush control with properly mounted accessible type, or install sensor flush. <i>Notes:</i> WC 19" o.c. 	PCODE WB10 ADAAG 4.16.5 ADA 2010 604.6 CBC 2010 1115B.4.1.5 CBC 2013 11B-604.6 Priority 4 Severity 3 TBD Contract Work	1	JOB	\$500	\$500

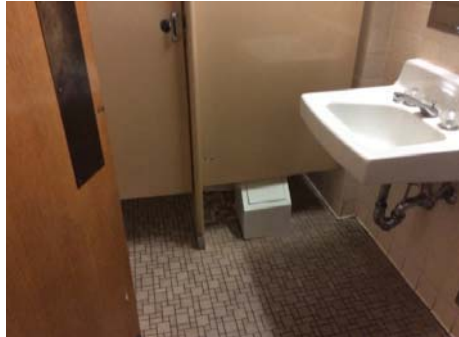
<u>Restroom</u>						
1060	<ul style="list-style-type: none"> <i>As-Built Description:</i> Single accommodation restroom not accessible; multiple compliance violations. <i>Proposed Solution:</i> Remodel area to provide single-occupant accessible restroom. <i>Notes:</i> Room size 98"x70" 	PCODE WA01 ADAAG 4.22 ADA 2010 603 CBC 2010 1115B.3.2 CBC 2013 11B-603 Priority 3 Severity 2 TBD Contract Work	1	JOB	\$30,000	\$30,000

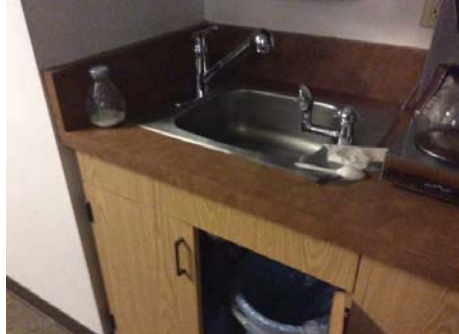
<u>Sink</u>						
1056	<ul style="list-style-type: none"> <i>As-Built Description:</i> Sink does not have knee space min. 27" high x 19" deep x 30" wide. <i>As-Built:</i> Also drinking fountain not compliant. <i>Proposed Solution:</i> Remodel sink cabinet. 	PCODE IN06A ADAAG 4.24.3 ADA 2010 606.2 CBC 2010 1115B.4.7.1 CBC 2013 11B-606.2 Priority 2 Severity 2 TBD Contract Work	1	JOB	\$1,750	\$1,750

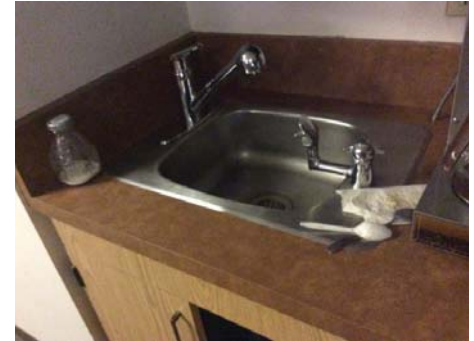
Item No. and Name	Existing Architectural Barrier and Proposed Solution	Codes / Mitigation Info	Qty	Unit	Cost	Total
1057	<ul style="list-style-type: none"> • <i>As-Built Description:</i> Sink rim higher than 34" above floor. • <i>As-Built:</i> 35.75" • <i>Proposed Solution:</i> Remodel sink cabinet to lower sink. 	<p>PCODE IN06REF</p> <p>ADAAG 4.24.2</p> <p>ADA 2010 606.3</p> <p>CBC 2010 1115B.4.7.1</p> <p>CBC 2013 11B-606.3</p> <p>Priority 2</p> <p>Severity 4</p> <p>TBD Contract Work</p>

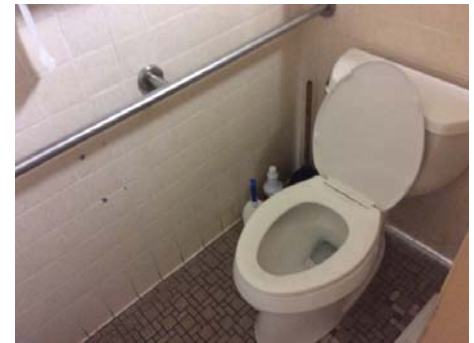
1061	<ul style="list-style-type: none"> • <i>As-Built Description:</i> Toilet stall less than 60" wide. • <i>As-Built:</i> 36" wide • <i>Proposed Solution:</i> Provide new accessible stall (alternate stalls 36" x 69" or 48" x 69" not recommended). 	<p>PCODE WB06REF</p> <p>ADAAG 4.17.3</p> <p>ADA 2010 604.8.1.1</p> <p>CBC 2010 1115B.3.1.4.1</p> <p>CBC 2013 11B-604.8.1.1</p> <p>Priority 3</p> <p>Severity 1</p> <p>TBD Contract Work</p>				
------	---	---	--	--	--	--

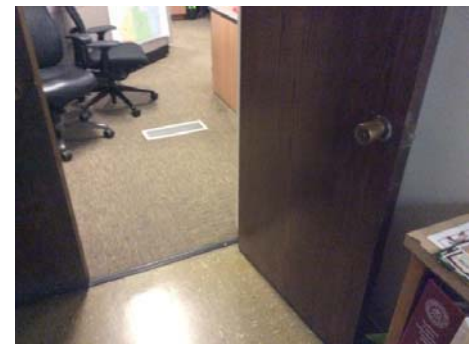
1063	<ul style="list-style-type: none"> • <i>As-Built Description:</i> Pair of doors on accessible route has less than 32" clear opening width with one leaf open 90°. • <i>As-Built:</i> 27.5" • <i>Proposed Solution:</i> Provide new door leaves, unequal in width, to existing frame for pair of doors. 	<p>PCODE ID08A</p> <p>ADAAG 4.13.4</p> <p>ADA 2010 404.2.2</p> <p>CBC 2010 1133B.2.3.1</p> <p>CBC 2013 11B-404.2.2</p> <p>Priority 4</p> <p>Severity 2</p> <p>TBD Contract Work</p>	1	JOB	\$1,500	\$1,500
------	---	---	---	-----	---------	----------------

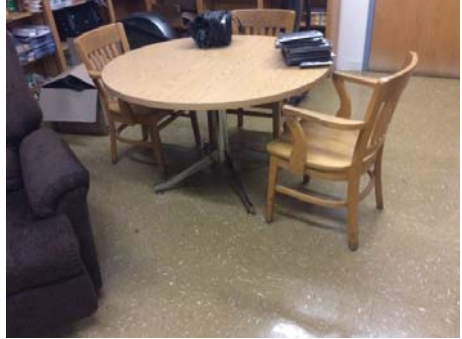
Item No. and Name	Existing Architectural Barrier and Proposed Solution	Codes / Mitigation Info	Qty	Unit	Cost	Total
<u>Non-Fixed Desk</u>						
1069	<ul style="list-style-type: none"> <i>As-Built Description:</i> Accessible non-fixed table or desk (top 28" to 34" high; knee space at least 27" high x 19" deep x 30" wide) not provided. <i>As-Built:</i> due to table leg <i>Proposed Solution:</i> Provide table or desk with accessible dimensions when purchasing new furniture. 	PCODE IN02A ADAAG 4.32.3 & .4 ADA 2010 306.1 CBC 2010 1122B.3 & 4 CBC 2013 11B-306.1 & 11B-902.3 Priority 4 Severity 2 TBD Contract Work	1	JOB	\$1,600	\$1,600

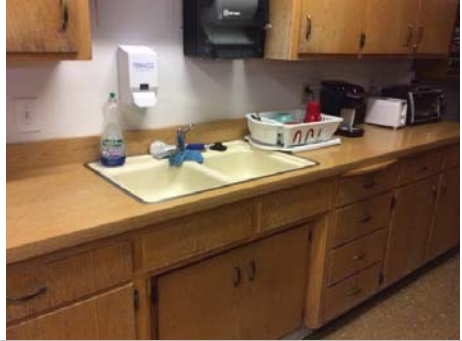
<u>Sink</u>						
1066	<ul style="list-style-type: none"> <i>As-Built Description:</i> Sink does not have knee space min. 27" high x 19" deep x 30" wide. <i>Proposed Solution:</i> Remodel sink cabinet. 	PCODE IN06A ADAAG 4.24.3 ADA 2010 606.2 CBC 2010 1115B.4.7.1 CBC 2013 11B-606.2 Priority 4 Severity 2 TBD Contract Work	1	JOB	\$1,750	\$1,750

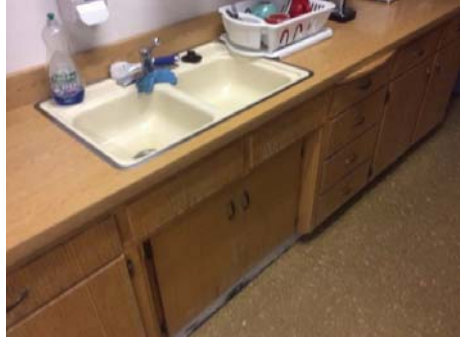
1067	<ul style="list-style-type: none"> <i>As-Built Description:</i> Sink rim higher than 34" above floor. <i>As-Built:</i> 36" <i>Proposed Solution:</i> Remodel sink cabinet to lower sink. 	PCODE IN06REF ADAAG 4.24.2 ADA 2010 606.3 CBC 2010 1115B.4.7.1 CBC 2013 11B-606.3 Priority 4 Severity 4 TBD Contract Work	REF

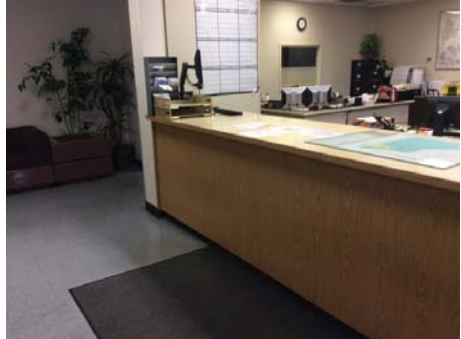
772	<ul style="list-style-type: none"> <i>As-Built Description:</i> Service counter (stand-up): Accessible section min. 36" length and 36" max. height (in CA: 28" to 34" high) not provided. <i>As-Built:</i> Planning: 42" <i>Proposed Solution:</i> Provide auxiliary shelf, clipboard, or table as equivalent facilitation. 	<p>PCODE IN03 ADAAG 7.2(2) ADA 2010 904.4 CBC 2010 1122B.4 CBC 2013 11B-904.4 Priority 1 Severity 3 TBD Contract Work</p>	1	JOB	\$150	\$150
-----	--	---	---	-----	-------	--------------

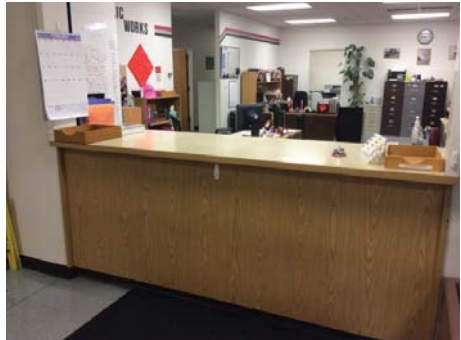
774	<ul style="list-style-type: none"> <i>As-Built Description:</i> Service counter (stand-up): Accessible section min. 36" length and 36" max. height (in CA: 28" to 34" high) not provided. <i>As-Built:</i> Public works: 42.25" <i>Proposed Solution:</i> Provide auxiliary shelf, clipboard, or table as equivalent facilitation. 	<p>PCODE IN03 ADAAG 7.2(2) ADA 2010 904.4 CBC 2010 1122B.4 CBC 2013 11B-904.4 Priority 1 Severity 3 TBD Contract Work</p>	1	JOB	\$150	\$150
-----	---	---	---	-----	-------	--------------

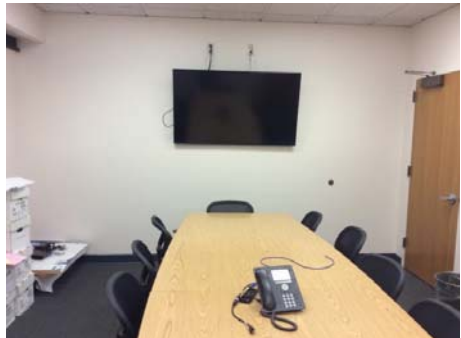
779	<ul style="list-style-type: none"> <i>As-Built Description:</i> No portable assistive listening system provided for small meeting room. <i>Proposed Solution:</i> Share existing portable assistive listening system from other facility if needed. 	<p>PCODE GI01E ADAAG 4.1.3(19)(b) & 4.33.7 ADA 2010 219.1 & 706.1 CBC 2010 1104B.2 CBC 2013 11B-219.2 Priority 3 Severity 3 TBD Contract Work</p>	REF			
-----	---	---	-----	--	--	--

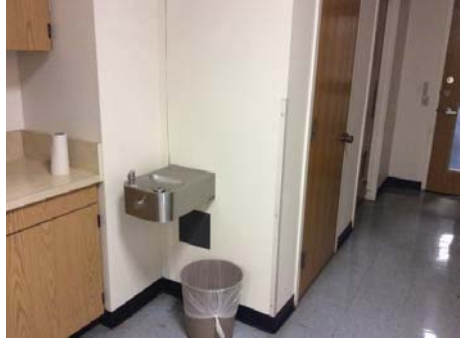
Item No. and Name	Existing Architectural Barrier and Proposed Solution	Codes / Mitigation Info	Qty	Unit	Cost	Total
<u>Drinking Fountain</u>						
785	<ul style="list-style-type: none"> <i>As-Built Description:</i> Where only one drinking fountain is provided per floor: Fountain is not accessible to individuals who use wheelchairs, or to those who have difficulty bending or stooping. <i>As-Built:</i> 9.25" on center from wall <i>Proposed Solution:</i> Provide additional fountain or hi-lo combination fountain. <i>Notes:</i> Also provide within an alcove or provide pedestrian protection. 	PCODE IA01A ADAAG 4.1.3(10)(a) ADA 2010 211.1 CBC 2010 1115B.4.6.1 CBC 2013 11B-211.1 Priority 3 Severity 2 TBD Contract Work	1	JOB	\$2,000	\$2,000

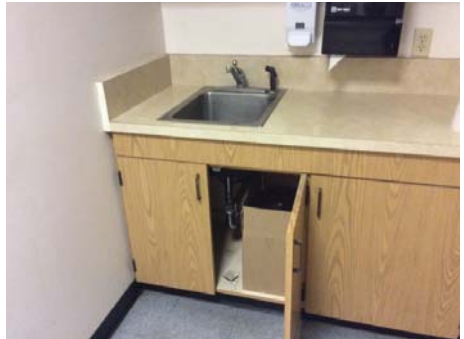
<u>Sink</u>						
786	<ul style="list-style-type: none"> <i>As-Built Description:</i> Sink does not have knee space min. 27" high x 19" deep x 30" wide. <i>Proposed Solution:</i> Remodel sink cabinet. 	PCODE IN06A ADAAG 4.24.3 ADA 2010 606.2 CBC 2010 1115B.4.7.1 CBC 2013 11B-606.2 Priority 3 Severity 2 TBD Contract Work	1	JOB	\$1,750	\$1,750

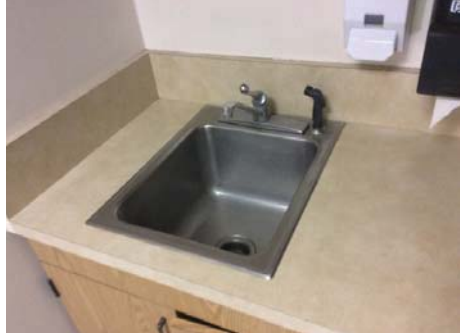
789	<ul style="list-style-type: none"> <i>As-Built Description:</i> Sink is more than 6 1/2" deep. <i>As-Built:</i> 10" <i>Proposed Solution:</i> Provide new sink remodel and cabinet as needed. 	PCODE IN06BREF ADAAG 4.24.4 CBC 2010 1115B.4.7.1 CBC 2013 11B-606.7 Priority 3 Severity 3 TBD Contract Work	REF

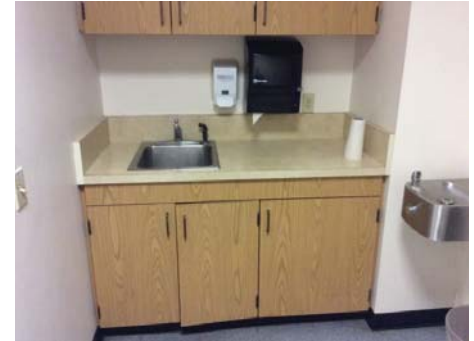
Item No. and Name	Existing Architectural Barrier and Proposed Solution	Codes / Mitigation Info	Qty	Unit	Cost	Total
787	<ul style="list-style-type: none"> As-Built Description: Sink rim higher than 34" above floor. As-Built: 36" Proposed Solution: Remodel sink cabinet to lower sink. 	PCODE IN06REF ADAAG 4.24.2 ADA 2010 606.3 CBC 2010 1115B.4.7.1 CBC 2013 11B-606.3 Priority 3 Severity 4 TBD Contract Work		REF
