Facility: **WOMENS INFANTS & CHILDREN**

Address: 330 HARRIS ST.

Facility: **LEMORE HEALTH CLINIC**
 Address: 229 C ST.

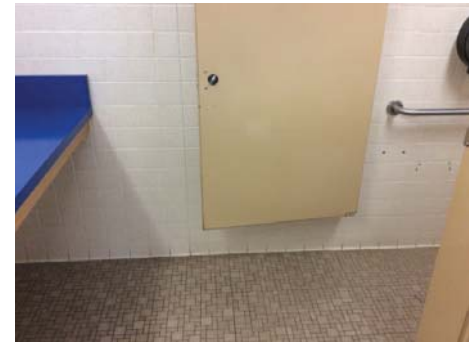
802	<ul style="list-style-type: none"> As-Built Description: Front approach: At pull side, door does not have clear and level maneuvering space measuring door width plus 18" x 60". As-Built: Stall door: 49" to lav Proposed Solution: Provide relocated new door and frame; remodel as needed. 	PCODE ID23BNT ADAAG Fig. 25(a) ADA 2010 404.2.4 CBC 2010 11B-26A(a) CBC 2013 11B-404.2.4 Priority 3 Severity 3 TBD Contract Work	1	JOB	\$2,600	\$2,600
-----	--	---	---	-----	---------	----------------

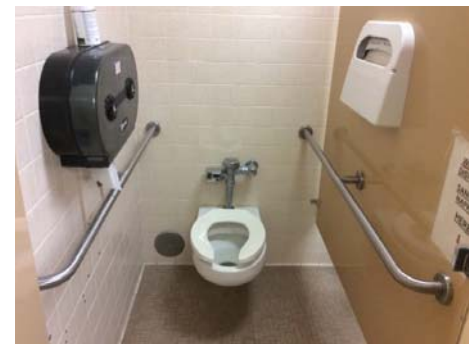
799	<ul style="list-style-type: none"> As-Built Description: Grab bars not provided or are not code compliant. Proposed Solution: Provide accessible grab bars. 	PCODE WB07 ADAAG 4.17.6 ADA 2010 604.5 CBC 2010 1115B.4.1.3 CBC 2013 11B-604.5 Priority 3 Severity 3 TBD Contract Work	1	JOB	\$500	\$500
-----	---	---	---	-----	-------	--------------

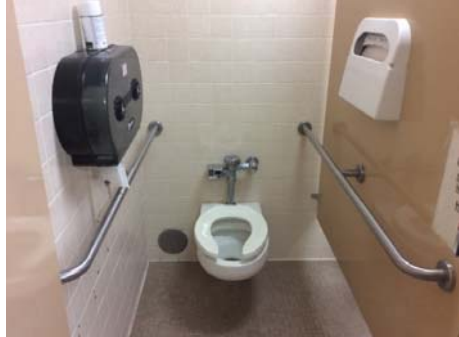
Item No. and Name	Existing Architectural Barrier and Proposed Solution	Codes / Mitigation Info	Qty	Unit	Cost	Total
<u>Toilet Stall</u>						
798	<ul style="list-style-type: none"> As-Built Description: Toilet stall less than 60" wide. As-Built: 39.5" Proposed Solution: Provide new accessible stall. Notes: WC: 19" o.c. 	PCODE WB06 ADAAG 4.17.3 ADA 2010 604.8.1.1 CBC 2010 1115B.3.1.4.1 CBC 2013 11B-604.8.1.1 Priority 3 Severity 2 TBD Contract Work	1	JOB	\$1,500	\$1,500

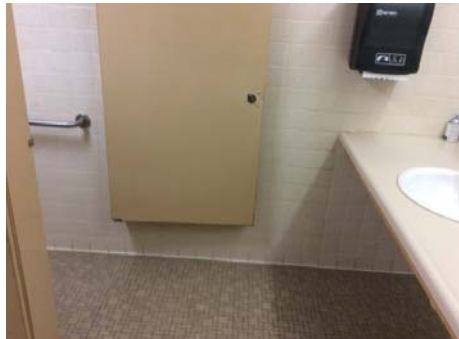
<u>Door Swing</u>						
828	<ul style="list-style-type: none"> As-Built Description: Front approach: At pull side, door does not have clear and level maneuvering space measuring door width plus 18" x 60". As-Built: Stall door: 46" to lav Proposed Solution: Provide relocated new door and frame; remodel as needed. 	PCODE ID23BNT ADAAG Fig. 25(a) ADA 2010 404.2.4 CBC 2010 11B-26A(a) CBC 2013 11B-404.2.4 Priority 3 Severity 3 TBD Contract Work	1	JOB	\$2,600	\$2,600

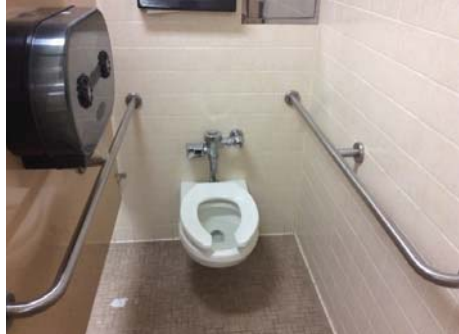
<u>Grab Bars</u>						
822	<ul style="list-style-type: none"> As-Built Description: Grab bars not provided or are not code compliant. Proposed Solution: Provide accessible grab bars. 	PCODE WB07 ADAAG 4.17.6 ADA 2010 604.5 CBC 2010 1115B.4.1.3 CBC 2013 11B-604.5 Priority 3 Severity 3 TBD Contract Work	1	JOB	\$500	\$500

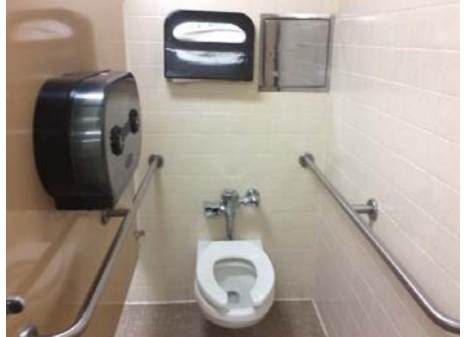
Item No. and Name	Existing Architectural Barrier and Proposed Solution	Codes / Mitigation Info	Qty	Unit	Cost	Total
<u>Toilet Stall</u>						
821	<ul style="list-style-type: none"> As-Built Description: Toilet stall less than 60" wide. As-Built: 38.5" Proposed Solution: Provide new accessible stall. 	PCODE WB06 ADAAG 4.17.3 ADA 2010 604.8.1.1 CBC 2010 1115B.3.1.4.1 CBC 2013 11B-604.8.1.1 Priority 3 Severity 1 TBD Contract Work	1	JOB	\$1,500	\$1,500

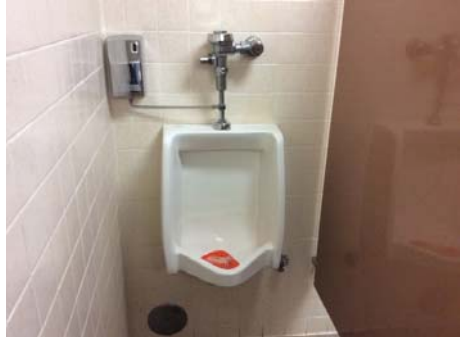
<u>Urinal</u>						
829	<ul style="list-style-type: none"> As-Built Description: Fixture mounted with rim more than 17" above floor. As-Built: 25" Proposed Solution: Provide accessible urinal. Remodel restroom as needed. 	PCODE WE02 ADAAG 4.18.2 ADA 2010 605.2 CBC 2010 1115B.4.2.1 CBC 2013 11B-605.2 Priority 3 Severity 2 TBD Contract Work	1	JOB	\$2,400	\$2,400

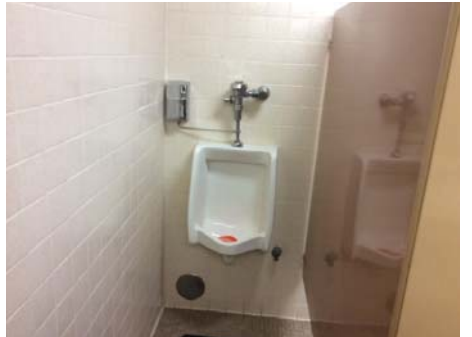
830	<ul style="list-style-type: none"> As-Built Description: 36" wide clearance in front of accessible urinal not provided when walls or partitions project more than 24" from the front edge of 30" x 48" clear space. As-Built: 32.5" wide 60" deep Proposed Solution: Provide 36" clear floor space in front of accessible urinal. Remodel restroom as needed. 	PCODE WE04A ADAAG 4.18.3 ADA 2010 605.3 CBC 2010 1115B.4.2.3 CBC 2013 11B-605.3 Priority 3 Severity 2 TBD Contract Work	1	JOB	\$1,500	\$1,500

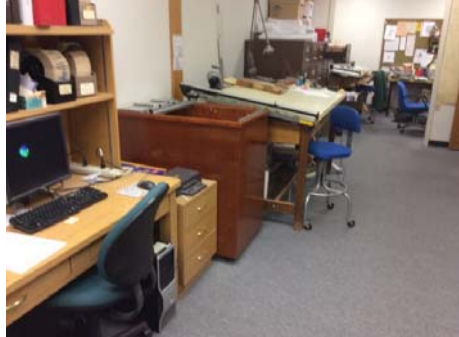
Item No. and Name	Existing Architectural Barrier and Proposed Solution	Codes / Mitigation Info	Qty	Unit	Cost	Total
<u>Non-Fixed Desk</u>						
816	<ul style="list-style-type: none"> <i>As-Built Description:</i> Accessible non-fixed table or desk (top 28" to 34" high; knee space at least 27" high x 19" deep x 30" wide) not provided. <i>As-Built:</i> PC: Knee 24" high Drafting table for viewing plans: Top: <i>Proposed Solution:</i> Provide table or desk with accessible dimensions when purchasing new furniture. 	PCODE IN02A ADAAG 4.32.3 & .4 ADA 2010 306.1 CBC 2010 1122B.3 & 4 CBC 2013 11B-306.1 & 11B-902.3 Priority 2 Severity 2 TBD Contract Work	1	JOB	\$1,600	\$1,600

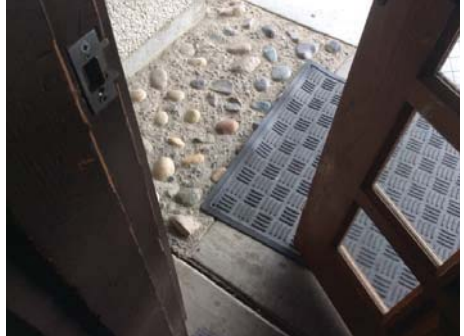
836	<ul style="list-style-type: none"> <i>As-Built Description:</i> Surface of required maneuvering clearance at door slopes more than 1/4":12" (2.0%). <i>As-Built:</i> 6" to irregular surface within DW + 24" at exterior door. <i>Proposed Solution:</i> Modify surface slope at door. 	PCODE ID11 ADAAG 4.13.6 ADA 2010 404.2.4.4 CBC 2010 1133B.2.4 CBC 2013 11B-404.2.4 Priority 2 Severity 1 TBD Contract Work	10	SF	\$40	\$400

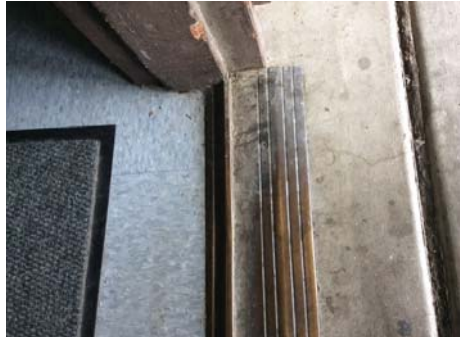
839	<ul style="list-style-type: none"> <i>As-Built Description:</i> Existing threshold at door is 1/2" high or less but without a beveled edge on both sides. <i>Proposed Solution:</i> Modify threshold to have beveled edge on each side. 	PCODE ID02 ADAAG 4.1.6(3)(d)(ii) ADA 2010 404.2.5 CBC 2010 1133B.2.4.1 CBC 2013 11B-404.2.5 Priority 2 Severity 4 TBD Contract Work	1	JOB	\$250	\$250

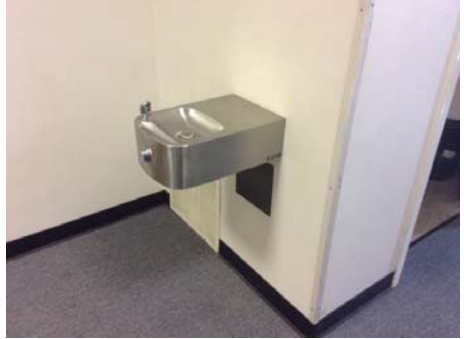
Item No. and Name	Existing Architectural Barrier and Proposed Solution	Codes / Mitigation Info	Qty	Unit	Cost	Total
<u>Drinking Fountain</u>						
841	<ul style="list-style-type: none"> <i>As-Built Description:</i> Where only one drinking fountain is provided per floor: Fountain is not accessible to individuals who use wheelchairs, or to those who have difficulty bending or stooping. <i>Proposed Solution:</i> Provide additional fountain or hi-lo combination fountain. 	PCODE IA01A ADAAG 4.1.3(10)(a) ADA 2010 211.1 CBC 2010 1115B.4.6.1 CBC 2013 11B-211.1 Priority 3 Severity 2 TBD Contract Work	1	JOB	\$2,000	\$2,000

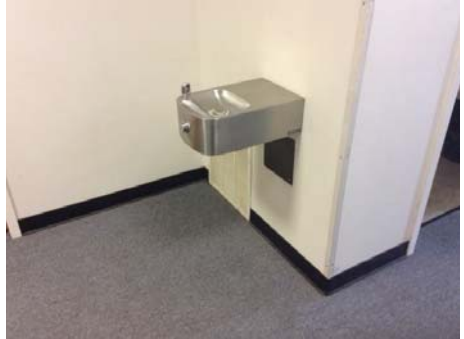
840	<ul style="list-style-type: none"> <i>As-Built Description:</i> CA only: Drinking fountain not located in an alcove (min. 32" wide x 18" deep) or otherwise encroaches into pedestrian way. <i>Proposed Solution:</i> Provide new alcove for drinking fountain, or, if unreasonable hardship is determined, provide wing walls or cane-detectable railings on each side of the drinking fountain. The wings must project out from the supporting wall at least as far as the drinking fountain to within 6" of the surface of the circulation path, but cannot reduce the required clear width of the adjacent accessible route. 	PCODE IA04 CBC 2010 1115B.4.6.3; Fig. CBC 2013 11B-602.9 Priority 3 Severity 2 TBD Contract Work	1	JOB	\$3,000	\$3,000

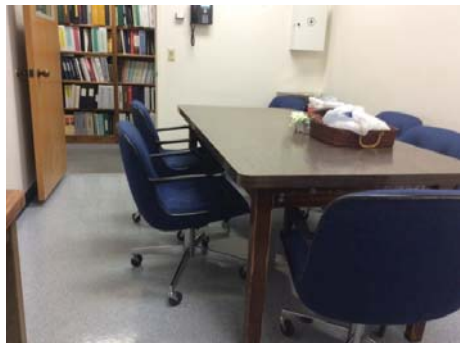
<u>Non-Fixed Desk</u>						
848	<ul style="list-style-type: none"> <i>As-Built Description:</i> Accessible non-fixed table or desk (top 28" to 34" high; knee space at least 27" high x 19" deep x 30" wide) not provided. <i>As-Built:</i> 24.75" <i>Proposed Solution:</i> Provide table or desk with accessible dimensions when purchasing new furniture. 	PCODE IN02A ADAAG 4.32.3 & .4 ADA 2010 306.1 CBC 2010 1122B.3 & 4 CBC 2013 11B-306.1 & 11B-902.3 Priority 4 Severity 2 TBD Contract Work	1	JOB	\$1,600	\$1,600

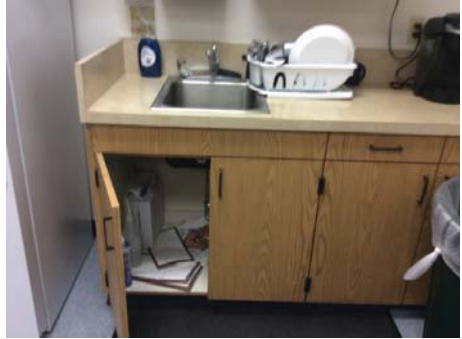
Item No. and Name	Existing Architectural Barrier and Proposed Solution	Codes / Mitigation Info	Qty	Unit	Cost	Total
Sink						
851	<ul style="list-style-type: none"> As-Built Description: Sink does not have knee space min. 27" high x 19" deep x 30" wide. Proposed Solution: Remodel sink cabinet. 	PCODE IN06AREF ADAAG 4.24.3 ADA 2010 606.2 CBC 2010 1115B.4.7.1 CBC 2013 11B-606.2 Priority 4 Severity 2 TBD Contract Work				
						REF

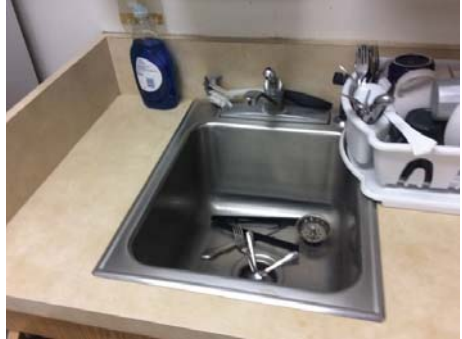
852	<ul style="list-style-type: none"> As-Built Description: Sink is more than 6 1/2" deep. As-Built: 10" Proposed Solution: Provide new sink remodel and cabinet as needed. 	PCODE IN06B ADAAG 4.24.4 CBC 2010 1115B.4.7.1 CBC 2013 11B-606.7 Priority 4 Severity 3 TBD Contract Work	1	JOB	\$1,850	\$1,850
						REF

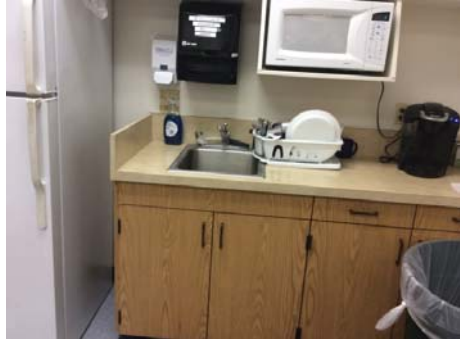
850	<ul style="list-style-type: none"> As-Built Description: Sink rim higher than 34" above floor. As-Built: 36" Proposed Solution: Remodel sink cabinet to lower sink. 	PCODE IN06REF ADAAG 4.24.2 ADA 2010 606.3 CBC 2010 1115B.4.7.1 CBC 2013 11B-606.3 Priority 4 Severity 4 TBD Contract Work

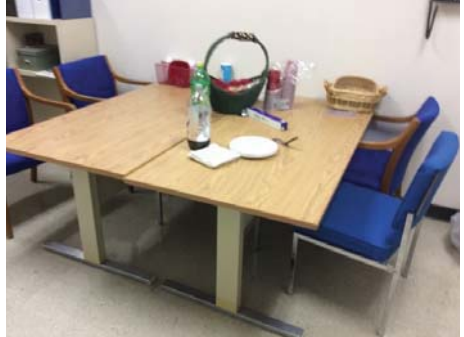
Item No. and Name	Existing Architectural Barrier and Proposed Solution	Codes / Mitigation Info	Qty	Unit	Cost	Total
<u>Non-Fixed Desk</u>						
868	<ul style="list-style-type: none"> <i>As-Built Description:</i> Accessible non-fixed table or desk (top 28" to 34" high; knee space at least 27" high x 19" deep x 30" wide) not provided. <i>As-Built:</i> 26" high knee, 15.5" deep <i>Proposed Solution:</i> Provide table or desk with accessible dimensions when purchasing new furniture. 	PCODE IN02A ADAAG 4.32.3 & .4 ADA 2010 306.1 CBC 2010 1122B.3 & 4 CBC 2013 11B-306.1 & 11B-902.3 Priority 4 Severity 2 TBD Contract Work	1	JOB	\$1,600	\$1,600

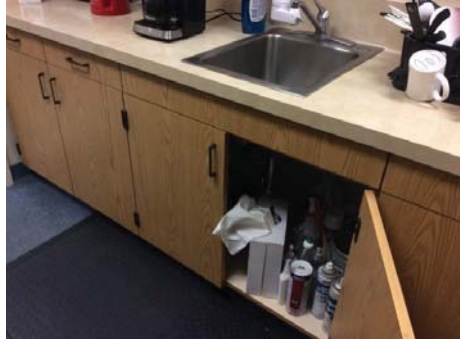
<u>Sink</u>						
864	<ul style="list-style-type: none"> <i>As-Built Description:</i> Sink does not have knee space min. 27" high x 19" deep x 30" wide. <i>Proposed Solution:</i> Remodel sink cabinet. 	PCODE IN06A ADAAG 4.24.3 ADA 2010 606.2 CBC 2010 1115B.4.7.1 CBC 2013 11B-606.2 Priority 4 Severity 2 TBD Contract Work	1	JOB	\$1,750	\$1,750

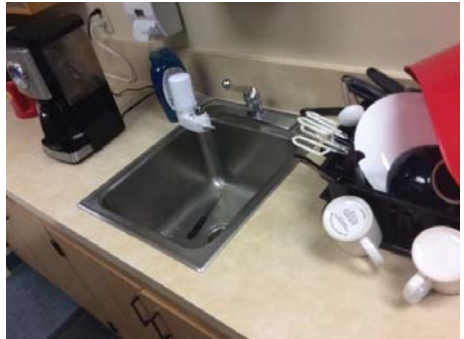
866	<ul style="list-style-type: none"> <i>As-Built Description:</i> Sink is more than 6 1/2" deep. <i>As-Built:</i> 10" <i>Proposed Solution:</i> Provide new sink remodel and cabinet as needed. 	PCODE IN06BREF ADAAG 4.24.4 CBC 2010 1115B.4.7.1 CBC 2013 11B-606.7 Priority 4 Severity 3 TBD Contract Work	REF

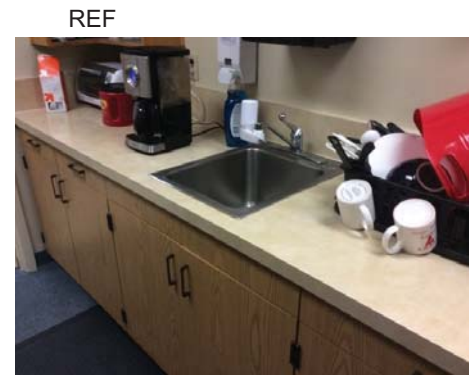
Item No. and Name	Existing Architectural Barrier and Proposed Solution	Codes / Mitigation Info	Qty	Unit	Cost	Total
865	<ul style="list-style-type: none"> As-Built Description: Sink rim higher than 34" above floor. Proposed Solution: Remodel sink cabinet to lower sink. 	PCODE IN06REF ADAAG 4.24.2 ADA 2010 606.3 CBC 2010 1115B.4.7.1 CBC 2013 11B-606.3 Priority 4 Severity 4 TBD Contract Work

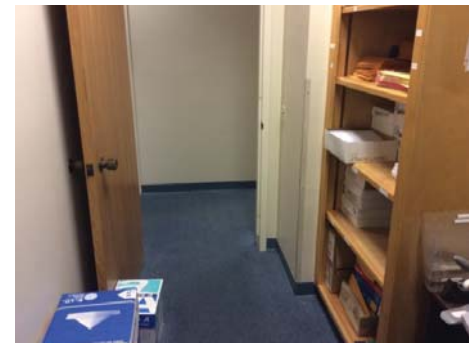
876	<ul style="list-style-type: none"> As-Built Description: Front approach: At push side, door does not have clear and level maneuvering space measuring door width x 48" (door width plus 12" if door has both, latch and closer). As-Built: 5" to wall Proposed Solution: Remove door. Notes: Remove door 	PCODE ID24 ADAAG Fig. 25(a) ADA 2010 404.2.4 CBC 2010 11B-26A(a) CBC 2013 11B-404.2.4 Priority 2 Severity 2 TBD Contract Work	1	JOB	\$500	\$500
-----	--	---	---	-----	-------	-------

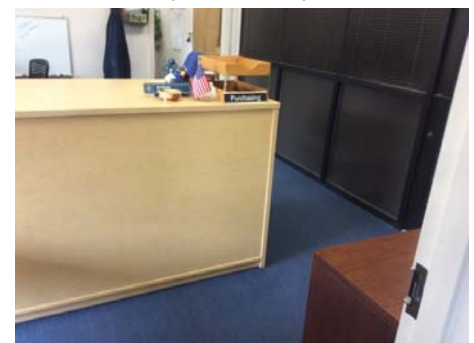
885	<ul style="list-style-type: none"> As-Built Description: Service counter (stand-up): Accessible section min. 36" length and 36" max. height (in CA: 28" to 34" high) not provided. As-Built: 42" Proposed Solution: Provide auxiliary shelf, clipboard, or table as equivalent facilitation. 	PCODE IN03 ADAAG 7.2(2) ADA 2010 904.4 CBC 2010 1122B.4 CBC 2013 11B-904.4 Priority 1 Severity 3 TBD Contract Work	1	JOB	\$150	\$150
-----	---	--	---	-----	-------	-------

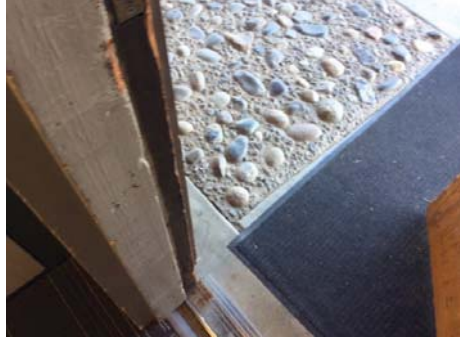
Item No. and Name	Existing Architectural Barrier and Proposed Solution	Codes / Mitigation Info	Qty	Unit	Cost	Total
Door						
903	<ul style="list-style-type: none"> <i>As-Built Description:</i> Surface of required maneuvering clearance at door slopes more than 1/4":12" (2.0%). <i>As-Built:</i> 3", irregular surface within DW + 24" at exterior door. <i>Proposed Solution:</i> Modify surface slope at door. 	PCODE ID11 ADAAG 4.13.6 ADA 2010 404.2.4.4 CBC 2010 1133B.2.4 CBC 2013 11B-404.2.4 Priority 2 Severity 1 TBD Contract Work	10	SF	\$40	\$400

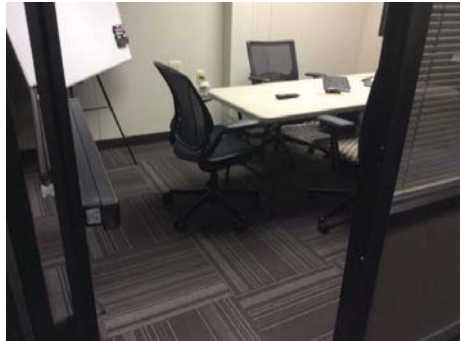
Door Clearance						
896	<ul style="list-style-type: none"> <i>As-Built Description:</i> Door on accessible route has less than 32" clear and 80" (78" min. to closer if provided) opening width when 90° open. <i>As-Built:</i> 31.5" <i>Proposed Solution:</i> Provide new, larger door and frame with new accessible hardware. 	PCODE ID01 ADAAG 4.13.5 ADA 2010 404.2.3 CBC 2010 1133B.1.1.1.1 CBC 2013 11B-404.2.3 Priority 3 Severity 3 TBD Contract Work	1	JOB	\$2,600	\$2,600

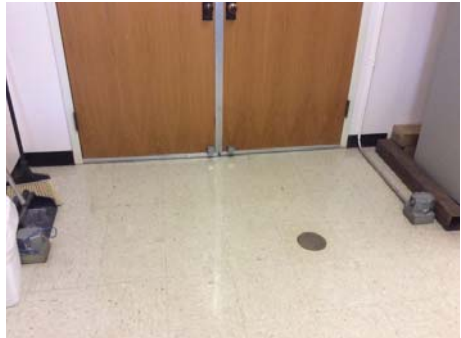
Door						
912	<ul style="list-style-type: none"> <i>As-Built Description:</i> Surface of required maneuvering clearance at door slopes more than 1/4":12" (2.0%). <i>As-Built:</i> 6.5% <i>Proposed Solution:</i> Modify surface slope at door. 	PCODE ID11 ADAAG 4.13.6 ADA 2010 404.2.4.4 CBC 2010 1133B.2.4 CBC 2013 11B-404.2.4 Priority 2 Severity 3 TBD Contract Work	60	SF	\$40	\$2,400

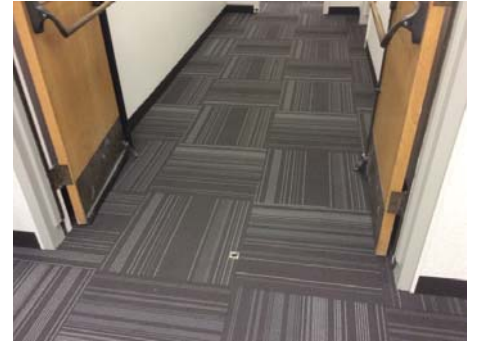
Item No. and Name	Existing Architectural Barrier and Proposed Solution	Codes / Mitigation Info	Qty	Unit	Cost	Total
920	<ul style="list-style-type: none"> <i>As-Built Description:</i> Surface of required maneuvering clearance at door slopes more than 1/4":12" (2.0%). <i>As-Built:</i> 4.2% <i>Proposed Solution:</i> Modify surface slope at door. 	PCODE ID11 ADAAG 4.13.6 ADA 2010 404.2.4.4 CBC 2010 1133B.2.4 CBC 2013 11B-404.2.4 Priority 2 Severity 3 TBD Contract Work	60	SF	\$40	\$2,400

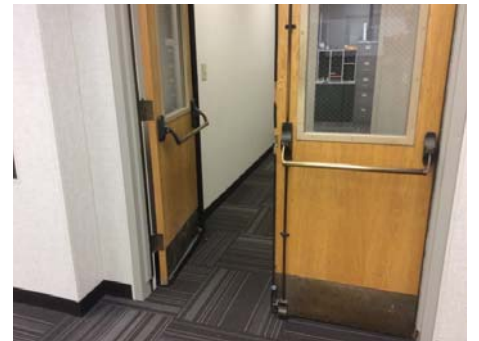
921	<ul style="list-style-type: none"> <i>As-Built Description:</i> Pair of doors on accessible route has less than 32" clear opening width with one leaf open 90°. <i>As-Built:</i> 28" <i>Proposed Solution:</i> Provide new door leaves, unequal in width, to existing frame for pair of doors. 	PCODE ID08A ADAAG 4.13.4 ADA 2010 404.2.2 CBC 2010 1133B.2.3.1 CBC 2013 11B-404.2.2 Priority 2 Severity 2 TBD Contract Work	1	JOB	\$1,500	\$1,500
-----	---	--	---	-----	---------	---------

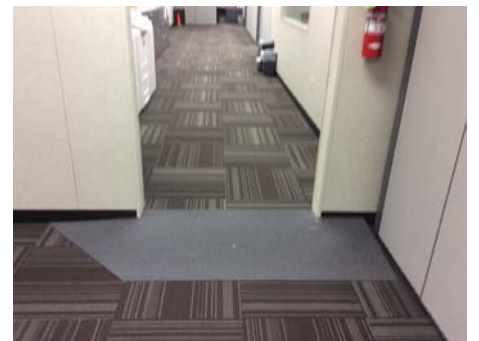
905	<ul style="list-style-type: none"> <i>As-Built Description:</i> Walk: Slope greater than 1:20 (5.0%), and walk does not comply with requirements for ramps. <i>As-Built:</i> 7.8% <i>Proposed Solution:</i> Modify walk/sidewalk slope to 1:20 or less. 	PCODE EF01 ADAAG 4.3.7 ADA 2010 403.3 CBC 2010 1133B.7.3 CBC 2013 11B-403.3 Priority 2 Severity 4 TBD Contract Work	20	SF	\$25	\$500
-----	--	--	----	----	------	-------

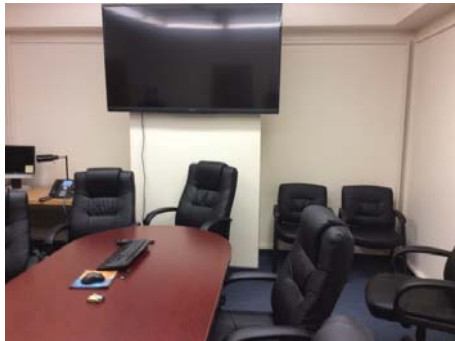
Item No. and Name	Existing Architectural Barrier and Proposed Solution	Codes / Mitigation Info	Qty	Unit	Cost	Total
<u>Assistive Listening</u>						
931	<ul style="list-style-type: none"> <i>As-Built Description:</i> No portable assistive listening system provided for small meeting room. <i>Proposed Solution:</i> Share existing portable assistive listening system from other facility if needed. 	PCODE GI01E ADAAG 4.1.3(19)(b) & 4.33.7 ADA 2010 219.1 & 706.1 CBC 2010 1104B.2 CBC 2013 11B-219.2 Priority 3 Severity 3 TBD Contract Work				
						REF

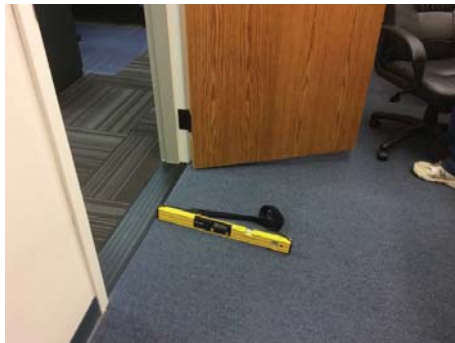
<u>Door</u>						
924	<ul style="list-style-type: none"> <i>As-Built Description:</i> Surface of required maneuvering clearance at door slopes more than 1/4":12" (2.0%). <i>As-Built:</i> 8.3% <i>Proposed Solution:</i> Modify surface slope at door. 	PCODE ID11 ADAAG 4.13.6 ADA 2010 404.2.4.4 CBC 2010 1133B.2.4 CBC 2013 11B-404.2.4 Priority 2 Severity 2 TBD Contract Work	60	SF	\$40	\$2,400

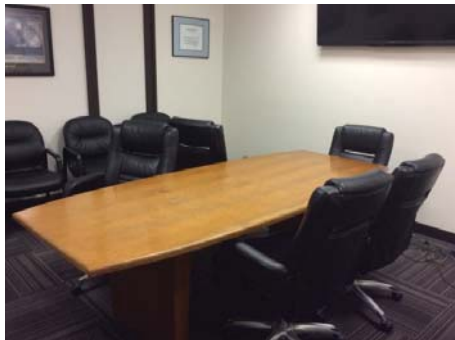
<u>Assistive Listening</u>						
936	<ul style="list-style-type: none"> <i>As-Built Description:</i> No portable assistive listening system provided for small meeting room. <i>Proposed Solution:</i> Share existing portable assistive listening system from other facility if needed. 	PCODE GI01E ADAAG 4.1.3(19)(b) & 4.33.7 ADA 2010 219.1 & 706.1 CBC 2010 1104B.2 CBC 2013 11B-219.2 Priority 3 Severity 3 TBD Contract Work				
						REF

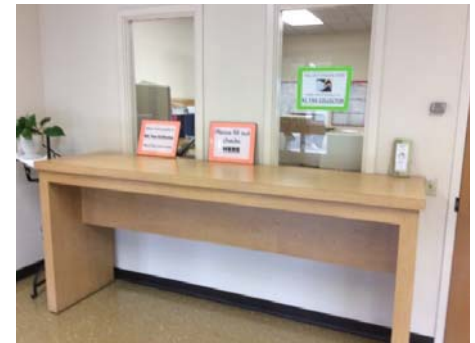
577	<ul style="list-style-type: none"> <i>As-Built Description:</i> Accessible fixed table or desk (top 28" to 34" high; knee space at least 27" high x 19" deep x 30" wide) not provided. <i>As-Built:</i> Top: 43.5" <i>Proposed Solution:</i> Provide new fixed accessible table or desk. 	<p>PCODE IN02 ADAAG 4.32.3 & .4 ADA 2010 306.1 CBC 2010 1122B.3 & 4 CBC 2013 11B-306.1 Priority 2 Severity 3 TBD Contract Work</p>	1	JOB	\$2,500	\$2,500
-----	---	--	---	-----	---------	----------------

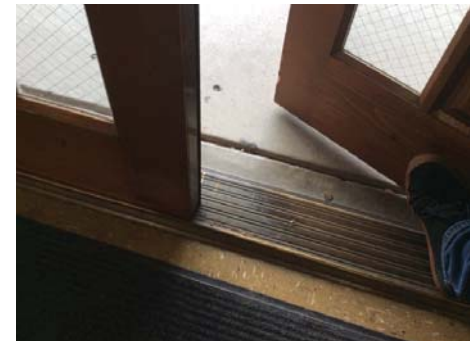
575	<ul style="list-style-type: none"> <i>As-Built Description:</i> Door inaccessible due to threshold or step at door exceeding 1/2". <i>As-Built:</i> 0.75" <i>Proposed Solution:</i> Modify threshold to be no more than 1/2" by removing existing paving at door and providing landing with edge ramping (slope 1:20 max). 	<p>PCODE ID02A ADAAG 4.13.8 ADA 2010 404.2.5 CBC 2010 1133B.2.4.1 CBC 2013 11B-404.2.5 Priority 1 Severity 4 TBD Contract Work</p>	2	JOB	\$400	\$800
-----	---	--	---	-----	-------	--------------

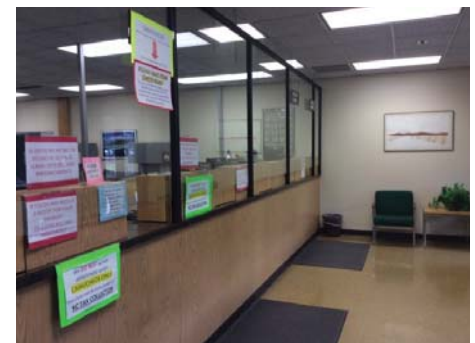
576	<ul style="list-style-type: none"> <i>As-Built Description:</i> Service counter (stand-up): Accessible section min. 36" length and 36" max. height (in CA: 28" to 34" high) not provided. <i>As-Built:</i> 42.25" <i>Proposed Solution:</i> Provide auxiliary shelf, clipboard, or table as equivalent facilitation. 	<p>PCODE IN03 ADAAG 7.2(2) ADA 2010 904.4 CBC 2010 1122B.4 CBC 2013 11B-904.4 Priority 1 Severity 3 TBD Contract Work</p>	1	JOB	\$150	\$150
-----	---	---	---	-----	-------	--------------

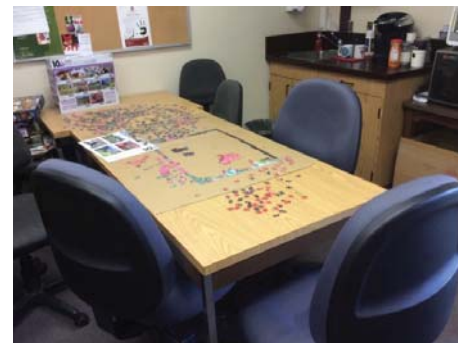
- 597
- *As-Built Description:*
Accessible non-fixed table or desk (top 28" to 34" high; knee space at least 27" high x 19" deep x 30" wide) not provided.
 - *As-Built:* 26"
 - *Proposed Solution:*
Provide table or desk with accessible dimensions when purchasing new furniture.

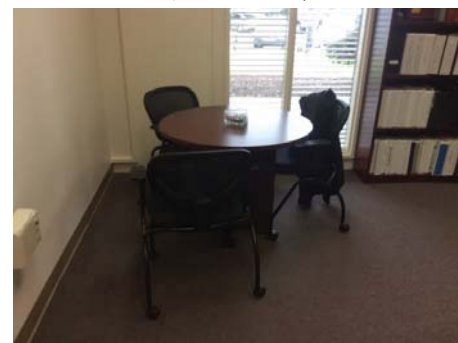
- 599
- *As-Built Description:*
Accessible non-fixed table or desk (top 28" to 34" high; knee space at least 27" high x 19" deep x 30" wide) not provided.
 - *As-Built:* Due to table legs
 - *Proposed Solution:*
Provide table or desk with accessible dimensions when purchasing new furniture.

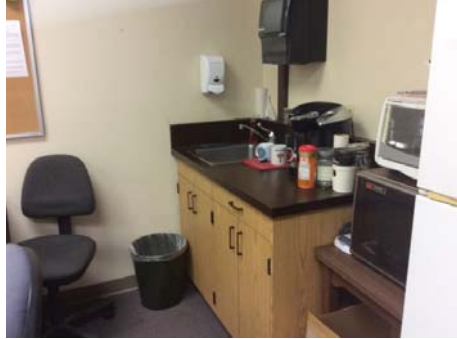
Item No. and Name	Existing Architectural Barrier and Proposed Solution	Codes / Mitigation Info	Qty	Unit	Cost	Total
Sink						
593	<ul style="list-style-type: none"> As-Built Description: Sink does not have knee space min. 27" high x 19" deep x 30" wide. Proposed Solution: Remodel sink cabinet. 	PCODE IN06A ADAAG 4.24.3 ADA 2010 606.2 CBC 2010 1115B.4.7.1 CBC 2013 11B-606.2 Priority 4 Severity 2 TBD Contract Work	1	JOB	\$1,750	\$1,750

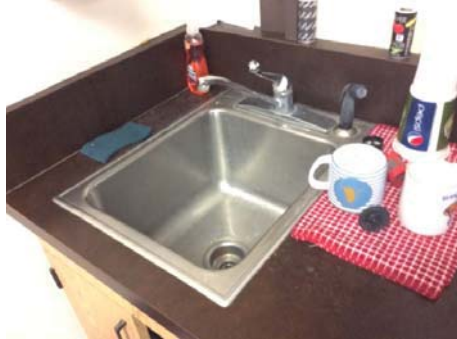
595	<ul style="list-style-type: none"> As-Built Description: Sink is more than 6 1/2" deep. As-Built: 10" Proposed Solution: Provide new sink remodel and cabinet as needed. 	PCODE IN06BREF ADAAG 4.24.4 CBC 2010 1115B.4.7.1 CBC 2013 11B-606.7 Priority 4 Severity 3 TBD Contract Work	REF

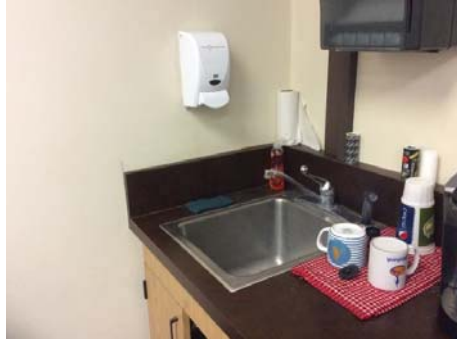
594	<ul style="list-style-type: none"> As-Built Description: Sink rim higher than 34" above floor. Proposed Solution: Remodel sink cabinet to lower sink. 	PCODE IN06REF ADAAG 4.24.2 ADA 2010 606.3 CBC 2010 1115B.4.7.1 CBC 2013 11B-606.3 Priority 4 Severity 4 TBD Contract Work	REF

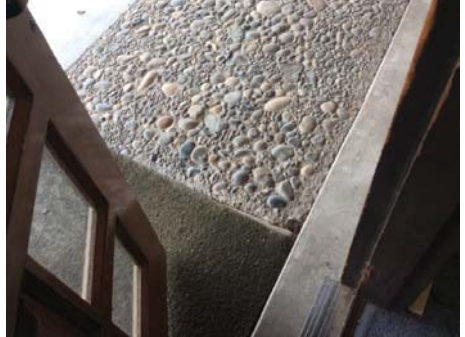
Item No. and Name	Existing Architectural Barrier and Proposed Solution	Codes / Mitigation Info	Qty	Unit	Cost	Total
Door						
602	<ul style="list-style-type: none"> <i>As-Built Description:</i> Surface of required maneuvering clearance at door slopes more than 1/4":12" (2.0%). <i>As-Built:</i> 3.5", irregular surface within DW + 24" at exterior door. <i>Proposed Solution:</i> Modify surface slope at door to provide accessible clear space at door. <i>Notes:</i> Staff Only 	PCODE ID11 ADAAG 4.13.6 ADA 2010 404.2.4.4 CBC 2010 1133B.2.4 CBC 2013 11B-404.2.4 Priority 4 Severity 1 TBD Contract Work	10	SF	\$40	\$400

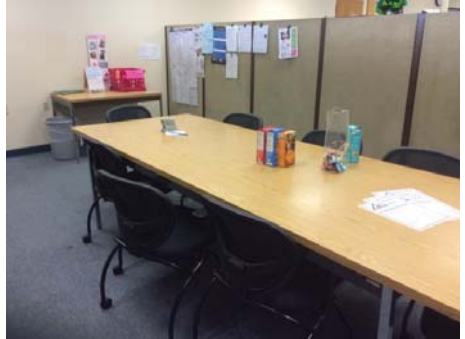
Non-Fixed Desk						
604	<ul style="list-style-type: none"> <i>As-Built Description:</i> Accessible non-fixed table or desk (top 28" to 34" high; knee space at least 27" high x 19" deep x 30" wide) not provided. <i>As-Built:</i> 26.5" <i>Proposed Solution:</i> Provide table or desk with accessible dimensions when purchasing new furniture. 	PCODE IN02A ADAAG 4.32.3 & .4 ADA 2010 306.1 CBC 2010 1122B.3 & 4 CBC 2013 11B-306.1 & 11B-902.3 Priority 2 Severity 2 TBD Contract Work	1	JOB	\$1,600	\$1,600

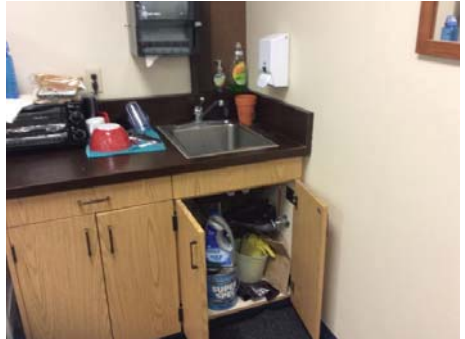
Sink						
605	<ul style="list-style-type: none"> <i>As-Built Description:</i> Sink does not have knee space min. 27" high x 19" deep x 30" wide. <i>Proposed Solution:</i> Remodel sink cabinet. 	PCODE IN06A ADAAG 4.24.3 ADA 2010 606.2 CBC 2010 1115B.4.7.1 CBC 2013 11B-606.2 Priority 2 Severity 2 TBD Contract Work	1	JOB	\$1,750	\$1,750

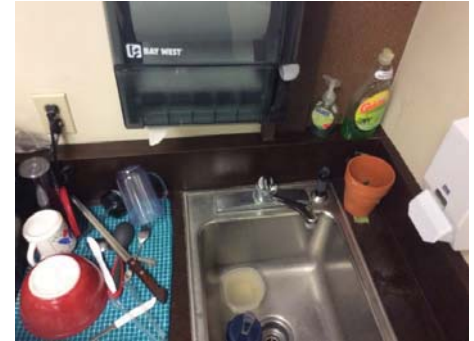
Item No. and Name	Existing Architectural Barrier and Proposed Solution	Codes / Mitigation Info	Qty	Unit	Cost	Total
607	<ul style="list-style-type: none"> As-Built Description: Sink is more than 6 1/2" deep. As-Built: 10" Proposed Solution: Provide new sink remodel and cabinet as needed. 	<p>PCODE IN06B ADAAG 4.24.4 CBC 2010 1115B.4.7.1 CBC 2013 11B-606.7 Priority 2 Severity 3 TBD Contract Work</p>	1	JOB	\$1,850	\$1,850

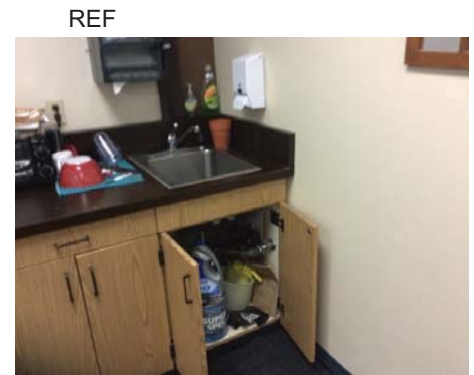
606	<ul style="list-style-type: none"> As-Built Description: Sink rim higher than 34" above floor. As-Built: 36" Proposed Solution: Remodel sink cabinet to lower sink. 	<p>PCODE IN06REF ADAAG 4.24.2 ADA 2010 606.3 CBC 2010 1115B.4.7.1 CBC 2013 11B-606.3 Priority 2 Severity 4 TBD Contract Work</p>				
-----	--	--	--	--	--	--

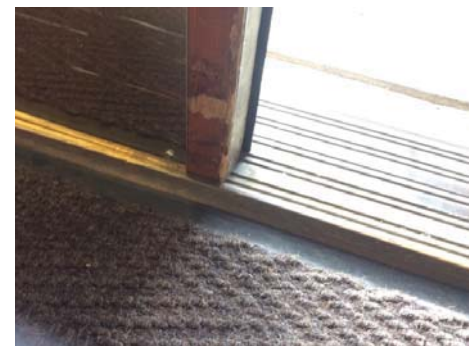
614	<ul style="list-style-type: none"> As-Built Description: Door inaccessible due to threshold or step at door exceeding 1/2". As-Built: 0.75" Proposed Solution: Modify threshold to be no more than 1/2" by removing existing paving at door and providing landing with edge ramping (slope 1:20 max). 	<p>PCODE ID02A ADAAG 4.13.8 ADA 2010 404.2.5 CBC 2010 1133B.2.4.1 CBC 2013 11B-404.2.5 Priority 1 Severity 4 TBD Contract Work</p>	1	JOB	\$400	\$400
-----	--	--	---	-----	-------	-------

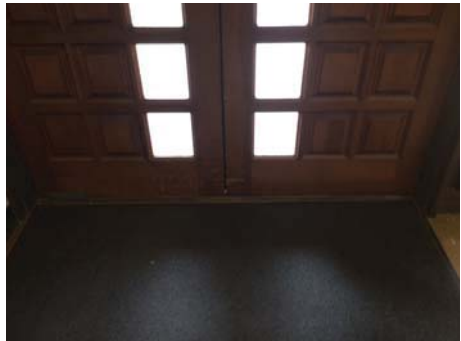
Item No. and Name	Existing Architectural Barrier and Proposed Solution	Codes / Mitigation Info	Qty	Unit	Cost	Total
<u>Door Threshold</u>						
619	<ul style="list-style-type: none"> <i>As-Built Description:</i> Door inaccessible due to threshold or step at door exceeding 1/2". <i>As-Built:</i> 0.75" <i>Proposed Solution:</i> Modify threshold to be no more than 1/2" by removing existing paving at door and providing landing with edge ramping (slope 1:20 max). 	PCODE ID02A ADAAG 4.13.8 ADA 2010 404.2.5 CBC 2010 1133B.2.4.1 CBC 2013 11B-404.2.5 Priority 1 Severity 4 TBD Contract Work	1	JOB	\$400	\$400

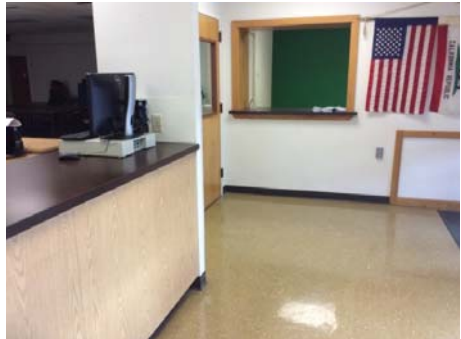
<u>Public Counter</u>						
625	<ul style="list-style-type: none"> <i>As-Built Description:</i> Service counter (stand-up): Accessible section min. 36" length and 36" max. height (in CA: 28" to 34" high) not provided. <i>As-Built:</i> 42.25" AFF <i>Proposed Solution:</i> Provide auxiliary shelf, clipboard, or table as equivalent facilitation. <i>Notes:</i> To be remodeled 	PCODE IN03 ADAAG 7.2(2) ADA 2010 904.4 CBC 2010 1122B.4 CBC 2013 11B-904.4 Priority 1 Severity 3 TBD Contract Work	1	JOB	\$150	\$150

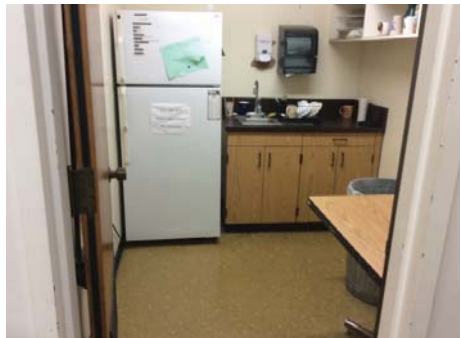
8 Elections Staff Break Room

<u>Door Clearance</u>						
637	<ul style="list-style-type: none"> <i>As-Built Description:</i> Door on accessible route has less than 32" clear and 80" (78" min. to closer if provided) opening width when 90° open. <i>As-Built:</i> 29" clear <i>Proposed Solution:</i> Provide new, larger door and frame with new accessible hardware. 	PCODE ID01 ADAAG 4.13.5 ADA 2010 404.2.3 CBC 2010 1133B.1.1.1.1 CBC 2013 11B-404.2.3 Priority 4 Severity 3 TBD Contract Work	1	JOB	\$2,600	\$2,600

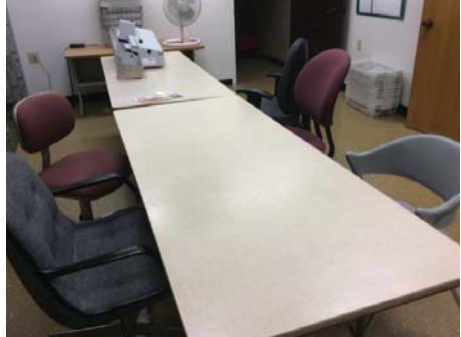
Item No. and Name	Existing Architectural Barrier and Proposed Solution	Codes / Mitigation Info	Qty	Unit	Cost	Total
<u>Non-Fixed Desk</u>						
635	<ul style="list-style-type: none"> • <i>As-Built Description:</i> Accessible non-fixed table or desk (top 28" to 34" high; knee space at least 27" high x 19" deep x 30" wide) not provided. • <i>As-Built:</i> 26.5" • <i>Proposed Solution:</i> Provide table or desk with accessible dimensions when purchasing new furniture. 	PCODE IN02A ADAAG 4.32.3 & .4 ADA 2010 306.1 CBC 2010 1122B.3 & 4 CBC 2013 11B-306.1 & 11B-902.3 Priority 4 Severity 2 TBD Contract Work	1	JOB	\$1,600	\$1,600

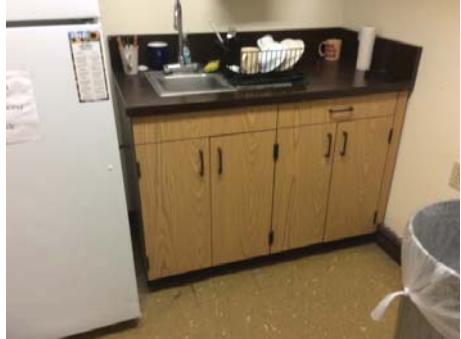
<u>Sink</u>						
639	<ul style="list-style-type: none"> • <i>As-Built Description:</i> Sink does not have knee space min. 27" high x 19" deep x 30" wide. • <i>Proposed Solution:</i> Remodel sink cabinet. 	PCODE IN06A ADAAG 4.24.3 ADA 2010 606.2 CBC 2010 1115B.4.7.1 CBC 2013 11B-606.2 Priority 4 Severity 2 TBD Contract Work	1	JOB	\$1,750	\$1,750

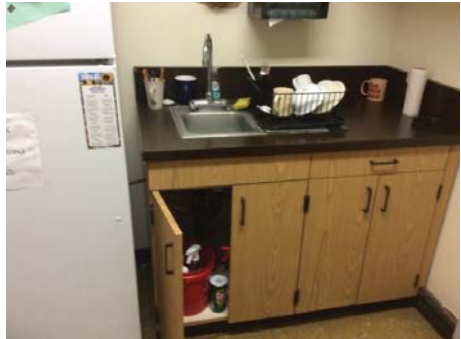
640	<ul style="list-style-type: none"> • <i>As-Built Description:</i> Sink rim higher than 34" above floor. • <i>As-Built:</i> 36" • <i>Proposed Solution:</i> Remodel sink cabinet to lower sink. 	PCODE IN06REF ADAAG 4.24.2 ADA 2010 606.3 CBC 2010 1115B.4.7.1 CBC 2013 11B-606.3 Priority 4 Severity 4 TBD Contract Work	REF

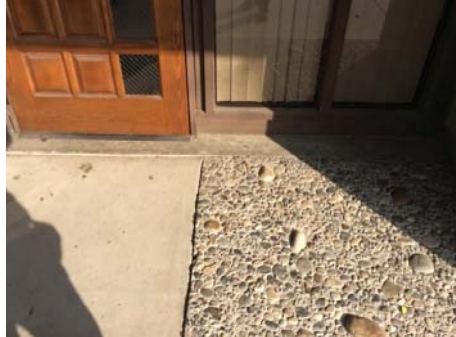
9 Courtesy Room

Item No. and Name	Existing Architectural Barrier and Proposed Solution	Codes / Mitigation Info	Qty	Unit	Cost	Total
<u>Door</u>						
642	<ul style="list-style-type: none"> <i>As-Built Description:</i> Surface of required maneuvering clearance at door slopes more than 1/4":12" (2.0%). <i>As-Built:</i> 3", irregular surface within DW + 24" at exterior door. <i>Proposed Solution:</i> Modify surface slope at door. 	PCODE ID11 ADAAG 4.13.6 ADA 2010 404.2.4.4 CBC 2010 1133B.2.4 CBC 2013 11B-404.2.4 Priority 2 Severity 1 TBD Contract Work	10	SF	\$40	\$400

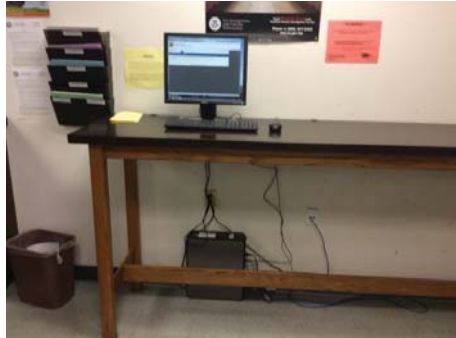
10 Assessor Lobby

<u>Desk</u>						
648	<ul style="list-style-type: none"> <i>As-Built Description:</i> Accessible fixed table or desk (top 28" to 34" high; knee space at least 27" high x 19" deep x 30" wide) not provided. <i>As-Built:</i> 43.5" top at PC station <i>Proposed Solution:</i> Provide new fixed accessible table or desk. 	PCODE IN02 ADAAG 4.32.3 & .4 ADA 2010 306.1 CBC 2010 1122B.3 & 4 CBC 2013 11B-306.1 Priority 2 Severity 3 TBD Contract Work	1	JOB	\$2,500	\$2,500

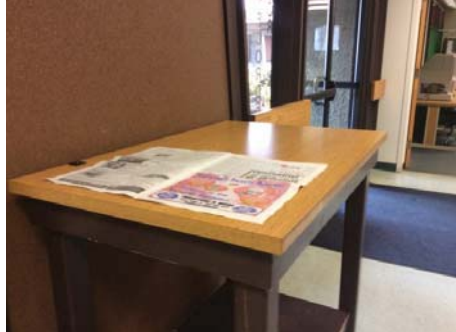
<u>Non-Fixed Desk</u>						
652	<ul style="list-style-type: none"> <i>As-Built Description:</i> Accessible non-fixed table or desk (top 28" to 34" high; knee space at least 27" high x 19" deep x 30" wide) not provided. <i>As-Built:</i> 41.5" work table <i>Proposed Solution:</i> Provide table or desk with accessible dimensions when purchasing new furniture. 	PCODE IN02A ADAAG 4.32.3 & .4 ADA 2010 306.1 CBC 2010 1122B.3 & 4 CBC 2013 11B-306.1 & 11B-902.3 Priority 2 Severity 2 TBD Contract Work	1	JOB	\$1,600	\$1,600

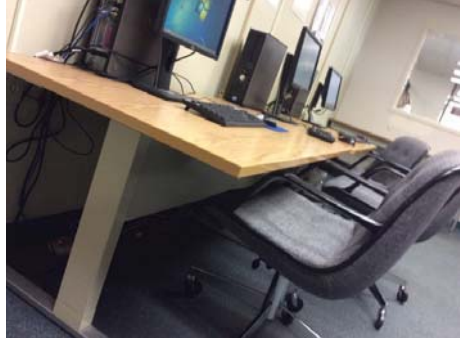
11 Records Room

Item No. and Name	Existing Architectural Barrier and Proposed Solution	Codes / Mitigation Info	Qty	Unit	Cost	Total
<u>Non-Fixed Desk</u>						
653	<ul style="list-style-type: none"> <i>As-Built Description:</i> Accessible non-fixed table or desk (top 28" to 34" high; knee space at least 27" high x 19" deep x 30" wide) not provided. <i>As-Built:</i> 25.5" high knee. 15" deep <i>Proposed Solution:</i> Provide table or desk with accessible dimensions when purchasing new furniture. 	PCODE IN02A ADAAG 4.32.3 & .4 ADA 2010 306.1 CBC 2010 1122B.3 & 4 CBC 2013 11B-306.1 & 11B-902.3 Priority 2 Severity 2 TBD Contract Work	1	JOB	\$1,600	\$1,600

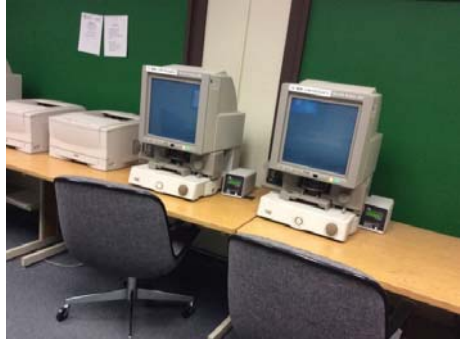
654	<ul style="list-style-type: none"> <i>As-Built Description:</i> Accessible non-fixed table or desk (top 28" to 34" high; knee space at least 27" high x 19" deep x 30" wide) not provided. <i>As-Built:</i> Microfilm stations 25.75" high knee space <i>Proposed Solution:</i> Provide table or desk with accessible dimensions when purchasing new furniture. 	PCODE IN02A ADAAG 4.32.3 & .4 ADA 2010 306.1 CBC 2010 1122B.3 & 4 CBC 2013 11B-306.1 & 11B-902.3 Priority 2 Severity 2 TBD Contract Work	1	JOB	\$1,600	\$1,600

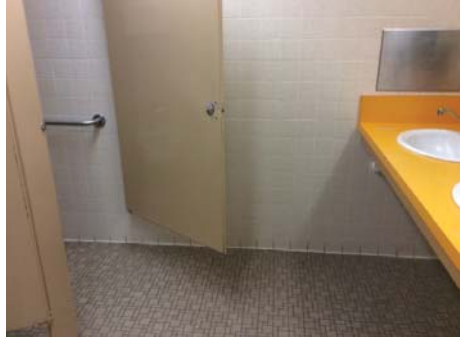
13 Staff Men's Restroom

676	<ul style="list-style-type: none"> <i>As-Built Description:</i> Front approach: At pull side, door does not have clear and level maneuvering space measuring door width plus 18" x 60". <i>As-Built:</i> 52" to lav <i>Proposed Solution:</i> Provide relocated new door and frame; remodel as needed. 	PCODE ID23BNT ADAAG Fig. 25(a) ADA 2010 404.2.4 CBC 2010 11B-26A(a) CBC 2013 11B-404.2.4 Priority 4 Severity 3 TBD Contract Work	1	JOB	\$2,600	\$2,600

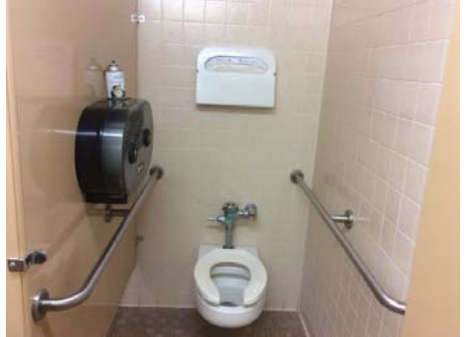
Item No. and Name	Existing Architectural Barrier and Proposed Solution	Codes / Mitigation Info	Qty	Unit	Cost	Total
<u>Grab Bars</u>						
678	<ul style="list-style-type: none"> As-Built Description: Grab bars not provided or are not code compliant. Proposed Solution: Provide accessible grab bars. 	PCODE WB07 ADAAG 4.17.6 ADA 2010 604.5 CBC 2010 1115B.4.1.3 CBC 2013 11B-604.5 Priority 4 Severity 3 TBD Contract Work	1	JOB	\$500	\$500

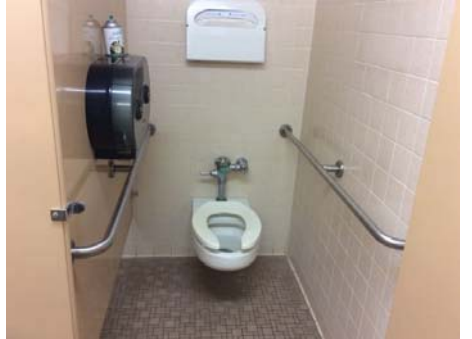
<u>Toilet Stall</u>						
677	<ul style="list-style-type: none"> As-Built Description: Toilet stall less than 60" wide. As-Built: 52" Proposed Solution: Provide new accessible stall. Notes: WC 18" o.c. 	PCODE WB06 ADAAG 4.17.3 ADA 2010 604.8.1.1 CBC 2010 1115B.3.1.4.1 CBC 2013 11B-604.8.1.1 Priority 4 Severity 3 TBD Contract Work	1	JOB	\$1,500	\$1,500

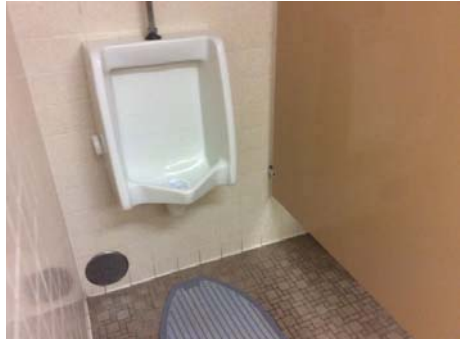
<u>Urinal</u>						
696	<ul style="list-style-type: none"> As-Built Description: Front of rim projects less than 13.5" from wall. As-Built: 12" Proposed Solution: Provide accessible urinal. Remodel restroom as needed. 	PCODE WE01 ADA 2010 605.2 CBC 2010 1115B.4.2.1 CBC 2013 11B-605.2 Priority 4 Severity 4 TBD Contract Work	1	JOB	\$4,000	\$4,000

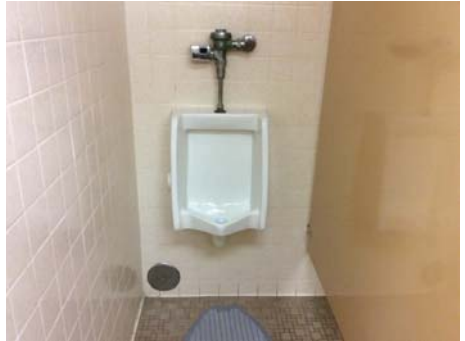
Item No. and Name	Existing Architectural Barrier and Proposed Solution	Codes / Mitigation Info	Qty	Unit	Cost	Total
695	<ul style="list-style-type: none"> • <i>As-Built Description:</i> Fixture mounted with rim more than 17" above floor. • <i>As-Built:</i> 24" • <i>Proposed Solution:</i> Provide accessible urinal. Remodel restroom as needed. 	<p>PCODE WE02 ADAAG 4.18.2 ADA 2010 605.2 CBC 2010 1115B.4.2.1 CBC 2013 11B-605.2 Priority 4 Severity 2 TBD Contract Work</p>	1	JOB	\$2,400	\$2,400

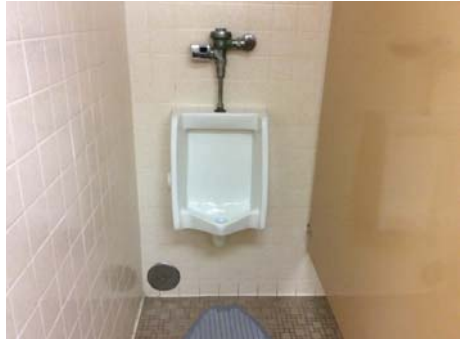
697	<ul style="list-style-type: none"> • <i>As-Built Description:</i> 36" wide clearance in front of accessible urinal not provided when walls or partitions project more than 24" from the front edge of 30" x 48" clear space. • <i>As-Built:</i> 35"@60" deep • <i>Proposed Solution:</i> Provide 36" clear floor space in front of accessible urinal. Remodel restroom as needed. 	<p>PCODE WE04A ADAAG 4.18.3 ADA 2010 605.3 CBC 2010 1115B.4.2.3 CBC 2013 11B-605.3 Priority 4 Severity 2 TBD Contract Work</p>	1	JOB	\$1,500	\$1,500

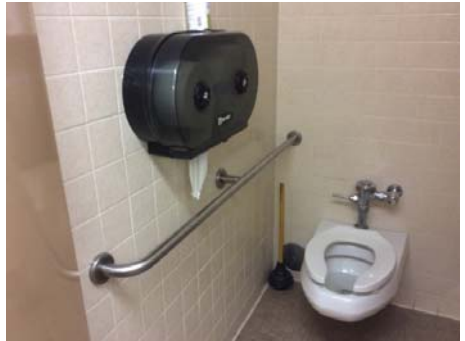
14 Staff Women's Restroom

692	<ul style="list-style-type: none"> • <i>As-Built Description:</i> Grab bars not provided or are not code compliant. • <i>Proposed Solution:</i> Provide accessible grab bars. 	<p>PCODE WB07 ADAAG 4.17.6 ADA 2010 604.5 CBC 2010 1115B.4.1.3 CBC 2013 11B-604.5 Priority 4 Severity 3 TBD Contract Work</p>	1	JOB	\$500	\$500

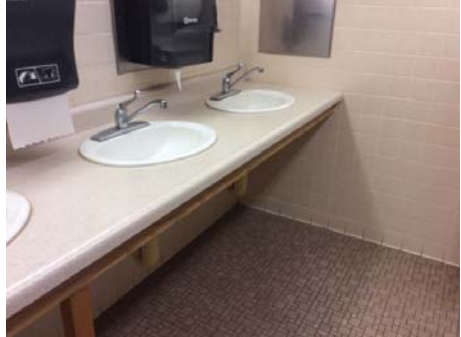
Item No. and Name	Existing Architectural Barrier and Proposed Solution	Codes / Mitigation Info	Qty	Unit	Cost	Total
<u>Lavatory</u>						
686	<ul style="list-style-type: none"> As-Built Description: Lavatory: Fixture rim or counter height more than 34" above floor. As-Built: 34.5" Proposed Solution: Remount compliant fixture at accessible height. 	PCODE WD02A ADAAG 4.19.2 ADA 2010 606.3 CBC 2010 1115B.4.3 CBC 2013 11B-606.3 Priority 4 Severity 4 TBD Contract Work	1	JOB	\$900	\$900

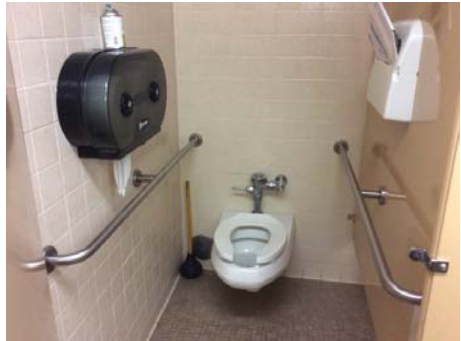
<u>Toilet Stall</u>						
691	<ul style="list-style-type: none"> As-Built Description: Toilet stall less than 60" wide. As-Built: 39" Proposed Solution: Provide new accessible stall. 	PCODE WB06 ADAAG 4.17.3 ADA 2010 604.8.1.1 CBC 2010 1115B.3.1.4.1 CBC 2013 11B-604.8.1.1 Priority 4 Severity 2 TBD Contract Work	1	JOB	\$1,500	\$1,500

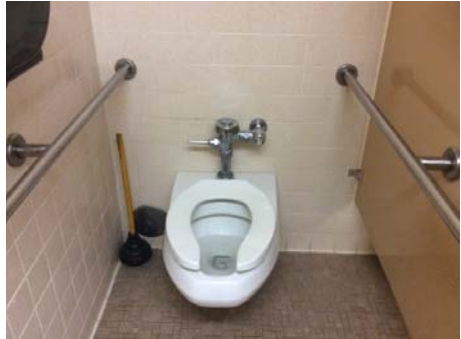
<u>Water Closet</u>						
694	<ul style="list-style-type: none"> As-Built Description: Flush Control: Operating handle not mounted toward wide side of stall. Proposed Solution: Replace flush control with properly mounted accessible type, or install sensor flush. Notes: WC 18" o.c. 	PCODE WB10 ADAAG 4.16.5 ADA 2010 604.6 CBC 2010 1115B.4.1.5 CBC 2013 11B-604.6 Priority 4 Severity 3 TBD Contract Work	1	JOB	\$500	\$500

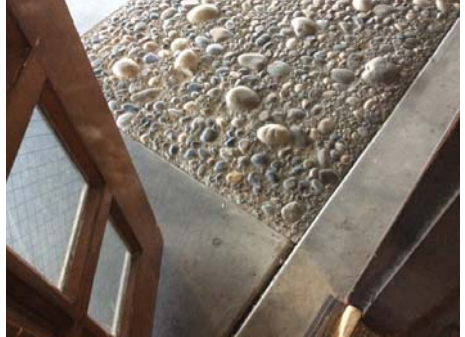
15 Assessors Office - Staff

Item No. and Name	Existing Architectural Barrier and Proposed Solution	Codes / Mitigation Info	Qty	Unit	Cost	Total
<u>Door</u>						
714	<ul style="list-style-type: none"> • <i>As-Built Description:</i> Surface of required maneuvering clearance at door slopes more than 1/4":12" (2.0%). • <i>As-Built:</i> 3", irregular surface within DW + 24" at exterior door. • <i>Proposed Solution:</i> Modify surface slope at door. 	PCODE ID11NT ADAAG 4.13.6 ADA 2010 404.2.4.4 CBC 2010 1133B.2.4 CBC 2013 11B-404.2.4 Priority 2 Severity 1 TBD Contract Work	10	SF	\$40	\$400

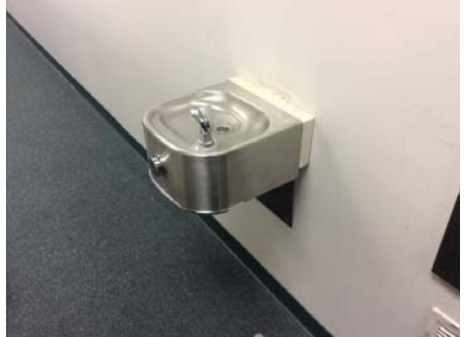
<u>Drinking Fountain</u>						
702	<ul style="list-style-type: none"> • <i>As-Built Description:</i> Where only one drinking fountain is provided per floor: Fountain is not accessible to individuals who use wheelchairs, or to those who have difficulty bending or stooping. • <i>As-Built:</i> 13.5" deep • <i>Proposed Solution:</i> Provide additional fountain or hi-lo combination fountain. 	PCODE IA01A ADAAG 4.1.3(10)(a) ADA 2010 211.1 CBC 2010 1115B.4.6.1 CBC 2013 11B-211.1 Priority 4 Severity 2 TBD Contract Work	1	JOB	\$2,000	\$2,000

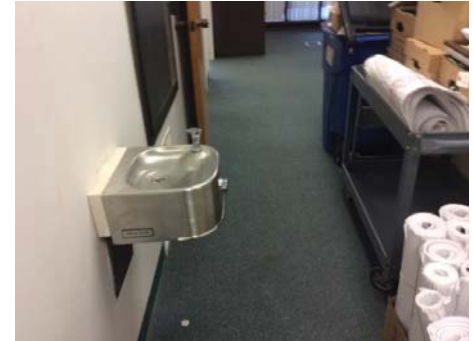
Item No. and Name	Existing Architectural Barrier and Proposed Solution	Codes / Mitigation Info	Qty	Unit	Cost	Total
703	<ul style="list-style-type: none"> <i>As-Built Description:</i> CA only: Drinking fountain not located in an alcove (min. 32" wide x 18" deep) or otherwise encroaches into pedestrian way. <i>Proposed Solution:</i> Provide new alcove for drinking fountain, or, if unreasonable hardship is determined, provide wing walls or cane-detectable railings on each side of the drinking fountain. The wings must project out from the supporting wall at least as far as the drinking fountain to within 6" of the surface of the circulation path, but cannot reduce the required clear width of the adjacent accessible route. 	<p>PCODE IA04</p> <p>CBC 2010 1115B.4.6.3; Fig.</p> <p>CBC 2013 11B-602.9</p> <p>Priority 3</p> <p>Severity 2</p> <p>TBD Contract Work</p>	1	JOB	\$3,000	\$3,000

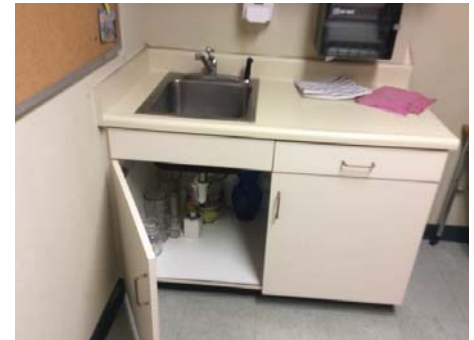
705	<ul style="list-style-type: none"> <i>As-Built Description:</i> Sink does not have knee space min. 27" high x 19" deep x 30" wide. <i>Proposed Solution:</i> Remodel sink cabinet. 	<p>PCODE IN06A</p> <p>ADAAG 4.24.3</p> <p>ADA 2010 606.2</p> <p>CBC 2010 1115B.4.7.1</p> <p>CBC 2013 11B-606.2</p> <p>Priority 2</p> <p>Severity 2</p> <p>TBD Contract Work</p>	1	JOB	\$1,750	\$1,750
-----	--	---	---	-----	---------	---------

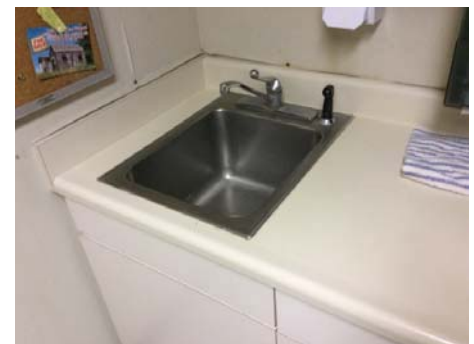
706	<ul style="list-style-type: none"> <i>As-Built Description:</i> Sink is more than 6 1/2" deep. <i>As-Built:</i> 10" <i>Proposed Solution:</i> Provide new sink remodel and cabinet as needed. 	<p>PCODE IN06BREF</p> <p>ADAAG 4.24.4</p> <p>CBC 2010 1115B.4.7.1</p> <p>CBC 2013 11B-606.7</p> <p>Priority 2</p> <p>Severity 3</p> <p>TBD Contract Work</p>	REF			
-----	--	---	-----	--	--	--

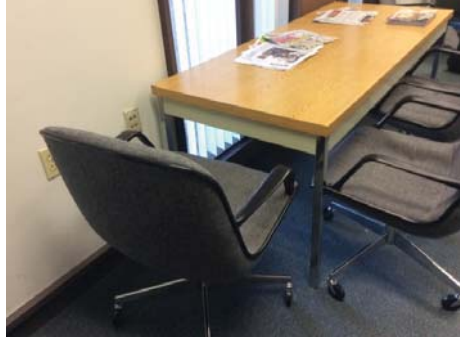
16 Assessors Office - Staff Break Room

Item No. and Name	Existing Architectural Barrier and Proposed Solution	Codes / Mitigation Info	Qty	Unit	Cost	Total
<u>Non-Fixed Desk</u>						
718	<ul style="list-style-type: none"> <i>As-Built Description:</i> Accessible non-fixed table or desk (top 28" to 34" high; knee space at least 27" high x 19" deep x 30" wide) not provided. <i>As-Built:</i> 24.5" <i>Proposed Solution:</i> Provide table or desk with accessible dimensions when purchasing new furniture. 	PCODE IN02A ADAAG 4.32.3 & .4 ADA 2010 306.1 CBC 2010 1122B.3 & 4 CBC 2013 11B-306.1 & 11B-902.3 Priority 4 Severity 2 TBD Contract Work	1	JOB	\$1,600	\$1,600

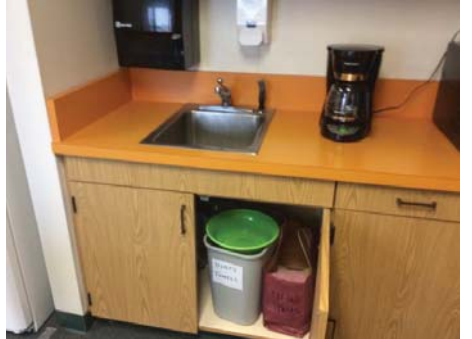
<u>Sink</u>						
723	<ul style="list-style-type: none"> <i>As-Built Description:</i> Sink does not have knee space min. 27" high x 19" deep x 30" wide. <i>Proposed Solution:</i> Remodel sink cabinet. 	PCODE IN06A ADAAG 4.24.3 ADA 2010 606.2 CBC 2010 1115B.4.7.1 CBC 2013 11B-606.2 Priority 4 Severity 2 TBD Contract Work	1	JOB	\$1,750	\$1,750

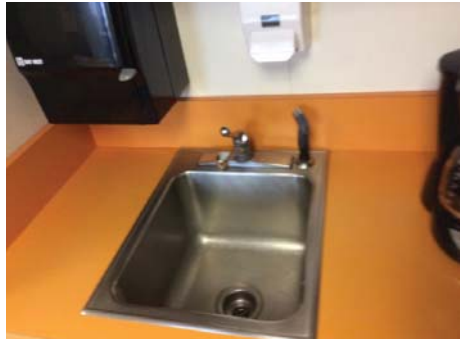
725	<ul style="list-style-type: none"> <i>As-Built Description:</i> Sink is more than 6 1/2" deep. <i>As-Built:</i> 10" <i>Proposed Solution:</i> Provide new sink remodel and cabinet as needed. 	PCODE IN06BREF ADAAG 4.24.4 CBC 2010 1115B.4.7.1 CBC 2013 11B-606.7 Priority 4 Severity 3 TBD Contract Work	REF

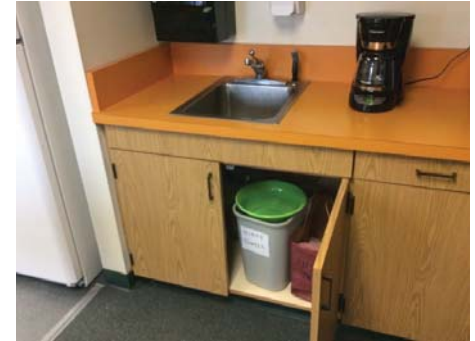
Item No. and Name	Existing Architectural Barrier and Proposed Solution	Codes / Mitigation Info	Qty	Unit	Cost	Total
724	<ul style="list-style-type: none"> • <i>As-Built Description:</i> Sink rim higher than 34" above floor. • <i>As-Built:</i> 36" • <i>Proposed Solution:</i> Remodel sink cabinet to lower sink. 	<p>PCODE IN06REF</p> <p>ADAAG 4.24.2</p> <p>ADA 2010 606.3</p> <p>CBC 2010 1115B.4.7.1</p> <p>CBC 2013 11B-606.3</p> <p>Priority 4</p> <p>Severity 4</p> <p>TBD Contract Work</p>

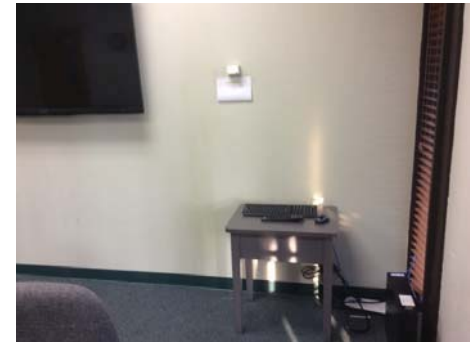
726	<ul style="list-style-type: none"> • <i>As-Built Description:</i> No portable assistive listening system provided for small meeting room. • <i>Proposed Solution:</i> Share existing portable assistive listening system from other facility if needed. 	<p>PCODE GI01E</p> <p>ADAAG 4.1.3(19)(b) & 4.33.7</p> <p>ADA 2010 219.1 & 706.1</p> <p>CBC 2010 1104B.2</p> <p>CBC 2013 11B-219.2</p> <p>Priority 3</p> <p>Severity 3</p> <p>TBD Contract Work</p>
