Facility: **WOMENS INFANTS & CHILDREN**

Address: 330 HARRIS ST.

Facility: **LEMORE HEALTH CLINIC**
 Address: 229 C ST.

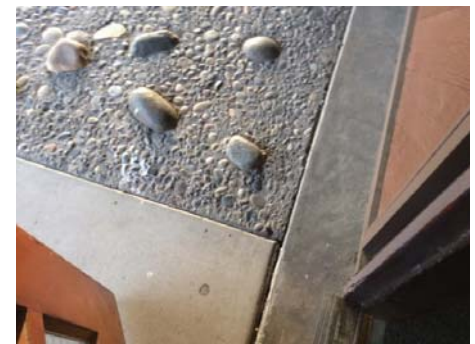
Door

730	<ul style="list-style-type: none"> • <i>As-Built Description:</i> Surface of required maneuvering clearance at door slopes more than 1/4":12" (2.0%). • <i>As-Built:</i> 3", irregular surface within DW + 24" at exterior door. • <i>Proposed Solution:</i> Modify surface slope at door. 	<p>PCODE ID11</p> <p>ADAAG 4.13.6</p> <p>ADA 2010 404.2.4.4</p> <p>CBC 2010 1133B.2.4</p> <p>CBC 2013 11B-404.2.4</p> <p>Priority 2</p> <p>Severity 1</p> <p>TBD Contract Work</p>	10	SF	\$40	\$400

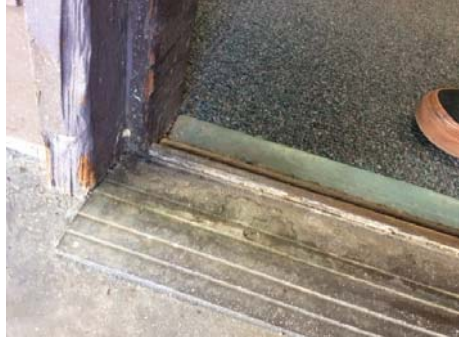
Item No. and Name	Existing Architectural Barrier and Proposed Solution	Codes / Mitigation Info	Qty	Unit	Cost	Total
<u>Door Threshold</u>						
729	<ul style="list-style-type: none"> <i>As-Built Description:</i> Existing threshold at door is 1/2" high or less but without a beveled edge on both sides. <i>As-Built:</i> No bevel <i>Proposed Solution:</i> Modify threshold to have beveled edge on each side. 	PCODE ID02 ADAAG 4.1.6(3)(d)(ii) ADA 2010 404.2.5 CBC 2010 1133B.2.4.1 CBC 2013 11B-404.2.5 Priority 2 Severity 4 TBD Contract Work	1	JOB	\$250	\$250

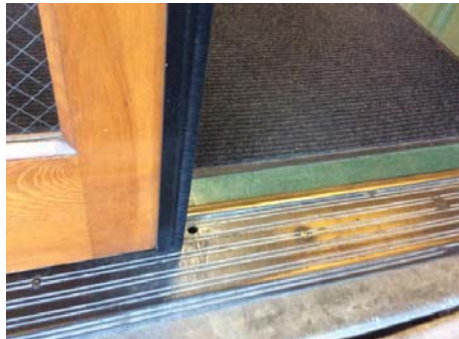
<u>Door Threshold</u>						
734	<ul style="list-style-type: none"> <i>As-Built Description:</i> Existing threshold at door is 1/2" high or less but without a beveled edge on both sides. <i>As-Built:</i> Gap and no bevel <i>Proposed Solution:</i> Modify threshold to have beveled edge on each side. 	PCODE ID02 ADAAG 4.1.6(3)(d)(ii) ADA 2010 404.2.5 CBC 2010 1133B.2.4.1 CBC 2013 11B-404.2.5 Priority 1 Severity 4 TBD Contract Work	1	JOB	\$250	\$250

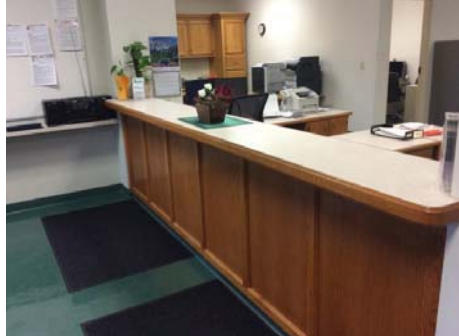
<u>Public Counter</u>						
737	<ul style="list-style-type: none"> <i>As-Built Description:</i> Service counter (stand-up): Accessible section min. 36" length and 36" max. height (in CA: 28" to 34" high) not provided. <i>As-Built:</i> 42" <i>Proposed Solution:</i> Provide auxiliary shelf, clipboard, or table as equivalent facilitation. 	PCODE IN03 ADAAG 7.2(2) ADA 2010 904.4 CBC 2010 1122B.4 CBC 2013 11B-904.4 Priority 1 Severity 3 TBD Contract Work	1	JOB	\$150	\$150

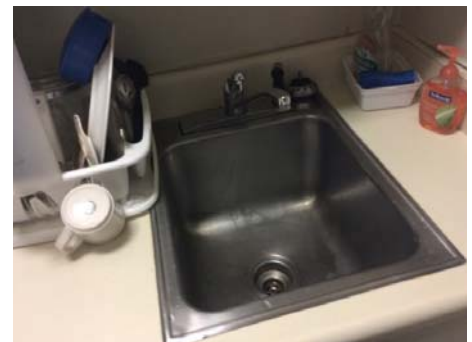
- 760
- *As-Built Description:*
Sink is more than 6 1/2" deep.
 - *As-Built:* 10"
 - *Proposed Solution:*
Provide new sink remodel and cabinet as needed.

PCODE **IN06BREF**
 ADAAG **4.24.4**
 CBC 2010 **1115B.4.7.1**
 CBC 2013 **11B-606.7**
 Priority **2**
 Severity **3**
 TBD **Contract Work**

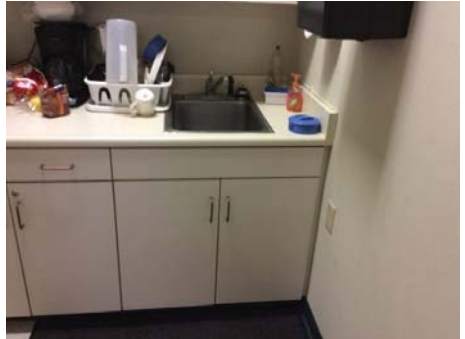
Item No. and Name	Existing Architectural Barrier and Proposed Solution	Codes / Mitigation Info	Qty	Unit	Cost	Total
758	<ul style="list-style-type: none"> As-Built Description: Sink rim higher than 34" above floor. As-Built: 36" Proposed Solution: Remodel sink cabinet to lower sink. 	PCODE IN06REF ADAAG 4.24.2 ADA 2010 606.3 CBC 2010 1115B.4.7.1 CBC 2013 11B-606.3 Priority 2 Severity 4 TBD Contract Work

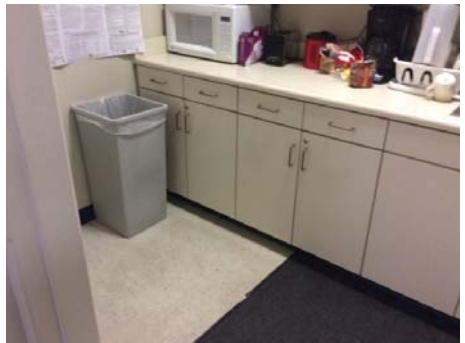
Turn Space

763	<ul style="list-style-type: none"> As-Built Description: Less than 60" diameter or T-shaped space provided for wheelchair turns. As-Built: 48.5" Proposed Solution: Retrofit space to provide 60" diameter or T-turn. 	PCODE IN04 ADAAG 4.2.3 ADA 2010 304.1 CBC 2010 1118B.3 CBC 2013 11B-304.1 Priority 2 Severity 2 TBD Contract Work				
-----	--	--	--	--	--	--

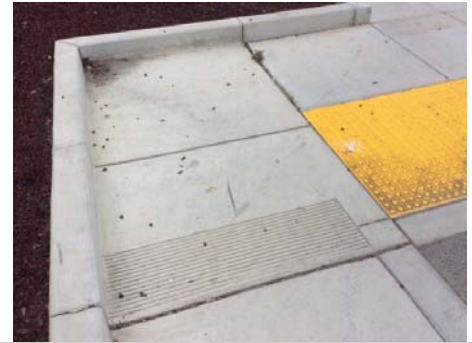
- 1097
- *As-Built Description:*
Walk: Pavement dislocation creates abrupt change in level exceeding 1/2" in accessible route.
 - *As-Built:* 0.5" gaps
 - *Proposed Solution:*
Remove, replace or repair area of pavement sufficient to correct abrupt change in level.

PCODE EF03REF
 ADAAG 4.3.8
 ADA 2010 403.4
 CBC 2010 1133B.7.4
 CBC 2013 11B-403.4
 Priority 1
 Severity 4
 TBD Contract Work

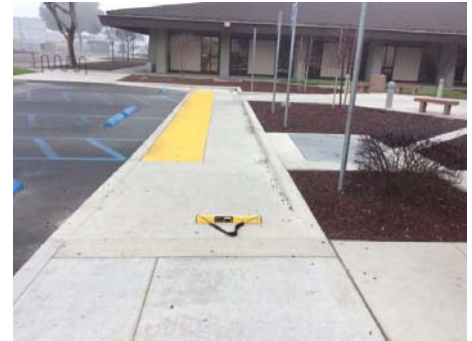
Cross Slope

- 1098
- *As-Built Description:*
Cross slope more than 1":48" (2.083%).
 - *As-Built:* 2.4%
 - *Proposed Solution:*
Modify cross slope.

PCODE EF07
 ADAAG 4.3.7
 ADA 2010 403.3
 CBC 2010 1133B.7.1.3
 CBC 2013 11B-403.3
 Priority 1
 Severity 4
 TBD Contract Work

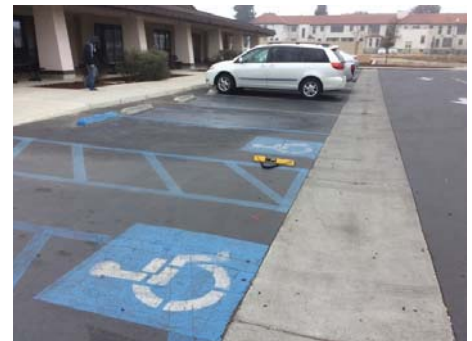
Floor or Ground Surfaces

- 1095
- *As-Built Description:*
Accessible parking space has slope greater than 1/4":12" (2%).
 - *As-Built:* Right two spaces: 2.4-3.3%
 - *Proposed Solution:*
Modify slope at accessible parking space.

PCODE EA05
 ADAAG 4.6.3
 ADA 2010 502.4
 CBC 2010 1129B.3.3
 CBC 2013 11B-502.4
 Priority 1
 Severity 4
 TBD Contract Work

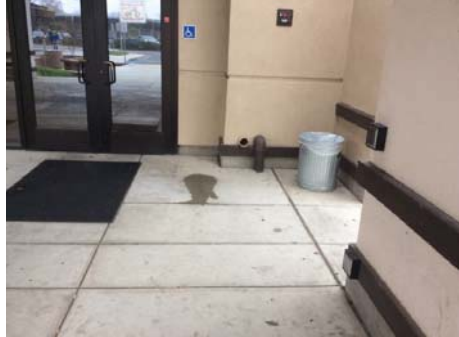
Item No. and Name	Existing Architectural Barrier and Proposed Solution	Codes / Mitigation Info	Qty	Unit	Cost	Total
<u>Operating Hardware</u>						
1102	<ul style="list-style-type: none"> <i>As-Built Description:</i> Where push plates are provided, two shall be provided: the centerline of one shall be located between 7-8" above the floor, and the second shall be located between 30-44" above the floor. <i>As-Built:</i> 9.5" AFF for bottom push plate <i>Proposed Solution:</i> Remount push plates such that they are compliant. <i>Notes:</i> 40" AFF for top push plate 	PCODE ID29 CBC 2013 11B-404.2.9 Priority 2 Severity 4 TBD Contract Work	1	JOB	\$200	\$200

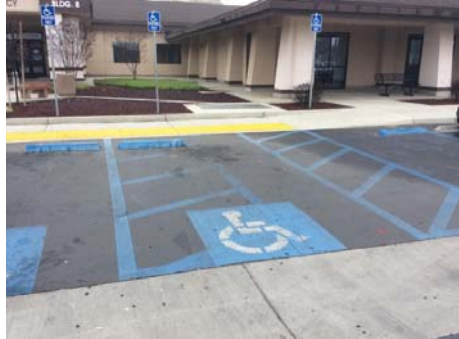
<u>Parking</u>						
1092	<ul style="list-style-type: none"> <i>As-Built Description:</i> Accessible parking space smaller than 8' wide (CA only: 9' x 18'). <i>As-Built:</i> Old striping causes confusion. <i>Proposed Solution:</i> Modify parking space(s) to create accessible space. 	PCODE EA02ANT ADAAG 4.6.3 ADA 2010 502.2 CBC 2010 1129B.3.1 CBC 2013 11B-502.2 Priority 1 Severity 4 TBD Contract Work	1	JOB	\$200	\$200

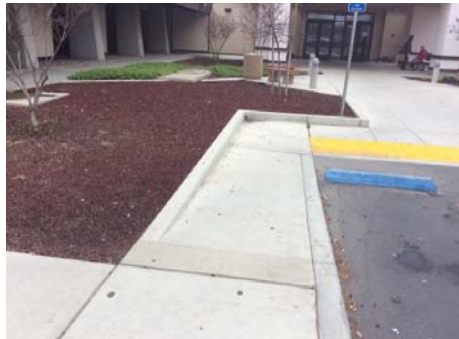
<u>Walk</u>						
1096	<ul style="list-style-type: none"> <i>As-Built Description:</i> Walk more than 36" but less than 48" wide (required in CA only). <i>As-Built:</i> 42" wide <i>Proposed Solution:</i> Enlarge width of walk to 48". 	PCODE EF08 CBC 2010 1133B.7.1 CBC 2013 11B-403.5.1.3 Priority 1 Severity 4 TBD Contract Work	44	SF	\$45	\$1,980

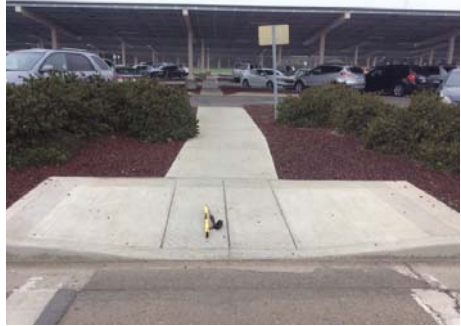
Item No. and Name	Existing Architectural Barrier and Proposed Solution	Codes / Mitigation Info	Qty	Unit	Cost	Total
Curb Ramp						
1106	<ul style="list-style-type: none"> As-Built Description: Slope greater than 1:12 (8.3%). As-Built: 9.6% Proposed Solution: Demolish existing and provide new curb ramp. 	PCODE EH02A ADAAG 4.7.2 ADA 2010 406.1 CBC 2010 1127B.5.3 CBC 2013 11B-406.2.1 Priority 1 Severity 4 TBD Contract Work	1	JOB	\$2,500	\$2,500

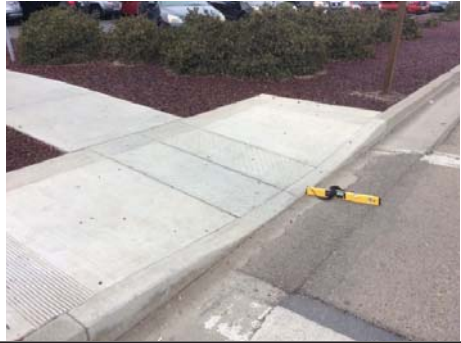
1107	<ul style="list-style-type: none"> As-Built Description: Maximum slope of adjoining gutters, street surface at bottom of ramp exceeds 5% (1:20). As-Built: 12.4% Proposed Solution: Modify road/gutter slopes. Demolish existing and provide new curb ramp. 	PCODE EH02EREF ADAAG 4.7.2 ADA 2010 406.2 CBC 2010 1127B.5.3 CBC 2013 11B-406.5.8 Priority 1 Severity 3 TBD Contract Work				REF

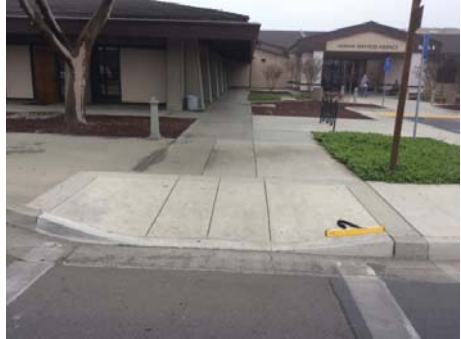
1105	<ul style="list-style-type: none"> As-Built Description: Side slopes more than 1:10 (10%). As-Built: Left: 12.5% Right: 12.7% Proposed Solution: Modify curb ramp. Demolish side slopes and replace with 1:10 side slopes if 48" level top landing is provided. 	PCODE EH05A ADAAG 4.7.5 ADA 2010 406.3 CBC 2010 1127B.5.3 CBC 2013 11B-406.2.2 Priority 1 Severity 4 TBD Contract Work	1	JOB	\$2,000	\$2,000

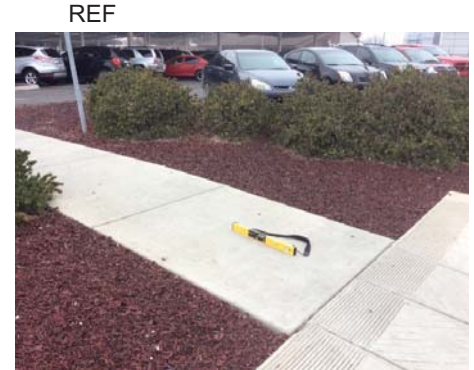
Item No. and Name	Existing Architectural Barrier and Proposed Solution	Codes / Mitigation Info	Qty	Unit	Cost	Total
1109	<ul style="list-style-type: none"> • <i>As-Built Description:</i> Curb ramp: Less than 48" level space at top and 1:12 flared sides not provided. • <i>As-Built:</i> 2.8% at TL • <i>Proposed Solution:</i> Demolish existing and provide new curb ramp. 	PCODE EH05BREF ADAAG 4.7.5; Fig.12(a) ADA 2010 406.4 CBC 2010 1127B.5.4 CBC 2013 11B-406.5.3 Priority 1 Severity 4 TBD Contract Work

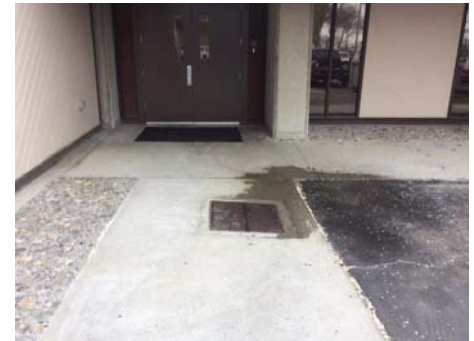
Cross Slope

1116	<ul style="list-style-type: none"> • <i>As-Built Description:</i> Cross slope more than 1":48" (2.083%). • <i>As-Built:</i> 2.7-4.5% • <i>Proposed Solution:</i> Modify cross slope. 	PCODE EF07 ADAAG 4.3.7 ADA 2010 403.3 CBC 2010 1133B.7.1.3 CBC 2013 11B-403.3 Priority 1 Severity 3 TBD Contract Work	240	SF	\$25	\$6,000

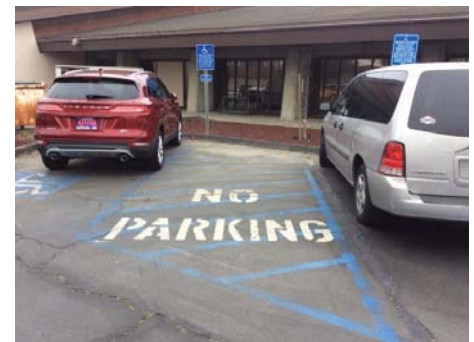
Floor or Ground Surfaces

1112	<ul style="list-style-type: none"> • <i>As-Built Description:</i> Accessible parking space has slope greater than 1/4":12" (2%). • <i>As-Built:</i> Portion: 2.4-2.6% • <i>Proposed Solution:</i> Modify slope at accessible parking space. 	PCODE EA05 ADAAG 4.6.3 ADA 2010 502.4 CBC 2010 1129B.3.3 CBC 2013 11B-502.4 Priority 1 Severity 4 TBD Contract Work	300	SF	\$12	\$3,600

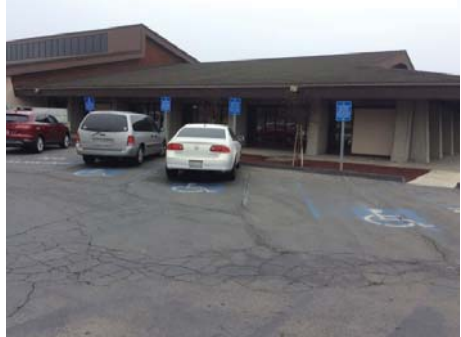
Item No. and Name	Existing Architectural Barrier and Proposed Solution	Codes / Mitigation Info	Qty	Unit	Cost	Total
<u>Parking</u>						
1110	<ul style="list-style-type: none"> <i>As-Built Description:</i> Accessible parking space does not have 5' wide access aisle; 8' wide for van accessible aisle. <i>As-Built:</i> Missing and faded <i>Proposed Solution:</i> Modify parking aisle(s) to create accessible space by restriping. <i>Notes:</i> 4 Acc 1 van 	PCODE EA02B ADAAG 4.6.3 ADA 2010 502.3 CBC 2010 1129B.3.1 CBC 2013 11B-502.2; 11B-502.3.1 Priority 1 Severity 1 TBD Contract Work	1	JOB	\$200	\$200

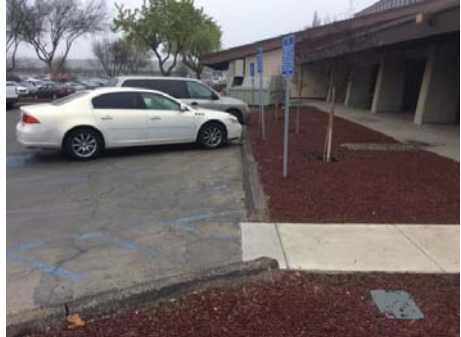
1114	<ul style="list-style-type: none"> <i>As-Built Description:</i> Disabled persons must wheel or walk behind parked car(s) other than their own. <i>Proposed Solution:</i> Relocate parking and provide curb ramp to accessible route. <i>Notes:</i> Provide walk along front. Provide wheel stops. 	PCODE EA03 ADAAG Fig.9 ADA 2010 502.3 CBC 2010 1129B.3.1 CBC 2013 11B-502.7.1 Priority 1 Severity 3 TBD Contract Work	1	JOB	\$730	\$730

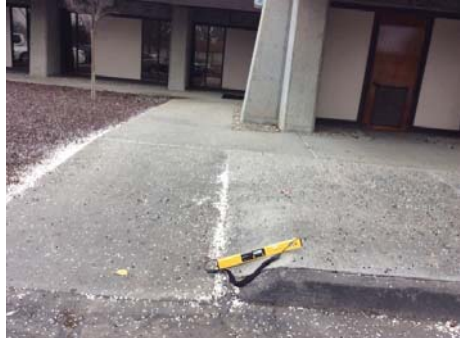
<u>Curb Ramp</u>						
1123	<ul style="list-style-type: none"> <i>As-Built Description:</i> Side slopes more than 1:10 (10%). <i>As-Built:</i> 34.1% <i>Proposed Solution:</i> Modify curb ramp. Demolish side slopes and replace with 1:10 side slopes if 48" level top landing is provided. 	PCODE EH05A ADAAG 4.7.5 ADA 2010 406.3 CBC 2010 1127B.5.3 CBC 2013 11B-406.2.2 Priority 1 Severity 1 TBD Contract Work	1	JOB	\$2,000	\$2,000

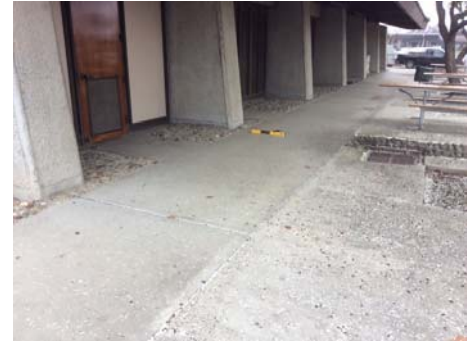
Item No. and Name	Existing Architectural Barrier and Proposed Solution	Codes / Mitigation Info	Qty	Unit	Cost	Total
1124	<ul style="list-style-type: none"> As-Built Description: Less than 48" level space at top and 1:12 flared sides not provided. As-Built: 2.6-3.5% Proposed Solution: Demolish existing and provide new curb ramp. Notes: To staff entry and picnic table 	PCODE EH05B ADAAG 4.7.5; Fig.12(a) ADA 2010 406.4 CBC 2010 1127B.5.4 CBC 2013 11B-406.5.3 Priority 1 Severity 4 TBD Contract Work	1	JOB	\$2,500	\$2,500

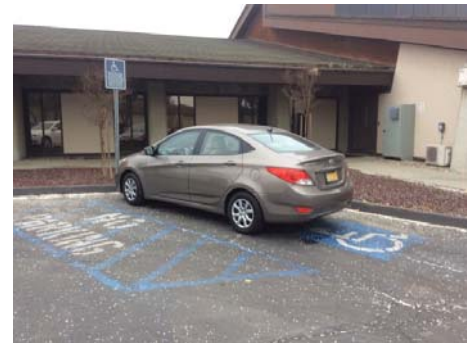
Floor or Ground Surfaces

1121	<ul style="list-style-type: none"> As-Built Description: Accessible parking space has slope greater than 1/4":12" (2%). As-Built: 3.0-3.1% Proposed Solution: Modify slope at accessible parking space. 	PCODE EA05 ADAAG 4.6.3 ADA 2010 502.4 CBC 2010 1129B.3.3 CBC 2013 11B-502.4 Priority 1 Severity 4 TBD Contract Work	162	SF	\$12	\$1,944
------	--	--	-----	----	------	----------------

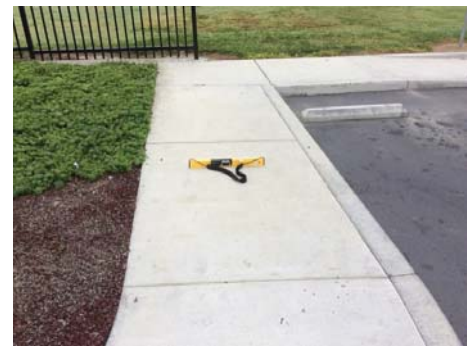
Cross Slope

1129	<ul style="list-style-type: none"> As-Built Description: Cross slope more than 1":48" (2.083%). As-Built: 3.2-3.6% Proposed Solution: Modify cross slope. 	PCODE EF07 ADAAG 4.3.7 ADA 2010 403.3 CBC 2010 1133B.7.1.3 CBC 2013 11B-403.3 Priority 1 Severity 4 TBD Contract Work	48	SF	\$25	\$1,200
------	--	--	----	----	------	----------------

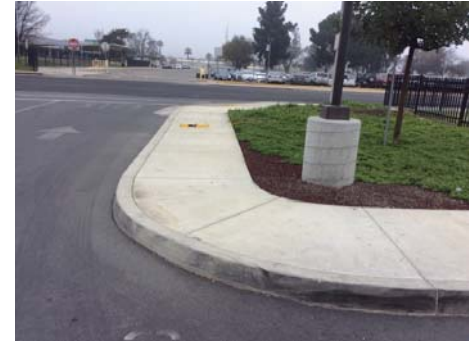
Item No. and Name	Existing Architectural Barrier and Proposed Solution	Codes / Mitigation Info	Qty	Unit	Cost	Total
1130	<ul style="list-style-type: none"> As-Built Description: Cross slope more than 1":48" (2.083%). As-Built: 2.6-2.7% Proposed Solution: Modify cross slope. 	PCODE EF07 ADAAG 4.3.7 ADA 2010 403.3 CBC 2010 1133B.7.1.3 CBC 2013 11B-403.3 Priority 1 Severity 4 TBD Contract Work	100	SF	\$25	\$2,500

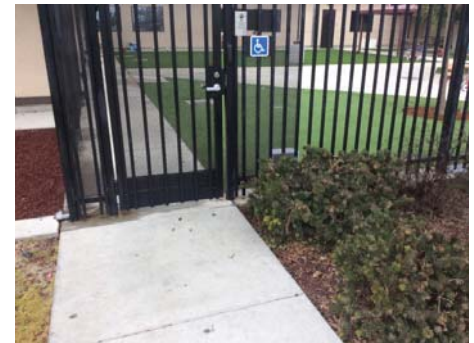
Door Swing

1132	<ul style="list-style-type: none"> As-Built Description: Front approach: At pull side, door does not have clear and level maneuvering space measuring door width plus 18"(CA only: 24" at exterior doors)x 60". As-Built: 3" Proposed Solution: Extend maneuvering space. Notes: Exterior 24" needed also 12" on push side. 	PCODE ID23D ADAAG Fig. 25(a) ADA 2010 404.2.4 CBC 2010 11B-26A(a) CBC 2013 11B-404.2.4 Priority 1 Severity 2 TBD Contract Work	1	JOB	\$800	\$800
------	---	---	---	-----	-------	-------

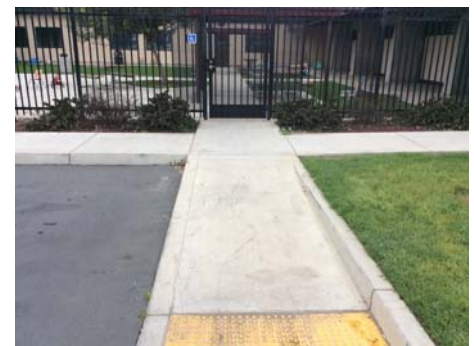
1133	<ul style="list-style-type: none"> As-Built Description: Front approach: At pull side, door does not have clear and level maneuvering space measuring door width plus 18"(CA only: 24" at exterior doors)x 60". As-Built: 7" Proposed Solution: Extend maneuvering space. 	PCODE ID23D ADAAG Fig. 25(a) ADA 2010 404.2.4 CBC 2010 11B-26A(a) CBC 2013 11B-404.2.4 Priority 1 Severity 3 TBD Contract Work	1	JOB	\$800	\$800
------	--	---	---	-----	-------	-------

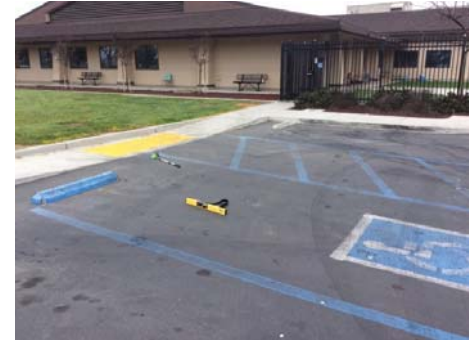
1128	<ul style="list-style-type: none"> As-Built Description: Accessible parking space has slope greater than 1/4":12" (2%). As-Built: 3.4-3.7% Proposed Solution: Modify slope at accessible parking space. 	PCODE EA05 ADAAG 4.6.3 ADA 2010 502.4 CBC 2010 1129B.3.3 CBC 2013 11B-502.4 Priority 1 Severity 4 TBD Contract Work	306	SF	\$12	\$3,672
------	--	--	-----	----	------	---------

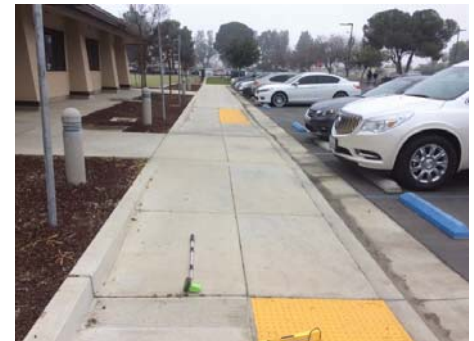
1137	<ul style="list-style-type: none"> As-Built Description: Cross slope more than 1":48" (2.083%). As-Built: 2.9-4.1% Proposed Solution: Modify cross slope. 	PCODE EF07 ADAAG 4.3.7 ADA 2010 403.3 CBC 2010 1133B.7.1.3 CBC 2013 11B-403.3 Priority 1 Severity 3 TBD Contract Work	564	SF	\$25	\$14,100
------	--	--	-----	----	------	----------

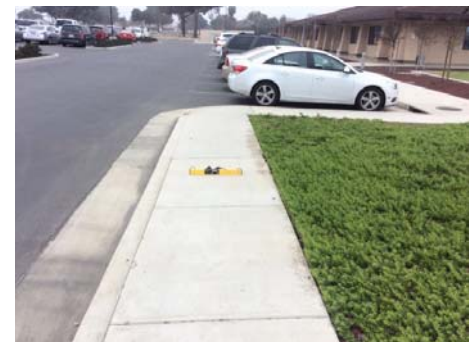
1135	<ul style="list-style-type: none"> As-Built Description: Cross slope more than 1":48" (2.083%). As-Built: 2.4% Proposed Solution: Modify cross slope. 	PCODE EF07 ADAAG 4.3.7 ADA 2010 403.3 CBC 2010 1133B.7.1.3 CBC 2013 11B-403.3 Priority 1 Severity 4 TBD Contract Work	112	SF	\$25	\$2,800
------	--	--	-----	----	------	---------

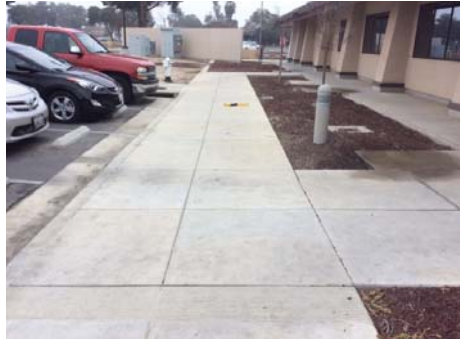
1138	<ul style="list-style-type: none"> As-Built Description: Cross slope more than 1":48" (2.083%). As-Built: 2.4-3.2% Proposed Solution: Modify cross slope. 	PCODE EF07 ADAAG 4.3.7 ADA 2010 403.3 CBC 2010 1133B.7.1.3 CBC 2013 11B-403.3 Priority 1 Severity 4 TBD Contract Work	360	SF	\$25	\$9,000

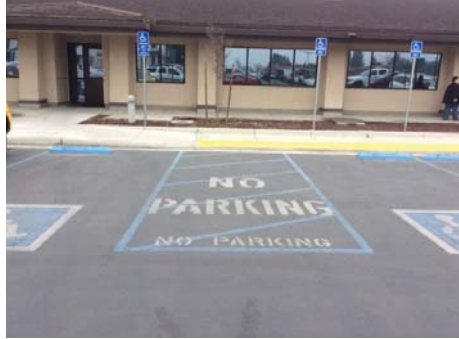
Item No. and Name	Existing Architectural Barrier and Proposed Solution	Codes / Mitigation Info	Qty	Unit	Cost	Total
Parking						
1141	<ul style="list-style-type: none"> As-Built Description: Accessible parking space does not have 5' wide access aisle; 8' wide for van accessible aisle. As-Built: 7'9" at van aisles Proposed Solution: Modify parking aisle(s) to create accessible space by restriping. Notes: 201" total 	PCODE EA02B ADAAG 4.6.3 ADA 2010 502.3 CBC 2010 1129B.3.1 CBC 2013 11B-502.2; 11B-502.3.1 Priority 1 Severity 4 TBD Contract Work	2	JOB	\$200	\$400

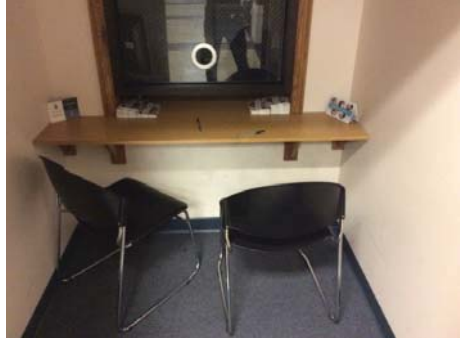
Item No. and Name	Existing Architectural Barrier and Proposed Solution	Codes / Mitigation Info	Qty	Unit	Cost	Total
Public Counter						
1172	<ul style="list-style-type: none"> <i>As-Built Description:</i> Public Counter (Seated Service): Accessible section not provided (knee space min. 27" high x 19" deep x 30" wide, top 28" to 34" high, min. 36" counter wide). <i>As-Built:</i> 13" deep <i>Proposed Solution:</i> Retrofit existing counter to provide accessible seating section. Interim solution: Provide auxiliary counter or table. <i>Notes:</i> 4 total make 1 accessible 	PCODE IN03A ADAAG 4.32.3 & 4 ADA 2010 306.3; 904.4 CBC 2010 1122B.3 & 4 CBC 2013 11B-306.3; 11B-904.4 Priority 2 Severity 2 TBD Contract Work	1	JOB	\$1,200	\$1,200

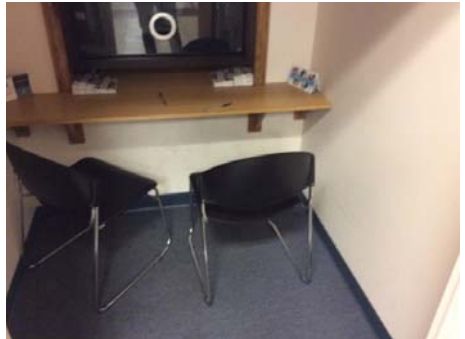
Turn Space						
1171	<ul style="list-style-type: none"> <i>As-Built Description:</i> Less than 60" diameter or T-shaped space provided for wheelchair turns. <i>As-Built:</i> 59.5" to wall 46" to counter <i>Proposed Solution:</i> Retrofit space to provide 60" diameter or T-turn. <i>Notes:</i> Counter 29" high 	PCODE IN04 ADAAG 4.2.3 ADA 2010 304.1 CBC 2010 1118B.3 CBC 2013 11B-304.1 Priority 2 Severity 2 TBD Contract Work	1	JOB	\$925	\$925

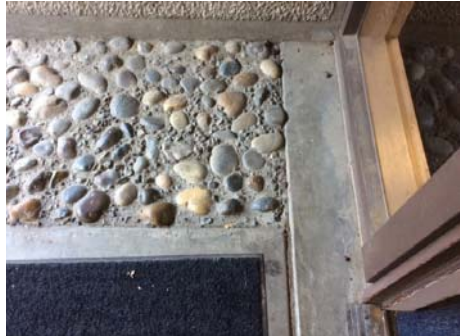
Door						
1176	<ul style="list-style-type: none"> <i>As-Built Description:</i> Surface of required maneuvering clearance at door slopes more than 1/4":12" (2.0%). <i>As-Built:</i> 8" to irregular surface within DW + 24" at exterior door. <i>Proposed Solution:</i> Modify surface slope at door. 	PCODE ID11 ADAAG 4.13.6 ADA 2010 404.2.4.4 CBC 2010 1133B.2.4 CBC 2013 11B-404.2.4 Priority 2 Severity 1 TBD Contract Work	10	SF	\$40	\$400

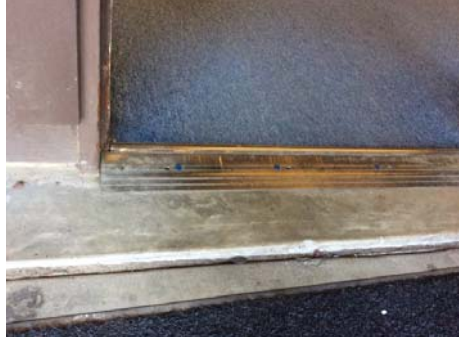
Item No. and Name	Existing Architectural Barrier and Proposed Solution	Codes / Mitigation Info	Qty	Unit	Cost	Total
<u>Door Threshold</u>						
1178	<ul style="list-style-type: none"> As-Built Description: Existing threshold at door is 1/2" high or less but without a beveled edge on both sides. As-Built: 0.5" Proposed Solution: Modify threshold to have beveled edge on each side. 	PCODE ID02 ADAAG 4.1.6(3)(d)(ii) ADA 2010 404.2.5 CBC 2010 1133B.2.4.1 CBC 2013 11B-404.2.5 Priority 4 Severity 4 TBD Contract Work	1	JOB	\$250	\$250

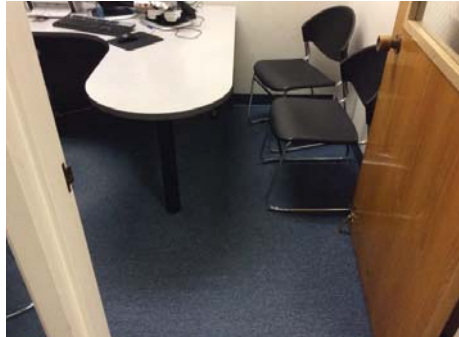
<u>Turn Space</u>						
1185	<ul style="list-style-type: none"> As-Built Description: Less than 60" diameter or T-shaped space provided for wheelchair turns. As-Built: 31" Proposed Solution: Retrofit space to provide 60" diameter or T-turn. Notes: Provide one wheelchair Acc. room Designate with ISA. 	PCODE IN04 ADAAG 4.2.3 ADA 2010 304.1 CBC 2010 1118B.3 CBC 2013 11B-304.1 Priority 2 Severity 2 TBD Contract Work	1	JOB	\$925	\$925

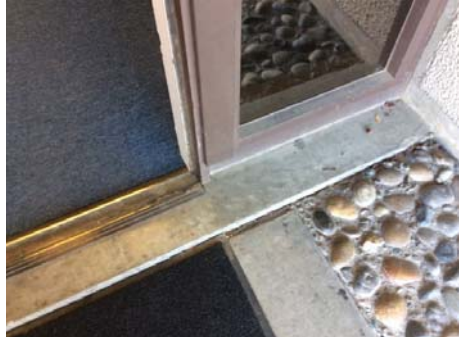
<u>Door</u>						
1199	<ul style="list-style-type: none"> As-Built Description: Surface of required maneuvering clearance at door slopes more than 1/4":12" (2.0%). As-Built: 10" to irregular surface within DW + 24" at exterior door. Proposed Solution: Modify surface slope at door. 	PCODE ID11REF ADAAG 4.13.6 ADA 2010 404.2.4.4 CBC 2010 1133B.2.4 CBC 2013 11B-404.2.4 Priority 2 Severity 1 TBD Contract Work	REF

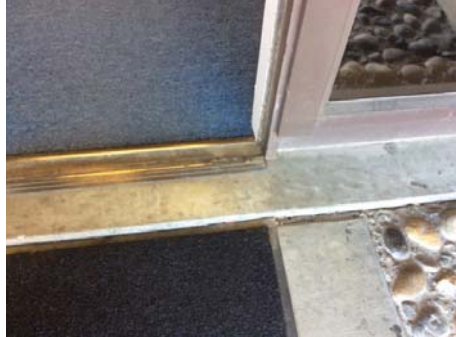
Item No. and Name	Existing Architectural Barrier and Proposed Solution	Codes / Mitigation Info	Qty	Unit	Cost	Total
<u>Door Threshold</u>						
1198	<ul style="list-style-type: none"> <i>As-Built Description:</i> Door inaccessible due to threshold or step at door exceeding 1/2". <i>As-Built:</i> 0.75" <i>Proposed Solution:</i> Modify threshold to be no more than 1/2" by removing existing paving at door and providing landing with edge ramping (slope 1:20 max). 	PCODE ID02A ADAAG 4.13.8 ADA 2010 404.2.5 CBC 2010 1133B.2.4.1 CBC 2013 11B-404.2.5 Priority 1 Severity 4 TBD Contract Work	1	JOB	\$400	\$400

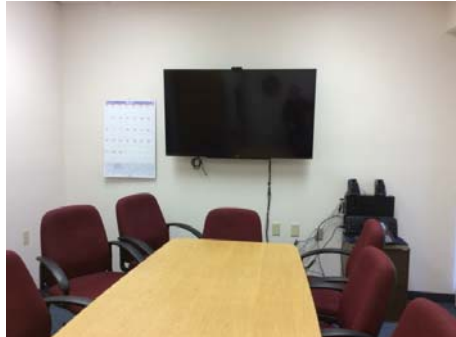
<u>Assistive Listening</u>							
1207	<ul style="list-style-type: none"> <i>As-Built Description:</i> No portable assistive listening system provided for small meeting room. <i>Proposed Solution:</i> Share existing portable assistive listening system from other facility if needed. 	PCODE GI01E ADAAG 4.1.3(19)(b) & 4.33.7 ADA 2010 219.1 & 706.1 CBC 2010 1104B.2 CBC 2013 11B-219.2 Priority 3 Severity 3 TBD Contract Work	REF

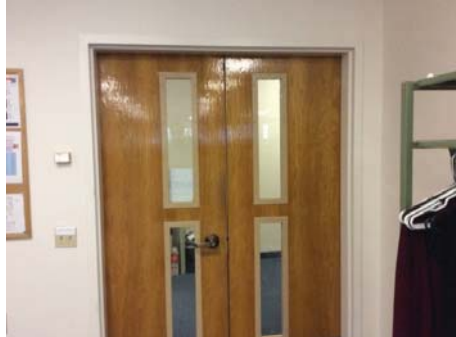
<u>Door Pair</u>						
1212	<ul style="list-style-type: none"> <i>As-Built Description:</i> Pair of doors on accessible route has less than 32" clear opening width with one leaf open 90°. <i>As-Built:</i> 27.5" <i>Proposed Solution:</i> Provide new door leaves, unequal in width, to existing frame for pair of doors. 	PCODE ID08A ADAAG 4.13.4 ADA 2010 404.2.2 CBC 2010 1133B.2.3.1 CBC 2013 11B-404.2.2 Priority 2 Severity 2 TBD Contract Work	1	JOB	\$1,500	\$1,500

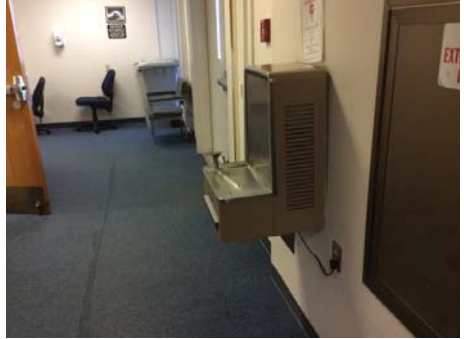
Item No. and Name	Existing Architectural Barrier and Proposed Solution	Codes / Mitigation Info	Qty	Unit	Cost	Total
<u>Drinking Fountain</u>						
1233	<ul style="list-style-type: none"> <i>As-Built Description:</i> Where only one drinking fountain is provided per floor: Fountain is not accessible to individuals who use wheelchairs, or to those who have difficulty bending or stooping. <i>Proposed Solution:</i> Provide additional fountain or hi-lo combination fountain. 	PCODE IA01A ADAAG 4.1.3(10)(a) ADA 2010 211.1 CBC 2010 1115B.4.6.1 CBC 2013 11B-211.1 Priority 3 Severity 2 TBD Contract Work	1	JOB	\$2,000	\$2,000

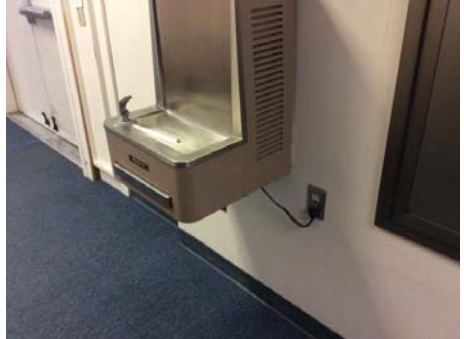
1234	<ul style="list-style-type: none"> <i>As-Built Description:</i> Wall- and post-mounted cantilevered units: Knee space not provided at drinking fountain (27" high, 8" deep, 30" wide from front of drinking fountain). <i>As-Built:</i> 26" <i>Proposed Solution:</i> Provide new, accessible fountain. 	PCODE IA02 ADAAG 4.15.5(1) ADA 2010 602.2 CBC 2010 1115B.4.6.2 CBC 2013 11B-602.2 Priority 3 Severity 2 TBD Contract Work	1	JOB	\$3,200	\$3,200

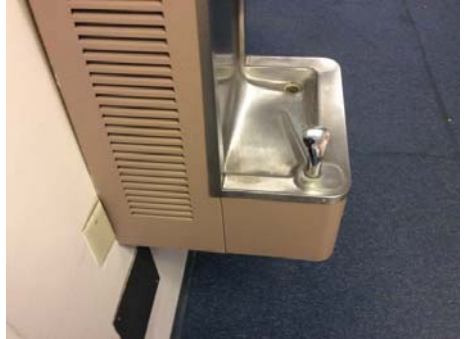
1235	<ul style="list-style-type: none"> <i>As-Built Description:</i> Drinking fountain is not 18" - 19" in depth. <i>As-Built:</i> Top: 9" deep <i>Proposed Solution:</i> Provide new, accessible fountain. 	PCODE IA02BREF ADAAG 4.15.5(1) ADA 2010 602.8 CBC 2010 1115B.4.6.2 CBC 2013 11B-602.8 Priority 3 Severity 1 TBD Contract Work	REF

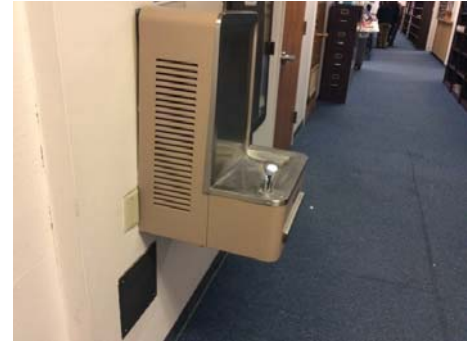
Item No. and Name	Existing Architectural Barrier and Proposed Solution	Codes / Mitigation Info	Qty	Unit	Cost	Total
1232	<ul style="list-style-type: none"> As-Built Description: CA only: Drinking fountain not located in an alcove (min. 32" wide x 18" deep) or otherwise encroaches into pedestrian way. Proposed Solution: Provide new alcove for drinking fountain, or, if unreasonable hardship is determined, provide wing walls or cane-detectable railings on each side of the drinking fountain. The wings must project out from the supporting wall at least as far as the drinking fountain to within 6" of the surface of the circulation path, but cannot reduce the required clear width of the adjacent accessible route. 	PCODE IA04 CBC 2010 1115B.4.6.3; Fig. CBC 2013 11B-602.9 Priority 3 Severity 2 TBD Contract Work	1	JOB	\$3,000	\$3,000

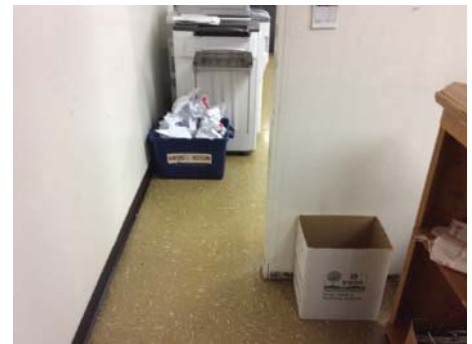
1244	<ul style="list-style-type: none"> As-Built Description: Corridor less than 36" wide. As-Built: 30" Proposed Solution: Enlarge corridor to 36" wide; relocate stud wall. 	PCODE IH03 ADAAG 4.3.3 ADA 2010 403.5.1 CBC 2010 1133B.3.1 CBC 2013 11B-403.5.1 Priority 2 Severity 2 TBD Contract Work	1	LF	\$140	\$140
------	--	--	---	----	-------	-------

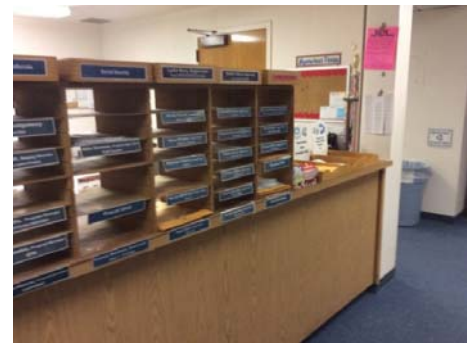
1252	<ul style="list-style-type: none"> As-Built Description: Service counter (stand-up): Accessible section min. 36" length and 36" max. height (in CA: 28" to 34" high) not provided. As-Built: 42-65.5" Proposed Solution: Provide auxiliary shelf, clipboard, or table as equivalent facilitation. Notes: Staff Only. Reach height. 	PCODE IN03NT ADAAG 7.2(2) ADA 2010 904.4 CBC 2010 1122B.4 CBC 2013 11B-904.4 Priority 4 Severity 1 TBD Contract Work	1	JOB	\$150	\$150
------	---	---	---	-----	-------	-------

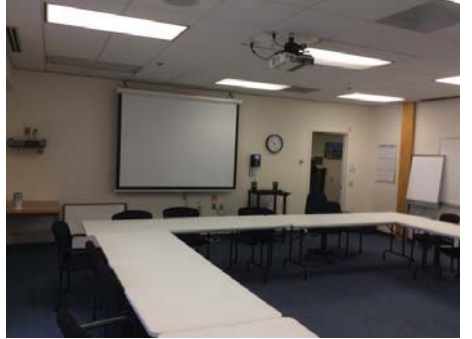
Item No. and Name	Existing Architectural Barrier and Proposed Solution	Codes / Mitigation Info	Qty	Unit	Cost	Total
<u>Assistive Listening</u>						
1258	<ul style="list-style-type: none"> <i>As-Built Description:</i> No portable assistive listening system provided for small meeting room. <i>Proposed Solution:</i> Share existing portable assistive listening system from other facility if needed. 	PCODE GI01E ADAAG 4.1.3(19)(b) & 4.33.7 ADA 2010 219.1 & 706.1 CBC 2010 1104B.2 CBC 2013 11B-219.2 Priority 3 Severity 3 TBD Contract Work				
						REF

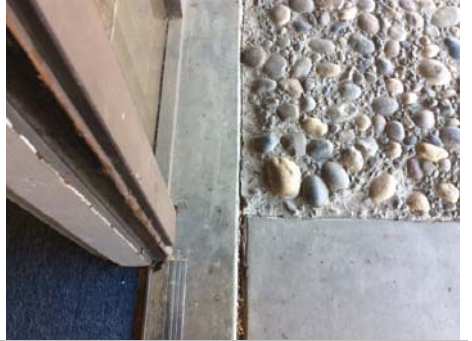
<u>Door</u>						
1261	<ul style="list-style-type: none"> <i>As-Built Description:</i> Surface of required maneuvering clearance at door slopes more than 1/4":12" (2.0%). <i>As-Built:</i> 5" to irregular surface within DW + 24" at exterior door. <i>Proposed Solution:</i> Modify surface slope at door. 	PCODE ID11 ADAAG 4.13.6 ADA 2010 404.2.4.4 CBC 2010 1133B.2.4 CBC 2013 11B-404.2.4 Priority 2 Severity 1 TBD Contract Work	5	SF	\$40	\$200

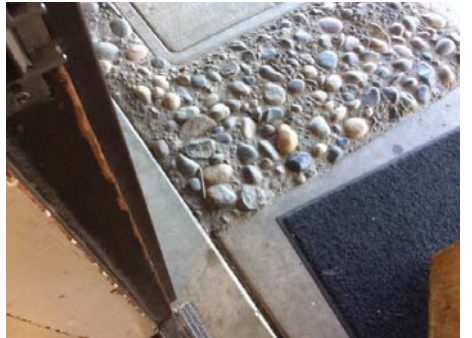
<u>Door</u>						
1270	<ul style="list-style-type: none"> <i>As-Built Description:</i> Surface of required maneuvering clearance at door slopes more than 1/4":12" (2.0%). <i>As-Built:</i> 5" to irregular surface within DW + 24" at exterior door. <i>Proposed Solution:</i> Modify surface slope at door. 	PCODE ID11 ADAAG 4.13.6 ADA 2010 404.2.4.4 CBC 2010 1133B.2.4 CBC 2013 11B-404.2.4 Priority 4 Severity 1 TBD Contract Work	10	SF	\$40	\$400

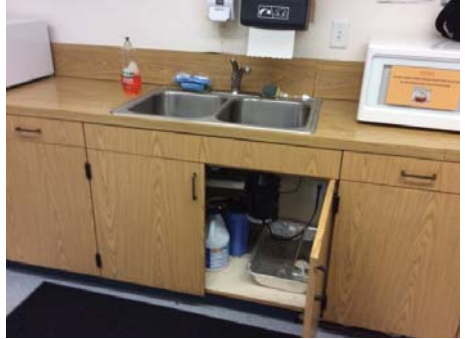
Item No. and Name	Existing Architectural Barrier and Proposed Solution	Codes / Mitigation Info	Qty	Unit	Cost	Total
Sink						
1272	<ul style="list-style-type: none"> <i>As-Built Description:</i> Sink does not have knee space min. 27" high x 19" deep x 30" wide. <i>Proposed Solution:</i> Remodel sink cabinet. 	PCODE IN06A ADAAG 4.24.3 ADA 2010 606.2 CBC 2010 1115B.4.7.1 CBC 2013 11B-606.2 Priority 4 Severity 2 TBD Contract Work	1	JOB	\$1,750	\$1,750

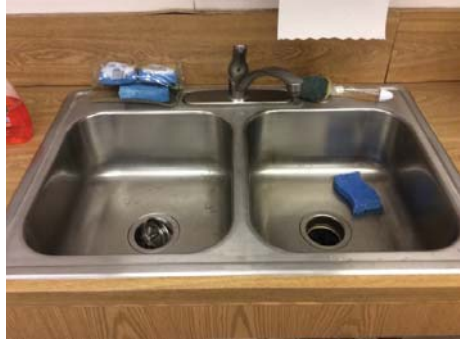
1274	<ul style="list-style-type: none"> <i>As-Built Description:</i> Sink is more than 6 1/2" deep. <i>As-Built:</i> 7" deep <i>Proposed Solution:</i> Provide new sink remodel and cabinet as needed. 	PCODE IN06B ADAAG 4.24.4 CBC 2010 1115B.4.7.1 CBC 2013 11B-606.7 Priority 4 Severity 4 TBD Contract Work	1	JOB	\$1,850	\$1,850

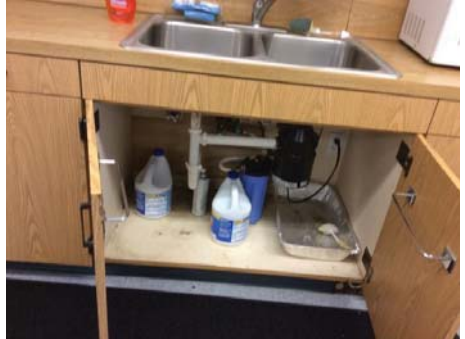
1275	<ul style="list-style-type: none"> <i>As-Built Description:</i> Food waste disposal at kitchen sink protrudes into knee space (recommended: remove equipment if requested as a reasonable accommodation by an employee). <i>Proposed Solution:</i> Remove unit. 	PCODE IN06DREF ADAAG 4.24.3 ADA 2010 606.2 CBC 2010 1115B.4.7.1 CBC 2013 11B-606.2 Priority 4 Severity 2 TBD Contract Work		REF

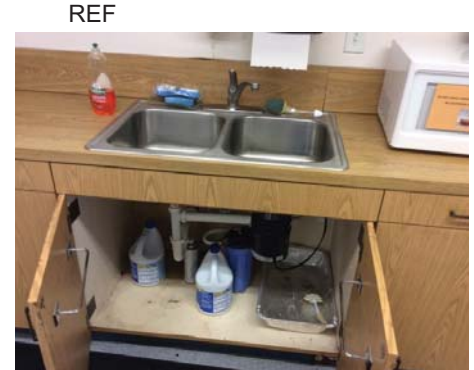
Item No. and Name	Existing Architectural Barrier and Proposed Solution	Codes / Mitigation Info	Qty	Unit	Cost	Total
1273	<ul style="list-style-type: none"> • <i>As-Built Description:</i> Sink rim higher than 34" above floor. • <i>As-Built:</i> 36" • <i>Proposed Solution:</i> Remodel sink cabinet to lower sink. 	PCODE IN06REF ADAAG 4.24.2 ADA 2010 606.3 CBC 2010 1115B.4.7.1 CBC 2013 11B-606.3 Priority 4 Severity 4 TBD Contract Work

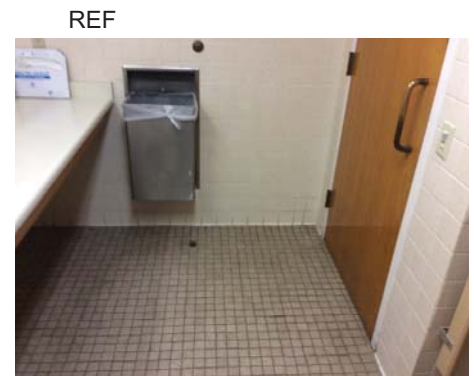
1283	<ul style="list-style-type: none"> • <i>As-Built Description:</i> Front approach: At pull side, door does not have clear and level maneuvering space measuring door width plus 18" x 60". • <i>As-Built:</i> 57" to lav • <i>Proposed Solution:</i> Provide relocated new door and frame; remodel walls as needed. 	PCODE ID23BREF ADAAG Fig. 25(a) ADA 2010 404.2.4 CBC 2010 11B-26A(a) CBC 2013 11B-404.2.4 Priority 4 Severity 4 TBD Contract Work				
------	---	--	--	--	--	--

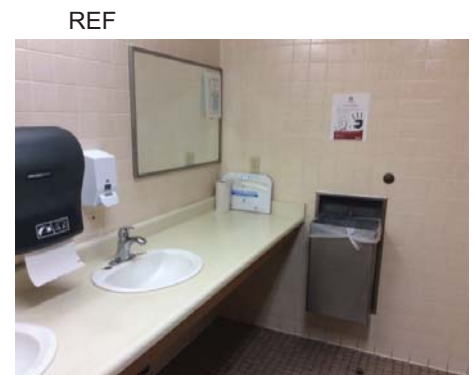
1282	<ul style="list-style-type: none"> • <i>As-Built Description:</i> Lavatory: Fixture rim or counter height more than 34" above floor. • <i>As-Built:</i> 34.5" • <i>Proposed Solution:</i> Remount compliant fixture at accessible height. 	PCODE WD02AREF ADAAG 4.19.2 ADA 2010 606.3 CBC 2010 1115B.4.3 CBC 2013 11B-606.3 Priority 4 Severity 4 TBD Contract Work				
------	--	---	--	--	--	--

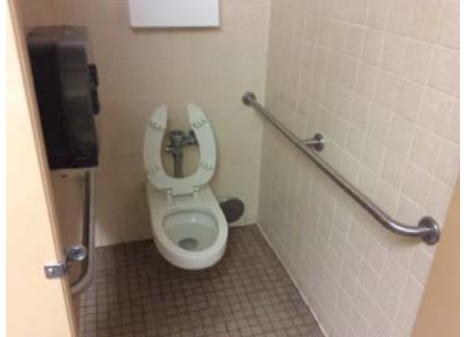
Item No. and Name	Existing Architectural Barrier and Proposed Solution	Codes / Mitigation Info	Qty	Unit	Cost	Total
<u>Restroom</u>						
1279	<ul style="list-style-type: none"> <i>As-Built Description:</i> Multiple accommodation restroom not accessible; multiple compliance violations. <i>Proposed Solution:</i> Remodel area to provide accessible restroom with one accessible stall, lavatory (and one urinal at Mens). 	PCODE WA01A ADAAG 4.22 ADA 2010 603 CBC 2010 1115B.3.1 CBC 2013 11B-603 Priority 4 Severity 1 TBD Contract Work	1	JOB	\$35,000	\$35,000

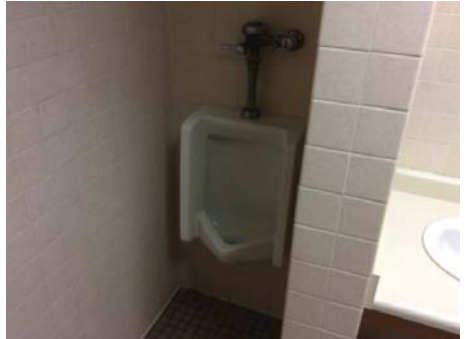
<u>Urinal</u>							
1281	<ul style="list-style-type: none"> <i>As-Built Description:</i> Fixture mounted with rim more than 17" above floor. <i>As-Built:</i> 21" <i>Proposed Solution:</i> Provide accessible urinal. Remodel restroom as needed. 	PCODE WE02REF ADAAG 4.18.2 ADA 2010 605.2 CBC 2010 1115B.4.2.1 CBC 2013 11B-605.2 Priority 4 Severity 3 TBD Contract Work	REF

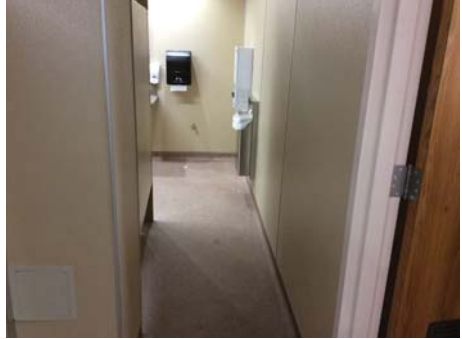
Item No. and Name	Existing Architectural Barrier and Proposed Solution	Codes / Mitigation Info	Qty	Unit	Cost	Total
Corridor						
1291	<ul style="list-style-type: none"> <i>As-Built Description:</i> Corridor less than 36" wide. <i>As-Built:</i> 33-38" to non accessible side. <i>Proposed Solution:</i> Enlarge corridor to 36" wide; relocate stud wall. <i>Notes:</i> Provide FND at accessible side 	PCODE IH03 ADAAG 4.3.3 ADA 2010 403.5.1 CBC 2010 1133B.3.1 CBC 2013 11B-403.5.1 Priority 4 Severity 3 TBD Contract Work	10	LF	\$140	\$1,400

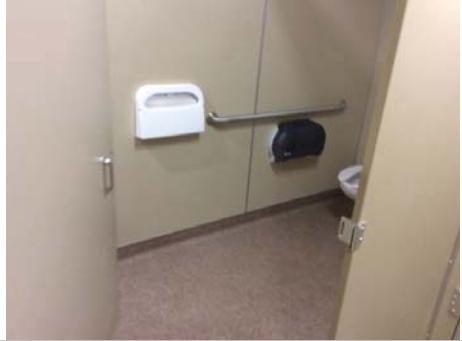
Stall Door						
1289	<ul style="list-style-type: none"> <i>As-Built Description:</i> Stall door opening less than 32" clear (CA only: ... or less than 34" at side entry door). <i>As-Built:</i> 32" side door <i>Proposed Solution:</i> Remove stall. Remodel floor and walls as needed. 	PCODE WB05A ADAAG 4.17.5 ADA 2010 604.8.1.2 CBC 2010 1115B.3.1.4.4 CBC 2013 11B-604.8.1.2 Priority 4 Severity 4 TBD Contract Work	1	JOB	\$250	\$250

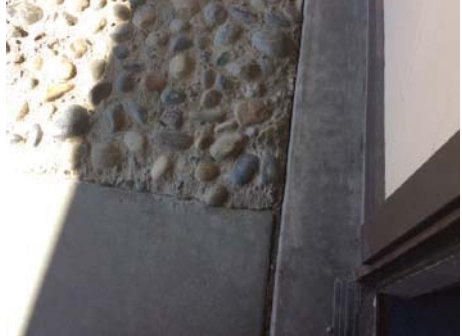
Door						
1318	<ul style="list-style-type: none"> <i>As-Built Description:</i> Surface of required maneuvering clearance at door slopes more than 1/4":12" (2.0%). <i>As-Built:</i> Irregular surface within DW + 24" at exterior door. <i>Proposed Solution:</i> Modify surface slope at door. <i>Notes:</i> To play yard 	PCODE ID11 ADAAG 4.13.6 ADA 2010 404.2.4.4 CBC 2010 1133B.2.4 CBC 2013 11B-404.2.4 Priority 2 Severity 1 TBD Contract Work	5	SF	\$40	\$200

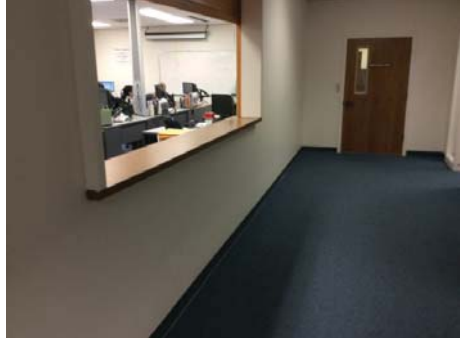
Item No. and Name	Existing Architectural Barrier and Proposed Solution	Codes / Mitigation Info	Qty	Unit	Cost	Total
Public Counter						
1320	<ul style="list-style-type: none"> <i>As-Built Description:</i> Service counter (stand-up): Accessible section min. 36" length and 36" max. height (in CA: 28" to 34" high) not provided. <i>As-Built:</i> 42" <i>Proposed Solution:</i> Provide auxiliary shelf, clipboard, or table as equivalent facilitation. 	PCODE IN03 ADAAG 7.2(2) ADA 2010 904.4 CBC 2010 1122B.4 CBC 2013 11B-904.4 Priority 1 Severity 3 TBD Contract Work	1	JOB	\$150	\$150

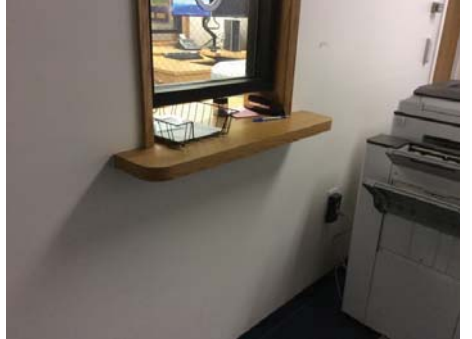
1305	<ul style="list-style-type: none"> <i>As-Built Description:</i> Service Counter (Stand-up): Accessible section min. 36" length and 36" max. height (in CA: 28" to 34" high) not provided. <i>As-Built:</i> staff only; 42.5" <i>Proposed Solution:</i> Provide auxiliary shelf, clipboard, or table as equivalent facilitation. 	PCODE IN03REF ADAAG 7.2(2) ADA 2010 904.4 CBC 2010 1122B.4 CBC 2013 11B-904.4 Priority 1 Severity 3 TBD Contract Work	REF

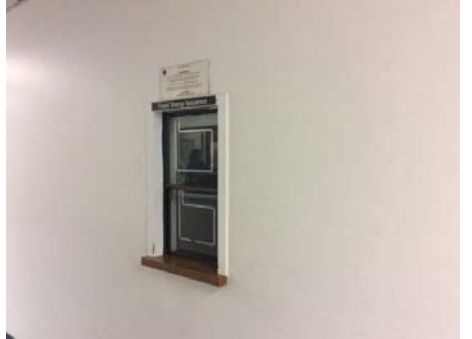
1310	<ul style="list-style-type: none"> <i>As-Built Description:</i> Service Counter (Stand-up): Accessible section min. 36" length and 36" max. height (in CA: 28" to 34" high) not provided. <i>As-Built:</i> No longer in use. 42" <i>Proposed Solution:</i> Provide auxiliary shelf, clipboard, or table as equivalent facilitation. 	PCODE IN03REF ADAAG 7.2(2) ADA 2010 904.4 CBC 2010 1122B.4 CBC 2013 11B-904.4 Priority 1 Severity 3 TBD Contract Work	REF

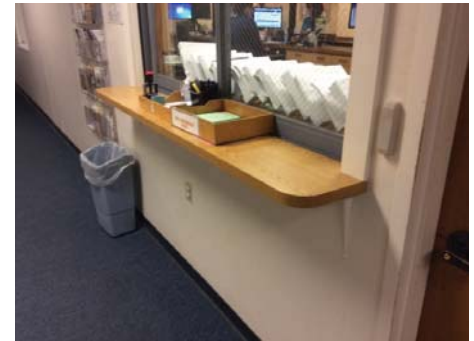
Item No. and Name	Existing Architectural Barrier and Proposed Solution	Codes / Mitigation Info	Qty	Unit	Cost	Total
1307	<ul style="list-style-type: none"> <i>As-Built Description:</i> Service Counter (Stand-up): Accessible section min. 36" length and 36" max. height (in CA: 28" to 34" high) not provided. <i>As-Built:</i> counter shelf 43" <i>Proposed Solution:</i> Provide auxiliary shelf, clipboard, or table as equivalent facilitation. <i>Notes:</i> Staff Only. Not used as counter. 	PCODE IN03REF ADAAG 7.2(2) ADA 2010 904.4 CBC 2010 1122B.4 CBC 2013 11B-904.4 Priority 4 Severity 3 TBD Contract Work

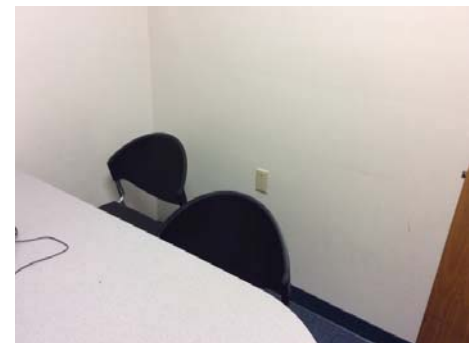
1316	<ul style="list-style-type: none"> <i>As-Built Description:</i> Less than 60" diameter or T-shaped space provided for wheelchair turns. <i>As-Built:</i> 30.5" to desk <i>Proposed Solution:</i> Retrofit space to provide 60" diameter or T-turn. <i>Notes:</i> Provide 2 Acc. rooms 15 total 	PCODE IN04 ADAAG 4.2.3 ADA 2010 304.1 CBC 2010 1118B.3 CBC 2013 11B-304.1 Priority 2 Severity 2 TBD Contract Work	2	JOB	\$925	\$1,850
------	---	---	---	-----	-------	---------

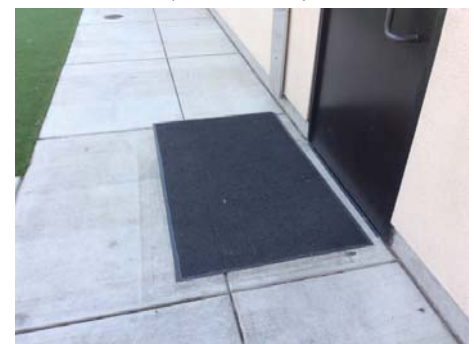
1355	<ul style="list-style-type: none"> <i>As-Built Description:</i> Doormat hinders access to disabled persons. <i>Proposed Solution:</i> Provide new doormat; recess or attach at edges. 	PCODE ID05 ADAAG 4.5.3 ADA 2010 302.2 CBC 2010 1124B.3 CBC 2013 11B-302.2 Priority 1 Severity 3 TBD Contract Work	1	JOB	\$500	\$500
------	---	---	---	-----	-------	-------

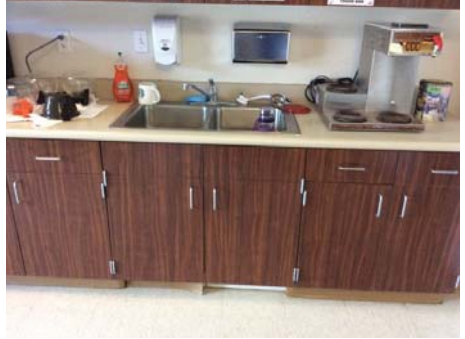
Item No. and Name	Existing Architectural Barrier and Proposed Solution	Codes / Mitigation Info	Qty	Unit	Cost	Total
Sink						
1361	<ul style="list-style-type: none"> As-Built Description: Sink rim higher than 34" above floor. As-Built: 34.5" Proposed Solution: Remodel sink cabinet to lower sink. 	PCODE IN06 ADAAG 4.24.2 ADA 2010 606.3 CBC 2010 1115B.4.7.1 CBC 2013 11B-606.3 Priority 4 Severity 4 TBD Contract Work	1	JOB	\$1,750	\$1,750

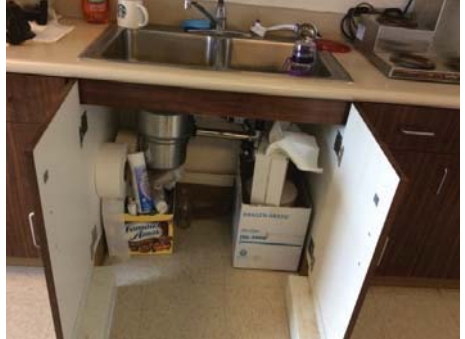
1358	<ul style="list-style-type: none"> As-Built Description: Hot or sharp-surfaced water/drain pipe not insulated or covered. Proposed Solution: Insulate or cover water/drain pipe. 	PCODE IN06C ADAAG 4.24.6 ADA 2010 606.5 CBC 2010 1115B.4.7.1 CBC 2013 11B-606.5 Priority 4 Severity 3 TBD Contract Work	1	JOB	\$120	\$120

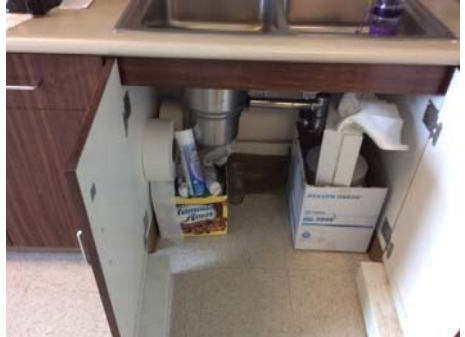
1359	<ul style="list-style-type: none"> As-Built Description: Food waste disposal at kitchen sink protrudes into knee space (recommended: remove equipment if requested as a reasonable accommodation by an employee). Proposed Solution: Remove unit. 	PCODE IN06D ADAAG 4.24.3 ADA 2010 606.2 CBC 2010 1115B.4.7.1 CBC 2013 11B-606.2 Priority 4 Severity 2 TBD Contract Work	1	JOB	\$300	\$300

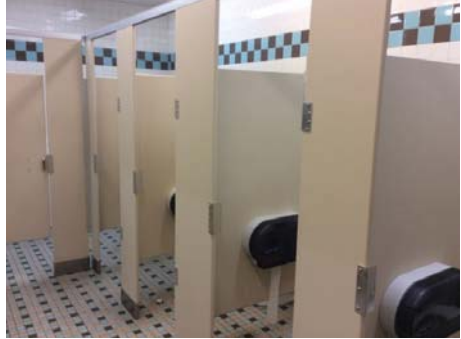
Item No. and Name	Existing Architectural Barrier and Proposed Solution	Codes / Mitigation Info	Qty	Unit	Cost	Total
<u>Semi-Ambulant Stall</u>						
1376	<ul style="list-style-type: none"> <i>As-Built Description:</i> Semi-ambulant stall in restroom not compliant (one required where 6 or more exist). <i>Proposed Solution:</i> Provide grab bars in otherwise compliant stall. <i>Notes:</i> 6 stalls no semi amb 	PCODE WB06BNT ADAAG 4.22.4 ADA 2010 213.3.1 CBC 2010 1115B.3.1.5 CBC 2013 11B-213.3.1 Priority 3 Severity 2 TBD Contract Work	1	JOB	\$400	\$400

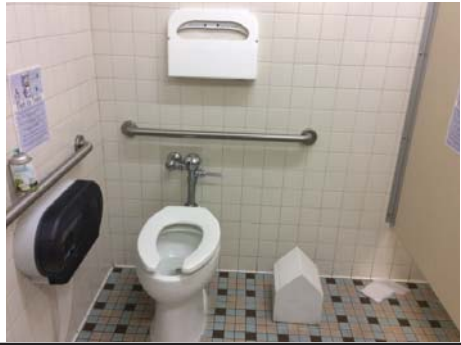
<u>Water Closet</u>						
1379	<ul style="list-style-type: none"> <i>As-Built Description:</i> Height of water closet seat less than 17" or more than 19" from floor. <i>As-Built:</i> 19.5" <i>Proposed Solution:</i> Provide new accessible water closet. 	PCODE WB08 ADAAG 4.16.3 ADA 2010 604.4 CBC 2010 1115B.4.1.4 CBC 2013 11B-604.4 Priority 3 Severity 4 TBD Contract Work	1	JOB	\$1,400	\$1,400

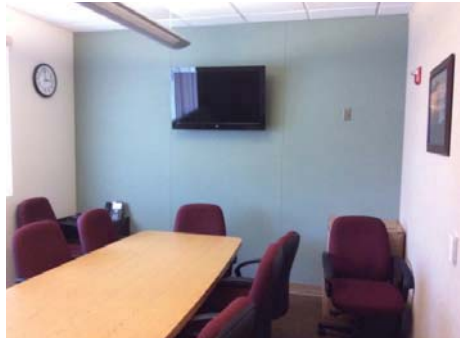
<u>Assistive Listening</u>							
1383	<ul style="list-style-type: none"> <i>As-Built Description:</i> No portable assistive listening system provided for small meeting room. <i>Proposed Solution:</i> Share existing portable assistive listening system from other facility if needed. 	PCODE GI01E ADAAG 4.1.3(19)(b) & 4.33.7 ADA 2010 219.1 & 706.1 CBC 2010 1104B.2 CBC 2013 11B-219.2 Priority 3 Severity 3 TBD Contract Work	REF

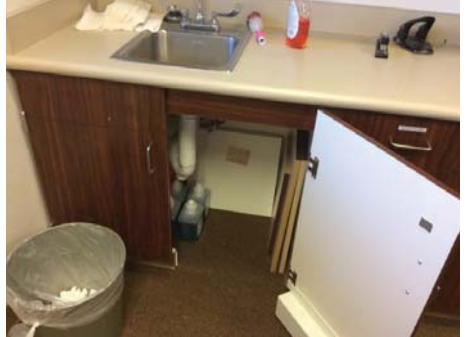
Item No. and Name	Existing Architectural Barrier and Proposed Solution	Codes / Mitigation Info	Qty	Unit	Cost	Total
Sink						
1385	<ul style="list-style-type: none"> As-Built Description: Sink rim higher than 34" above floor. As-Built: 34.5" Proposed Solution: Remodel sink cabinet to lower sink. 	PCODE IN06 ADAAG 4.24.2 ADA 2010 606.3 CBC 2010 1115B.4.7.1 CBC 2013 11B-606.3 Priority 3 Severity 4 TBD Contract Work	1	JOB	\$1,750	\$1,750

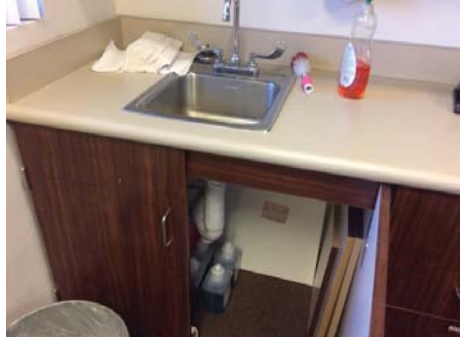
1386	<ul style="list-style-type: none"> As-Built Description: Sink does not have knee space min. 27" high x 19" deep x 30" wide. As-Built: 8" deep at 13" high Proposed Solution: Remodel sink cabinet. 	PCODE IN06A ADAAG 4.24.3 ADA 2010 606.2 CBC 2010 1115B.4.7.1 CBC 2013 11B-606.2 Priority 2 Severity 2 TBD Contract Work	1	JOB	\$1,750	\$1,750

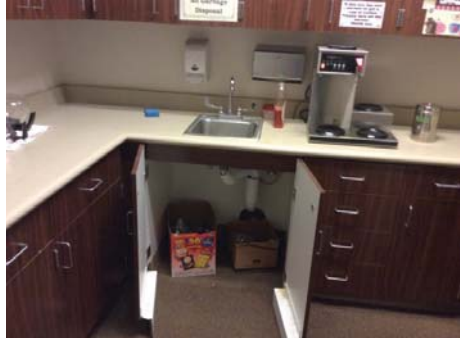
Sink						
1392	<ul style="list-style-type: none"> As-Built Description: Sink rim higher than 34" above floor. As-Built: 34.5" Proposed Solution: Remodel sink cabinet to lower sink. 	PCODE IN06 ADAAG 4.24.2 ADA 2010 606.3 CBC 2010 1115B.4.7.1 CBC 2013 11B-606.3 Priority 3 Severity 4 TBD Contract Work	1	JOB	\$1,750	\$1,750

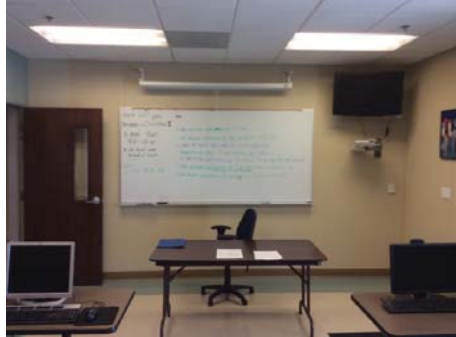
43 Cedar Classroom

Item No. and Name	Existing Architectural Barrier and Proposed Solution	Codes / Mitigation Info	Qty	Unit	Cost	Total
<u>Assistive Listening</u>						
1414	<ul style="list-style-type: none"> <i>As-Built Description:</i> No portable assistive listening system provided for small meeting room. <i>Proposed Solution:</i> Share existing portable assistive listening system from other facility if needed. 	PCODE GI01E ADAAG 4.1.3(19)(b) & 4.33.7 ADA 2010 219.1 & 706.1 CBC 2010 1104B.2 CBC 2013 11B-219.2 Priority 3 Severity 3 TBD Contract Work				
						REF
