Facility: **WOMENS INFANTS & CHILDREN**

Address: 330 HARRIS ST.

Facility: **LEMORE HEALTH CLINIC**
 Address: 229 C ST.

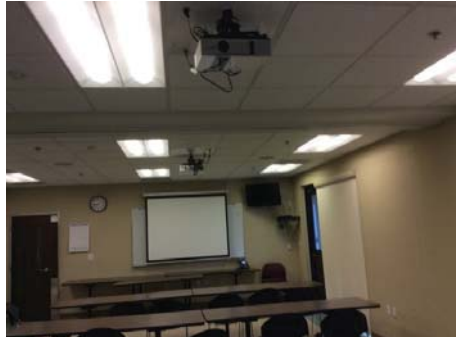
44 Sequoia Classroom

<u>Assistive Listening</u>						
1421	<ul style="list-style-type: none"> <i>As-Built Description:</i> No portable assistive listening system provided for small meeting room. <i>Proposed Solution:</i> Share existing portable assistive listening system from other facility if needed. 	PCODE GI01E ADAAG 4.1.3(19)(b) & 4.33.7 ADA 2010 219.1 & 706.1 CBC 2010 1104B.2 CBC 2013 11B-219.2 Priority 3 Severity 3 TBD Contract Work				
						REF

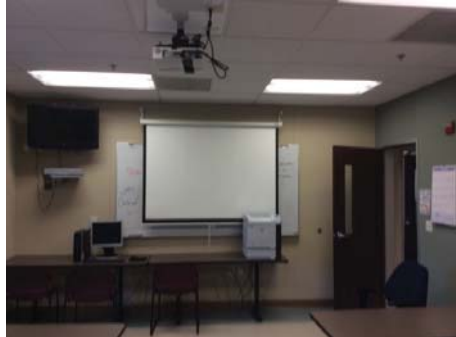
45 Pine Classroom

<u>Assistive Listening</u>						
1427	<ul style="list-style-type: none"> <i>As-Built Description:</i> No portable assistive listening system provided for small meeting room. <i>Proposed Solution:</i> Share existing portable assistive listening system from other facility if needed. 	PCODE GI01E ADAAG 4.1.3(19)(b) & 4.33.7 ADA 2010 219.1 & 706.1 CBC 2010 1104B.2 CBC 2013 11B-219.2 Priority 3 Severity 3 TBD Contract Work				
						REF

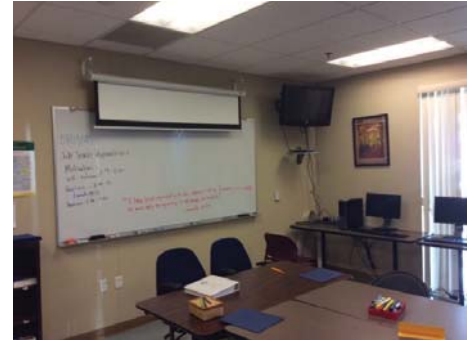
46 Classroom Lobby North

Item No. and Name	Existing Architectural Barrier and Proposed Solution	Codes / Mitigation Info	Qty	Unit	Cost	Total
<u>Assistive Listening</u>						
1434	<ul style="list-style-type: none"> <i>As-Built Description:</i> No portable assistive listening system provided for small meeting room. <i>Proposed Solution:</i> Share existing portable assistive listening system from other facility if needed. 	PCODE GI01E ADAAG 4.1.3(19)(b) & 4.33.7 ADA 2010 219.1 & 706.1 CBC 2010 1104B.2 CBC 2013 11B-219.2 Priority 3 Severity 3 TBD Contract Work				
						REF

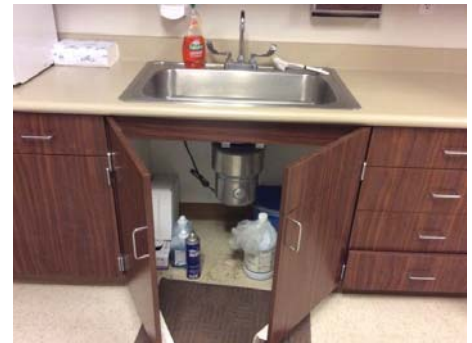
47 Classroom Lobby North - Women's RR

<u>Sink</u>						
1435	<ul style="list-style-type: none"> <i>As-Built Description:</i> Food waste disposal at kitchen sink protrudes into knee space (recommended: remove equipment if requested as a reasonable accommodation by an employee). <i>Proposed Solution:</i> Remove unit. Notes: Public area 	PCODE IN06D ADAAG 4.24.3 ADA 2010 606.2 CBC 2010 1115B.4.7.1 CBC 2013 11B-606.2 Priority 2 Severity 2 TBD Contract Work				
			1	JOB	\$300	\$300

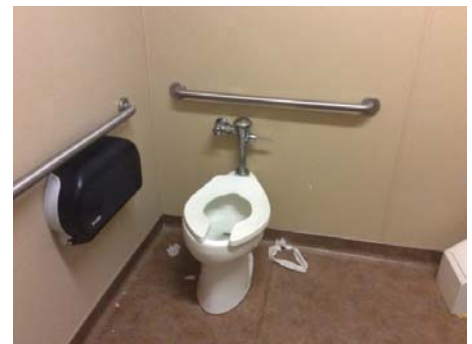
49 Classroom Lobby South

<u>Water Closet</u>						
1441	<ul style="list-style-type: none"> <i>As-Built Description:</i> Water closet not 17"-18" from near side wall to center line of water closet (2010 ADAS: 16"-18"). <i>As-Built:</i> 19" o.c. <i>Proposed Solution:</i> Relocate existing water closet and plumbing, remount with offset closet flange to provide 17"-18" from side wall. 	PCODE WB02C ADAAG Fig. 28 ADA 2010 604.2 CBC 2010 1115B.4.1.1 CBC 2013 11B-604.2 Priority 3 Severity 4 TBD Contract Work				
			1	JOB	\$500	\$500

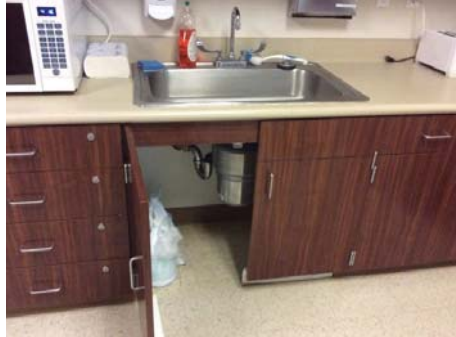
50 Classroom Lobby South - Women's RR

Item No. and Name	Existing Architectural Barrier and Proposed Solution	Codes / Mitigation Info	Qty	Unit	Cost	Total
Sink						
1451	<ul style="list-style-type: none"> <i>As-Built Description:</i> Food waste disposal at kitchen sink protrudes into knee space (recommended: remove equipment if requested as a reasonable accommodation by an employee). <i>Proposed Solution:</i> Remove unit. <i>Notes:</i> Public area 	PCODE IN06D ADAAG 4.24.3 ADA 2010 606.2 CBC 2010 1115B.4.7.1 CBC 2013 11B-606.2 Priority 2 Severity 2 TBD Contract Work	1	JOB	\$300	\$300

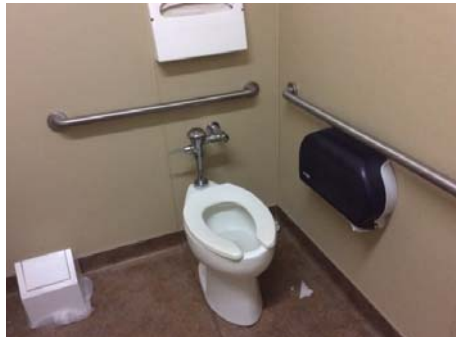
51 Classroom Lobby South - Men's RR

Water Closet						
1458	<ul style="list-style-type: none"> <i>As-Built Description:</i> Water closet not 17"-18" from near side wall to center line of water closet (2010 ADAS: 16"-18"). <i>As-Built:</i> 19" o.c. <i>Proposed Solution:</i> Relocate existing water closet and plumbing, remount with offset closet flange to provide 17"-18" from side wall. 	PCODE WB02C ADAAG Fig. 28 ADA 2010 604.2 CBC 2010 1115B.4.1.1 CBC 2013 11B-604.2 Priority 3 Severity 4 TBD Contract Work	1	JOB	\$500	\$500

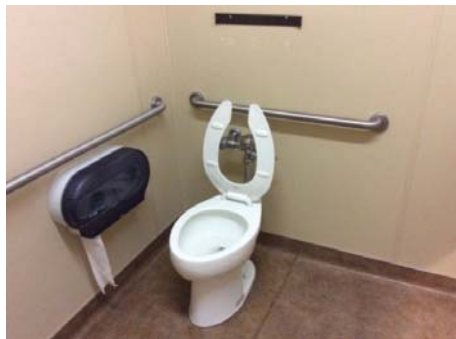
Water Closet						
1463	<ul style="list-style-type: none"> <i>As-Built Description:</i> Water closet not 17"-18" from near side wall to center line of water closet (2010 ADAS: 16"-18"). <i>As-Built:</i> 19" o.c. <i>Proposed Solution:</i> Relocate existing water closet and plumbing, remount with offset closet flange to provide 17"-18" from side wall. 	PCODE WB02C ADAAG Fig. 28 ADA 2010 604.2 CBC 2010 1115B.4.1.1 CBC 2013 11B-604.2 Priority 3 Severity 4 TBD Contract Work	1	JOB	\$500	\$500

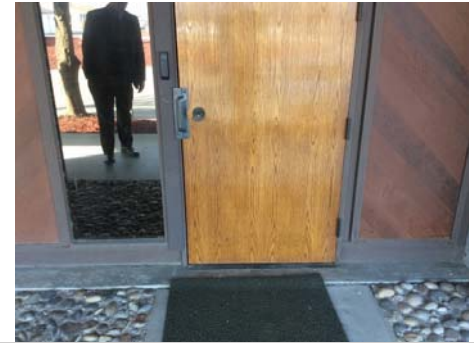
1468	<ul style="list-style-type: none"> As-Built Description: Surface of required maneuvering clearance at door slopes more than 1/4":12" (2.0%). As-Built: 5" to irregular surface within DW + 24" at exterior door. Proposed Solution: Modify surface slope at door. 	<p>PCODE ID11 ADAAG 4.13.6 ADA 2010 404.2.4.4 CBC 2010 1133B.2.4 CBC 2013 11B-404.2.4 Priority 2 Severity 1 TBD Contract Work</p>	10	SF	\$40	\$400
------	---	--	----	----	------	-------

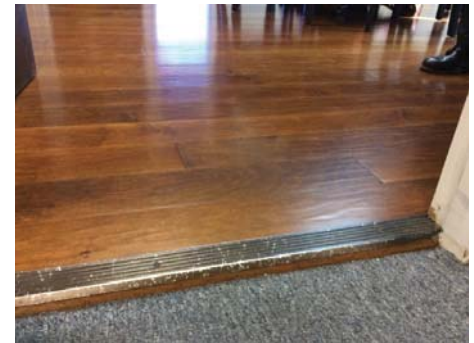
3 Staff Breakroom

1472	<ul style="list-style-type: none"> As-Built Description: Door inaccessible due to threshold or step at door exceeding 1/2". As-Built: 0.75" Proposed Solution: Modify threshold to be no more than 1/2" by removing existing paving at door and providing landing with edge ramping (slope 1:20 max). Notes: 26.75" 	<p>PCODE ID02A ADAAG 4.13.8 ADA 2010 404.2.5 CBC 2010 1133B.2.4.1 CBC 2013 11B-404.2.5 Priority 2 Severity 4 TBD Contract Work</p>	1	JOB	\$400	\$400
------	---	---	---	-----	-------	-------

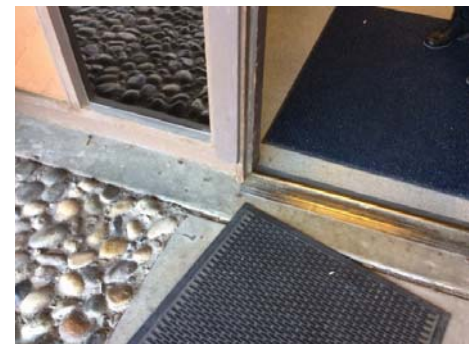
1478	<ul style="list-style-type: none"> As-Built Description: Surface of required maneuvering clearance at door slopes more than 1/4":12" (2.0%). As-Built: Irregular surface within DW + 24" at exterior door. Proposed Solution: Modify surface slope at door. 	<p>PCODE ID11 ADAAG 4.13.6 ADA 2010 404.2.4.4 CBC 2010 1133B.2.4 CBC 2013 11B-404.2.4 Priority 4 Severity 1 TBD Contract Work</p>	10	SF	\$40	\$400
------	---	--	----	----	------	-------

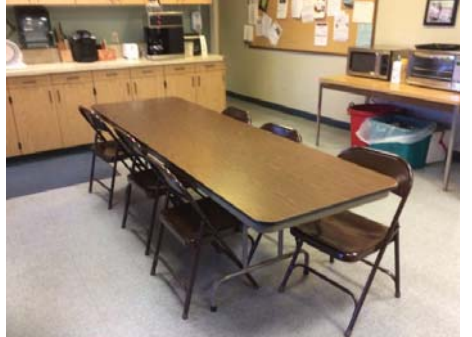
Item No. and Name	Existing Architectural Barrier and Proposed Solution	Codes / Mitigation Info	Qty	Unit	Cost	Total
Non-Fixed Desk						
1479	<ul style="list-style-type: none"> <i>As-Built Description:</i> Accessible non-fixed table or desk (top 28" to 34" high; knee space at least 27" high x 19" deep x 30" wide) not provided. <i>As-Built:</i> 26" <i>Proposed Solution:</i> Provide table or desk with accessible dimensions when purchasing new furniture. 	PCODE IN02A ADAAG 4.32.3 & .4 ADA 2010 306.1 CBC 2010 1122B.3 & 4 CBC 2013 11B-306.1 & 11B-902.3 Priority 4 Severity 2 TBD Contract Work	1	JOB	\$1,600	\$1,600

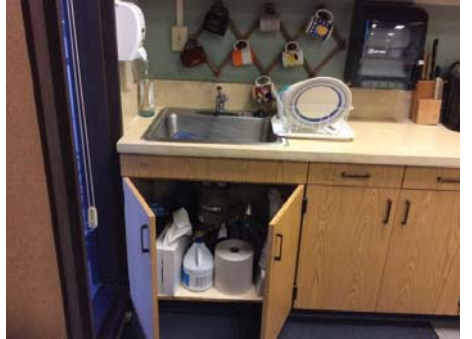
Sink						
1473	<ul style="list-style-type: none"> <i>As-Built Description:</i> Sink does not have knee space min. 27" high x 19" deep x 30" wide. <i>Proposed Solution:</i> Remodel sink cabinet. 	PCODE IN06A ADAAG 4.24.3 ADA 2010 606.2 CBC 2010 1115B.4.7.1 CBC 2013 11B-606.2 Priority 4 Severity 2 TBD Contract Work	1	JOB	\$1,750	\$1,750

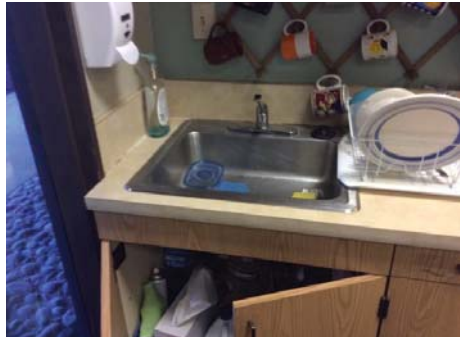
4 Staff Office West

1474	<ul style="list-style-type: none"> <i>As-Built Description:</i> Sink rim higher than 34" above floor. <i>As-Built:</i> 36", also has garbage disposal within knee space. <i>Proposed Solution:</i> Remodel sink cabinet to lower sink. 	PCODE IN06REF ADAAG 4.24.2 ADA 2010 606.3 CBC 2010 1115B.4.7.1 CBC 2013 11B-606.3 Priority 4 Severity 4 TBD Contract Work	REF

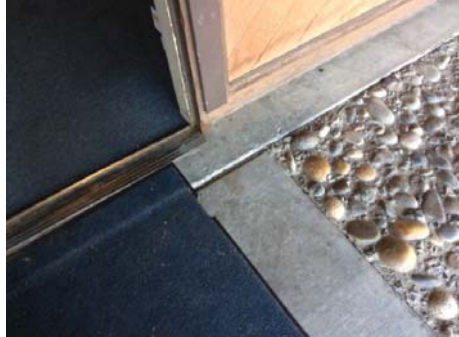
5 Sexual Assault Offices

Item No. and Name	Existing Architectural Barrier and Proposed Solution	Codes / Mitigation Info	Qty	Unit	Cost	Total
Door						
1486	<ul style="list-style-type: none"> <i>As-Built Description:</i> Surface of required maneuvering clearance at door slopes more than 1/4":12" (2.0%). <i>As-Built:</i> 5" to irregular surface within DW + 24" at exterior door. <i>Proposed Solution:</i> Modify surface slope at door. 	PCODE ID11 ADAAG 4.13.6 ADA 2010 404.2.4.4 CBC 2010 1133B.2.4 CBC 2013 11B-404.2.4 Priority 2 Severity 1 TBD Contract Work	10	SF	\$40	\$400

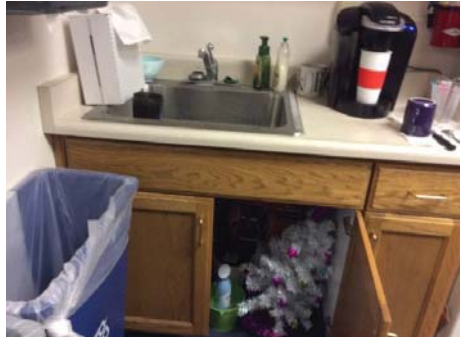
Sink						
1488	<ul style="list-style-type: none"> <i>As-Built Description:</i> Sink does not have knee space min. 27" high x 19" deep x 30" wide. <i>As-Built:</i> 26" <i>Proposed Solution:</i> Remodel sink cabinet. 	PCODE IN06A ADAAG 4.24.3 ADA 2010 606.2 CBC 2010 1115B.4.7.1 CBC 2013 11B-606.2 Priority 2 Severity 2 TBD Contract Work	1	JOB	\$1,750	\$1,750

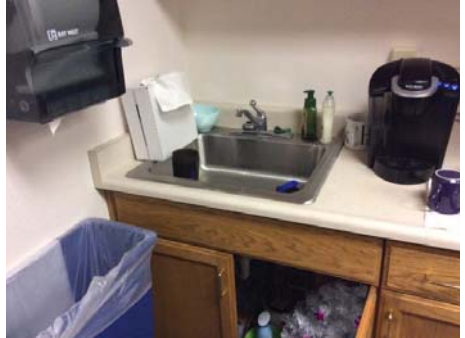
6 Sexual Assault Lobby

1489	<ul style="list-style-type: none"> <i>As-Built Description:</i> Sink rim higher than 34" above floor. <i>As-Built:</i> 34.5" <i>Proposed Solution:</i> Remodel sink cabinet to lower sink. 	PCODE IN06REF ADAAG 4.24.2 ADA 2010 606.3 CBC 2010 1115B.4.7.1 CBC 2013 11B-606.3 Priority 3 Severity 4 TBD Contract Work	REF

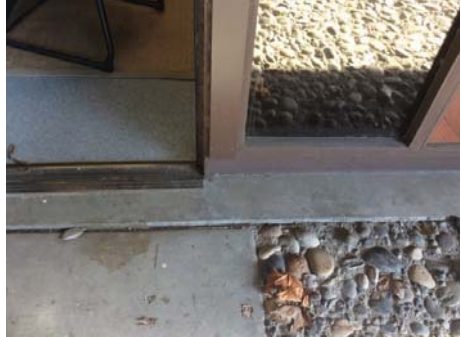
Item No. and Name	Existing Architectural Barrier and Proposed Solution	Codes / Mitigation Info	Qty	Unit	Cost	Total
<u>Door</u>						
1494	<ul style="list-style-type: none"> • <i>As-Built Description:</i> Surface of required maneuvering clearance at door slopes more than 1/4":12" (2.0%). • <i>As-Built:</i> 5" to irregular surface within DW + 24" at exterior door. • <i>Proposed Solution:</i> Modify surface slope at door. 	PCODE ID11 ADAAG 4.13.6 ADA 2010 404.2.4.4 CBC 2010 1133B.2.4 CBC 2013 11B-404.2.4 Priority 1 Severity 1 TBD Contract Work	10	SF	\$40	\$400

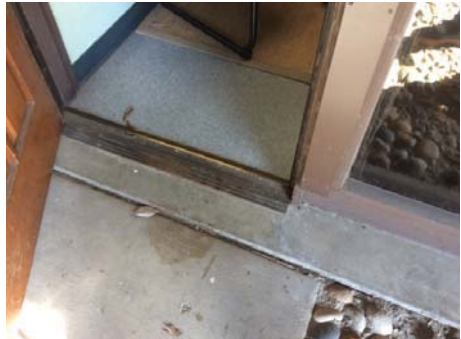
7 Sexual Assault Interview Room

<u>Door Threshold</u>						
1495	<ul style="list-style-type: none"> • <i>As-Built Description:</i> Existing threshold at door is 1/2" high or less but without a beveled edge on both sides. • <i>Proposed Solution:</i> Modify threshold to have beveled edge on each side. 	PCODE ID02 ADAAG 4.1.6(3)(d)(ii) ADA 2010 404.2.5 CBC 2010 1133B.2.4.1 CBC 2013 11B-404.2.5 Priority 1 Severity 4 TBD Contract Work	1	JOB	\$250	\$250

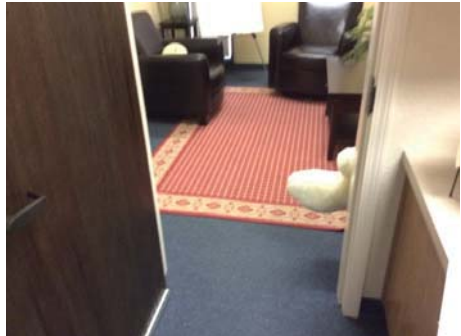
<u>Door Clearance</u>						
1504	<ul style="list-style-type: none"> • <i>As-Built Description:</i> Door on accessible route has less than 32" clear and 80" (78" min. to closer if provided) opening width when 90° open. • <i>As-Built:</i> 29" • <i>Proposed Solution:</i> Provide new, larger door and frame with new accessible hardware. 	PCODE ID01 ADAAG 4.13.5 ADA 2010 404.2.3 CBC 2010 1133B.1.1.1.1 CBC 2013 11B-404.2.3 Priority 2 Severity 3 TBD Contract Work	1	JOB	\$2,600	\$2,600

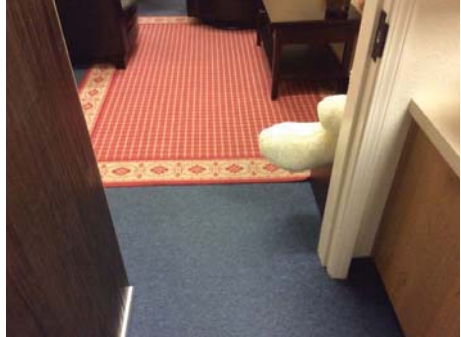
Item No. and Name	Existing Architectural Barrier and Proposed Solution	Codes / Mitigation Info	Qty	Unit	Cost	Total
<u>Door Swing</u>						
1503	<ul style="list-style-type: none"> • <i>As-Built Description:</i> Front approach: At pull side, door does not have clear and level maneuvering space measuring door width plus 18" x 60". • <i>As-Built:</i> 4" to desk counter • <i>Proposed Solution:</i> Provide relocated new door and frame; remodel walls as needed. 	<p>PCODE ID23BREF ADAAG Fig. 25(a) ADA 2010 404.2.4 CBC 2010 11B-26A(a) CBC 2013 11B-404.2.4 Priority 2 Severity 2 TBD Contract Work</p>				
						REF

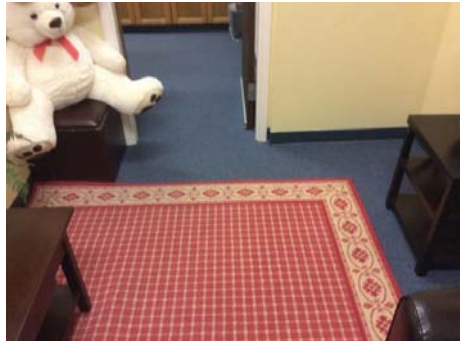
8 DA Staff Conference Room

<u>Turn Space</u>						
1507	<ul style="list-style-type: none"> • <i>As-Built Description:</i> Less than 60" diameter or T-shaped space provided for wheelchair turns. • <i>As-Built:</i> 50" • <i>Proposed Solution:</i> Retrofit space to provide 60" diameter or T-turn. 	<p>PCODE IN04 ADAAG 4.2.3 ADA 2010 304.1 CBC 2010 1118B.3 CBC 2013 11B-304.1 Priority 2 Severity 2 TBD Contract Work</p>	1	JOB	\$925	\$925

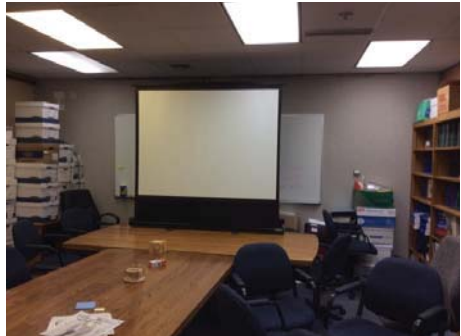
9 DA Restroom Corridor

<u>Assistive Listening</u>						
1512	<ul style="list-style-type: none"> • <i>As-Built Description:</i> No portable assistive listening system provided for small meeting room. • <i>Proposed Solution:</i> Share existing portable assistive listening system from other facility if needed. 	<p>PCODE GI01E ADAAG 4.1.3(19)(b) & 4.33.7 ADA 2010 219.1 & 706.1 CBC 2010 1104B.2 CBC 2013 11B-219.2 Priority 3 Severity 3 TBD Contract Work</p>				
						REF

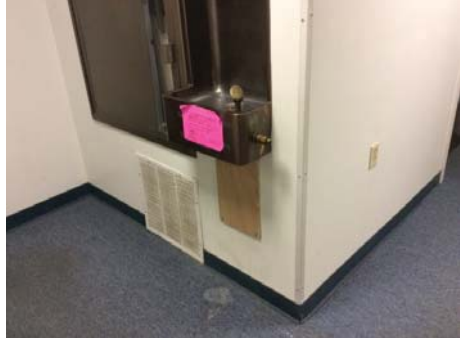
Item No. and Name	Existing Architectural Barrier and Proposed Solution	Codes / Mitigation Info	Qty	Unit	Cost	Total
<u>Drinking Fountain</u>						
1515	<ul style="list-style-type: none"> <i>As-Built Description:</i> Where only one drinking fountain is provided per floor: Fountain is not accessible to individuals who use wheelchairs, or to those who have difficulty bending or stooping. <i>Proposed Solution:</i> Provide additional fountain or hi-lo combination fountain. 	PCODE IA01A ADAAG 4.1.3(10)(a) ADA 2010 211.1 CBC 2010 1115B.4.6.1 CBC 2013 11B-211.1 Priority 3 Severity 2 TBD Contract Work	1	JOB	\$2,000	\$2,000

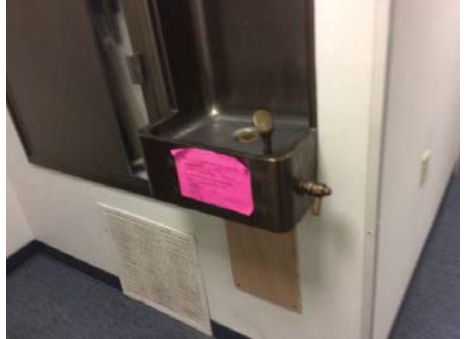
1516	<ul style="list-style-type: none"> <i>As-Built Description:</i> Wall- and post-mounted cantilevered units: Knee space not provided at drinking fountain (27" high, 8" deep, 30" wide from front of drinking fountain). <i>As-Built:</i> 6.5" deep <i>Proposed Solution:</i> Provide new, accessible fountain. 	PCODE IA02 ADAAG 4.15.5(1) ADA 2010 602.2 CBC 2010 1115B.4.6.2 CBC 2013 11B-602.2 Priority 3 Severity 1 TBD Contract Work	1	JOB	\$3,200	\$3,200

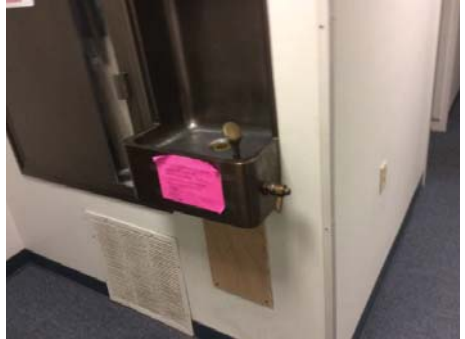
1517	<ul style="list-style-type: none"> <i>As-Built Description:</i> Drinking fountain bubbler more than 36" above floor. <i>As-Built:</i> 40" AFF <i>Proposed Solution:</i> Provide new, accessible fountain. 	PCODE IA03B ADAAG 4.15.2 ADA 2010 602.4 CBC 2010 1115B.4.6.4 CBC 2013 11B-602.4 Priority 3 Severity 4 TBD Contract Work	1	JOB	\$3,200	\$3,200

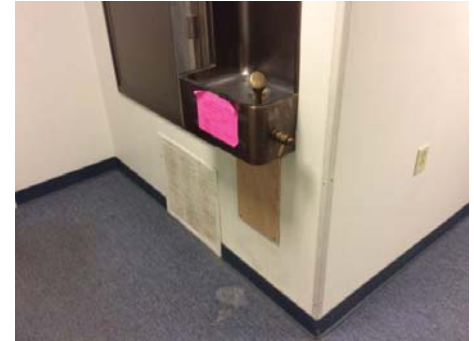
10 DA Restroom Corridor - Kitchenette

Item No. and Name	Existing Architectural Barrier and Proposed Solution	Codes / Mitigation Info	Qty	Unit	Cost	Total
1514	<ul style="list-style-type: none"> <i>As-Built Description:</i> CA only: Drinking fountain not located in an alcove (min. 32" wide x 18" deep) or otherwise encroaches into pedestrian way. <i>Proposed Solution:</i> Provide new alcove for drinking fountain, or, if unreasonable hardship is determined, provide wing walls or cane-detectable railings on each side of the drinking fountain. The wings must project out from the supporting wall at least as far as the drinking fountain to within 6" of the surface of the circulation path, but cannot reduce the required clear width of the adjacent accessible route. 	<p>PCODE IA04</p> <p>CBC 2010 1115B.4.6.3; Fig.</p> <p>CBC 2013 11B-602.9</p> <p>Priority 3</p> <p>Severity 2</p> <p>TBD Contract Work</p>	1	JOB	\$3,000	\$3,000

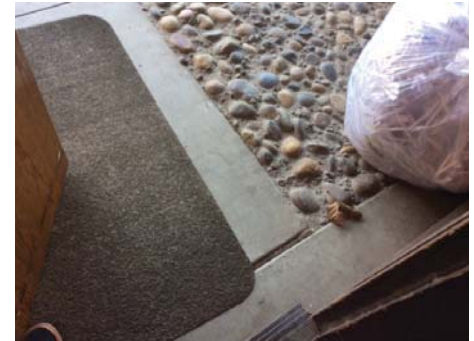
1529	<ul style="list-style-type: none"> <i>As-Built Description:</i> Surface of required maneuvering clearance at door slopes more than 1/4":12" (2.0%). <i>As-Built:</i> 8" to irregular surface within DW + 24" at exterior door. <i>Proposed Solution:</i> Modify surface slope at door. 	<p>PCODE ID11</p> <p>ADAAG 4.13.6</p> <p>ADA 2010 404.2.4.4</p> <p>CBC 2010 1133B.2.4</p> <p>CBC 2013 11B-404.2.4</p> <p>Priority 3</p> <p>Severity 1</p> <p>TBD Contract Work</p>	10	SF	\$40	\$400
------	---	--	----	----	------	--------------

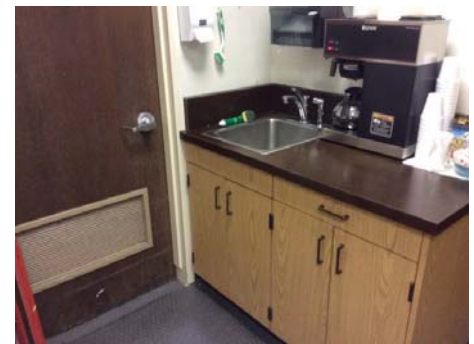
1523	<ul style="list-style-type: none"> <i>As-Built Description:</i> Sink does not have knee space min. 27" high x 19" deep x 30" wide. <i>Proposed Solution:</i> Remodel sink cabinet. 	<p>PCODE IN06A</p> <p>ADAAG 4.24.3</p> <p>ADA 2010 606.2</p> <p>CBC 2010 1115B.4.7.1</p> <p>CBC 2013 11B-606.2</p> <p>Priority 2</p> <p>Severity 2</p> <p>TBD Contract Work</p>	1	JOB	\$1,750	\$1,750
------	--	---	---	-----	---------	----------------

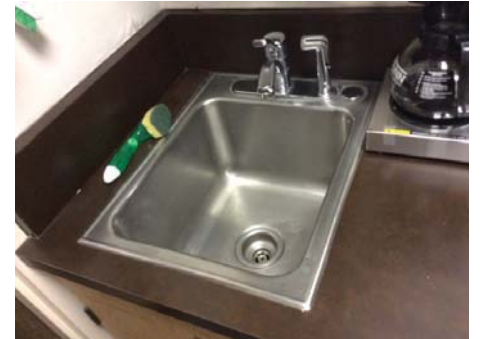
Item No. and Name	Existing Architectural Barrier and Proposed Solution	Codes / Mitigation Info	Qty	Unit	Cost	Total
1524	<ul style="list-style-type: none"> As-Built Description: Sink is more than 6 1/2" deep. As-Built: 10" Proposed Solution: Provide new sink remodel and cabinet as needed. 	<p>PCODE IN06B ADAAG 4.24.4 CBC 2010 1115B.4.7.1 CBC 2013 11B-606.7 Priority 3 Severity 3 TBD Contract Work</p>	1	JOB	\$1,850	\$1,850

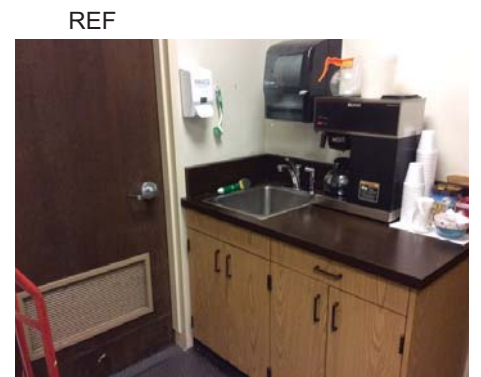
1525	<ul style="list-style-type: none"> As-Built Description: Sink rim higher than 34" above floor. As-Built: 35.5" Proposed Solution: Remodel sink cabinet to lower sink. 	<p>PCODE IN06REF ADAAG 4.24.2 ADA 2010 606.3 CBC 2010 1115B.4.7.1 CBC 2013 11B-606.3 Priority 3 Severity 4 TBD Contract Work</p>				
------	--	--	--	--	--	--

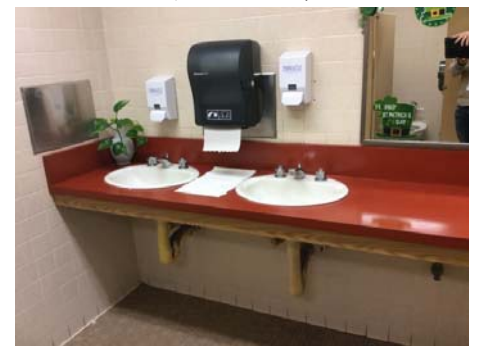
Lavatory

1537	<ul style="list-style-type: none"> As-Built Description: Lavatory: Fixture rim or counter height more than 34" above floor. As-Built: 34.5" Proposed Solution: Provide new accessible lavatory. Remodel restroom as needed. 	<p>PCODE WD02 ADAAG 4.19.2 ADA 2010 606.3 CBC 2010 1115B.4.3 CBC 2013 11B-606.3 Priority 4 Severity 4 TBD Contract Work</p>	1	JOB	\$3,400	\$3,400
------	--	---	---	-----	---------	---------

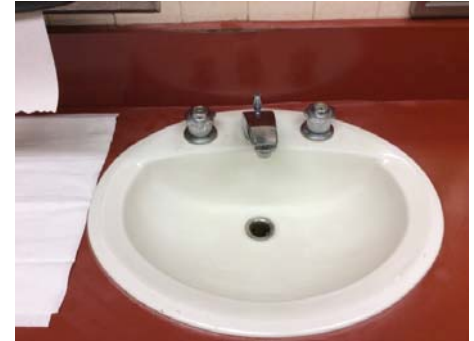
Item No. and Name	Existing Architectural Barrier and Proposed Solution	Codes / Mitigation Info	Qty	Unit	Cost	Total
1538	<ul style="list-style-type: none"> <i>As-Built Description:</i> Lavatory: Accessible faucet (lever-operated, push-type or electronically controlled) not provided at otherwise accessible lavatory. <i>Proposed Solution:</i> Provide accessible faucet at accessible lavatory. 	PCODE WD06 ADAAG 4.19.5 ADA 2010 606.4 CBC 2010 1115B.4.3 CBC 2013 11B-606.4 Priority 4 Severity 3 TBD Contract Work	1	JOB	\$600	\$600

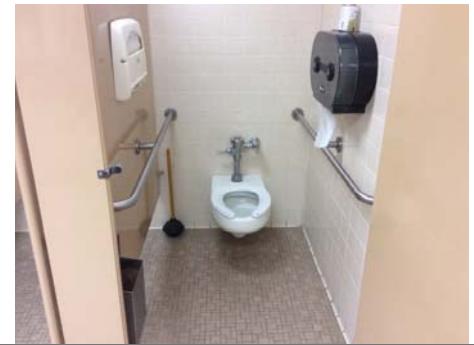
Toilet Stall

1544	<ul style="list-style-type: none"> <i>As-Built Description:</i> Toilet stall less than 60" wide. <i>As-Built:</i> 40" <i>Proposed Solution:</i> Provide new accessible stall. <i>Notes:</i> Multiple items. WC 18.5" o.c. 	PCODE WB06 ADAAG 4.17.3 ADA 2010 604.8.1.1 CBC 2010 1115B.3.1.4.1 CBC 2013 11B-604.8.1.1 Priority 4 Severity 2 TBD Contract Work	1	JOB	\$1,500	\$1,500
------	--	---	---	-----	---------	----------------

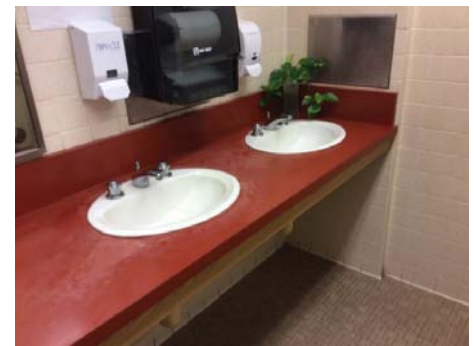
Lavatory

1554	<ul style="list-style-type: none"> <i>As-Built Description:</i> Lavatory: Fixture rim or counter height more than 34" above floor. <i>As-Built:</i> 34.5" <i>Proposed Solution:</i> Provide new accessible lavatory. Remodel restroom as needed. 	PCODE WD02 ADAAG 4.19.2 ADA 2010 606.3 CBC 2010 1115B.4.3 CBC 2013 11B-606.3 Priority 4 Severity 4 TBD Contract Work	1	JOB	\$3,400	\$3,400
------	---	---	---	-----	---------	----------------

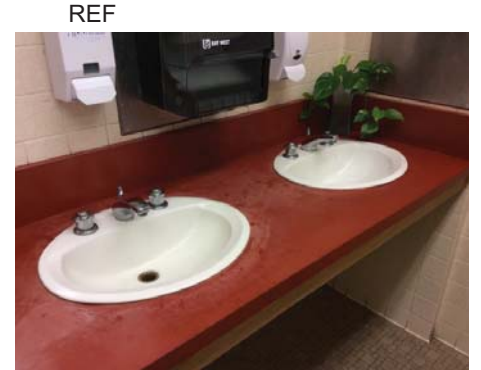
Item No. and Name	Existing Architectural Barrier and Proposed Solution	Codes / Mitigation Info	Qty	Unit	Cost	Total
1553	<ul style="list-style-type: none"> <i>As-Built Description:</i> Lavatory: Accessible faucet (lever-operated, push-type or electronically controlled) not provided at otherwise accessible lavatory. <i>Proposed Solution:</i> Provide accessible faucet at accessible lavatory. 	PCODE WD06REF ADAAG 4.19.5 ADA 2010 606.4 CBC 2010 1115B.4.3 CBC 2013 11B-606.4 Priority 4 Severity 3 TBD Contract Work

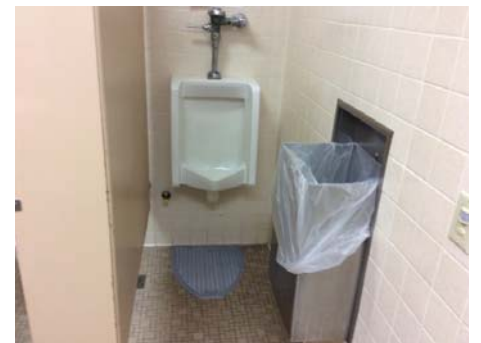
Restroom

1551	<ul style="list-style-type: none"> <i>As-Built Description:</i> Multiple accommodation restroom not accessible; multiple compliance violations. <i>As-Built:</i> 22" to urinal <i>Proposed Solution:</i> Remodel area to provide accessible restroom with one accessible stall, lavatory (and one urinal at Mens). 	PCODE WA01A ADAAG 4.22 ADA 2010 603 CBC 2010 1115B.3.1 CBC 2013 11B-603 Priority 4 Severity 1 TBD Contract Work	1	JOB	\$35,000	\$35,000
------	---	--	---	-----	----------	-----------------

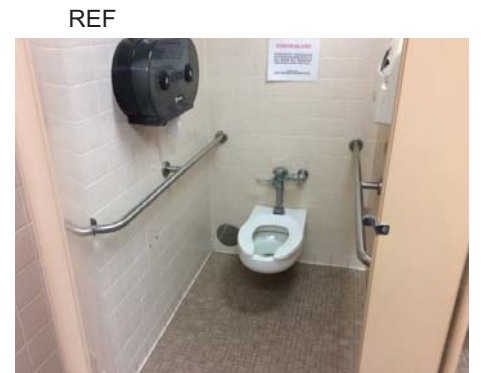
Toilet Stall

1552	<ul style="list-style-type: none"> <i>As-Built Description:</i> Toilet stall less than 60" wide. <i>As-Built:</i> 39.5" <i>Proposed Solution:</i> Provide new accessible stall (alternate stalls 36" x 69" or 48" x 69" not recommended). 	PCODE WB06REF ADAAG 4.17.3 ADA 2010 604.8.1.1 CBC 2010 1115B.3.1.4.1 CBC 2013 11B-604.8.1.1 Priority 4 Severity 2 TBD Contract Work				
------	--	--	--	--	--	--

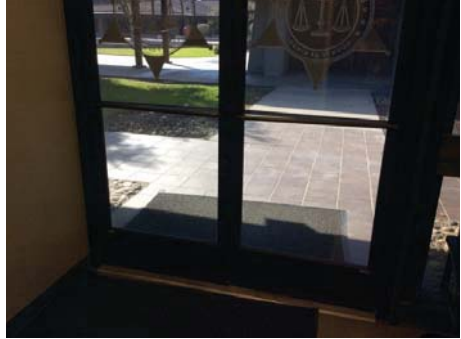
Item No. and Name	Existing Architectural Barrier and Proposed Solution	Codes / Mitigation Info	Qty	Unit	Cost	Total
<u>Door Pair</u>						
1560	<ul style="list-style-type: none"> • <i>As-Built Description:</i> Pair of doors on accessible route has less than 32" clear opening width with one leaf open 90°. • <i>As-Built:</i> 30" • <i>Proposed Solution:</i> Provide new door leaves, unequal in width, to existing frame for pair of doors. 	PCODE ID08A ADAAG 4.13.4 ADA 2010 404.2.2 CBC 2010 1133B.2.3.1 CBC 2013 11B-404.2.2 Priority 1 Severity 3 TBD Contract Work	1	JOB	\$1,500	\$1,500

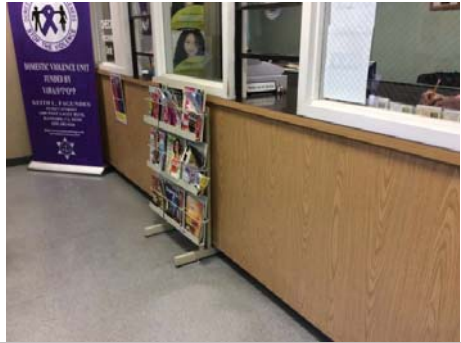
<u>Public Counter</u>						
1563	<ul style="list-style-type: none"> • <i>As-Built Description:</i> Service counter (stand-up): Accessible section min. 36" length and 36" max. height (in CA: 28" to 34" high) not provided. • <i>As-Built:</i> 42" • <i>Proposed Solution:</i> Provide auxiliary shelf, clipboard, or table as equivalent facilitation. 	PCODE IN03 ADAAG 7.2(2) ADA 2010 904.4 CBC 2010 1122B.4 CBC 2013 11B-904.4 Priority 1 Severity 3 TBD Contract Work	1	JOB	\$150	\$150

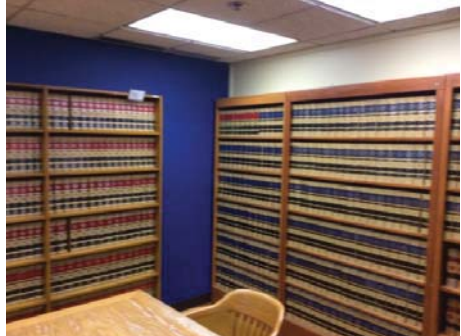
<u>Book Shelves</u>						
1579	<ul style="list-style-type: none"> • <i>As-Built Description:</i> CA only: Book shelves are more than 54" maximum height. • <i>As-Built:</i> 68" • <i>Proposed Solution:</i> Provide attendant when needed. • Notes: Attendant part time. Ensure that help can be received when needed. 	PCODE BD01A ADAAG 4.2.6; Fig. 6 ADA 2010 225.2.2 CBC 2010 1106B.4.3 CBC 2013 11B-225.2.3 Priority 2 Severity 2 TBD Contract Work	JOB		\$0

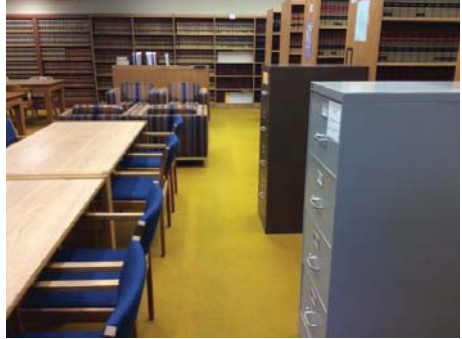
Item No. and Name	Existing Architectural Barrier and Proposed Solution	Codes / Mitigation Info	Qty	Unit	Cost	Total
Open Stack						
1575	<ul style="list-style-type: none"> <i>As-Built Description:</i> Open stacks (i.e. public use) do not have min 36" (44" preferred) wide aisles (CA only: 44" min. width at main aisles and 36" min. at end aisles). <i>As-Built:</i> 28" to chairs <i>Proposed Solution:</i> Enlarge open stack aisles to 44" wide and/or end of aisles to 36". 	PCODE BB01 ADAAG 8.5 CBC 2010 1106B.4.2 CBC 2013 11B-403.5.1 Priority 2 Severity 2 TBD Contract Work	4	LF	\$60	\$240

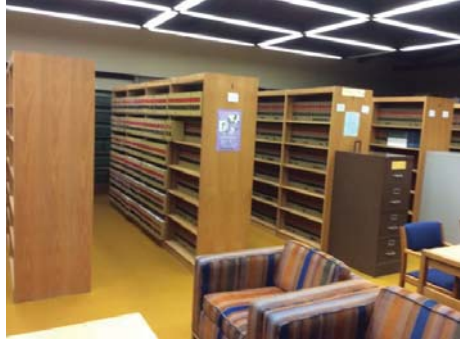
1576	<ul style="list-style-type: none"> <i>As-Built Description:</i> Open stacks (i.e. public use) do not have min 36" (44" preferred) wide aisles (CA only: 44" min. width at main aisles and 36" min. at end aisles). <i>As-Built:</i> 41" <i>Proposed Solution:</i> Enlarge open stack aisles to 44" wide and/or end of aisles to 36". 	PCODE BB01 ADAAG 8.5 CBC 2010 1106B.4.2 CBC 2013 11B-403.5.1 Priority 2 Severity 4 TBD Contract Work	116	LF	\$60	\$6,960

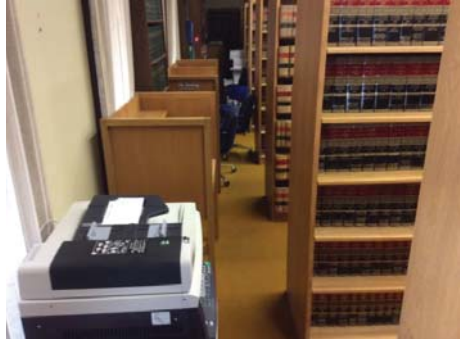
1577	<ul style="list-style-type: none"> <i>As-Built Description:</i> Open stacks (i.e. public use) do not have min 36" (44" preferred) wide aisles (CA only: 44" min. width at main aisles and 36" min. at end aisles). <i>As-Built:</i> 18" <i>Proposed Solution:</i> Enlarge open stack aisles to 44" wide and/or end of aisles to 36". 	PCODE BB01REF ADAAG 8.5 CBC 2010 1106B.4.2 CBC 2013 11B-403.5.1 Priority 2 Severity 1 TBD Contract Work	REF

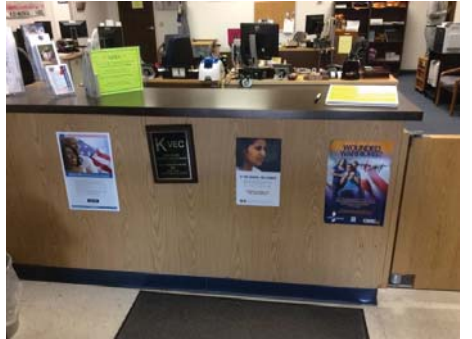
<u>Public Counter</u>						
1588	<ul style="list-style-type: none"> <i>As-Built Description:</i> Service counter (stand-up): Accessible section min. 36" length and 36" max. height (in CA: 28" to 34" high) not provided. <i>As-Built:</i> 42.25" <i>Proposed Solution:</i> Provide auxiliary shelf, clipboard, or table as equivalent facilitation. 	PCODE IN03 ADAAG 7.2(2) ADA 2010 904.4 CBC 2010 1122B.4 CBC 2013 11B-904.4 Priority 1 Severity 3 TBD Contract Work	1	JOB	\$150	\$150

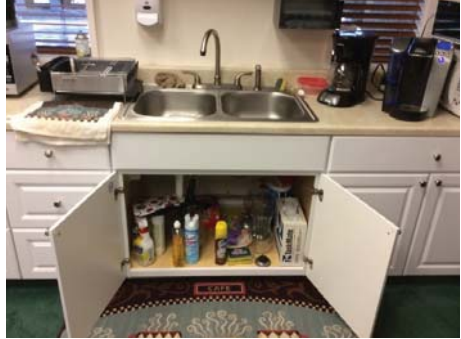
Item No. and Name	Existing Architectural Barrier and Proposed Solution	Codes / Mitigation Info	Qty	Unit	Cost	Total
Sink						
1608	<ul style="list-style-type: none"> As-Built Description: Sink does not have knee space min. 27" high x 19" deep x 30" wide. Proposed Solution: Remodel sink cabinet. 	PCODE IN06A ADAAG 4.24.3 ADA 2010 606.2 CBC 2010 1115B.4.7.1 CBC 2013 11B-606.2 Priority 4 Severity 2 TBD Contract Work	1	JOB	\$1,750	\$1,750

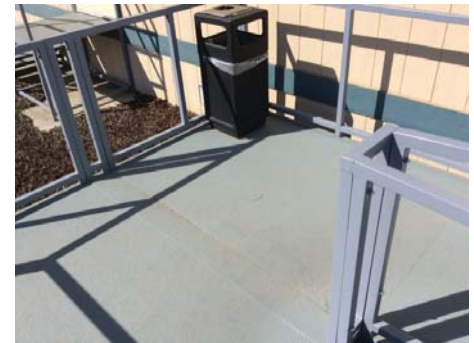
Change in Direction

<p>1620</p> <ul style="list-style-type: none"> • <i>As-Built Description:</i> Landing at change of direction not 60" minimum by 72" minimum in the direction of downward travel from the upper ramp run. • <i>As-Built:</i> 70.5" to rail. 72" to platform edge. • <i>Proposed Solution:</i> Modify landing at change of direction to 60" x 72". • <i>Notes:</i> Modify railing and relocate bin 	<p>PCODE EB08 ADAAG 4.8.4(3) ADA 2010 405.7.4 CBC 2010 1133B.5.4 CBC 2013 11B-405.7.4 Priority 1 Severity 4 TBD Contract Work</p>	<p>8 SF \$45 \$360</p>
---	---	-------------------------------

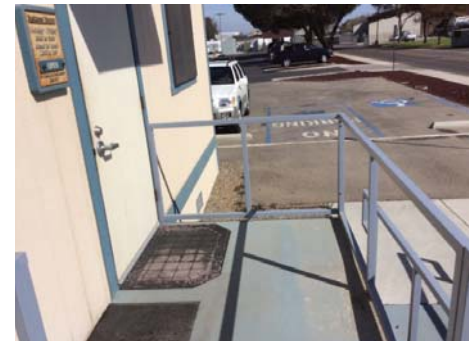
Door Swing

<p>1622</p> <ul style="list-style-type: none"> • <i>As-Built Description:</i> Front approach: At pull side, door does not have clear and level maneuvering space measuring door width plus 18"(CA only: 24" at exterior doors)x 60". • <i>As-Built:</i> 58.5" to rail • <i>Proposed Solution:</i> Extend maneuvering space and relocate railing. 	<p>PCODE ID23D ADAAG Fig. 25(a) ADA 2010 404.2.4 CBC 2010 11B-26A(a) CBC 2013 11B-404.2.4 Priority 1 Severity 4 TBD Contract Work</p>	<p>1 JOB \$800 \$800</p>
---	---	---------------------------------

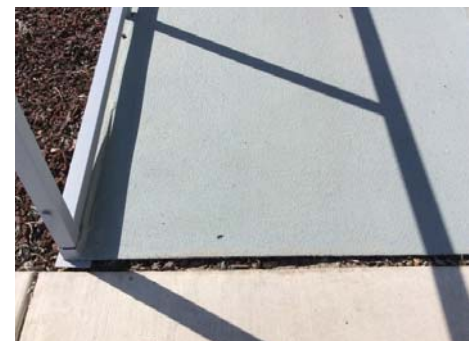
Ramps

<p>1619</p> <ul style="list-style-type: none"> • <i>As-Built Description:</i> Ramp: Pavement dislocation creates abrupt change in level exceeding 1/2" in ramp. • <i>As-Built:</i> 1" gap at bottom. • <i>Proposed Solution:</i> Remove, replace or repair area of pavement sufficient to correct abrupt change in level. 	<p>PCODE EB04 ADAAG 4.5.2 ADA 2010 303.4 CBC 2010 1133B.7.1 CBC 2013 11B-405.4 Priority 1 Severity 3 TBD Contract Work</p>	<p>4 SF \$25 \$100</p>
--	--	-------------------------------

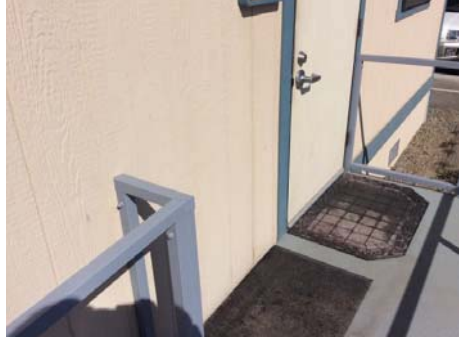
Item No. and Name	Existing Architectural Barrier and Proposed Solution	Codes / Mitigation Info	Qty	Unit	Cost	Total
<u>Top and Bottom Extension at Ramps</u>						
1621	<ul style="list-style-type: none"> • <i>As-Built Description:</i> Ramp handrail does not extend horizontally 12" past top and / or bottom of ramp. • <i>As-Built:</i> 0" • <i>Proposed Solution:</i> Provide ramp handrail extension (cost for each extension piece). 	PCODE ED05 ADAAG 4.8.5(2) ADA 2010 505.10.1 CBC 2010 1133B.4.2.2 & CBC 2013 11B-505.10.1 Priority 1 Severity 2 TBD Contract Work	1	JOB	\$170	\$170

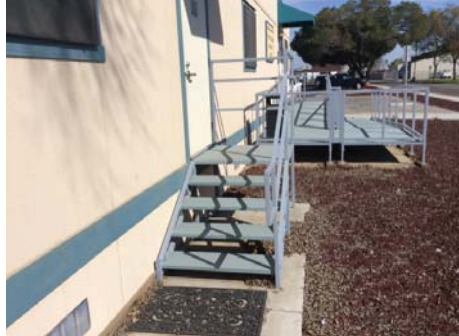
Handrails

1624	<ul style="list-style-type: none"> • <i>As-Built Description:</i> Handrail not provided at stairs or ramp, required on both sides (not required at curb ramps or adjacent to seating areas). • <i>Proposed Solution:</i> Provide new handrail for each side including extensions. 	PCODE ED01 ADAAG 4.8.5 & 4.9.4 ADA 2010 505.2 CBC 2010 1133B.4.1.1 & .5.5 CBC 2013 11B-505.2 Priority 4 Severity 2 TBD Contract Work	6	LF	\$95	\$570

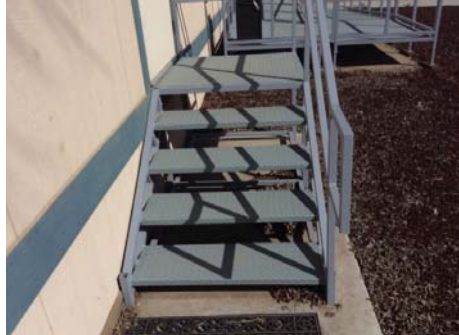
Open Risers

1627	<ul style="list-style-type: none"> • <i>As-Built Description:</i> Stair does not have closed risers. • <i>Proposed Solution:</i> Modify stair to have closed risers 	PCODE EC03 ADAAG 4.9.2 ADA 2010 504.3 CBC 2010 1133B.4.5.3 CBC 2013 11B-504.3 Priority 4 Severity 3 TBD Contract Work	15	LF	\$36	\$540

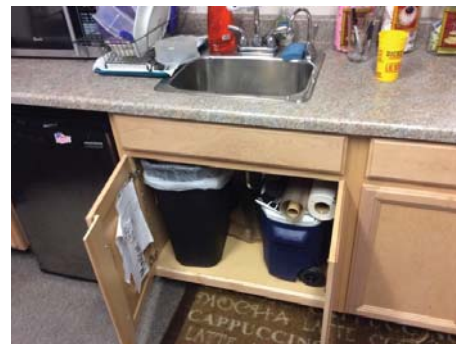
- 1639
- *As-Built Description:*
Sink does not have knee space min. 27" high x 19" deep x 30" wide.
 - *Proposed Solution:*
Remodel sink cabinet.

PCODE **IN06A**
 ADAAG **4.24.3**
 ADA 2010 **606.2**
 CBC 2010 **1115B.4.7.1**
 CBC 2013 **11B-606.2**
 Priority **4**
 Severity **2**
TBD Contract Work

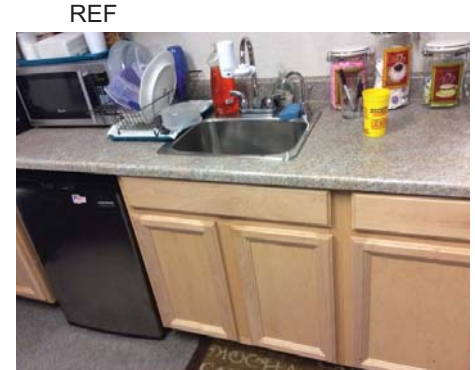
Item No. and Name	Existing Architectural Barrier and Proposed Solution	Codes / Mitigation Info	Qty	Unit	Cost	Total
1640	<ul style="list-style-type: none"> As-Built Description: Sink rim higher than 34" above floor. As-Built: 35" Proposed Solution: Remodel sink cabinet to lower sink. 	PCODE IN06REF ADAAG 4.24.2 ADA 2010 606.3 CBC 2010 1115B.4.7.1 CBC 2013 11B-606.3 Priority 4 Severity 4 TBD Contract Work

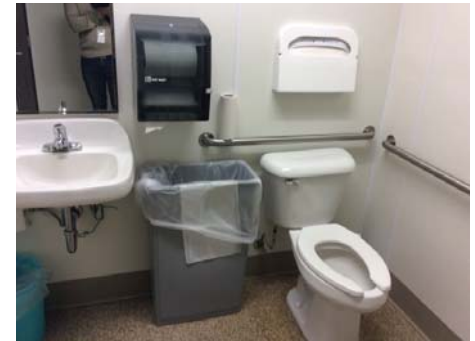
Toilet Stall

1651	<ul style="list-style-type: none"> As-Built Description: The lavatory or other unintended fixture, encroaches on the necessary clearance around a water closet (60" x 56"). As-Built: 53" and 28" to lav Proposed Solution: Remove adjacent fixture and provide new enclosure at accessible water closet. 	PCODE WB01A ADA 2010 604.3.1; 604.3.2 CBC 2013 11B-604.3.1; 11B-604.3.2 Priority 3 Severity 4 TBD Contract Work	1	JOB	\$2,000	\$2,000

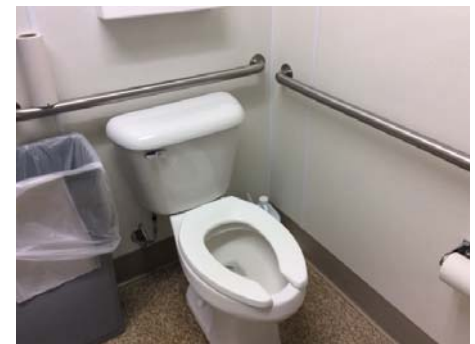
Water Closet

1646	<ul style="list-style-type: none"> As-Built Description: Water closet not 17"-18" from near side wall to center line of water closet (2010 ADAS: 16"-18"). As-Built: 19" o.c. Proposed Solution: Relocate existing water closet and plumbing, remount with offset closet flange to provide 17"-18" from side wall. 	PCODE WB02C ADAAG Fig. 28 ADA 2010 604.2 CBC 2010 1115B.4.1.1 CBC 2013 11B-604.2 Priority 3 Severity 4 TBD Contract Work	1	JOB	\$500	\$500

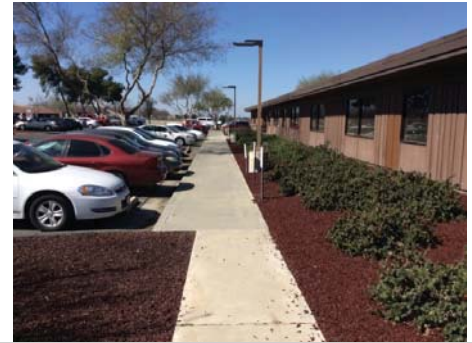
Cross Slope

2076	<ul style="list-style-type: none"> As-Built Description: Cross slope more than 1":48" (2.083%). As-Built: 2.2-2.8% Proposed Solution: Modify cross slope. 	PCODE EF07 ADAAG 4.3.7 ADA 2010 403.3 CBC 2010 1133B.7.1.3 CBC 2013 11B-403.3 Priority 1 Severity 4 TBD Contract Work	648	SF	\$25	\$16,200
------	--	--	-----	----	------	----------

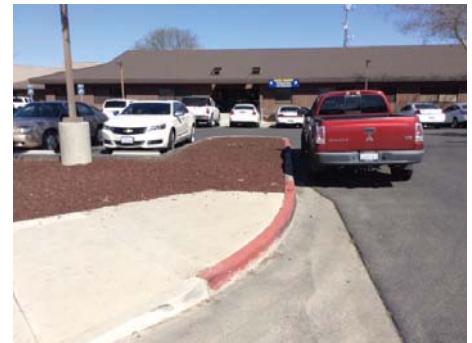
Slope

2059	<ul style="list-style-type: none"> As-Built Description: Level 2% max. landing for ramp not provided. Proposed Solution: Rebuild ramp to provide landings for each ramp run with slopes no greater than 2% Notes: Site entry on side street 	PCODE EB05A ADAAG 4.8.4 ADA 2010 405.7.1 CBC 2010 1133B.5.4.1 CBC 2013 11B-405.7.1 Priority 1 Severity 4 TBD Contract Work	10	SF	\$100	\$1,000
------	--	---	----	----	-------	---------

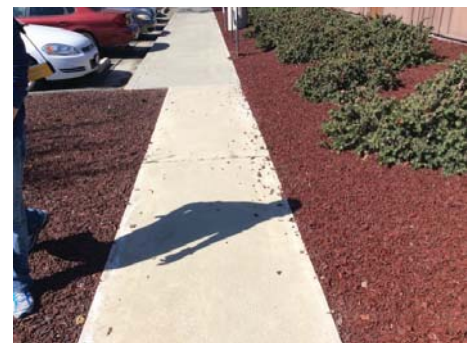
2077	<ul style="list-style-type: none"> As-Built Description: Walk more than 36" but less than 48" wide (required in CA only). As-Built: 47" Proposed Solution: Enlarge width of walk to 48". 	PCODE EF08 CBC 2010 1133B.7.1 CBC 2013 11B-403.5.1.3 Priority 1 Severity 4 TBD Contract Work	88	SF	\$45	\$3,960
------	---	---	----	----	------	---------

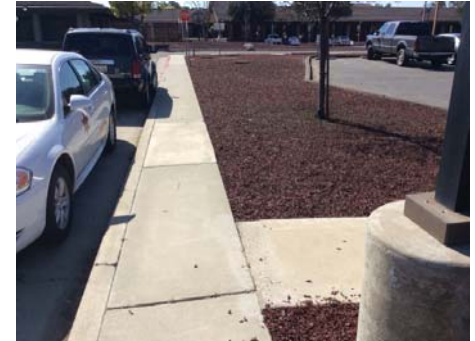
Item No. and Name	Existing Architectural Barrier and Proposed Solution	Codes / Mitigation Info	Qty	Unit	Cost	Total
2075	<ul style="list-style-type: none"> <i>As-Built Description:</i> Walk more than 36" but less than 48" wide (required in CA only). <i>Proposed Solution:</i> Enlarge width of walk to 48". <i>Notes:</i> PRoW 36" sidewalk 	<p>PCODE EF08REF</p> <p>ADA 2010 403.5</p> <p>CBC 2010 1133B.7.1</p> <p>CBC 2013 11B-403.5.1.3</p> <p>Priority 1</p> <p>Severity 3</p> <p>TBD Contract Work</p>

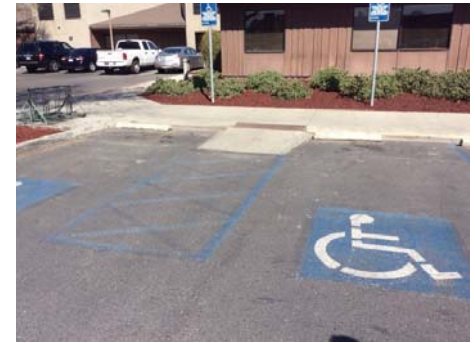
Floor or Ground Surfaces

2062	<ul style="list-style-type: none"> <i>As-Built Description:</i> Accessible parking space has slope greater than 1/4":12" (2%). <i>As-Built:</i> 2.5-5.1% <i>Proposed Solution:</i> Modify slope at accessible parking space. 	<p>PCODE EA05</p> <p>ADAAG 4.6.3</p> <p>ADA 2010 502.4</p> <p>CBC 2010 1129B.3.3</p> <p>CBC 2013 11B-502.4</p> <p>Priority 1</p> <p>Severity 3</p> <p>TBD Contract Work</p>	162	SF	\$12	\$1,944
------	---	---	-----	----	------	---------

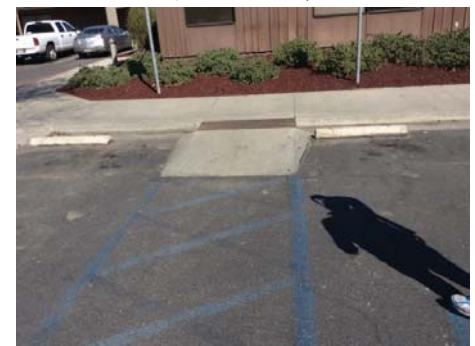
2063	<ul style="list-style-type: none"> <i>As-Built Description:</i> Access aisle at accessible parking space has slope greater than 1/4":12" (2%) due to built-up curb ramp within aisle. <i>As-Built:</i> 22% at flares <i>Proposed Solution:</i> Provide curb cut. 	<p>PCODE EA05A</p> <p>ADAAG 4.6.3</p> <p>ADA 2010 502.4</p> <p>CBC 2010 1129B.3.3</p> <p>CBC 2013 11B-502.4</p> <p>Priority 1</p> <p>Severity 1</p> <p>TBD Contract Work</p>	1	JOB	\$2,500	\$2,500
------	---	--	---	-----	---------	---------

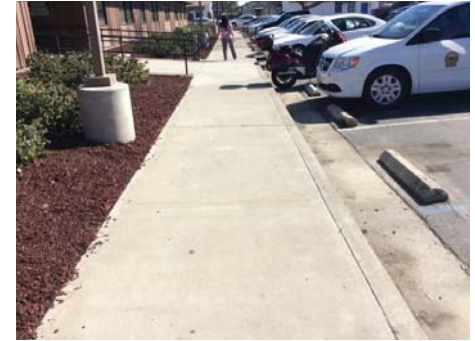
Cross Slope

2068	<ul style="list-style-type: none"> • <i>As-Built Description:</i> Cross slope more than 1":48" (2.083%). • <i>As-Built:</i> 2.3-5.0% • <i>Proposed Solution:</i> Modify cross slope. 	PCODE EF07 ADAAG 4.3.7 ADA 2010 403.3 CBC 2010 1133B.7.1.3 CBC 2013 11B-403.3 Priority 1 Severity 3 TBD Contract Work	300	SF	\$25	\$7,500
------	---	--	-----	----	------	----------------

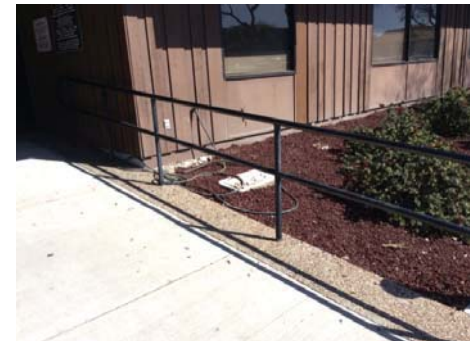
Curb or Barrier

2072	<ul style="list-style-type: none"> • <i>As-Built Description:</i> No curb (2" minimum height) or wheel guide (centered approx. 3" above surface of ramp) at sides of ramp. • <i>Proposed Solution:</i> Provide 2" minimum curb or wheel guide. • <i>Notes:</i> 2" diameter 	PCODE EB14 ADAAG 4.8.7 ADA 2010 405.9.2 CBC 2010 1133B.5.6 CBC 2013 11B-405.9.2 Priority 1 Severity 2 TBD Contract Work	70	LF	\$17	\$1,190
------	--	--	----	----	------	----------------

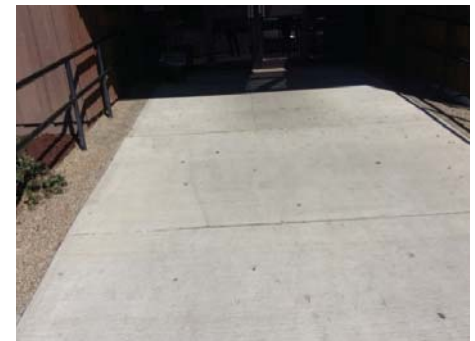
2071	<ul style="list-style-type: none"> • <i>As-Built Description:</i> Slope greater than 1:12 (8.3%). • <i>As-Built:</i> 8.8% at middle panel • <i>Proposed Solution:</i> Demolish existing and provide new ramp with handrails. 	PCODE EB02 ADAAG 4.8.2 ADA 2010 405.2 CBC 2010 1133B.5.3 CBC 2013 11B-405.2 Priority 1 Severity 4 TBD Contract Work	66	SF	\$100	\$6,600
------	---	--	----	----	-------	----------------

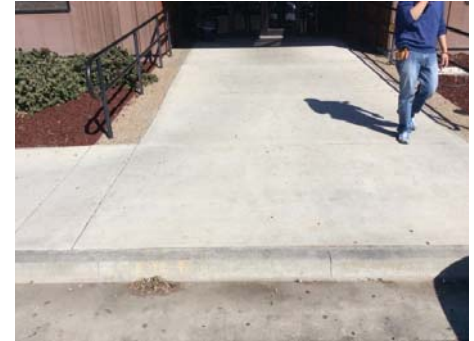
Item No. and Name	Existing Architectural Barrier and Proposed Solution	Codes / Mitigation Info	Qty	Unit	Cost	Total
2070	<ul style="list-style-type: none"> As-Built Description: Level 2% max. landing for ramp not provided. As-Built: 5% Proposed Solution: Rebuild ramp to provide landings for each ramp run with slopes no greater than 2% 	PCODE EB05AREF ADAAG 4.8.4 ADA 2010 405.7.1 CBC 2010 1133B.5.4.1 CBC 2013 11B-405.7.1 Priority 1 Severity 3 TBD Contract Work				
						REF

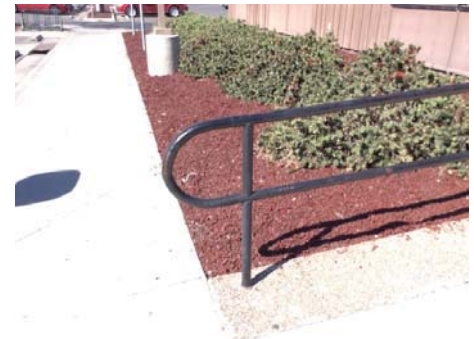
Top and Bottom Extension at Ramps

2073	<ul style="list-style-type: none"> As-Built Description: Ramp handrail does not extend horizontally 12" past top and / or bottom of ramp. Proposed Solution: Provide ramp handrail extension (cost for each extension piece). 	PCODE ED05 ADAAG 4.8.5(2) ADA 2010 505.10.1 CBC 2010 1133B.4.2.2 & CBC 2013 11B-505.10.1 Priority 1 Severity 4 TBD Contract Work	4	JOB	\$170	\$680
------	---	--	---	-----	-------	-------

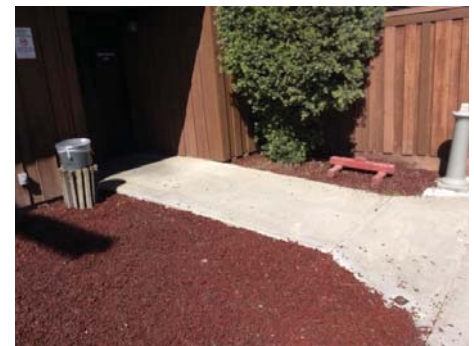
Walk

2079	<ul style="list-style-type: none"> As-Built Description: Walk: Slope greater than 1:20 (5.0%), and walk does not comply with requirements for ramps. As-Built: 8.8% Proposed Solution: Provide ramp with handrails on both (2) sides. 	PCODE EF01A ADAAG 4.8.1 ADA 2010 405.1 CBC 2010 1133B.7.3 CBC 2013 11B-405.1 Priority 2 Severity 4 TBD Contract Work	30	LF	\$260	\$7,800
------	--	--	----	----	-------	---------

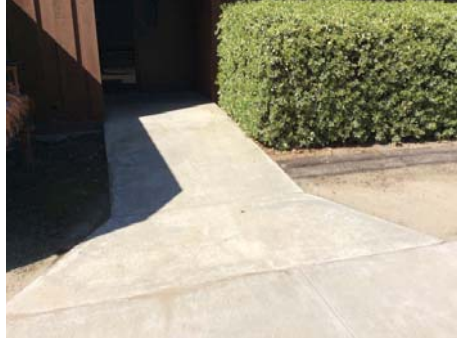
Item No. and Name	Existing Architectural Barrier and Proposed Solution	Codes / Mitigation Info	Qty	Unit	Cost	Total
Walk						
2080	<ul style="list-style-type: none"> As-Built Description: Walk: Slope greater than 1:20 (5.0%), and walk does not comply with requirements for ramps. As-Built: 8.8% Proposed Solution: Provide ramp with handrails on both (2) sides. 	PCODE EF01A ADAAG 4.8.1 ADA 2010 405.1 CBC 2010 1133B.7.3 CBC 2013 11B-405.1 Priority 2 Severity 4 TBD Contract Work	30	LF	\$260	\$7,800

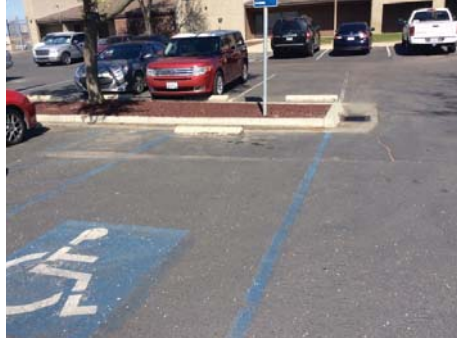
Floor or Ground Surfaces

2084	<ul style="list-style-type: none"> As-Built Description: Accessible parking space has slope greater than 1/4":12" (2%). As-Built: 3.0-3.6% Proposed Solution: Modify slope at accessible parking space. 	PCODE EA05 ADAAG 4.6.3 ADA 2010 502.4 CBC 2010 1129B.3.3 CBC 2013 11B-502.4 Priority 1 Severity 4 TBD Contract Work	162	SF	\$12	\$1,944

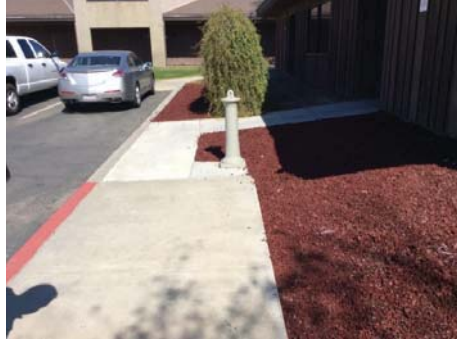
Cross Slope

2089	<ul style="list-style-type: none"> As-Built Description: Cross slope more than 1":48" (2.083%). As-Built: 3.6-3.9% Proposed Solution: Modify cross slope. 	PCODE EF07 ADAAG 4.3.7 ADA 2010 403.3 CBC 2010 1133B.7.1.3 CBC 2013 11B-403.3 Priority 1 Severity 4 TBD Contract Work	168	SF	\$25	\$4,200

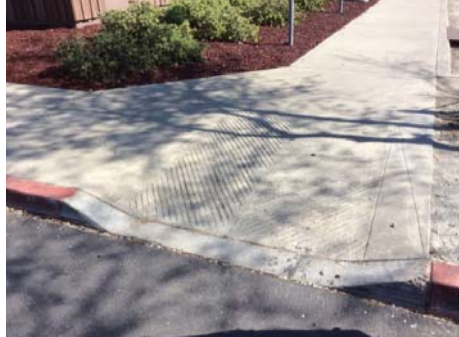
Item No. and Name	Existing Architectural Barrier and Proposed Solution	Codes / Mitigation Info	Qty	Unit	Cost	Total
Curb Ramp						
2086	<ul style="list-style-type: none"> As-Built Description: Side slopes more than 1:10 (10%). As-Built: 29% Proposed Solution: Modify curb ramp. Demolish side slopes and replace with 1:10 side slopes if 48" level top landing is provided. 	PCODE EH05A ADAAG 4.7.5 ADA 2010 406.3 CBC 2010 1127B.5.3 CBC 2013 11B-406.2.2 Priority 1 Severity 1 TBD Contract Work	1	JOB	\$2,000	\$2,000

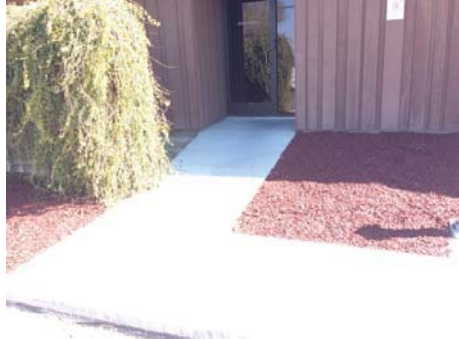
Walk						
2091	<ul style="list-style-type: none"> As-Built Description: Walk: Slope greater than 1:20 (5.0%), and walk does not comply with requirements for ramps. As-Built: 9.0% Proposed Solution: Provide ramp with handrails on both (2) sides. Notes: Landing 41" 	PCODE EF01A ADAAG 4.8.1 ADA 2010 405.1 CBC 2010 1133B.7.3 CBC 2013 11B-405.1 Priority 1 Severity 3 TBD Contract Work	30	LF	\$260	\$7,800

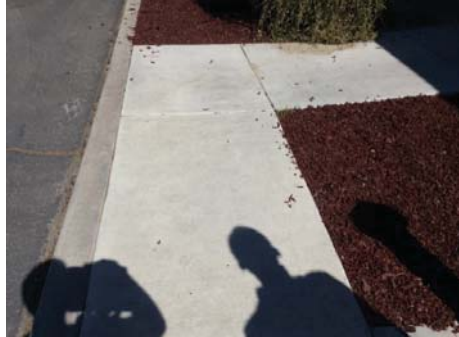
2090	<ul style="list-style-type: none"> As-Built Description: Walk more than 36" but less than 48" wide (required in CA only). As-Built: 42" Proposed Solution: Enlarge width of walk to 48". 	PCODE EF08REF ADA 2010 403.5 CBC 2010 1133B.7.1 CBC 2013 11B-403.5.1.3 Priority 1 Severity 4 TBD Contract Work	REF

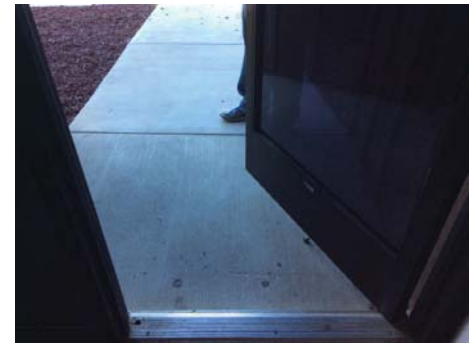
Door

1901	<ul style="list-style-type: none"> <i>As-Built Description:</i> Surface of required maneuvering clearance at door slopes more than 1/4":12" (2.0%). <i>As-Built:</i> 3.0%-11.3% <i>Proposed Solution:</i> Modify surface slope at door. 	<p>PCODE ID11</p> <p>ADAAG 4.13.6</p> <p>ADA 2010 404.2.4.4</p> <p>CBC 2010 1133B.2.4</p> <p>CBC 2013 11B-404.2.4</p> <p>Priority 2</p> <p>Severity 1</p> <p>TBD Contract Work</p>	30	SF	\$40	\$1,200
------	--	--	----	----	------	---------

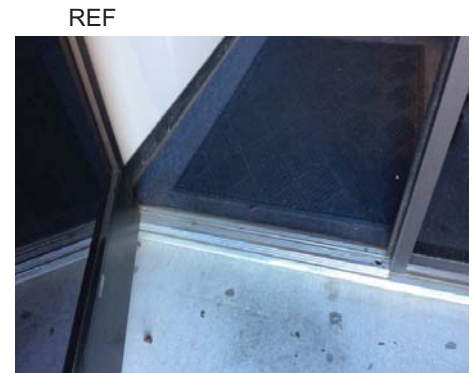
Door Threshold

1902	<ul style="list-style-type: none"> <i>As-Built Description:</i> Door inaccessible due to threshold or step at door exceeding 1/2". <i>As-Built:</i> 1.75" <i>Proposed Solution:</i> Modify threshold to be no more than 1/2" by removing existing paving at door and providing landing with edge ramping (slope 1:20 max). 	<p>PCODE ID02AREF</p> <p>ADAAG 4.13.8</p> <p>ADA 2010 404.2.5</p> <p>CBC 2010 1133B.2.4.1</p> <p>CBC 2013 11B-404.2.5</p> <p>Priority 1</p> <p>Severity 3</p> <p>TBD Contract Work</p>				
------	---	--	--	--	--	--
