Facility: **WOMENS INFANTS & CHILDREN**

Address: 330 HARRIS ST.

Facility: **LEMORE HEALTH CLINIC**
 Address: 229 C ST.

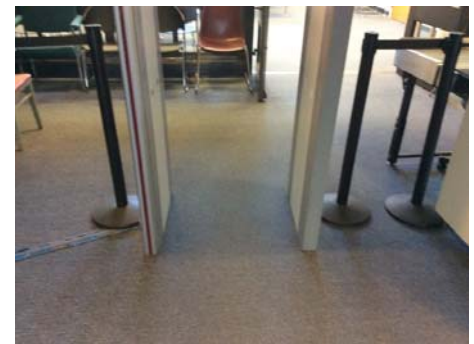
Corridor

1917	<ul style="list-style-type: none"> <i>As-Built Description:</i> Corridor, for occupant load less than 10, less than 36" wide. <i>As-Built:</i> 29" wide. 23" deep <i>Proposed Solution:</i> Enlarge corridor to 36" wide; relocate stud wall. <i>Notes:</i> Through security checkpoint 	<p>PCODE IH03NT</p> <p>ADAAG 4.3.3</p> <p>ADA 2010 403.5.1</p> <p>CBC 2010 1133B.3.1</p> <p>CBC 2013 11B-403.5.1</p> <p>Priority 1</p> <p>Severity 2</p> <p>TBD Contract Work</p>	2	LF	\$140	\$280
------	--	---	---	----	-------	-------

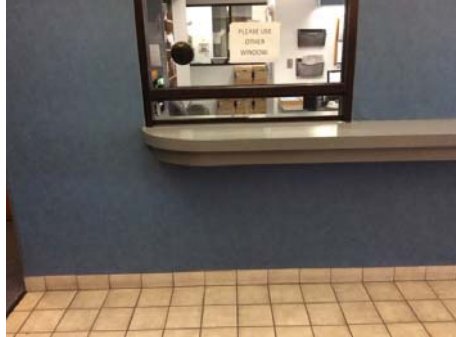
Item No. and Name	Existing Architectural Barrier and Proposed Solution	Codes / Mitigation Info	Qty	Unit	Cost	Total
Public Counter						
1915	<ul style="list-style-type: none"> <i>As-Built Description:</i> Service counter (stand-up): Accessible section min. 36" length and 36" max. height (in CA: 28" to 34" high) not provided. <i>As-Built:</i> 41.25" <i>Proposed Solution:</i> Provide auxiliary shelf, clipboard, or table as equivalent facilitation. <i>Notes:</i> 1 for each dept. 	PCODE IN03 ADAAG 7.2(2) ADA 2010 904.4 CBC 2010 1122B.4 CBC 2013 11B-904.4 Priority 1 Severity 3 TBD Contract Work	2	JOB	\$150	\$300

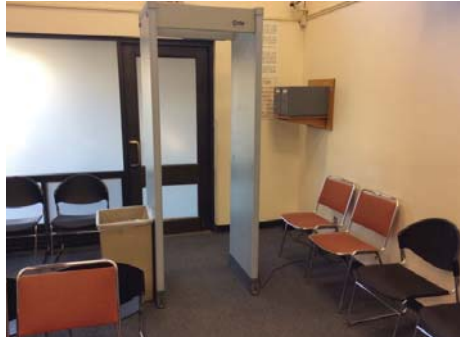
Corridor						
1928	<ul style="list-style-type: none"> <i>As-Built Description:</i> Corridor, for occupant load less than 10, less than 36" wide. <i>As-Built:</i> 28" wide & 24" deep <i>Proposed Solution:</i> Enlarge corridor to 36" wide; relocate stud wall. 	PCODE IH03NT ADAAG 4.3.3 ADA 2010 403.5.1 CBC 2010 1133B.3.1 CBC 2013 11B-403.5.1 Priority 1 Severity 2 TBD Contract Work	2	LF	\$140	\$280

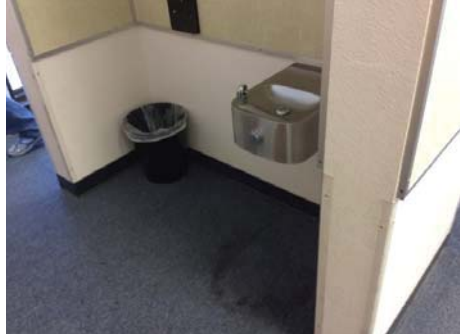
Drinking Fountain						
1939	<ul style="list-style-type: none"> <i>As-Built Description:</i> Where only one drinking fountain is provided per floor: Fountain is not accessible to individuals who use wheelchairs, or to those who have difficulty bending or stooping. <i>Proposed Solution:</i> Provide additional fountain or hi-lo combination fountain. 	PCODE IA01A ADAAG 4.1.3(10)(a) ADA 2010 211.1 CBC 2010 1115B.4.6.1 CBC 2013 11B-211.1 Priority 3 Severity 2 TBD Contract Work	1	JOB	\$2,000	\$2,000

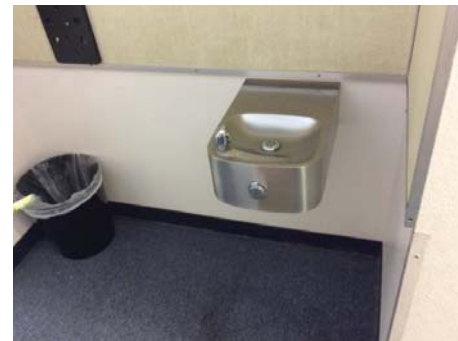
Item No. and Name	Existing Architectural Barrier and Proposed Solution	Codes / Mitigation Info	Qty	Unit	Cost	Total
1938	<ul style="list-style-type: none"> <i>As-Built Description:</i> Wall- and post-mounted cantilevered units: Knee space not provided at drinking fountain (27" high, 8" deep, 30" wide from front of drinking fountain). Unit in good condition. <i>As-Built:</i> 23.75" <i>Proposed Solution:</i> Remount fountain at accessible height. 	<p>PCODE IA02A ADAAG 4.15.5(1) ADA 2010 602.2 CBC 2010 1115B.4.6.2 CBC 2013 11B-602.2 Priority 3 Severity 2 TBD Contract Work</p>	1	JOB	\$1,200	\$1,200

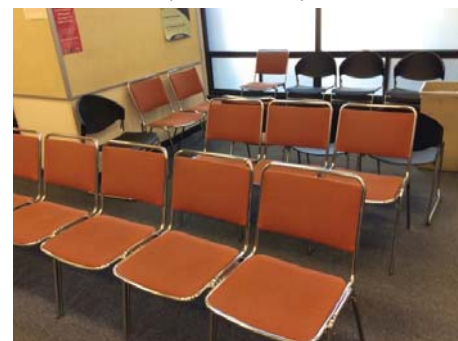
Fixed Bench

1931	<ul style="list-style-type: none"> <i>As-Built Description:</i> Clear floor or ground space (30" x 48") not overlapping with other clear space requirements, is not provided at at least one end of the bench. <i>Proposed Solution:</i> Provide and position clear floor or ground space to allow wheelchair users to be seated shoulder-to-shoulder with an individual seated on the bench. 	<p>PCODE NO07 ADAAG 4.32.2 ADA 2010 903.2 CBC 2010 1118B.4 CBC 2013 11B-903.2 Priority 2 Severity 2 TBD Contract Work</p>	1	JOB	\$500	\$500
------	---	--	---	-----	-------	-------

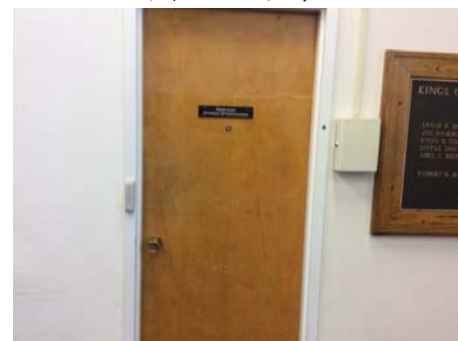
Door Clearance

1935	<ul style="list-style-type: none"> <i>As-Built Description:</i> Door on accessible route has less than 32" clear and 80" (78" min. to closer if provided) opening width when 90° open. <i>As-Built:</i> 29" <i>Proposed Solution:</i> Provide new, larger door and frame with new accessible hardware. 	<p>PCODE ID01 ADAAG 4.13.5 ADA 2010 404.2.3 CBC 2010 1133B.1.1.1.1 CBC 2013 11B-404.2.3 Priority 2 Severity 3 TBD Contract Work</p>	5	JOB	\$2,600	\$13,000
------	---	--	---	-----	---------	----------

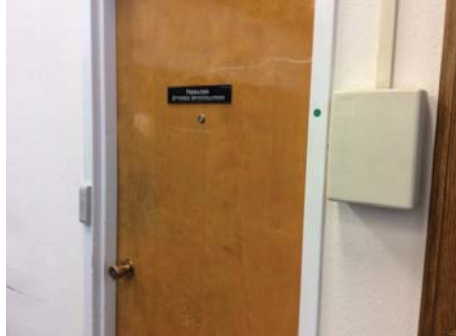
Item No. and Name	Existing Architectural Barrier and Proposed Solution	Codes / Mitigation Info	Qty	Unit	Cost	Total
<u>Restroom</u>						
1948	<ul style="list-style-type: none"> <i>As-Built Description:</i> Single accommodation restroom not accessible; multiple compliance violations. <i>Proposed Solution:</i> Remodel area to provide single-occupant accessible restroom. 	PCODE WA01 ADAAG 4.22 ADA 2010 603 CBC 2010 1115B.3.2 CBC 2013 11B-603 Priority 3 Severity 2 TBD Contract Work	1	JOB	\$30,000	\$30,000

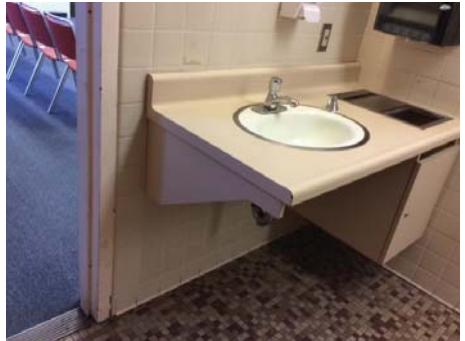
Door Swing

1941	<ul style="list-style-type: none"> <i>As-Built Description:</i> Front approach: At pull side, door does not have clear and level maneuvering space measuring door width plus 18" x 60". <i>As-Built:</i> 6" to lav <i>Proposed Solution:</i> Remodel as needed. 	PCODE ID23BREF ADAAG Fig. 25(a) ADA 2010 404.2.4 CBC 2010 11B-26A(a) CBC 2013 11B-404.2.4 Priority 3 Severity 3 TBD Contract Work	REF

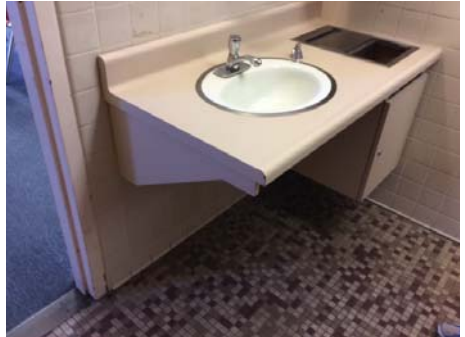
Lavatory

1944	<ul style="list-style-type: none"> <i>As-Built Description:</i> Lavatory: Fixture rim or counter height more than 34" above floor. <i>As-Built:</i> 34.5" <i>Proposed Solution:</i> Remount compliant fixture at accessible height. <i>Notes:</i> Also protrusion 	PCODE WD02A ADAAG 4.19.2 ADA 2010 606.3 CBC 2010 1115B.4.3 CBC 2013 11B-606.3 Priority 3 Severity 4 TBD Contract Work	1	JOB	\$900	\$900

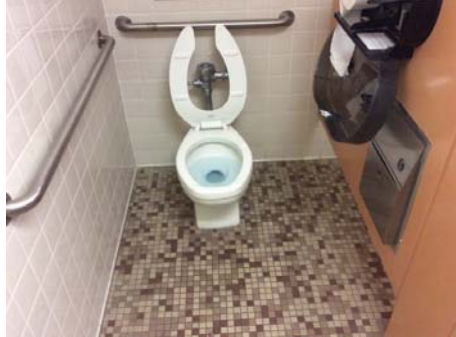
Item No. and Name	Existing Architectural Barrier and Proposed Solution	Codes / Mitigation Info	Qty	Unit	Cost	Total
Toilet Stall						
1952	<ul style="list-style-type: none"> As-Built Description: Toilet stall less than 60" wide. As-Built: 41" wide Proposed Solution: Provide new accessible stall. Notes: Multiple items 	PCODE WB06 ADAAG 4.17.3 ADA 2010 604.8.1.1 CBC 2010 1115B.3.1.4.1 CBC 2013 11B-604.8.1.1 Priority 3 Severity 2 TBD Contract Work	1	JOB	\$1,500	\$1,500

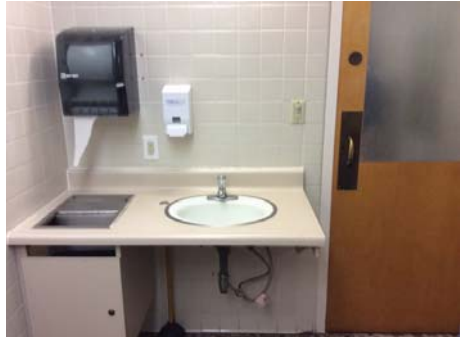
Door Swing							
1958	<ul style="list-style-type: none"> As-Built Description: Front approach: At pull side, door does not have clear and level maneuvering space measuring door width plus 18" x 60". As-Built: 6" to lav Proposed Solution: Remodel as needed. 	PCODE ID23BREF ADAAG Fig. 25(a) ADA 2010 404.2.4 CBC 2010 11B-26A(a) CBC 2013 11B-404.2.4 Priority 3 Severity 3 TBD Contract Work	REF

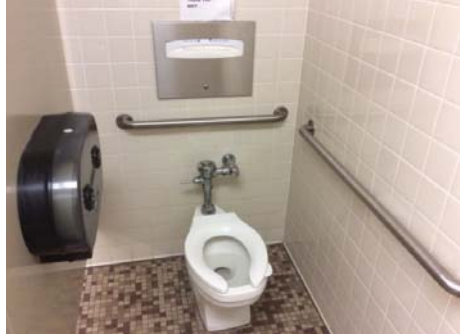
Restroom						
1957	<ul style="list-style-type: none"> As-Built Description: Multiple accommodation restroom not accessible; multiple compliance violations. As-Built: 41" Proposed Solution: Remodel area to provide accessible restroom with one accessible stall, lavatory (and one urinal at Mens). 	PCODE WA01A ADAAG 4.22 ADA 2010 603 CBC 2010 1115B.3.1 CBC 2013 11B-603 Priority 3 Severity 1 TBD Contract Work	1	JOB	\$35,000	\$35,000

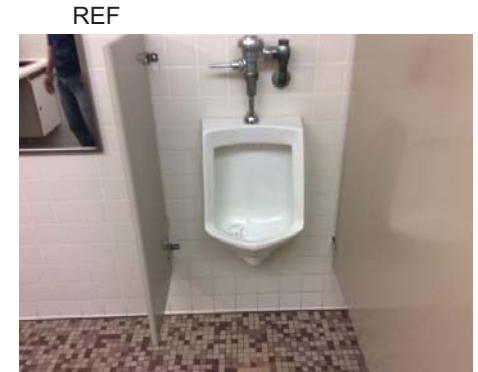
- 1959
- *As-Built Description:*
CA only: Front of rim projects less than 13.5" from wall.
 - *As-Built:* 10"
 - *Proposed Solution:*
Provide accessible urinal. Remodel restroom as needed.

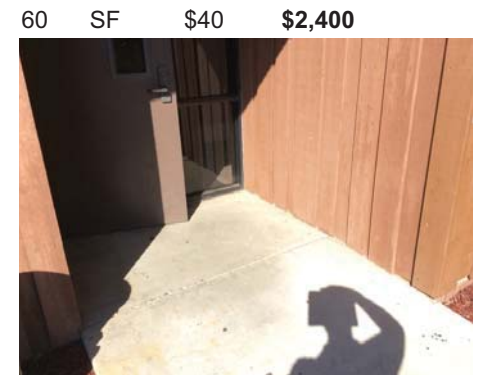
Door

- 1974
- *As-Built Description:*
Surface of required maneuvering clearance at door slopes more than 1/4":12" (2.0%).
 - *As-Built:* 8.6% at 40" from door
 - *Proposed Solution:*
Modify surface slope at door.

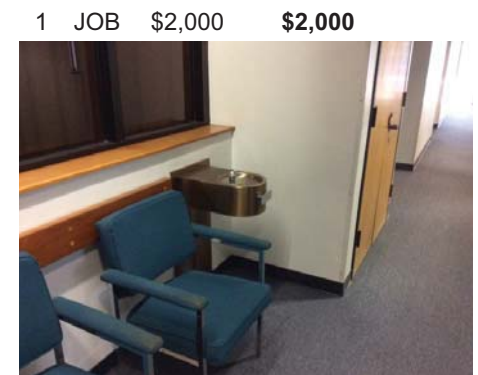
Drinking Fountain

- 1968
- *As-Built Description:*
Where only one drinking fountain is provided per floor: Fountain is not accessible to individuals who use wheelchairs, or to those who have difficulty bending or stooping.
 - *Proposed Solution:*
Provide additional fountain or hi-lo combination fountain.

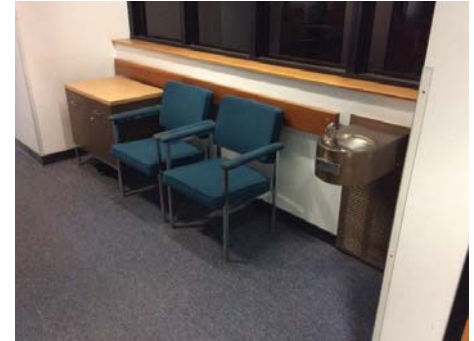
Item No. and Name	Existing Architectural Barrier and Proposed Solution	Codes / Mitigation Info	Qty	Unit	Cost	Total
1970	<ul style="list-style-type: none"> <i>As-Built Description:</i> CA only: Drinking fountain not located in an alcove (min. 32" wide x 18" deep) or otherwise encroaches into pedestrian way. <i>Proposed Solution:</i> Provide fixed chair or object 	<p>PCODE IA04REF</p> <p>CBC 2010 1115B.4.6.3; Fig.</p> <p>CBC 2013 11B-602.9</p> <p>Priority 3</p> <p>Severity 2</p> <p>TBD Contract Work</p>

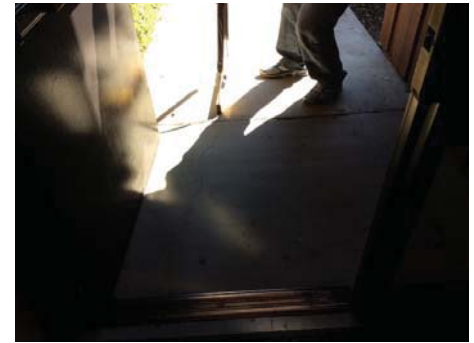
Door

1991	<ul style="list-style-type: none"> <i>As-Built Description:</i> Surface of required maneuvering clearance at door slopes more than 1/4":12" (2.0%). <i>As-Built:</i> 10.3% at 40" from door <i>Proposed Solution:</i> Modify surface slope at door. 	<p>PCODE ID11</p> <p>ADAAG 4.13.6</p> <p>ADA 2010 404.2.4.4</p> <p>CBC 2010 1133B.2.4</p> <p>CBC 2013 11B-404.2.4</p> <p>Priority 2</p> <p>Severity 1</p> <p>TBD Contract Work</p>	30	SF	\$40	\$1,200

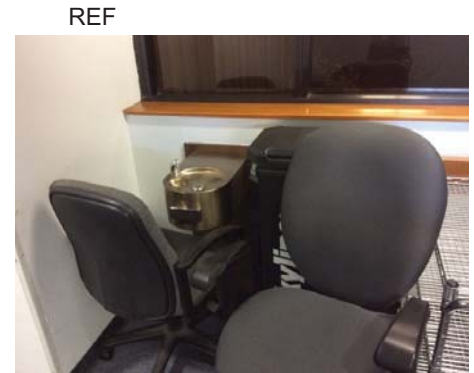
Drinking Fountain

1985	<ul style="list-style-type: none"> <i>As-Built Description:</i> Where only one drinking fountain is provided per floor: Fountain it is not accessible to individuals who use wheelchairs, or to those who have difficulty bending or stooping. <i>Proposed Solution:</i> Provide additional fountain or hi-lo combination fountain. 	<p>PCODE IA01AREF</p> <p>ADAAG 4.1.3(10)(a)</p> <p>ADA 2010 211.1</p> <p>CBC 2010 1115B.4.6.1</p> <p>CBC 2013 11B-211.1</p> <p>Priority 3</p> <p>Severity 2</p> <p>TBD Contract Work</p>

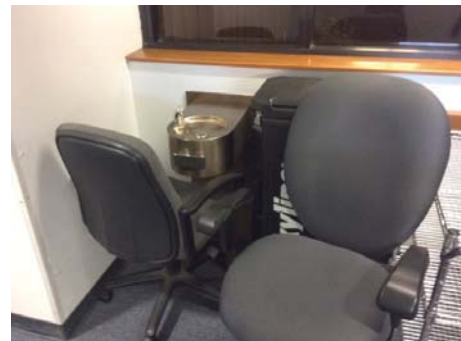
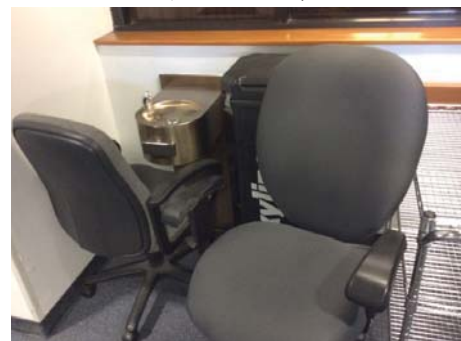
Item No. and Name	Existing Architectural Barrier and Proposed Solution	Codes / Mitigation Info	Qty	Unit	Cost	Total
1984	<ul style="list-style-type: none"> <i>As-Built Description:</i> Wall- and post-mounted cantilevered units: Knee space not provided at drinking fountain (27" high, 8" deep, 30" wide from front of drinking fountain). Unit in good condition. <i>As-Built:</i> Furniture items <i>Proposed Solution:</i> Remount fountain at accessible height. 	PCODE IA02A ADAAG 4.15.5(1) ADA 2010 602.2 CBC 2010 1115B.4.6.2 CBC 2013 11B-602.2 Priority 3 Severity 4 TBD Contract Work	1	JOB	\$50	\$50
1986	<ul style="list-style-type: none"> <i>As-Built Description:</i> CA only: Drinking fountain not located in an alcove (min. 32" wide x 18" deep) or otherwise encroaches into pedestrian way. <i>As-Built:</i> provide fixed object <i>Proposed Solution:</i> Provide new alcove for drinking fountain, or, if unreasonable hardship is determined, provide wing walls or cane-detectable railings on each side of the drinking fountain. The wings must project out from the supporting wall at least as far as the drinking fountain to within 6" of the surface of the circulation path, but cannot reduce the required clear width of the adjacent accessible route. 	PCODE IA04NT CBC 2010 1115B.4.6.3; Fig. CBC 2013 11B-602.9 Priority 3 Severity 2 TBD Contract Work	1	JOB	\$3,000	\$3,000

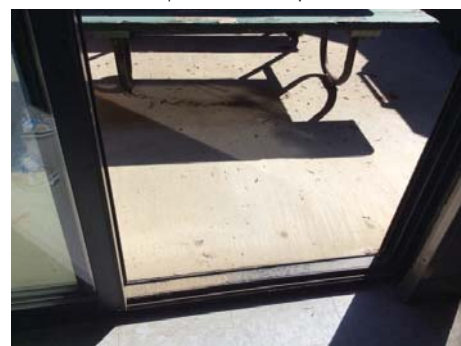
Door Threshold

2002	<ul style="list-style-type: none"> <i>As-Built Description:</i> Door inaccessible due to threshold or step at door exceeding 1/2". <i>As-Built:</i> 1" <i>Proposed Solution:</i> Modify threshold to be no more than 1/2" by removing existing paving at door and providing landing with edge ramping (slope 1:20 max). 	PCODE ID02A ADAAG 4.13.8 ADA 2010 404.2.5 CBC 2010 1133B.2.4.1 CBC 2013 11B-404.2.5 Priority 4 Severity 4 TBD Contract Work	1	JOB	\$400	\$400
------	--	---	---	-----	-------	-------

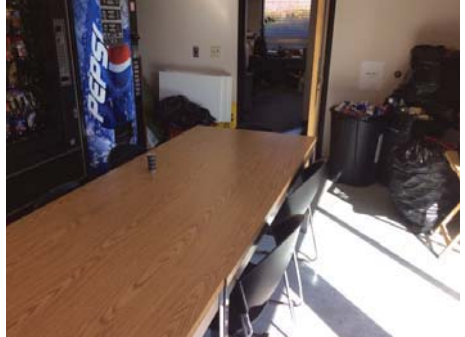
Item No. and Name	Existing Architectural Barrier and Proposed Solution	Codes / Mitigation Info	Qty	Unit	Cost	Total
<u>Non-Fixed Desk</u>						
1999	<ul style="list-style-type: none"> <i>As-Built Description:</i> Accessible non-fixed table or desk (top 28" to 34" high; knee space at least 27" high x 19" deep x 30" wide) not provided. <i>As-Built:</i> 26" high knee <i>Proposed Solution:</i> Provide table or desk with accessible dimensions when purchasing new furniture. 	PCODE IN02A ADAAG 4.32.3 & .4 ADA 2010 306.1 CBC 2010 1122B.3 & 4 CBC 2013 11B-306.1 & 11B-902.3 Priority 4 Severity 2 TBD Contract Work	1	JOB	\$1,600	\$1,600

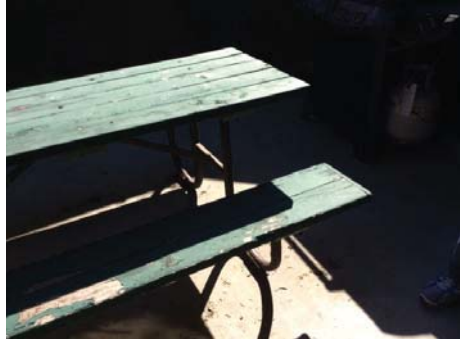
<u>Picnic Area</u>						
2003	<ul style="list-style-type: none"> <i>As-Built Description:</i> Knee clearance at minimums 27" high, 30" wide, and 19" deep is not provided. <i>As-Built:</i> 11" deep <i>Proposed Solution:</i> Modify picnic table as required to provide knee clearance. 	PCODE NH11A ADAAG 16.5.4. ADA 2010 902.2 CBC 2010 1132B.1 CBC 2013 11-902.2 Priority 4 Severity 2 TBD Contract Work	1	JOB	\$850	\$850

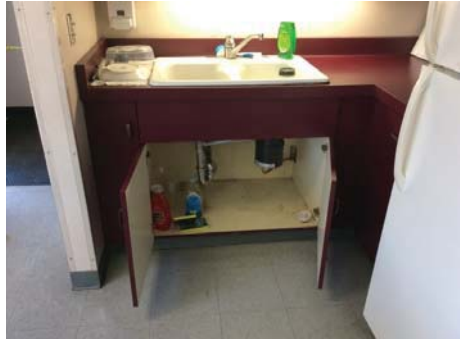
<u>Sink</u>						
1995	<ul style="list-style-type: none"> <i>As-Built Description:</i> Sink does not have knee space min. 27" high x 19" deep x 30" wide. <i>Proposed Solution:</i> Remodel sink cabinet. 	PCODE IN06A ADAAG 4.24.3 ADA 2010 606.2 CBC 2010 1115B.4.7.1 CBC 2013 11B-606.2 Priority 4 Severity 2 TBD Contract Work	1	JOB	\$1,750	\$1,750

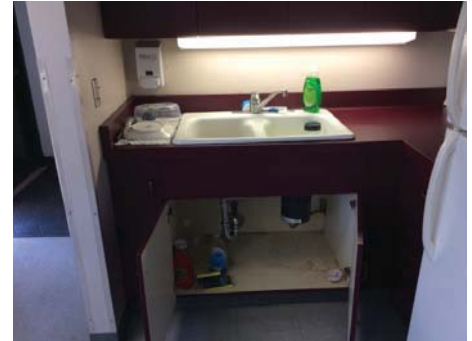
Item No. and Name	Existing Architectural Barrier and Proposed Solution	Codes / Mitigation Info	Qty	Unit	Cost	Total
1996	<ul style="list-style-type: none"> • <i>As-Built Description:</i> Sink rim higher than 34" above floor. • <i>As-Built:</i> 36.5" • <i>Proposed Solution:</i> Remodel sink cabinet to lower sink. 	<p>PCODE IN06REF</p> <p>ADAAG 4.24.2</p> <p>ADA 2010 606.3</p> <p>CBC 2010 1115B.4.7.1</p> <p>CBC 2013 11B-606.3</p> <p>Priority 4</p> <p>Severity 4</p> <p>TBD Contract Work</p>

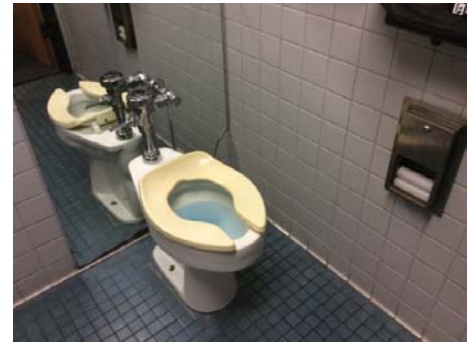
Grab Bars

2009	<ul style="list-style-type: none"> • <i>As-Built Description:</i> Grab bars not provided or are not code compliant. • <i>Proposed Solution:</i> Provide accessible grab bars. 	<p>PCODE WB07</p> <p>ADAAG 4.17.6</p> <p>ADA 2010 604.5</p> <p>CBC 2010 1115B.4.1.3</p> <p>CBC 2013 11B-604.5</p> <p>Priority 2</p> <p>Severity 3</p> <p>TBD Contract Work</p>	1	JOB	\$500	\$500
------	---	--	---	-----	-------	-------

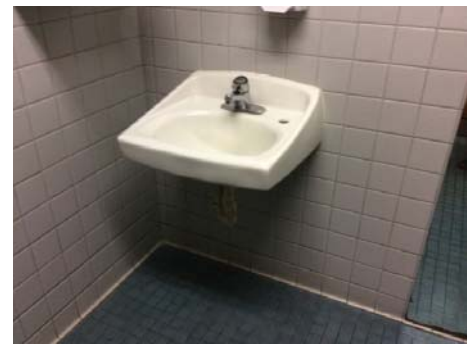
Lavatory

2010	<ul style="list-style-type: none"> • <i>As-Built Description:</i> Wheelchair clearance under lavatory apron or lavatory counter front edge less than 29" high. • <i>As-Built:</i> 28.5" • <i>Proposed Solution:</i> Remount compliant fixture to accessible height. 	<p>PCODE WD03A</p> <p>ADAAG 4.19.2</p> <p>ADA 2010 606.3</p> <p>CBC 2010 1115B.4.3.3</p> <p>CBC 2013 11B-306.3.1</p> <p>Priority 2</p> <p>Severity 3</p> <p>TBD Contract Work</p>	1	JOB	\$1,500	\$1,500
------	--	---	---	-----	---------	---------

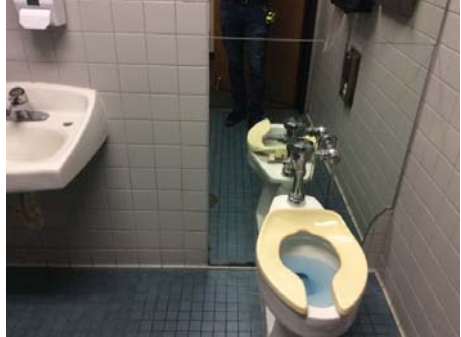
Item No. and Name	Existing Architectural Barrier and Proposed Solution	Codes / Mitigation Info	Qty	Unit	Cost	Total
<u>Toilet Stall</u>						
2016	<ul style="list-style-type: none"> <i>As-Built Description:</i> The lavatory or other unintended fixture, encroaches on the necessary clearance around a water closet (60" x 56"). <i>As-Built:</i> 22" from WC 48" from sidewall <i>Proposed Solution:</i> Remove adjacent fixture and provide new enclosure at accessible water closet. 	PCODE WB01A ADA 2010 604.3.1; 604.3.2 CBC 2013 11B-604.3.1; 11B-604.3.2 Priority 2 Severity 2 TBD Contract Work	1	JOB	\$2,000	\$2,000

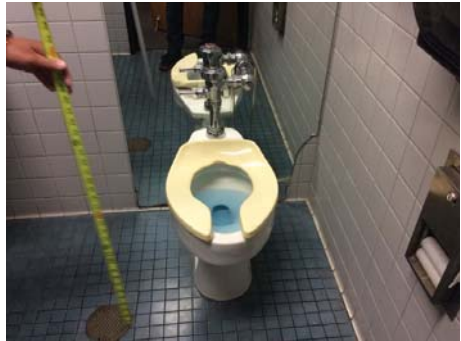
<u>Water Closet</u>						
2014	<ul style="list-style-type: none"> <i>As-Built Description:</i> Water closet not 17"-18" from near side wall to center line of water closet (2010 ADAS: 16"-18"). <i>As-Built:</i> 19.5" o.c. <i>Proposed Solution:</i> Relocate existing water closet and plumbing, remount with offset closet flange to provide 17"-18" from side wall. 	PCODE WB02C ADAAG Fig. 28 ADA 2010 604.2 CBC 2010 1115B.4.1.1 CBC 2013 11B-604.2 Priority 2 Severity 4 TBD Contract Work	1	JOB	\$500	\$500

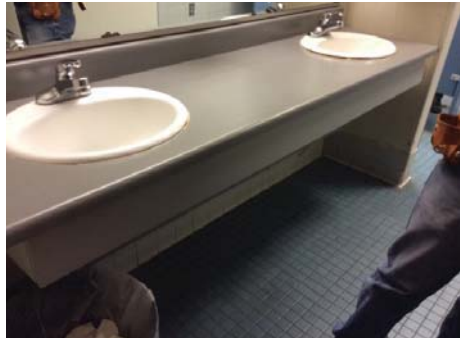
<u>Lavatory</u>							
2022	<ul style="list-style-type: none"> <i>As-Built Description:</i> Lavatory: Fixture rim or counter height more than 34" above floor. <i>As-Built:</i> 34.5" to lav rim <i>Proposed Solution:</i> Provide new accessible lavatory. Remodel restroom as needed. 	PCODE WD02REF ADAAG 4.19.2 ADA 2010 606.3 CBC 2010 1115B.4.3 CBC 2013 11B-606.3 Priority 4 Severity 4 TBD Contract Work	REF

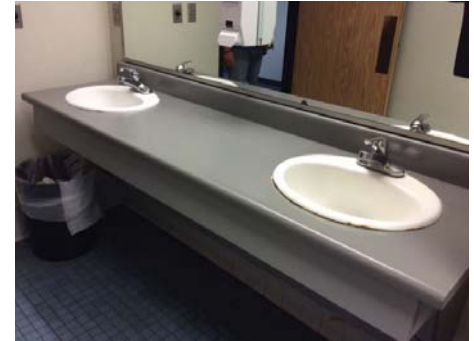
Item No. and Name	Existing Architectural Barrier and Proposed Solution	Codes / Mitigation Info	Qty	Unit	Cost	Total
2021	<ul style="list-style-type: none"> <i>As-Built Description:</i> Wheelchair clearance under lavatory apron or lavatory counter front edge less than 29" high. <i>As-Built:</i> 27" <i>Proposed Solution:</i> Provide new accessible lavatory. Remodel restroom as needed. 	<p>PCODE WD03 ADAAG 4.19.2 ADA 2010 606.3 CBC 2010 1115B.4.3.3 CBC 2013 11B-606.3 Priority 4 Severity 3 TBD Contract Work</p>	1	JOB	\$3,400	\$3,400

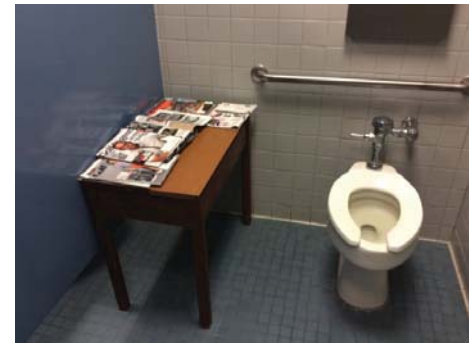
Toilet Stall

2033	<ul style="list-style-type: none"> <i>As-Built Description:</i> The lavatory or other unintended fixture, encroaches on the necessary clearance around a water closet (60" x 56"). <i>Proposed Solution:</i> Remove adjacent fixture and provide new enclosure at accessible water closet. 	<p>PCODE WB01A ADA 2010 604.3.1; 604.3.2 CBC 2013 11B-604.3.1; 11B-604.3.2 Priority 4 Severity 4 TBD Contract Work</p>	1	JOB	\$2,000	\$2,000
------	--	---	---	-----	---------	----------------

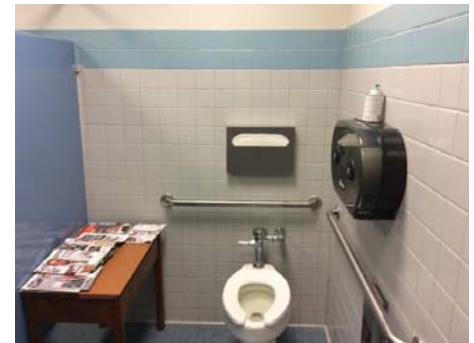
2031	<ul style="list-style-type: none"> <i>As-Built Description:</i> Toilet stall less than 60" wide. <i>As-Built:</i> 59.5" <i>Proposed Solution:</i> Provide new accessible stall. 	<p>PCODE WB06 ADAAG 4.17.3 ADA 2010 604.8.1.1 CBC 2010 1115B.3.1.4.1 CBC 2013 11B-604.8.1.1 Priority 4 Severity 4 TBD Contract Work</p>	1	JOB	\$1,500	\$1,500
------	--	--	---	-----	---------	----------------

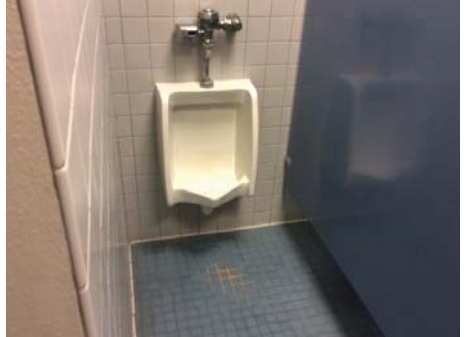
Item No. and Name	Existing Architectural Barrier and Proposed Solution	Codes / Mitigation Info	Qty	Unit	Cost	Total
<u>Urinal</u>						
2026	<ul style="list-style-type: none"> <i>As-Built Description:</i> Front of rim projects less than 13.5" from wall. <i>As-Built:</i> 12" deep <i>Proposed Solution:</i> Provide accessible urinal. Remodel restroom as needed. 	PCODE WE01 ADA 2010 605.2 CBC 2010 1115B.4.2.1 CBC 2013 11B-605.2 Priority 4 Severity 4 TBD Contract Work	1	JOB	\$4,000	\$4,000

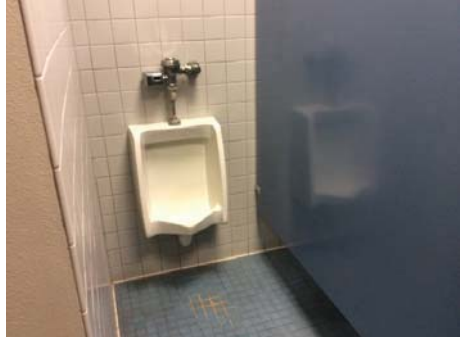
2025	<ul style="list-style-type: none"> <i>As-Built Description:</i> 36" wide clearance in front of accessible urinal not provided when walls or partitions project more than 24" from the front edge of 30" x 48" clear space. <i>As-Built:</i> 33" wide <i>Proposed Solution:</i> Provide 36" clear floor space in front of accessible urinal. Remodel restroom as needed. 	PCODE WE04A ADAAG 4.18.3 ADA 2010 605.3 CBC 2010 1115B.4.2.3 CBC 2013 11B-605.3 Priority 4 Severity 2 TBD Contract Work	1	JOB	\$1,500	\$1,500

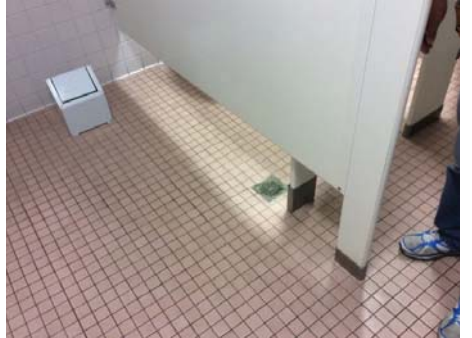
<u>Cross Slope</u>						
2054	<ul style="list-style-type: none"> <i>As-Built Description:</i> Cross slope more than 1":48" (2.083%). <i>As-Built:</i> Slope around drain <i>Proposed Solution:</i> Modify cross slope. 	PCODE EF07 ADAAG 4.3.7 ADA 2010 403.3 CBC 2010 1133B.7.1.3 CBC 2013 11B-403.3 Priority 4 Severity 4 TBD Contract Work	25	SF	\$25	\$625

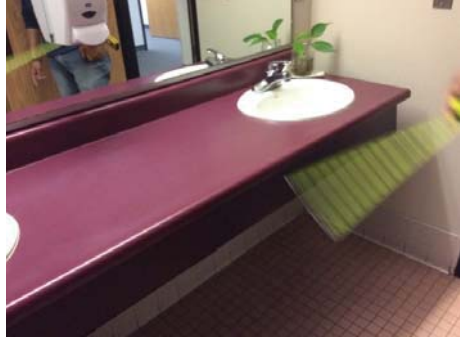
Item No. and Name	Existing Architectural Barrier and Proposed Solution	Codes / Mitigation Info	Qty	Unit	Cost	Total
Lavatory						
2042	<ul style="list-style-type: none"> As-Built Description: Lavatory: Fixture rim or counter height more than 34" above floor. As-Built: 34.5" to rim Proposed Solution: Provide new accessible lavatory. Remodel restroom as needed. 	PCODE WD02 ADAAG 4.19.2 ADA 2010 606.3 CBC 2010 1115B.4.3 CBC 2013 11B-606.3 Priority 4 Severity 4 TBD Contract Work	1	JOB	\$3,400	\$3,400

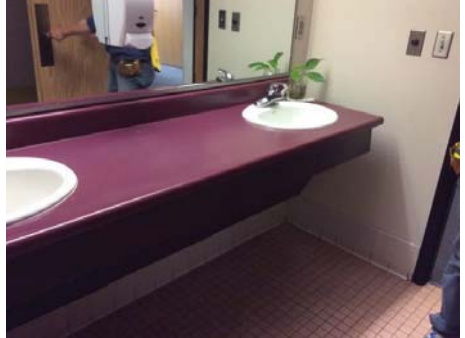
2040	<ul style="list-style-type: none"> As-Built Description: Wheelchair clearance under lavatory apron or lavatory counter front edge less than 29" high. As-Built: 27" Proposed Solution: Provide new accessible lavatory. Remodel restroom as needed. 	PCODE WD03 ADAAG 4.19.2 ADA 2010 606.3 CBC 2010 1115B.4.3.3 CBC 2013 11B-606.3 Priority 4 Severity 3 TBD Contract Work	1	JOB	\$3,400	\$3,400

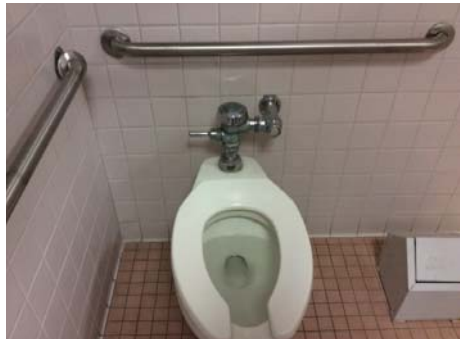
Water Closet						
2048	<ul style="list-style-type: none"> As-Built Description: Flush Control: Operating handle not mounted toward wide side of stall. Proposed Solution: Replace flush control with properly mounted accessible type, or install sensor flush. 	PCODE WB10 ADAAG 4.16.5 ADA 2010 604.6 CBC 2010 1115B.4.1.5 CBC 2013 11B-604.6 Priority 4 Severity 3 TBD Contract Work	1	JOB	\$500	\$500

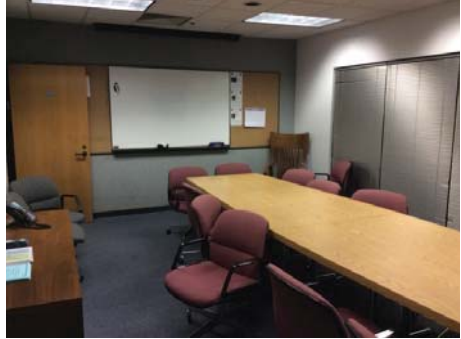
Item No. and Name	Existing Architectural Barrier and Proposed Solution	Codes / Mitigation Info	Qty	Unit	Cost	Total
<u>Assistive Listening</u>						
2056	<ul style="list-style-type: none"> <i>As-Built Description:</i> No portable assistive listening system provided for small meeting room. <i>Proposed Solution:</i> Share existing portable assistive listening system from other facility if needed. 	PCODE GI01E ADAAG 4.1.3(19)(b) & 4.33.7 ADA 2010 219.1 & 706.1 CBC 2010 1104B.2 CBC 2013 11B-219.2 Priority 3 Severity 3 TBD Contract Work				
						REF

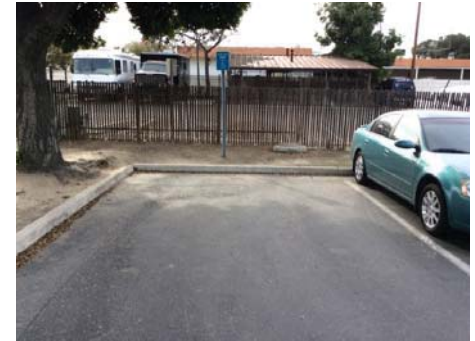
2617	<ul style="list-style-type: none"> <i>As-Built Description:</i> Accessible parking space has slope greater than 1/4":12" (2%). <i>As-Built:</i> 3.2-3.5% <i>Proposed Solution:</i> Modify slope at accessible parking space. 	<p>PCODE EA05</p> <p>ADAAG 4.6.3</p> <p>ADA 2010 502.4</p> <p>CBC 2010 1129B.3.3</p> <p>CBC 2013 11B-502.4</p> <p>Priority 1</p> <p>Severity 4</p> <p>TBD Contract Work</p>	162	SF	\$12	\$1,944
------	---	---	-----	----	------	---------

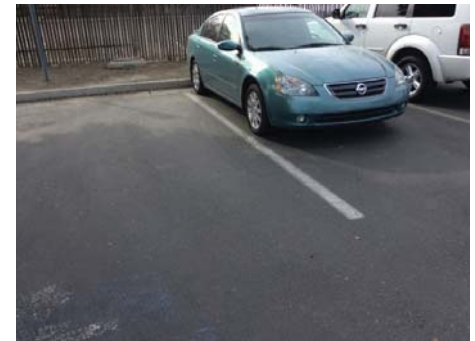
2613	<ul style="list-style-type: none"> <i>As-Built Description:</i> Accessible parking space does not have 5' wide access aisle; 8' wide for van accessible aisle. <i>As-Built:</i> No aisle <i>Proposed Solution:</i> Modify parking aisle(s) to create accessible space by restriping. 	<p>PCODE EA02B</p> <p>ADAAG 4.6.3</p> <p>ADA 2010 502.3</p> <p>CBC 2010 1129B.3.1</p> <p>CBC 2013 11B-502.2; 11B-502.3.1</p> <p>Priority 1</p> <p>Severity 1</p> <p>TBD Contract Work</p>	1	JOB	\$200	\$200
------	---	---	---	-----	-------	-------

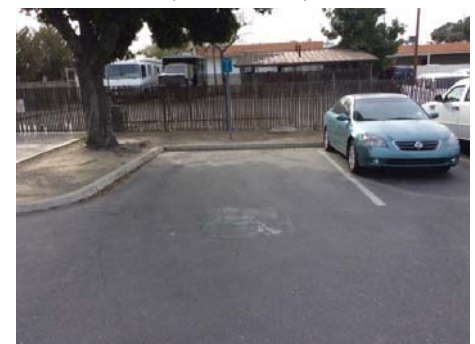
2612	<ul style="list-style-type: none"> <i>As-Built Description:</i> International Symbol of Accessibility (36" square, in white on blue) is not painted on the pavement near the rear end of the parking space (required in CA only). <i>As-Built:</i> Faded <i>Proposed Solution:</i> Apply symbol on parking space pavement when altering area. 	<p>PCODE EA04A</p> <p>CBC 2010 1129B.4</p> <p>CBC 2013 11B-502.6.4</p> <p>Priority 1</p> <p>Severity 4</p> <p>TBD Contract Work</p>	1	JOB	\$120	\$120
------	--	---	---	-----	-------	-------

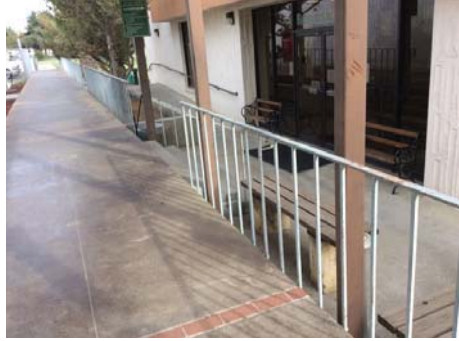
2628	<ul style="list-style-type: none"> As-Built Description: (CA requirement only) Abrupt changes in level, except between a walk or sidewalk and an adjacent street or driveway, exceeding 4" in depth must be identified by a 6" min. curb above the potential drop off. As-Built: 10"-27" drop between rails Proposed Solution: Provide a 6" curb as a warning curb for the blind or a handrail centered +/- 3" above finished surface. Notes: 27" drop 	<p>PCODE EG08</p> <p>CBC 2010 1133B.8.1</p> <p>CBC 2013 11B-303.5</p> <p>Priority 1</p> <p>Severity 1</p> <p>TBD Contract Work</p>	48	LF	\$45	\$2,160
------	---	--	----	----	------	---------

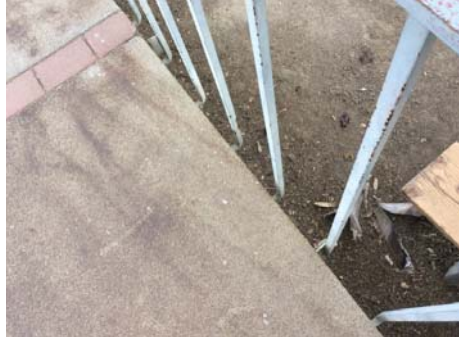
2626	<ul style="list-style-type: none"> As-Built Description: (CA requirement only) Abrupt changes in level, except between a walk or sidewalk and an adjacent street or driveway, exceeding 4" in depth must be identified by a 6" min. curb above the potential drop off. Proposed Solution: Provide a 6" curb as a warning curb for the blind or a handrail centered +/- 3" above finished surface. 	<p>PCODE EG08REF</p> <p>CBC 2010 1133B.8.1</p> <p>CBC 2013 11B-303.5</p> <p>Priority 1</p> <p>Severity 1</p> <p>TBD Contract Work</p>	REF			
------	---	---	-----	--	--	--

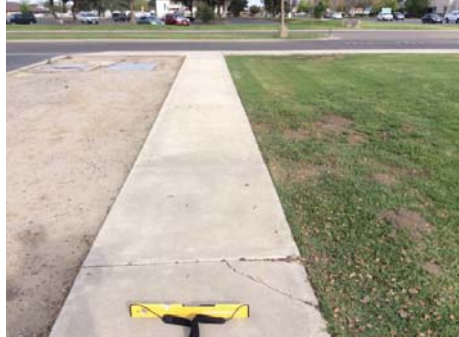
2618	<ul style="list-style-type: none"> As-Built Description: Walk: Pavement dislocation creates abrupt change in level exceeding 1/2" in accessible route. As-Built: 0.75" Proposed Solution: Remove, replace or repair area of pavement sufficient to correct abrupt change in level. 	<p>PCODE EF03</p> <p>ADAAG 4.3.8</p> <p>ADA 2010 403.4</p> <p>CBC 2010 1133B.7.4</p> <p>CBC 2013 11B-403.4</p> <p>Priority 1</p> <p>Severity 4</p> <p>TBD Contract Work</p>	4	SF	\$21	\$84
------	--	---	---	----	------	------

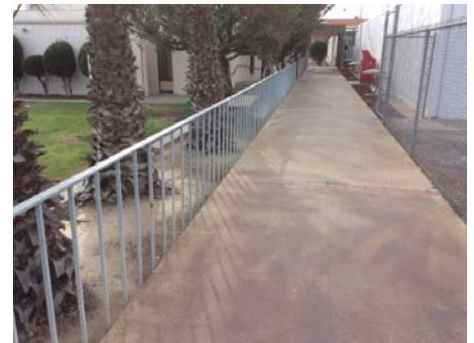
- 2625
- *As-Built Description:*
 Open guards does not have balusters or ornamental patterns such that a 4-inch-diameter (102 mm) sphere cannot pass through any opening.
 - *As-Built:* 8"
 - *Proposed Solution:*
 Provide new guards which do not allow passage of an 4 inch sphere at any opening.
 - **Notes:**
33" ht

PCODE **ED08A**
 ADA 2010 **405.9.2**
 CBC 2010 **1013.3**
 CBC 2013 **11B-405.9.2**
 Priority **1**
 Severity **3**
TBD Contract Work

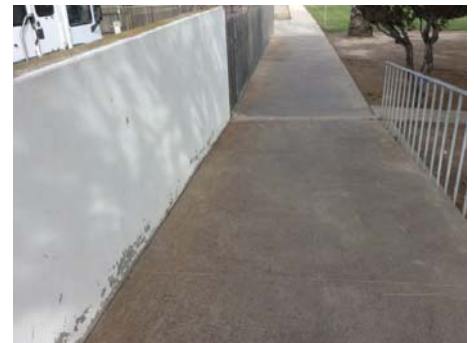
- 2622
- *As-Built Description:*
 Handrail not provided at stairs or ramp, required on both sides (not required at curb ramps or adjacent to seating areas).
 - *Proposed Solution:*
 Provide new handrail for each side including extensions.

PCODE **ED01REF**
 ADAAG **4.8.5 & 4.9.4**
 ADA 2010 **505.2**
 CBC 2010 **1133B.4.1.1 & .5.5**
 CBC 2013 **11B-505.2**
 Priority **1**
 Severity **2**
TBD Contract Work

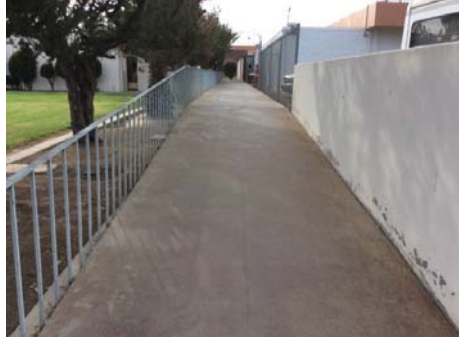
Item No. and Name	Existing Architectural Barrier and Proposed Solution	Codes / Mitigation Info	Qty	Unit	Cost	Total
<u>Slope</u>						
2621	<ul style="list-style-type: none"> • <i>As-Built Description:</i> Slope greater than 1:12 (8.3%). • <i>As-Built:</i> 7.8-10.4% • <i>Proposed Solution:</i> Demolish existing and provide new ramp with handrails. 	PCODE EB02 ADAAG 4.8.2 ADA 2010 405.2 CBC 2010 1133B.5.3 CBC 2013 11B-405.2 Priority 1 Severity 4 TBD Contract Work	240	SF	\$100	\$24,000

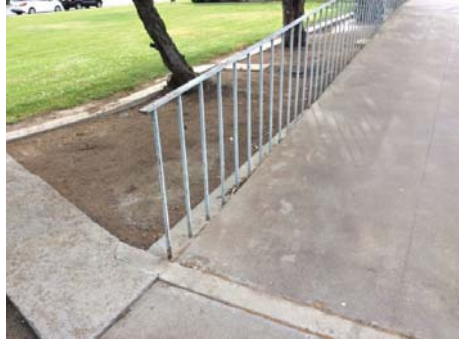
<u>Top and Bottom Extension at Ramps</u>							
2624	<ul style="list-style-type: none"> • <i>As-Built Description:</i> Ramp handrail does not extend horizontally 12" past top and / or bottom of ramp. • <i>Proposed Solution:</i> Provide ramp handrail extension (cost for each extension piece). 	PCODE ED05REF ADAAG 4.8.5(2) ADA 2010 505.10.1 CBC 2010 1133B.4.2.2 & CBC 2013 11B-505.10.1 Priority 1 Severity 2 TBD Contract Work	REF

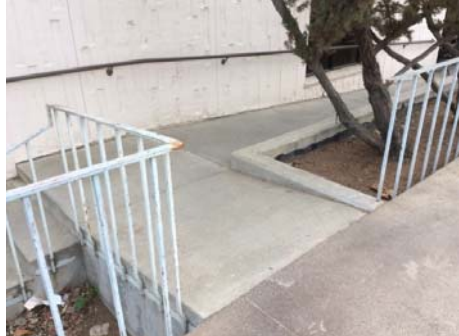
<u>Change in Direction</u>						
2638	<ul style="list-style-type: none"> • <i>As-Built Description:</i> Landing at change of direction not 60" minimum by 72" minimum in the direction of downward travel from the upper ramp run. • <i>As-Built:</i> 58" • <i>Proposed Solution:</i> Modify landing at change of direction to 60" x 72". 	PCODE EB08 ADAAG 4.8.4(3) ADA 2010 405.7.4 CBC 2010 1133B.5.4 CBC 2013 11B-405.7.4 Priority 1 Severity 4 TBD Contract Work	72	SF	\$45	\$3,240

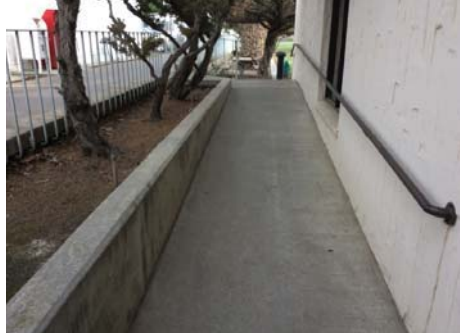
<u>Handrails</u>						
2633	<ul style="list-style-type: none"> <i>As-Built Description:</i> Handrail not provided at stairs or ramp, required on both sides (not required at curb ramps or adjacent to seating areas). <i>Proposed Solution:</i> Provide new handrail for each side including extensions. <i>Notes:</i> 6.1%-6.9% 	PCODE ED01 ADAAG 4.8.5 & 4.9.4 ADA 2010 505.2 CBC 2010 1133B.4.1.1 & .5.5 CBC 2013 11B-505.2 Priority 1 Severity 2 TBD Contract Work	24	LF	\$95	\$2,280

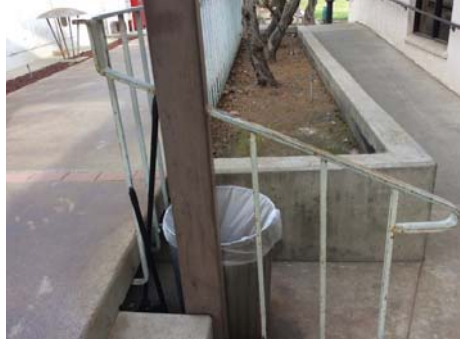
Item No. and Name	Existing Architectural Barrier and Proposed Solution	Codes / Mitigation Info	Qty	Unit	Cost	Total
2632	<ul style="list-style-type: none"> <i>As-Built Description:</i> Handrail not provided at stairs or ramp, required on both sides (not required at curb ramps or adjacent to seating areas). <i>As-Built:</i> Obstructed <i>Proposed Solution:</i> Provide new handrail for each side including extensions. 	<p>PCODE ED01REF ADAAG 4.8.5 & 4.9.4 ADA 2010 505.2 CBC 2010 1133B.4.1.1 & .5.5 CBC 2013 11B-505.2 Priority 1 Severity 2 TBD Contract Work</p>				
						REF

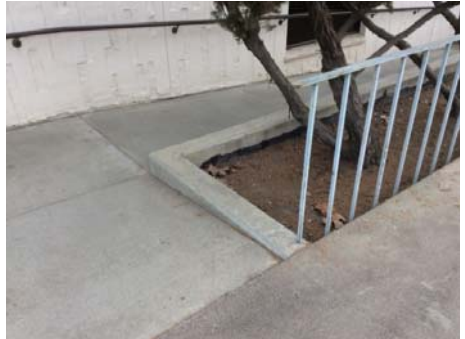
2639	<ul style="list-style-type: none"> <i>As-Built Description:</i> Handrail not provided at stairs or ramp, required on both sides (not required at curb ramps or adjacent to seating areas). <i>Proposed Solution:</i> Provide new handrail for each side including extensions. 	<p>PCODE ED01REF ADAAG 4.8.5 & 4.9.4 ADA 2010 505.2 CBC 2010 1133B.4.1.1 & .5.5 CBC 2013 11B-505.2 Priority 1 Severity 2 TBD Contract Work</p>

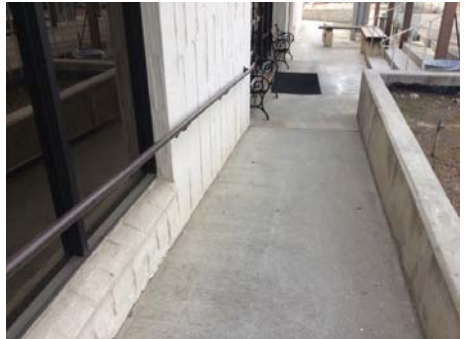
Height					
2637	<ul style="list-style-type: none"> <i>As-Built Description:</i> Handrail gripping surface top not mounted between 34" and 38" above ramp surface or stair nosings. <i>As-Built:</i> 33"-34" <i>Proposed Solution:</i> Remove existing and provide new handrail. Notes: Lower portion 	<p>PCODE ED02 ADAAG 4.9.4(5) ADA 2010 505.4 CBC 2010 1133B.4.2.1 & CBC 2013 11B-505.4 Priority 1 Severity 4 TBD Contract Work</p>	12	LF	\$75	\$900

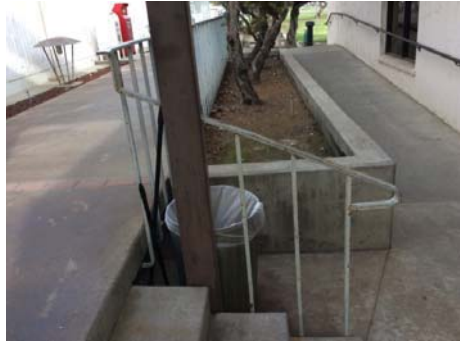
Item No. and Name	Existing Architectural Barrier and Proposed Solution	Codes / Mitigation Info	Qty	Unit	Cost	Total
2631	<ul style="list-style-type: none"> • <i>As-Built Description:</i> Handrail gripping surface top not mounted between 34" and 38" above ramp surface or stair nosings. • <i>As-Built:</i> 32"-33" • <i>Proposed Solution:</i> Remove existing and provide new handrail. 	<p>PCODE ED02 ADAAG 4.9.4(5) ADA 2010 505.4 CBC 2010 1133B.4.2.1 & CBC 2013 11B-505.4 Priority 4 Severity 4 TBD Contract Work</p>	12	LF	\$75	\$900

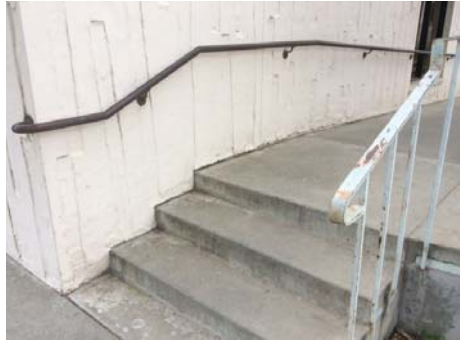
2643	<ul style="list-style-type: none"> • <i>As-Built Description:</i> Handrail gripping surface top not mounted between 34" and 38" above ramp surface or stair nosings. • <i>As-Built:</i> 33" • <i>Proposed Solution:</i> Remove existing and provide new handrail. 	<p>PCODE ED02 ADAAG 4.9.4(5) ADA 2010 505.4 CBC 2010 1133B.4.2.1 & CBC 2013 11B-505.4 Priority 4 Severity 4 TBD Contract Work</p>	10	LF	\$75	\$750

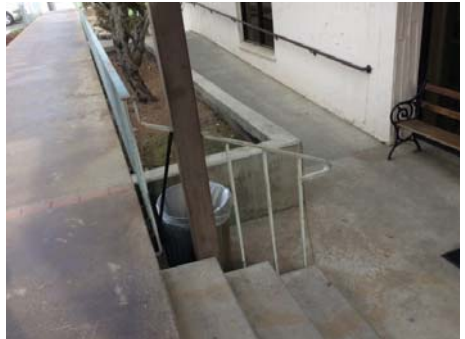
<u>Top & Bottom Extension at Stairs</u>						
2630	<ul style="list-style-type: none"> • <i>As-Built Description:</i> Stair handrail does not extend horizontally 12" minimum beyond top nosing, and one tread width sloped, plus 12" minimum horizontally beyond the bottom nosing. • <i>Proposed Solution:</i> Extend stair handrail at top and bottom (cost for each extension piece). 	<p>PCODE ED06 ADAAG 4.9.4(2) ADA 2010 505.10.2; 505.10.3 CBC 2010 1133B.4.2.2 CBC 2013 11B-505.10.2; 11B-505.10.3 Priority 4 Severity 2 TBD Contract Work</p>	4	JOB	\$170	\$680

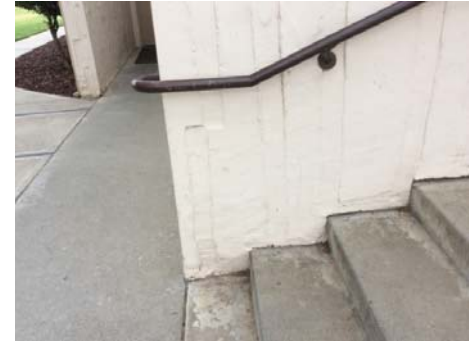
Item No. and Name	Existing Architectural Barrier and Proposed Solution	Codes / Mitigation Info	Qty	Unit	Cost	Total
2644	<ul style="list-style-type: none"> <i>As-Built Description:</i> Stair handrail does not extend horizontally 12" minimum beyond top nosing, and one tread width sloped, plus 12" minimum horizontally beyond the bottom nosing. <i>As-Built:</i> does not continue one tread width <i>Proposed Solution:</i> Extend stair handrail at top and bottom (cost for each extension piece). 	<p>PCODE ED06 ADAAG 4.9.4(2) ADA 2010 505.10.2; 505.10.3 CBC 2010 1133B.4.2.2 CBC 2013 11B-505.10.2; 11B-505.10.3 Priority 4 Severity 2 TBD Contract Work</p>	1	JOB	\$170	\$170

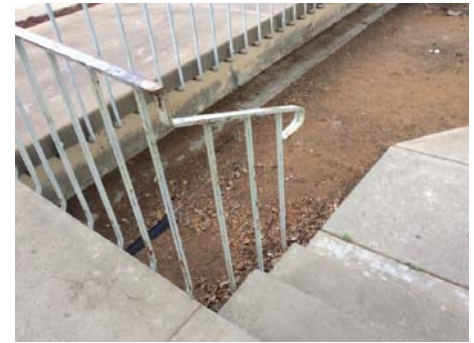
2642	<ul style="list-style-type: none"> <i>As-Built Description:</i> Stair handrail does not extend horizontally 12" minimum beyond top nosing, and one tread width sloped, plus 12" minimum horizontally beyond the bottom nosing. <i>Proposed Solution:</i> Extend stair handrail at top and bottom (cost for each extension piece). 	<p>PCODE ED06REF ADAAG 4.9.4(2) ADA 2010 505.10.2; 505.10.3 CBC 2010 1133B.4.2.2 CBC 2013 11B-505.10.2; 11B-505.10.3 Priority 4 Severity 2 TBD Contract Work</p>	REF			
------	---	--	-----	--	--	--

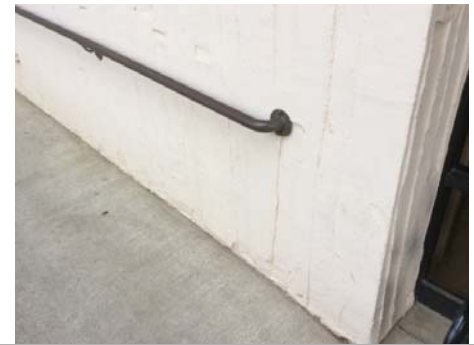
2636	<ul style="list-style-type: none"> <i>As-Built Description:</i> Ramp handrail does not extend horizontally 12" past top and / or bottom of ramp. <i>Proposed Solution:</i> Provide ramp handrail extension (cost for each extension piece). 	<p>PCODE ED05 ADAAG 4.8.5(2) ADA 2010 505.10.1 CBC 2010 1133B.4.2.2 & CBC 2013 11B-505.10.1 Priority 1 Severity 2 TBD Contract Work</p>	1	JOB	\$170	\$170
------	---	---	---	-----	-------	-------

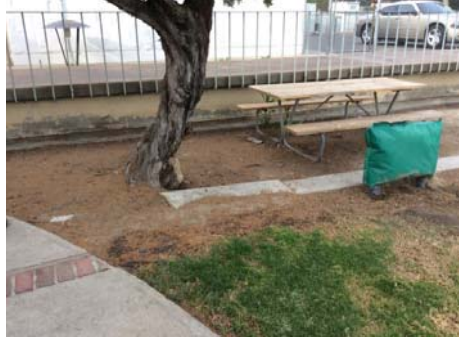
Item No. and Name	Existing Architectural Barrier and Proposed Solution	Codes / Mitigation Info	Qty	Unit	Cost	Total
<u>Accessible Route</u>						
2647	<ul style="list-style-type: none"> <i>As-Built Description:</i> No walk / sidewalk provided to connect accessible facilities or elements that are on the same site. <i>Proposed Solution:</i> Provide new 48" wide walk / sidewalk. 	PCODE EF13 ADAAG 4.3.2 ADA 2010 206.1 CBC 2010 1114B.1.2 CBC 2013 11B-206.1 Priority 1 Severity 1 TBD Contract Work	15	LF	\$45	\$675

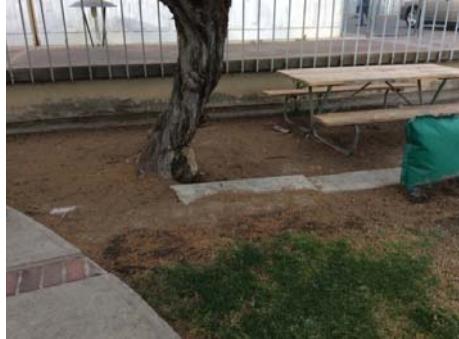
<u>Picnic Area</u>						
2648	<ul style="list-style-type: none"> <i>As-Built Description:</i> Knee clearance at minimums 27" high, 30" wide, and 19" deep is not provided. <i>As-Built:</i> 14" deep <i>Proposed Solution:</i> Modify picnic table as required to provide knee clearance. 	PCODE NH11A ADAAG 16.5.4. ADA 2010 902.2 CBC 2010 1132B.1 CBC 2013 11-902.2 Priority 1 Severity 2 TBD Contract Work	1	JOB	\$850	\$850

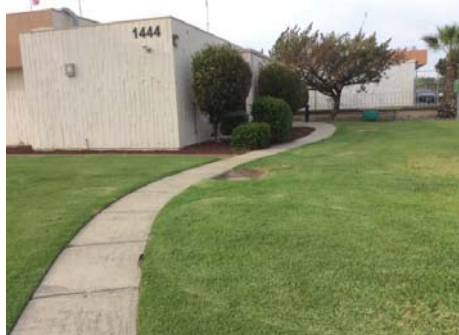
<u>Walk</u>						
2645	<ul style="list-style-type: none"> <i>As-Built Description:</i> Walk more than 36" but less than 48" wide (required in CA only). <i>As-Built:</i> 36" <i>Proposed Solution:</i> Enlarge width of walk to 48". 	PCODE EF08 CBC 2010 1133B.7.1 CBC 2013 11B-403.5.1.3 Priority 1 Severity 3 TBD Contract Work	220	SF	\$45	\$9,900

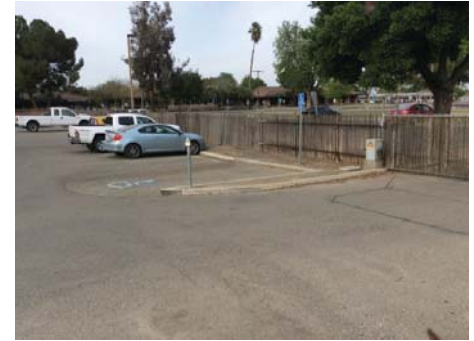
2651	<ul style="list-style-type: none"> <i>As-Built Description:</i> Accessible parking space has slope greater than 1/4":12" (2%). <i>As-Built:</i> Irregular surface <i>Proposed Solution:</i> Modify slope at accessible parking space. 	PCODE EA05 ADAAG 4.6.3 ADA 2010 502.4 CBC 2010 1129B.3.3 CBC 2013 11B-502.4 Priority 1 Severity 4 TBD Contract Work	162	SF	\$12	\$1,944
------	--	--	-----	----	------	---------

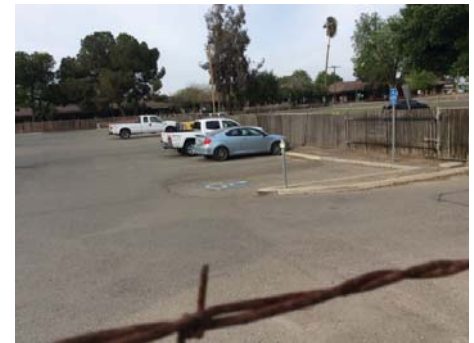
2649	<ul style="list-style-type: none"> <i>As-Built Description:</i> Accessible parking space does not have 5' wide access aisle; 8' wide for van accessible aisle. <i>Proposed Solution:</i> Modify parking aisle(s) to create accessible space by restriping. 	PCODE EA02B ADAAG 4.6.3 ADA 2010 502.3 CBC 2010 1129B.3.1 CBC 2013 11B-502.2; 11B-502.3.1 Priority 1 Severity 1 TBD Contract Work	1	JOB	\$200	\$200
------	--	--	---	-----	-------	-------

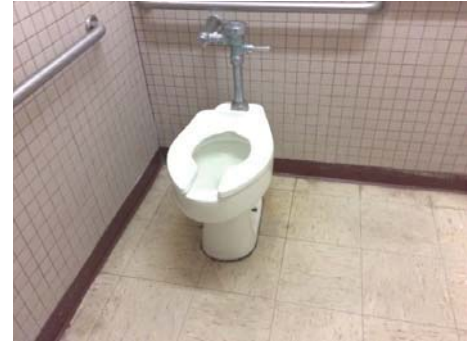
Item No. and Name	Existing Architectural Barrier and Proposed Solution	Codes / Mitigation Info	Qty	Unit	Cost	Total
1835	<ul style="list-style-type: none"> <i>As-Built Description:</i> Height of water closet seat less than 17" or more than 19" from floor. <i>As-Built:</i> 19.5" <i>Proposed Solution:</i> Provide new accessible water closet. 	<p>PCODE WB08 ADAAG 4.16.3 ADA 2010 604.4 CBC 2010 1115B.4.1.4 CBC 2013 11B-604.4 Priority 3 Severity 4 TBD Contract Work</p>	1	JOB	\$1,400	\$1,400

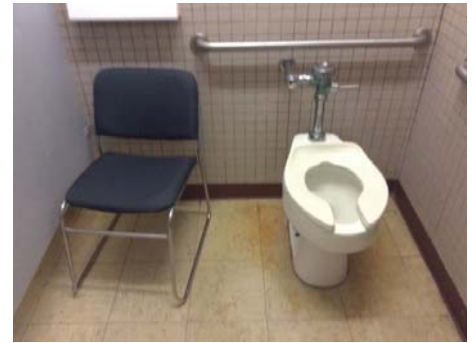
1856	<ul style="list-style-type: none"> <i>As-Built Description:</i> Toilet stall less than 60" wide. <i>As-Built:</i> Seat in clear space <i>Proposed Solution:</i> Provide new accessible stall (alternate stalls 36" x 69" or 48" x 69" not recommended). 	<p>PCODE WB06NT ADAAG 4.17.3 ADA 2010 604.8.1.1 CBC 2010 1115B.3.1.4.1 CBC 2013 11B-604.8.1.1 Priority 3 Severity 4 TBD Contract Work</p>	1	JOB	\$1,500	\$1,500
------	--	--	---	-----	---------	----------------

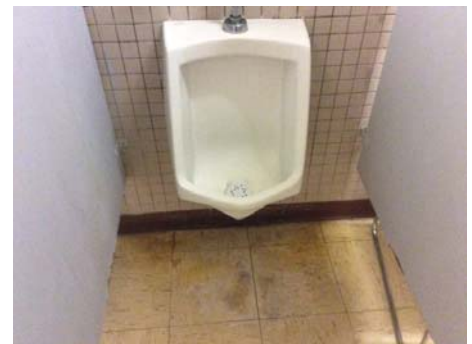
1849	<ul style="list-style-type: none"> <i>As-Built Description:</i> Front of rim projects less than 13.5" from wall. <i>Proposed Solution:</i> Provide accessible urinal. Remodel restroom as needed. 	<p>PCODE WE01 ADA 2010 605.2 CBC 2010 1115B.4.2.1 CBC 2013 11B-605.2 Priority 3 Severity 4 TBD Contract Work</p>	1	JOB	\$4,000	\$4,000
------	---	---	---	-----	---------	----------------

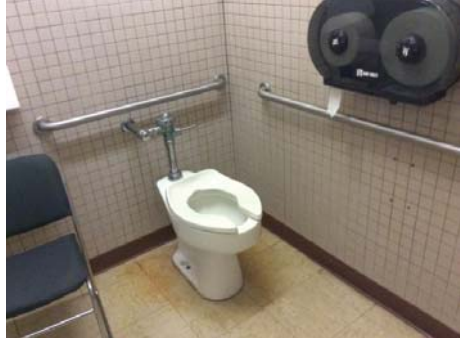
Item No. and Name	Existing Architectural Barrier and Proposed Solution	Codes / Mitigation Info	Qty	Unit	Cost	Total
Water Closet						
1851	<ul style="list-style-type: none"> <i>As-Built Description:</i> Water closet not 17"-18" from near side wall to center line of water closet (2010 ADAS: 16"-18"). <i>As-Built:</i> 18.75" o.c. <i>Proposed Solution:</i> Relocate existing water closet and plumbing, remount with offset closet flange to provide 17"-18" from side wall. 	PCODE WB02C ADAAG Fig. 28 ADA 2010 604.2 CBC 2010 1115B.4.1.1 CBC 2013 11B-604.2 Priority 3 Severity 4 TBD Contract Work	1	JOB	\$500	\$500

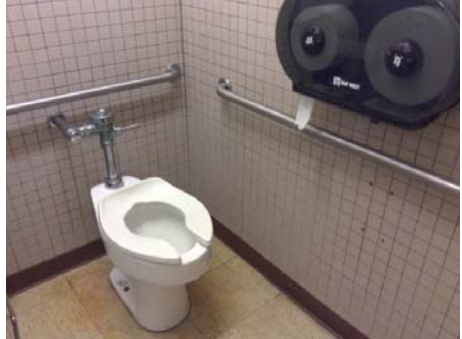
1852	<ul style="list-style-type: none"> <i>As-Built Description:</i> Height of water closet seat less than 17" or more than 19" from floor. <i>As-Built:</i> 19.5" <i>Proposed Solution:</i> Provide new accessible water closet. 	PCODE WB08 ADAAG 4.16.3 ADA 2010 604.4 CBC 2010 1115B.4.1.4 CBC 2013 11B-604.4 Priority 3 Severity 4 TBD Contract Work	1	JOB	\$1,400	\$1,400

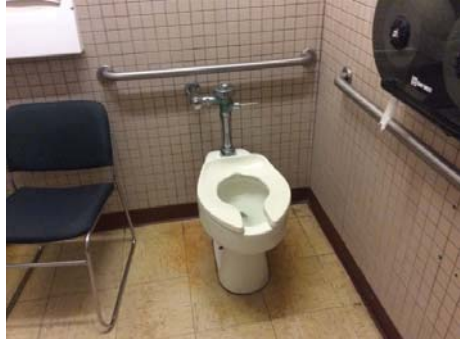
1850	<ul style="list-style-type: none"> <i>As-Built Description:</i> Flush Control: Operating handle not mounted toward wide side of stall. <i>Proposed Solution:</i> Replace flush control with properly mounted accessible type, or install sensor flush. 	PCODE WB10 ADAAG 4.16.5 ADA 2010 604.6 CBC 2010 1115B.4.1.5 CBC 2013 11B-604.6 Priority 3 Severity 3 TBD Contract Work	1	JOB	\$500	\$500

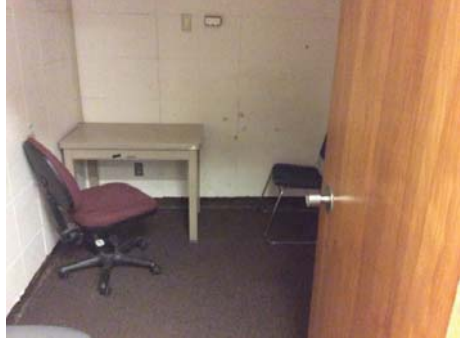
Item No. and Name	Existing Architectural Barrier and Proposed Solution	Codes / Mitigation Info	Qty	Unit	Cost	Total
<u>Door Clearance</u>						
1859	<ul style="list-style-type: none"> <i>As-Built Description:</i> Door on accessible route has less than 32" clear and 80" (78" min. to closer if provided) opening width when 90° open. <i>As-Built:</i> 29" clear <i>Proposed Solution:</i> Provide new, larger door and frame with new accessible hardware. 	PCODE ID01 ADAAG 4.13.5 ADA 2010 404.2.3 CBC 2010 1133B.1.1.1.1 CBC 2013 11B-404.2.3 Priority 2 Severity 3 TBD Contract Work	1	JOB	\$2,600	\$2,600

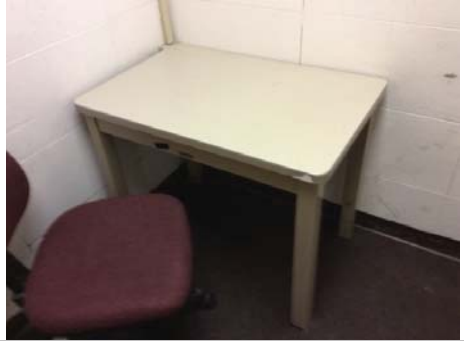
<u>Non-Fixed Desk</u>						
1860	<ul style="list-style-type: none"> <i>As-Built Description:</i> Accessible non-fixed table or desk (top 28" to 34" high; knee space at least 27" high x 19" deep x 30" wide) not provided. <i>As-Built:</i> 25" high knee <i>Proposed Solution:</i> Provide table or desk with accessible dimensions when purchasing new furniture. 	PCODE IN02A ADAAG 4.32.3 & .4 ADA 2010 306.1 CBC 2010 1122B.3 & 4 CBC 2013 11B-306.1 & 11B-902.3 Priority 2 Severity 2 TBD Contract Work	1	JOB	\$1,600	\$1,600
