Facility: **WOMENS INFANTS & CHILDREN**

Address: 330 HARRIS ST.

Facility: **LEMORE HEALTH CLINIC**
 Address: 229 C ST.

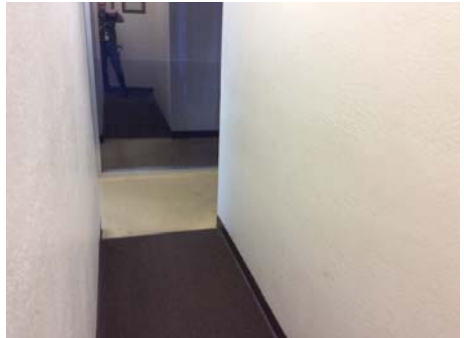
<u>Corridor</u>						
1862	<ul style="list-style-type: none"> <i>As-Built Description:</i> Corridor less than 36" wide. <i>As-Built:</i> 35" <i>Proposed Solution:</i> Enlarge corridor to 36" wide; relocate stud wall. 	PCODE IH03 ADAAG 4.3.3 ADA 2010 403.5.1 CBC 2010 1133B.3.1 CBC 2013 11B-403.5.1 Priority 2 Severity 3 TBD Contract Work	8	LF	\$140	\$1,120

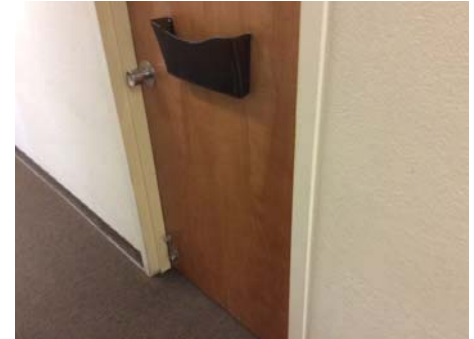
1865	<ul style="list-style-type: none"> <i>As-Built Description:</i> Door on accessible route has less than 32" clear and 80" (78" min. to closer if provided) opening width when 90° open. <i>Proposed Solution:</i> Provide new, larger door and frame with new accessible hardware. 	PCODE ID01 ADAAG 4.13.5 ADA 2010 404.2.3 CBC 2010 1133B.1.1.1.1 CBC 2013 11B-404.2.3 Priority 2 Severity 3 TBD Contract Work	8	JOB	\$2,600	\$20,800
------	---	---	---	-----	---------	----------

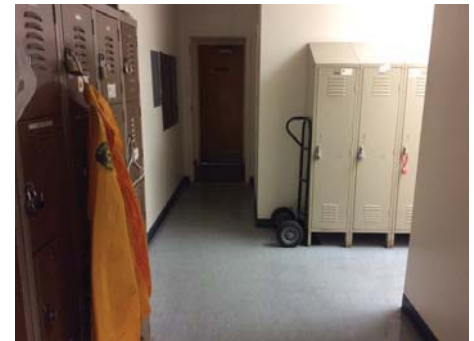
1878	<ul style="list-style-type: none"> <i>As-Built Description:</i> Accessible locker(s) in dressing room not provided (5% of lockers; not less than one). <i>As-Built:</i> Large ones not acc. <i>Proposed Solution:</i> Provide new locker(s) with accessible locking hardware that is operable with one hand and does not require grasping, pinching or twisting. <i>Notes:</i> provide if requested. 	PCODE GG04 ADAAG 4.1.3(12)(a) ADA 2010 222.1 CBC 2010 1115B.8.5 CBC 2013 11B-222.1 Priority 2 Severity 3 TBD Contract Work	1	JOB	\$750	\$750
------	---	---	---	-----	-------	-------

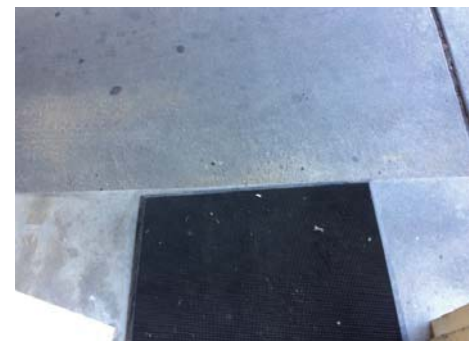
1871	<ul style="list-style-type: none"> <i>As-Built Description:</i> Door inaccessible due to threshold or step at door more than 6" high. <i>As-Built:</i> 6" <i>Proposed Solution:</i> Provide ramp including handrails and compliant landings, matching floor level inside door (+/-1/4"). 	PCODE ID02B ADAAG 4.8.5 ADA 2010 404.2.5 CBC 2010 1133B.2.4.1 CBC 2013 11B-404.2.5 Priority 4 Severity 1 TBD Contract Work	50	SF	\$100	\$5,000
------	---	---	----	----	-------	---------

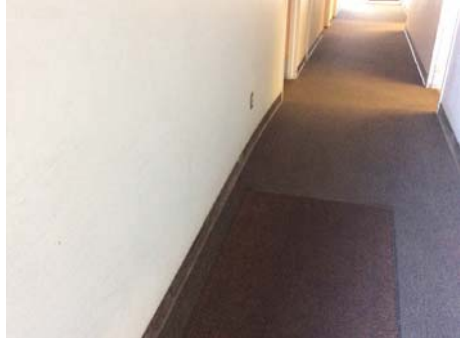
Item No. and Name	Existing Architectural Barrier and Proposed Solution	Codes / Mitigation Info	Qty	Unit	Cost	Total
Ramp						
1869	<ul style="list-style-type: none"> As-Built Description: Ramp: Slope not steep but greater than 1:20 (5.0%) without handrails. Proposed Solution: Provide steel handrails for ramp. 	PCODE EB03REF ADAAG 4.8.1 ADA 2010 405.1 CBC 2010 1133B.5.5.1 CBC 2013 11B-405.8 Priority 4 Severity 4 TBD Contract Work				
						REF

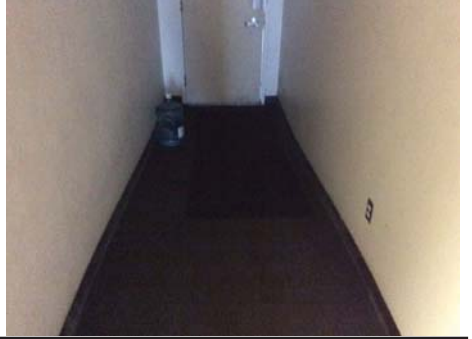
Slope						
1868	<ul style="list-style-type: none"> As-Built Description: Slope greater than 1:12 (8.3%). As-Built: 10.1% Proposed Solution: Demolish existing and provide new ramp with handrails. 	PCODE EB02 ADAAG 4.8.2 ADA 2010 405.2 CBC 2010 1133B.5.3 CBC 2013 11B-405.2 Priority 1 Severity 4 TBD Contract Work	40	SF	\$100	\$4,000

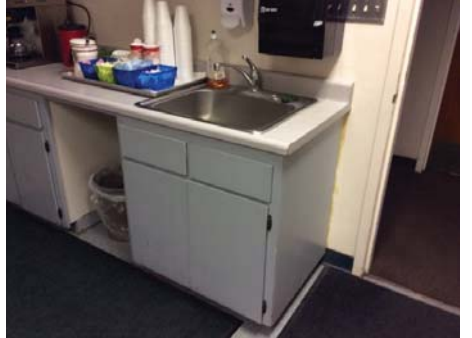
Sink						
1872	<ul style="list-style-type: none"> As-Built Description: Sink does not have knee space min. 27" high x 19" deep x 30" wide. Proposed Solution: Remodel sink cabinet. 	PCODE IN06A ADAAG 4.24.3 ADA 2010 606.2 CBC 2010 1115B.4.7.1 CBC 2013 11B-606.2 Priority 4 Severity 2 TBD Contract Work	1	JOB	\$1,750	\$1,750

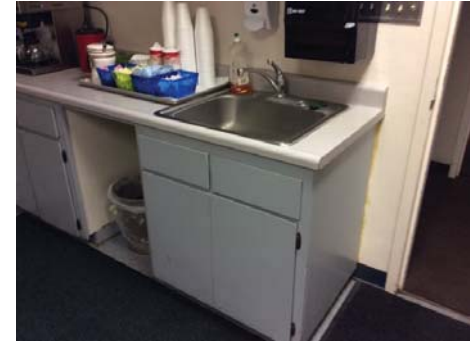
Item No. and Name	Existing Architectural Barrier and Proposed Solution	Codes / Mitigation Info	Qty	Unit	Cost	Total
1873	<ul style="list-style-type: none"> • <i>As-Built Description:</i> Sink rim higher than 34" above floor. • <i>As-Built:</i> 36" • <i>Proposed Solution:</i> Remodel sink cabinet to lower sink. 	<p>PCODE IN06REF</p> <p>ADAAG 4.24.2</p> <p>ADA 2010 606.3</p> <p>CBC 2010 1115B.4.7.1</p> <p>CBC 2013 11B-606.3</p> <p>Priority 4</p> <p>Severity 4</p> <p>TBD Contract Work</p>

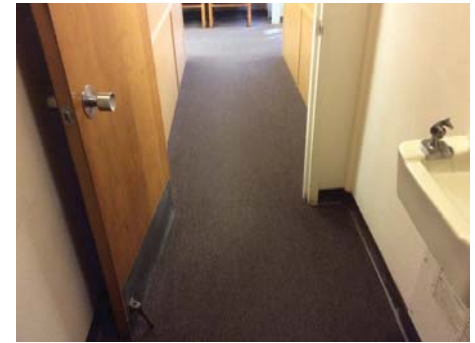
1876	<ul style="list-style-type: none"> • <i>As-Built Description:</i> Door on accessible route has less than 32" clear and 80" (78" min. to closer if provided) opening width when 90° open. • <i>As-Built:</i> 29" • <i>Proposed Solution:</i> Provide new, larger door and frame with new accessible hardware. 	<p>PCODE ID01</p> <p>ADAAG 4.13.5</p> <p>ADA 2010 404.2.3</p> <p>CBC 2010 1133B.1.1.1.1</p> <p>CBC 2013 11B-404.2.3</p> <p>Priority 3</p> <p>Severity 3</p> <p>TBD Contract Work</p>	1	JOB	\$2,600	\$2,600

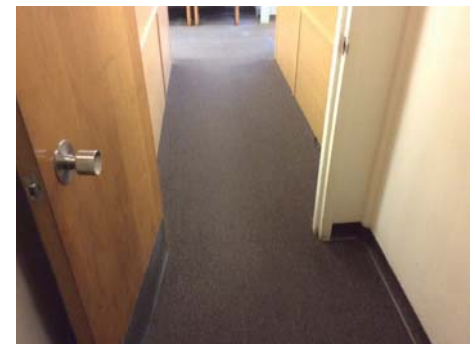
1884	<ul style="list-style-type: none"> • <i>As-Built Description:</i> Front approach: At pull side, door does not have clear and level maneuvering space measuring door width plus 18" x 60". • <i>As-Built:</i> 9" • <i>Proposed Solution:</i> Provide relocated new door and frame; remodel walls as needed. 	<p>PCODE ID23B</p> <p>ADAAG Fig. 25(a)</p> <p>ADA 2010 404.2.4</p> <p>CBC 2010 11B-26A(a)</p> <p>CBC 2013 11B-404.2.4</p> <p>Priority 3</p> <p>Severity 3</p> <p>TBD Contract Work</p>	1	JOB	\$2,600	\$2,600

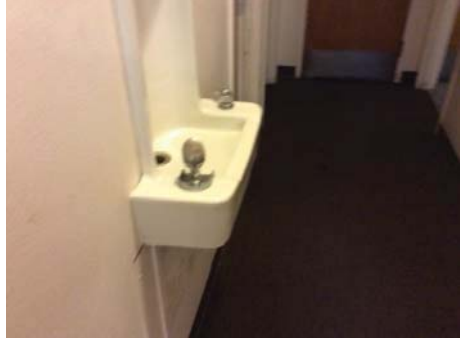
Item No. and Name	Existing Architectural Barrier and Proposed Solution	Codes / Mitigation Info	Qty	Unit	Cost	Total
<u>Drinking Fountain</u>						
1882	<ul style="list-style-type: none"> <i>As-Built Description:</i> Where only one drinking fountain is provided per floor: Fountain is not accessible to individuals who use wheelchairs, or to those who have difficulty bending or stooping. <i>Proposed Solution:</i> Provide additional fountain or hi-lo combination fountain. 	PCODE IA01A ADAAG 4.1.3(10)(a) ADA 2010 211.1 CBC 2010 1115B.4.6.1 CBC 2013 11B-211.1 Priority 3 Severity 2 TBD Contract Work	1	JOB	\$2,000	\$2,000

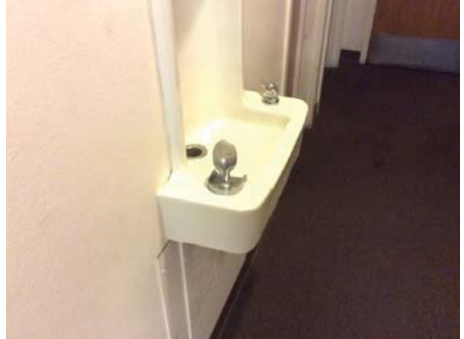
1883	<ul style="list-style-type: none"> <i>As-Built Description:</i> Drinking fountain is not 18" - 19" in depth. <i>As-Built:</i> 8" deep <i>Proposed Solution:</i> Provide new, accessible fountain. 	PCODE IA02B ADAAG 4.15.5(1) ADA 2010 602.8 CBC 2010 1115B.4.6.2 CBC 2013 11B-602.8 Priority 3 Severity 1 TBD Contract Work	1	JOB	\$3,200	\$3,200

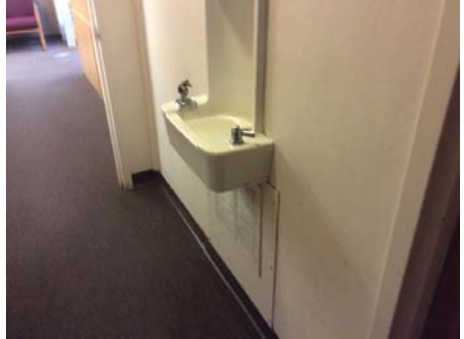
1881	<ul style="list-style-type: none"> <i>As-Built Description:</i> CA only: Drinking fountain not located in an alcove (min. 32" wide x 18" deep) or otherwise encroaches into pedestrian way. <i>Proposed Solution:</i> Provide new alcove for drinking fountain, or, if unreasonable hardship is determined, provide wing walls or cane-detectable railings on each side of the drinking fountain. The wings must project out from the supporting wall at least as far as the drinking fountain to within 6" of the surface of the circulation path, but cannot reduce the required clear width of the adjacent accessible route. 	PCODE IA04 CBC 2010 1115B.4.6.3; Fig. CBC 2013 11B-602.9 Priority 3 Severity 2 TBD Contract Work	1	JOB	\$3,000	\$3,000

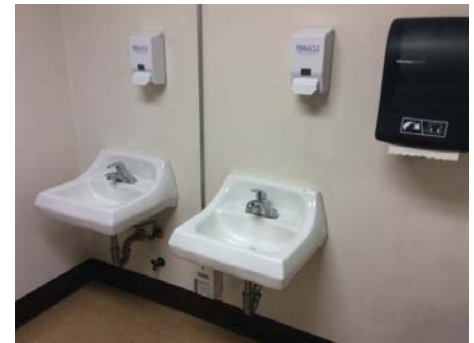
- 1889
- *As-Built Description:*
 Wheelchair clearance under lavatory apron or lavatory counter front edge less than 29" high.
 - *As-Built:* 26.5"
 - *Proposed Solution:*
 Provide new accessible lavatory. Remodel restroom as needed.

PCODE WD03REF
 ADAAG 4.19.2
 ADA 2010 606.3
 CBC 2010 1115B.4.3.3
 CBC 2013 11B-606.3
 Priority 4
 Severity 3
 TBD Contract Work

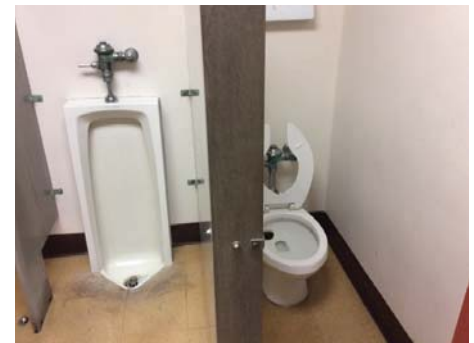
- 1887
- *As-Built Description:*
 Multiple accommodation restroom not accessible; multiple compliance violations.
 - *Proposed Solution:*
 Remodel area to provide accessible restroom with one accessible stall, lavatory (and one urinal at Mens).

PCODE WA01A
 ADAAG 4.22
 ADA 2010 603
 CBC 2010 1115B.3.1
 CBC 2013 11B-603
 Priority 4
 Severity 1
 TBD Contract Work

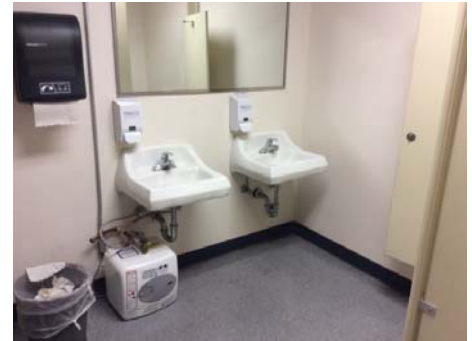
- 1892
- *As-Built Description:*
 Wheelchair clearance under lavatory apron or lavatory counter front edge less than 29" high.
 - *As-Built:* 26"
 - *Proposed Solution:*
 Provide new accessible lavatory. Remodel restroom as needed.

PCODE WD03REF
 ADAAG 4.19.2
 ADA 2010 606.3
 CBC 2010 1115B.4.3.3
 CBC 2013 11B-606.3
 Priority 4
 Severity 3
 TBD Contract Work

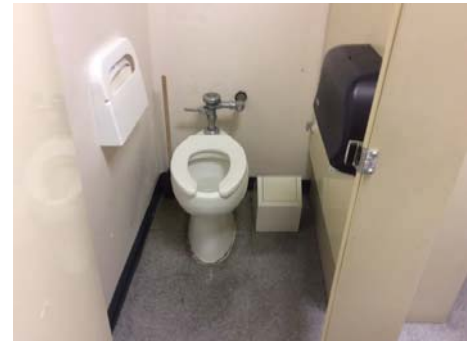
- 1890
- *As-Built Description:*
 Multiple accommodation restroom not accessible; multiple compliance violations.
 - *As-Built:* 35" wide
 - *Proposed Solution:*
 Remodel area to provide accessible restroom with one accessible stall, lavatory (and one urinal at Mens).

PCODE WA01A
 ADAAG 4.22
 ADA 2010 603
 CBC 2010 1115B.3.1
 CBC 2013 11B-603
 Priority 4
 Severity 1
 TBD Contract Work

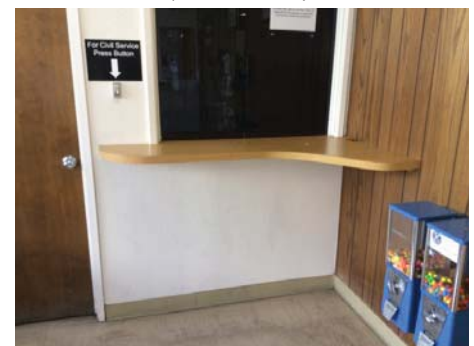
- *As-Built Description:*
Service counter (stand-up): Accessible section min. 36" length and 36" max. height (in CA: 28" to 34" high) not provided.
- *As-Built:* 42"
- *Proposed Solution:*
Provide auxiliary shelf, clipboard, or table as equivalent facilitation.

PCODE **IN03**
 ADAAG **7.2(2)**
 ADA 2010 **904.4**
 CBC 2010 **1122B.4**
 CBC 2013 **11B-904.4**
 Priority **1**
 Severity **3**
TBD Contract Work

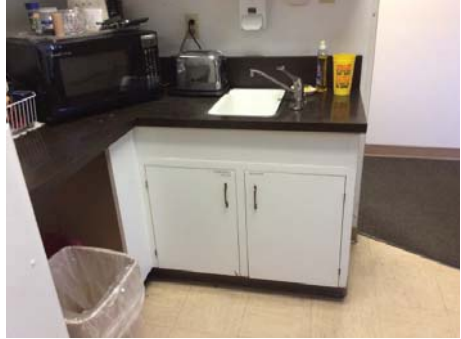
Item No. and Name	Existing Architectural Barrier and Proposed Solution	Codes / Mitigation Info	Qty	Unit	Cost	Total
Sink						
1762	<ul style="list-style-type: none"> As-Built Description: Sink rim higher than 34" above floor. As-Built: 36.25" Proposed Solution: Remodel sink cabinet to lower sink. 	PCODE IN06 ADAAG 4.24.2 ADA 2010 606.3 CBC 2010 1115B.4.7.1 CBC 2013 11B-606.3 Priority 4 Severity 4 TBD Contract Work	1	JOB	\$1,750	\$1,750

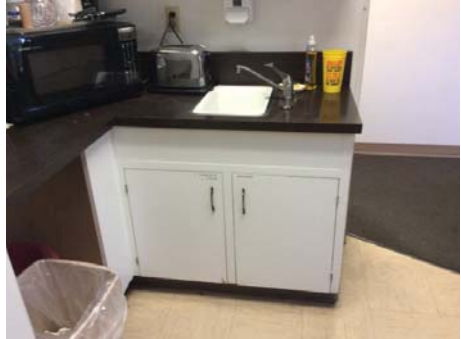
1761	<ul style="list-style-type: none"> As-Built Description: Sink does not have knee space min. 27" high x 19" deep x 30" wide. Proposed Solution: Remodel sink cabinet. 	PCODE IN06A ADAAG 4.24.3 ADA 2010 606.2 CBC 2010 1115B.4.7.1 CBC 2013 11B-606.2 Priority 4 Severity 2 TBD Contract Work	1	JOB	\$1,750	\$1,750

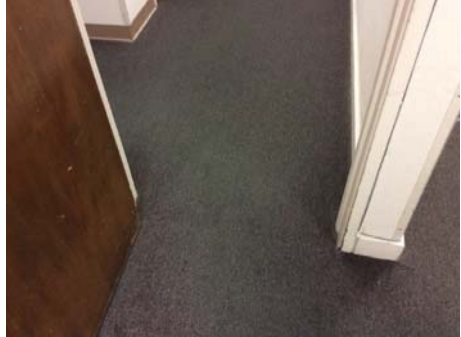
1763	<ul style="list-style-type: none"> As-Built Description: Door on accessible route has less than 32" clear and 80" (78" min. to closer if provided) opening width when 90° open. As-Built: 29" Proposed Solution: Provide new, larger door and frame with new accessible hardware. 	PCODE ID01 ADAAG 4.13.5 ADA 2010 404.2.3 CBC 2010 1133B.1.1.1.1 CBC 2013 11B-404.2.3 Priority 2 Severity 3 TBD Contract Work	1	JOB	\$2,600	\$2,600

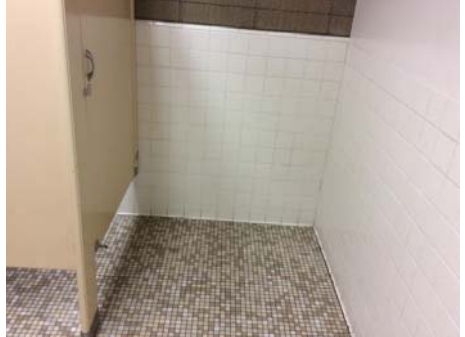
Item No. and Name	Existing Architectural Barrier and Proposed Solution	Codes / Mitigation Info	Qty	Unit	Cost	Total
<u>Door Swing</u>						
1785	<ul style="list-style-type: none"> As-Built Description: Latch approach: At pull side, door does not have clear and level maneuvering space measuring door width plus 24" x 48" or 54" if door has closer (CA only: door width plus 24" x 60"). As-Built: Stall door: 46" Proposed Solution: Remodel restroom as needed. 	PCODE ID27BNT ADAAG Fig. 25(c) ADA 2010 404.2.4 CBC 2010 11B-26A(c) CBC 2013 11B-404.2.4 Priority 4 Severity 4 TBD Contract Work	1	JOB	\$1,600	\$1,600

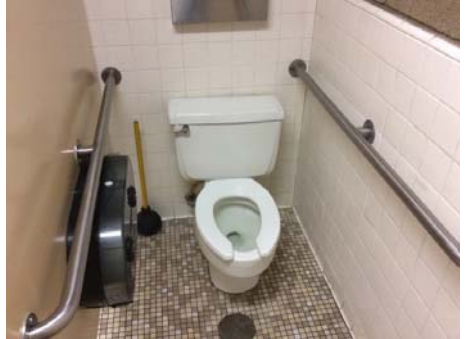
<u>Grab Bars</u>						
1779	<ul style="list-style-type: none"> As-Built Description: Grab bars not provided or are not code compliant. Proposed Solution: Provide accessible grab bars. 	PCODE WB07 ADAAG 4.17.6 ADA 2010 604.5 CBC 2010 1115B.4.1.3 CBC 2013 11B-604.5 Priority 4 Severity 3 TBD Contract Work	1	JOB	\$500	\$500

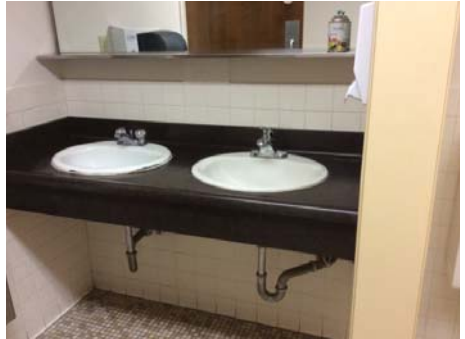
<u>Lavatory</u>						
1774	<ul style="list-style-type: none"> As-Built Description: Lavatory: Fixture rim or counter height more than 34" above floor. As-Built: 36.25" Proposed Solution: Provide new accessible lavatory. Remodel restroom as needed. 	PCODE WD02 ADAAG 4.19.2 ADA 2010 606.3 CBC 2010 1115B.4.3 CBC 2013 11B-606.3 Priority 4 Severity 4 TBD Contract Work	1	JOB	\$3,400	\$3,400

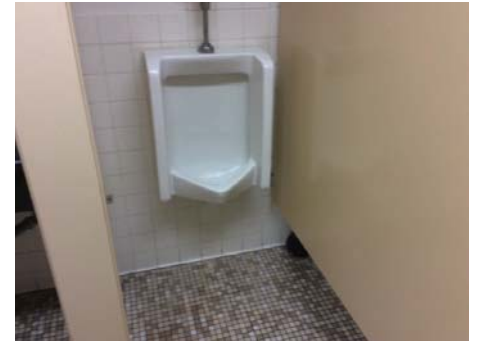
- 1782
- *As-Built Description:*
Fixture mounted with rim more than 17" above floor.
 - *As-Built:* 23"
 - *Proposed Solution:*
Provide accessible urinal. Remodel restroom as needed.

PCODE **WE02**
 ADAAG **4.18.2**
 ADA 2010 **605.2**
 CBC 2010 **1115B.4.2.1**
 CBC 2013 **11B-605.2**
 Priority **4**
 Severity **2**
TBD Contract Work

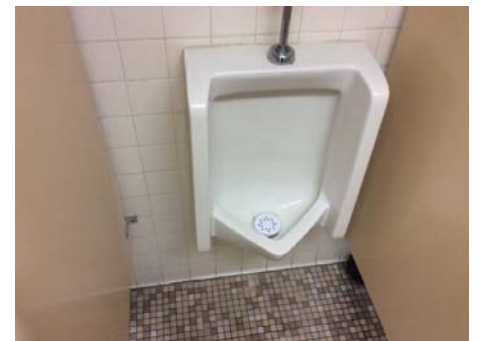
- 1783
- *As-Built Description:*
Fixture mounted with rim more than 17" above floor.
 - *As-Built:* 12"
 - *Proposed Solution:*
Provide accessible urinal. Remodel restroom as needed.

PCODE **WE02REF**
 ADAAG **4.18.2**
 ADA 2010 **605.2**
 CBC 2010 **1115B.4.2.1**
 CBC 2013 **11B-605.2**
 Priority **4**
 Severity **3**
TBD Contract Work

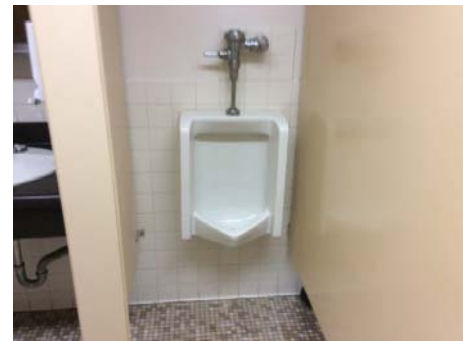
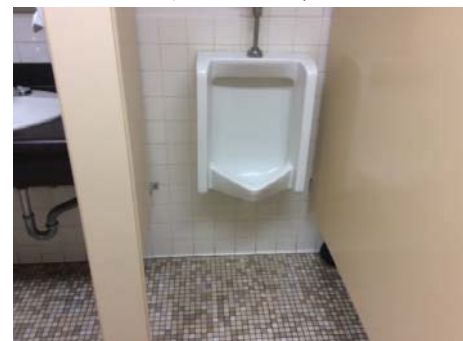
Item No. and Name	Existing Architectural Barrier and Proposed Solution	Codes / Mitigation Info	Qty	Unit	Cost	Total
1784	<ul style="list-style-type: none"> • <i>As-Built Description:</i> Urinal flush control lever more than 48" above floor (CA only: 44" max.). • <i>As-Built:</i> 51" • <i>Proposed Solution:</i> Provide accessible urinal flush control. 	<p>PCODE WE03REF</p> <p>ADAAG 4.18.4</p> <p>ADA 2010 605.4</p> <p>CBC 2010 1115B.4.2.2</p> <p>CBC 2013 11B-605.4</p> <p>Priority 4</p> <p>Severity 3</p> <p>TBD Contract Work</p>				
1781	<ul style="list-style-type: none"> • <i>As-Built Description:</i> 36" wide clearance in front of accessible urinal not provided when walls or partitions project more than 24" from the front edge of 30" x 48" clear space. • <i>As-Built:</i> 30.5" • <i>Proposed Solution:</i> Provide 36" clear floor space in front of accessible urinal. Remodel restroom as needed. 	<p>PCODE WE04A</p> <p>ADAAG 4.18.3</p> <p>ADA 2010 605.3</p> <p>CBC 2010 1115B.4.2.3</p> <p>CBC 2013 11B-605.3</p> <p>Priority 4</p> <p>Severity 2</p> <p>TBD Contract Work</p>	1	JOB	\$1,500	\$1,500

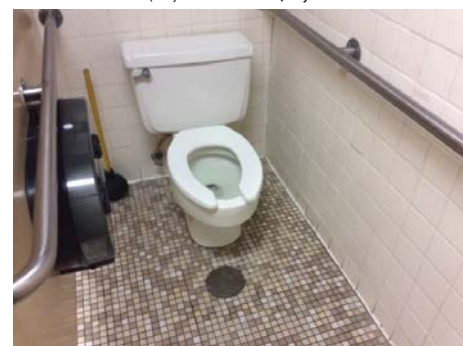
1780	<ul style="list-style-type: none"> • <i>As-Built Description:</i> Height of water closet seat less than 17" or more than 19" from floor. • <i>As-Built:</i> 15.5" • <i>Proposed Solution:</i> Provide new accessible water closet. 	<p>PCODE WB08</p> <p>ADAAG 4.16.3</p> <p>ADA 2010 604.4</p> <p>CBC 2010 1115B.4.1.4</p> <p>CBC 2013 11B-604.4</p> <p>Priority 4</p> <p>Severity 4</p> <p>TBD Contract Work</p>	1	JOB	\$1,400	\$1,400

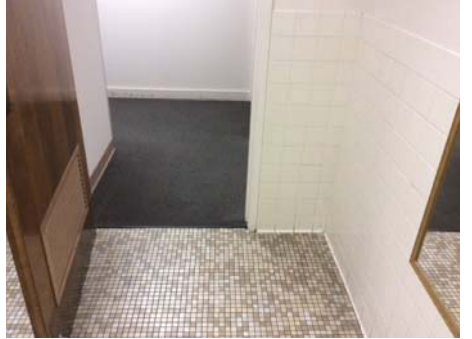
1791	<ul style="list-style-type: none"> • <i>As-Built Description:</i> Front approach: At pull side, door does not have clear and level maneuvering space measuring door width plus 18" x 60". • <i>As-Built:</i> 17.75" -18" • <i>Proposed Solution:</i> Modify tiling. 	<p>PCODE ID23BNT ADAAG Fig. 25(a) ADA 2010 404.2.4 CBC 2010 11B-26A(a) CBC 2013 11B-404.2.4 Priority 4 Severity 4 TBD Contract Work</p>	1	JOB	\$260	\$260
------	--	--	---	-----	-------	-------

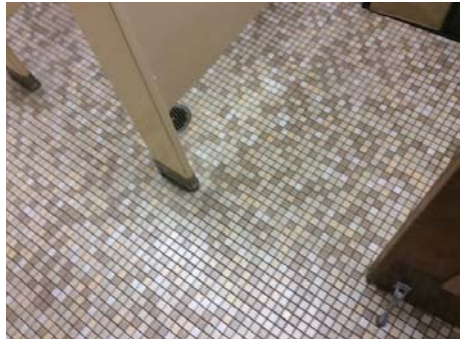
1793	<ul style="list-style-type: none"> • <i>As-Built Description:</i> Front approach: At pull side, door does not have clear and level maneuvering space measuring door width plus 18"(CA only: 24" at exterior doors)x 60". • <i>As-Built:</i> 59" to bracing • <i>Proposed Solution:</i> Remodel restroom as needed. 	<p>PCODE ID23REF ADAAG Fig. 25(a) ADA 2010 404.2.4 CBC 2010 11B-26A(a) CBC 2013 11B-404.2.4 Priority 4 Severity 4 TBD Contract Work</p>		REF		
------	---	--	--	-----	--	--

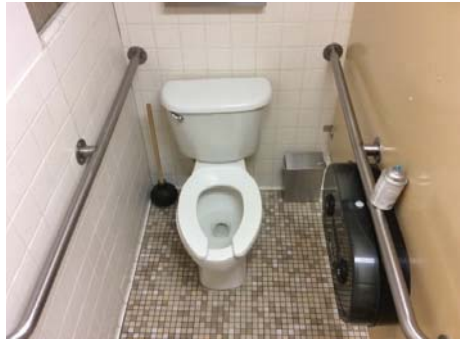
1804	<ul style="list-style-type: none"> • <i>As-Built Description:</i> Grab bars not provided or are not code compliant. • <i>Proposed Solution:</i> Provide accessible grab bars. 	<p>PCODE WB07 ADAAG 4.17.6 ADA 2010 604.5 CBC 2010 1115B.4.1.3 CBC 2013 11B-604.5 Priority 4 Severity 3 TBD Contract Work</p>	1	JOB	\$500	\$500
------	---	--	---	-----	-------	-------

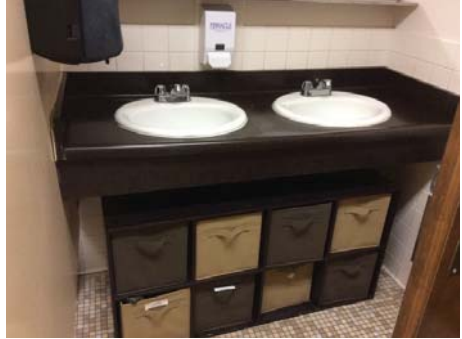
Item No. and Name	Existing Architectural Barrier and Proposed Solution	Codes / Mitigation Info	Qty	Unit	Cost	Total
Lavatory						
1794	<ul style="list-style-type: none"> As-Built Description: Lavatory: Fixture rim or counter height more than 34" above floor. As-Built: 36" Proposed Solution: Provide new accessible lavatory. Remodel restroom as needed. 	PCODE WD02 ADAAG 4.19.2 ADA 2010 606.3 CBC 2010 1115B.4.3 CBC 2013 11B-606.3 Priority 4 Severity 4 TBD Contract Work	1	JOB	\$3,400	\$3,400

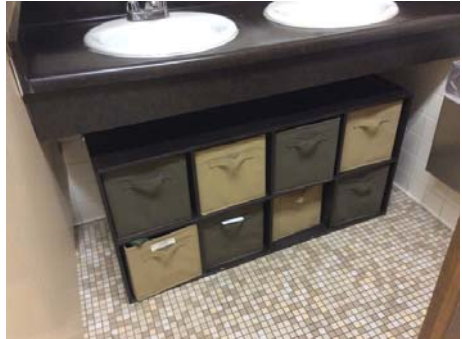
1795	<ul style="list-style-type: none"> As-Built Description: Knee clearance 27" min. high starting 8" back from the front edge of the lavatory towards the wall is not provided. As-Built: Storage items. Proposed Solution: Provide new accessible lavatory. Remodel restroom as needed. Notes: Relocate if required 	PCODE WD04REF ADAAG Fig. 31 ADA 2010 606.3 CBC 2010 1115B.4.3 CBC 2013 11B-306.3.3 Priority 4 Severity 2 TBD Contract Work				REF

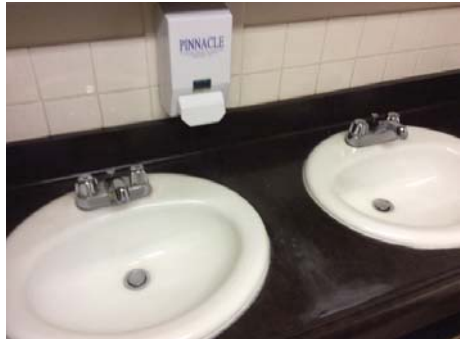
1796	<ul style="list-style-type: none"> As-Built Description: Lavatory: Accessible faucet (lever-operated, push-type or electronically controlled) not provided at otherwise accessible lavatory. Proposed Solution: Provide accessible faucet at accessible lavatory. 	PCODE WD06 ADAAG 4.19.5 ADA 2010 606.4 CBC 2010 1115B.4.3 CBC 2013 11B-606.4 Priority 4 Severity 3 TBD Contract Work	1	JOB	\$600	\$600

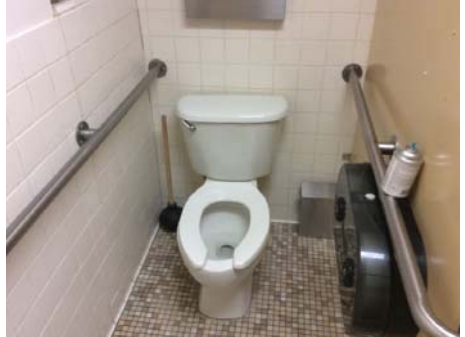
Item No. and Name	Existing Architectural Barrier and Proposed Solution	Codes / Mitigation Info	Qty	Unit	Cost	Total
<u>Toilet Stall</u>						
1801	<ul style="list-style-type: none"> • <i>As-Built Description:</i> Toilet stall less than 60" wide. • <i>As-Built:</i> 38" • <i>Proposed Solution:</i> Provide new accessible stall. 	PCODE WB06 ADAAG 4.17.3 ADA 2010 604.8.1.1 CBC 2010 1115B.3.1.4.1 CBC 2013 11B-604.8.1.1 Priority 4 Severity 2 TBD Contract Work	1	JOB	\$1,500	\$1,500

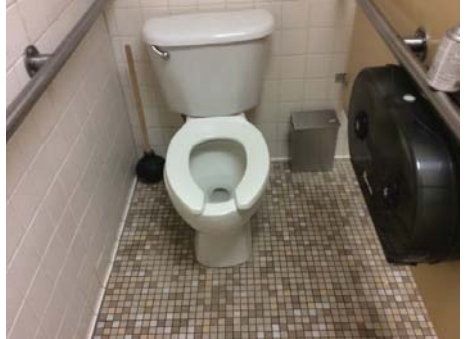
<u>Water Closet</u>						
1802	<ul style="list-style-type: none"> • <i>As-Built Description:</i> Height of water closet seat less than 17" or more than 19" from floor. • <i>As-Built:</i> 16.5" • <i>Proposed Solution:</i> Provide new accessible water closet. 	PCODE WB08 ADAAG 4.16.3 ADA 2010 604.4 CBC 2010 1115B.4.1.4 CBC 2013 11B-604.4 Priority 4 Severity 4 TBD Contract Work	1	JOB	\$1,400	\$1,400

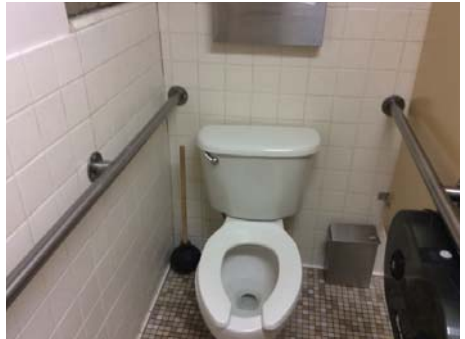
1803	<ul style="list-style-type: none"> • <i>As-Built Description:</i> Flush Control: Operating handle not mounted toward wide side of stall. • <i>Proposed Solution:</i> Replace flush control with properly mounted accessible type, or install sensor flush. 	PCODE WB10 ADAAG 4.16.5 ADA 2010 604.6 CBC 2010 1115B.4.1.5 CBC 2013 11B-604.6 Priority 4 Severity 3 TBD Contract Work	1	JOB	\$500	\$500

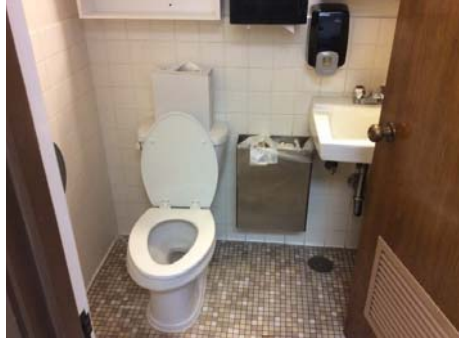
Item No. and Name	Existing Architectural Barrier and Proposed Solution	Codes / Mitigation Info	Qty	Unit	Cost	Total
<u>Restroom</u>						
1806	<ul style="list-style-type: none"> • <i>As-Built Description:</i> Single accommodation restroom not accessible; multiple compliance violations. • <i>As-Built:</i> 28" to RR • <i>Proposed Solution:</i> Remodel area to provide single-occupant accessible restroom. • <i>Notes:</i> Staff RR 	<p>PCODE WA01 ADAAG 4.22 ADA 2010 603 CBC 2010 1115B.3.2 CBC 2013 11B-603 Priority 4 Severity 2 TBD Contract Work</p>	1	JOB	\$30,000	\$30,000

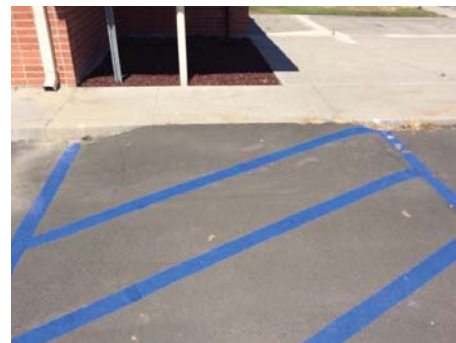
2914	<ul style="list-style-type: none"> <i>As-Built Description:</i> Access aisle at accessible parking space has slope greater than 1/4":12" (2%) due to built-up curb ramp within aisle. <i>As-Built:</i> 7.8% <i>Proposed Solution:</i> Provide curb cut. 	<p>PCODE EA05A ADAAG 4.6.3 ADA 2010 502.4 CBC 2010 1129B.3.3 CBC 2013 11B-502.4 Priority 1 Severity 2 TBD Contract Work</p>	1	JOB	\$2,500	\$2,500
------	--	---	---	-----	---------	---------

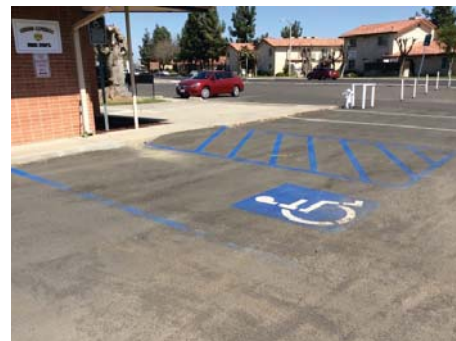
2916	<ul style="list-style-type: none"> <i>As-Built Description:</i> Accessible parking space smaller than 8' wide (CA only: 9' x 18'). <i>As-Built:</i> 17'10" long <i>Proposed Solution:</i> Modify parking space(s) to create accessible space. 	<p>PCODE EA02A ADAAG 4.6.3 ADA 2010 502.2 CBC 2010 1129B.3.1 CBC 2013 11B-502.2 Priority 1 Severity 4 TBD Contract Work</p>	1	JOB	\$200	\$200
------	--	---	---	-----	-------	-------

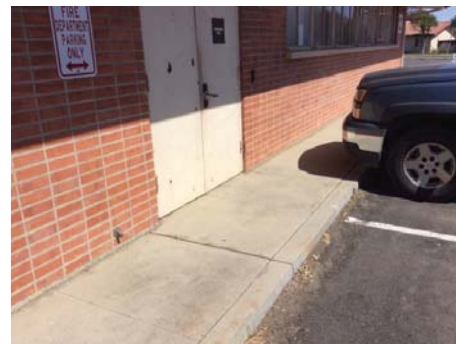
2918	<ul style="list-style-type: none"> <i>As-Built Description:</i> Front approach: At pull side, door does not have clear and level maneuvering space measuring door width plus 18"(CA only: 24" at exterior doors)x 60". <i>As-Built:</i> 48" <i>Proposed Solution:</i> Extend maneuvering space. <i>Notes:</i> Enlarge sidewalk. 	<p>PCODE ID23D ADAAG Fig. 25(a) ADA 2010 404.2.4 CBC 2010 11B-26A(a) CBC 2013 11B-404.2.4 Priority 3 Severity 3 TBD Contract Work</p>	1	JOB	\$800	\$800
------	--	---	---	-----	-------	-------

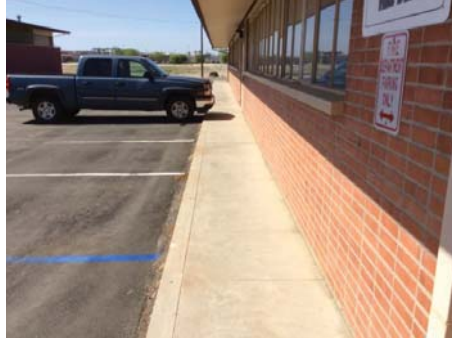
Item No. and Name	Existing Architectural Barrier and Proposed Solution	Codes / Mitigation Info	Qty	Unit	Cost	Total
Walk						
2917	<ul style="list-style-type: none"> <i>As-Built Description:</i> Walk more than 36" but less than 48" wide (required in CA only). <i>Proposed Solution:</i> Enlarge width of walk to 48". <i>Notes:</i> Provide wheel stops at parking spaces. 	<p>PCODE EF08NT</p> <p>CBC 2010 1133B.7.1</p> <p>CBC 2013 11B-403.5.1.3</p> <p>Priority 3</p> <p>Severity 3</p> <p>TBD Contract Work</p>	15	JOB	\$45	\$675

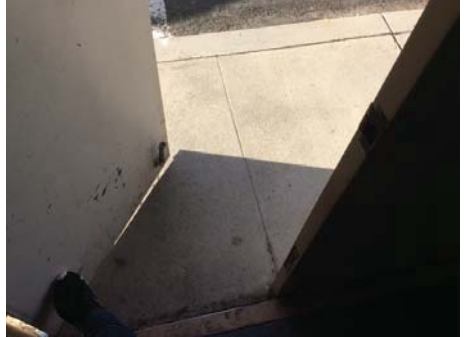
Item No. and Name	Existing Architectural Barrier and Proposed Solution	Codes / Mitigation Info	Qty	Unit	Cost	Total
<u>Door Swing</u>						
2667	<ul style="list-style-type: none"> <i>As-Built Description:</i> Front approach: At pull side, door does not have clear and level maneuvering space measuring door width plus 18"(CA only: 24" at exterior doors)x 60". <i>As-Built:</i> 52" <i>Proposed Solution:</i> Extend maneuvering space. <i>Notes:</i> Modify walkway 	PCODE ID23D ADAAG Fig. 25(a) ADA 2010 404.2.4 CBC 2010 11B-26A(a) CBC 2013 11B-404.2.4 Priority 1 Severity 3 TBD Contract Work	1	JOB	\$800	\$800

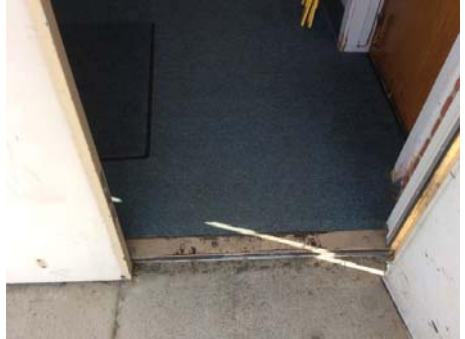
<u>Door Threshold</u>						
2665	<ul style="list-style-type: none"> <i>As-Built Description:</i> Door inaccessible due to threshold or step at door exceeding 1/2". <i>As-Built:</i> 1.25" <i>Proposed Solution:</i> Modify threshold to be no more than 1/2" by removing existing paving at door and providing landing with edge ramping (slope 1:20 max). 	PCODE ID02A ADAAG 4.13.8 ADA 2010 404.2.5 CBC 2010 1133B.2.4.1 CBC 2013 11B-404.2.5 Priority 4 Severity 4 TBD Contract Work	1	JOB	\$400	\$400

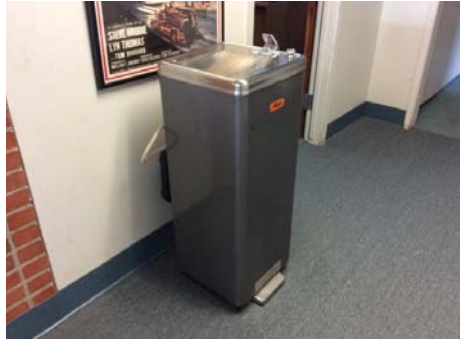
<u>Drinking Fountain</u>						
2671	<ul style="list-style-type: none"> <i>As-Built Description:</i> Wall- and post-mounted cantilevered units: Knee space not provided at drinking fountain (27" high, 8" deep, 30" wide from front of drinking fountain). <i>Proposed Solution:</i> Provide new, accessible fountain. 	PCODE IA02 ADAAG 4.15.5(1) ADA 2010 602.2 CBC 2010 1115B.4.6.2 CBC 2013 11B-602.2 Priority 4 Severity 2 TBD Contract Work	1	JOB	\$3,200	\$3,200

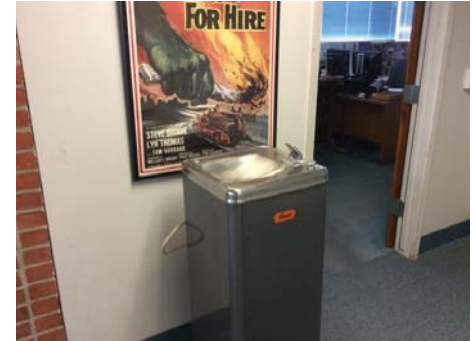
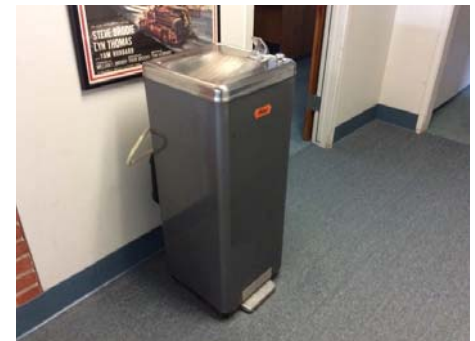
Item No. and Name	Existing Architectural Barrier and Proposed Solution	Codes / Mitigation Info	Qty	Unit	Cost	Total
2672	<ul style="list-style-type: none"> • <i>As-Built Description:</i> Drinking fountain bubbler more than 36" above floor. • <i>As-Built:</i> 42" • <i>Proposed Solution:</i> Provide new, accessible fountain. 	<p>PCODE IA03BREF ADAAG 4.15.2 ADA 2010 602.4 CBC 2010 1115B.4.6.4 CBC 2013 11B-602.4 Priority 4 Severity 3 TBD Contract Work</p>				
2670	<ul style="list-style-type: none"> • <i>As-Built Description:</i> CA only: Drinking fountain not located in an alcove (min. 32" wide x 18" deep) or otherwise encroaches into pedestrian way. • <i>Proposed Solution:</i> Provide new alcove for drinking fountain, or, if unreasonable hardship is determined, provide wing walls or cane-detectable railings on each side of the drinking fountain. The wings must project out from the supporting wall at least as far as the drinking fountain to within 6" of the surface of the circulation path, but cannot reduce the required clear width of the adjacent accessible route. 	<p>PCODE IA04 CBC 2010 1115B.4.6.3; Fig. CBC 2013 11B-602.9 Priority 3 Severity 2 TBD Contract Work</p>	1	JOB	\$3,000	\$3,000

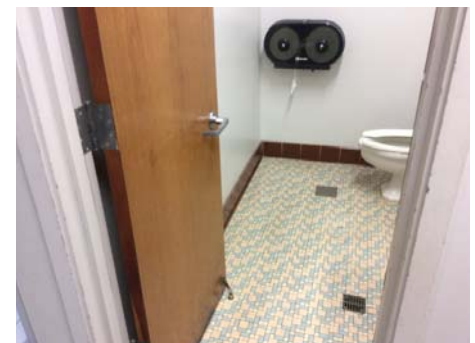
Door Clearance

2676	<ul style="list-style-type: none"> • <i>As-Built Description:</i> Door on accessible route has less than 32" clear and 80" (78" min. to closer if provided) opening width when 90° open. • <i>As-Built:</i> 25" • <i>Proposed Solution:</i> Provide new, larger door and frame with new accessible hardware. 	<p>PCODE ID01REF ADAAG 4.13.5 ADA 2010 404.2.3 CBC 2010 1133B.1.1.1.1 CBC 2013 11B-404.2.3 Priority 4 Severity 2 TBD Contract Work</p>

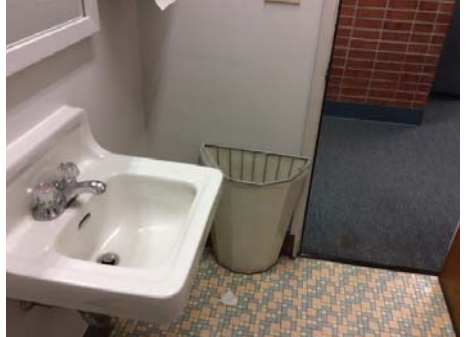
Item No. and Name	Existing Architectural Barrier and Proposed Solution	Codes / Mitigation Info	Qty	Unit	Cost	Total
<u>Door Swing</u>						
2678	<ul style="list-style-type: none"> As-Built Description: Front approach: At pull side, door does not have clear and level maneuvering space measuring door width plus 18" x 60". As-Built: DW +10" at 22" to lavatory Proposed Solution: Remodel as needed. 	PCODE ID23BREF ADAAG Fig. 25(a) ADA 2010 404.2.4 CBC 2010 11B-26A(a) CBC 2013 11B-404.2.4 Priority 4 Severity 2 TBD Contract Work				
						REF

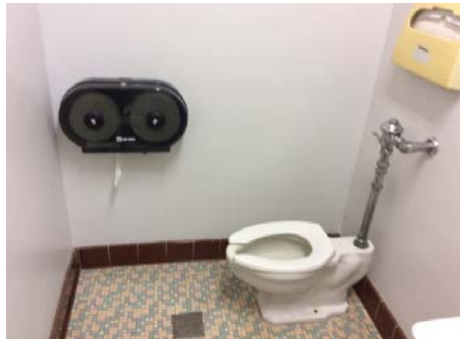
<u>Water Closet</u>						
2677	<ul style="list-style-type: none"> As-Built Description: CA only: In single-accommodation restroom less than 48" in front of water closet provided. As-Built: 30" Proposed Solution: Remodel restroom to provide at least 48" in front of water closet. 	PCODE WB03AREF CBC 2010 1115B.3.2.1 CBC 2013 11B-604.3.1 Priority 4 Severity 1 TBD Contract Work				
						REF

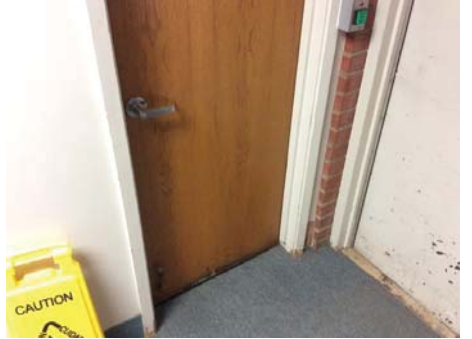
Item No. and Name	Existing Architectural Barrier and Proposed Solution	Codes / Mitigation Info	Qty	Unit	Cost	Total
<u>Door Clearance</u>						
2680	<ul style="list-style-type: none"> <i>As-Built Description:</i> Door on accessible route has less than 32" clear and 80" (78" min. to closer if provided) opening width when 90° open. <i>As-Built:</i> 25" <i>Proposed Solution:</i> Provide new, larger door and frame with new accessible hardware. 	<p>PCODE ID01REF</p> <p>ADAAG 4.13.5</p> <p>ADA 2010 404.2.3</p> <p>CBC 2010 1133B.1.1.1.1</p> <p>CBC 2013 11B-404.2.3</p> <p>Priority 4</p> <p>Severity 2</p> <p>TBD Contract Work</p>				REF

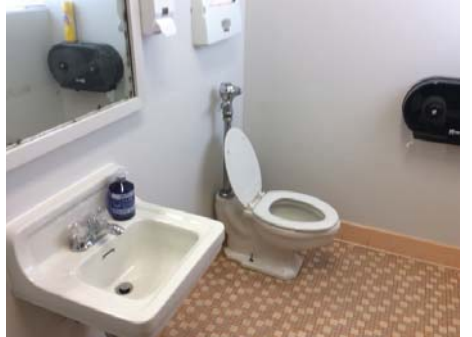
<u>Restroom</u>						
2683	<ul style="list-style-type: none"> <i>As-Built Description:</i> Single accommodation restroom not accessible; multiple compliance violations. <i>Proposed Solution:</i> Remodel area to provide single-occupant accessible restroom. Notes: RR 60"x88" 	<p>PCODE WA01</p> <p>ADAAG 4.22</p> <p>ADA 2010 603</p> <p>CBC 2010 1115B.3.2</p> <p>CBC 2013 11B-603</p> <p>Priority 4</p> <p>Severity 2</p> <p>TBD Contract Work</p>	1	JOB	\$30,000	\$30,000

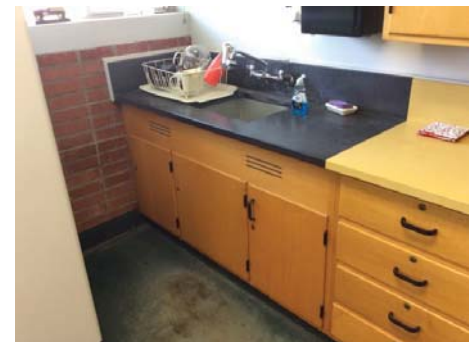
- 2686
- *As-Built Description:*
Sink does not have knee space min. 27" high x 19" deep x 30" wide.
 - *Proposed Solution:*
Remodel sink cabinet.

PCODE **IN06A**
 ADAAG **4.24.3**
 ADA 2010 **606.2**
 CBC 2010 **1115B.4.7.1**
 CBC 2013 **11B-606.2**
 Priority **2**
 Severity **2**
TBD Contract Work

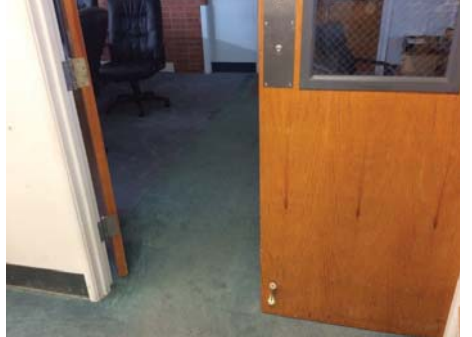
Item No. and Name	Existing Architectural Barrier and Proposed Solution	Codes / Mitigation Info	Qty	Unit	Cost	Total
<u>Door Pair</u>						
2694	<ul style="list-style-type: none"> As-Built Description: Pair of doors on accessible route has less than 32" clear opening width with one leaf open 90°. As-Built: 28" Proposed Solution: Provide new door leaves, unequal in width, to existing frame for pair of doors. 	PCODE ID08A ADAAG 4.13.4 ADA 2010 404.2.2 CBC 2010 1133B.2.3.1 CBC 2013 11B-404.2.2 Priority 2 Severity 2 TBD Contract Work	1	JOB	\$1,500	\$1,500

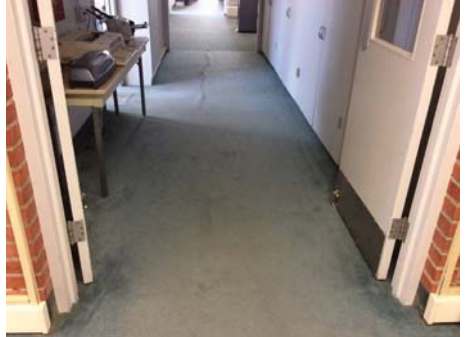
2691	<ul style="list-style-type: none"> As-Built Description: Pair of doors on accessible route has less than 32" clear opening width with one leaf open 90°. As-Built: 29" Proposed Solution: Provide new door leaves, unequal in width, to existing frame for pair of doors. 	PCODE ID08A ADAAG 4.13.4 ADA 2010 404.2.2 CBC 2010 1133B.2.3.1 CBC 2013 11B-404.2.2 Priority 2 Severity 3 TBD Contract Work	1	JOB	\$1,500	\$1,500

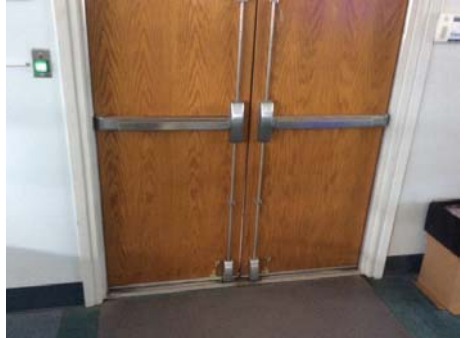
<u>Door Pair</u>						
2699	<ul style="list-style-type: none"> As-Built Description: Pair of doors on accessible route has less than 32" clear opening width with one leaf open 90°. As-Built: 28" Proposed Solution: Provide new door leaves, unequal in width, to existing frame for pair of doors. 	PCODE ID08A ADAAG 4.13.4 ADA 2010 404.2.2 CBC 2010 1133B.2.3.1 CBC 2013 11B-404.2.2 Priority 2 Severity 2 TBD Contract Work	1	JOB	\$1,500	\$1,500

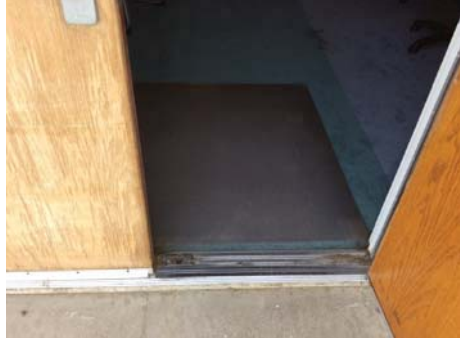
Item No. and Name	Existing Architectural Barrier and Proposed Solution	Codes / Mitigation Info	Qty	Unit	Cost	Total
<u>Door Threshold</u>						
2698	<ul style="list-style-type: none"> As-Built Description: Door inaccessible due to threshold or step at door exceeding 1/2". As-Built: 1.5" Proposed Solution: Modify threshold to be no more than 1/2" by removing existing paving at door and providing landing with edge ramping (slope 1:20 max). 	PCODE ID02A ADAAG 4.13.8 ADA 2010 404.2.5 CBC 2010 1133B.2.4.1 CBC 2013 11B-404.2.5 Priority 2 Severity 4 TBD Contract Work	1	JOB	\$400	\$400

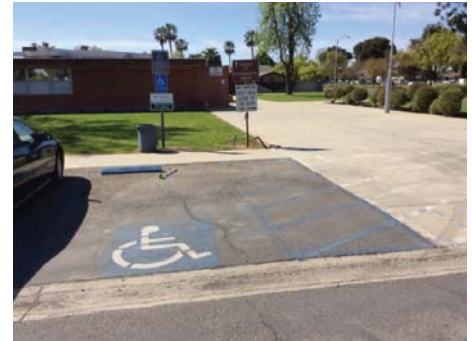
2941	<ul style="list-style-type: none"> <i>As-Built Description:</i> Accessible parking space has slope greater than 1/4":12" (2%). <i>As-Built:</i> 3.8% along drain <i>Proposed Solution:</i> Modify slope at accessible parking space. 	PCODE EA05 ADAAG 4.6.3 ADA 2010 502.4 CBC 2010 1129B.3.3 CBC 2013 11B-502.4 Priority 1 Severity 4 TBD Contract Work	50	SF	\$12	\$600
------	---	--	----	----	------	-------

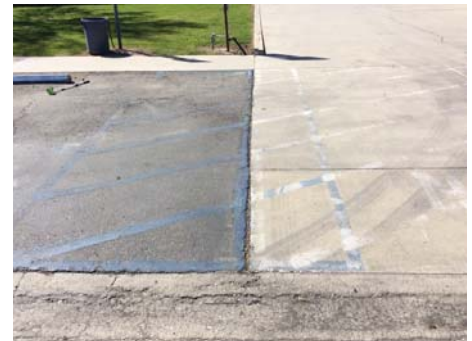
2942	<ul style="list-style-type: none"> <i>As-Built Description:</i> Accessible parking space does not have 5' wide access aisle; 8' wide for van accessible aisle. <i>As-Built:</i> Striping faded. <i>Proposed Solution:</i> Modify parking aisle(s) to create accessible space by restriping. <i>Notes:</i> Provide 8' wide for Van space. 	PCODE EA02B ADAAG 4.6.3 ADA 2010 502.3 CBC 2010 1129B.3.1 CBC 2013 11B-502.2; 11B-502.3.1 Priority 1 Severity 4 TBD Contract Work	1	JOB	\$200	\$200
------	--	--	---	-----	-------	-------

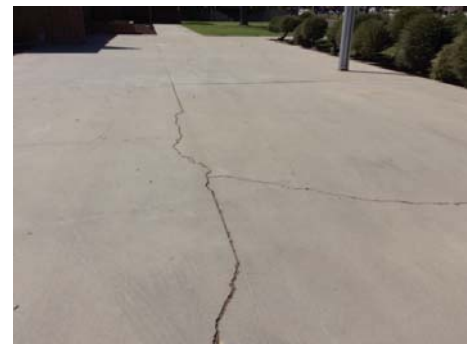
2944	<ul style="list-style-type: none"> <i>As-Built Description:</i> Walk: Pavement dislocation creates abrupt change in level exceeding 1/2" in accessible route. <i>As-Built:</i> Various cracks & gaps <i>Proposed Solution:</i> Remove, replace or repair area of pavement sufficient to correct abrupt change in level. 	PCODE EF03NT ADAAG 4.3.8 ADA 2010 403.4 CBC 2010 1133B.7.4 CBC 2013 11B-403.4 Priority 1 Severity 4 TBD Contract Work	40	SF	\$21	\$840
------	--	--	----	----	------	-------

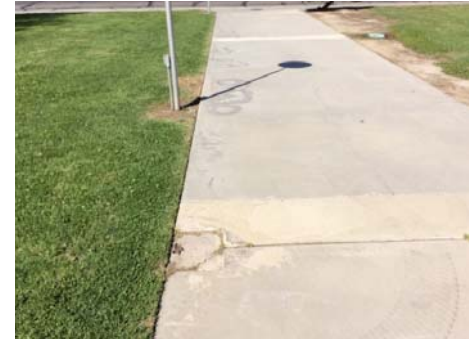
2946 • *As-Built Description:*
 Walk: Pavement dislocation creates abrupt change in level exceeding 1/2" in accessible route.
 • *As-Built:* 1"
 • *Proposed Solution:*
 Remove, replace or repair area of pavement sufficient to correct abrupt change in level.

PCODE EF03
 ADAAG 4.3.8
 ADA 2010 403.4
 CBC 2010 1133B.7.4
 CBC 2013 11B-403.4
 Priority 1
 Severity 4
 TBD Contract Work

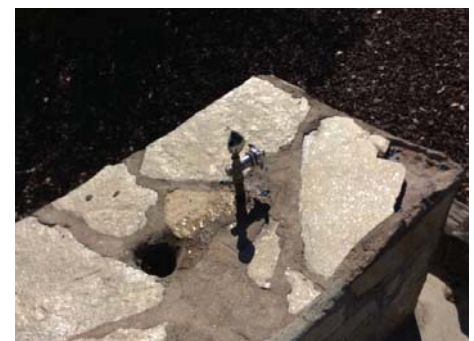
2949 • *As-Built Description:*
 Drinking fountain water flow less than 4" high; unit in good condition.
 • *Proposed Solution:*
 Adjust water flow.

PCODE IA03DREF
 ADAAG 4.15.3
 ADA 2010 602.6
 CBC 2010 1115B.4.6.5
 CBC 2013 11B-602.6
 Priority 3
 Severity 2
 TBD Contract Work

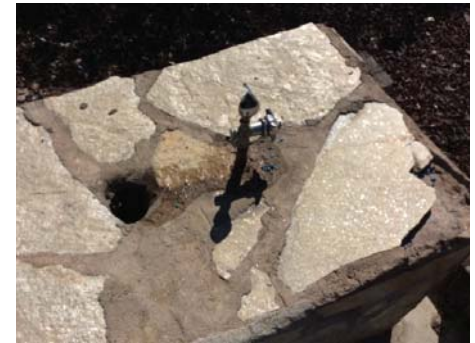
Item No. and Name	Existing Architectural Barrier and Proposed Solution	Codes / Mitigation Info	Qty	Unit	Cost	Total
2950	<ul style="list-style-type: none"> <i>As-Built Description:</i> Fountain bubbler not easily activated by lever, push bar, or other accessible control. <i>Proposed Solution:</i> Provide new, accessible fountain. 	PCODE IA03REF ADAAG 4.15.4 ADA 2010 602.3 CBC 2010 1115B.4.6.5 CBC 2013 11B-602.3 Priority 1 Severity 2 TBD Contract Work

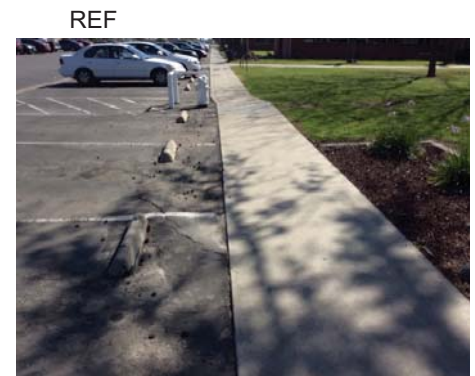
2953	<ul style="list-style-type: none"> <i>As-Built Description:</i> Walk: Pavement dislocation creates abrupt change in level exceeding 1/2" in accessible route. <i>As-Built:</i> 1"-2" lip adjacent to POT. <i>Proposed Solution:</i> Remove, replace or repair area of pavement sufficient to correct abrupt change in level. <i>Notes:</i> A curb may be necessary to distinguish between vehicular area and POT. 	PCODE EF03REF ADAAG 4.3.8 ADA 2010 403.4 CBC 2010 1133B.7.4 CBC 2013 11B-403.4 Priority 1 Severity 2 TBD Contract Work				
------	--	--	--	--	--	--

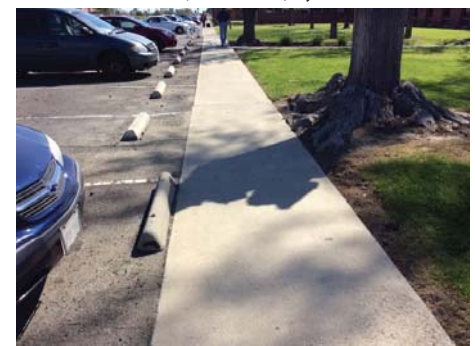
2951	<ul style="list-style-type: none"> <i>As-Built Description:</i> Cross slope more than 1":48" (2.083%). <i>As-Built:</i> 2.3-5.2% <i>Proposed Solution:</i> Modify cross slope. 	PCODE EF07 ADAAG 4.3.7 ADA 2010 403.3 CBC 2010 1133B.7.1.3 CBC 2013 11B-403.3 Priority 1 Severity 3 TBD Contract Work	160	SF	\$25	\$4,000
------	---	---	-----	----	------	---------

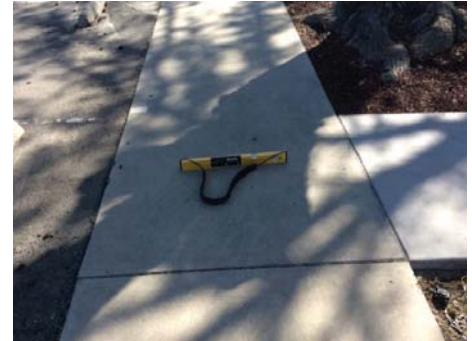
Item No. and Name	Existing Architectural Barrier and Proposed Solution	Codes / Mitigation Info	Qty	Unit	Cost	Total
2954	<ul style="list-style-type: none"> As-Built Description: Cross slope more than 1":48" (2.083%). As-Built: 2.7% Proposed Solution: Modify cross slope. 	PCODE EF07 ADAAG 4.3.7 ADA 2010 403.3 CBC 2010 1133B.7.1.3 CBC 2013 11B-403.3 Priority 1 Severity 4 TBD Contract Work	16	SF	\$25	\$400

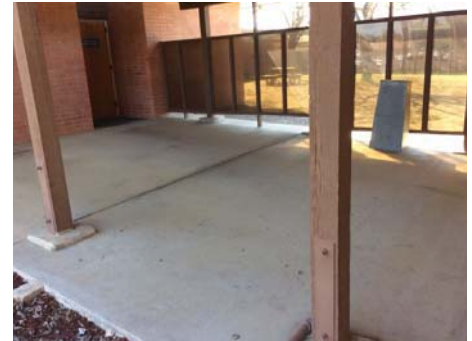
2956	<ul style="list-style-type: none"> As-Built Description: Walk: Slope greater than 1:20 (5.0%), and walk does not comply with requirements for ramps. As-Built: 5.6-6.7% Proposed Solution: Provide ramp with handrails on both (2) sides. Notes: Also provide landings and wheel guides. 	PCODE EF01A ADAAG 4.8.1 ADA 2010 405.1 CBC 2010 1133B.7.3 CBC 2013 11B-405.1 Priority 1 Severity 4 TBD Contract Work	20	LF	\$260	\$5,200
------	--	---	----	----	-------	---------

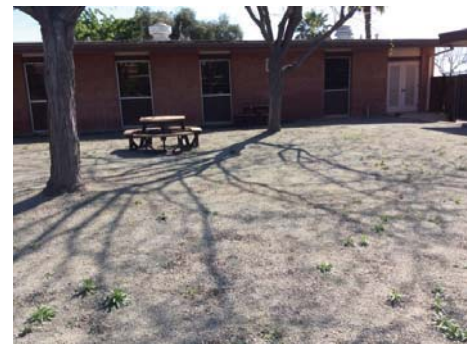
2960	<ul style="list-style-type: none"> As-Built Description: No walk / sidewalk provided to connect accessible facilities or elements that are on the same site. As-Built: To picnic tables Proposed Solution: Provide new 48" wide walk / sidewalk. Notes: relocate 	PCODE EF13 ADAAG 4.3.2 ADA 2010 206.1 CBC 2010 1114B.1.2 CBC 2013 11B-206.1 Priority 4 Severity 1 TBD Contract Work	30	LF	\$45	\$1,350
------	--	--	----	----	------	---------

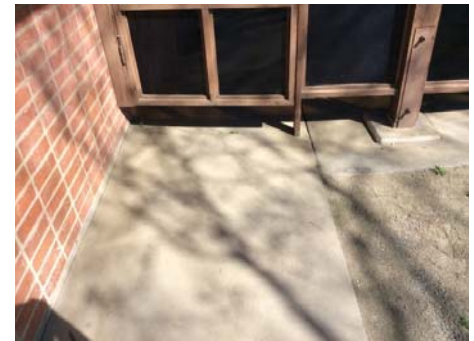
2959

- As-Built Description:
 Surface of required maneuvering clearance at door slopes more than 1/4":12" (2.0%).
- As-Built: 2.6%
- Proposed Solution:
 Modify surface slope at door.

PCODE ID11
 ADAAG 4.13.6
 ADA 2010 404.2.4.4
 CBC 2010 1133B.2.4
 CBC 2013 11B-404.2.4
 Priority 2
 Severity 4
 TBD Contract Work

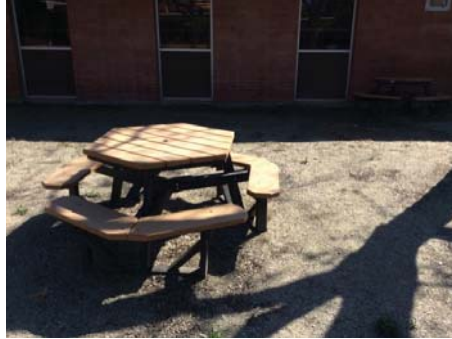
Item No. and Name	Existing Architectural Barrier and Proposed Solution	Codes / Mitigation Info	Qty	Unit	Cost	Total
<u>Picnic Area</u>						
2961	<ul style="list-style-type: none"> <i>As-Built Description:</i> Knee clearance at minimums 27" high, 30" wide, and 19" deep is not provided. <i>Proposed Solution:</i> Modify picnic table as required to provide knee clearance. 	PCODE NH11A ADAAG 16.5.4. ADA 2010 902.2 CBC 2010 1132B.1 CBC 2013 11-902.2 Priority 4 Severity 2 TBD Contract Work	1	JOB	\$850	\$850

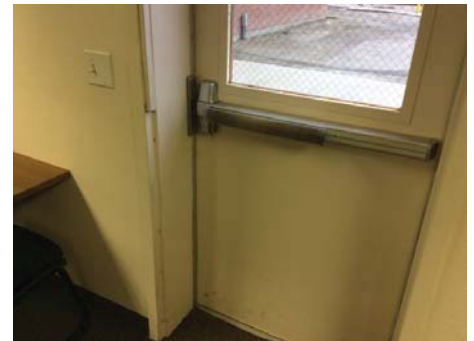
- 2536
- *As-Built Description:*
Front approach: At push side, door does not have clear and level maneuvering space measuring door width x 48" (door width plus 12" if door has both, latch and closer).
 - *As-Built:* 11" deep
 - *Proposed Solution:*
Provide relocated new door and frame; remodel walls as needed.
 - *Notes:*
Reset door frame

PCODE **ID24BNT**
 ADAAG **Fig. 25(a)**
 ADA 2010 **404.2.4**
 CBC 2010 **11B-26A(a)**
 CBC 2013 **11B-404.2.4**
 Priority **2**
 Severity **2**
 TBD **Contract Work**

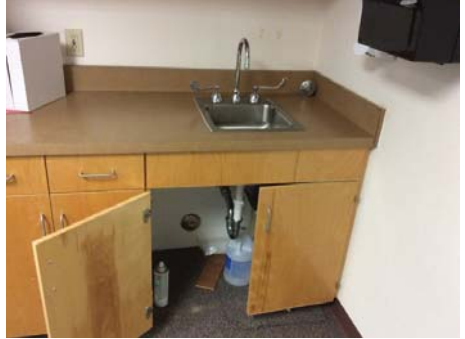
Item No. and Name	Existing Architectural Barrier and Proposed Solution	Codes / Mitigation Info	Qty	Unit	Cost	Total
<u>Sink</u>						
2541	<ul style="list-style-type: none"> As-Built Description: Sink rim higher than 34" above floor. As-Built: 36" Proposed Solution: Remodel sink cabinet to lower sink. 	PCODE IN06 ADAAG 4.24.2 ADA 2010 606.3 CBC 2010 1115B.4.7.1 CBC 2013 11B-606.3 Priority 3 Severity 4 TBD Contract Work	1	JOB	\$1,750	\$1,750

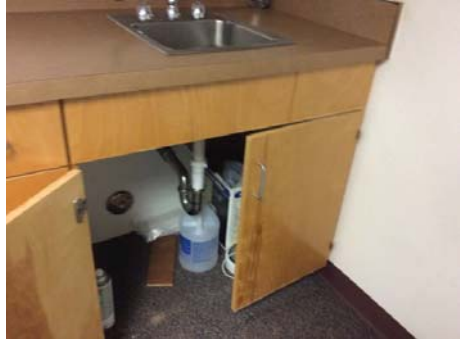
2542	<ul style="list-style-type: none"> As-Built Description: Hot or sharp-surfaced water/drain pipe not insulated or covered. Proposed Solution: Insulate or cover water/drain pipe. 	PCODE IN06C ADAAG 4.24.6 ADA 2010 606.5 CBC 2010 1115B.4.7.1 CBC 2013 11B-606.5 Priority 3 Severity 3 TBD Contract Work	1	JOB	\$120	\$120

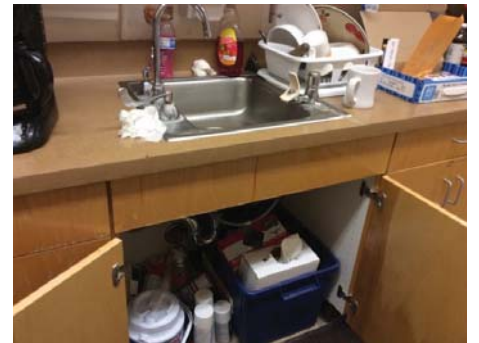
2550	<ul style="list-style-type: none"> As-Built Description: Sink rim higher than 34" above floor. As-Built: 36" Proposed Solution: Remodel sink cabinet to lower sink. 	PCODE IN06 ADAAG 4.24.2 ADA 2010 606.3 CBC 2010 1115B.4.7.1 CBC 2013 11B-606.3 Priority 3 Severity 4 TBD Contract Work	1	JOB	\$1,750	\$1,750
------	--	--	---	-----	---------	----------------

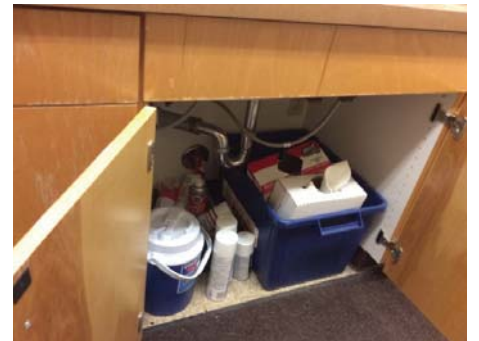
2551	<ul style="list-style-type: none"> As-Built Description: Hot or sharp-surfaced water/drain pipe not insulated or covered. Proposed Solution: Insulate or cover water/drain pipe. 	PCODE IN06C ADAAG 4.24.6 ADA 2010 606.5 CBC 2010 1115B.4.7.1 CBC 2013 11B-606.5 Priority 3 Severity 3 TBD Contract Work	1	JOB	\$120	\$120
------	--	---	---	-----	-------	--------------

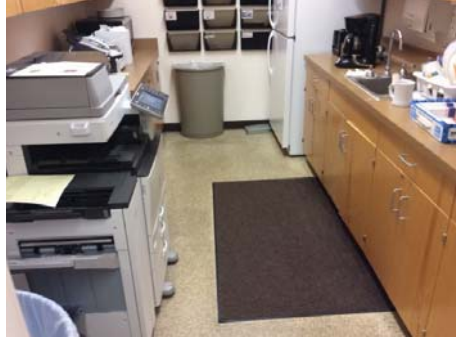
Item No. and Name	Existing Architectural Barrier and Proposed Solution	Codes / Mitigation Info	Qty	Unit	Cost	Total
Turn Space						
2554	<ul style="list-style-type: none"> <i>As-Built Description:</i> Less than 60" diameter or T-shaped space provided for wheelchair turns. <i>As-Built:</i> 42"-49" <i>Proposed Solution:</i> Retrofit space to provide 60" diameter or T-turn. 	PCODE IN04 ADAAG 4.2.3 ADA 2010 304.1 CBC 2010 1118B.3 CBC 2013 11B-304.1 Priority 2 Severity 2 TBD Contract Work	1	JOB	\$925	\$925
