Facility: **WOMENS INFANTS & CHILDREN**

Address: 330 HARRIS ST.

Facility: **LEMORE HEALTH CLINIC**
 Address: 229 C ST.

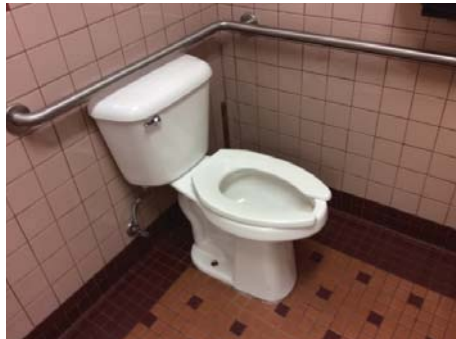
Water Closet						
2565	<ul style="list-style-type: none"> <i>As-Built Description:</i> More than 18" from near side wall to centerline of water closet. <i>As-Built:</i> 20" o.c. <i>Proposed Solution:</i> Provide new accessible water closet and relocate plumbing. 	PCODE WB02A ADAAG Fig. 28 ADA 2010 604.2 CBC 2010 1115B.4.1.1 CBC 2013 11B-604.2 Priority 3 Severity 3 TBD Contract Work	1	JOB	\$4,500	\$4,500

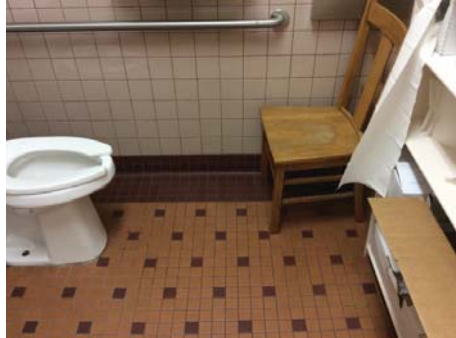
2561	<ul style="list-style-type: none"> <i>As-Built Description:</i> CA only: In single-accommodation restroom less than 48" in front of water closet provided. <i>As-Built:</i> 41" <i>Proposed Solution:</i> Remodel restroom to provide at least 48" in front of water closet. <i>Notes:</i> Relocate items 	PCODE WB03AREF CBC 2010 1115B.3.2.1 CBC 2013 11B-604.3.1 Priority 3 Severity 3 TBD Contract Work	REF

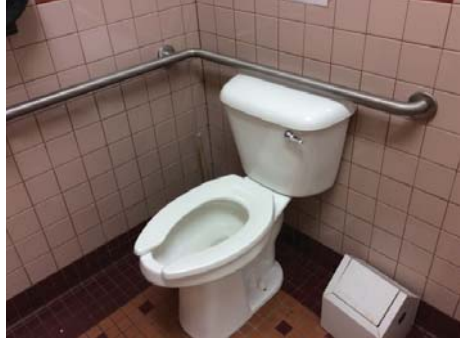
Item No. and Name	Existing Architectural Barrier and Proposed Solution	Codes / Mitigation Info	Qty	Unit	Cost	Total
<u>Water Closet</u>						
2574	<ul style="list-style-type: none"> <i>As-Built Description:</i> More than 18" from near side wall to centerline of water closet. <i>As-Built:</i> 21" o.c. <i>Proposed Solution:</i> Provide new accessible water closet and relocate plumbing. 	PCODE WB02A ADAAG Fig. 28 ADA 2010 604.2 CBC 2010 1115B.4.1.1 CBC 2013 11B-604.2 Priority 3 Severity 3 TBD Contract Work	1	JOB	\$4,500	\$4,500

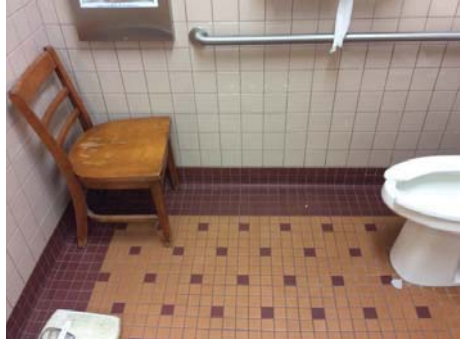
2577	<ul style="list-style-type: none"> <i>As-Built Description:</i> CA only: In single-accommodation restroom less than 48" in front of water closet provided. <i>As-Built:</i> 34" <i>Proposed Solution:</i> Remodel restroom to provide at least 48" in front of water closet. <i>Notes:</i> relocate. 	PCODE WB03AREF CBC 2010 1115B.3.2.1 CBC 2013 11B-604.3.1 Priority 3 Severity 2 TBD Contract Work	REF

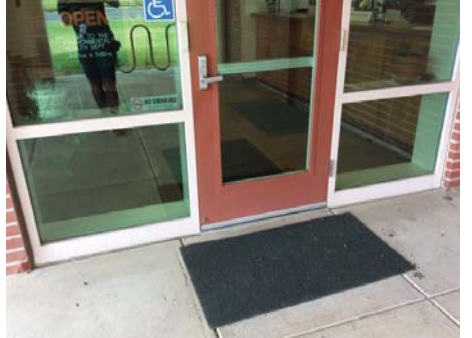
<u>Door</u>						
2579	<ul style="list-style-type: none"> <i>As-Built Description:</i> Surface of required maneuvering clearance at door slopes more than 1/4":12" (2.0%). <i>As-Built:</i> 5.0% <i>Proposed Solution:</i> Modify surface slope at door. <i>Notes:</i> Provide power door operator. 	PCODE ID11 ADAAG 4.13.6 ADA 2010 404.2.4.4 CBC 2010 1133B.2.4 CBC 2013 11B-404.2.4 Priority 1 Severity 3 TBD Contract Work	30	SF	\$40	\$1,200

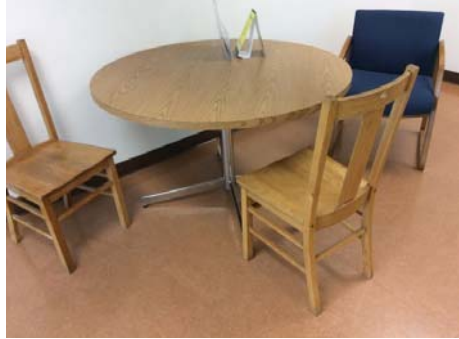
Item No. and Name	Existing Architectural Barrier and Proposed Solution	Codes / Mitigation Info	Qty	Unit	Cost	Total
<u>Non-Fixed Desk</u>						
2583	<ul style="list-style-type: none"> <i>As-Built Description:</i> Accessible non-fixed table or desk (top 28" to 34" high; knee space at least 27" high x 19" deep x 30" wide) not provided. <i>As-Built:</i> due to table legs <i>Proposed Solution:</i> Provide table or desk with accessible dimensions when purchasing new furniture. 	<p>PCODE IN02A ADAAG 4.32.3 & .4 ADA 2010 306.1 CBC 2010 1122B.3 & 4 CBC 2013 11B-306.1 & 11B-902.3 Priority 1 Severity 2 TBD Contract Work</p>	1	JOB	\$1,600	\$1,600

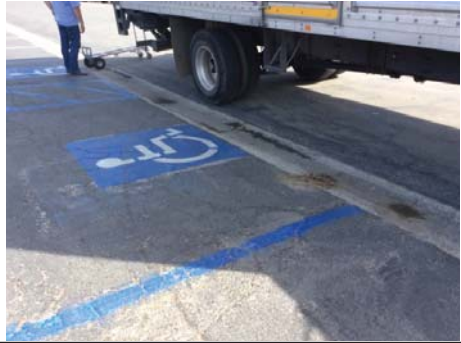
2746	<ul style="list-style-type: none"> <i>As-Built Description:</i> Accessible parking space has slope greater than 1/4":12" (2%). <i>As-Built:</i> 3.8-4.1% along the swale <i>Proposed Solution:</i> Modify slope at accessible parking space. 	PCODE EA05 ADAAG 4.6.3 ADA 2010 502.4 CBC 2010 1129B.3.3 CBC 2013 11B-502.4 Priority 1 Severity 3 TBD Contract Work	104	SF	\$12	\$1,248

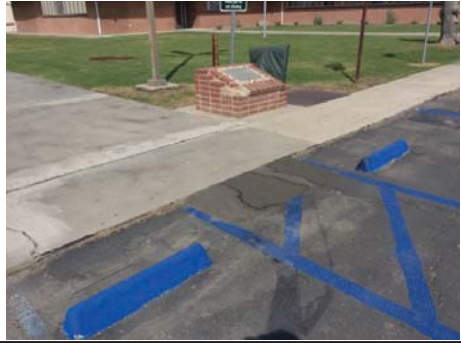
2747	<ul style="list-style-type: none"> <i>As-Built Description:</i> Access aisle at accessible parking space has slope greater than 1/4":12" (2%) due to built-up curb ramp within aisle. <i>As-Built:</i> 5.8% <i>Proposed Solution:</i> Provide curb cut. 	PCODE EA05A ADAAG 4.6.3 ADA 2010 502.4 CBC 2010 1129B.3.3 CBC 2013 11B-502.4 Priority 1 Severity 3 TBD Contract Work	1	JOB	\$2,500	\$2,500

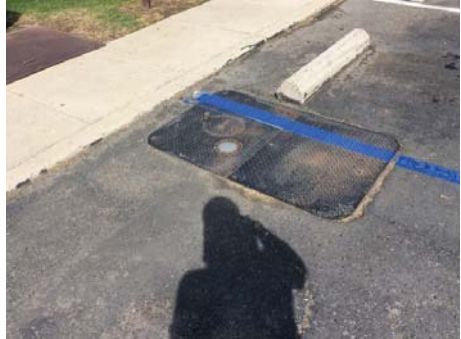
2749	<ul style="list-style-type: none"> <i>As-Built Description:</i> Accessible parking space has slope greater than 1/4":12" (2%). <i>As-Built:</i> Lip around lip, potential tripping hazard. <i>Proposed Solution:</i> Modify slope at accessible parking space. 	PCODE EA05NT ADAAG 4.6.3 ADA 2010 502.4 CBC 2010 1129B.3.3 CBC 2013 11B-502.4 Priority 1 Severity 1 TBD Contract Work	6	SF	\$12	\$72

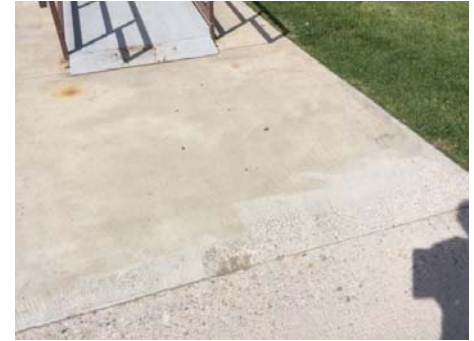
- 2752
- *As-Built Description:*
Walk: Pavement dislocation creates abrupt change in level exceeding 1/2" in accessible route.
 - *As-Built:* Missing pavement. 0.5"
 - *Proposed Solution:*
Remove, replace or repair area of pavement sufficient to correct abrupt change in level.

PCODE EF03
 ADAAG 4.3.8
 ADA 2010 403.4
 CBC 2010 1133B.7.4
 CBC 2013 11B-403.4
 Priority 1
 Severity 4
 TBD Contract Work

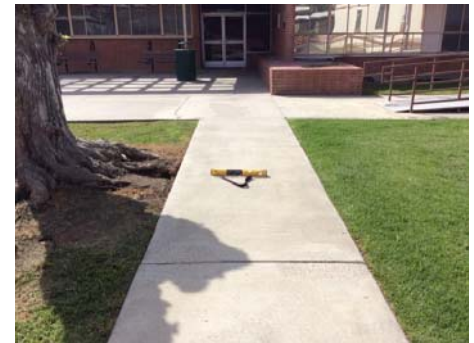
- 2754
- *As-Built Description:*
Cross slope more than 1":48" (2.083%).
 - *As-Built:* 2.7%
 - *Proposed Solution:*
Modify cross slope.

PCODE EF07
 ADAAG 4.3.7
 ADA 2010 403.3
 CBC 2010 1133B.7.1.3
 CBC 2013 11B-403.3
 Priority 1
 Severity 4
 TBD Contract Work

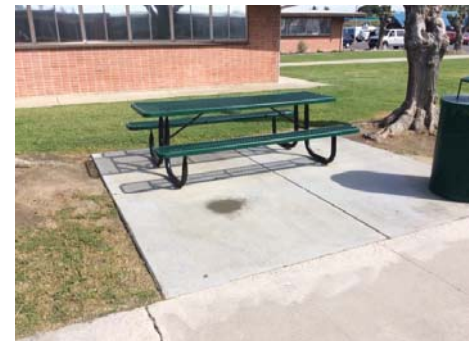
- 2751
- *As-Built Description:*
Knee clearance at minimums 27" high, 30" wide, and 19" deep is not provided.
 - *As-Built:* 11" deep
 - *Proposed Solution:*
Modify picnic table as required to provide knee clearance.
 - *Notes:*
And rotate table.

PCODE NH11A
 ADAAG 16.5.4.
 ADA 2010 902.2
 CBC 2010 1132B.1
 CBC 2013 11-902.2
 Priority 1
 Severity 2
 TBD Contract Work

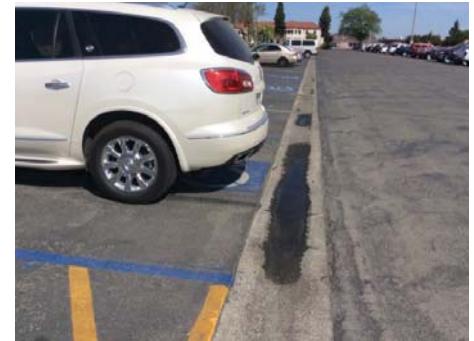
2758

PCODE EA05
 ADAAG 4.6.3
 ADA 2010 502.4
 CBC 2010 1129B.3.3
 CBC 2013 11B-502.4
 Priority 1
 Severity 4
 TBD Contract Work

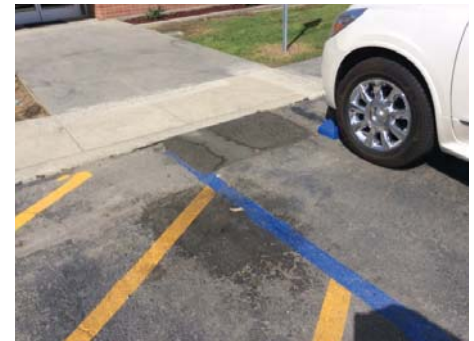
2759

- *As-Built Description:*
 Access aisle at accessible parking space has slope greater than 1/4":12" (2%) due to built-up curb ramp within aisle.
- *As-Built:* 6.2%
- *Proposed Solution:*
 Provide curb cut.

PCODE EA05A
 ADAAG 4.6.3
 ADA 2010 502.4
 CBC 2010 1129B.3.3
 CBC 2013 11B-502.4
 Priority 1
 Severity 3
 TBD Contract Work

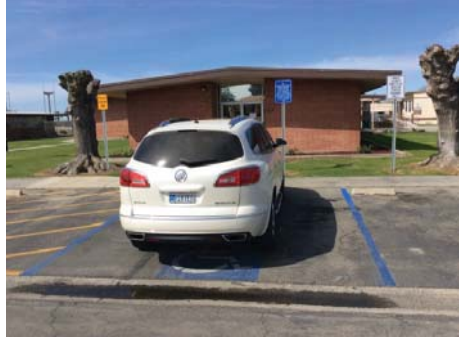
Item No. and Name	Existing Architectural Barrier and Proposed Solution	Codes / Mitigation Info	Qty	Unit	Cost	Total
<u>Parking</u>						
2755	<ul style="list-style-type: none"> <i>As-Built Description:</i> Accessible parking space does not have 5' wide access aisle; 8' wide for van accessible aisle. <i>As-Built:</i> not provided. "freight" <i>Proposed Solution:</i> Modify parking aisle(s) to create accessible space by restriping. 	PCODE EA02B ADAAG 4.6.3 ADA 2010 502.3 CBC 2010 1129B.3.1 CBC 2013 11B-502.2; 11B-502.3.1 Priority 1 Severity 1 TBD Contract Work	1	JOB	\$200	\$200

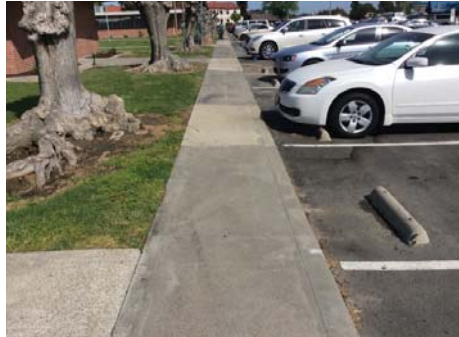
Item No. and Name	Existing Architectural Barrier and Proposed Solution	Codes / Mitigation Info	Qty	Unit	Cost	Total
<u>Cross Slope</u>						
2763	<ul style="list-style-type: none"> <i>As-Built Description:</i> Cross slope more than 1":48" (2.083%). <i>As-Built:</i> 4.1-8.0% <i>Proposed Solution:</i> Modify cross slope. 	PCODE EF07 ADAAG 4.3.7 ADA 2010 403.3 CBC 2010 1133B.7.1.3 CBC 2013 11B-403.3 Priority 1 Severity 2 TBD Contract Work	200	SF	\$25	\$5,000

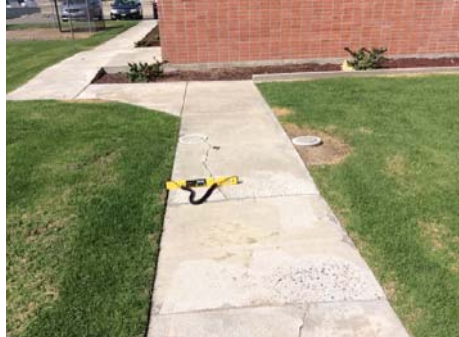
Item No. and Name	Existing Architectural Barrier and Proposed Solution	Codes / Mitigation Info	Qty	Unit	Cost	Total
<u>Cross Slope</u>						
2764	<ul style="list-style-type: none"> <i>As-Built Description:</i> Cross slope more than 1":48" (2.083%). <i>As-Built:</i> 3.6% and cracks <i>Proposed Solution:</i> Modify cross slope. 	PCODE EF07 ADAAG 4.3.7 ADA 2010 403.3 CBC 2010 1133B.7.1.3 CBC 2013 11B-403.3 Priority 2 Severity 4 TBD Contract Work	48	SF	\$25	\$1,200

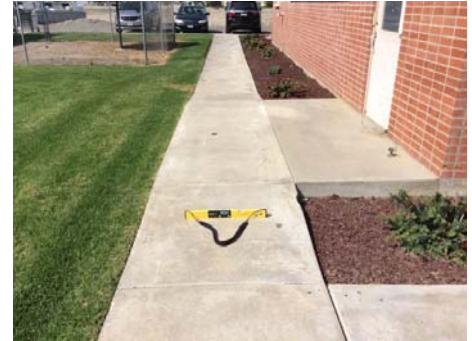
Item No. and Name	Existing Architectural Barrier and Proposed Solution	Codes / Mitigation Info	Qty	Unit	Cost	Total
2765	<ul style="list-style-type: none"> As-Built Description: Cross slope more than 1":48" (2.083%). As-Built: 3.4% Proposed Solution: Modify cross slope. Notes: 7.7 slope 	PCODE EF07 ADAAG 4.3.7 ADA 2010 403.3 CBC 2010 1133B.7.1.3 CBC 2013 11B-403.3 Priority 2 Severity 4 TBD Contract Work	80	SF	\$25	\$2,000

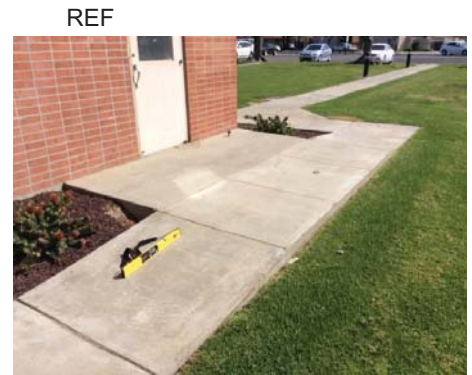
Walk

2766	<ul style="list-style-type: none"> As-Built Description: Walk: Slope greater than 1:20 (5.0%), and walk does not comply with requirements for ramps. As-Built: 7.7-10% Proposed Solution: Modify walk/sidewalk slope to 1:20 or less. 	PCODE EF01REF ADAAG 4.3.7 ADA 2010 403.3 CBC 2010 1133B.7.3 CBC 2013 11B-403.3 Priority 2 Severity 3 TBD Contract Work				
------	--	---	--	--	--	--

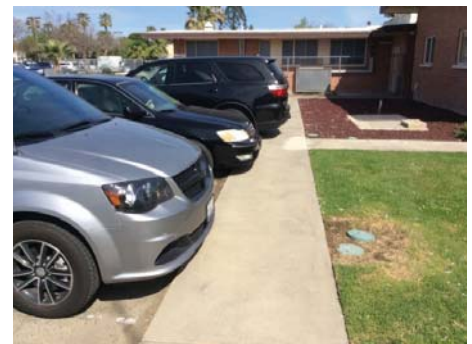
2768	<ul style="list-style-type: none"> As-Built Description: Walk more than 36" but less than 48" wide (required in CA only). As-Built: Wheel stops needed. Proposed Solution: Provide wheel stops in adjacent parking spaces. 	PCODE EF08NT CBC 2010 1133B.7.1 CBC 2013 11B-403.5.1.3 Priority 1 Severity 3 TBD Contract Work	12	JOB	\$100	\$1,200
------	---	---	----	-----	-------	---------

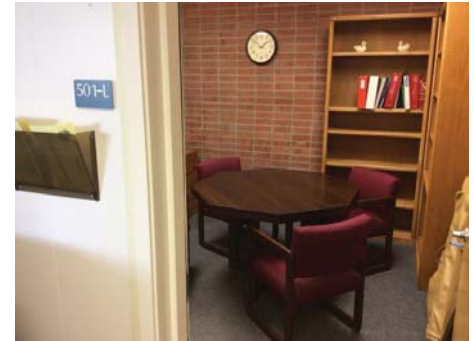
PCODE **IN02**
 ADAAG **4.32.3 & .4**
 ADA 2010 **306.1**
 CBC 2010 **1122B.3 & 4**
 CBC 2013 **11B-306.1**
 Priority **4**
 Severity **2**
TBD Contract Work

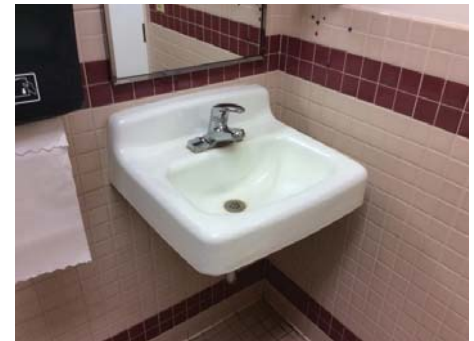
Lavatory

PCODE **WD01**
 ADAAG **4.19.3**
 ADA 2010 **606.2**
 CBC 2010 **1115B.4.3**
 CBC 2013 **11B-606.2, 11B-606.6**
 Priority **4**
 Severity **2**
TBD Contract Work

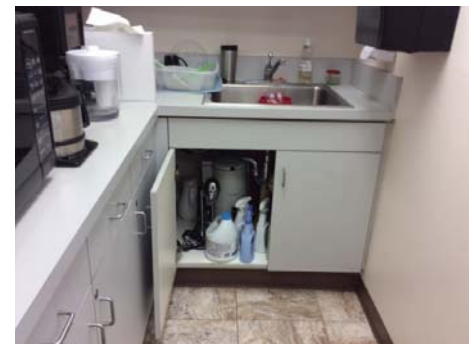
2112

PCODE **IN06A**
 ADAAG **4.24.3**
 ADA 2010 **606.2**
 CBC 2010 **1115B.4.7.1**
 CBC 2013 **11B-606.2**
 Priority **4**
 Severity **2**
TBD Contract Work

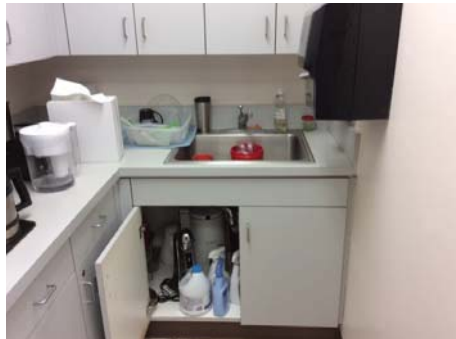
Item No. and Name	Existing Architectural Barrier and Proposed Solution	Codes / Mitigation Info	Qty	Unit	Cost	Total
2113	<ul style="list-style-type: none"> As-Built Description: Sink rim higher than 34" above floor. As-Built: 37.25" Proposed Solution: Remodel sink cabinet to lower sink. 	PCODE IN06REF ADAAG 4.24.2 ADA 2010 606.3 CBC 2010 1115B.4.7.1 CBC 2013 11B-606.3 Priority 4 Severity 4 TBD Contract Work

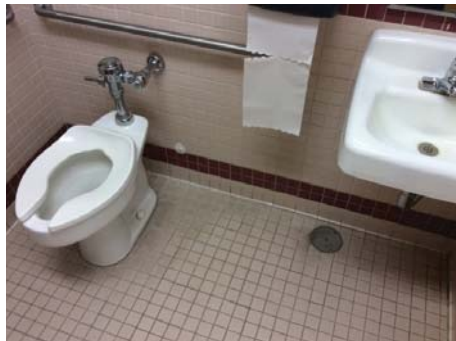
Toilet Stall

2130	<ul style="list-style-type: none"> As-Built Description: The lavatory or other unintended fixture, encroaches on the necessary clearance around a water closet (60" x 56"). As-Built: 53" from wall, 28" to lavatory Proposed Solution: Remove adjacent fixture and provide new enclosure at accessible water closet. 	PCODE WB01A ADA 2010 604.3.1; 604.3.2 CBC 2013 11B-604.3.1; 11B-604.3.2 Priority 4 Severity 4 TBD Contract Work	1	JOB	\$2,000	\$2,000

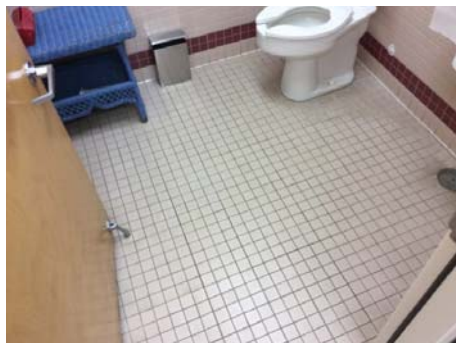
Turning Space

2129	<ul style="list-style-type: none"> As-Built Description: Wheelchair clearance: Clear space, floor to 27" high with a diameter of 60", not provided (space 56" x 63" acceptable). As-Built: Door swings more than 12" Proposed Solution: Provide wheelchair clearance space in restroom. Notes: 75" x 77" 	PCODE WC01 ADAAG 4.22.3 ADA 2010 603.2.1 CBC 2010 1115B.3.1 CBC 2013 11B-603.2.1; 11B-304.3 Priority 4 Severity 2 TBD Contract Work	1	JOB	\$1,190	\$1,190

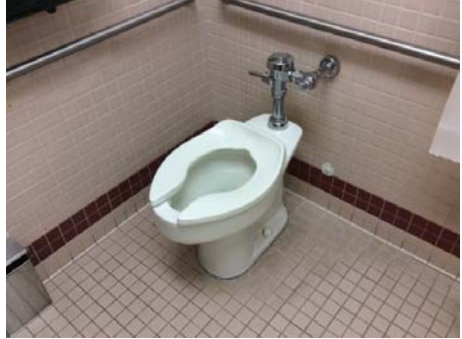
Item No. and Name	Existing Architectural Barrier and Proposed Solution	Codes / Mitigation Info	Qty	Unit	Cost	Total
<u>Water Closet</u>						
2125	<ul style="list-style-type: none"> <i>As-Built Description:</i> Water closet not 17"-18" from near side wall to center line of water closet (2010 ADAS: 16"-18"). <i>As-Built:</i> 18.5" o.c. <i>Proposed Solution:</i> Relocate existing water closet and plumbing, remount with offset closet flange to provide 17"-18" from side wall. 	PCODE WB02C ADAAG Fig. 28 ADA 2010 604.2 CBC 2010 1115B.4.1.1 CBC 2013 11B-604.2 Priority 4 Severity 4 TBD Contract Work	1	JOB	\$500	\$500

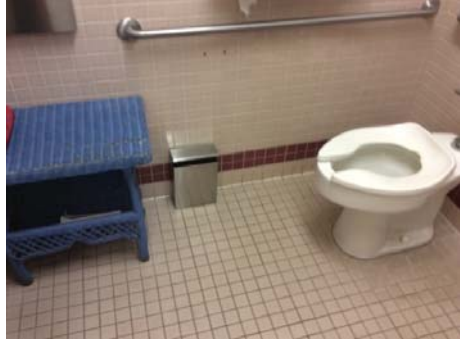
2128	<ul style="list-style-type: none"> <i>As-Built Description:</i> CA only: In single-accommodation restroom less than 48" in front of water closet provided. <i>Proposed Solution:</i> Remodel restroom to provide at least 48" in front of water closet. 	PCODE WB03A CBC 2010 1115B.3.2.1 CBC 2013 11B-604.3.1 Priority 4 Severity 4 TBD Contract Work	1	JOB	\$5,000	\$5,000

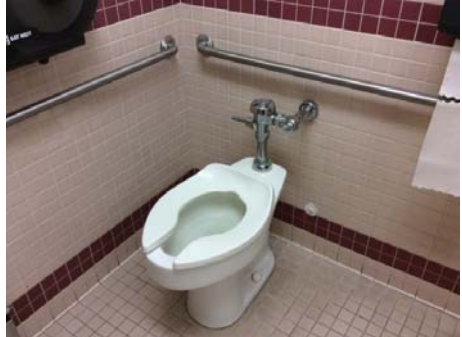
2126	<ul style="list-style-type: none"> <i>As-Built Description:</i> Height of water closet seat less than 17" or more than 19" from floor. <i>As-Built:</i> 19.25" <i>Proposed Solution:</i> Provide new accessible water closet. 	PCODE WB08 ADAAG 4.16.3 ADA 2010 604.4 CBC 2010 1115B.4.1.4 CBC 2013 11B-604.4 Priority 4 Severity 4 TBD Contract Work	1	JOB	\$1,400	\$1,400

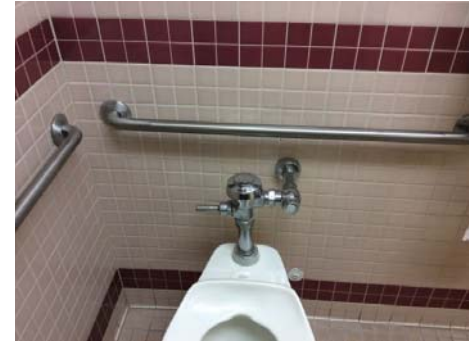
Item No. and Name	Existing Architectural Barrier and Proposed Solution	Codes / Mitigation Info	Qty	Unit	Cost	Total
2127	<ul style="list-style-type: none"> <i>As-Built Description:</i> Flush Control: Operating handle not mounted toward wide side of stall. <i>Proposed Solution:</i> Replace flush control with properly mounted accessible type, or install sensor flush. 	PCODE WB10 ADAAG 4.16.5 ADA 2010 604.6 CBC 2010 1115B.4.1.5 CBC 2013 11B-604.6 Priority 4 Severity 3 TBD Contract Work	1	JOB	\$500	\$500

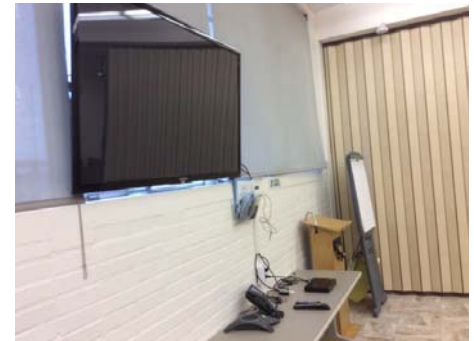
Assistive Listening

2143	<ul style="list-style-type: none"> <i>As-Built Description:</i> No portable assistive listening system provided for small meeting room. <i>Proposed Solution:</i> Share existing portable assistive listening system from other facility if needed. 	PCODE GI01E ADAAG 4.1.3(19)(b) & 4.33.7 ADA 2010 219.1 & 706.1 CBC 2010 1104B.2 CBC 2013 11B-219.2 Priority 3 Severity 3 TBD Contract Work		REF		
------	---	---	--	-----	--	--

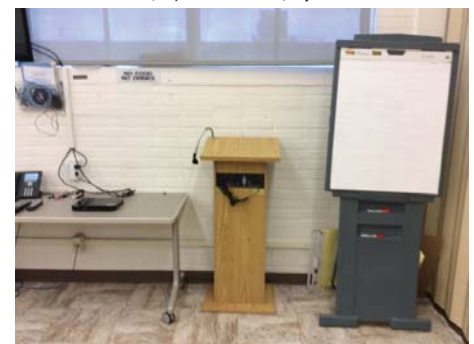
Non-Fixed Desk

2138	<ul style="list-style-type: none"> <i>As-Built Description:</i> Accessible non-fixed table or desk (top 28" to 34" high; knee space at least 27" high x 19" deep x 30" wide) not provided. <i>As-Built:</i> Podium 43" <i>Proposed Solution:</i> Provide table or desk with accessible dimensions when purchasing new furniture. 	PCODE IN02A ADAAG 4.32.3 & .4 ADA 2010 306.1 CBC 2010 1122B.3 & 4 CBC 2013 11B-306.1 & 11B-902.3 Priority 2 Severity 2 TBD Contract Work	1	JOB	\$1,600	\$1,600
------	---	---	---	-----	---------	---------

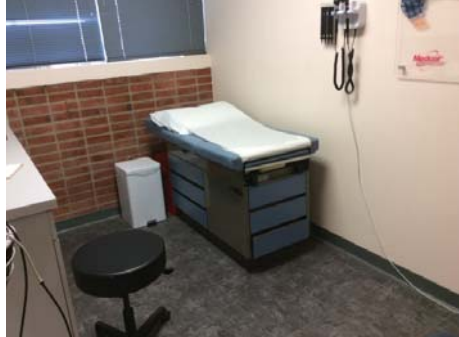
Item No. and Name	Existing Architectural Barrier and Proposed Solution	Codes / Mitigation Info	Qty	Unit	Cost	Total
<u>Exam Bed</u>						
2165	<ul style="list-style-type: none"> <i>As-Built Description:</i> Seat front edge height is not between 17" min. to 19" max. above ground of floor space. <i>As-Built:</i> 32.5" <i>Proposed Solution:</i> Provide transfer or lift beds in designated accessible exam rooms. <i>Notes:</i> Not County equipment. private company. 	PCODE NO06ANT ADAAG 4.37.5 ADA 2010 903.5 CBC 2010 1132B.1 CBC 2013 11B-903.5 Priority 2 Severity 1 TBD Contract Work	1	JOB	\$600	\$600

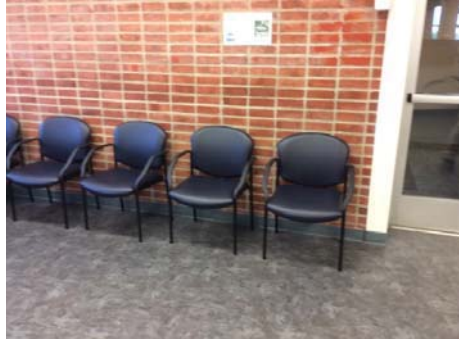
<u>Fixed Bench</u>						
2154	<ul style="list-style-type: none"> <i>As-Built Description:</i> Clear floor or ground space (30" x 48") not overlapping with other clear space requirements, is not provided at at least one end of the bench. <i>Proposed Solution:</i> Provide and position clear floor or ground space to allow wheelchair users to be seated shoulder-to-shoulder with an individual seated on the bench. 	PCODE NO07 ADAAG 4.32.2 ADA 2010 903.2 CBC 2010 1118B.4 CBC 2013 11B-903.2 Priority 2 Severity 2 TBD Contract Work	1	JOB	\$500	\$500

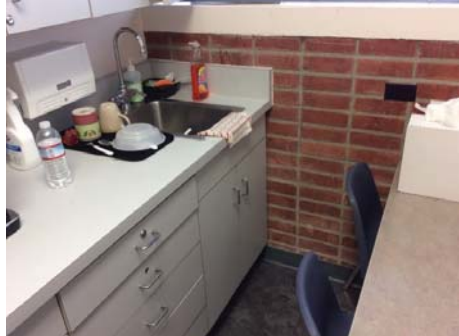
<u>Sink</u>						
2168	<ul style="list-style-type: none"> <i>As-Built Description:</i> Sink does not have knee space min. 27" high x 19" deep x 30" wide. <i>Proposed Solution:</i> Remodel sink cabinet. 	PCODE IN06A ADAAG 4.24.3 ADA 2010 606.2 CBC 2010 1115B.4.7.1 CBC 2013 11B-606.2 Priority 4 Severity 2 TBD Contract Work	1	JOB	\$1,750	\$1,750

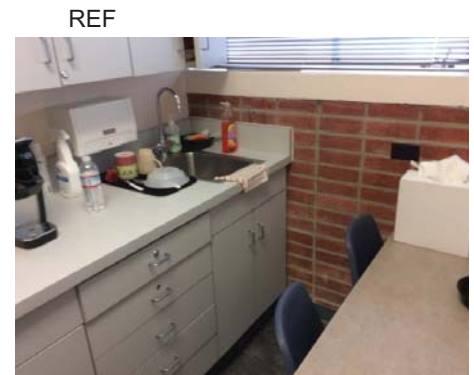
Item No. and Name	Existing Architectural Barrier and Proposed Solution	Codes / Mitigation Info	Qty	Unit	Cost	Total
2169	<ul style="list-style-type: none"> • <i>As-Built Description:</i> Sink rim higher than 34" above floor. • <i>As-Built:</i> 37" • <i>Proposed Solution:</i> Remodel sink cabinet to lower sink. 	<p>PCODE IN06REF</p> <p>ADAAG 4.24.2</p> <p>ADA 2010 606.3</p> <p>CBC 2010 1115B.4.7.1</p> <p>CBC 2013 11B-606.3</p> <p>Priority 4</p> <p>Severity 4</p> <p>TBD Contract Work</p>

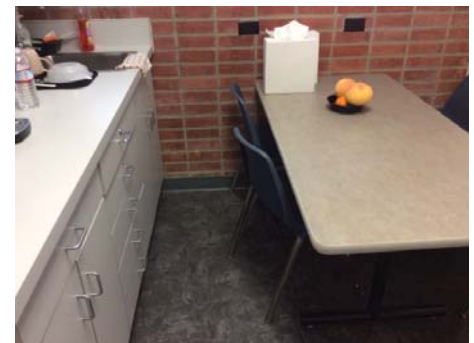
Turn Space

2172	<ul style="list-style-type: none"> • <i>As-Built Description:</i> Less than 60" diameter or T-shaped space provided for wheelchair turns. • <i>Proposed Solution:</i> Retrofit space to provide 60" diameter or T-turn. 	<p>PCODE IN04</p> <p>ADAAG 4.2.3</p> <p>ADA 2010 304.1</p> <p>CBC 2010 1118B.3</p> <p>CBC 2013 11B-304.1</p> <p>Priority 4</p> <p>Severity 2</p> <p>TBD Contract Work</p>	1	JOB	\$925	\$925
------	---	---	---	-----	-------	-------

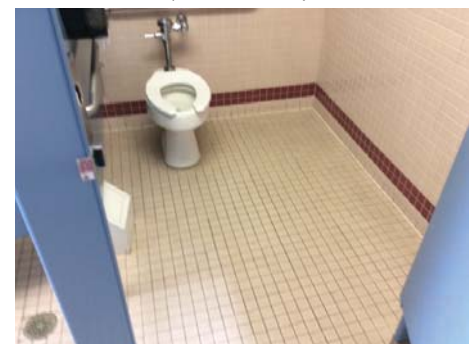
Accessible Compartment

2184	<ul style="list-style-type: none"> • <i>As-Built Description:</i> The location of the stall door is not in front of the clear space (next to the water closet), with a maximum stile width of 4". • <i>As-Built:</i> Stile 19" • <i>Proposed Solution:</i> Remodel compartment. 	<p>PCODE WB05D</p> <p>ADAAG 4.17.3 & Fig. 30(a)</p> <p>ADA 2010 604.8.1.2</p> <p>CBC 2010 1115B.3.1.4.3</p> <p>CBC 2013 11B-604.8.1.2</p> <p>Priority 4</p> <p>Severity 2</p> <p>TBD Contract Work</p>	1	JOB	\$500	\$500
------	--	--	---	-----	-------	-------

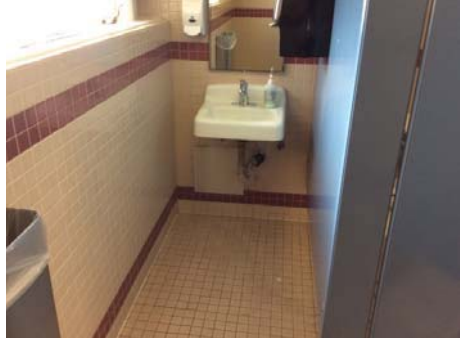
Item No. and Name	Existing Architectural Barrier and Proposed Solution	Codes / Mitigation Info	Qty	Unit	Cost	Total
Corridor						
2180	<ul style="list-style-type: none"> As-Built Description: Corridor less than 36" wide. As-Built: 34.5" wide Proposed Solution: Enlarge corridor to 36" wide; relocate stud wall. 	PCODE IH03 ADAAG 4.3.3 ADA 2010 403.5.1 CBC 2010 1133B.3.1 CBC 2013 11B-403.5.1 Priority 4 Severity 3 TBD Contract Work	5	LF	\$140	\$700

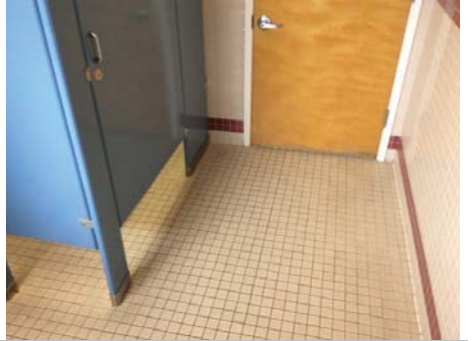
Door Swing						
2183	<ul style="list-style-type: none"> As-Built Description: Front approach: At pull side, door does not have clear and level maneuvering space measuring door width plus 18" x 60". As-Built: Stall door 53" Proposed Solution: Remodel as needed. 	PCODE ID23BNT ADAAG Fig. 25(a) ADA 2010 404.2.4 CBC 2010 11B-26A(a) CBC 2013 11B-404.2.4 Priority 4 Severity 3 TBD Contract Work	1	JOB	\$2,600	\$2,600

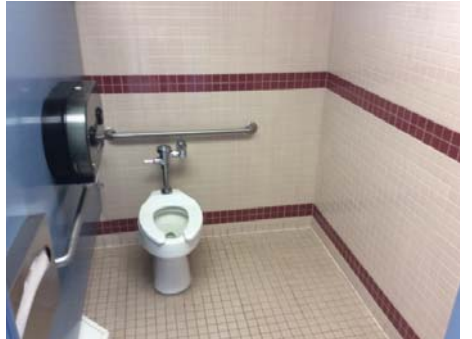
Toilet Stall						
2189	<ul style="list-style-type: none"> As-Built Description: Toilet stall less than 60" wide. As-Built: 59.5" Proposed Solution: Provide new accessible stall. 	PCODE WB06 ADAAG 4.17.3 ADA 2010 604.8.1.1 CBC 2010 1115B.3.1.4.1 CBC 2013 11B-604.8.1.1 Priority 4 Severity 4 TBD Contract Work	1	JOB	\$1,500	\$1,500

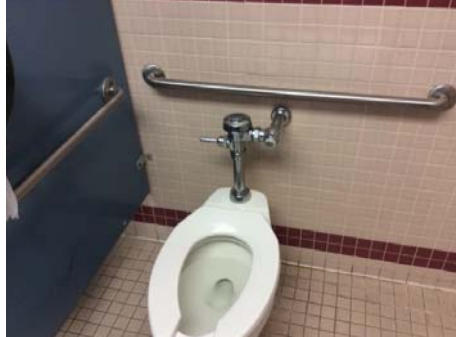
Item No. and Name	Existing Architectural Barrier and Proposed Solution	Codes / Mitigation Info	Qty	Unit	Cost	Total
<u>Water Closet</u>						
2187	<ul style="list-style-type: none"> <i>As-Built Description:</i> Flush Control: Operating handle not mounted toward wide side of stall. <i>Proposed Solution:</i> Replace flush control with properly mounted accessible type, or install sensor flush. 	PCODE WB10 ADAAG 4.16.5 ADA 2010 604.6 CBC 2010 1115B.4.1.5 CBC 2013 11B-604.6 Priority 4 Severity 3 TBD Contract Work	1	JOB	\$500	\$500

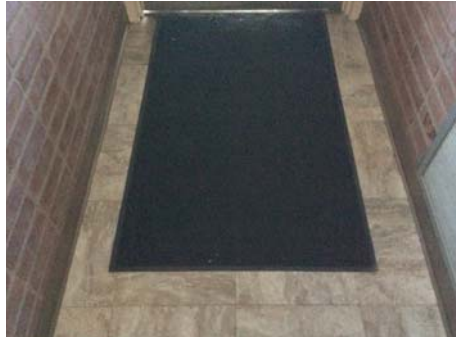
<u>Doormat</u>						
2208	<ul style="list-style-type: none"> <i>As-Built Description:</i> Doormat hinders access to disabled persons. <i>Proposed Solution:</i> Provide new doormat; recess or attach at edges. 	PCODE ID05 ADAAG 4.5.3 ADA 2010 302.2 CBC 2010 1124B.3 CBC 2013 11B-302.2 Priority 1 Severity 3 TBD Contract Work	1	JOB	\$500	\$500

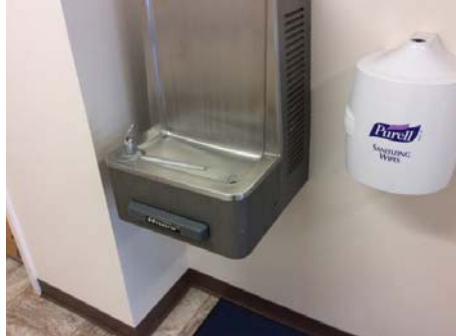
<u>Drinking Fountain</u>						
2200	<ul style="list-style-type: none"> <i>As-Built Description:</i> Drinking fountain bubbler more than 36" above floor. <i>As-Built:</i> 38", top 8.5" deep <i>Proposed Solution:</i> Provide new, accessible fountain. 	PCODE IA03B ADAAG 4.15.2 ADA 2010 602.4 CBC 2010 1115B.4.6.4 CBC 2013 11B-602.4 Priority 3 Severity 4 TBD Contract Work	1	JOB	\$3,200	\$3,200

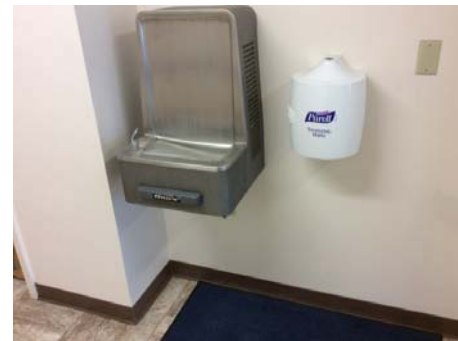
Item No. and Name	Existing Architectural Barrier and Proposed Solution	Codes / Mitigation Info	Qty	Unit	Cost	Total
2199	<ul style="list-style-type: none"> <i>As-Built Description:</i> CA only: Drinking fountain not located in an alcove (min. 32" wide x 18" deep) or otherwise encroaches into pedestrian way. <i>As-Built:</i> 15.5" deep <i>Proposed Solution:</i> Provide new alcove for drinking fountain, or, if unreasonable hardship is determined, provide wing walls or cane-detectable railings on each side of the drinking fountain. The wings must project out from the supporting wall at least as far as the drinking fountain to within 6" of the surface of the circulation path, but cannot reduce the required clear width of the adjacent accessible route. 	<p>PCODE IA04</p> <p>CBC 2010 1115B.4.6.3; Fig.</p> <p>CBC 2013 11B-602.9</p> <p>Priority 3</p> <p>Severity 2</p> <p>TBD Contract Work</p>	1	JOB	\$3,000	\$3,000

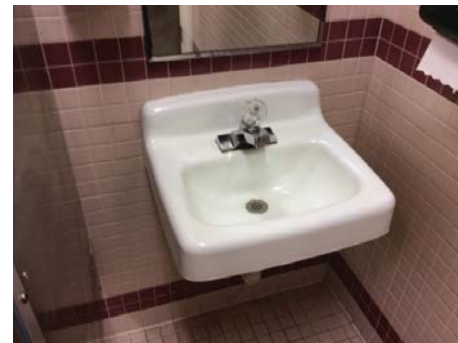
Lavatory

2223	<ul style="list-style-type: none"> <i>As-Built Description:</i> Clear floor space, 30" x 48" in front of fixture, extending 19" max. under the lavatory, not provided (CA only: Less than 18" from side wall to centerline of lavatory). <i>As-Built:</i> 16.75" <i>Proposed Solution:</i> Provide new accessible lavatory. Remodel restroom as needed. 	<p>PCODE WD01</p> <p>ADAAG 4.19.3</p> <p>ADA 2010 606.2</p> <p>CBC 2010 1115B.4.3</p> <p>CBC 2013 11B-606.2, 11B-606.6</p> <p>Priority 3</p> <p>Severity 2</p> <p>TBD Contract Work</p>	1	JOB	\$3,400	\$3,400
------	--	---	---	-----	---------	---------

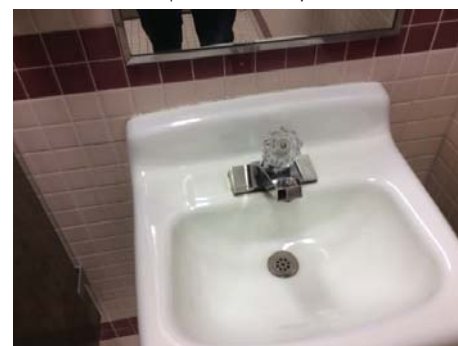
2219	<ul style="list-style-type: none"> <i>As-Built Description:</i> Lavatory: Accessible faucet (lever-operated, push-type or electronically controlled) not provided at otherwise accessible lavatory. <i>As-Built:</i> For temp control <i>Proposed Solution:</i> Provide accessible faucet at accessible lavatory. 	<p>PCODE WD06</p> <p>ADAAG 4.19.5</p> <p>ADA 2010 606.4</p> <p>CBC 2010 1115B.4.3</p> <p>CBC 2013 11B-606.4</p> <p>Priority 3</p> <p>Severity 3</p> <p>TBD Contract Work</p>	1	JOB	\$600	\$600
------	--	--	---	-----	-------	-------

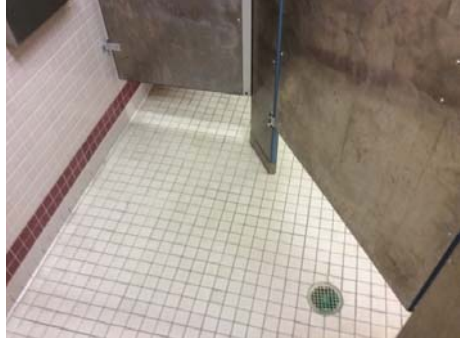
Item No. and Name	Existing Architectural Barrier and Proposed Solution	Codes / Mitigation Info	Qty	Unit	Cost	Total
Toilet Stall						
2226	<ul style="list-style-type: none"> As-Built Description: Toilet stall less than 60" wide. As-Built: 27"-58" Proposed Solution: Provide new accessible stall. 	PCODE WB06 ADAAG 4.17.3 ADA 2010 604.8.1.1 CBC 2010 1115B.3.1.4.1 CBC 2013 11B-604.8.1.1 Priority 3 Severity 1 TBD Contract Work	1	JOB	\$1,500	\$1,500

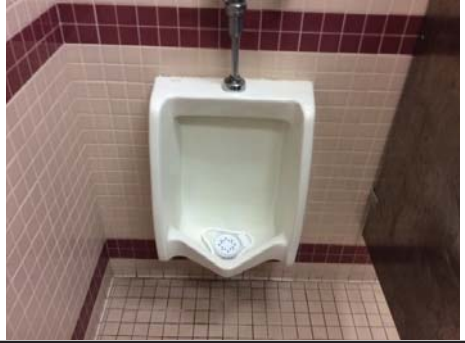
Urinal						
2217	<ul style="list-style-type: none"> As-Built Description: Front of rim projects less than 13.5" from wall. As-Built: 12" Proposed Solution: Provide accessible urinal. Remodel restroom as needed. 	PCODE WE01 ADA 2010 605.2 CBC 2010 1115B.4.2.1 CBC 2013 11B-605.2 Priority 3 Severity 4 TBD Contract Work	1	JOB	\$4,000	\$4,000

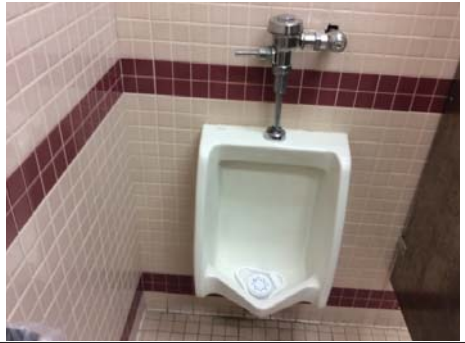
2218	<ul style="list-style-type: none"> As-Built Description: Urinal flush control lever more than 48" above floor (CA only: 44" max.). As-Built: 45" Proposed Solution: Provide accessible urinal flush control. 	PCODE WE03 ADAAG 4.18.4 ADA 2010 605.4 CBC 2010 1115B.4.2.2 CBC 2013 11B-605.4 Priority 3 Severity 4 TBD Contract Work	1	JOB	\$500	\$500

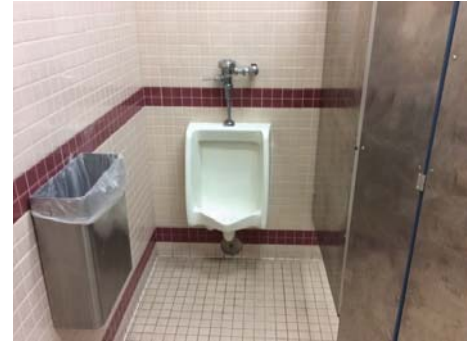
Item No. and Name	Existing Architectural Barrier and Proposed Solution	Codes / Mitigation Info	Qty	Unit	Cost	Total
2216	<ul style="list-style-type: none"> • <i>As-Built Description:</i> 30" x 48" clear floor space in front of accessible urinal not provided. • <i>As-Built:</i> 32" to trash bin • <i>Proposed Solution:</i> Provide clear floor space in front of accessible urinal. Remodel restroom as needed. • <i>Notes:</i> 38" to stall 	PCODE WE04 ADAAG 4.18.3 ADA 2010 605.3 CBC 2010 1115B.4.2.3 CBC 2013 11B-605.3 Priority 3 Severity 2 TBD Contract Work	1	JOB	\$1,500	\$1,500

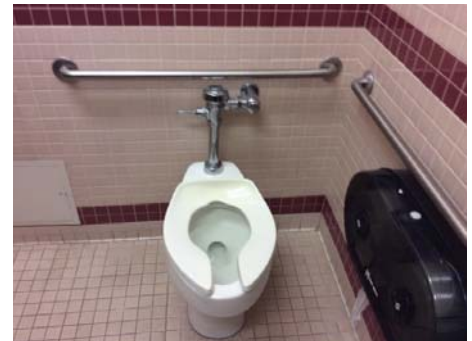
2228	<ul style="list-style-type: none"> • <i>As-Built Description:</i> More than 18" from near side wall to centerline of water closet. • <i>As-Built:</i> 20.5" o.c. • <i>Proposed Solution:</i> Provide new accessible water closet and relocate plumbing. 	PCODE WB02A ADAAG Fig. 28 ADA 2010 604.2 CBC 2010 1115B.4.1.1 CBC 2013 11B-604.2 Priority 3 Severity 3 TBD Contract Work	1	JOB	\$4,500	\$4,500
------	--	---	---	-----	---------	----------------

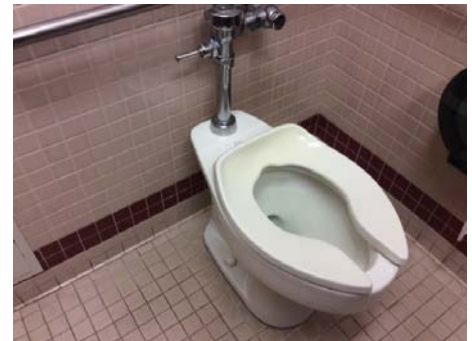
2230	<ul style="list-style-type: none"> • <i>As-Built Description:</i> Height of water closet seat less than 17" or more than 19" from floor. • <i>As-Built:</i> 19.25" • <i>Proposed Solution:</i> Provide new accessible water closet. 	PCODE WB08 ADAAG 4.16.3 ADA 2010 604.4 CBC 2010 1115B.4.1.4 CBC 2013 11B-604.4 Priority 3 Severity 4 TBD Contract Work	1	JOB	\$1,400	\$1,400
------	--	---	---	-----	---------	----------------

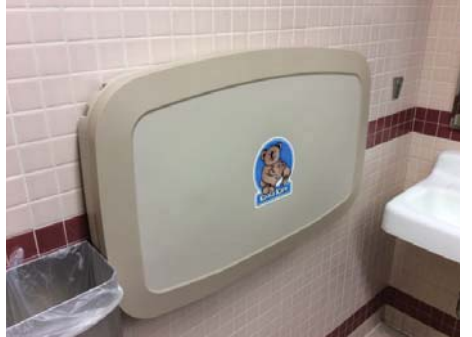
Item No. and Name	Existing Architectural Barrier and Proposed Solution	Codes / Mitigation Info	Qty	Unit	Cost	Total
Accessories						
2238	<ul style="list-style-type: none"> <i>As-Built Description:</i> Accessories in sanitary facilities not accessible, hardware requires tight grasping, pinching, or twisting of the wrist. <i>As-Built:</i> No u-pull 36" down <i>Proposed Solution:</i> Provide accessories with accessible operating mechanism. 	PCODE WG05 ADAAG 4.27.4 ADA 2010 309.4 CBC 2010 1117B.6 CBC 2013 11B-309.4 Priority 3 Severity 3 TBD Contract Work	1	JOB	\$400	\$400

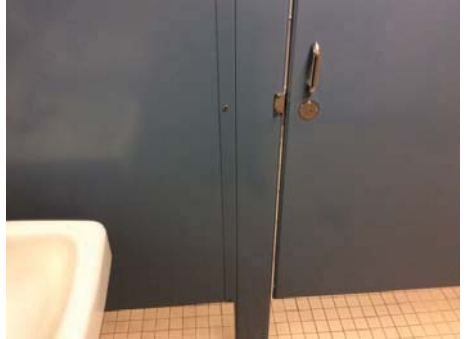
Door Swing						
2240	<ul style="list-style-type: none"> <i>As-Built Description:</i> Front approach: At pull side, door does not have clear and level maneuvering space measuring door width plus 18" x 60". <i>As-Built:</i> Stall 17" to lav <i>Proposed Solution:</i> Remodel as needed. 	PCODE ID23BNT ADAAG Fig. 25(a) ADA 2010 404.2.4 CBC 2010 11B-26A(a) CBC 2013 11B-404.2.4 Priority 3 Severity 4 TBD Contract Work	1	JOB	\$2,600	\$2,600

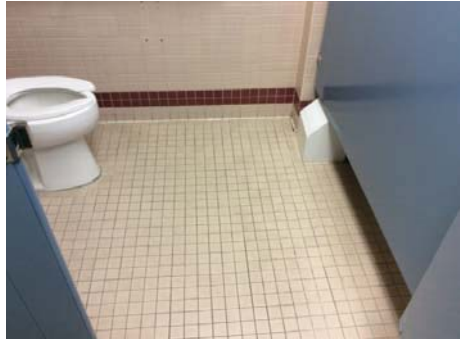
Water Closet						
2242	<ul style="list-style-type: none"> <i>As-Built Description:</i> CA only: In single-accommodation restroom less than 48" in front of water closet provided. <i>As-Built:</i> 44" <i>Proposed Solution:</i> Remodel restroom to provide at least 48" in front of water closet. 	PCODE WB03A CBC 2010 1115B.3.2.1 CBC 2013 11B-604.3.1 Priority 3 Severity 4 TBD Contract Work	1	JOB	\$5,000	\$5,000

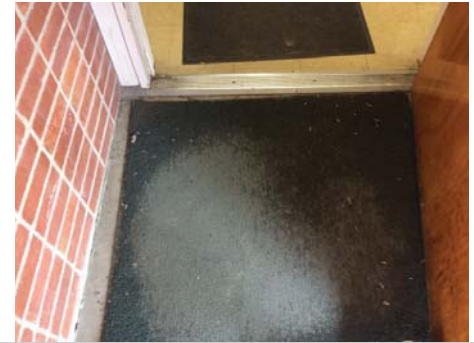
2466	<ul style="list-style-type: none"> <i>As-Built Description:</i> Surface of required maneuvering clearance at door slopes more than 1/4":12" (2.0%). <i>As-Built:</i> 3.5% <i>Proposed Solution:</i> Modify surface slope at door. 	PCODE ID11 ADAAG 4.13.6 ADA 2010 404.2.4.4 CBC 2010 1133B.2.4 CBC 2013 11B-404.2.4 Priority 2 Severity 4 TBD Contract Work	20	SF	\$40	\$800
------	--	---	----	----	------	-------

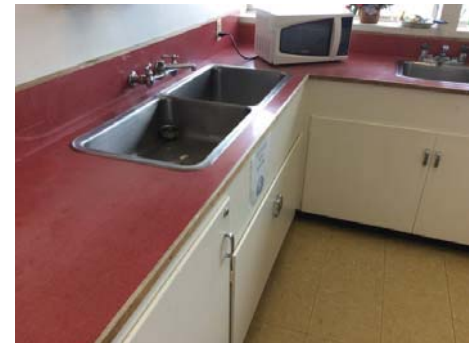
2479	<ul style="list-style-type: none"> <i>As-Built Description:</i> Sink rim higher than 34" above floor. <i>As-Built:</i> 36.25" <i>Proposed Solution:</i> Remodel sink cabinet to lower sink. 	PCODE IN06 ADAAG 4.24.2 ADA 2010 606.3 CBC 2010 1115B.4.7.1 CBC 2013 11B-606.3 Priority 4 Severity 4 TBD Contract Work	1	JOB	\$1,750	\$1,750
------	--	---	---	-----	---------	---------

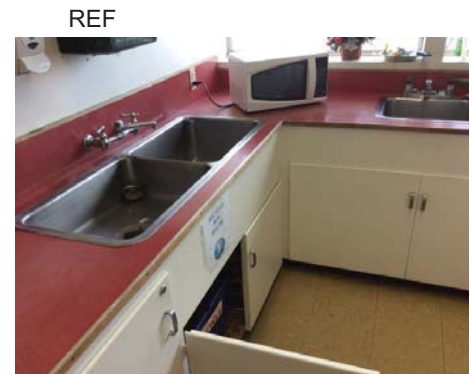
2480	<ul style="list-style-type: none"> <i>As-Built Description:</i> Sink does not have knee space min. 27" high x 19" deep x 30" wide. <i>Proposed Solution:</i> Remodel sink cabinet. 	PCODE IN06AREF ADAAG 4.24.3 ADA 2010 606.2 CBC 2010 1115B.4.7.1 CBC 2013 11B-606.2 Priority 2 Severity 2 TBD Contract Work				
------	--	---	--	--	--	--

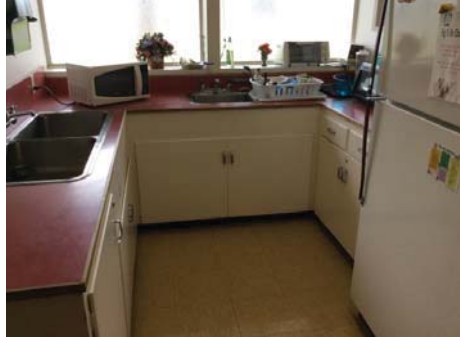
Item No. and Name	Existing Architectural Barrier and Proposed Solution	Codes / Mitigation Info	Qty	Unit	Cost	Total
<u>Turn Space</u>						
2481	<ul style="list-style-type: none"> <i>As-Built Description:</i> Less than 60" diameter or T-shaped space provided for wheelchair turns. <i>As-Built:</i> 43"-52" <i>Proposed Solution:</i> Retrofit space to provide 60" diameter or T-turn. 	PCODE IN04 ADAAG 4.2.3 ADA 2010 304.1 CBC 2010 1118B.3 CBC 2013 11B-304.1 Priority 4 Severity 2 TBD Contract Work	1	JOB	\$925	\$925

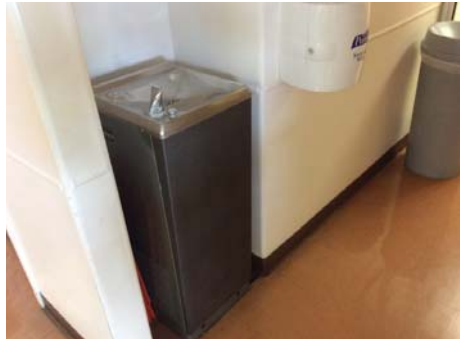
2496	<ul style="list-style-type: none"> <i>As-Built Description:</i> Where only one drinking fountain is provided per floor: Fountain is not accessible to individuals who use wheelchairs, or to those who have difficulty bending or stooping. <i>Proposed Solution:</i> Provide additional fountain or hi-lo combination fountain. 	PCODE IA01A ADAAG 4.1.3(10)(a) ADA 2010 211.1 CBC 2010 1115B.4.6.1 CBC 2013 11B-211.1 Priority 3 Severity 2 TBD Contract Work	1	JOB	\$2,000	\$2,000

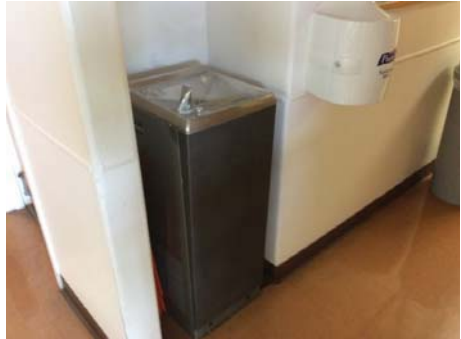
2495	<ul style="list-style-type: none"> <i>As-Built Description:</i> Wall- and post-mounted cantilevered units: Knee space not provided at drinking fountain (27" high, 8" deep, 30" wide from front of drinking fountain). <i>Proposed Solution:</i> Provide new, accessible fountain. 	PCODE IA02 ADAAG 4.15.5(1) ADA 2010 602.2 CBC 2010 1115B.4.6.2 CBC 2013 11B-602.2 Priority 3 Severity 2 TBD Contract Work	1	JOB	\$3,200	\$3,200

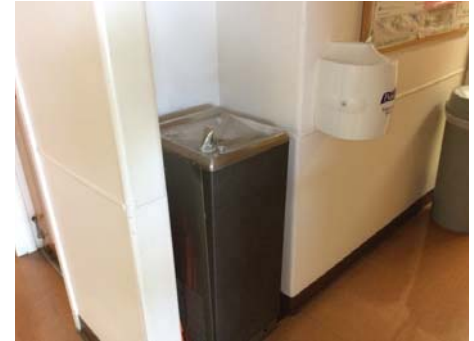
Item No. and Name	Existing Architectural Barrier and Proposed Solution	Codes / Mitigation Info	Qty	Unit	Cost	Total
2494	<ul style="list-style-type: none"> <i>As-Built Description:</i> CA only: Drinking fountain not located in an alcove (min. 32" wide x 18" deep) or otherwise encroaches into pedestrian way. <i>As-Built:</i> 24" wide <i>Proposed Solution:</i> Provide new alcove for drinking fountain, or, if unreasonable hardship is determined, provide wing walls or cane-detectable railings on each side of the drinking fountain. The wings must project out from the supporting wall at least as far as the drinking fountain to within 6" of the surface of the circulation path, but cannot reduce the required clear width of the adjacent accessible route. 	<p>PCODE IA04</p> <p>CBC 2010 1115B.4.6.3; Fig.</p> <p>CBC 2013 11B-602.9</p> <p>Priority 3</p> <p>Severity 2</p> <p>TBD Contract Work</p>	1	JOB	\$3,000	\$3,000

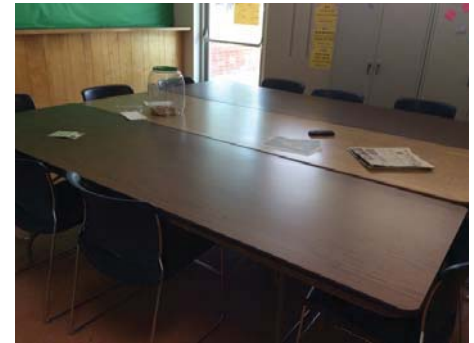
2489	<ul style="list-style-type: none"> <i>As-Built Description:</i> Accessible non-fixed table or desk (top 28" to 34" high; knee space at least 27" high x 19" deep x 30" wide) not provided. <i>As-Built:</i> 26.5" <i>Proposed Solution:</i> Provide table or desk with accessible dimensions when purchasing new furniture. 	<p>PCODE IN02A</p> <p>ADAAG 4.32.3 & .4</p> <p>ADA 2010 306.1</p> <p>CBC 2010 1122B.3 & 4</p> <p>CBC 2013 11B-306.1 & 11B-902.3</p> <p>Priority 4</p> <p>Severity 2</p> <p>TBD Contract Work</p>	1	JOB	\$1,600	\$1,600
------	--	--	---	-----	---------	----------------

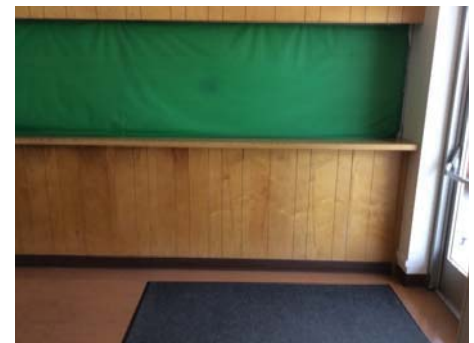
2492	<ul style="list-style-type: none"> <i>As-Built Description:</i> Service Counter (Stand-up): Accessible section min. 36" length and 36" max. height (in CA: 28" to 34" high) not provided. <i>As-Built:</i> 42" <i>Proposed Solution:</i> Provide auxiliary shelf, clipboard, or table as equivalent facilitation. <i>Notes:</i> No longer in use 	<p>PCODE IN03REF</p> <p>ADAAG 7.2(2)</p> <p>ADA 2010 904.4</p> <p>CBC 2010 1122B.4</p> <p>CBC 2013 11B-904.4</p> <p>Priority 2</p> <p>Severity 3</p> <p>TBD Contract Work</p>	REF			
------	---	---	-----	--	--	--

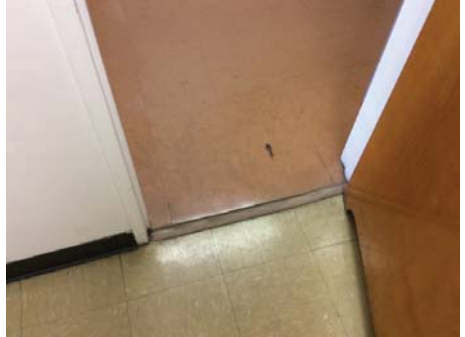
Item No. and Name	Existing Architectural Barrier and Proposed Solution	Codes / Mitigation Info	Qty	Unit	Cost	Total
<u>Door Clearance</u>						
2502	<ul style="list-style-type: none"> <i>As-Built Description:</i> Door on accessible route has less than 32" clear and 80" (78" min. to closer if provided) opening width when 90° open. <i>As-Built:</i> 27" <i>Proposed Solution:</i> Provide new, larger door and frame with new accessible hardware. 	PCODE ID01REF ADAAG 4.13.5 ADA 2010 404.2.3 CBC 2010 1133B.1.1.1.1 CBC 2013 11B-404.2.3 Priority 3 Severity 2 TBD Contract Work				REF

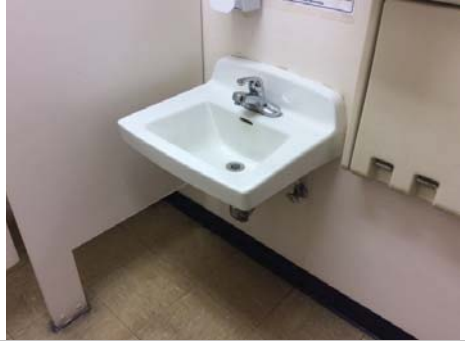
<u>Lavatory</u>						
2504	<ul style="list-style-type: none"> <i>As-Built Description:</i> Knee clearance 27" min. high starting 8" back from the front edge of the lavatory towards the wall is not provided. <i>As-Built:</i> 24" <i>Proposed Solution:</i> Provide new accessible lavatory. Remodel restroom as needed. 	PCODE WD04REF ADAAG Fig. 31 ADA 2010 606.3 CBC 2010 1115B.4.3 CBC 2013 11B-306.3.3 Priority 3 Severity 2 TBD Contract Work				REF

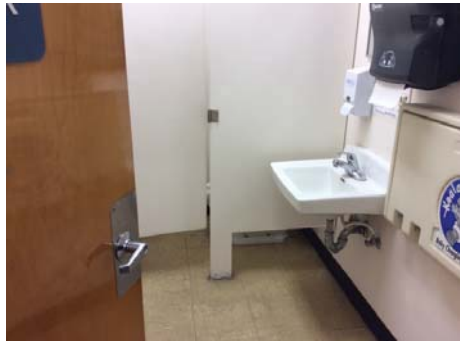
<u>Restroom</u>						
2499	<ul style="list-style-type: none"> <i>As-Built Description:</i> Single accommodation restroom not accessible; multiple compliance violations. <i>Proposed Solution:</i> Remodel area to provide single-occupant accessible restroom. Notes: Provide one compliant unisex RR 	PCODE WA01 ADAAG 4.22 ADA 2010 603 CBC 2010 1115B.3.2 CBC 2013 11B-603 Priority 3 Severity 2 TBD Contract Work	1	JOB	\$30,000	\$30,000

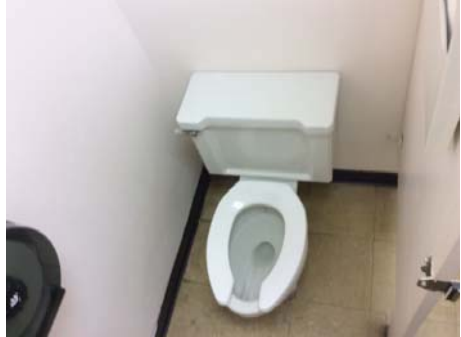
Item No. and Name	Existing Architectural Barrier and Proposed Solution	Codes / Mitigation Info	Qty	Unit	Cost	Total
<u>Toilet Stall</u>						
2503	<ul style="list-style-type: none"> • <i>As-Built Description:</i> Toilet stall less than 60" wide. • <i>As-Built:</i> 35.5" • <i>Proposed Solution:</i> Provide new accessible stall. 	<p>PCODE WB06</p> <p>ADAAG 4.17.3</p> <p>ADA 2010 604.8.1.1</p> <p>CBC 2010 1115B.3.1.4.1</p> <p>CBC 2013 11B-604.8.1.1</p> <p>Priority 3</p> <p>Severity 1</p> <p>TBD Contract Work</p>	1	JOB	\$1,500	\$1,500

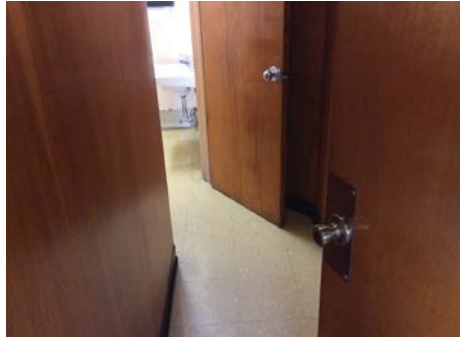
<u>Door Clearance</u>						
2516	<ul style="list-style-type: none"> • <i>As-Built Description:</i> Door on accessible route has less than 32" clear and 80" (78" min. to closer if provided) opening width when 90° open. • <i>As-Built:</i> 27" • <i>Proposed Solution:</i> Provide new, larger door and frame with new accessible hardware. 	<p>PCODE ID01REF</p> <p>ADAAG 4.13.5</p> <p>ADA 2010 404.2.3</p> <p>CBC 2010 1133B.1111</p> <p>CBC 2013 11B-404.2.3</p> <p>Priority 3</p> <p>Severity 2</p> <p>TBD Contract Work</p>	REF

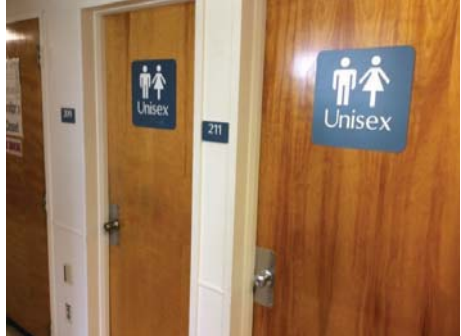
<u>Restroom</u>						
2515	<ul style="list-style-type: none"> • <i>As-Built Description:</i> Single accommodation restroom not accessible; multiple compliance violations. • <i>Proposed Solution:</i> Remodel area to provide single-occupant accessible restroom. • Notes: Provide one compliant unisex RR 	<p>PCODE WA01</p> <p>ADAAG 4.22</p> <p>ADA 2010 603</p> <p>CBC 2010 1115B.3.2</p> <p>CBC 2013 11B-603</p> <p>Priority 3</p> <p>Severity 2</p> <p>TBD Contract Work</p>	1	JOB	\$30,000	\$30,000

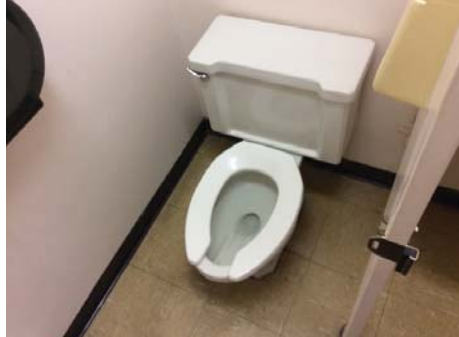
Item No. and Name	Existing Architectural Barrier and Proposed Solution	Codes / Mitigation Info	Qty	Unit	Cost	Total
<u>Toilet Stall</u>						
2517	<ul style="list-style-type: none"> As-Built Description: Toilet stall less than 60" wide. As-Built: 35.5" Proposed Solution: Provide new accessible stall. 	PCODE WB06 ADAAG 4.17.3 ADA 2010 604.8.1.1 CBC 2010 1115B.3.1.4.1 CBC 2013 11B-604.8.1.1 Priority 3 Severity 1 TBD Contract Work	1	JOB	\$1,500	\$1,500

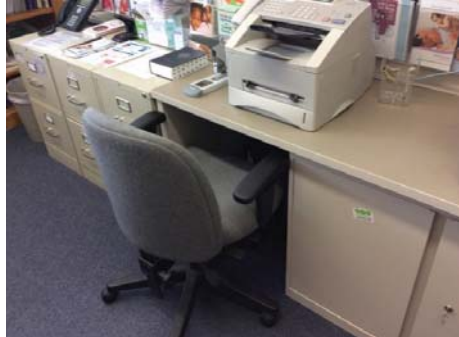
2520	<ul style="list-style-type: none"> As-Built Description: Accessible non-fixed table or desk (top 28" to 34" high; knee space at least 27" high x 19" deep x 30" wide) not provided. As-Built: 22.5" wide Proposed Solution: Provide table or desk with accessible dimensions when purchasing new furniture. 	PCODE IN02A ADAAG 4.32.3 & .4 ADA 2010 306.1 CBC 2010 1122B.3 & 4 CBC 2013 11B-306.1 & 11B-902.3 Priority 2 Severity 2 TBD Contract Work	1	JOB	\$1,600	\$1,600

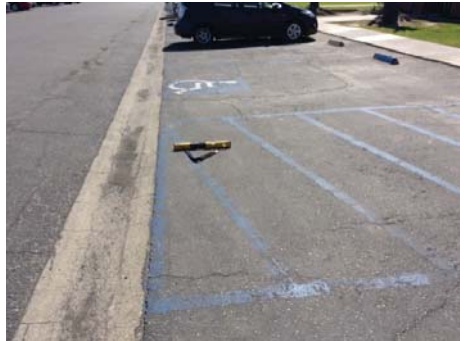
2925	<ul style="list-style-type: none"> <i>As-Built Description:</i> Accessible parking space has slope greater than 1/4":12" (2%). <i>As-Built:</i> Portions along drainage <i>Proposed Solution:</i> Modify slope at accessible parking space. 	PCODE EA05 ADAAG 4.6.3 ADA 2010 502.4 CBC 2010 1129B.3.3 CBC 2013 11B-502.4 Priority 1 Severity 4 TBD Contract Work	160	SF	\$12	\$1,920
------	--	--	-----	----	------	---------

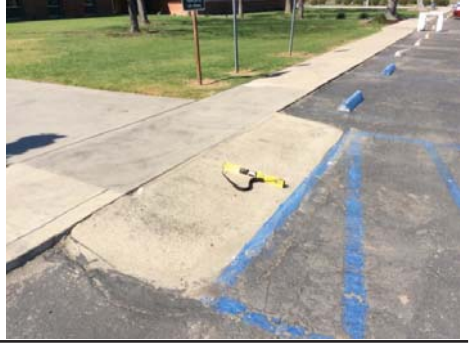
2926	<ul style="list-style-type: none"> <i>As-Built Description:</i> Access aisle at accessible parking space has slope greater than 1/4":12" (2%) due to built-up curb ramp within aisle. <i>As-Built:</i> 11.7% <i>Proposed Solution:</i> Provide curb cut. 	PCODE EA05A ADAAG 4.6.3 ADA 2010 502.4 CBC 2010 1129B.3.3 CBC 2013 11B-502.4 Priority 1 Severity 1 TBD Contract Work	1	JOB	\$2,500	\$2,500
------	---	---	---	-----	---------	---------

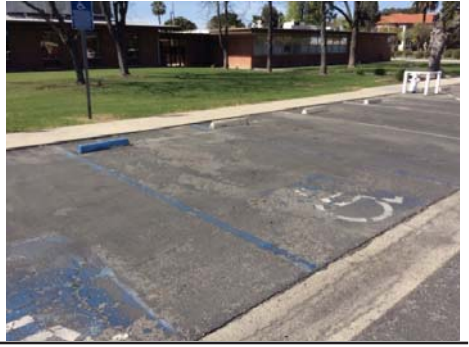
2923	<ul style="list-style-type: none"> <i>As-Built Description:</i> Accessible parking space does not have 5' wide access aisle; 8' wide for van accessible aisle. <i>Proposed Solution:</i> Modify parking aisle(s) to create accessible space by restriping. 	PCODE EA02B ADAAG 4.6.3 ADA 2010 502.3 CBC 2010 1129B.3.1 CBC 2013 11B-502.2; 11B-502.3.1 Priority 1 Severity 1 TBD Contract Work	1	JOB	\$200	\$200
------	--	--	---	-----	-------	-------

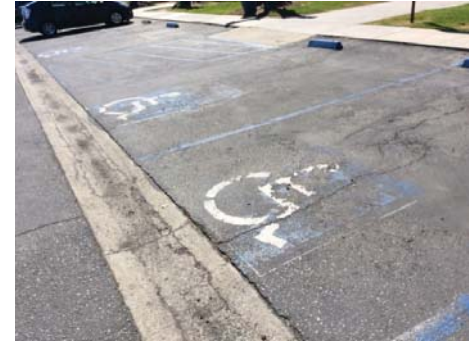
Item No. and Name	Existing Architectural Barrier and Proposed Solution	Codes / Mitigation Info	Qty	Unit	Cost	Total
2924	<ul style="list-style-type: none"> <i>As-Built Description:</i> International Symbol of Accessibility (36" square, in white on blue) is not painted on the pavement near the rear end of the parking space (required in CA only). <i>As-Built:</i> Faded <i>Proposed Solution:</i> Apply symbol on parking space pavement when altering area. 	PCODE EA04A CBC 2010 1129B.4 CBC 2013 11B-502.6.4 Priority 1 Severity 4 TBD Contract Work	1	JOB	\$120	\$120
