Facility: **WOMENS INFANTS & CHILDREN**

Address: 330 HARRIS ST.

Facility: **LEMORE HEALTH CLINIC**
 Address: 229 C ST.

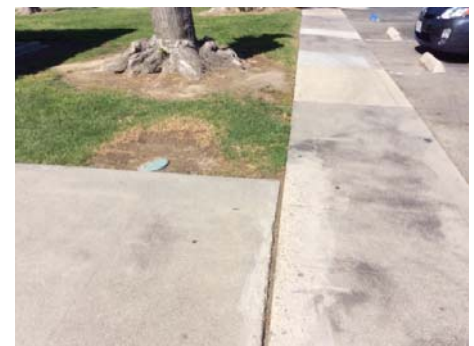
2930	<ul style="list-style-type: none"> <i>As-Built Description:</i> Walk: Pavement dislocation creates abrupt change in level exceeding 1/2" in accessible route. <i>As-Built:</i> 1" gap <i>Proposed Solution:</i> Remove, replace or repair area of pavement sufficient to correct abrupt change in level. 	PCODE EF03REF ADAAG 4.3.8 ADA 2010 403.4 CBC 2010 1133B.7.4 CBC 2013 11B-403.4 Priority 1 Severity 4 TBD Contract Work	REF			
------	---	---	-----	--	--	--

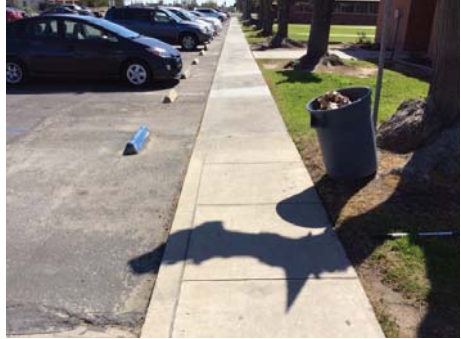
2928	<ul style="list-style-type: none"> As-Built Description: Cross slope more than 1":48" (2.083%). As-Built: 2.3-9.1% Proposed Solution: Modify cross slope. 	PCODE EF07 ADAAG 4.3.7 ADA 2010 403.3 CBC 2010 1133B.7.1.3 CBC 2013 11B-403.3 Priority 1 Severity 2 TBD Contract Work	280	SF	\$25	\$7,000
------	--	--	-----	----	------	---------

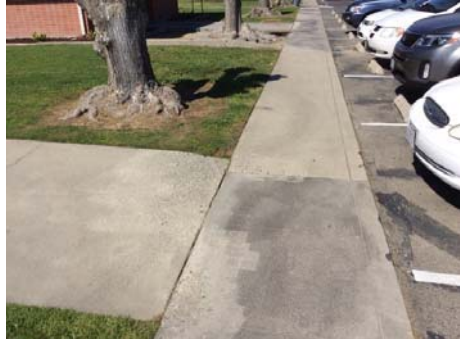
2932	<ul style="list-style-type: none"> As-Built Description: Cross slope more than 1":48" (2.083%). As-Built: 2.5-4.2% Proposed Solution: Modify cross slope. 	PCODE EF07 ADAAG 4.3.7 ADA 2010 403.3 CBC 2010 1133B.7.1.3 CBC 2013 11B-403.3 Priority 1 Severity 3 TBD Contract Work	200	SF	\$25	\$5,000
------	--	--	-----	----	------	---------

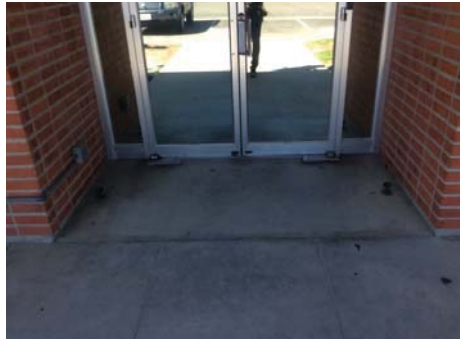
2931	<ul style="list-style-type: none"> As-Built Description: Surface of required maneuvering clearance at door slopes more than 1/4":12" (2.0%). As-Built: 3.7% Proposed Solution: Modify surface slope at door. 	PCODE ID11REF ADAAG 4.13.6 ADA 2010 404.2.4.4 CBC 2010 1133B.2.4 CBC 2013 11B-404.2.4 Priority 1 Severity 4 TBD Contract Work	REF			
------	---	--	-----	--	--	--

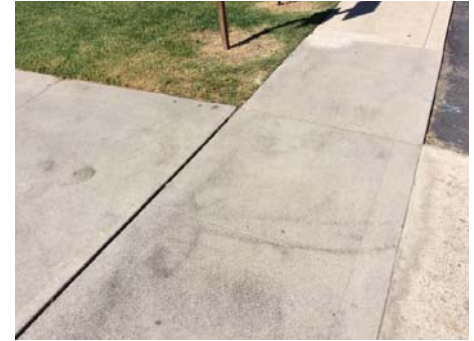
- 2934
- *As-Built Description:*
Walk: Pavement dislocation creates abrupt change in level exceeding 1/2" in accessible route.
 - *As-Built:* 0.75" gap
 - *Proposed Solution:*
Remove, replace or repair area of pavement sufficient to correct abrupt change in level.

PCODE **EF03REF**
 ADAAG **4.3.8**
 ADA 2010 **403.4**
 CBC 2010 **1133B.7.4**
 CBC 2013 **11B-403.4**
 Priority **1**
 Severity **4**
 TBD Contract Work

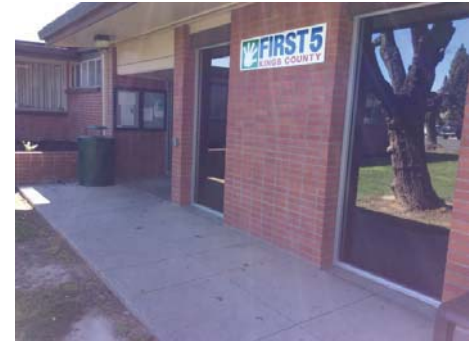
- 2935
- *As-Built Description:*
Cross slope more than 1":48" (2.083%).
 - *As-Built:* 2.3-3.4%
 - *Proposed Solution:*
Modify cross slope.

PCODE **EF07**
 ADAAG **4.3.7**
 ADA 2010 **403.3**
 CBC 2010 **1133B.7.1.3**
 CBC 2013 **11B-403.3**
 Priority **1**
 Severity **4**
 TBD Contract Work

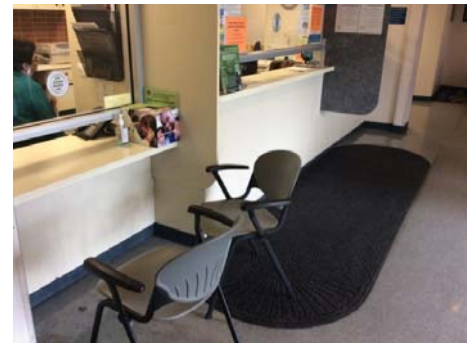
2439 • *As-Built Description:*
 Service counter (stand-up): Accessible section min. 36" length and 36" max. height (in CA: 28" to 34" high) not provided.

PCODE IN03
 ADAAG 7.2(2)
 ADA 2010 904.4
 CBC 2010 1122B.4
 CBC 2013 11B-904.4
 Priority 1
 Severity 3
TBD Contract Work

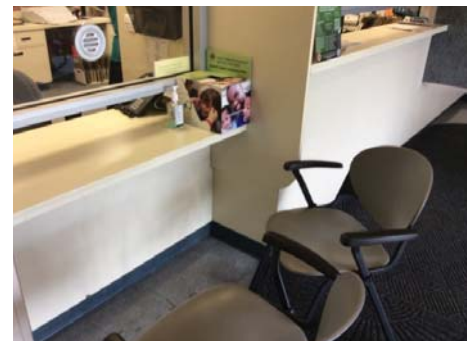
2440 • *As-Built Description:*
 Public Counter (Seated Service): Accessible section not provided (knee space min. 27" high x 19" deep x 30" wide, top 28" to 34" high, min. 36" counter wide).

• *As-Built:* 9" deep
 • *Proposed Solution:*
 Retrofit existing counter to provide accessible seating section.
 Interim solution: Provide auxiliary counter or table.

PCODE IN03A
 ADAAG 4.32.3 & 4
 ADA 2010 306.3; 904.4
 CBC 2010 1122B.3 & 4
 CBC 2013 11B-306.3; 11B-904.4
 Priority 1
 Severity 2
TBD Contract Work

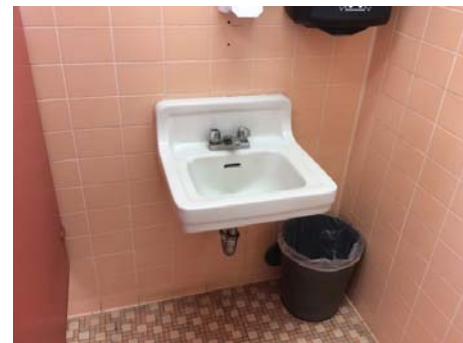
2455 • *As-Built Description:*
 Lavatory: Accessible faucet (lever-operated, push-type or electronically controlled) not provided at otherwise accessible lavatory.
 • *Proposed Solution:*
 Provide accessible faucet at accessible lavatory.

PCODE WD06REF
ADAAG 4.19.5
ADA 2010 606.4
CBC 2010 1115B.4.3
CBC 2013 11B-606.4
Priority 3
Severity 3
TBD Contract Work

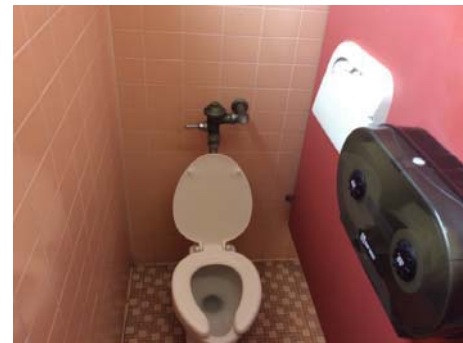
2454 • *As-Built Description:*
 Multiple accommodation restroom not accessible; multiple compliance violations.
 • *As-Built:* 33.5"
 • *Proposed Solution:*
 Remodel area to provide accessible restroom with one accessible stall, lavatory (and one urinal at Mens).

PCODE WA01A
ADAAG 4.22
ADA 2010 603
CBC 2010 1115B.3.1
CBC 2013 11B-603
Priority 3
Severity 1
TBD Contract Work

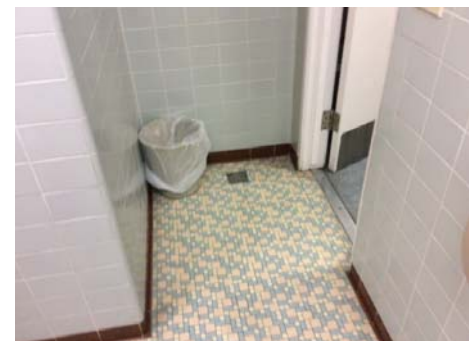
- 2460
- *As-Built Description:*
 Front approach: At pull side, door does not have clear and level maneuvering space measuring door width plus 18" x 60".
 - *As-Built:* 35"
 - *Proposed Solution:*
 Provide relocated new door and frame; remodel walls as needed.

PCODE **ID23BREF**
 ADAAG **Fig. 25(a)**
 ADA 2010 **404.2.4**
 CBC 2010 **11B-26A(a)**
 CBC 2013 **11B-404.2.4**
 Priority **3**
 Severity **2**
TBD Contract Work

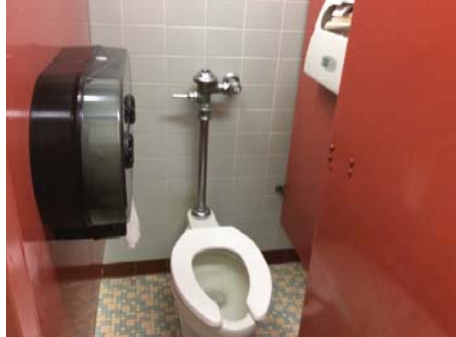
Item No. and Name	Existing Architectural Barrier and Proposed Solution	Codes / Mitigation Info	Qty	Unit	Cost	Total
<u>Toilet Stall</u>						
2461	<ul style="list-style-type: none"> As-Built Description: Toilet stall less than 60" wide. As-Built: 32" Proposed Solution: Provide new accessible stall (alternate stalls 36" x 69" or 48" x 69" not recommended). 	PCODE WB06REF ADAAG 4.17.3 ADA 2010 604.8.1.1 CBC 2010 1115B.3.1.4.1 CBC 2013 11B-604.8.1.1 Priority 3 Severity 1 TBD Contract Work				
						REF

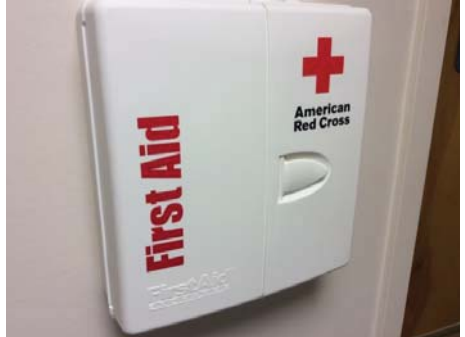
2254	<ul style="list-style-type: none"> As-Built Description: Accessories in sanitary facilities not accessible, hardware requires tight grasping, pinching, or twisting of the wrist. As-Built: First Aid Proposed Solution: Provide accessories with accessible operating mechanism. 	PCODE WG05REF ADAAG 4.27.4 ADA 2010 309.4 CBC 2010 1117B.6 CBC 2013 11B-309.4 Priority 3 Severity 3 TBD Contract Work				
						REF

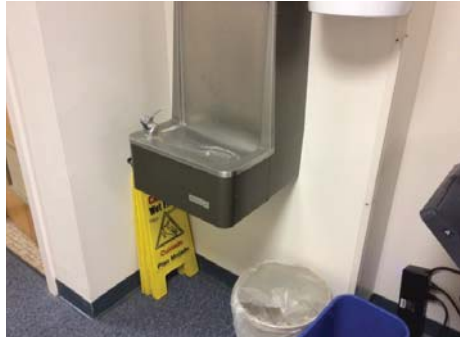
2257	<ul style="list-style-type: none"> As-Built Description: Where only one drinking fountain is provided per floor: Fountain is not accessible to individuals who use wheelchairs, or to those who have difficulty bending or stooping. Proposed Solution: Provide additional fountain or hi-lo combination fountain. 	PCODE IA01A ADAAG 4.1.3(10)(a) ADA 2010 211.1 CBC 2010 1115B.4.6.1 CBC 2013 11B-211.1 Priority 3 Severity 2 TBD Contract Work	1	JOB	\$2,000	\$2,000

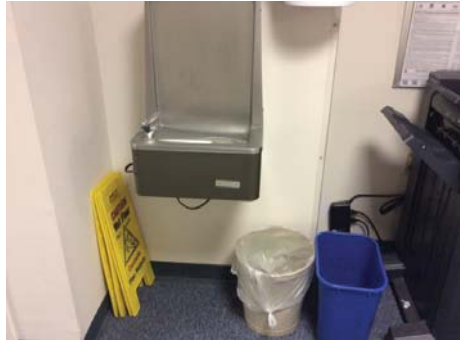
Item No. and Name	Existing Architectural Barrier and Proposed Solution	Codes / Mitigation Info	Qty	Unit	Cost	Total
2256	<ul style="list-style-type: none"> • <i>As-Built Description:</i> Drinking fountain bubbler more than 36" above floor. • <i>As-Built:</i> 38" • <i>Proposed Solution:</i> Provide new, accessible fountain. 	PCODE IA03B ADAAG 4.15.2 ADA 2010 602.4 CBC 2010 1115B.4.6.4 CBC 2013 11B-602.4 Priority 3 Severity 4 TBD Contract Work	1	JOB	\$3,200	\$3,200

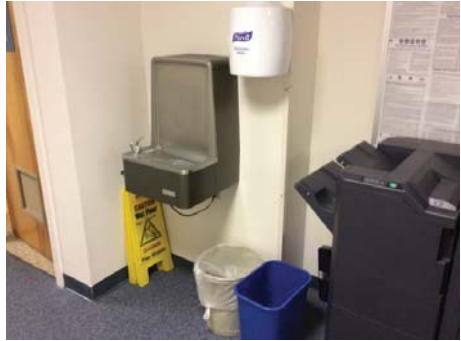
2255	<ul style="list-style-type: none"> • <i>As-Built Description:</i> CA only: Drinking fountain not located in an alcove (min. 32" wide x 18" deep) or otherwise encroaches into pedestrian way. • <i>Proposed Solution:</i> Provide new alcove for drinking fountain, or, if unreasonable hardship is determined, provide wing walls or cane-detectable railings on each side of the drinking fountain. The wings must project out from the supporting wall at least as far as the drinking fountain to within 6" of the surface of the circulation path, but cannot reduce the required clear width of the adjacent accessible route. 	PCODE IA04 CBC 2010 1115B.4.6.3; Fig. CBC 2013 11B-602.9 Priority 3 Severity 2 TBD Contract Work	1	JOB	\$3,000	\$3,000

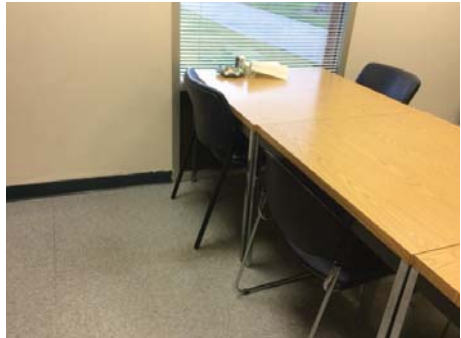
2272	<ul style="list-style-type: none"> • <i>As-Built Description:</i> Accessible non-fixed table or desk (top 28" to 34" high; knee space at least 27" high x 19" deep x 30" wide) not provided. • <i>As-Built:</i> 26.5" • <i>Proposed Solution:</i> Provide table or desk with accessible dimensions when purchasing new furniture. 	PCODE IN02A ADAAG 4.32.3 & .4 ADA 2010 306.1 CBC 2010 1122B.3 & 4 CBC 2013 11B-306.1 & 11B-902.3 Priority 4 Severity 2 TBD Contract Work	1	JOB	\$1,600	\$1,600

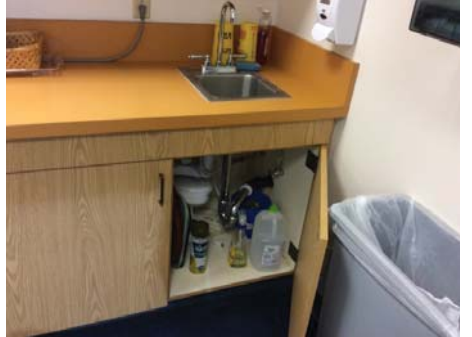
Item No. and Name	Existing Architectural Barrier and Proposed Solution	Codes / Mitigation Info	Qty	Unit	Cost	Total
Sink						
2269	<ul style="list-style-type: none"> As-Built Description: Sink does not have knee space min. 27" high x 19" deep x 30" wide. Proposed Solution: Remodel sink cabinet. 	PCODE IN06A ADAAG 4.24.3 ADA 2010 606.2 CBC 2010 1115B.4.7.1 CBC 2013 11B-606.2 Priority 4 Severity 2 TBD Contract Work	1	JOB	\$1,750	\$1,750

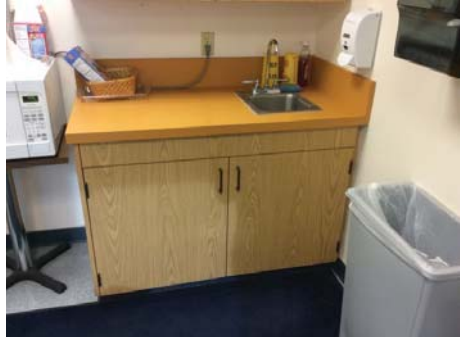
2268	<ul style="list-style-type: none"> As-Built Description: Sink rim higher than 34" above floor. As-Built: 36" Proposed Solution: Remodel sink cabinet to lower sink. 	PCODE IN06REF ADAAG 4.24.2 ADA 2010 606.3 CBC 2010 1115B.4.7.1 CBC 2013 11B-606.3 Priority 4 Severity 4 TBD Contract Work	REF

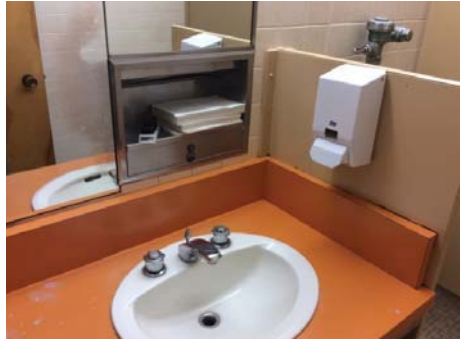
2281	<ul style="list-style-type: none"> As-Built Description: Lavatory: Accessible faucet (lever-operated, push-type or electronically controlled) not provided at otherwise accessible lavatory. Proposed Solution: Provide accessible faucet at accessible lavatory. 	PCODE WD06REF ADAAG 4.19.5 ADA 2010 606.4 CBC 2010 1115B.4.3 CBC 2013 11B-606.4 Priority 4 Severity 3 TBD Contract Work	REF

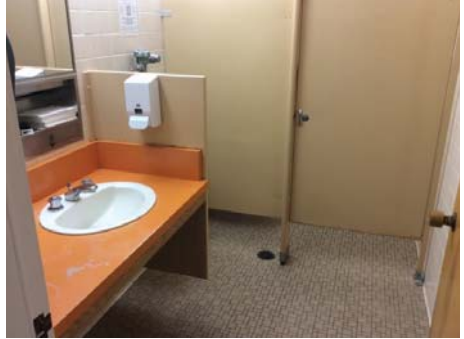
Item No. and Name	Existing Architectural Barrier and Proposed Solution	Codes / Mitigation Info	Qty	Unit	Cost	Total
<u>Restroom</u>						
2277	<ul style="list-style-type: none"> <i>As-Built Description:</i> Single accommodation restroom not accessible; multiple compliance violations. <i>Proposed Solution:</i> Remodel area to provide single-occupant accessible restroom. 	PCODE WA01 ADAAG 4.22 ADA 2010 603 CBC 2010 1115B.3.2 CBC 2013 11B-603 Priority 4 Severity 2 TBD Contract Work	1	JOB	\$30,000	\$30,000

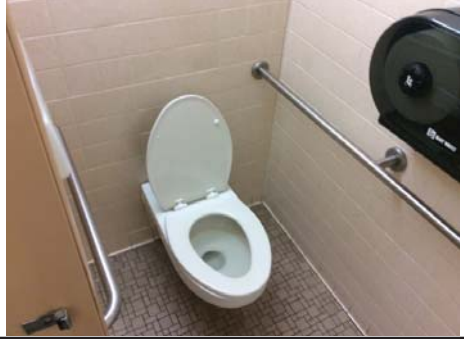
<u>Toilet Stall</u>						
2278	<ul style="list-style-type: none"> <i>As-Built Description:</i> Toilet stall less than 60" wide. <i>As-Built:</i> 37" <i>Proposed Solution:</i> Provide new accessible stall. 	PCODE WB06 ADAAG 4.17.3 ADA 2010 604.8.1.1 CBC 2010 1115B.3.1.4.1 CBC 2013 11B-604.8.1.1 Priority 4 Severity 2 TBD Contract Work	1	JOB	\$1,500	\$1,500

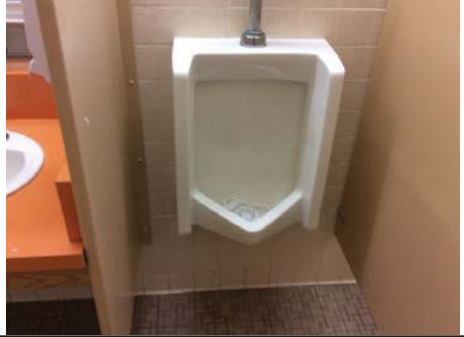
<u>Urinal</u>						
2279	<ul style="list-style-type: none"> <i>As-Built Description:</i> Fixture mounted with rim more than 17" above floor. <i>As-Built:</i> 25" <i>Proposed Solution:</i> Provide accessible urinal. Remodel restroom as needed. 	PCODE WE02REF ADAAG 4.18.2 ADA 2010 605.2 CBC 2010 1115B.4.2.1 CBC 2013 11B-605.2 Priority 4 Severity 2 TBD Contract Work	REF

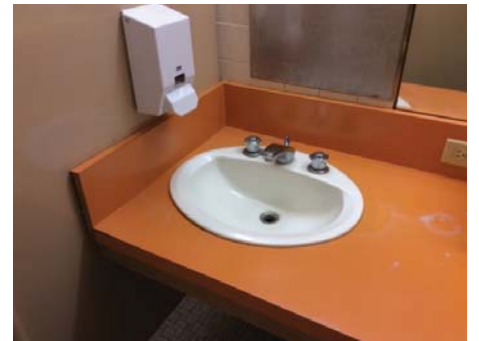
- 2290
- *As-Built Description:*
 Lavatory: Accessible faucet (lever-operated, push-type or electronically controlled) not provided at otherwise accessible lavatory.
 - *Proposed Solution:*
 Provide accessible faucet at accessible lavatory.

PCODE **WD06REF**
 ADAAG **4.19.5**
 ADA 2010 **606.4**
 CBC 2010 **1115B.4.3**
 CBC 2013 **11B-606.4**
 Priority **4**
 Severity **3**
 TBD **Contract Work**

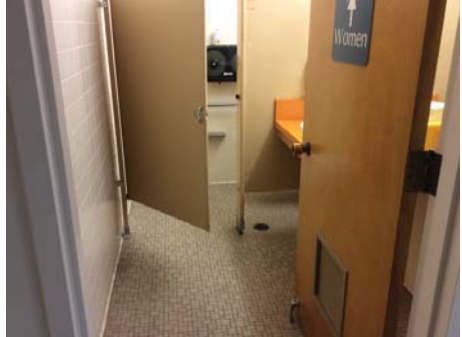
Item No. and Name	Existing Architectural Barrier and Proposed Solution	Codes / Mitigation Info	Qty	Unit	Cost	Total
<u>Restroom</u>						
2287	<ul style="list-style-type: none"> <i>As-Built Description:</i> Multiple accommodation restroom not accessible; multiple compliance violations. <i>Proposed Solution:</i> Remodel area to provide accessible restroom with one accessible stall, lavatory (and one urinal at Mens). 	PCODE WA01A ADAAG 4.22 ADA 2010 603 CBC 2010 1115B.3.1 CBC 2013 11B-603 Priority 4 Severity 1 TBD Contract Work	1	JOB	\$35,000	\$35,000

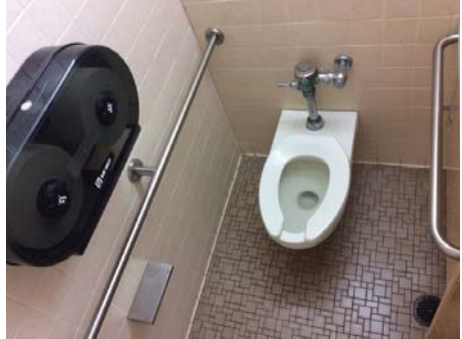
<u>Toilet Stall</u>						
2288	<ul style="list-style-type: none"> <i>As-Built Description:</i> Toilet stall less than 60" wide. <i>As-Built:</i> 37" <i>Proposed Solution:</i> Provide new accessible stall (alternate stalls 36" x 69" or 48" x 69" not recommended). 	PCODE WB06REF ADAAG 4.17.3 ADA 2010 604.8.1.1 CBC 2010 1115B.3.1.4.1 CBC 2013 11B-604.8.1.1 Priority 4 Severity 2 TBD Contract Work	REF

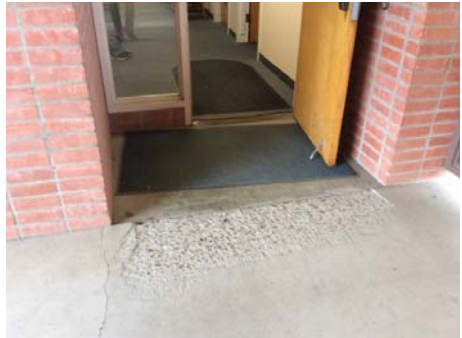
8 Corridor Exit to Building 2

<u>Door</u>						
2296	<ul style="list-style-type: none"> <i>As-Built Description:</i> Surface of required maneuvering clearance at door slopes more than 1/4":12" (2.0%). <i>As-Built:</i> 3.9% at 49" from door <i>Proposed Solution:</i> Modify surface slope at door. 	PCODE ID11 ADAAG 4.13.6 ADA 2010 404.2.4.4 CBC 2010 1133B.2.4 CBC 2013 11B-404.2.4 Priority 2 Severity 4 TBD Contract Work	5	SF	\$40	\$200

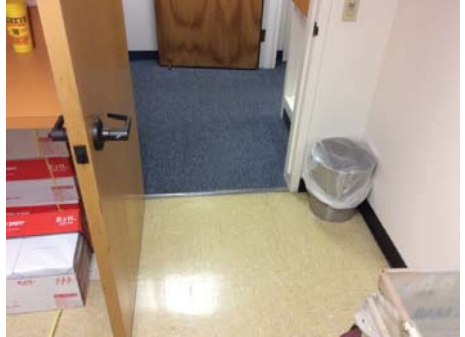
9 Mail Room

Item No. and Name	Existing Architectural Barrier and Proposed Solution	Codes / Mitigation Info	Qty	Unit	Cost	Total
Door Swing						
2301	<ul style="list-style-type: none"> As-Built Description: Front approach: At pull side, door does not have clear and level maneuvering space measuring door width plus 18" x 60". As-Built: 14.5" Proposed Solution: Change door swing from latch to hinge side. 	PCODE ID23 ADAAG Fig. 25(a) ADA 2010 404.2.4 CBC 2010 11B-26A(a) CBC 2013 11B-404.2.4 Priority 2 Severity 4 TBD Contract Work	1	JOB	\$500	\$500

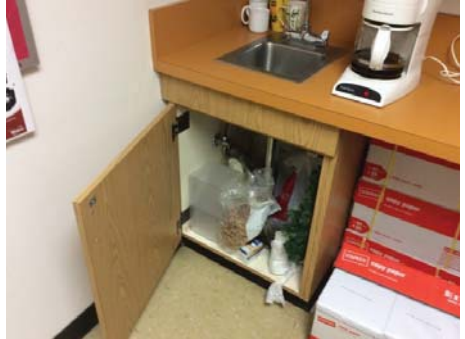
Sink						
2303	<ul style="list-style-type: none"> As-Built Description: Sink does not have knee space min. 27" high x 19" deep x 30" wide. Proposed Solution: Remodel sink cabinet. 	PCODE IN06A ADAAG 4.24.3 ADA 2010 606.2 CBC 2010 1115B.4.7.1 CBC 2013 11B-606.2 Priority 2 Severity 2 TBD Contract Work	1	JOB	\$1,750	\$1,750

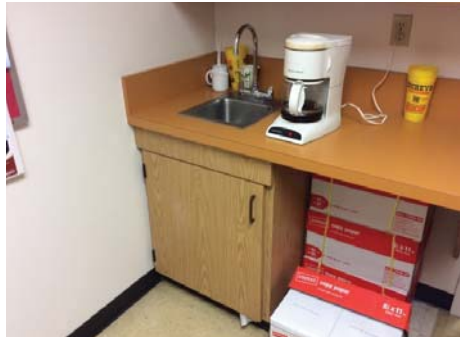
2302	<ul style="list-style-type: none"> As-Built Description: Sink rim higher than 34" above floor. As-Built: 36" Proposed Solution: Remodel sink cabinet to lower sink. 	PCODE IN06REF ADAAG 4.24.2 ADA 2010 606.3 CBC 2010 1115B.4.7.1 CBC 2013 11B-606.3 Priority 3 Severity 4 TBD Contract Work	REF

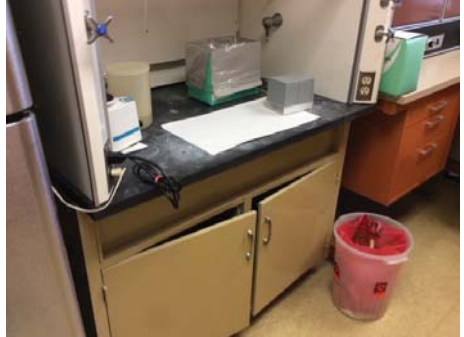
10 Lab

Item No. and Name	Existing Architectural Barrier and Proposed Solution	Codes / Mitigation Info	Qty	Unit	Cost	Total
Counter						
2319	<ul style="list-style-type: none"> <i>As-Built Description:</i> Accessible counter (top 28" to 34" high; knee space at least 27" high x 19" deep x 30" wide) not provided. <i>As-Built:</i> Fume hood. 36.5" <i>Proposed Solution:</i> Provide new section of counter at 34" high max. 	PCODE IN02B ADAAG 4.32.3 & .4 ADA 2010 902.3 CBC 2010 1122B.3 & 4 CBC 2013 11B-902.3 Priority 2 Severity 2 TBD Contract Work	1	JOB	\$2,500	\$2,500

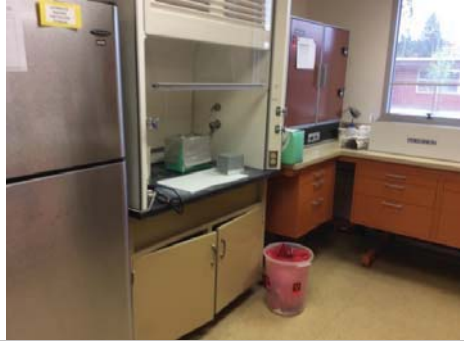
Lab						
2318	<ul style="list-style-type: none"> <i>As-Built Description:</i> Minimum of at least one of each type of sink and other specialized equipment such as fume hoods, microscopes, emergency eyewash and showers, etc, associated with the special use activity is not accessible. <i>Proposed Solution:</i> Remodel existing cabinet/counter to make specialized equipment accessible to disabled persons. 	PCODE LB01B CBC 2010 1106B.2 CBC 2013 11B-805.7 Priority 2 Severity 3 TBD Contract Work	1	JOB	\$1,800	\$1,800

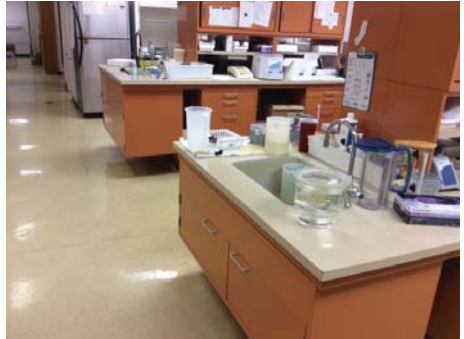
Sink						
2317	<ul style="list-style-type: none"> <i>As-Built Description:</i> Sink does not have knee space min. 27" high x 19" deep x 30" wide. <i>Proposed Solution:</i> Remodel sink cabinet. 	PCODE IN06A ADAAG 4.24.3 ADA 2010 606.2 CBC 2010 1115B.4.7.1 CBC 2013 11B-606.2 Priority 2 Severity 2 TBD Contract Work	1	JOB	\$1,750	\$1,750

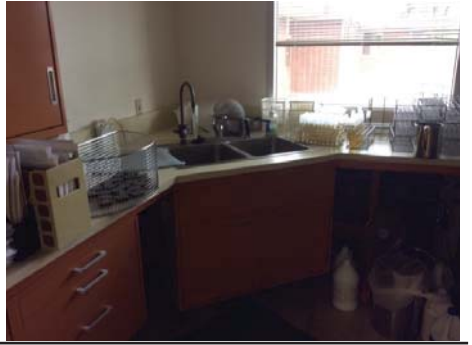
Item No. and Name	Existing Architectural Barrier and Proposed Solution	Codes / Mitigation Info	Qty	Unit	Cost	Total
2321	<ul style="list-style-type: none"> <i>As-Built Description:</i> Sink does not have knee space min. 27" high x 19" deep x 30" wide. <i>Proposed Solution:</i> Remodel sink cabinet. 	PCODE IN06A ADAAG 4.24.3 ADA 2010 606.2 CBC 2010 1115B.4.7.1 CBC 2013 11B-606.2 Priority 2 Severity 2 TBD Contract Work	1	JOB	\$1,750	\$1,750

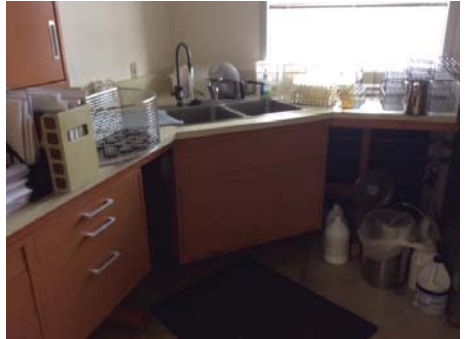
2322	<ul style="list-style-type: none"> <i>As-Built Description:</i> Sink rim higher than 34" above floor. <i>As-Built:</i> 37.5" <i>Proposed Solution:</i> Remodel sink cabinet to lower sink. 	PCODE IN06REF ADAAG 4.24.2 ADA 2010 606.3 CBC 2010 1115B.4.7.1 CBC 2013 11B-606.3 Priority 3 Severity 4 TBD Contract Work				REF

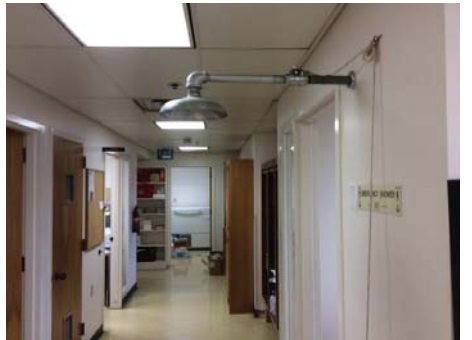
Vertical Clearance

2320	<ul style="list-style-type: none"> <i>As-Built Description:</i> Overhead clearance less than 80" above finished floor. <i>As-Built:</i> Emergency shower. 78.5" <i>Proposed Solution:</i> Modify overhead clearance. 	PCODE EG01 ADAAG 4.4.2 ADA 2010 307.4 CBC 2010 1133B.8.6.2 CBC 2013 11B-307.4 Priority 2 Severity 2 TBD Contract Work	1	JOB	\$120	\$120

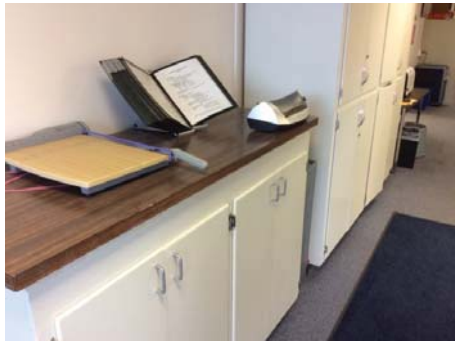
11 Nurses Offices - Staff Only

Item No. and Name	Existing Architectural Barrier and Proposed Solution	Codes / Mitigation Info	Qty	Unit	Cost	Total
Counter						
2340	<ul style="list-style-type: none"> <i>As-Built Description:</i> Accessible counter (top 28" to 34" high; knee space at least 27" high x 19" deep x 30" wide) not provided. <i>As-Built:</i> 42" <i>Proposed Solution:</i> Provide new section of counter at 34" high max. <i>Notes:</i> Staff Only 	PCODE IN02B ADAAG 4.32.3 & .4 ADA 2010 902.3 CBC 2010 1122B.3 & 4 CBC 2013 11B-902.3 Priority 4 Severity 3 TBD Contract Work	1	JOB	\$2,500	\$2,500

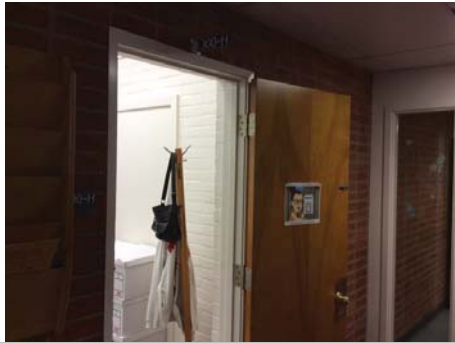
Door Clearance						
2336	<ul style="list-style-type: none"> <i>As-Built Description:</i> Door on accessible route has less than 32" clear and 80" (78" min. to closer if provided) opening width when 90° open. <i>As-Built:</i> 29" wide <i>Proposed Solution:</i> Provide new, larger door and frame with new accessible hardware. <i>Notes:</i> Room 300-H only 	PCODE ID01 ADAAG 4.13.5 ADA 2010 404.2.3 CBC 2010 1133B.1.1.1.1 CBC 2013 11B-404.2.3 Priority 4 Severity 3 TBD Contract Work	1	JOB	\$2,600	\$2,600

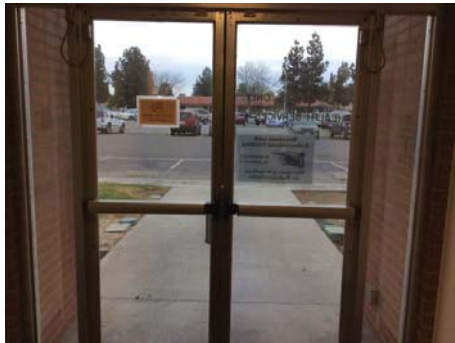
Door Pair						
2333	<ul style="list-style-type: none"> <i>As-Built Description:</i> Pair of doors on accessible route has less than 32" clear opening width with one leaf open 90°. <i>As-Built:</i> 26.5" <i>Proposed Solution:</i> Provide new door leaves, unequal in width, to existing frame for pair of doors. 	PCODE ID08A ADAAG 4.13.4 ADA 2010 404.2.2 CBC 2010 1133B.2.3.1 CBC 2013 11B-404.2.2 Priority 4 Severity 2 TBD Contract Work	1	JOB	\$1,500	\$1,500

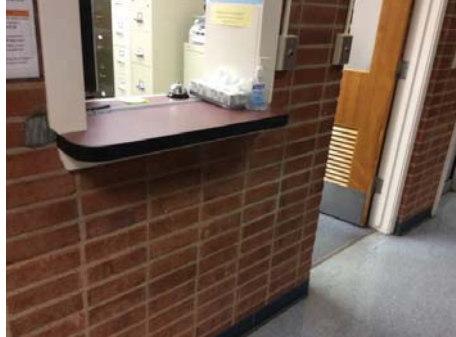
12 Nurses Offices Lobby

Item No. and Name	Existing Architectural Barrier and Proposed Solution	Codes / Mitigation Info	Qty	Unit	Cost	Total
<u>Public Counter</u>						
2343	<ul style="list-style-type: none"> • <i>As-Built Description:</i> Service counter (stand-up): Accessible section min. 36" length and 36" max. height (in CA: 28" to 34" high) not provided. • <i>As-Built:</i> 43.25" • <i>Proposed Solution:</i> Provide auxiliary shelf, clipboard, or table as equivalent facilitation. 	PCODE IN03 ADAAG 7.2(2) ADA 2010 904.4 CBC 2010 1122B.4 CBC 2013 11B-904.4 Priority 1 Severity 3 TBD Contract Work	1	JOB	\$150	\$150

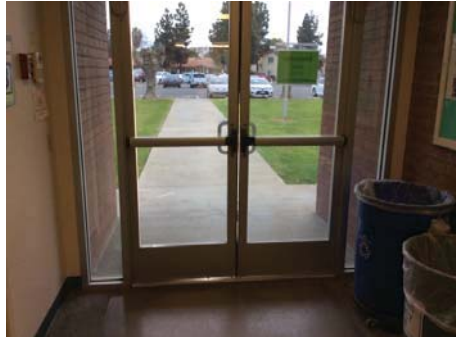
13 Staff Corridor Medical Records

<u>Door Pair</u>						
2355	<ul style="list-style-type: none"> • <i>As-Built Description:</i> Pair of doors on accessible route has less than 32" clear opening width with one leaf open 90°. • <i>As-Built:</i> 27" • <i>Proposed Solution:</i> Provide new door leaves, unequal in width, to existing frame for pair of doors. 	PCODE ID08A ADAAG 4.13.4 ADA 2010 404.2.2 CBC 2010 1133B.2.3.1 CBC 2013 11B-404.2.2 Priority 1 Severity 2 TBD Contract Work	1	JOB	\$1,500	\$1,500

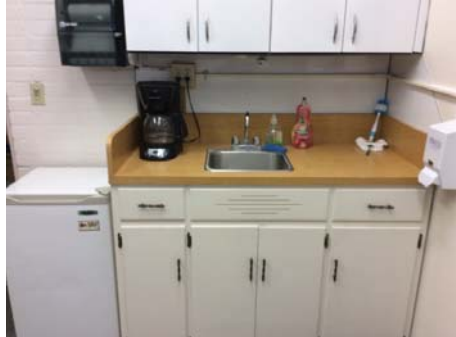
14 Breastfeeding Lounge

<u>Sink</u>						
2362	<ul style="list-style-type: none"> • <i>As-Built Description:</i> Sink rim higher than 34" above floor. • <i>As-Built:</i> 39" • <i>Proposed Solution:</i> Remodel sink cabinet to lower sink. 	PCODE IN06 ADAAG 4.24.2 ADA 2010 606.3 CBC 2010 1115B.4.7.1 CBC 2013 11B-606.3 Priority 3 Severity 4 TBD Contract Work	1	JOB	\$1,750	\$1,750

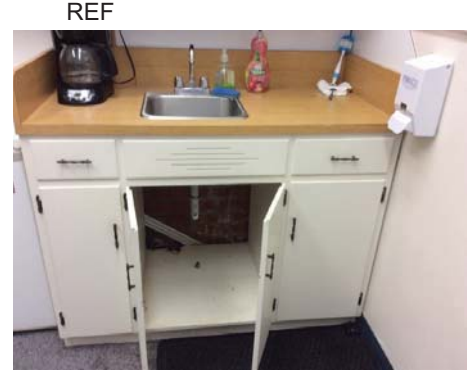
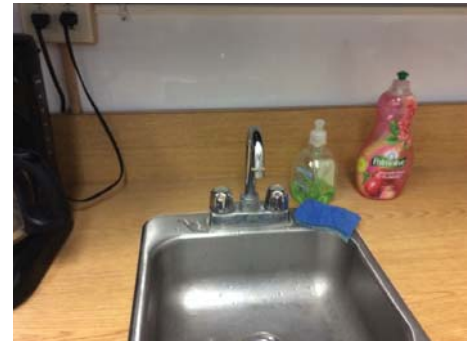
Item No. and Name	Existing Architectural Barrier and Proposed Solution	Codes / Mitigation Info	Qty	Unit	Cost	Total
2363	<ul style="list-style-type: none"> • <i>As-Built Description:</i> Sink does not have knee space min. 27" high x 19" deep x 30" wide. • <i>Proposed Solution:</i> Remodel sink cabinet. 	PCODE IN06AREF ADAAG 4.24.3 ADA 2010 606.2 CBC 2010 1115B.4.7.1 CBC 2013 11B-606.2 Priority 2 Severity 2 TBD Contract Work				
2364	<ul style="list-style-type: none"> • <i>As-Built Description:</i> Sink faucet controls not accessible. • <i>Proposed Solution:</i> Provide accessible sink faucet controls. 	PCODE IN07 ADAAG 4.24.7 ADA 2010 606.4 CBC 2010 1115B.4.7.1 CBC 2013 11B-606.4 Priority 3 Severity 2 TBD Contract Work	1	JOB	\$600	\$600

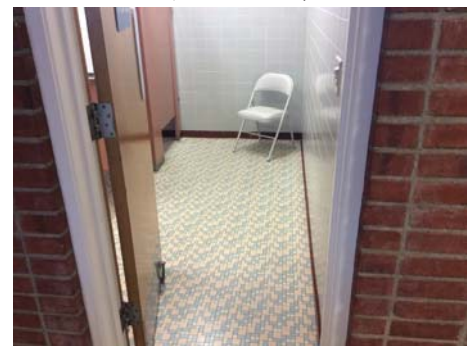
Door Clearance

2370	<ul style="list-style-type: none"> • <i>As-Built Description:</i> Door on accessible route has less than 32" clear and 80" (78" min. to closer if provided) opening width when 90° open. • <i>As-Built:</i> 27" • <i>Proposed Solution:</i> Provide new, larger door and frame with new accessible hardware. 	PCODE ID01 ADAAG 4.13.5 ADA 2010 404.2.3 CBC 2010 1133B.1.1.1.1 CBC 2013 11B-404.2.3 Priority 4 Severity 2 TBD Contract Work	1	JOB	\$2,600	\$2,600

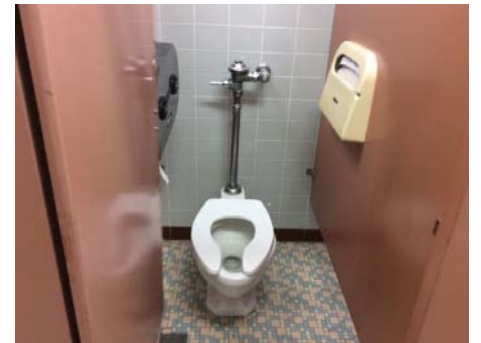
<u>Restroom</u>						
2371	<ul style="list-style-type: none"> As-Built Description: Multiple accommodation restroom not accessible; multiple compliance violations. As-Built: 32" wide Proposed Solution: Remodel area to provide accessible restroom with one accessible stall, lavatory (and one urinal at Mens). 	PCODE WA01A ADAAG 4.22 ADA 2010 603 CBC 2010 1115B.3.1 CBC 2013 11B-603 Priority 4 Severity 1 TBD Contract Work	1	JOB	\$35,000	\$35,000

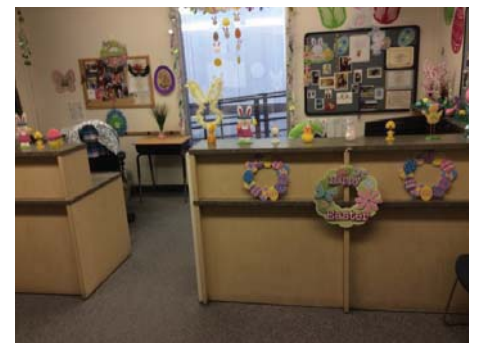
17 CD Office

<u>Public Counter</u>						
2378	<ul style="list-style-type: none"> As-Built Description: Service counter (stand-up): Accessible section min. 36" length and 36" max. height (in CA: 28" to 34" high) not provided. As-Built: 42" Proposed Solution: Provide auxiliary shelf, clipboard, or table as equivalent facilitation. Notes: Staff Only 	PCODE IN03 ADAAG 7.2(2) ADA 2010 904.4 CBC 2010 1122B.4 CBC 2013 11B-904.4 Priority 4 Severity 3 TBD Contract Work	1	JOB	\$150	\$150

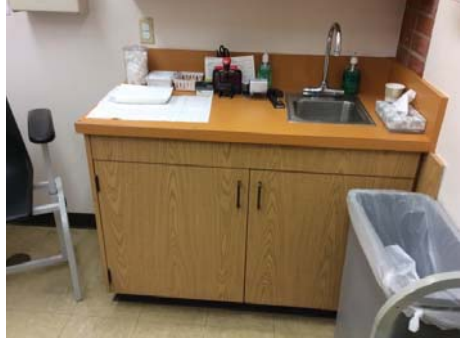
19 Exam Room 304

Item No. and Name	Existing Architectural Barrier and Proposed Solution	Codes / Mitigation Info	Qty	Unit	Cost	Total
Sink						
2388	<ul style="list-style-type: none"> As-Built Description: Sink rim higher than 34" above floor. As-Built: 36" Proposed Solution: Remodel sink cabinet to lower sink. Notes: Staff Only 	PCODE IN06 ADAAG 4.24.2 ADA 2010 606.3 CBC 2010 1115B.4.7.1 CBC 2013 11B-606.3 Priority 4 Severity 4 TBD Contract Work	1	JOB	\$1,750	\$1,750

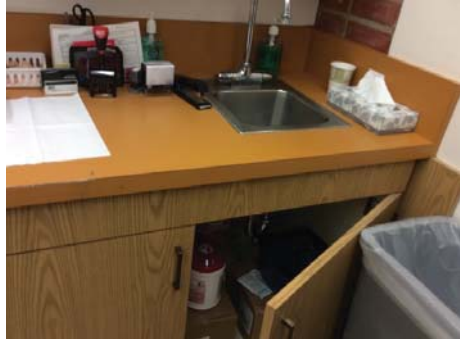
2389	<ul style="list-style-type: none"> As-Built Description: Sink does not have knee space min. 27" high x 19" deep x 30" wide. Proposed Solution: Remodel sink cabinet. Notes: Staff Only 	PCODE IN06AREF ADAAG 4.24.3 ADA 2010 606.2 CBC 2010 1115B.4.7.1 CBC 2013 11B-606.2 Priority 4 Severity 2 TBD Contract Work				
			REF

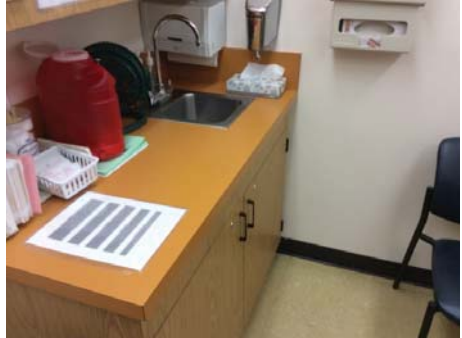
20 Exam Room 306 - Check Up

Sink						
2395	<ul style="list-style-type: none"> As-Built Description: Sink does not have knee space min. 27" high x 19" deep x 30" wide. Proposed Solution: Remodel sink cabinet. Notes: Staff Only 	PCODE IN06A ADAAG 4.24.3 ADA 2010 606.2 CBC 2010 1115B.4.7.1 CBC 2013 11B-606.2 Priority 4 Severity 2 TBD Contract Work	1	JOB	\$1,750	\$1,750

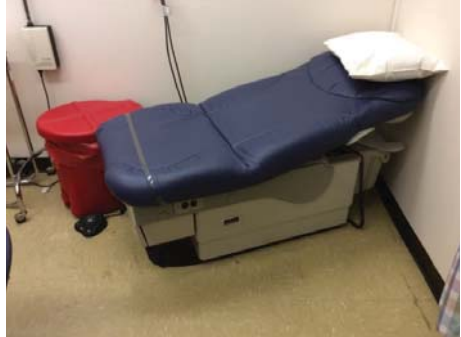
22 Exam Room 312

Item No. and Name	Existing Architectural Barrier and Proposed Solution	Codes / Mitigation Info	Qty	Unit	Cost	Total
<u>Exam Bed</u>						
2403	<ul style="list-style-type: none"> <i>As-Built Description:</i> Seat front edge height is not between 17" min. to 19" max. above ground of floor space. <i>As-Built:</i> 24" <i>Proposed Solution:</i> Provide transfer or lift beds in designated accessible exam rooms. <i>Notes:</i> Provide existing adjustable bed in accessible room. 	PCODE NO06ANT ADAAG 4.37.5 ADA 2010 903.5 CBC 2010 1132B.1 CBC 2013 11B-903.5 Priority 2 Severity 2 TBD Contract Work	1	JOB	\$600	\$600

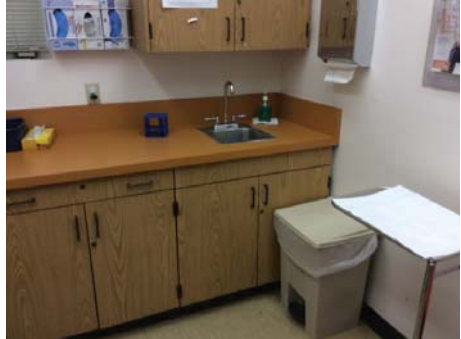
<u>Sink</u>						
2401	<ul style="list-style-type: none"> <i>As-Built Description:</i> Sink does not have knee space min. 27" high x 19" deep x 30" wide. <i>As-Built:</i> Top 36" AFF <i>Proposed Solution:</i> Remodel sink cabinet. <i>Notes:</i> Top 36" AFF. Staff Only 	PCODE IN06A ADAAG 4.24.3 ADA 2010 606.2 CBC 2010 1115B.4.7.1 CBC 2013 11B-606.2 Priority 4 Severity 2 TBD Contract Work	1	JOB	\$1,750	\$1,750

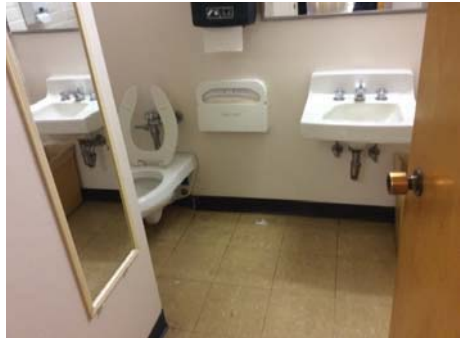
23 Unisex Restroom

<u>Restroom</u>						
2406	<ul style="list-style-type: none"> <i>As-Built Description:</i> Single accommodation restroom not accessible; multiple compliance violations. <i>Proposed Solution:</i> Remodel area to provide single-occupant accessible restroom. 	PCODE WA01 ADAAG 4.22 ADA 2010 603 CBC 2010 1115B.3.2 CBC 2013 11B-603 Priority 3 Severity 2 TBD Contract Work	1	JOB	\$30,000	\$30,000

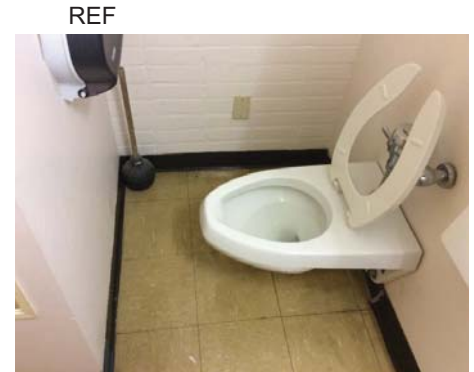
Item No. and Name	Existing Architectural Barrier and Proposed Solution	Codes / Mitigation Info	Qty	Unit	Cost	Total
<u>Water Closet</u>						
2407	<ul style="list-style-type: none"> <i>As-Built Description:</i> CA only: In single-accommodation restroom less than 48" in front of water closet provided. <i>As-Built:</i> 12.5" <i>Proposed Solution:</i> Remodel restroom to provide at least 48" in front of water closet. 	PCODE WB03AREF CBC 2010 1115B.3.2.1 CBC 2013 11B-604.3.1 Priority 3 Severity 1 TBD Contract Work

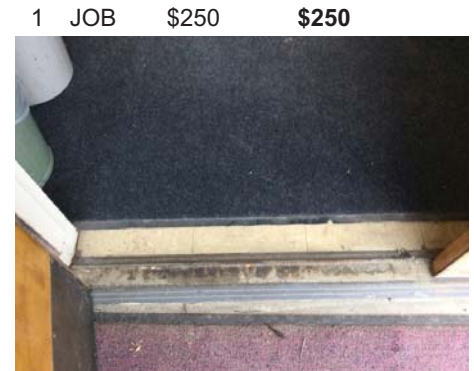
24 Corridor to Lab

<u>Door Threshold</u>						
2422	<ul style="list-style-type: none"> <i>As-Built Description:</i> Existing threshold at door is 1/2" high or less but without a beveled edge on both sides. <i>As-Built:</i> 0.5" <i>Proposed Solution:</i> Modify threshold to have beveled edge on each side. 	PCODE ID02 ADAAG 4.1.6(3)(d)(ii) ADA 2010 404.2.5 CBC 2010 1133B.2.4.1 CBC 2013 11B-404.2.5 Priority 2 Severity 4 TBD Contract Work

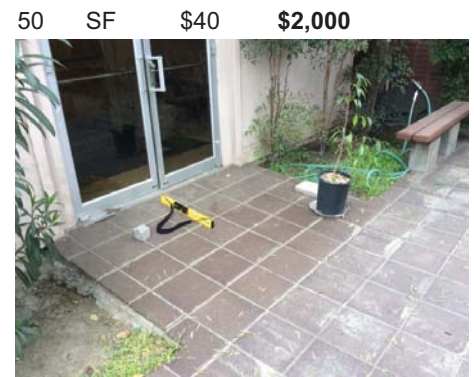
25 Patio

<u>Door</u>						
2427	<ul style="list-style-type: none"> <i>As-Built Description:</i> Surface of required maneuvering clearance at door slopes more than 1/4":12" (2.0%). <i>As-Built:</i> 8.1% <i>Proposed Solution:</i> Modify surface slope at door. 	PCODE ID11 ADAAG 4.13.6 ADA 2010 404.2.4.4 CBC 2010 1133B.2.4 CBC 2013 11B-404.2.4 Priority 2 Severity 2 TBD Contract Work

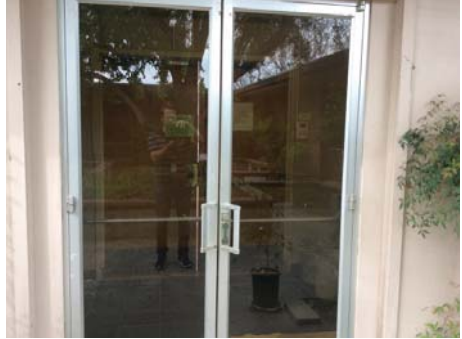
Item No. and Name	Existing Architectural Barrier and Proposed Solution	Codes / Mitigation Info	Qty	Unit	Cost	Total
<u>Door Pair</u>						
2425	<ul style="list-style-type: none"> <i>As-Built Description:</i> Pair of doors on accessible route has less than 32" clear opening width with one leaf open 90°. <i>As-Built:</i> 27" <i>Proposed Solution:</i> Provide new door leaves, unequal in width, to existing frame for pair of doors. 	PCODE ID08A ADAAG 4.13.4 ADA 2010 404.2.2 CBC 2010 1133B.2.3.1 CBC 2013 11B-404.2.2 Priority 1 Severity 2 TBD Contract Work	1	JOB	\$1,500	\$1,500

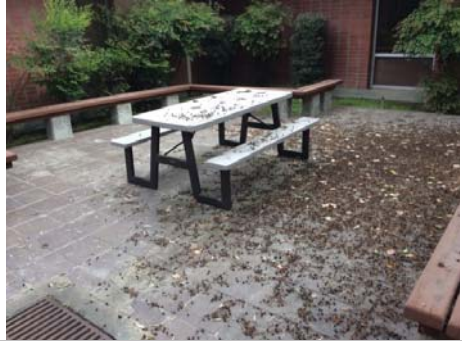
<u>Picnic Area</u>						
2428	<ul style="list-style-type: none"> <i>As-Built Description:</i> Knee clearance at minimums 27" high, 30" wide, and 19" deep is not provided. <i>As-Built:</i> 4.5" deep <i>Proposed Solution:</i> Modify picnic table as required to provide knee clearance. 	PCODE NH11A ADAAG 16.5.4. ADA 2010 902.2 CBC 2010 1132B.1 CBC 2013 11-902.2 Priority 2 Severity 2 TBD Contract Work	1	JOB	\$850	\$850

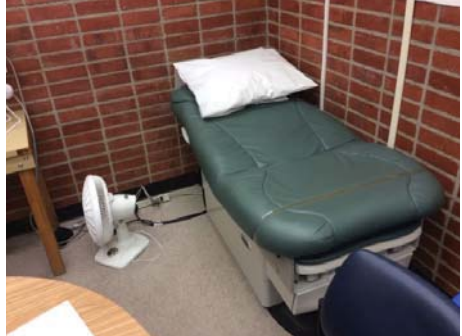
26 Negative Pressure Room

<u>Exam Bed</u>						
2434	<ul style="list-style-type: none"> <i>As-Built Description:</i> Seat front edge height is not between 17" min. to 19" max. above ground of floor space. <i>As-Built:</i> 27" <i>Proposed Solution:</i> Provide transfer or lift beds in designated accessible exam rooms. 	PCODE NO06ANT ADAAG 4.37.5 ADA 2010 903.5 CBC 2010 1132B.1 CBC 2013 11B-903.5 Priority 2 Severity 1 TBD Contract Work	1	JOB	\$600	\$600

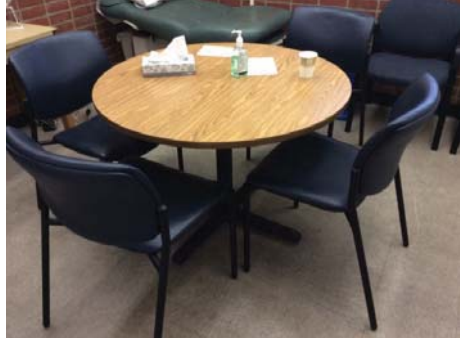
Item No. and Name	Existing Architectural Barrier and Proposed Solution	Codes / Mitigation Info	Qty	Unit	Cost	Total
<u>Non-Fixed Desk</u>						
2431	<ul style="list-style-type: none"> <i>As-Built Description:</i> Accessible non-fixed table or desk (top 28" to 34" high; knee space at least 27" high x 19" deep x 30" wide) not provided. <i>As-Built:</i> due to table leg <i>Proposed Solution:</i> Provide table or desk with accessible dimensions when purchasing new furniture. 	PCODE IN02A ADAAG 4.32.3 & .4 ADA 2010 306.1 CBC 2010 1122B.3 & 4 CBC 2013 11B-306.1 & 11B-902.3 Priority 2 Severity 2 TBD Contract Work	1	JOB	\$1,600	\$1,600

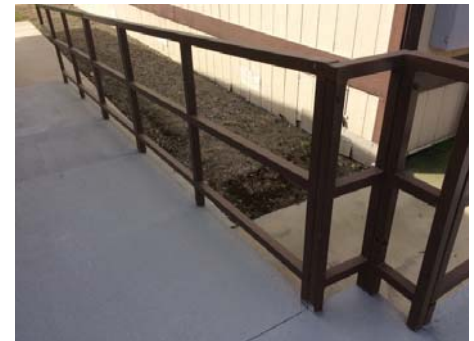
- 2733
- *As-Built Description:*
No curb (2" minimum height) or wheel guide (centered approx. 3" above surface of ramp) at sides of ramp.
 - *As-Built:* 5"-6.5" o.c.
 - *Proposed Solution:*
Provide 2" minimum curb or wheel guide.

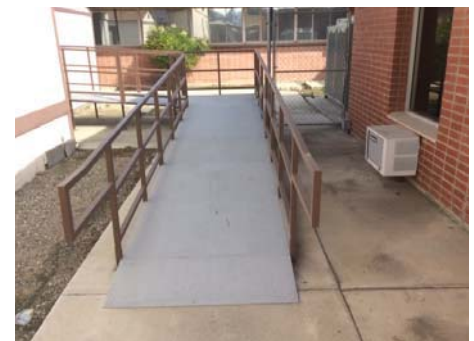
- 2732
- *As-Built Description:*
Slope greater than 1:12 (8.3%).
 - *As-Built:* 8.7%-18.5% at lower ramp
 - *Proposed Solution:*
Demolish existing and provide new ramp with handrails.
 - *Notes:*
Provide longer ramp and extend handrails

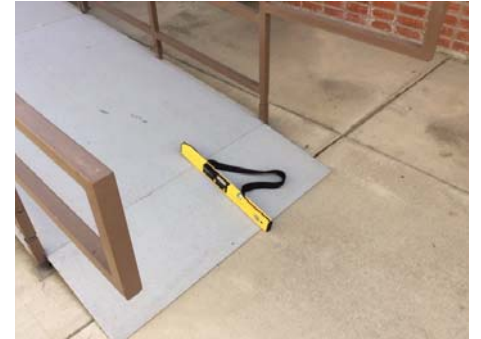
Item No. and Name	Existing Architectural Barrier and Proposed Solution	Codes / Mitigation Info	Qty	Unit	Cost	Total
2731	<ul style="list-style-type: none"> <i>As-Built Description:</i> Slope greater than 1:12 (8.3%). <i>As-Built:</i> Transition at bottom: 18.5% <i>Proposed Solution:</i> Demolish existing and provide new ramp with handrails. 	PCODE EB02REF ADAAG 4.8.2 ADA 2010 405.2 CBC 2010 1133B.5.3 CBC 2013 11B-405.2 Priority 1 Severity 2 TBD Contract Work				
						REF

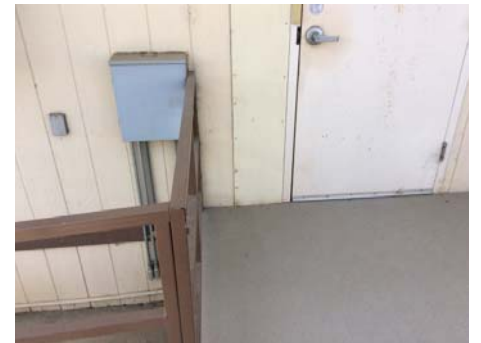
2734	<ul style="list-style-type: none"> <i>As-Built Description:</i> Ramp handrail does not extend horizontally 12" past top and / or bottom of ramp. <i>Proposed Solution:</i> Provide ramp handrail extension (cost for each extension piece). <i>Notes:</i> Remodel area. 	PCODE ED05REF ADAAG 4.8.5(2) ADA 2010 505.10.1 CBC 2010 1133B.4.2.2 & CBC 2013 11B-505.10.1 Priority 1 Severity 2 TBD Contract Work				
						REF

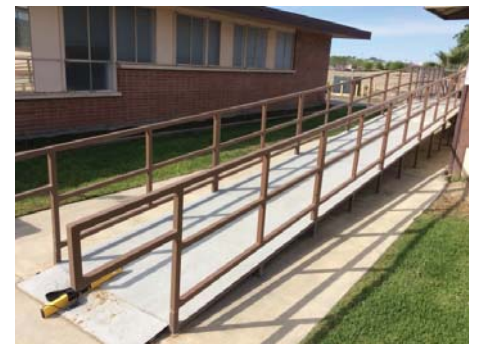
2 South Entrance

2737	<ul style="list-style-type: none"> <i>As-Built Description:</i> No curb (2" minimum height) or wheel guide (centered approx. 3" above surface of ramp) at sides of ramp. <i>As-Built:</i> 5.5" o.c. <i>Proposed Solution:</i> Provide 2" minimum curb or wheel guide. 	PCODE EB14 ADAAG 4.8.7 ADA 2010 405.9.2 CBC 2010 1133B.5.6 CBC 2013 11B-405.9.2 Priority 1 Severity 2 TBD Contract Work	60	LF	\$17	\$1,020
------	--	--	----	----	------	---------

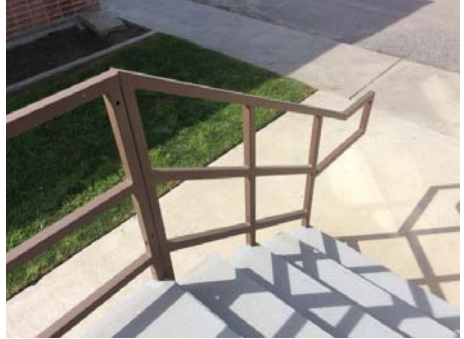
Item No. and Name	Existing Architectural Barrier and Proposed Solution	Codes / Mitigation Info	Qty	Unit	Cost	Total
Height						
2740	<ul style="list-style-type: none"> As-Built Description: Handrail gripping surface top not mounted between 34" and 38" above ramp surface or stair nosings. As-Built: 33" at top Proposed Solution: Remove existing and provide new handrail. 	PCODE ED02 ADAAG 4.9.4(5) ADA 2010 505.4 CBC 2010 1133B.4.2.1 & CBC 2013 11B-505.4 Priority 4 Severity 4 TBD Contract Work	12	LF	\$75	\$900

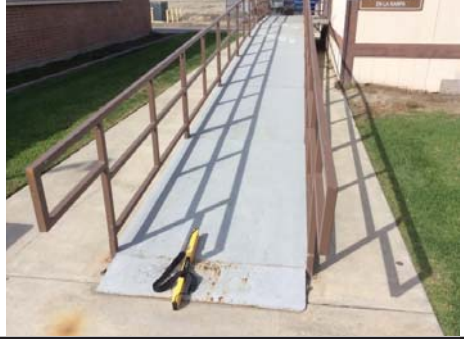
Slope						
2736	<ul style="list-style-type: none"> As-Built Description: Slope greater than 1:12 (8.3%). As-Built: 11.5% at transition Proposed Solution: Demolish existing and provide new ramp with handrails. 	PCODE EB02 ADAAG 4.8.2 ADA 2010 405.2 CBC 2010 1133B.5.3 CBC 2013 11B-405.2 Priority 1 Severity 3 TBD Contract Work	12	SF	\$50	\$600

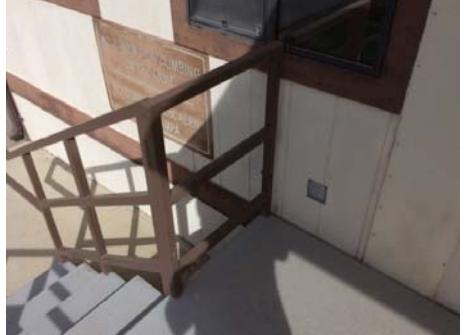
Top & Bottom Extension at Stairs						
2741	<ul style="list-style-type: none"> As-Built Description: Stair handrail does not extend horizontally 12" minimum beyond top nosing, and one tread width sloped, plus 12" minimum horizontally beyond the bottom nosing. Proposed Solution: Extend stair handrail at top and bottom (cost for each extension piece). 	PCODE ED06 ADAAG 4.9.4(2) ADA 2010 505.10.2; 505.10.3 CBC 2010 1133B.4.2.2 CBC 2013 11B-505.10.2; 11B-505.10.3 Priority 4 Severity 2 TBD Contract Work	1	JOB	\$170	\$170

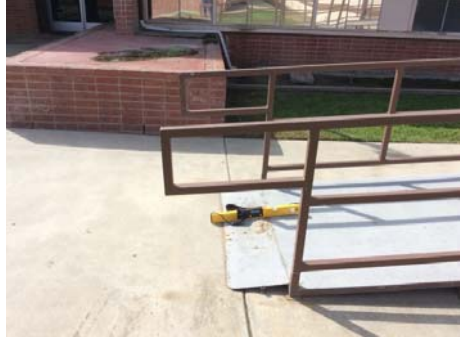
2738	<ul style="list-style-type: none"> <i>As-Built Description:</i> Ramp handrail does not extend horizontally 12" past top and / or bottom of ramp. <i>As-Built:</i> not horizontal <i>Proposed Solution:</i> Provide ramp handrail extension (cost for each extension piece). 	PCODE ED05 ADAAG 4.8.5(2) ADA 2010 505.10.1 CBC 2010 1133B.4.2.2 & CBC 2013 11B-505.10.1 Priority 1 Severity 4 TBD Contract Work	1	JOB	\$170	\$170

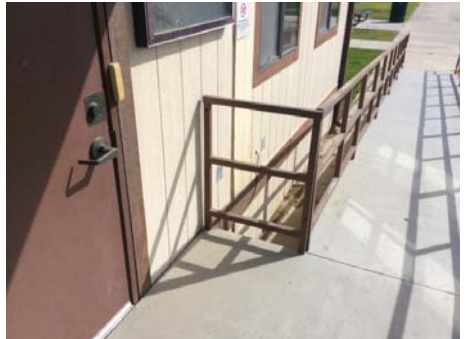
2742	<ul style="list-style-type: none"> <i>As-Built Description:</i> Ramp handrail does not extend horizontally 12" past top and / or bottom of ramp. <i>Proposed Solution:</i> Provide ramp handrail extension (cost for each extension piece). <i>Notes:</i> Cannot extend without obstructing door clearance. 	PCODE ED05REF ADAAG 4.8.5(2) ADA 2010 505.10.1 CBC 2010 1133B.4.2.2 & CBC 2013 11B-505.10.1 Priority 1 Severity 2 TBD Contract Work		REF

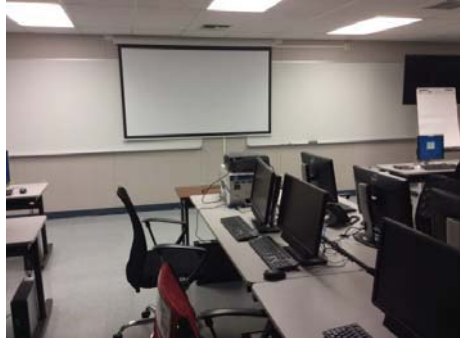
3 EOC Main Room

2707	<ul style="list-style-type: none"> <i>As-Built Description:</i> No portable assistive listening system provided for small meeting room. <i>Proposed Solution:</i> Share existing portable assistive listening system from other facility if needed. 	PCODE GI01E ADAAG 4.1.3(19)(b) & 4.33.7 ADA 2010 219.1 & 706.1 CBC 2010 1104B.2 CBC 2013 11B-219.2 Priority 3 Severity 3 TBD Contract Work		REF

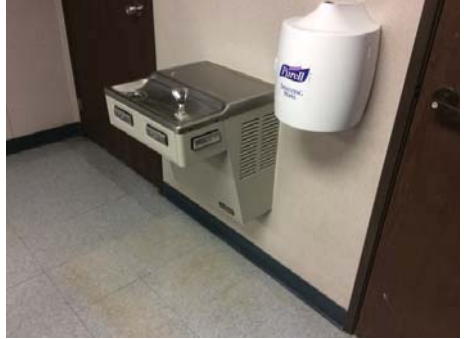
Item No. and Name	Existing Architectural Barrier and Proposed Solution	Codes / Mitigation Info	Qty	Unit	Cost	Total
<u>Drinking Fountain</u>						
2710	<ul style="list-style-type: none"> <i>As-Built Description:</i> Where only one drinking fountain is provided per floor: Fountain is not accessible to individuals who use wheelchairs, or to those who have difficulty bending or stooping. <i>Proposed Solution:</i> Provide additional fountain or hi-lo combination fountain. 	PCODE IA01A ADAAG 4.1.3(10)(a) ADA 2010 211.1 CBC 2010 1115B.4.6.1 CBC 2013 11B-211.1 Priority 3 Severity 2 TBD Contract Work	1	JOB	\$2,000	\$2,000

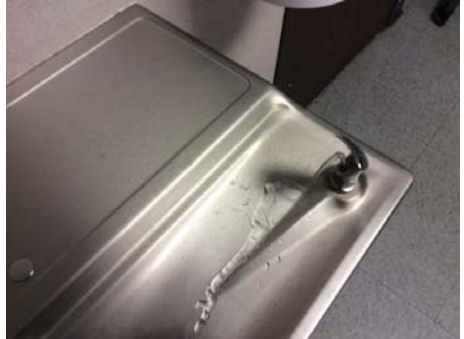
2711	<ul style="list-style-type: none"> <i>As-Built Description:</i> Drinking fountain water flow less than 4" high; unit in good condition. <i>As-Built:</i> 1" <i>Proposed Solution:</i> Adjust water flow. 	PCODE IA03D ADAAG 4.15.3 ADA 2010 602.6 CBC 2010 1115B.4.6.5 CBC 2013 11B-602.6 Priority 3 Severity 3 TBD Contract Work	1	JOB	\$75	\$75

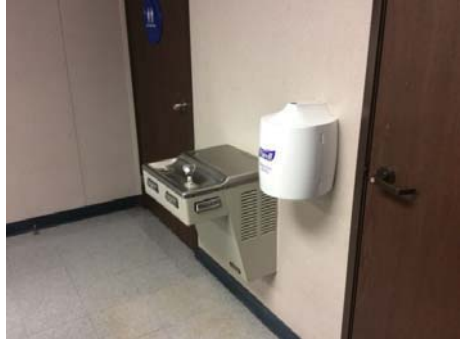
2709	<ul style="list-style-type: none"> <i>As-Built Description:</i> CA only: Drinking fountain not located in an alcove (min. 32" wide x 18" deep) or otherwise encroaches into pedestrian way. <i>Proposed Solution:</i> Provide new alcove for drinking fountain, or, if unreasonable hardship is determined, provide wing walls or cane-detectable railings on each side of the drinking fountain. The wings must project out from the supporting wall at least as far as the drinking fountain to within 6" of the surface of the circulation path, but cannot reduce the required clear width of the adjacent accessible route. 	PCODE IA04 CBC 2010 1115B.4.6.3; Fig. CBC 2013 11B-602.9 Priority 3 Severity 2 TBD Contract Work	1	JOB	\$3,000	\$3,000

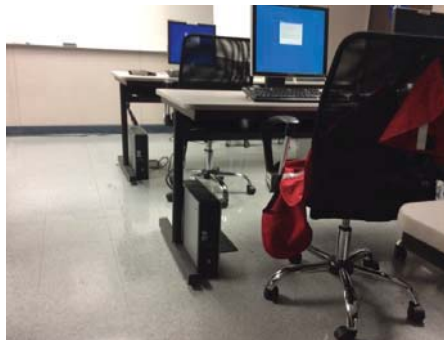
Item No. and Name	Existing Architectural Barrier and Proposed Solution	Codes / Mitigation Info	Qty	Unit	Cost	Total
<u>Non-Fixed Desk</u>						
2708	<ul style="list-style-type: none"> <i>As-Built Description:</i> Accessible non-fixed table or desk (top 28" to 34" high; knee space at least 27" high x 19" deep x 30" wide) not provided. <i>As-Built:</i> 12" deep <i>Proposed Solution:</i> Provide table or desk with accessible dimensions when purchasing new furniture. 	PCODE IN02A ADAAG 4.32.3 & .4 ADA 2010 306.1 CBC 2010 1122B.3 & 4 CBC 2013 11B-306.1 & 11B-902.3 Priority 2 Severity 2 TBD Contract Work	1	JOB	\$1,600	\$1,600

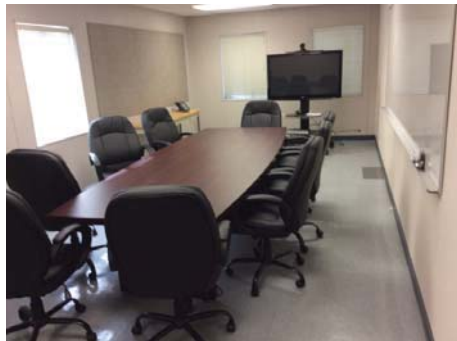
4 EOC Main Room

2713	<ul style="list-style-type: none"> <i>As-Built Description:</i> No portable assistive listening system provided for small meeting room. <i>Proposed Solution:</i> Share existing portable assistive listening system from other facility if needed. 	PCODE GI01E ADAAG 4.1.3(19)(b) & 4.33.7 ADA 2010 219.1 & 706.1 CBC 2010 1104B.2 CBC 2013 11B-219.2 Priority 3 Severity 3 TBD Contract Work	REF

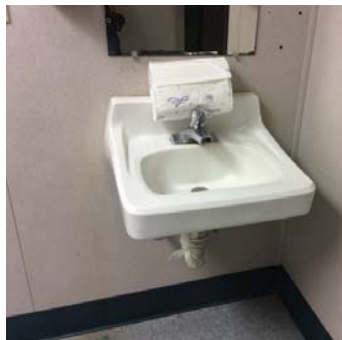
5 Unisex Restroom

2724	<ul style="list-style-type: none"> <i>As-Built Description:</i> Clear floor space, 30" x 48" in front of fixture, extending 19" max. under the lavatory, not provided (CA only: Less than 18" from side wall to centerline of lavatory). <i>As-Built:</i> 17" oc <i>Proposed Solution:</i> Relocate existing lavatory. <i>Notes:</i> provide smaller lav so as not to encroach into to WC clear space of 60" 	PCODE WD01A ADAAG 4.19.3 ADA 2010 606.2 CBC 2010 1115B.4.3 CBC 2013 11B-606.2, 11B-606.6 Priority 3 Severity 2 TBD Contract Work	1	JOB	\$900	\$900

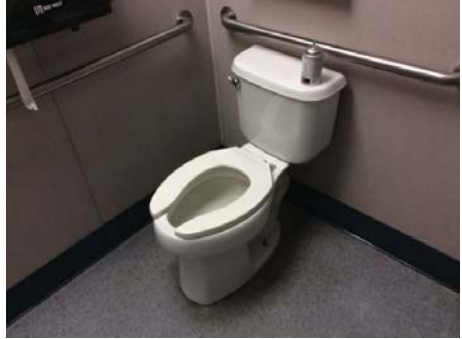
Item No. and Name	Existing Architectural Barrier and Proposed Solution	Codes / Mitigation Info	Qty	Unit	Cost	Total
Water Closet						
2727	<ul style="list-style-type: none"> <i>As-Built Description:</i> Water closet not 17"-18" from near side wall to center line of water closet (2010 ADAS: 16"-18"). <i>As-Built:</i> 18.5" o.c. <i>Proposed Solution:</i> Relocate existing water closet and plumbing, remount with offset closet flange to provide 17"-18" from side wall. 	PCODE WB02C ADAAG Fig. 28 ADA 2010 604.2 CBC 2010 1115B.4.1.1 CBC 2013 11B-604.2 Priority 3 Severity 4 TBD Contract Work	1	JOB	\$500	\$500
