Facility: **WOMENS INFANTS & CHILDREN**

Address: 330 HARRIS ST.

Facility: **LEMORE HEALTH CLINIC**
 Address: 229 C ST.

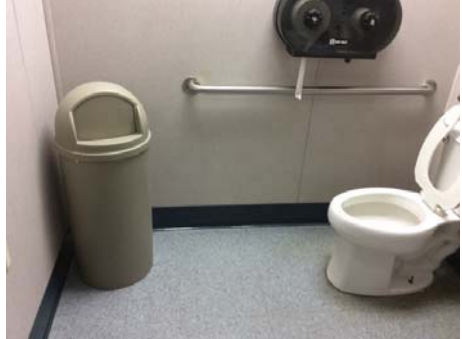
2720	<ul style="list-style-type: none"> <i>As-Built Description:</i> CA only: In single-accommodation restroom less than 48" in front of water closet provided. <i>As-Built:</i> 32" to trash bin <i>Proposed Solution:</i> Remodel restroom to provide at least 48" in front of water closet. <i>Notes:</i> Relocate 	PCODE WB03AREF CBC 2010 1115B.3.2.1 CBC 2013 11B-604.3.1 Priority 3 Severity 2 TBD Contract Work	REF

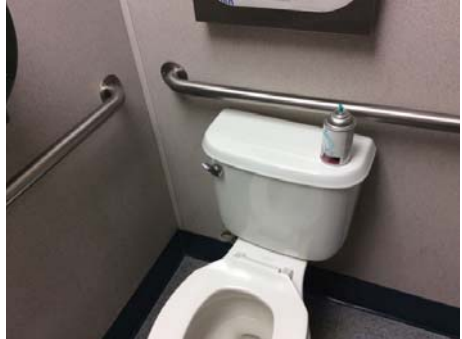
2721	<ul style="list-style-type: none"> <i>As-Built Description:</i> Flush Control: Operating handle not mounted toward wide side of stall. <i>Proposed Solution:</i> Replace flush control with properly mounted accessible type, or install sensor flush. 	PCODE WB10 ADAAG 4.16.5 ADA 2010 604.6 CBC 2010 1115B.4.1.5 CBC 2013 11B-604.6 Priority 3 Severity 3 TBD Contract Work	1	JOB	\$500	\$500

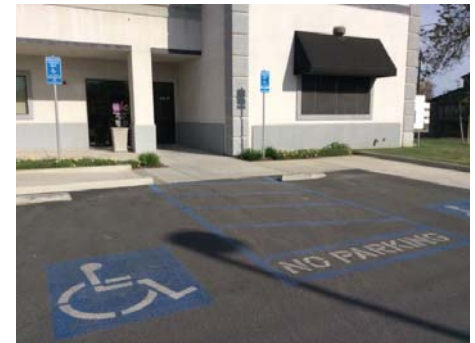
2828	<ul style="list-style-type: none"> <i>As-Built Description:</i> Accessible parking space has slope greater than 1/4":12" (2%). <i>As-Built:</i> 2.3%-3.5% <i>Proposed Solution:</i> Modify slope at accessible parking space. <i>Notes:</i> <p>2 Acc 1 Van 26 tot</p>	<p>PCODE EA05 ADAAG 4.6.3 ADA 2010 502.4 CBC 2010 1129B.3.3 CBC 2013 11B-502.4 Priority 1 Severity 4 TBD Contract Work</p>	468	SF	\$12	\$5,616
------	--	--	-----	----	------	---------

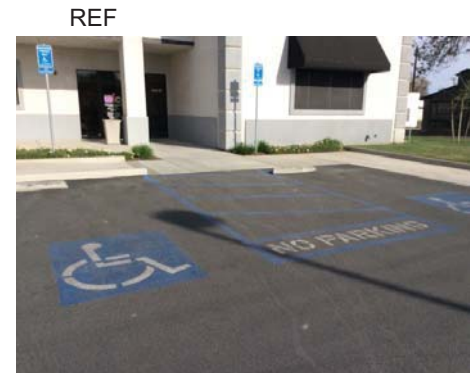
2829	<ul style="list-style-type: none"> <i>As-Built Description:</i> Accessible parking space smaller than 8' wide (CA only: 9' x 18'). <i>As-Built:</i> 17' long <i>Proposed Solution:</i> Modify parking space(s) to create accessible space. 	<p>PCODE EA02AREF ADAAG 4.6.3 ADA 2010 502.2 CBC 2010 1129B.3.1 CBC 2013 11B-502.2 Priority 1 Severity 4 TBD Contract Work</p>				
------	---	--	--	--	--	--

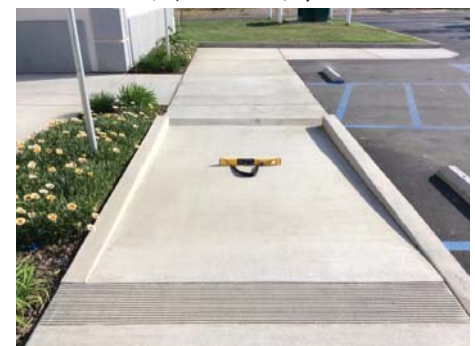
2830	<ul style="list-style-type: none"> <i>As-Built Description:</i> Cross slope greater than 2% <i>As-Built:</i> 2.4-2.9% <i>Proposed Solution:</i> Demolish existing and provide new curb ramp. 	<p>PCODE EH02F ADAAG 4.8.6 ADA 2010 405.3 CBC 2010 1133B.5.3.1 CBC 2013 11B-406.5.7 Priority 1 Severity 4 TBD Contract Work</p>	1	JOB	\$2,500	\$2,500
------	---	---	---	-----	---------	---------

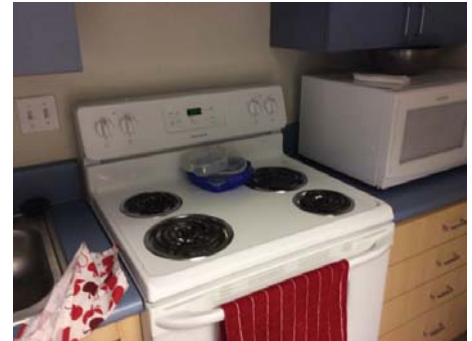
2776	<ul style="list-style-type: none"> As-Built Description: Oven controls are not on front panel of oven. Proposed Solution: Provide oven with accessible controls. Notes: Controls located over burners. 	PCODE KF22 ADAAG 13.3.4(7) ADA 2010 804.6.5.3 CBC 2010 1111B.5.1 CBC 2013 11B-804.6.5.3 Priority 3 Severity 3 TBD Contract Work	1	JOB	\$800	\$800
------	---	--	---	-----	-------	--------------

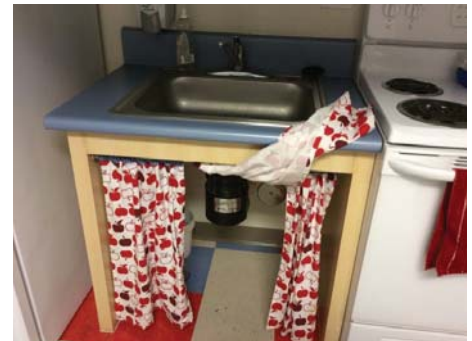
2775	<ul style="list-style-type: none"> As-Built Description: Food waste disposal at kitchen sink protrudes into knee space (recommended: remove equipment if requested as a reasonable accommodation by an employee). Proposed Solution: Remove unit. Notes: Determine if staff only 	PCODE IN06DNT ADAAG 4.24.3 ADA 2010 606.2 CBC 2010 1115B.4.7.1 CBC 2013 11B-606.2 Priority 4 Severity 2 TBD Contract Work	1	JOB	\$300	\$300
------	---	--	---	-----	-------	--------------

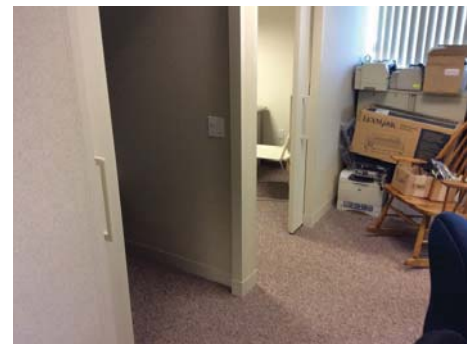
2780	<ul style="list-style-type: none"> As-Built Description: Sliding or folding door: More than 5 lbs force required to open door. As-Built: 8-11 lbs Proposed Solution: Provide new guides and track. Provide opening and patch. Notes: Sliding doors, adjust & maintain. 	PCODE ID20 ADAAG 4.13.11(2) ADA 2010 404.2.9 CBC 2010 1133B.2.5 CBC 2013 11B-404.2.9 Priority 4 Severity 3 TBD Contract Work	4	JOB	\$750	\$3,000
------	---	---	---	-----	-------	----------------

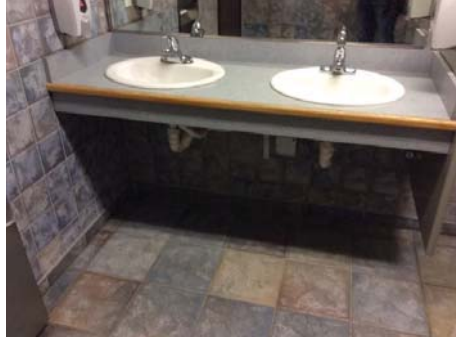
Item No. and Name	Existing Architectural Barrier and Proposed Solution	Codes / Mitigation Info	Qty	Unit	Cost	Total
<u>Lavatory</u>						
2783	<ul style="list-style-type: none"> <i>As-Built Description:</i> Wheelchair clearance under lavatory apron or lavatory counter front edge less than 29" high. <i>As-Built:</i> 28.5"-28.75" <i>Proposed Solution:</i> Provide new accessible lavatory. Remodel restroom as needed. 	PCODE WD03 ADAAG 4.19.2 ADA 2010 606.3 CBC 2010 1115B.4.3.3 CBC 2013 11B-606.3 Priority 3 Severity 3 TBD Contract Work	1	JOB	\$3,400	\$3,400

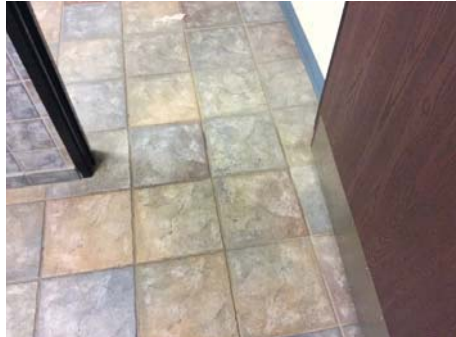
<u>Door Clearance</u>						
2791	<ul style="list-style-type: none"> <i>As-Built Description:</i> Door on accessible route has less than 32" clear and 80" (78" min. to closer if provided) opening width when 90° open. <i>As-Built:</i> Door difficult to open 90 degrees. <i>Proposed Solution:</i> Provide new, larger door and frame with new accessible hardware. 	PCODE ID01 ADAAG 4.13.5 ADA 2010 404.2.3 CBC 2010 1133B.1.1.1.1 CBC 2013 11B-404.2.3 Priority 3 Severity 4 TBD Contract Work	1	JOB	\$2,600	\$2,600

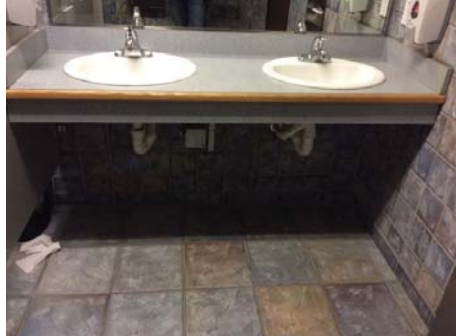
<u>Lavatory</u>						
2792	<ul style="list-style-type: none"> <i>As-Built Description:</i> Wheelchair clearance under lavatory apron or lavatory counter front edge less than 29" high. <i>As-Built:</i> Left 28.75" Right 29" <i>Proposed Solution:</i> Provide new accessible lavatory. Remodel restroom as needed. 	PCODE WD03REF ADAAG 4.19.2 ADA 2010 606.3 CBC 2010 1115B.4.3.3 CBC 2013 11B-606.3 Priority 3 Severity 3 TBD Contract Work	REF

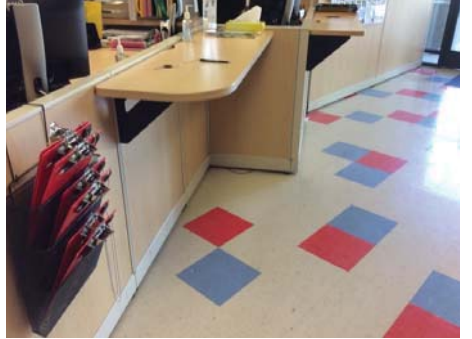
Item No. and Name	Existing Architectural Barrier and Proposed Solution	Codes / Mitigation Info	Qty	Unit	Cost	Total
Public Counter						
2804	<ul style="list-style-type: none"> <i>As-Built Description:</i> Service counter (stand-up): Accessible section min. 36" length and 36" max. height (in CA: 28" to 34" high) not provided. <i>As-Built:</i> 40" <i>Proposed Solution:</i> Provide auxiliary shelf, clipboard, or table as equivalent facilitation. <i>Notes:</i> Additional nearby room provided with lower counter desk. Also clipboards provided. 	PCODE IN03 ADAAG 7.2(2) ADA 2010 904.4 CBC 2010 1122B.4 CBC 2013 11B-904.4 Priority 1 Severity 3 TBD Contract Work	1	JOB	\$150	\$150

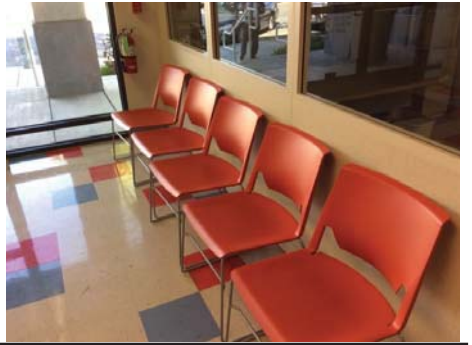
Seating						
2806	<ul style="list-style-type: none"> <i>As-Built Description:</i> Clear floor or ground space (30" x 48") not overlapping with other clear space requirements, is not provided at at least one end of the bench. <i>Proposed Solution:</i> Relocate one chair. 	PCODE NO07NT ADAAG 16.12.4 ADA 2010 903.2 CBC 2010 1132B.1 CBC 2013 11B-903.2 Priority 2 Severity 2 TBD Contract Work	1	JOB	\$50	\$50

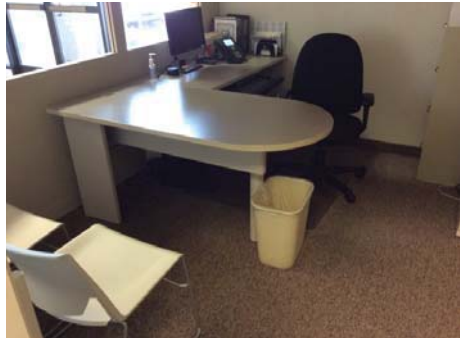
Non-Fixed Desk						
2811	<ul style="list-style-type: none"> <i>As-Built Description:</i> Accessible non-fixed table or desk (top 28" to 34" high; knee space at least 27" high x 19" deep x 30" wide) not provided. <i>As-Built:</i> 9.75" deep <i>Proposed Solution:</i> Provide table or desk with accessible dimensions when purchasing new furniture. 	PCODE IN02A ADAAG 4.32.3 & .4 ADA 2010 306.1 CBC 2010 1122B.3 & 4 CBC 2013 11B-306.1 & 11B-902.3 Priority 2 Severity 2 TBD Contract Work	1	JOB	\$1,600	\$1,600

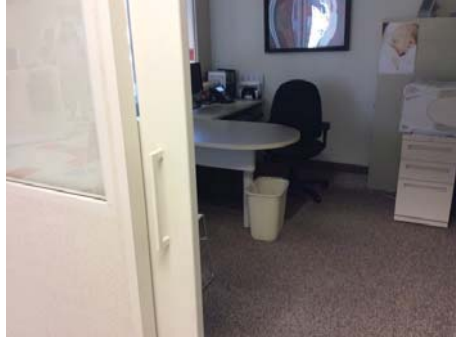
Item No. and Name	Existing Architectural Barrier and Proposed Solution	Codes / Mitigation Info	Qty	Unit	Cost	Total
<u>Sliding/Folding Door</u>						
2812	<ul style="list-style-type: none"> • <i>As-Built Description:</i> Sliding or folding door: More than 5 lbs force required to open door. • <i>As-Built:</i> 7 lbs • <i>Proposed Solution:</i> Provide new guides and track. Provide opening and patch. • <i>Notes:</i> Maintain .adjust costs on others 	PCODE ID20 ADAAG 4.13.11(2) ADA 2010 404.2.9 CBC 2010 1133B.2.5 CBC 2013 11B-404.2.9 Priority 2 Severity 4 TBD Contract Work	1	JOB	\$75	\$75

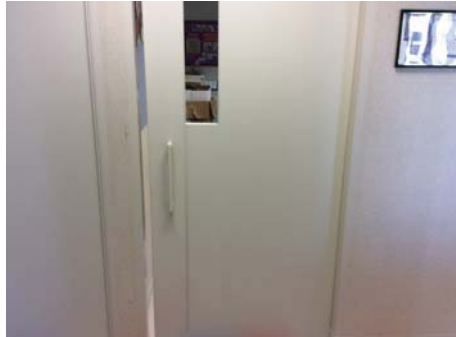
<u>Sliding/Folding Door</u>						
2814	<ul style="list-style-type: none"> • <i>As-Built Description:</i> Sliding or folding door: More than 5 lbs force required to open door. • <i>As-Built:</i> 9 lbs • <i>Proposed Solution:</i> Provide new guides and track. Provide opening and patch. 	PCODE ID20 ADAAG 4.13.11(2) ADA 2010 404.2.9 CBC 2010 1133B.2.5 CBC 2013 11B-404.2.9 Priority 4 Severity 4 TBD Contract Work	1	JOB	\$750	\$750

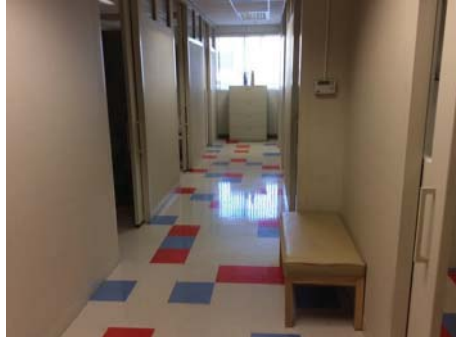
<u>Sliding/Folding Door</u>						
2817	<ul style="list-style-type: none"> • <i>As-Built Description:</i> Sliding or folding door: More than 5 lbs force required to open door. • <i>As-Built:</i> 8-10 lbs • <i>Proposed Solution:</i> Provide new guides and track. Provide opening and patch. • <i>Notes:</i> Adjust 	PCODE ID20 ADAAG 4.13.11(2) ADA 2010 404.2.9 CBC 2010 1133B.2.5 CBC 2013 11B-404.2.9 Priority 2 Severity 4 TBD Contract Work	8	JOB	\$750	\$6,000

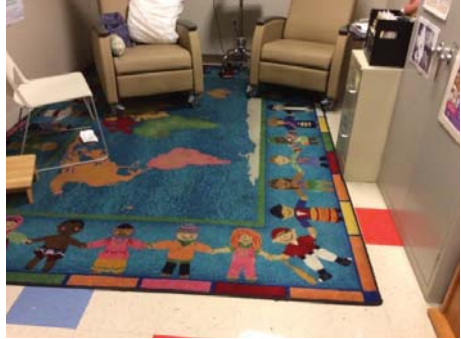
Item No. and Name	Existing Architectural Barrier and Proposed Solution	Codes / Mitigation Info	Qty	Unit	Cost	Total
<u>Carpet</u>						
2821	<ul style="list-style-type: none"> <i>As-Built Description:</i> Carpet or carpet tile is not securely attached to the floor surface. <i>Proposed Solution:</i> Attach carpet or carpet tile securely to floor. <i>Notes:</i> Attach corners 	PCODE IM01A ADAAG 4.5.3 ADA 2010 302.2 CBC 2010 1124B.3 CBC 2013 11B-302.2 Priority 2 Severity 3 TBD Contract Work	10	SF	\$4	\$40

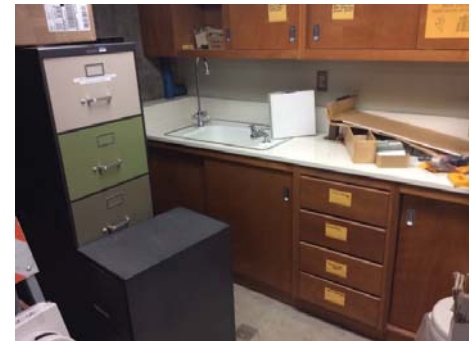
- 3086
- *As-Built Description:*
 Sink does not have knee space min. 27" high x 19" deep x 30" wide.
 - *As-Built:* Top 36" AFF
 - *Proposed Solution:*
 Remodel sink cabinet.

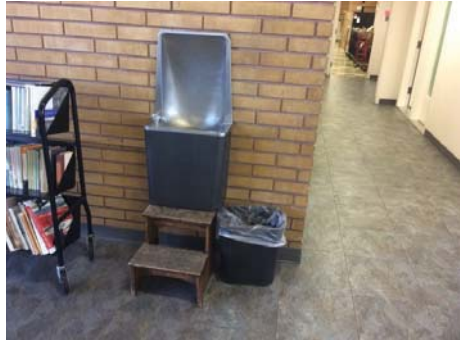
<p>2974</p> <ul style="list-style-type: none"> <i>As-Built Description:</i> Where only one drinking fountain is provided per floor: Fountain is not accessible to individuals who use wheelchairs, or to those who have difficulty bending or stooping. <i>Proposed Solution:</i> Provide additional fountain or hi-lo combination fountain. 	<p>PCODE IA01A ADAAG 4.1.3(10)(a) ADA 2010 211.1 CBC 2010 1115B.4.6.1 CBC 2013 11B-211.1 Priority 3 Severity 2 TBD Contract Work</p>	<p>1 JOB \$2,000 \$2,000</p>

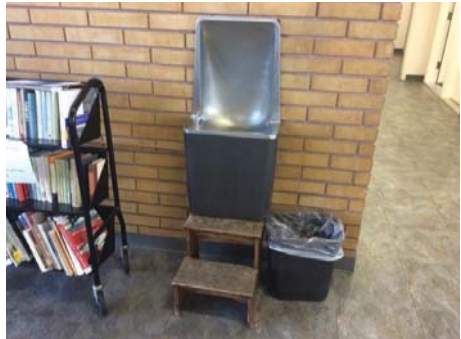
<p>2973</p> <ul style="list-style-type: none"> <i>As-Built Description:</i> Wall- and post-mounted cantilevered units: Knee space not provided at drinking fountain (27" high, 8" deep, 30" wide from front of drinking fountain). <i>Proposed Solution:</i> Provide new, accessible fountain. 	<p>PCODE IA02 ADAAG 4.15.5(1) ADA 2010 602.2 CBC 2010 1115B.4.6.2 CBC 2013 11B-602.2 Priority 3 Severity 2 TBD Contract Work</p>	<p>1 JOB \$3,200 \$3,200</p>

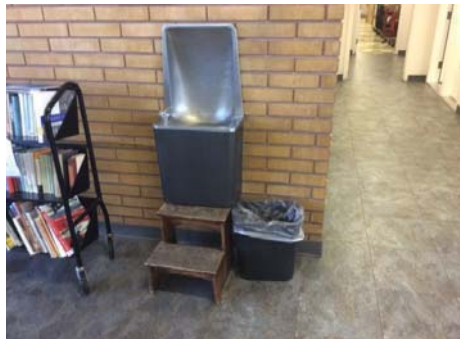
<p>2975</p> <ul style="list-style-type: none"> <i>As-Built Description:</i> CA only: Drinking fountain not located in an alcove (min. 32" wide x 18" deep) or otherwise encroaches into pedestrian way. <i>Proposed Solution:</i> Provide new alcove for drinking fountain, or, if unreasonable hardship is determined, provide wing walls or cane-detectable railings on each side of the drinking fountain. The wings must project out from the supporting wall at least as far as the drinking fountain to within 6" of the surface of the circulation path, but cannot reduce the required clear width of the adjacent accessible route. 	<p>PCODE IA04 CBC 2010 1115B.4.6.3; Fig. CBC 2013 11B-602.9 Priority 3 Severity 2 TBD Contract Work</p>	<p>1 JOB \$3,000 \$3,000</p>

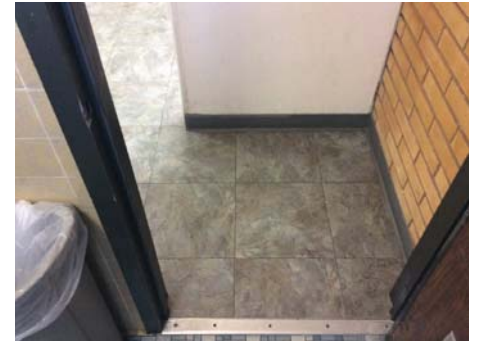
- 3001
- *As-Built Description:*
 Latch approach: At push side, door does not have clear and level maneuvering space measuring door width plus 24" (starting at hinge) x 42", or 48" if door has closer (CA only: door width plus 24" x 44").
 - *As-Built:* 36"
 - *Proposed Solution:*
 Provide relocated new door and frame; remodel walls as needed.

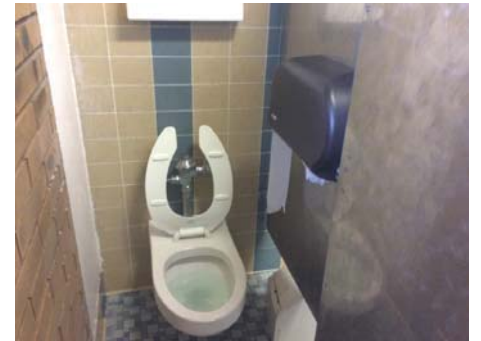
- 3012
- *As-Built Description:*
 Grab bars not provided or are not code compliant.
 - *Proposed Solution:*
 Provide accessible grab bars.

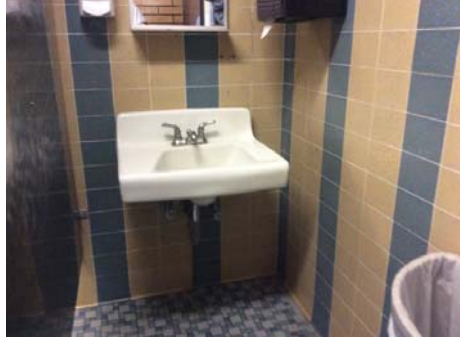
Item No. and Name	Existing Architectural Barrier and Proposed Solution	Codes / Mitigation Info	Qty	Unit	Cost	Total
<u>Lavatory</u>						
3008	<ul style="list-style-type: none"> <i>As-Built Description:</i> Knee clearance 27" min. high starting 8" back from the front edge of the lavatory towards the wall is not provided. <i>As-Built:</i> 24.5" <i>Proposed Solution:</i> Provide new accessible lavatory. Remodel restroom as needed. 	PCODE WD04REF ADAAG Fig. 31 ADA 2010 606.3 CBC 2010 1115B.4.3 CBC 2013 11B-306.3.3 Priority 3 Severity 2 TBD Contract Work				
						REF

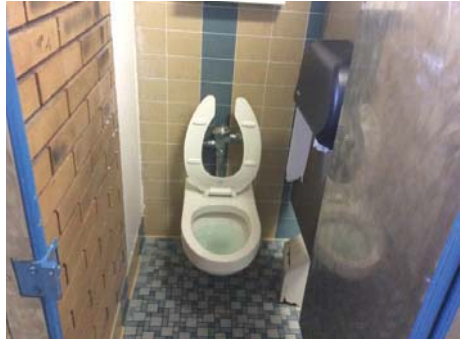
<u>Toilet Stall</u>						
3010	<ul style="list-style-type: none"> <i>As-Built Description:</i> Toilet stall less than 60" wide. <i>As-Built:</i> 31.5" <i>Proposed Solution:</i> Provide new accessible stall (alternate stalls 36" x 69" or 48" x 69" not recommended). 	PCODE WB06REF ADAAG 4.17.3 ADA 2010 604.8.1.1 CBC 2010 1115B.3.1.4.1 CBC 2013 11B-604.8.1.1 Priority 3 Severity 1 TBD Contract Work				
						REF

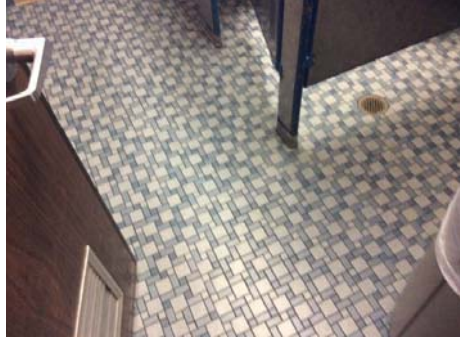
Item No. and Name	Existing Architectural Barrier and Proposed Solution	Codes / Mitigation Info	Qty	Unit	Cost	Total
<u>Turning Space</u>						
3004	<ul style="list-style-type: none"> <i>As-Built Description:</i> Wheelchair clearance: Clear space, floor to 27" high with a diameter of 60", not provided (space 56" x 63" acceptable). <i>As-Built:</i> 46.5" <i>Proposed Solution:</i> Provide wheelchair clearance space in restroom. 	PCODE WC01REF ADAAG 4.22.3 ADA 2010 603.2.1 CBC 2010 1115B.3.2 CBC 2013 11B-603.2.1; 11B-304.3 Priority 3 Severity 2 TBD Contract Work				REF

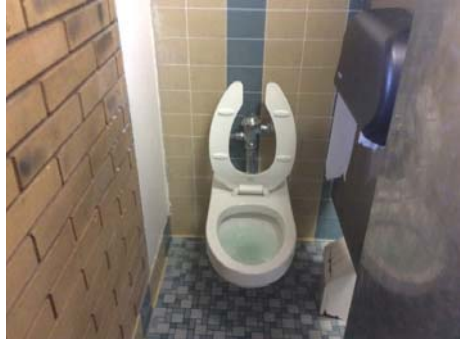
<u>Water Closet</u>						
3011	<ul style="list-style-type: none"> <i>As-Built Description:</i> Flush Control: Operating handle not mounted toward wide side of stall. <i>Proposed Solution:</i> Replace flush control with properly mounted accessible type, or install sensor flush. 	PCODE WB10REF ADAAG 4.16.5 ADA 2010 604.6 CBC 2010 1115B.4.1.5 CBC 2013 11B-604.6 Priority 3 Severity 3 TBD Contract Work				REF

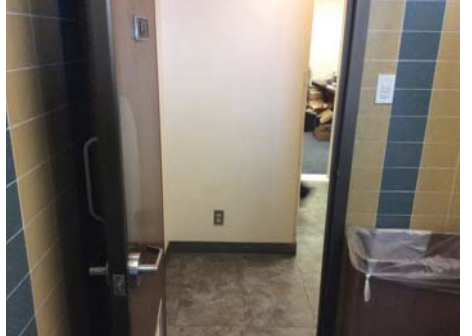
<u>Door Clearance</u>						
3021	<ul style="list-style-type: none"> <i>As-Built Description:</i> Door on accessible route has less than 32" clear and 80" (78" min. to closer if provided) opening width when 90° open. <i>As-Built:</i> 29" <i>Proposed Solution:</i> Provide new, larger door and frame with new accessible hardware. 	PCODE ID01REF ADAAG 4.13.5 ADA 2010 404.2.3 CBC 2010 1133B.1.1.1.1 CBC 2013 11B-404.2.3 Priority 3 Severity 3 TBD Contract Work				REF

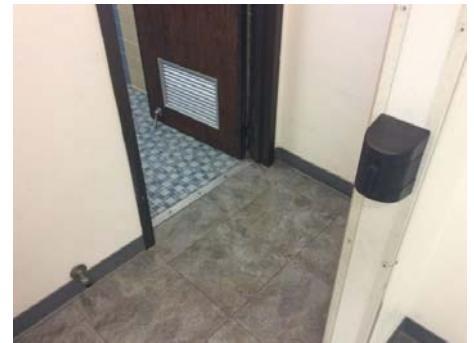
- 3020
- *As-Built Description:*
 Latch approach: At push side, door does not have clear and level maneuvering space measuring door width plus 24" (starting at hinge) x 42", or 48" if door has closer (CA only: door width plus 24" x 44").
 - *As-Built:* 36"
 - *Proposed Solution:*
 Provide relocated new door and frame; remodel walls as needed.

PCODE ID28BREF
 ADAAG Fig. 25(c)
 ADA 2010 404.2.4
 CBC 2010 11B-26A(c)
 CBC 2013 11B-404.2.4
 Priority 3
 Severity 3
 TBD Contract Work

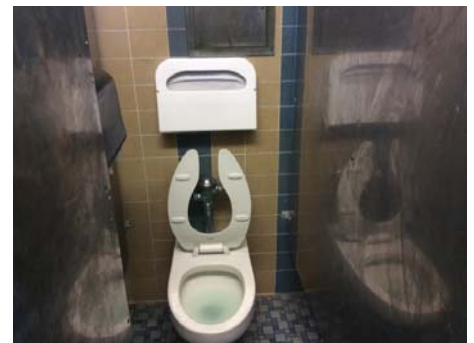
- 3030
- *As-Built Description:*
 Grab bars not provided or are not code compliant.
 - *Proposed Solution:*
 Provide accessible grab bars.

PCODE WB07REF
 ADAAG 4.17.6
 ADA 2010 604.5
 CBC 2010 1115B.4.1.3
 CBC 2013 11B-604.5
 Priority 3
 Severity 3
 TBD Contract Work

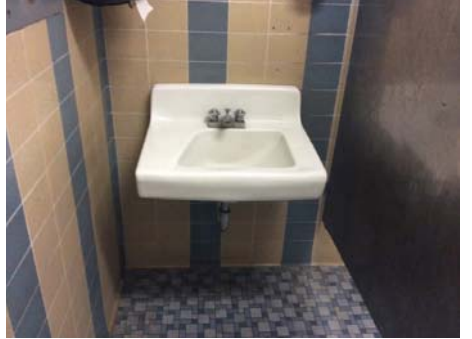
Item No. and Name	Existing Architectural Barrier and Proposed Solution	Codes / Mitigation Info	Qty	Unit	Cost	Total
<u>Lavatory</u>						
3022	<ul style="list-style-type: none"> <i>As-Built Description:</i> Knee clearance 27" min. high starting 8" back from the front edge of the lavatory towards the wall is not provided. <i>As-Built:</i> 25" <i>Proposed Solution:</i> Provide new accessible lavatory. Remodel restroom as needed. 	PCODE WD04REF ADAAG Fig. 31 ADA 2010 606.3 CBC 2010 1115B.4.3 CBC 2013 11B-306.3.3 Priority 3 Severity 2 TBD Contract Work				
						REF

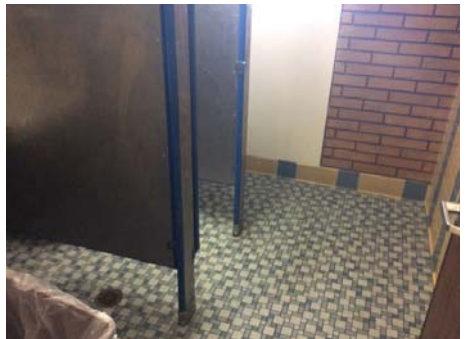
<u>Restroom</u>						
3017	<ul style="list-style-type: none"> <i>As-Built Description:</i> Multiple accommodation restroom not accessible; multiple compliance violations. <i>Proposed Solution:</i> Remodel area to provide accessible restroom with one accessible stall, lavatory (and one urinal at Mens). 	PCODE WA01A ADAAG 4.22 ADA 2010 603 CBC 2010 1115B.3.1 CBC 2013 11B-603 Priority 3 Severity 1 TBD Contract Work	1	JOB	\$35,000	\$35,000

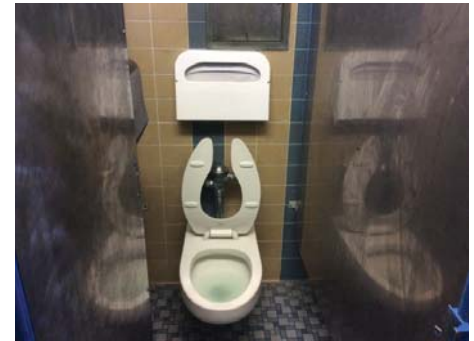
- 3029
- *As-Built Description:*
Toilet stall less than 60" wide.
 - *As-Built:* 31"
 - *Proposed Solution:*
Provide new accessible stall (alternate stalls 36" x 69" or 48" x 69" not recommended).

PCODE **WB06REF**
 ADAAG **4.17.3**
 ADA 2010 **604.8.1.1**
 CBC 2010 **1115B.3.1.4.1**
 CBC 2013 **11B-604.8.1.1**
 Priority **3**
 Severity **1**
 TBD Contract Work

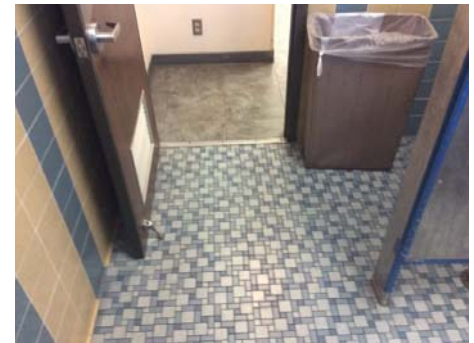
- 3027
- *As-Built Description:*
Wheelchair clearance: Clear space, floor to 27" high with a diameter of 60", not provided (space 56" x 63" acceptable).
 - *As-Built:* 44"
 - *Proposed Solution:*
Provide wheelchair clearance space in restroom.

PCODE **WC01**
 ADAAG **4.22.3**
 ADA 2010 **603.2.1**
 CBC 2010 **1115B.3.1**
 CBC 2013 **11B-603.2.1; 11B-304.3**
 Priority **3**
 Severity **2**
 TBD Contract Work

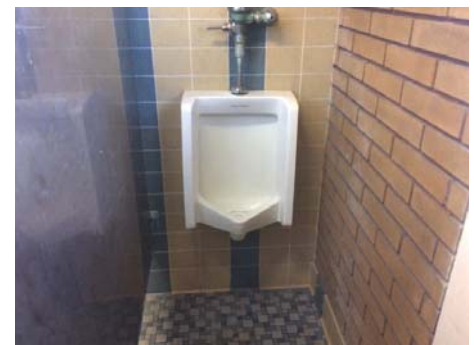
- 3031
- *As-Built Description:*
CA only: Front of rim projects less than 13.5" from wall.
 - *As-Built:* 12.5"
 - *Proposed Solution:*
Provide accessible urinal. Remodel restroom as needed.

PCODE **WE01REF**
 ADA 2010 **605.2**
 CBC 2010 **1115B.4.2.1**
 CBC 2013 **11B-605.2**
 Priority **3**
 Severity **4**
 TBD Contract Work

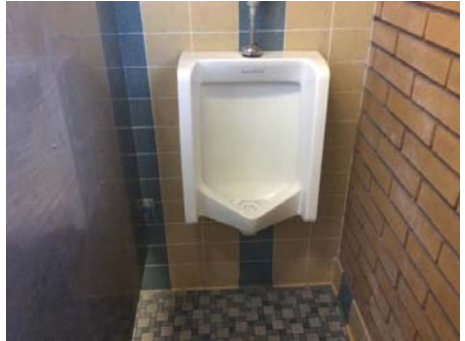
Item No. and Name	Existing Architectural Barrier and Proposed Solution	Codes / Mitigation Info	Qty	Unit	Cost	Total
3032	<ul style="list-style-type: none"> • <i>As-Built Description:</i> Fixture mounted with rim more than 17" above floor. • <i>As-Built:</i> 24" • <i>Proposed Solution:</i> Provide accessible urinal. Remodel restroom as needed. 	PCODE WE02REF ADAAG 4.18.2 ADA 2010 605.2 CBC 2010 1115B.4.2.1 CBC 2013 11B-605.2 Priority 3 Severity 2 TBD Contract Work				
						REF

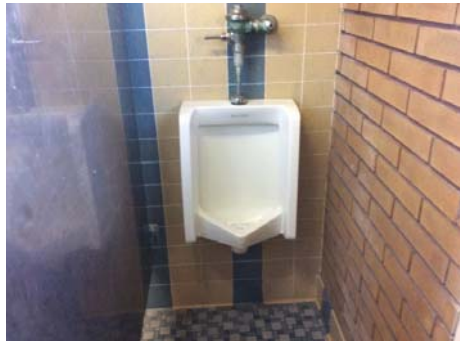
3033	<ul style="list-style-type: none"> • <i>As-Built Description:</i> 36" wide clearance in front of accessible urinal not provided when walls or partitions project more than 24" from the front edge of 30" x 48" clear space. • <i>As-Built:</i> 31" • <i>Proposed Solution:</i> Provide 36" clear floor space in front of accessible urinal. Remodel restroom as needed. 	PCODE WE04AREF ADAAG 4.18.3 ADA 2010 605.3 CBC 2010 1115B.4.2.3 CBC 2013 11B-605.3 Priority 3 Severity 2 TBD Contract Work

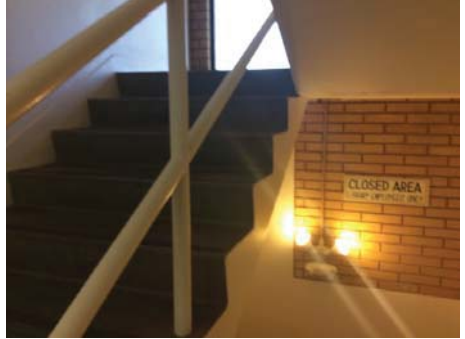
Item No. and Name	Existing Architectural Barrier and Proposed Solution	Codes / Mitigation Info	Qty	Unit	Cost	Total
<u>Handrail</u>						
3039	<ul style="list-style-type: none"> <i>As-Built Description:</i> Open guards does not have balusters or ornamental patterns such that a 4-inch-diameter (102 mm) sphere cannot pass through any opening. <i>As-Built:</i> 13" <i>Proposed Solution:</i> Provide new guards which do not allow passage of an 4 inch sphere at any opening. 	PCODE ED08A ADA 2010 405.9.2 CBC 2010 1013.3 CBC 2013 11B-405.9.2 Priority 4 Severity 2 TBD Contract Work	40	LF	\$120	\$4,800

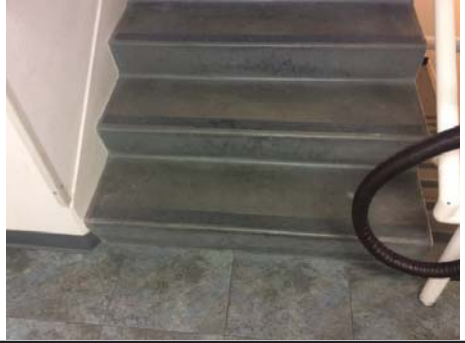
<u>Stairway</u>						
3038	<ul style="list-style-type: none"> <i>As-Built Description:</i> The leading 2" of the tread does not have visual contrast of dark-on-light or light-on-dark from the remainder of the tread. <i>Proposed Solution:</i> Provide 2" wide contrasting color strip 1" max. from nosing on top & bottom treads when altering area. 	PCODE I102B ADA 2010 504.4 CBC 2010 1133B.4.4 CBC 2013 11B-504.4.1 Priority 4 Severity 3 TBD Contract Work	32	LF	\$14	\$448

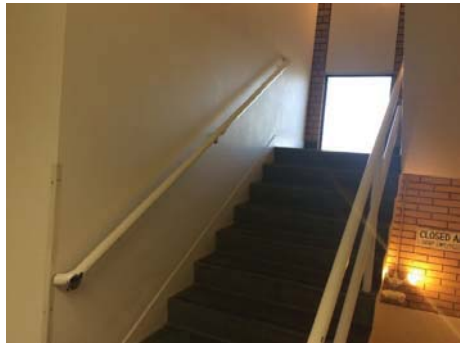
<u>Top & Bottom Extension at Stairs</u>						
3040	<ul style="list-style-type: none"> <i>As-Built Description:</i> Stair handrail does not extend horizontally 12" minimum beyond top nosing, and one tread width sloped, plus 12" minimum horizontally beyond the bottom nosing. <i>Proposed Solution:</i> Extend stair handrail at top and bottom (cost for each extension piece). 	PCODE ED06 ADAAG 4.9.4(2) ADA 2010 505.10.2; 505.10.3 CBC 2010 1133B.4.2.2 CBC 2013 11B-505.10.2; 11B-505.10.3 Priority 4 Severity 2 TBD Contract Work	10	JOB	\$170	\$1,700
