Triangle Courtyard: Takeover Agreement Amendment

Presented to Kings County Board of Supervisors
February 27, 2024

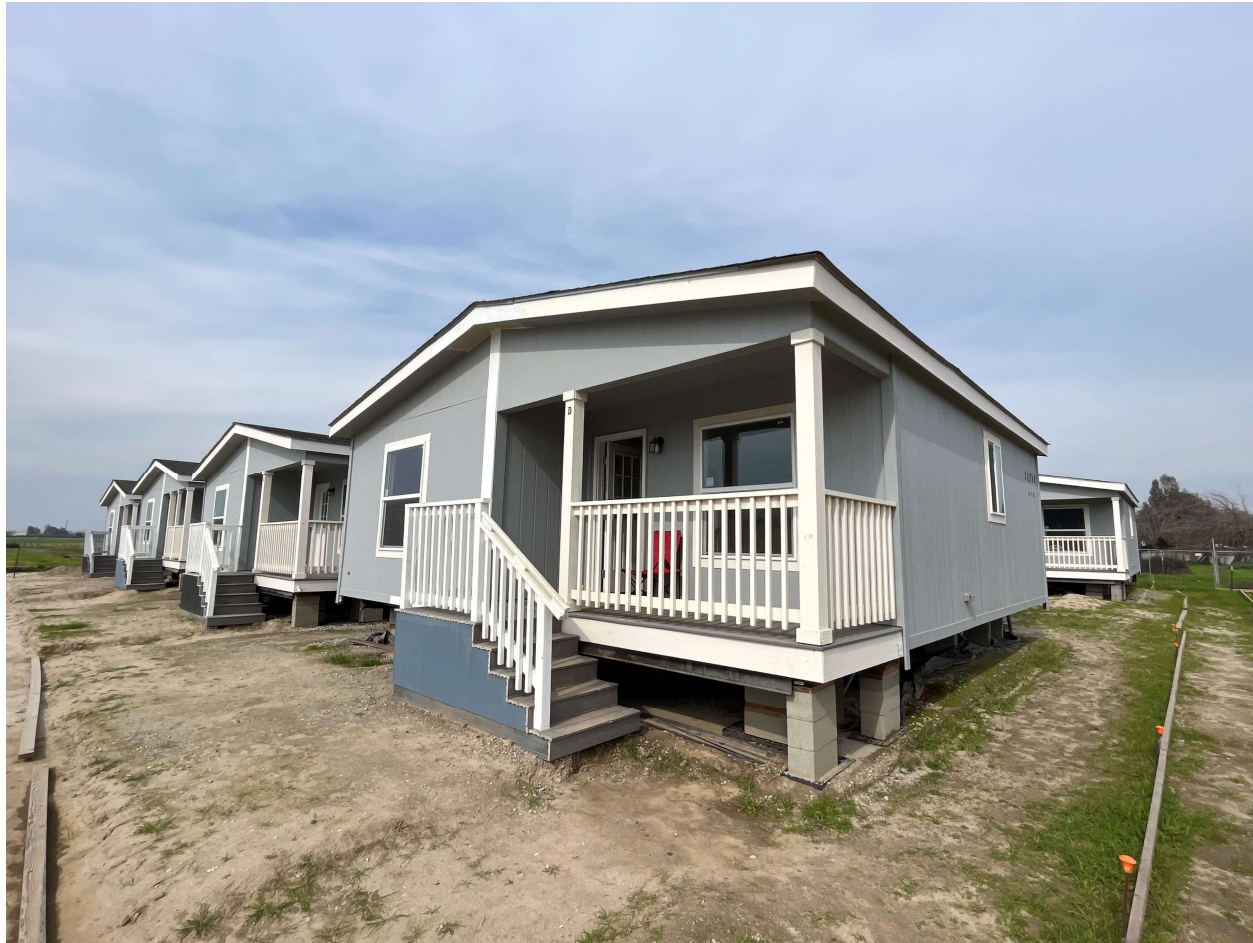
- j. Water and sewer connections to all 20 units and mains were completed and tested.
- k. Installed all interior doors.
- l. Fire Marshall discrepancies were discovered in November 2023 when the Fire Marshall inspected the Fire Main located inside the property; this work was performed in early 2022 by Grizzly (subcontractor of GGB). The work was not inspected prior to trenches being closed and no documentation of inspection exists. This required holes to be dug to verify thrust blocks, connections, joints, and type of pipe. This was completed in January 2024.
